MINUTE MAN NATIONAL HISTORICAL PARK
JOHN NELSON HOUSE & BARN

HISTORIC STRUCTURE ASSESSMENT REPORT

NOVEMBER 2008

PREPARED BY:
JOHN MILNER ARCHITECTS, INC.
CHADDS FORD, PA

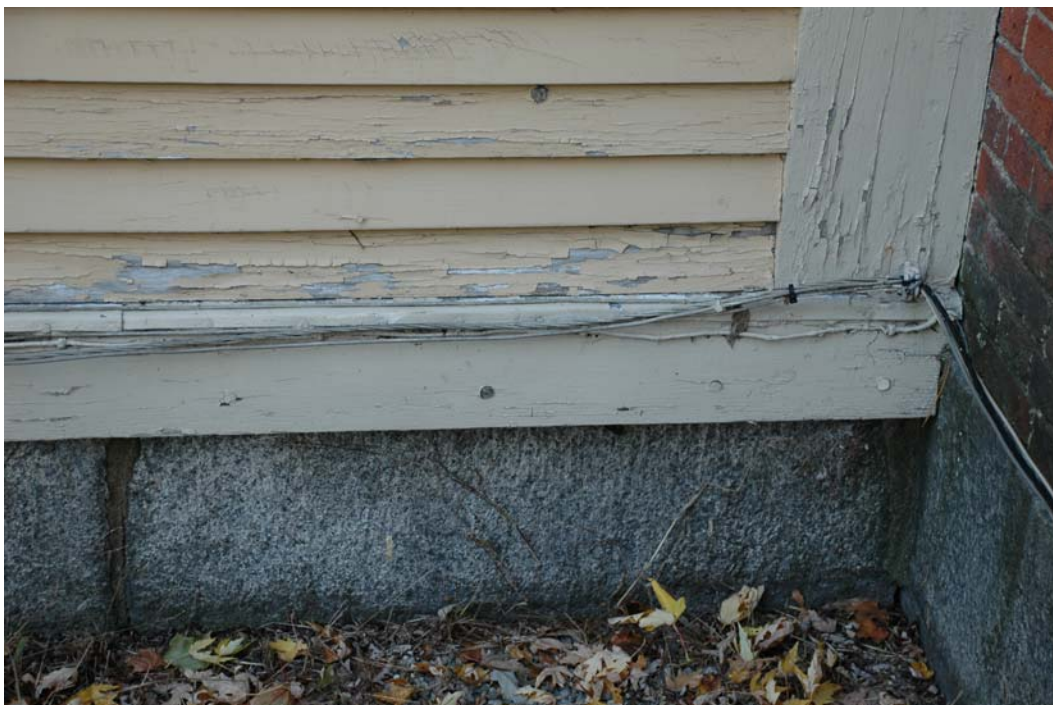
- The exposed portions of the south elevation foundation walls at the northwest wing and main block are composed of dressed ashlar granite blocks [fig. SE-6]. The south elevation of the northeast wing foundation wall is granite block for approximately 3'-0" from the west corner and is formed concrete for the remainder of the south elevation [fig. SE-13]. The foundation walls below grade, where observable, are random rubble fieldstone [fig. SE-6].
- Pointing mortar at the granite block joints is hard (cement-based) and is chipped, shrunken and missing in areas.

- Generally, the wood clapboards are in fair condition with localized areas of severe wood rot, warped and split boards. Areas closest to the foundation wall and surrounding the windows and doors appear to have the most deterioration. The paint finish is poor with extensive cracking and peeling [figs. SE-6 & SE-8].

Figure SE-6. South Elevation foundation wall at northwest wing where it meets the main block, showing condition of granite foundation wall, mortar, apron board, siding and corner board.

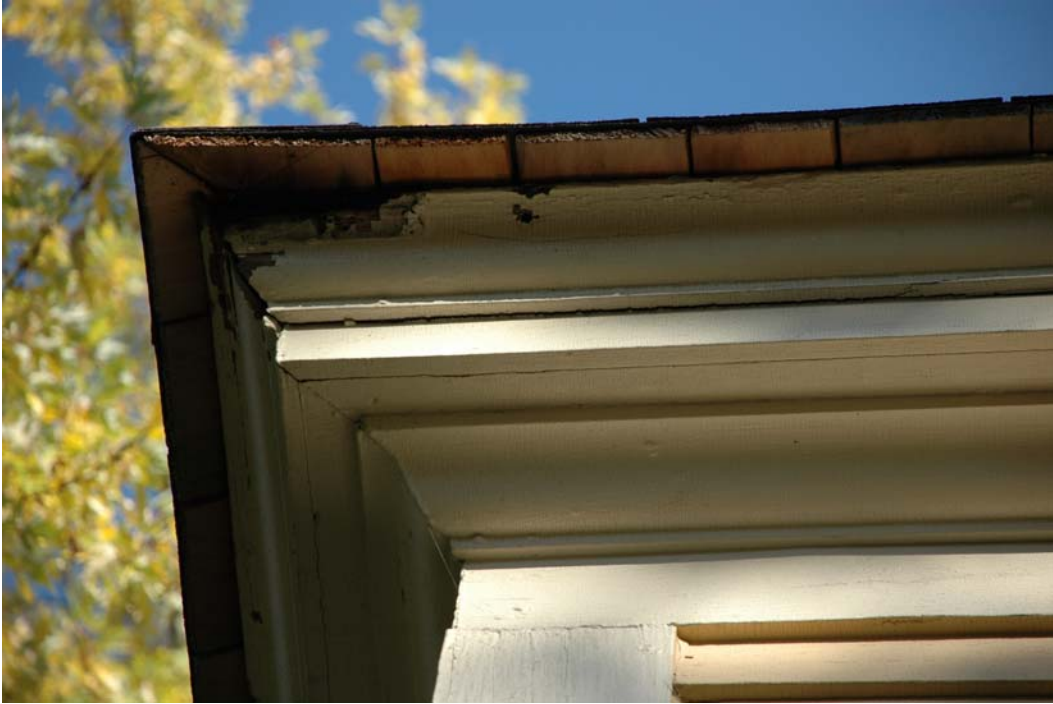
Figure SE-7. Roof cornice condition at southwest corner of northwest wing. Also note wood shingle drip course.

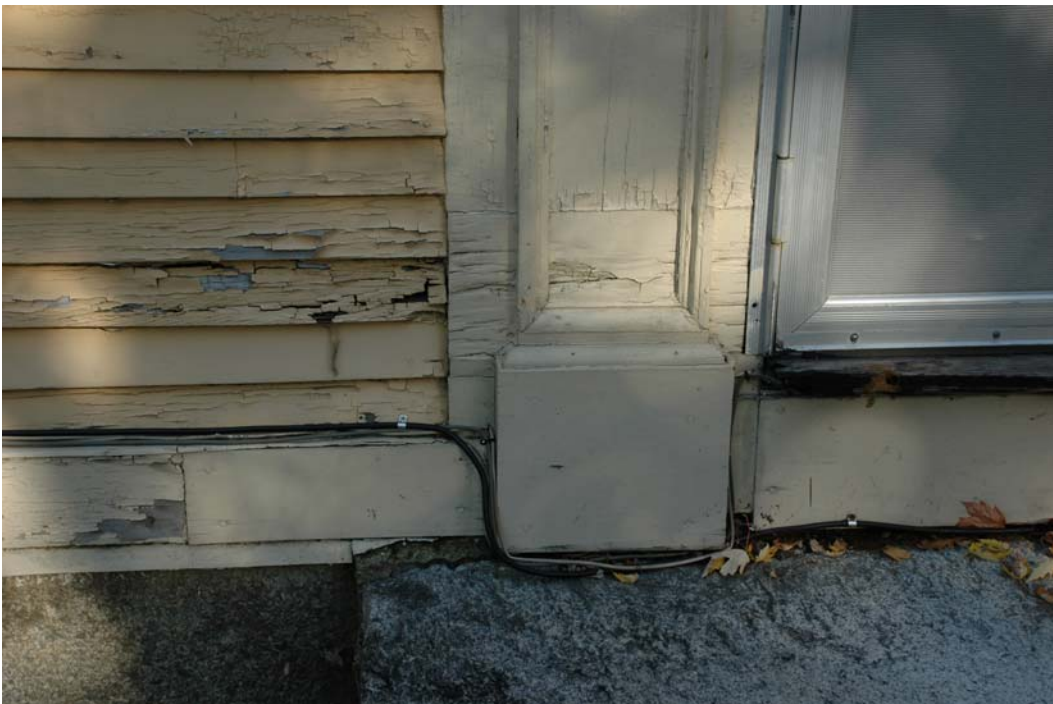
Figure SE-8. Condition of sill, pilaster, wood siding and apron board at Door 1/105.

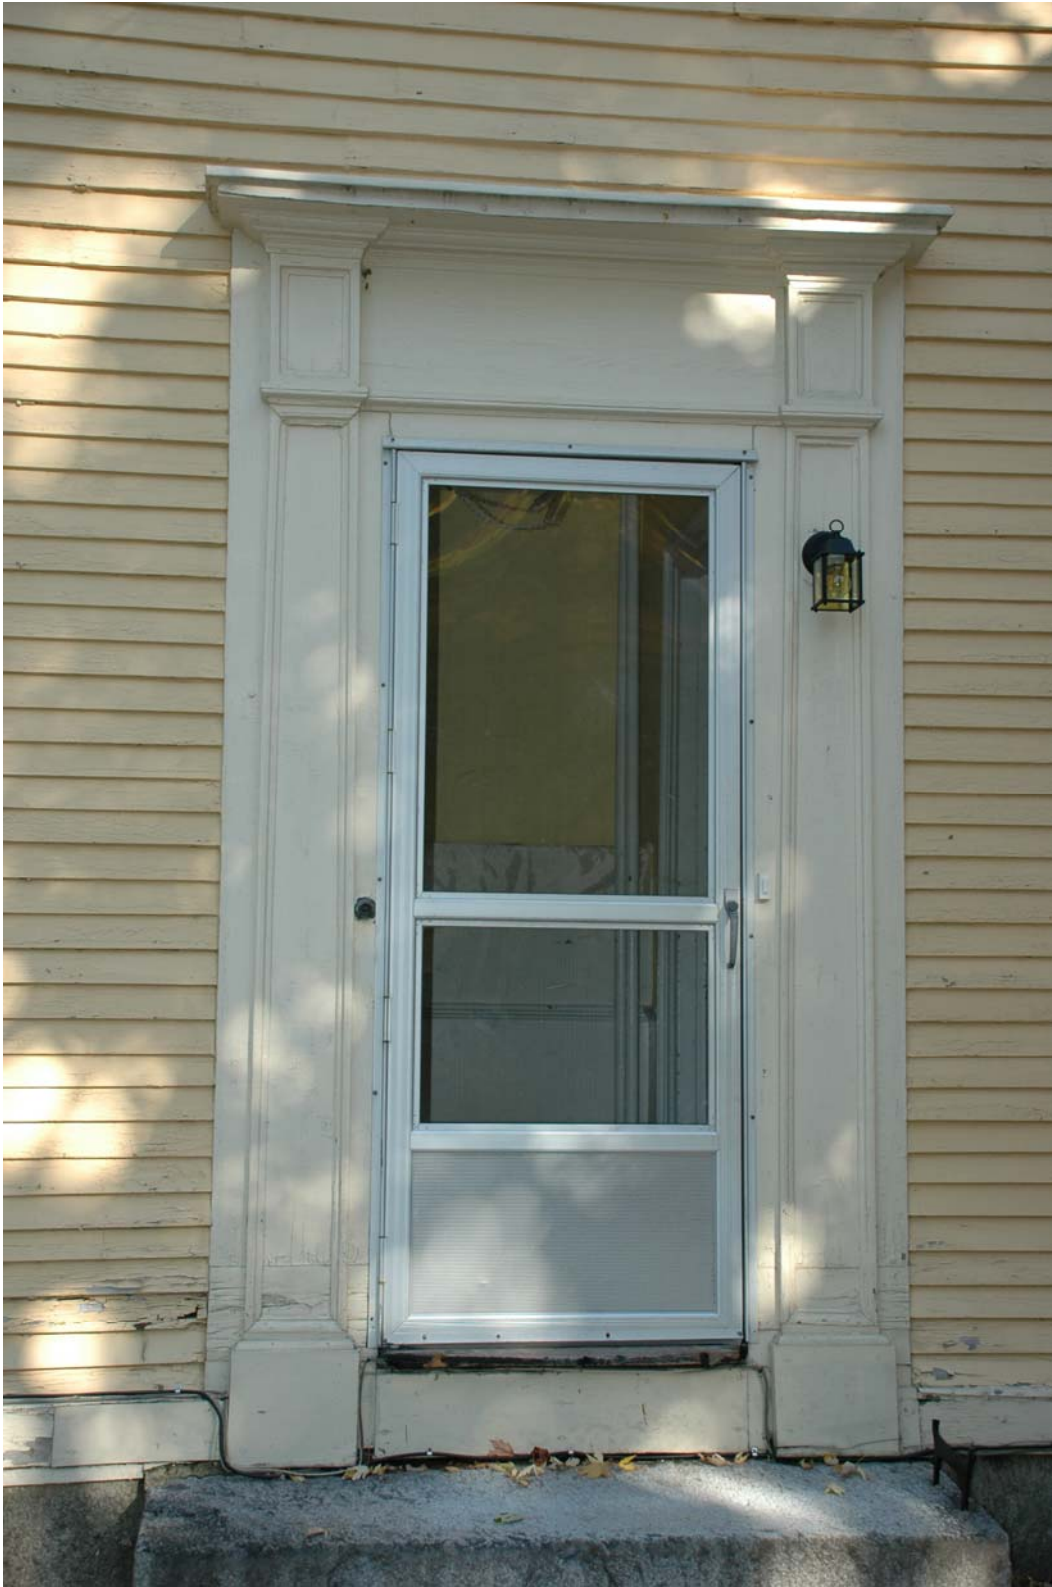
- The decorative wood door surround appears to be original to the northwest wing. The surround is designed with simple pilasters flanking each side with a flat frieze board and a projecting cornice. The surround is in fair condition with some areas of rot and decay near the base. The lower portion of the surround appears to have been repaired with replacement boards along the bottom 1'-6". The wood sill is extremely deteriorated from rot and insect infestation. The painted finish is generally cracked and peeling [fig. SE-8].
- A modern aluminum screen door is installed on the exterior.
- The wood door leaf is 6-panel with lights in place of panels at the top, and it appears to be original.
- Two granite slabs serve as stair risers and treads. There are no railings.

Figure SE-9. Door 1/105 – entrance to the northwest wing.

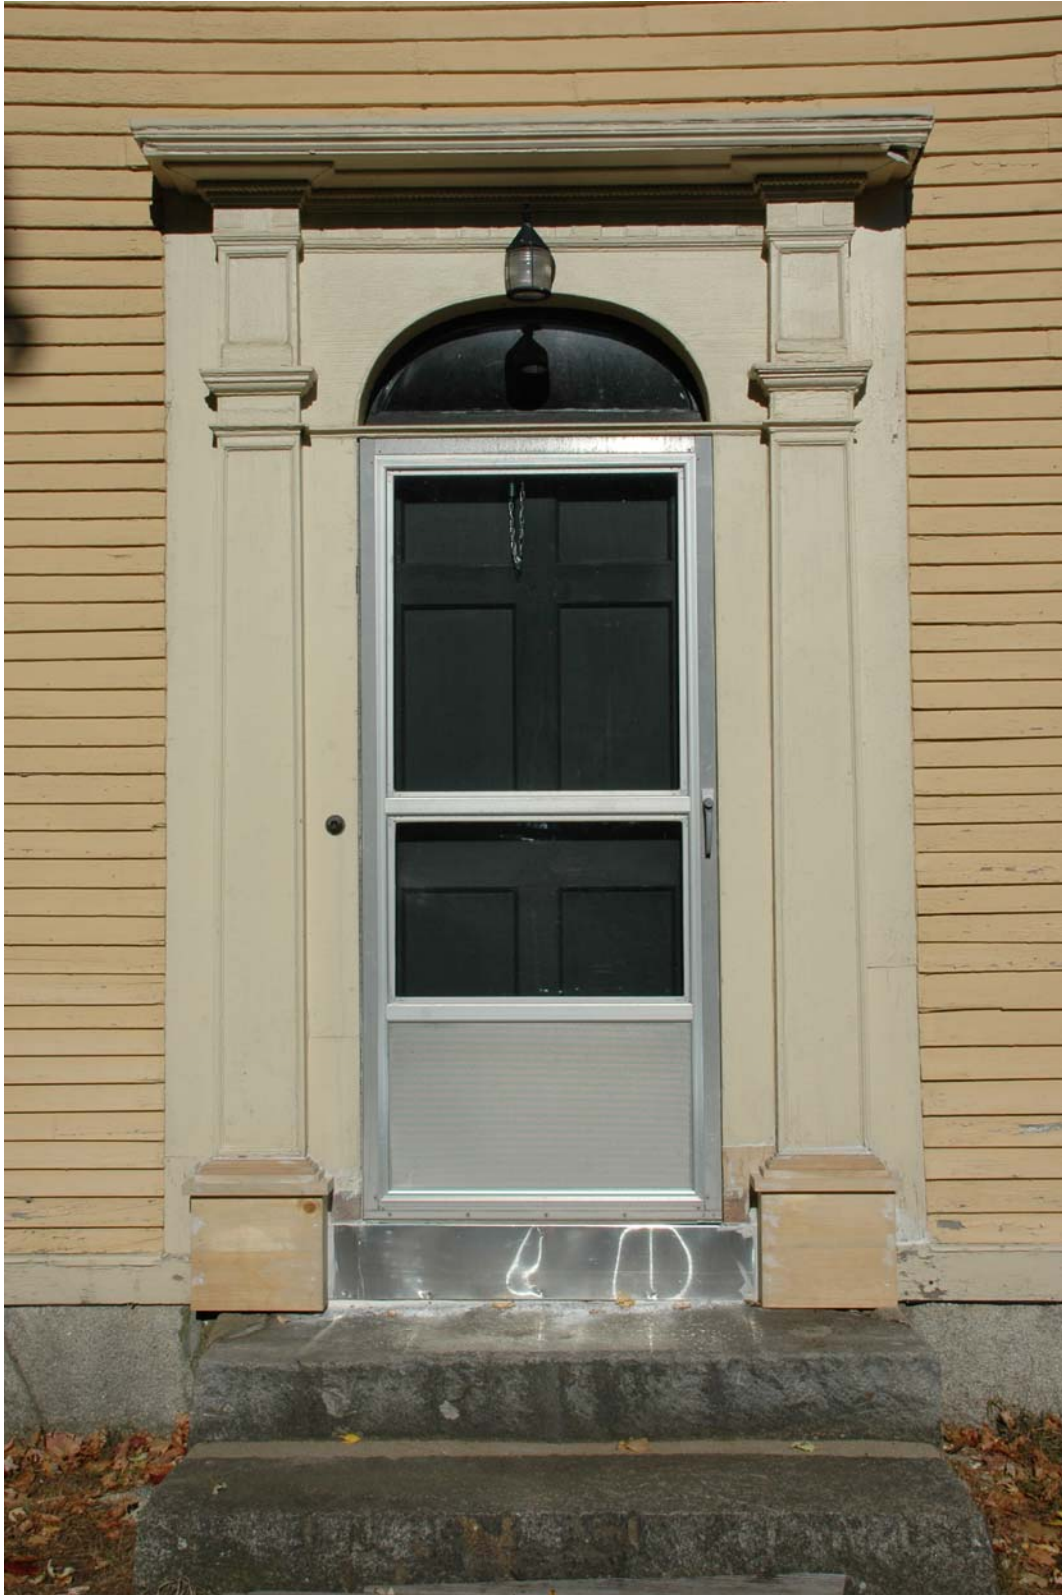
Figure SE-10. Door 1/101 - entrance to the main block. The rotted sill and pilaster bases were replaced by the NPS in October, 2007.

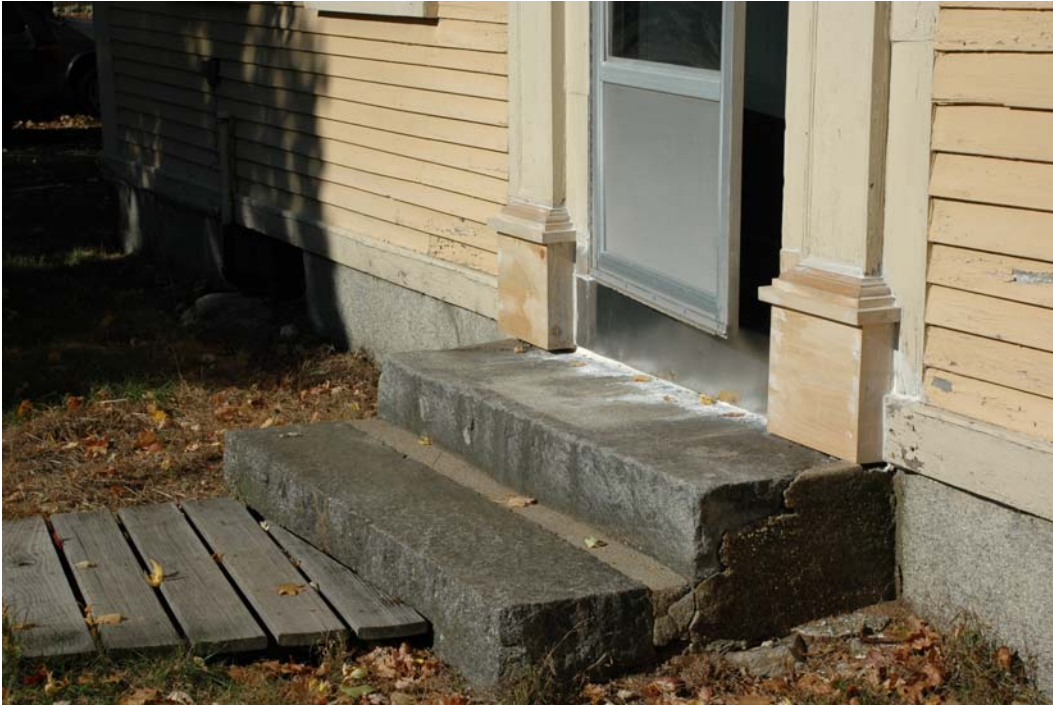
- The decorative wood portico appears to be original to the construction of the main block. The surround is designed with pilasters flanking the door, a fanlight (now a single light), flat arched frieze board, and a projecting cornice. The pilaster bases and sill were recently replaced (October, 2007) by the NPS due to severe deterioration. The surround is in fair condition with areas of rot and peeling paint. Small sections of the decorative trim at the pilaster caps and cornice are missing [fig. SE-12].
- A modern aluminum screen door is installed on the exterior.
- The wood door leaf is 6-panel.
- Two large granite slabs serve as risers and treads. Cement-based mortar has been applied to patch and fill large gaps between the slabs [fig. SE-11].

Figure SE-11. Detail of Door 1/101 showing new aluminum flashing at the sill and replaced pilaster bases. The granite slab steps were previously repaired with incompatible cement-based mortar.

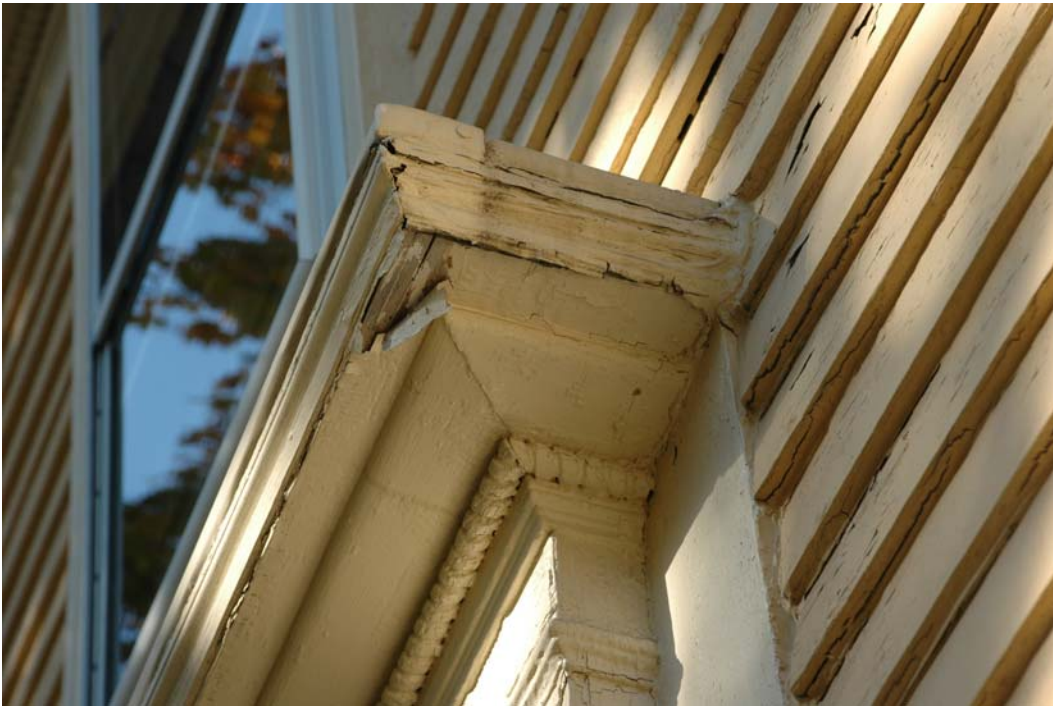
Figure SE-12. Door 1/101: detail of door surround cornice showing condition. Note unique decorative spiral rope molding, also found along the main block roof cornice.

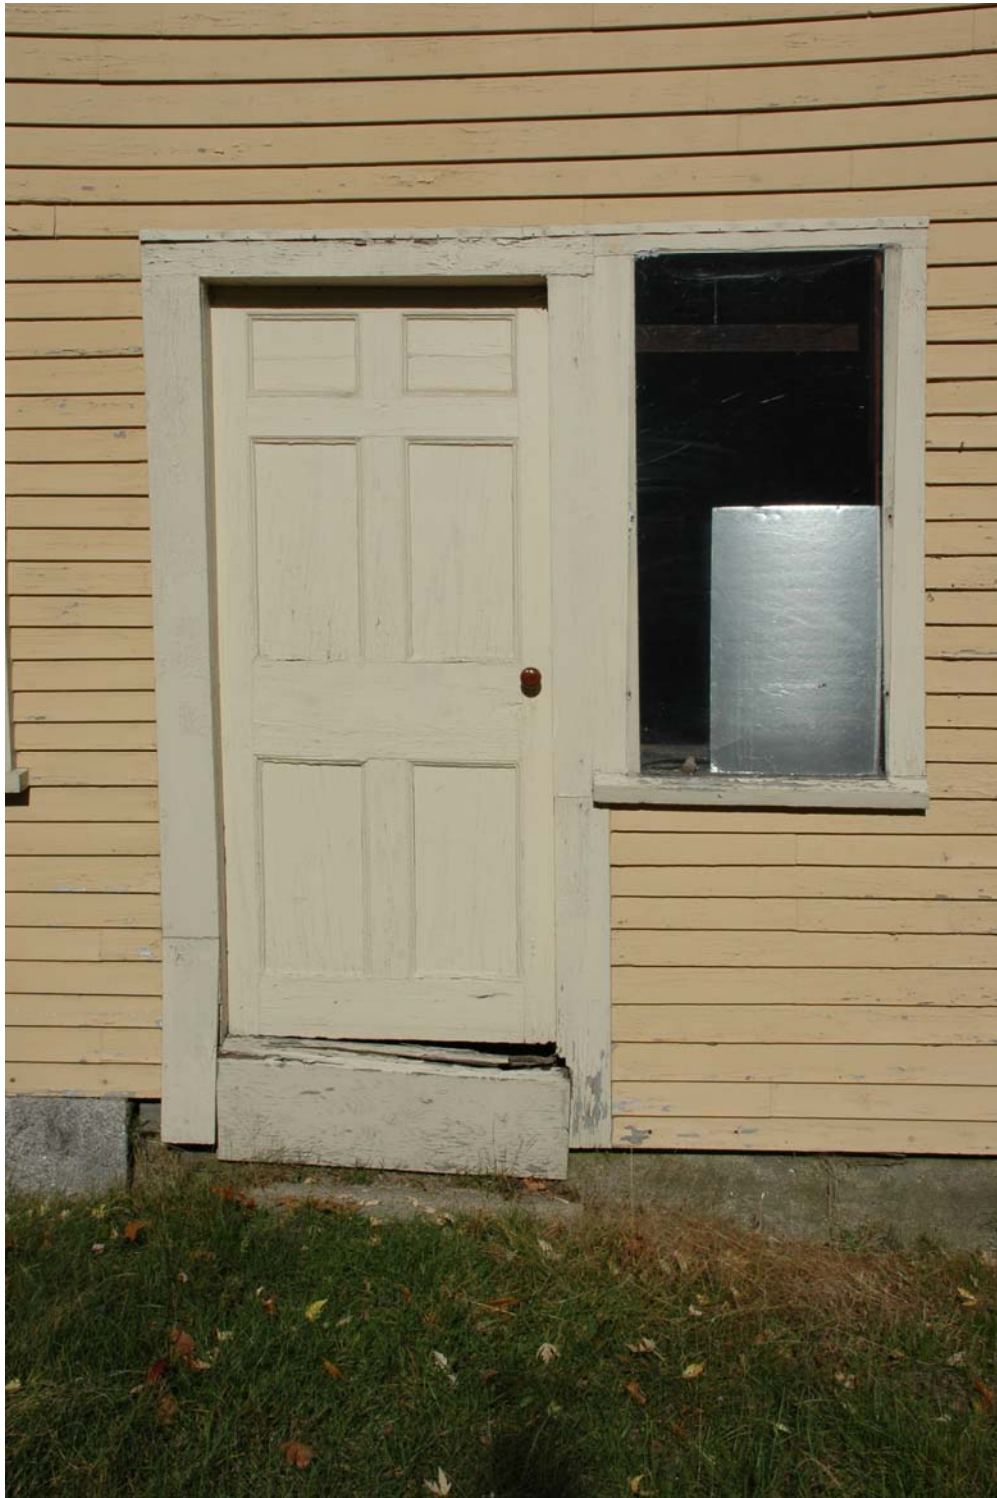
- **Window 111:** Type w-D. The frame opening is infilled with a single piece of Plexiglas. The frame and sill are integral with Door 1/109 frame. The window sill exhibits severe rot and is projecting away from the frame wall.

Figure SE-13. Door 1/109 and Window #111, Type w-D. The door sill is extremely deteriorated. The window sash is missing and has been replaced with a single piece of Plexiglas. The foundation wall is granite block on the left of the door, at the 18th century block, and formed concrete to the east of this point.

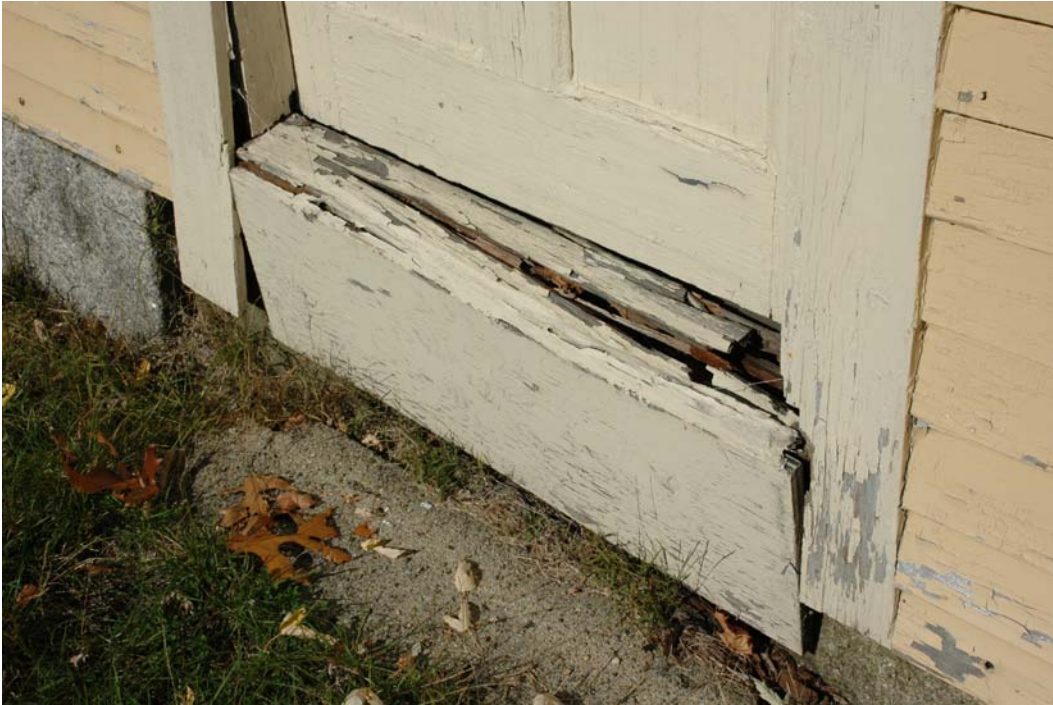
- The door frame and trim is comprised of a simple flat board. The door trim is deteriorated and warped, especially on the west side of the door where a replacement board has started to detach from the frame. The door sill is extremely deteriorated with rot and insect infestation; it has detached from the door frame and a large hole is open to the interior [fig. SE-14].
- The door leaf is 6-panel and is rotted, warped and has a large amount of peeling paint.

Figure SE-14. Door 1/109: detail of rotted and warped sill.

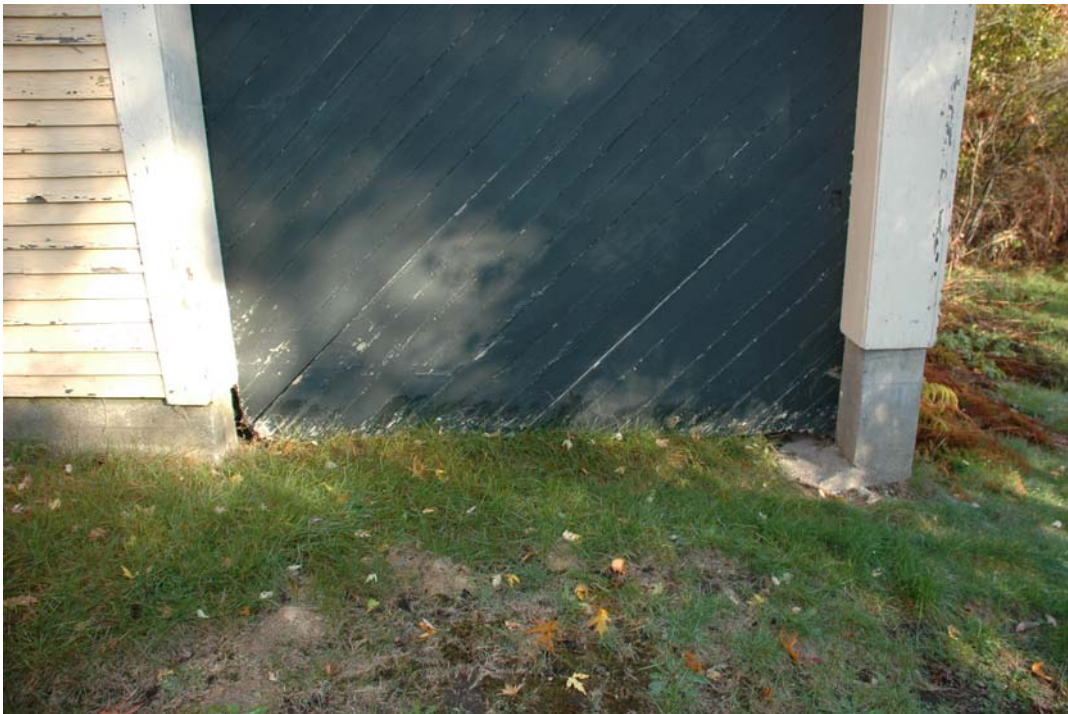
- The door trim is a simple flat board and is in poor condition with areas of rot and peeling paint. The east trim board also serves as the southeast corner board of the northeast wing. The corner board is rotted and gouged. There is no door sill at the carriage house door.
- The single carriage house door leaf is composed of diagonal flat boards. The door is deteriorated near the bottom and has warped boards and peeling paint throughout.

Figure SE-15. Door 1/110: detail showing deterioration at the lower edge of the diagonal-board carriage house door. The foundation at south elevation of carriage house is formed concrete.

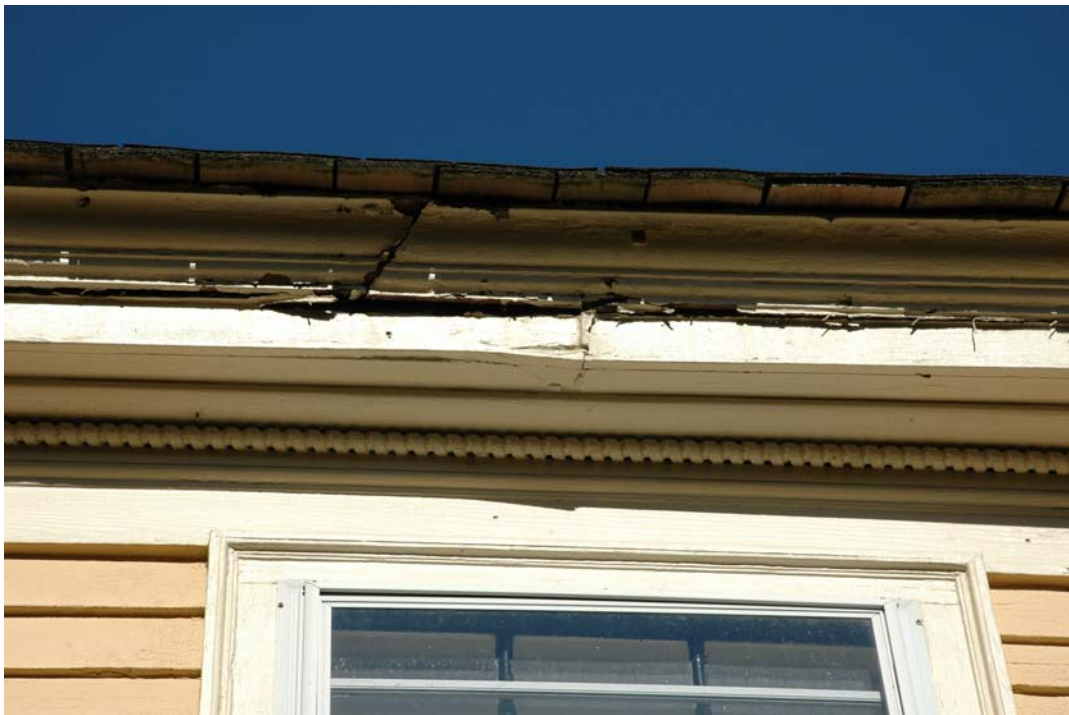
Figure SE-20. Deteriorated roof cornice at the center of main block, above window # 208.

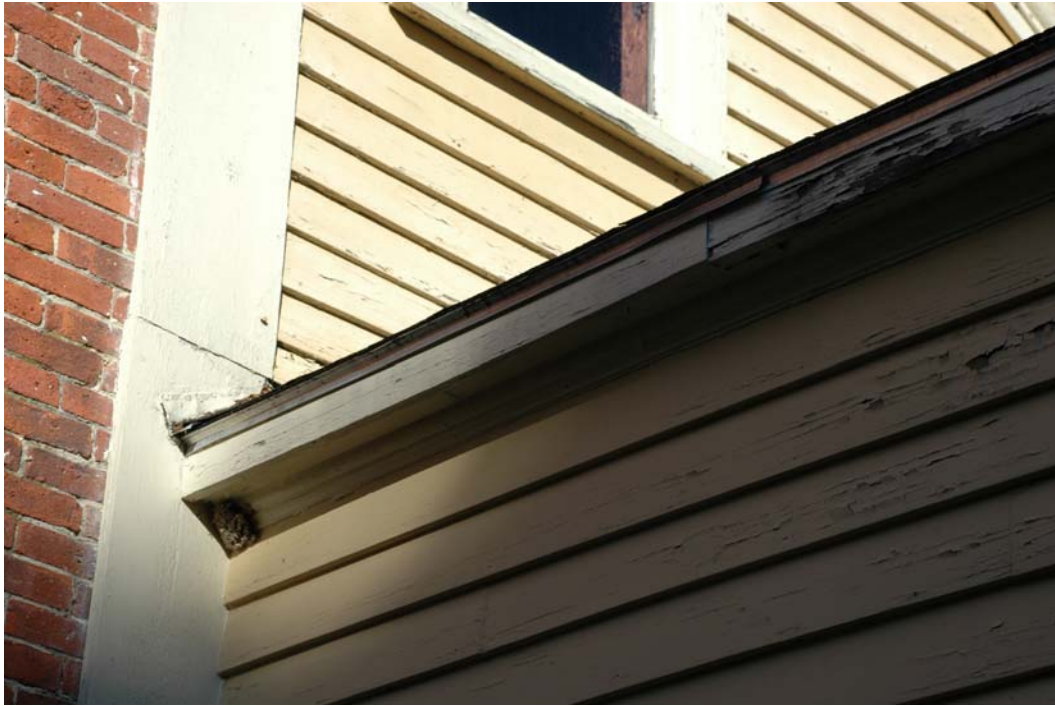
Figure SE-21. Deteriorated roof cornice at northeast wing.

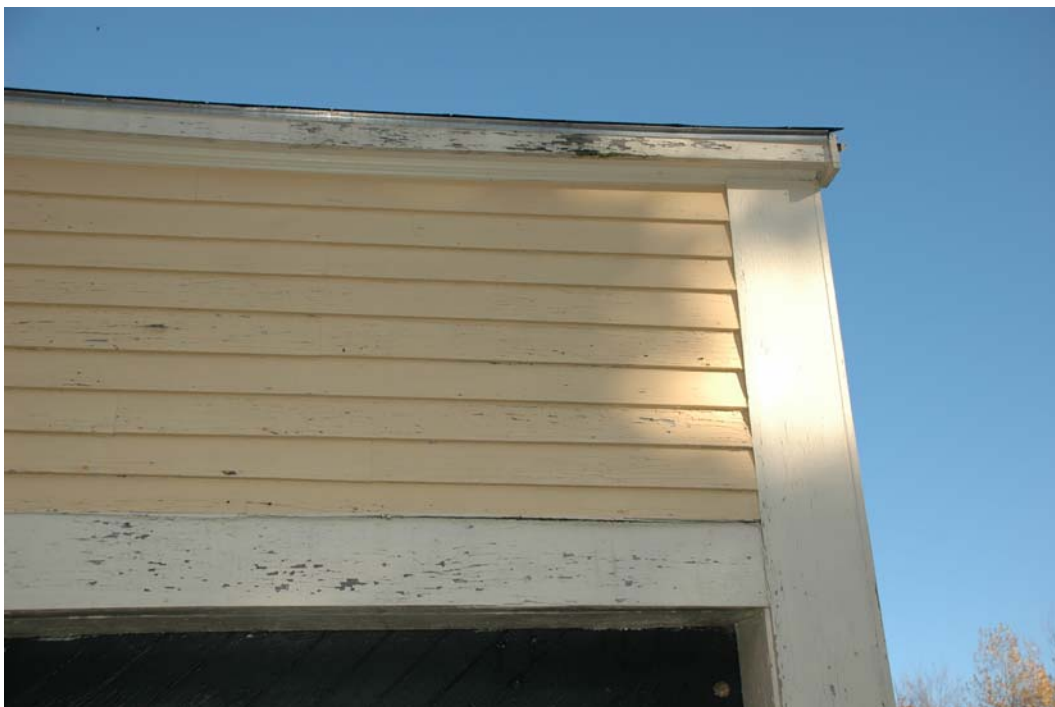
Figure SE-22. Deteriorated roof cornice at east side of northeast wing.

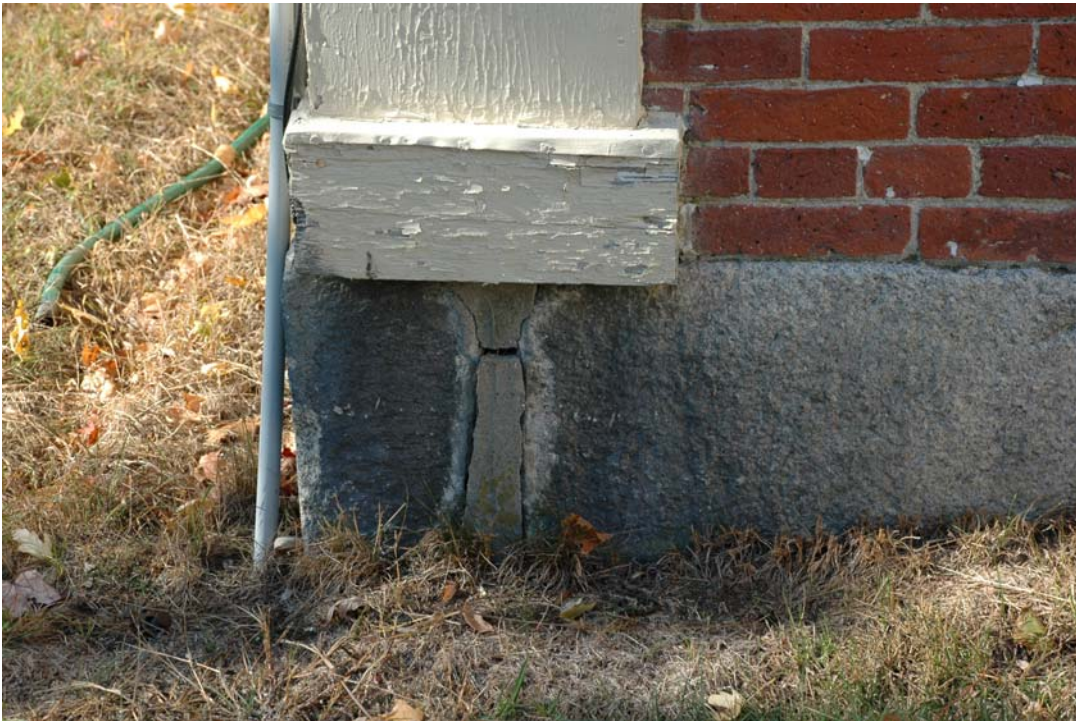
Figure EE-4. Foundation wall at east elevation of main block, with deteriorated corner board and chipped and cracked concrete mortar at foundation wall.

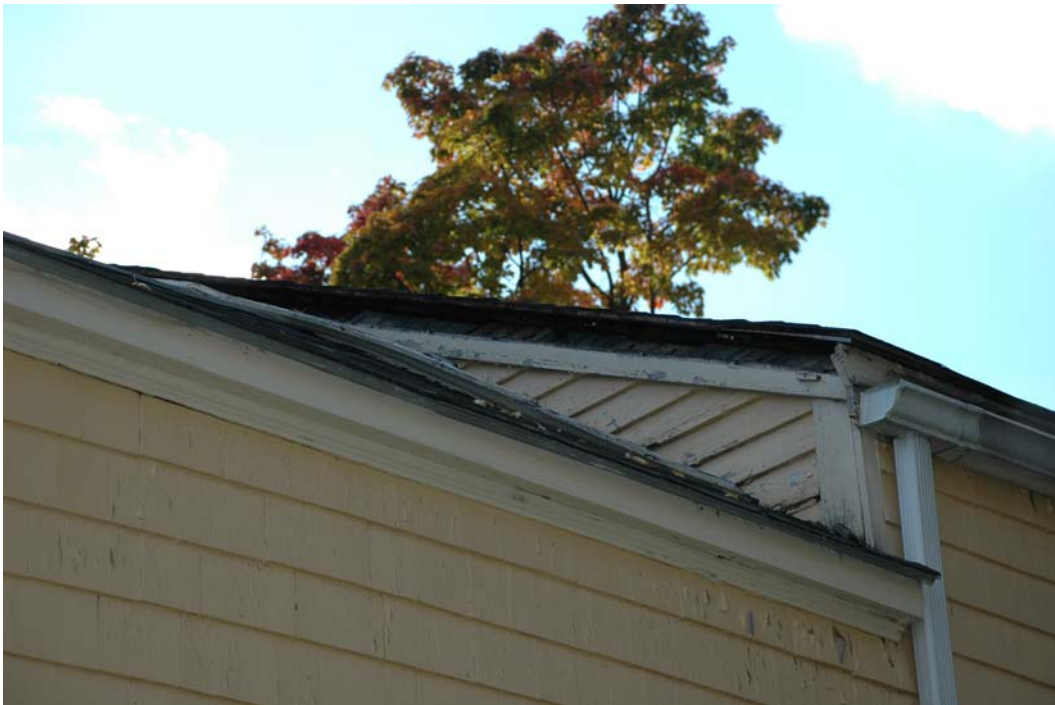
Figure EE-6. East rear addition gable end wall above northeast wing. The raking board is deteriorated and has detached from wall.

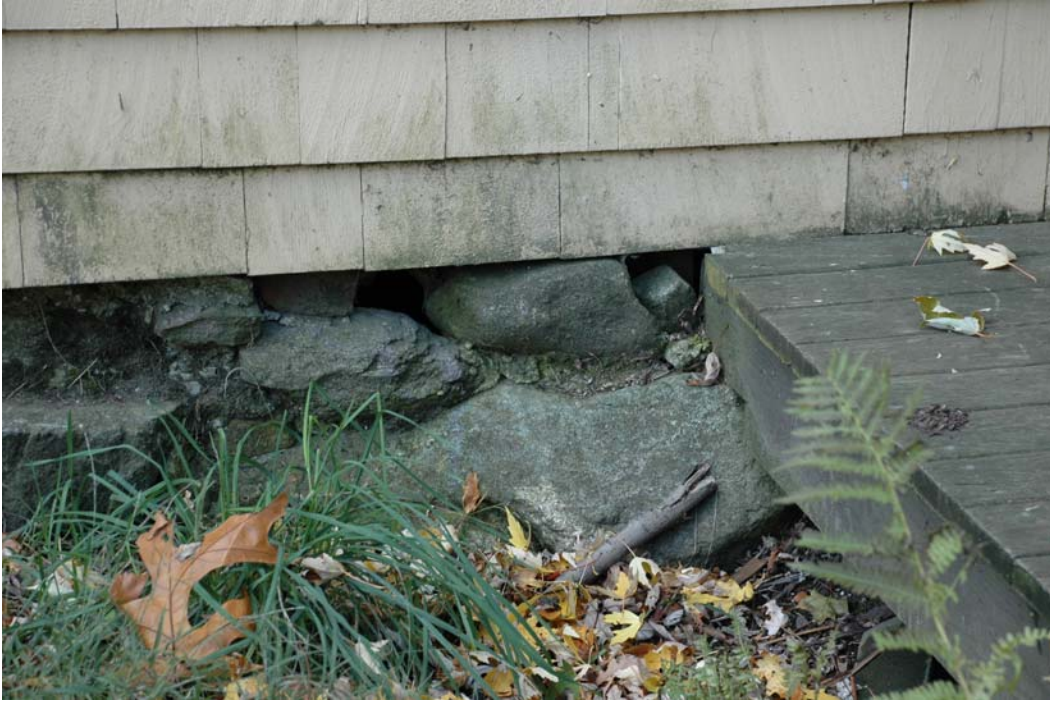
Figure NE-6. Foundation wall near rear porch with areas of missing foundation stones.

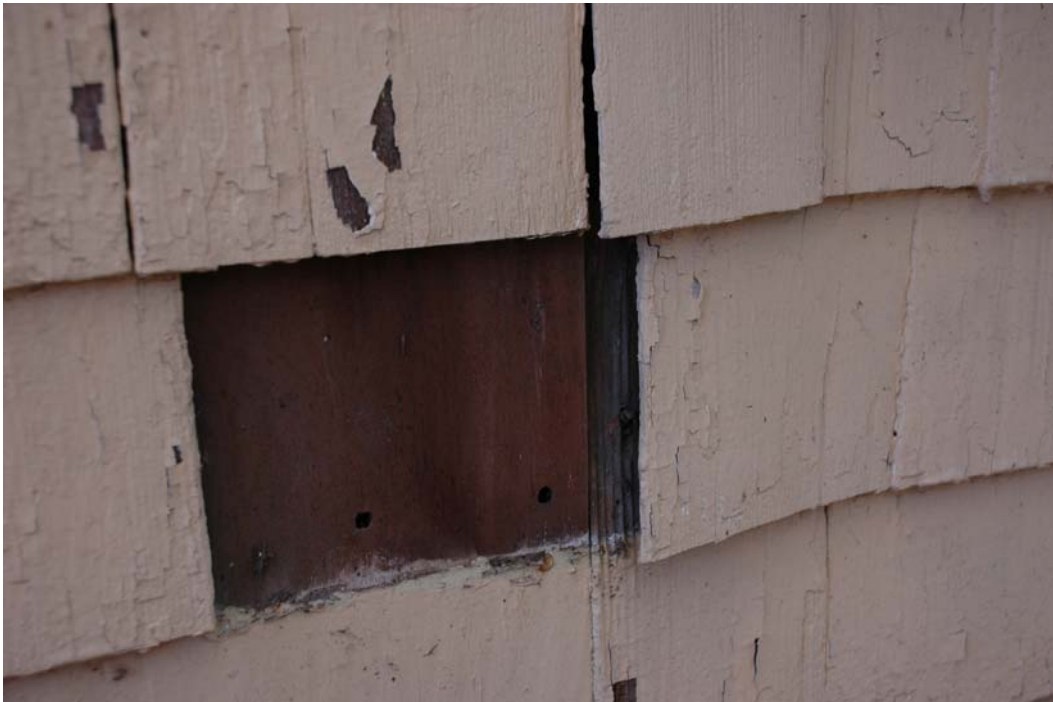
Figure NE-7. Deteriorated and missing areas of shingle siding at the north elevation.

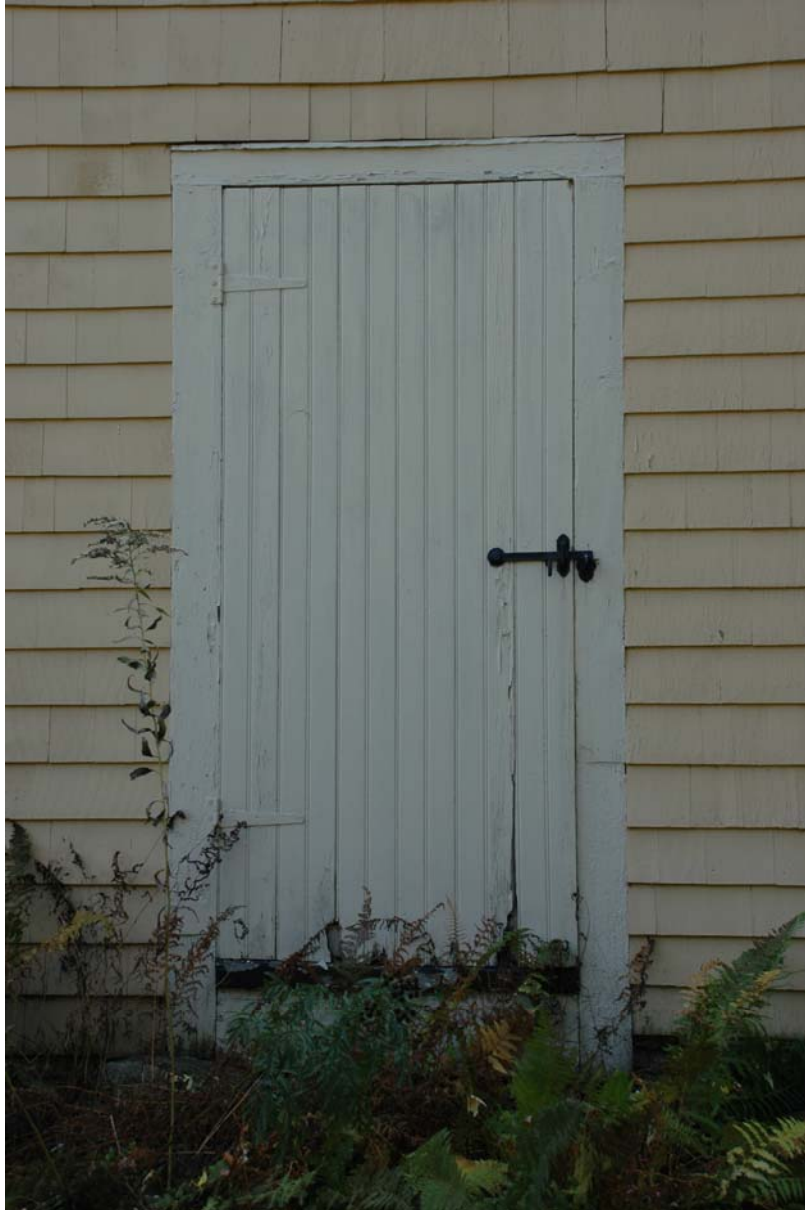
Figure NE-10. Door 2/109: board-and-batten door with deterioration along the bottom and the sill.

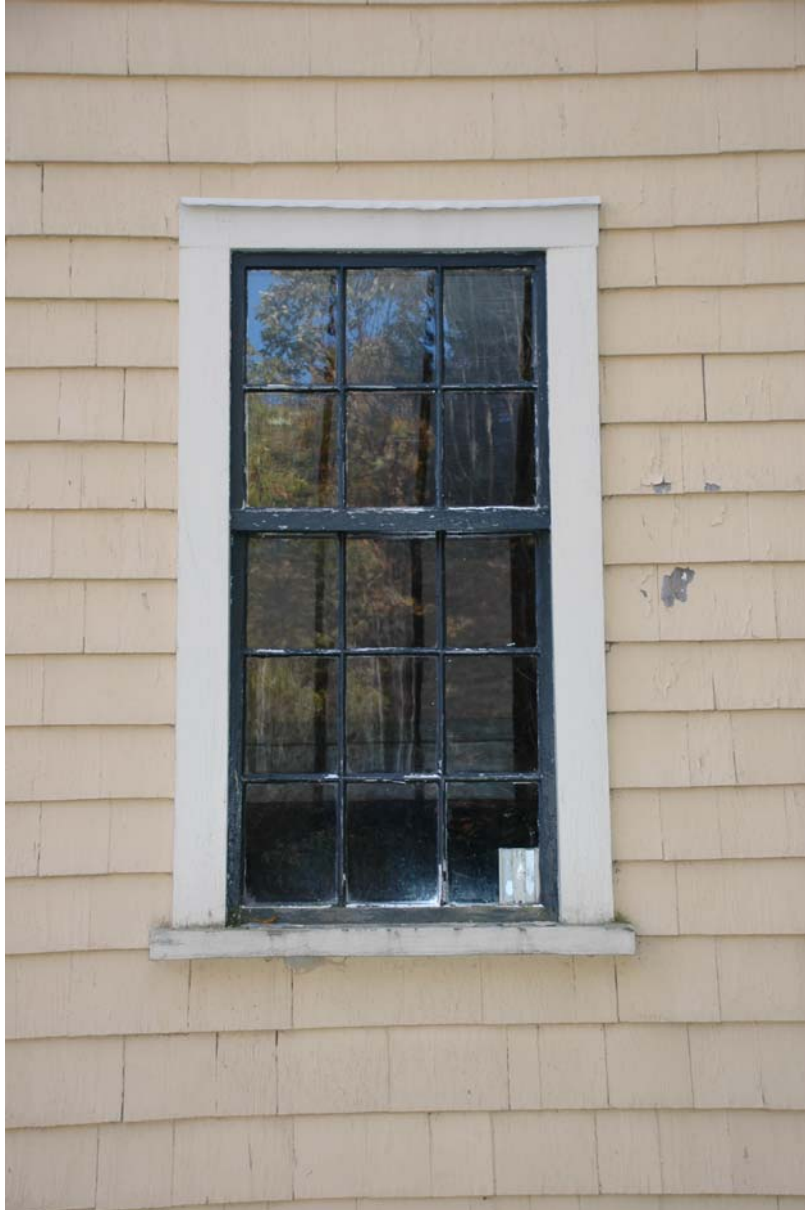
Figure NE-13. Window #112, Type w-C. Wood sash and sill are deteriorated.

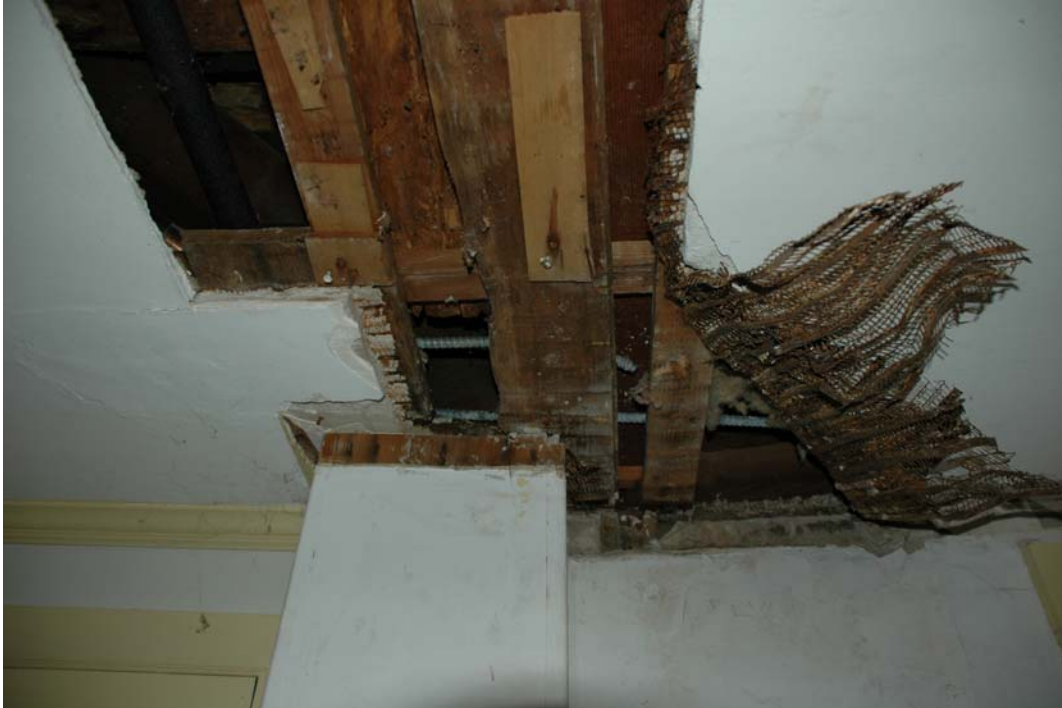
Figure 107-4. Room 107, ceiling view with plaster removed to expose failed structural members.

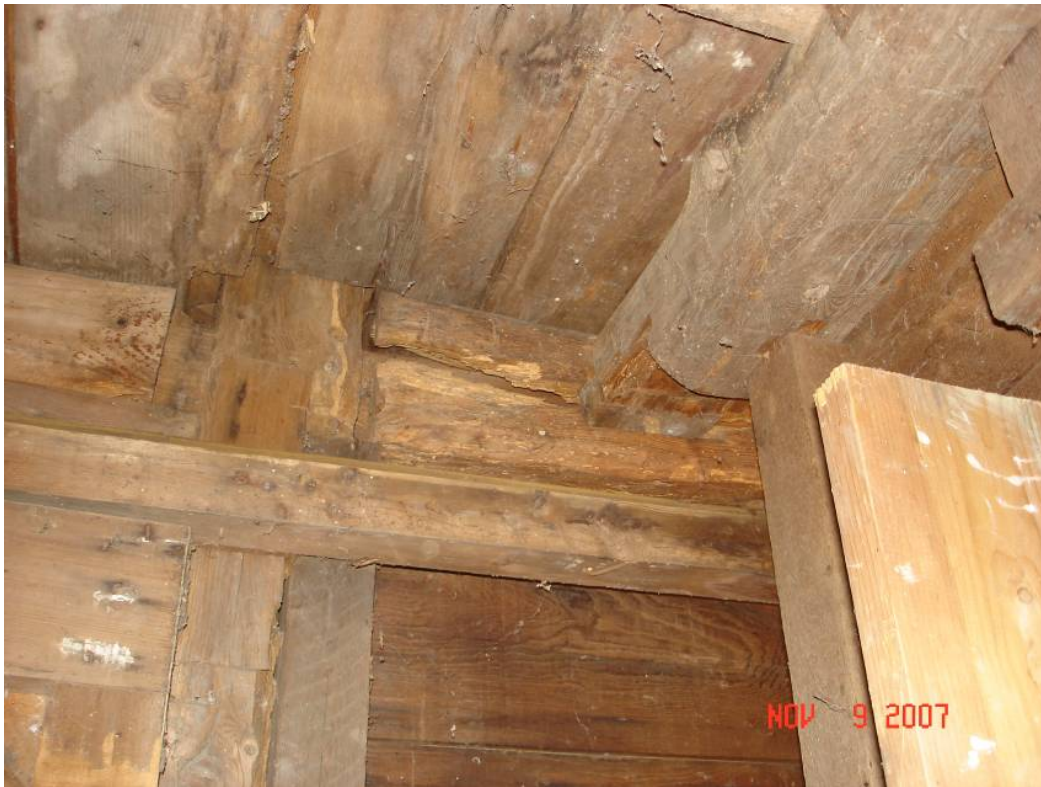
Figure S-15. Tenon pullout on tie-beam at south wall.

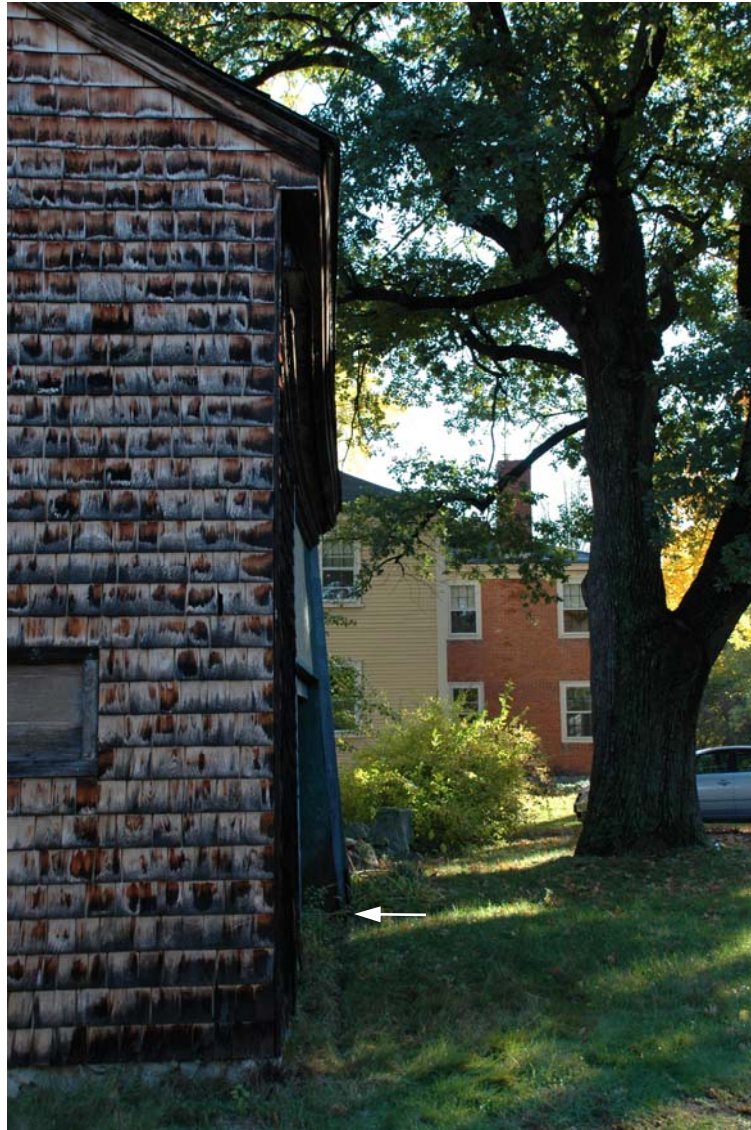
Figure SE-3. View looking east, showing the extent of movement of the south elevation due to structural deterioration.

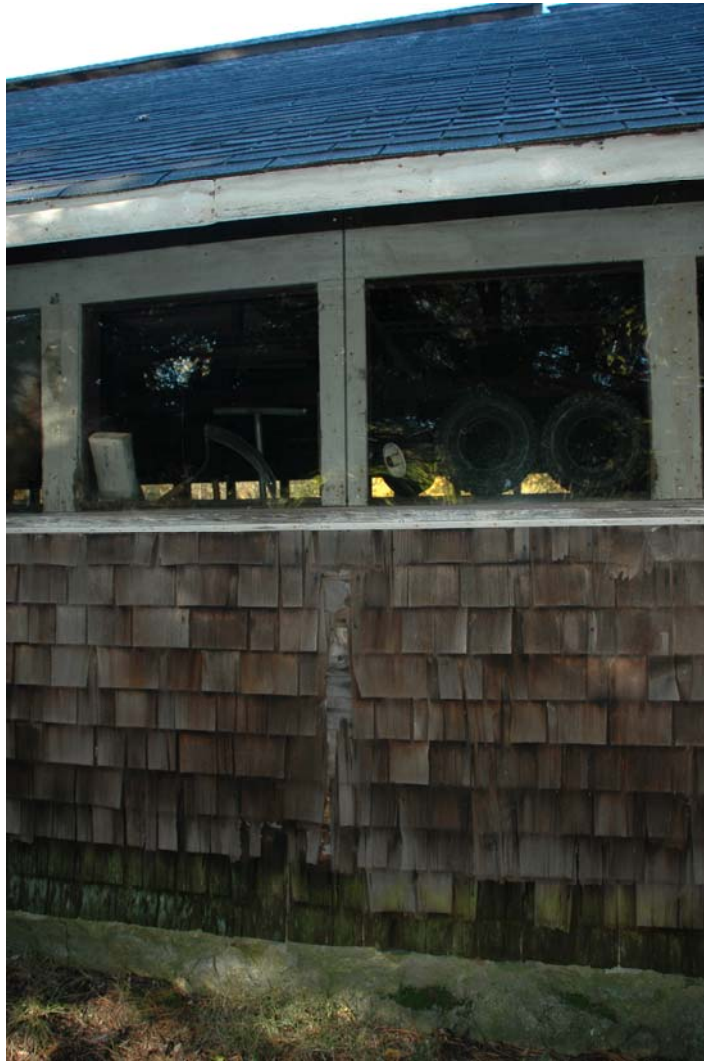
Figure EE-6. Windows #B-106 at the east elevation of the north block. The deteriorated condition of the shingles is typical along the east elevation.

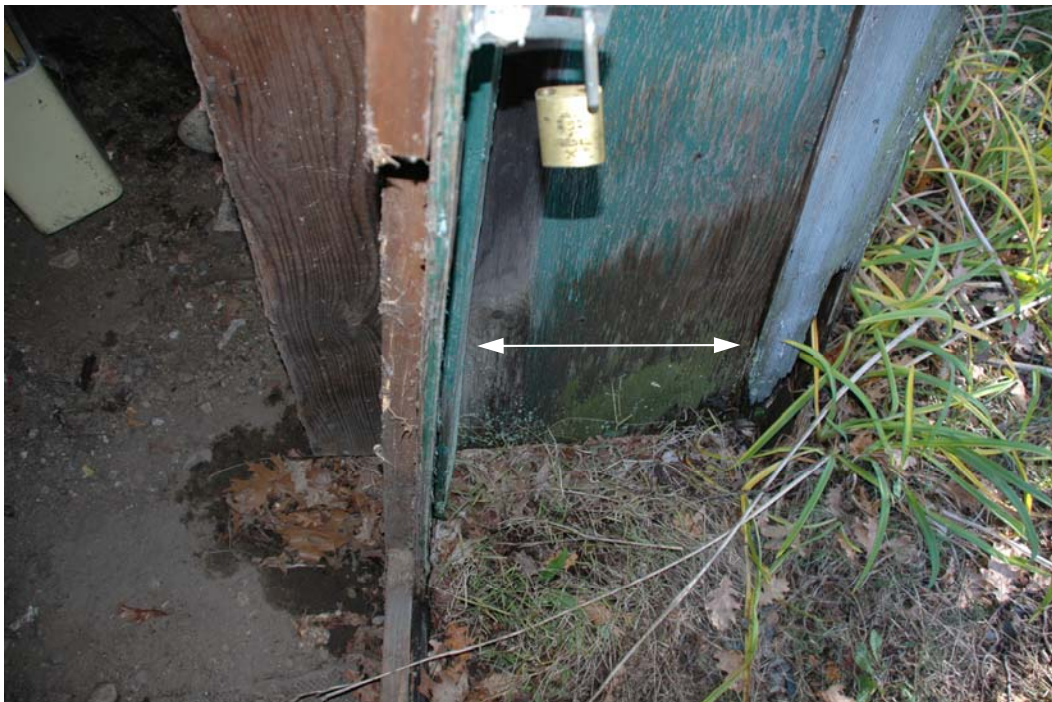
Figure B101-6. Room B-101, jamb at Door B-1/101 where the south wall has projected out due to structural deterioration. The arrows show the extent of movement.
