MINUTE MAN NATIONAL HISTORICAL PARK
JOHN NELSON HOUSE & BARN

HISTORIC STRUCTURE ASSESSMENT REPORT

NOVEMBER 2008

PREPARED BY:
JOHN MILNER ARCHITECTS, INC.
CHADDS FORD, PA

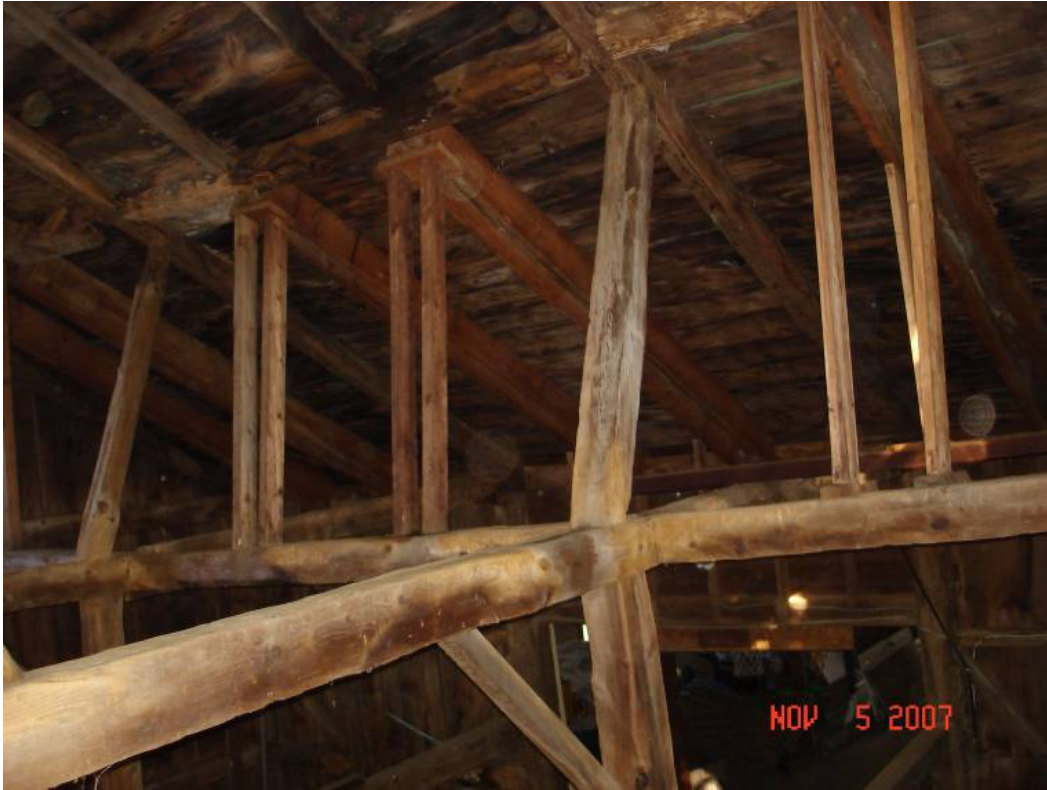
Figure BS-5. Shoring struts supporting the north roof.
