DISTRICT OF COLUMBIA WAR MEMORIAL

Historic Structure Report
& Cultural Landscape Assessment

National Mall & Memorial Parks
PMIS NO. 43699

May 2006

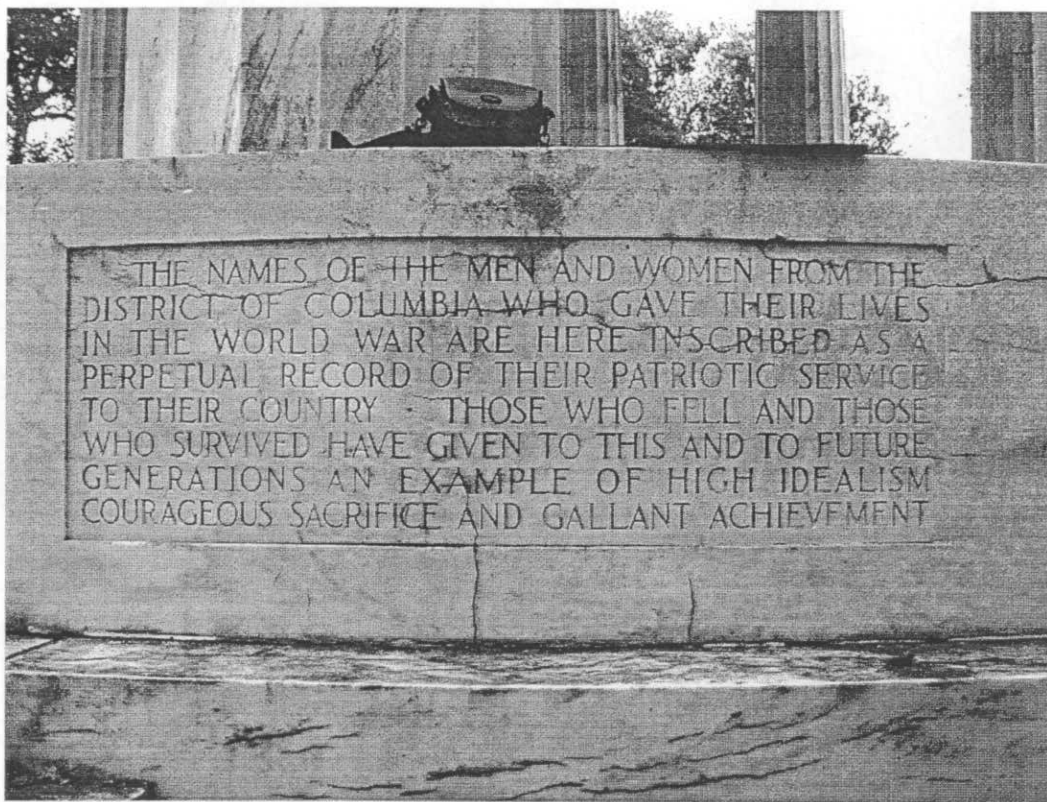
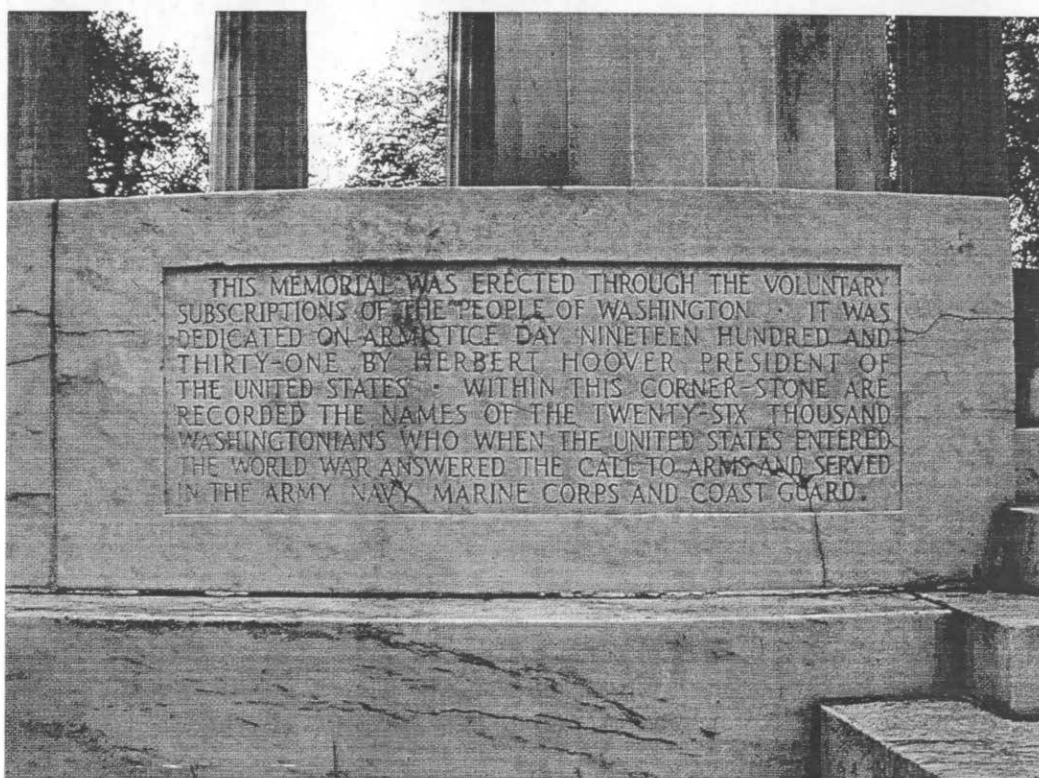
Fissures, cracks, and natural imperfections in the carved marble panels at the base of the Memorial. [NPS, 2004]

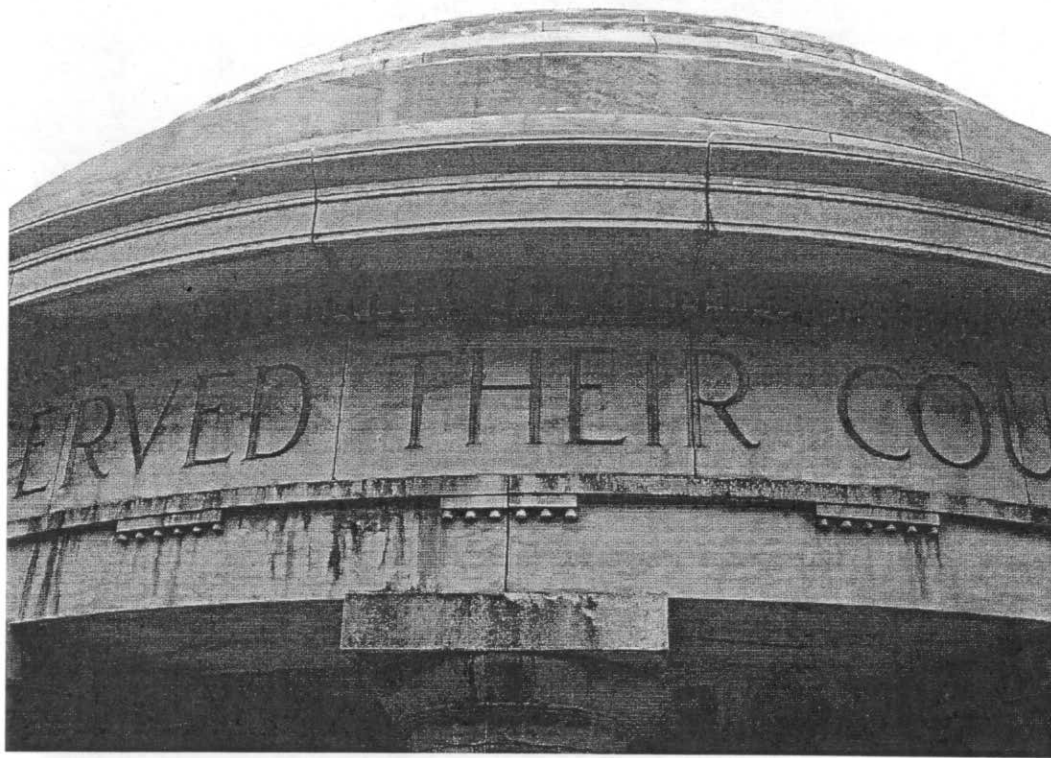
The Memorial entablature. Note the open mortar joints in the marble construction. [JGWA, 2005]

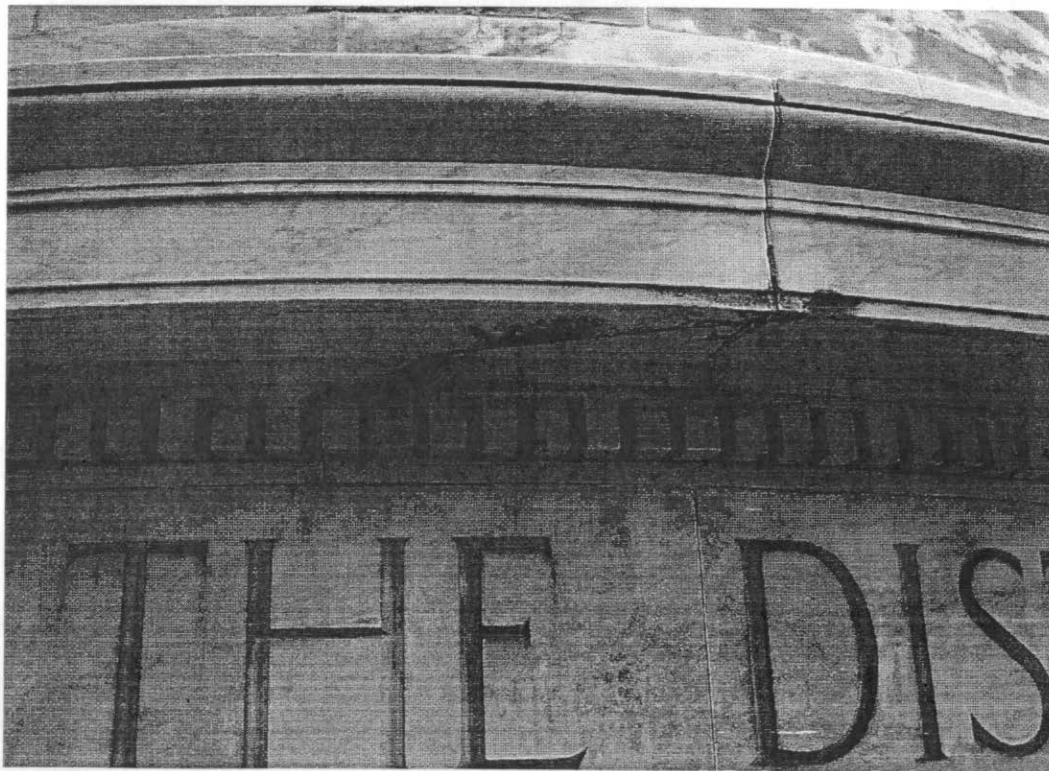
Detail of the cornice. Several of the cornice stones are cracked. [JGWA, 2005]

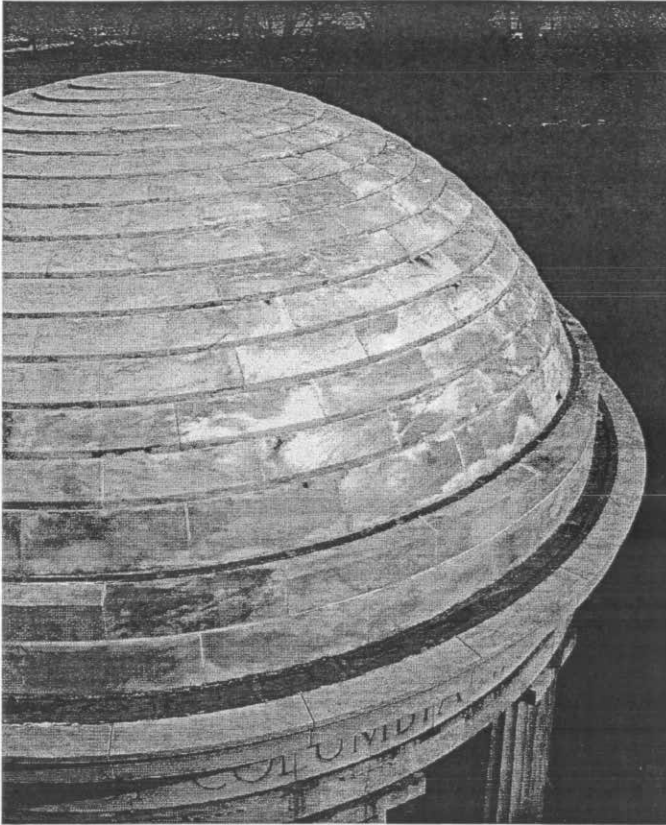
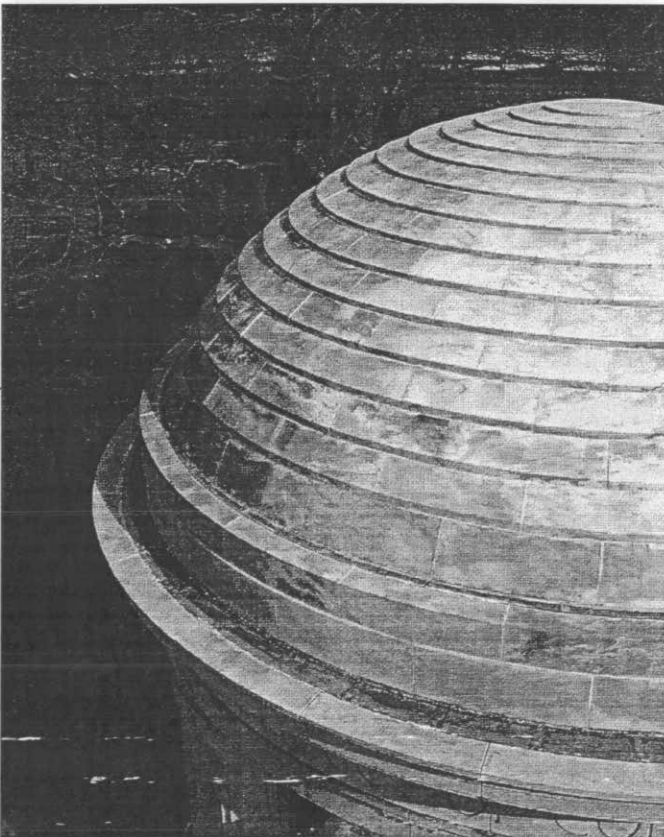
Views of the dome from the south, looking northeast (upper photo) and northwest (lower photo). Note the shallow gutter construction in the protruding cornice. [JGWA, 2005]

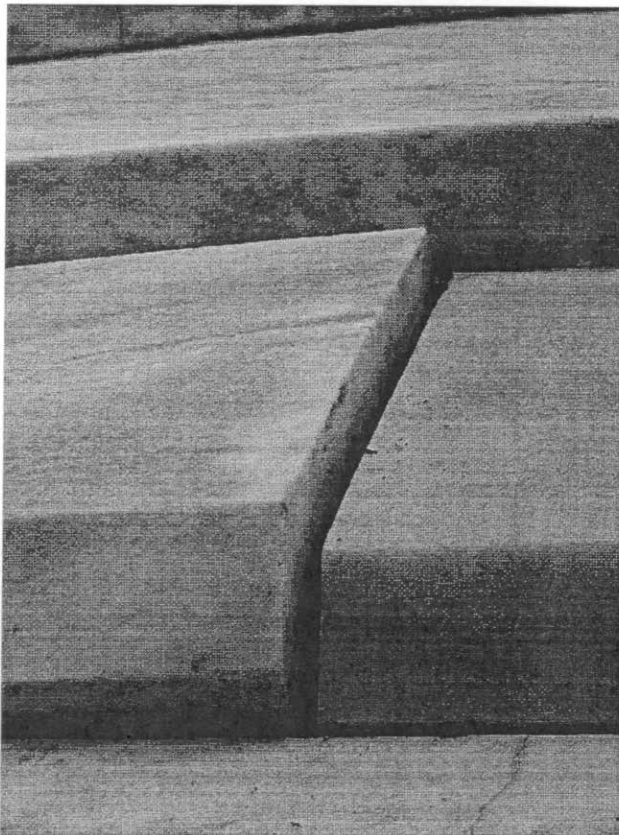
*Detail of a displaced marble roofing tile. Water infiltration and freeze-thaw cycling may be contributing to the displacement of the marble.
[JGWA, 2005]*

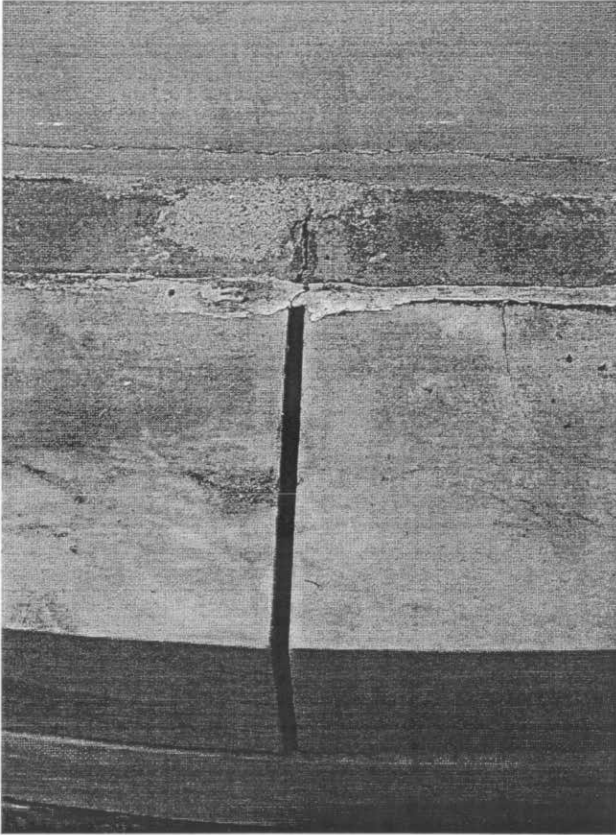
The original lead flashing on the marble capstones of the drum has been torn by the displacement of the stones. The movement of the stones appears to be the result of water infiltration at the open joints in the masonry and subsequent freeze-thaw cracking. [JGWA, 2005]

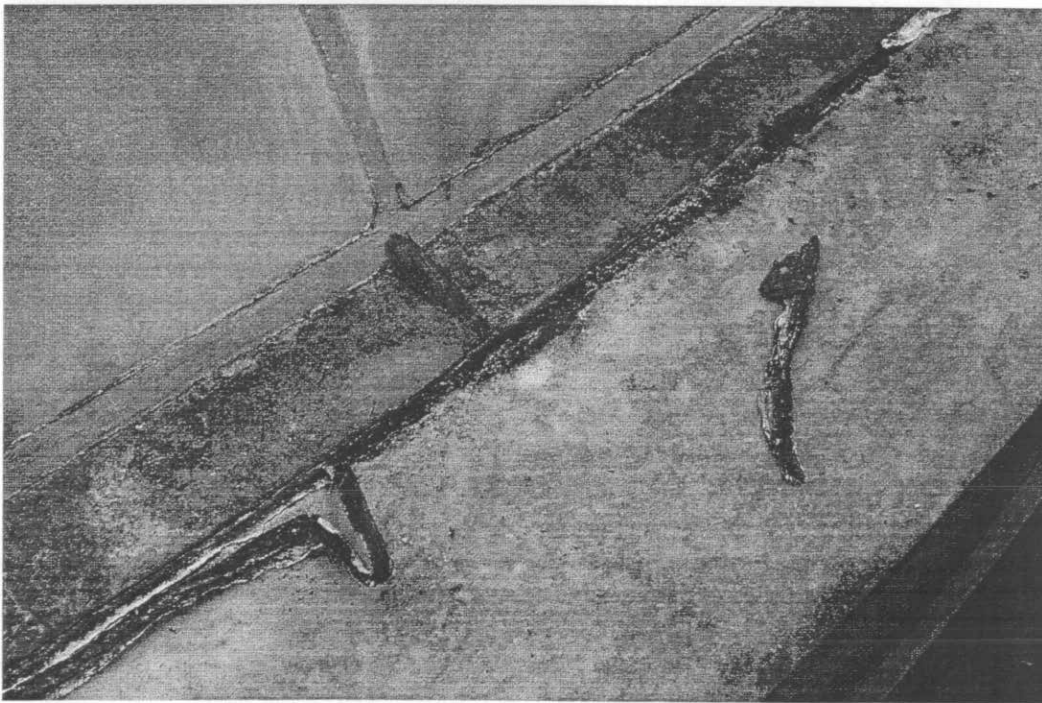
The original lead flashing on the capstones of the drum was wedged into a reglet cut in the stone. Lead wool was used to retain the flashing in the reglet; the reglet has subsequently been filled with sealant in a misguided attempt to repair the flashing. [JGWA, 2005]

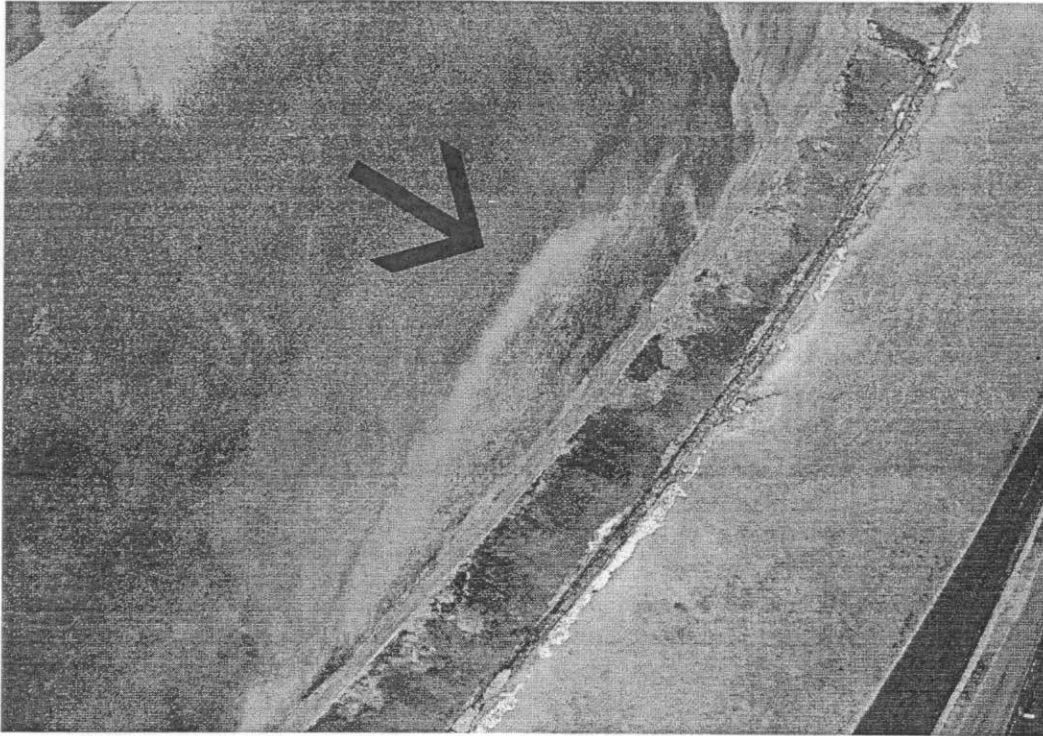
The bright orange and yellow discoloration visible on the outer marble dome appears to be a biological growth below the surface of the marble. [JGWA, 2005]

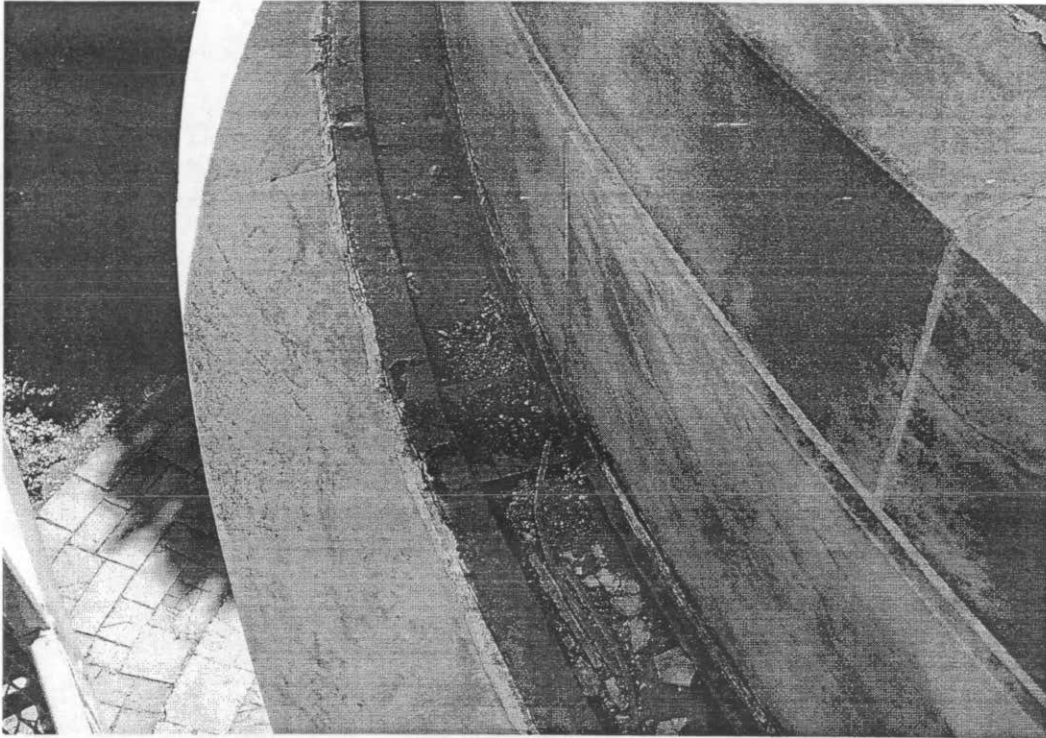
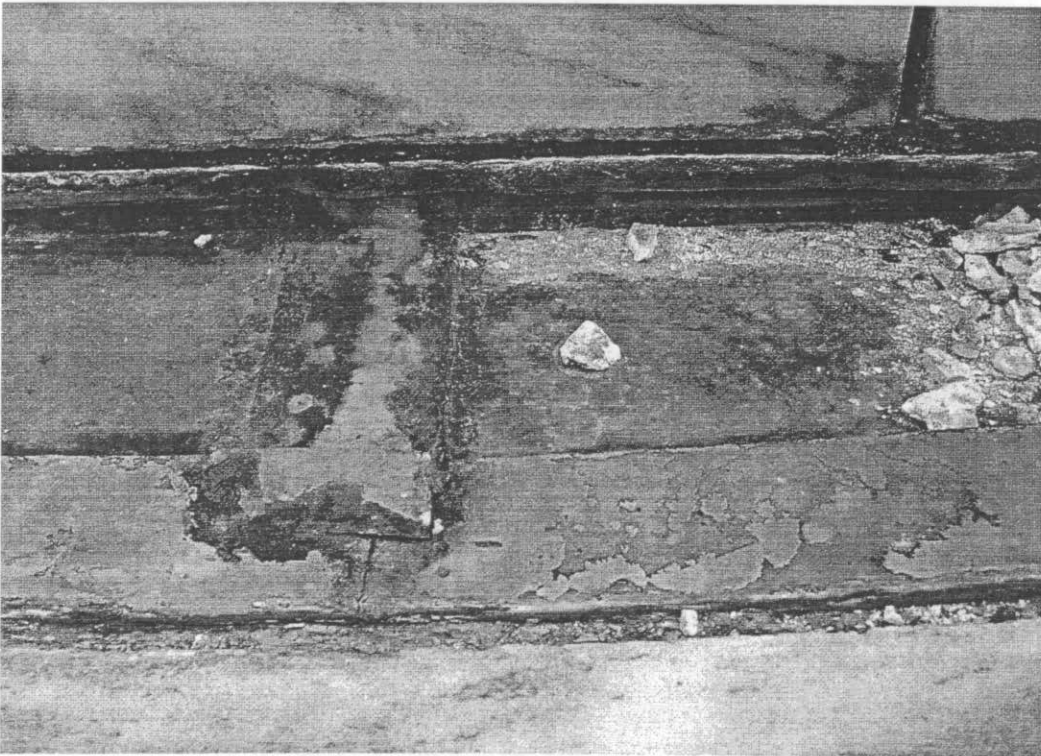
- The pitch of the gutter is insufficient for proper drainage to the four downspout outlets. Cross seams in the copper gutter are pronounced, preventing proper drainage.

The shallow gutter in the projecting cornice is lined with lead-coated copper (which replaced the original lead flashing). The metal has oxidized and eroded, exposing the intermediate layer of tin. Insufficient pitch, pronounced cross seams, and pieces of deteriorated mortar prevent proper drainage. [JGWA, 2005]

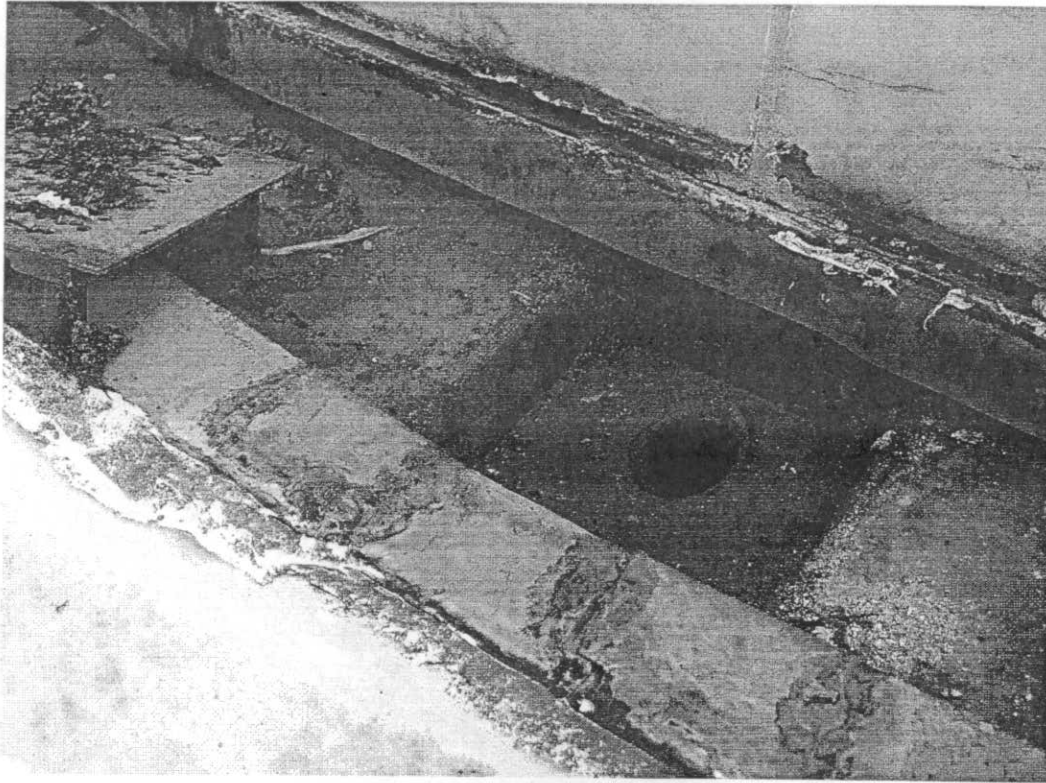
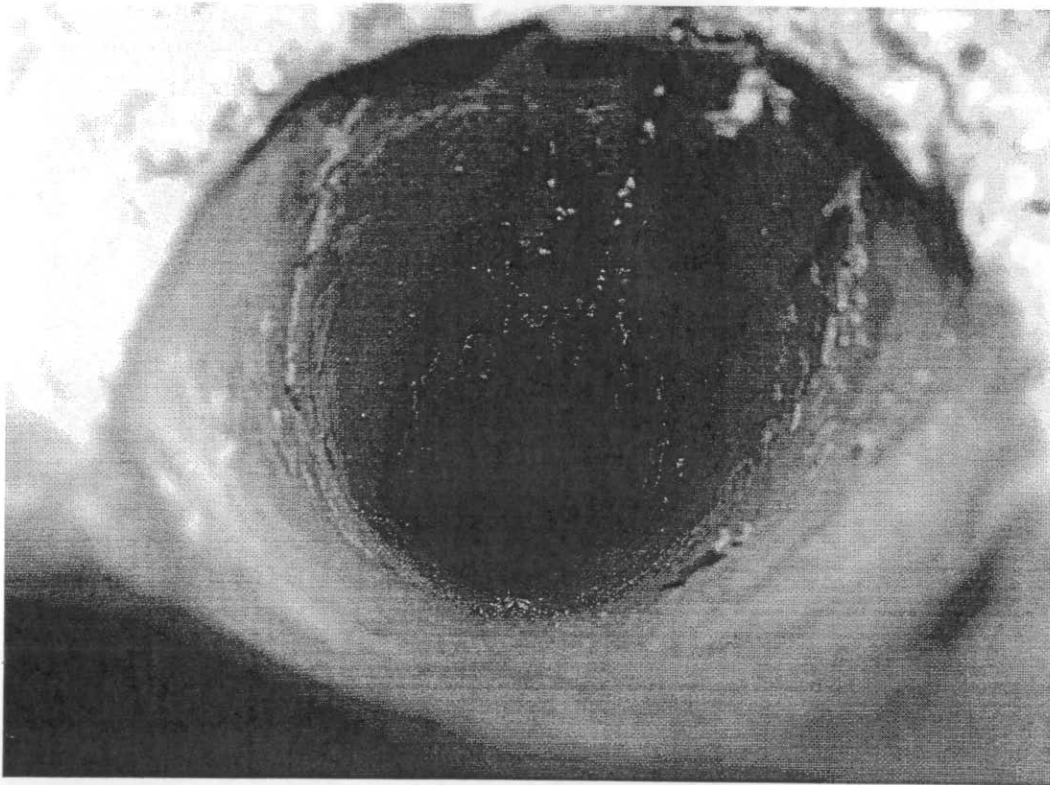
The downspout outlets from the cornice gutter form a "Y" juncture with the condensate drainage outlets in the attic, draining into internal downspouts routed through four of the columns. [JGWA,

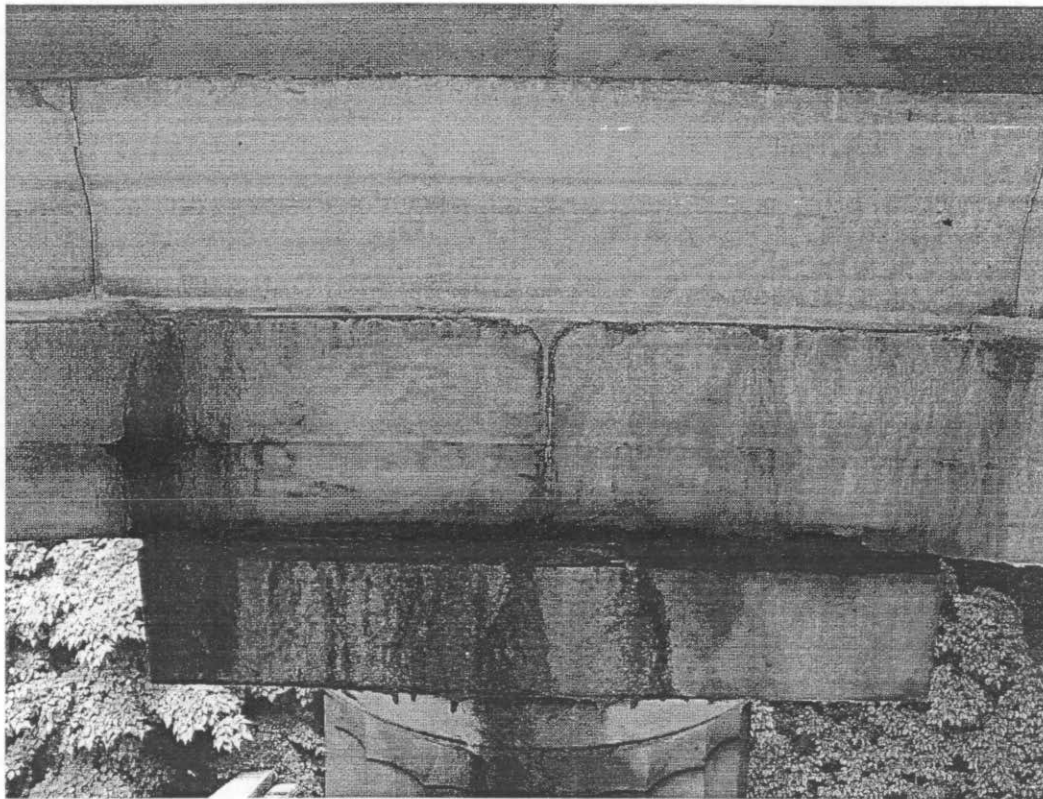
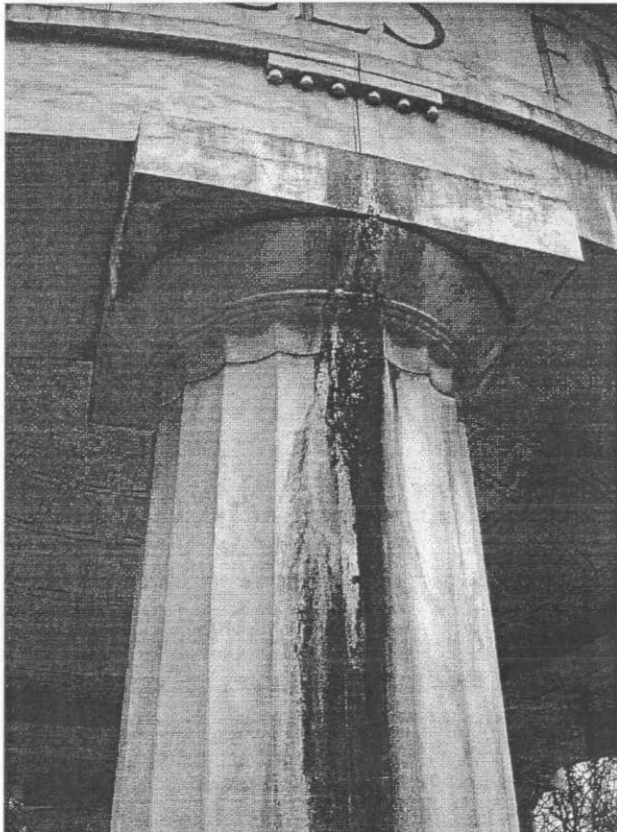
Most of the column capitals are heavily encrusted with calcium carbonate resulting from the percolation of water through the masonry construction. The staining on the capitals and columns is partially attributable to the dry deposition of sulfur contaminants and the formation of gypsum. [JGWA, 2005]

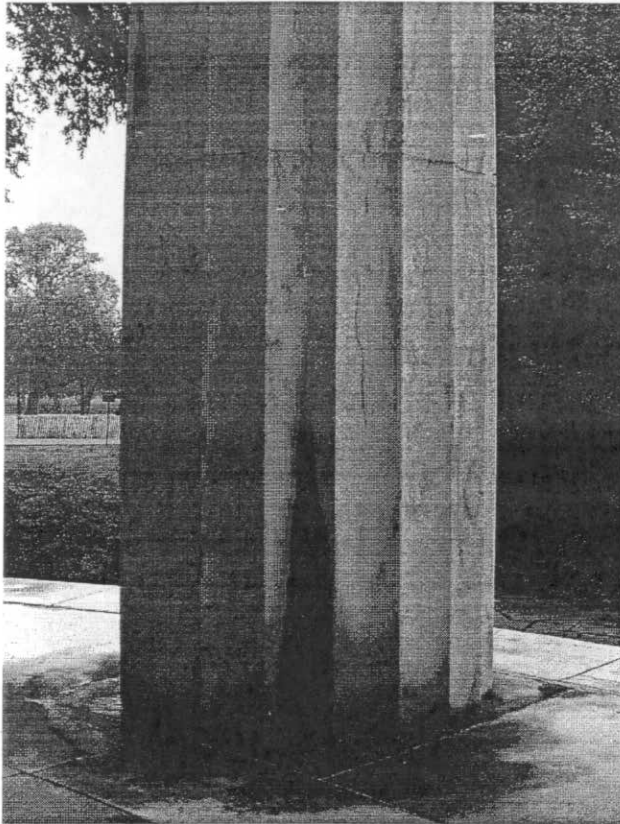
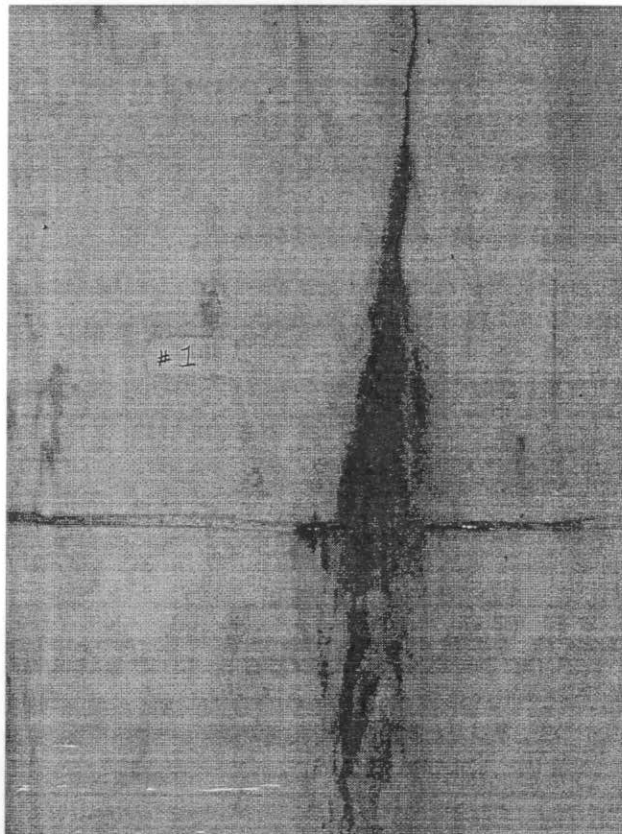
The vertical staining on column 1 (lower photograph) and on column 4 (upper photograph) is indicative of the staining that has occurred on the four columns with failed internal downspouts. The stains originate at fissures and imperfections in the marble where the storm water drainage has escaped. [JGWA, 2005]

Field observations on July 15, 2005, revealed that the downspouts in Columns 1, 4, 7, and 10 have apparently failed. Original specifications indicate that these downspouts were of cast-iron construction. Water was found leaking from the horizontal base joints at each of these columns. This appears to be a chronic problem because the constant presence of water on the marble paving at the base of these columns is supporting the growth of algae.

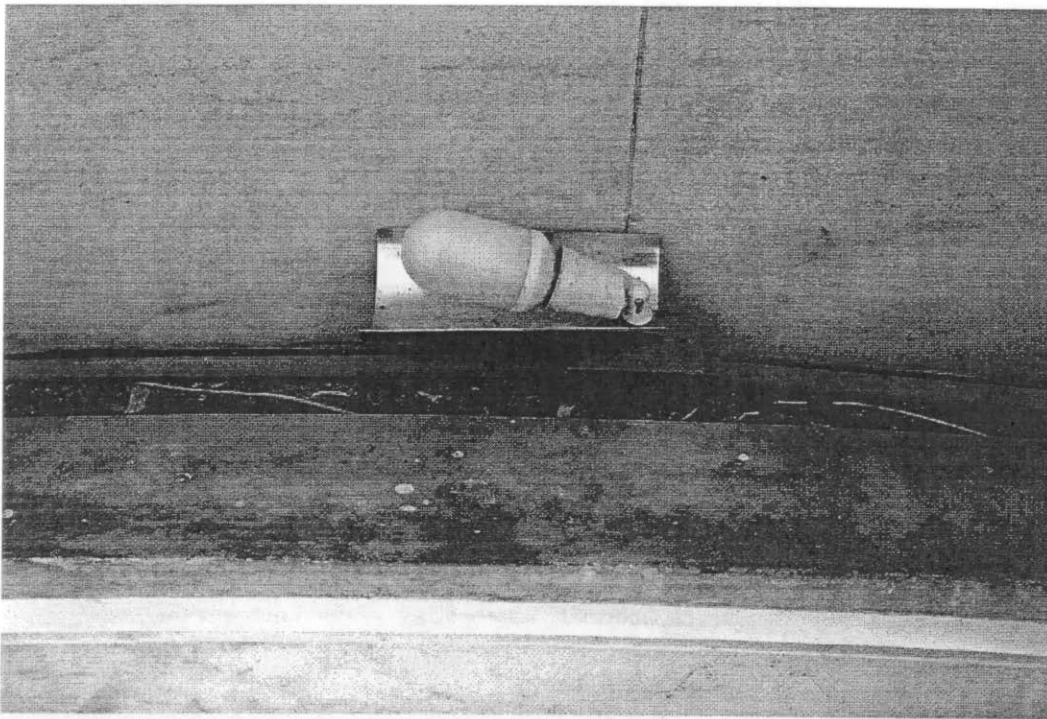
Modern fluorescent lighting has replaced the original incandescent cove lighting at the base of the lower dome. The quality of the fluorescent lighting detracts from the historic character of the Memorial. [JGWA, 2005]

Alternate: Install sheet metal flashings and drip edges over the capstones at the base of the outer dome, and over the built-in gutter.
5. Replace the electrical panel box and circuit wiring that services the memorial.
6. Replace the cove lighting beneath the lower dome.

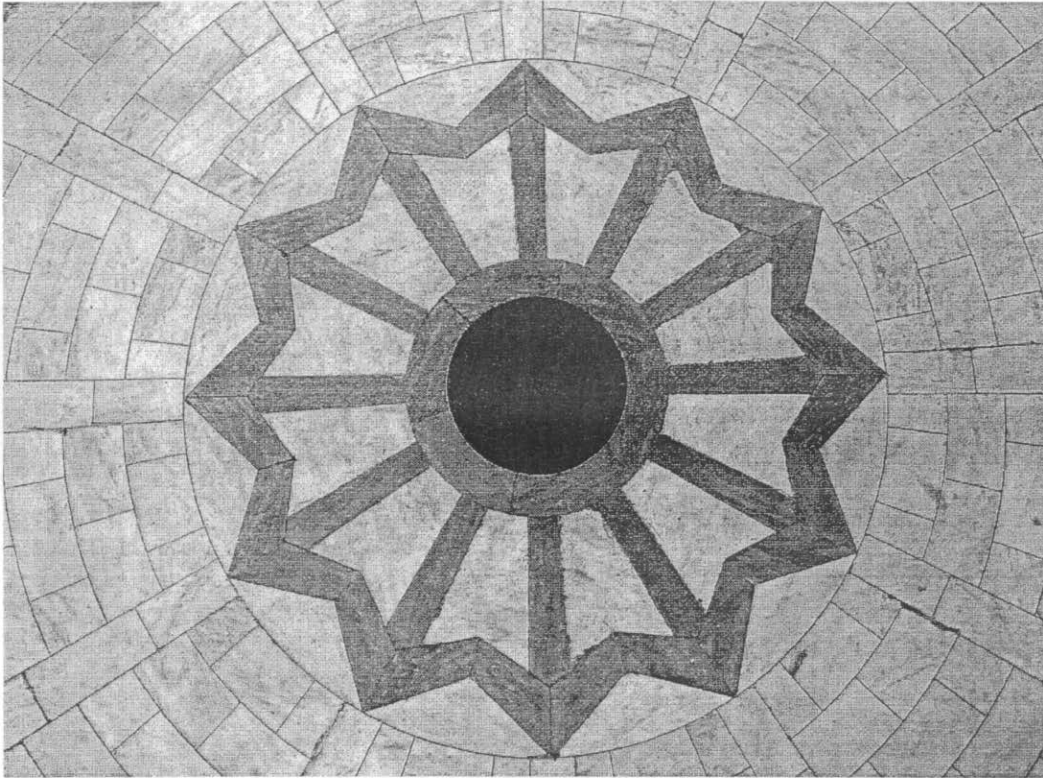
The floor of the Memorial. The original decorative access cover to the vault at the center of the marble floor was stolen in 1970, and has been replaced by a steel cover. [JGWA, 2005]

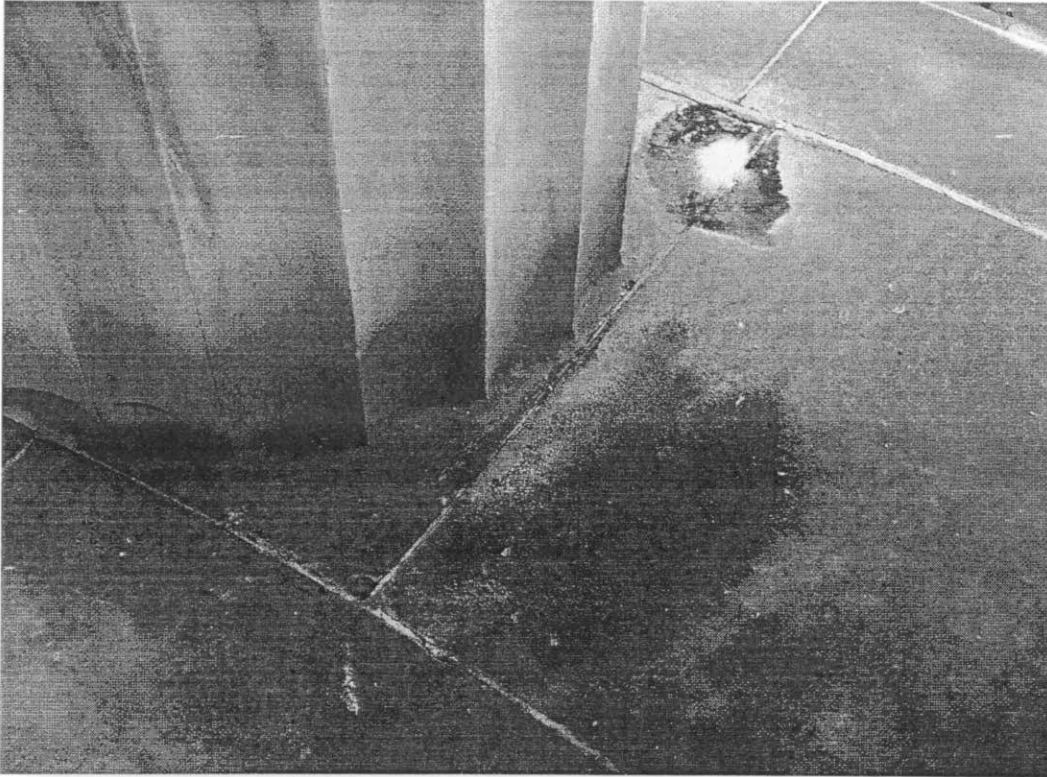
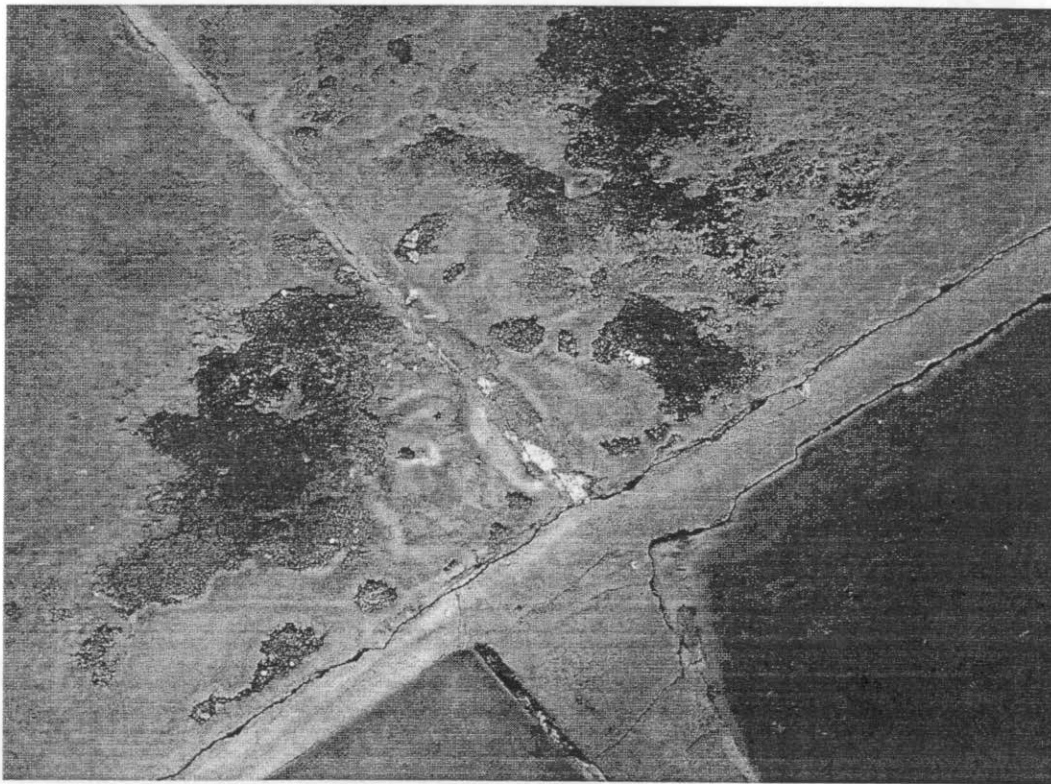
Between the bases of the columns, the marble floor is darkly stained. Areas of encrustation are pronounced in these locations. [JGWA, 2005]

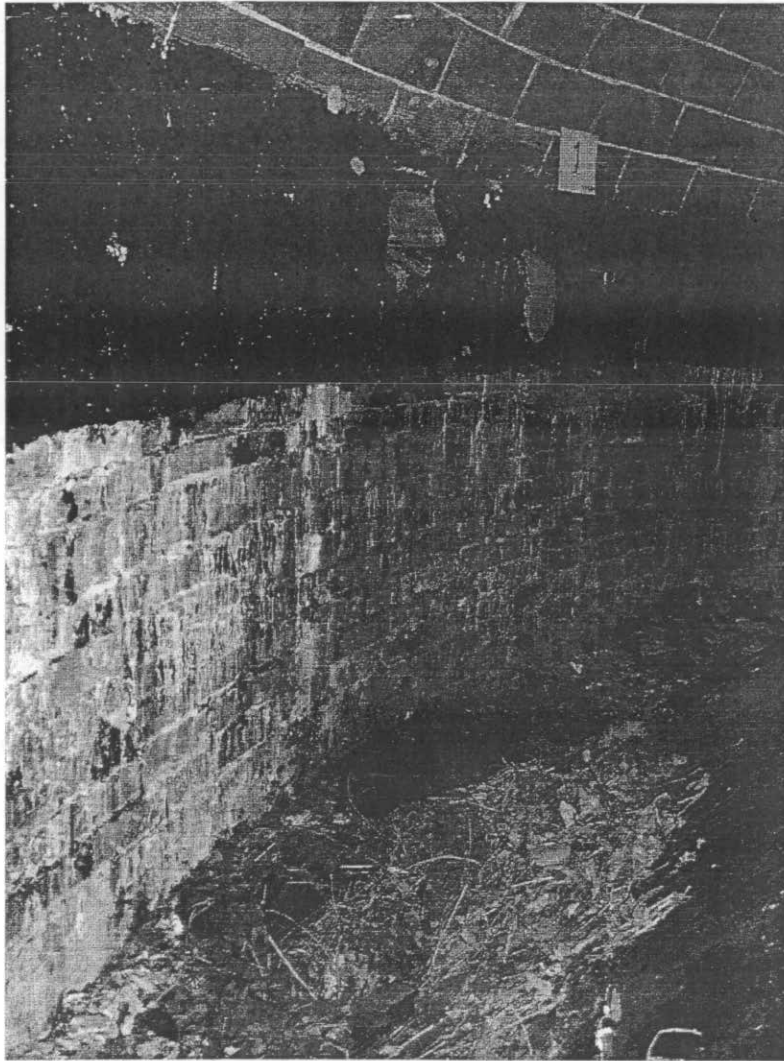
A significant buildup of debris has occurred in the attic space adjacent to an air vent at the base of the upper dome. The waterproof coating on the drum of the dome appears to have delaminated as the result of water infiltration and freeze-thaw cycling. Efflorescence is visible on the brick drum. [JGWA, 2005]

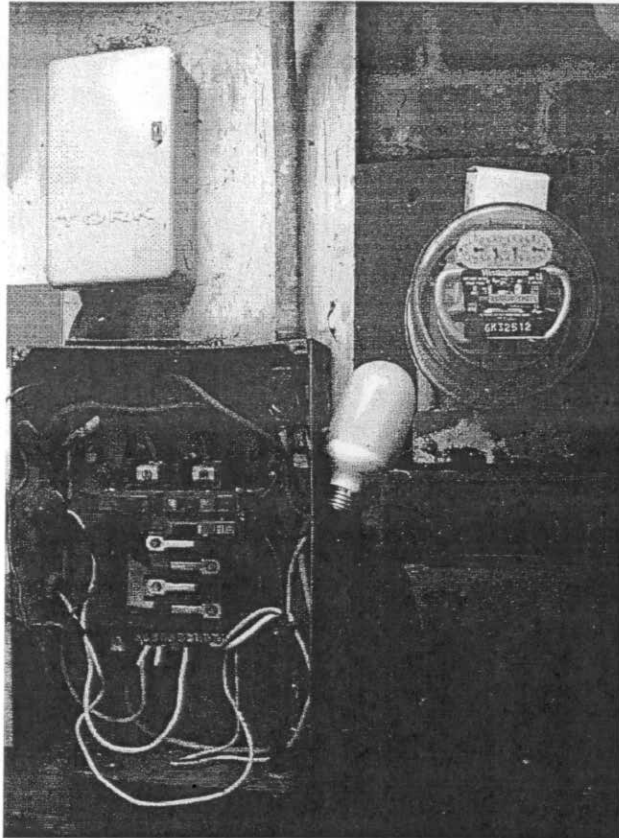
An open electrical junction box and a panel box with exposed conductors are located in the electrical vault beneath the Memorial. These are significant electrical shock hazards. [JGWA, 2005]

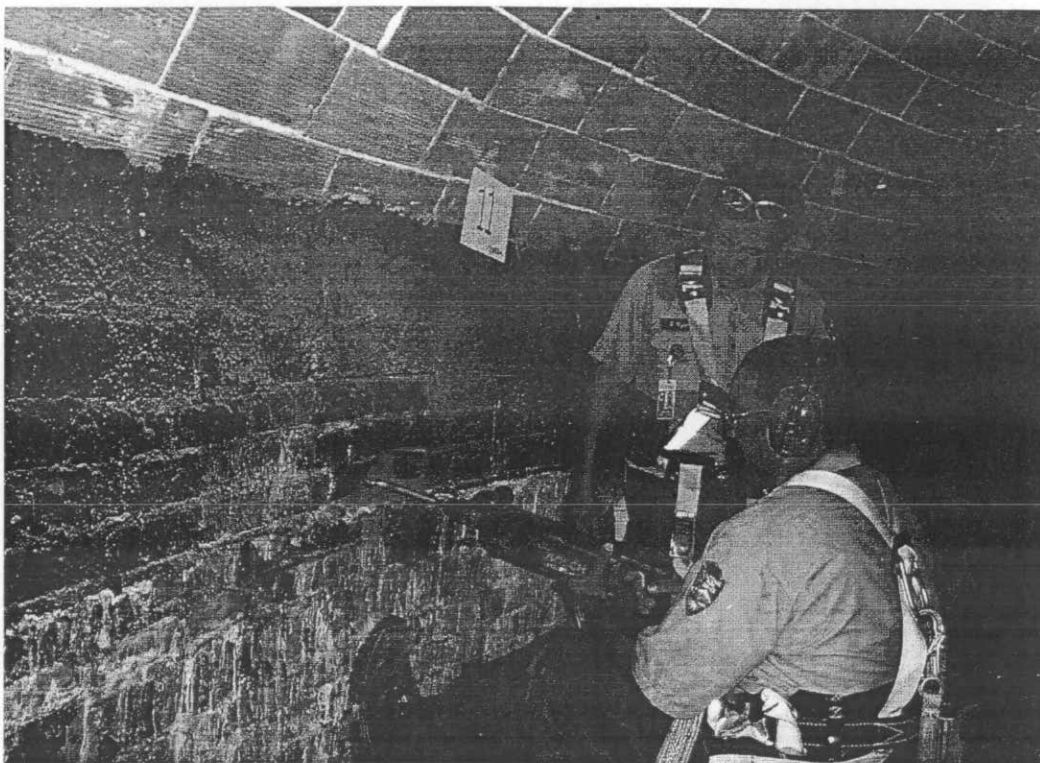
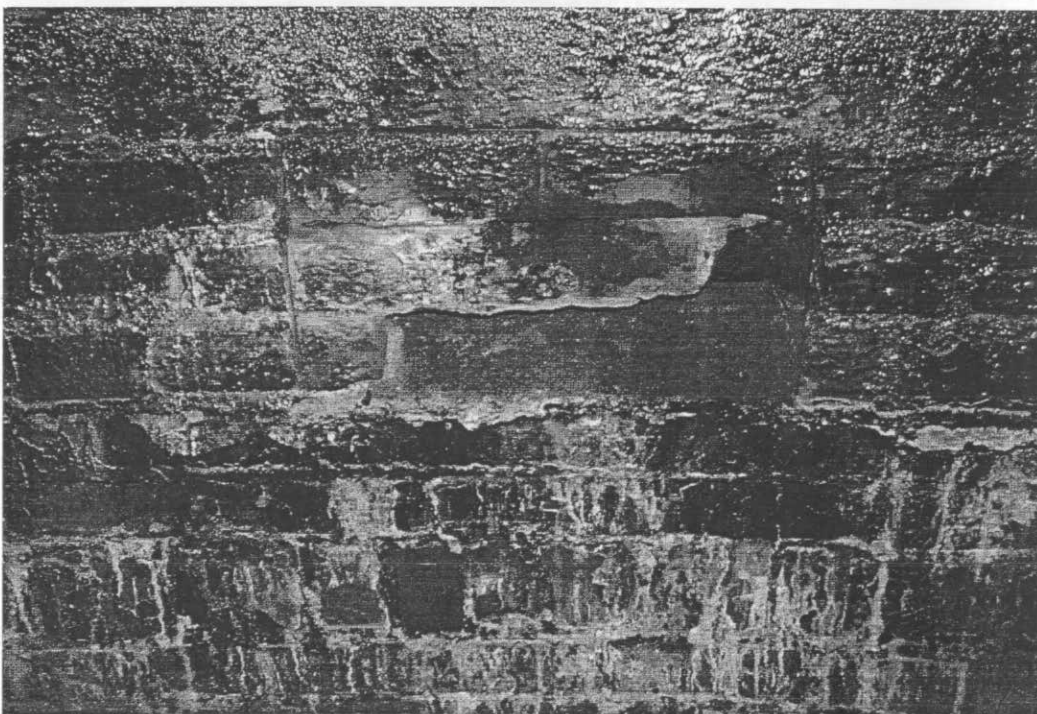
If the through-wall flashing simply continued up the outer surface of the upper tile dome, we would expect the steel-angle tension ring to be seriously corroded as water was shed off the base of the tile dome. This was not the case. The steel was found to be in very good condition, with only a minor degree of surface rust. The membrane on the outer surface of the upper tile dome may have continued out to the lead flashing at the base of the marble dome tiles. In this way the integrity of the steel angle may have been preserved. The 3"± void between the vertical leg of the steel angle and the back face of the marble cap stone of the outer drum may have contributed to the survival of the angle (see drawings).

Probe A investigated the condition of the steel angle tension ring at the base of the upper dome. Binh Nguyen and Ray Wooden of the National Park Service removed brick and mortar from the drum construction supporting the dome. The probe was located between columns 10 and 11. [JGWA, 2005]

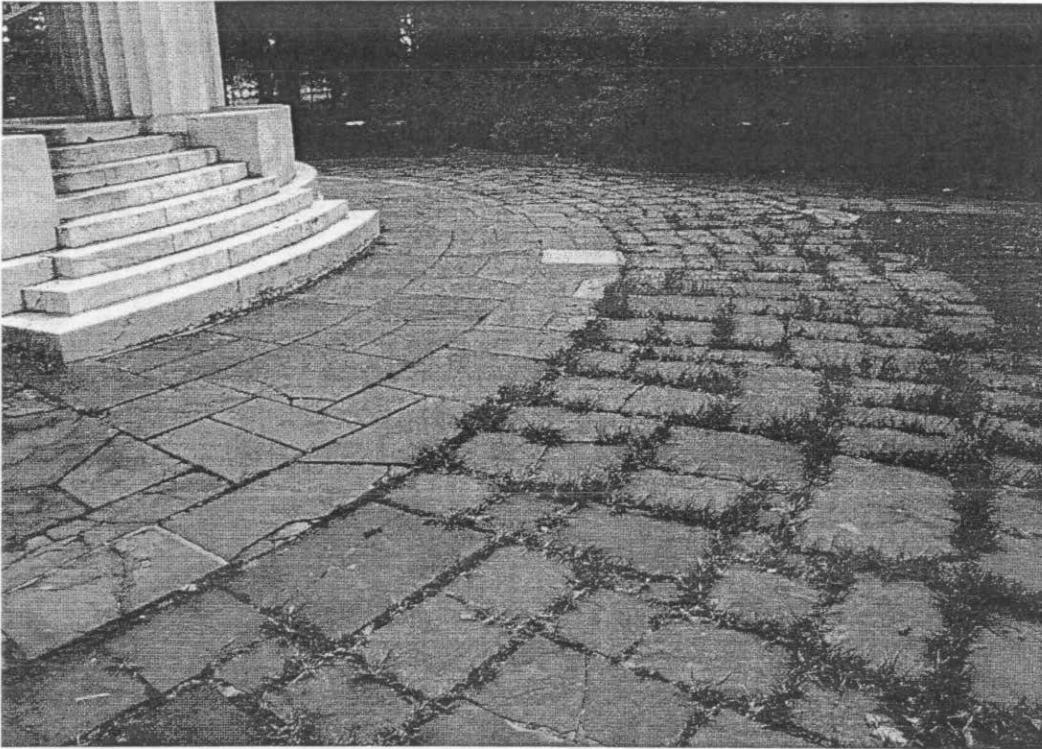
The outer walk with gravel base has weed infiltration, while the inner walk on concrete does not. [EDC, 2005]

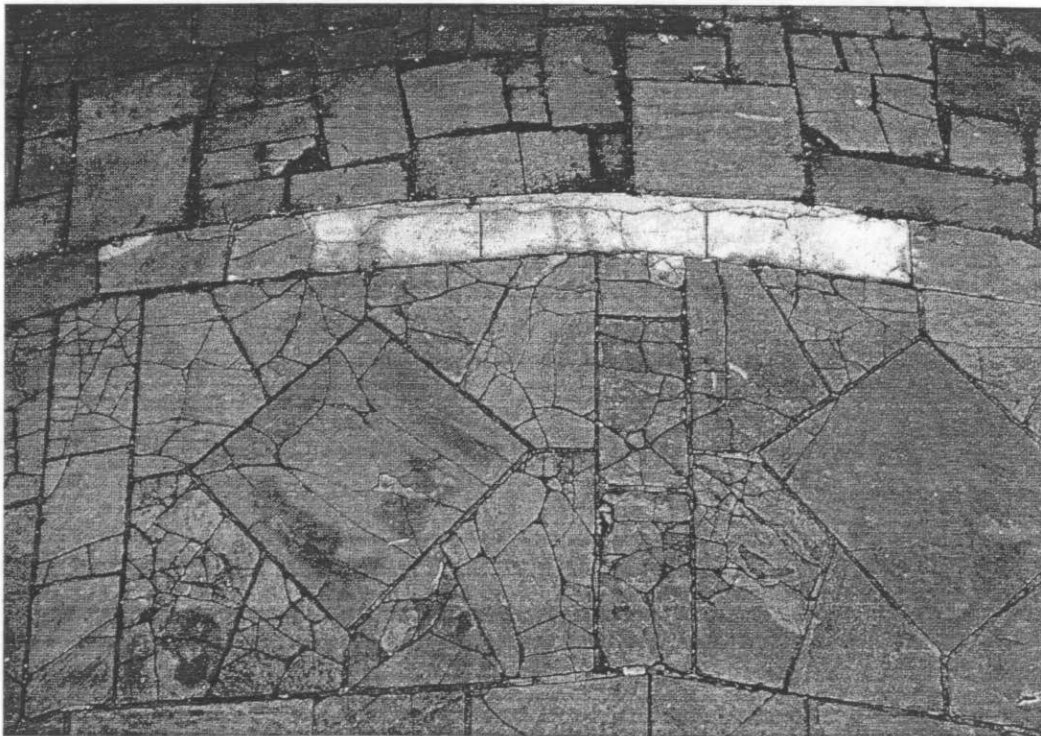
The inner walk has an ornate pattern, while the outer walk is paved with random-cut flagstones.. Note the broken stones due to vehicular traffic. [EDC, 2005]

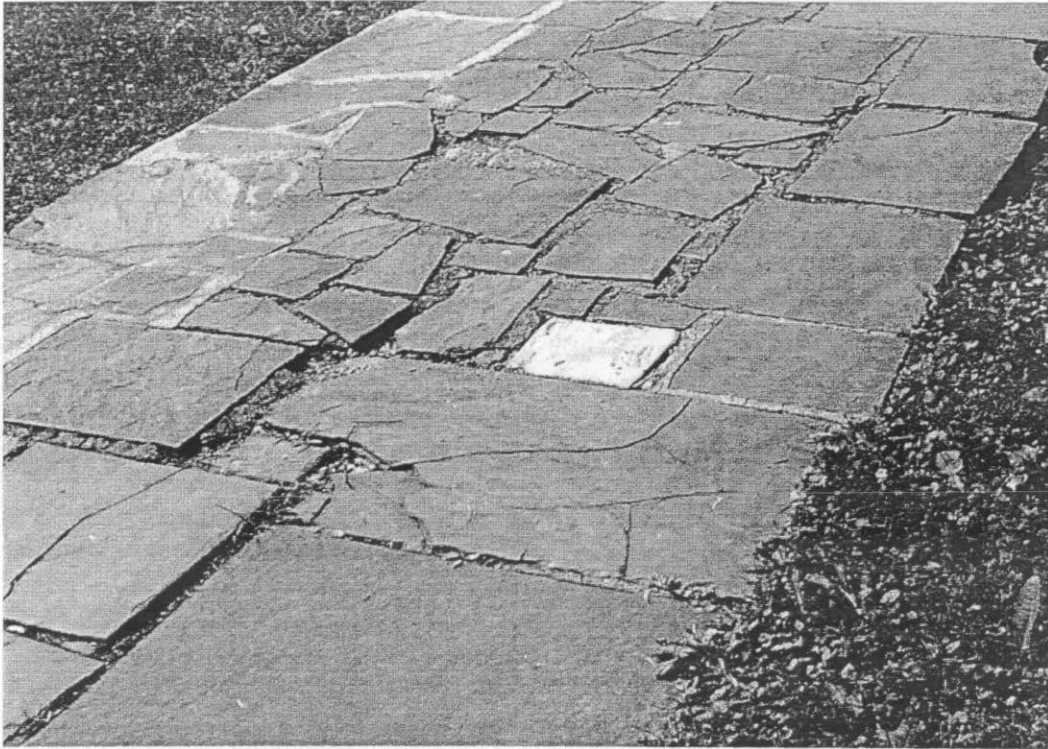
Concrete has been used to fill in missing flagstones. [EDC, 2005]
