DISTRICT OF COLUMBIA WAR MEMORIAL

Historic Structure Report
& Cultural Landscape Assessment

National Mall & Memorial Parks
PMIS NO. 43699

May 2006

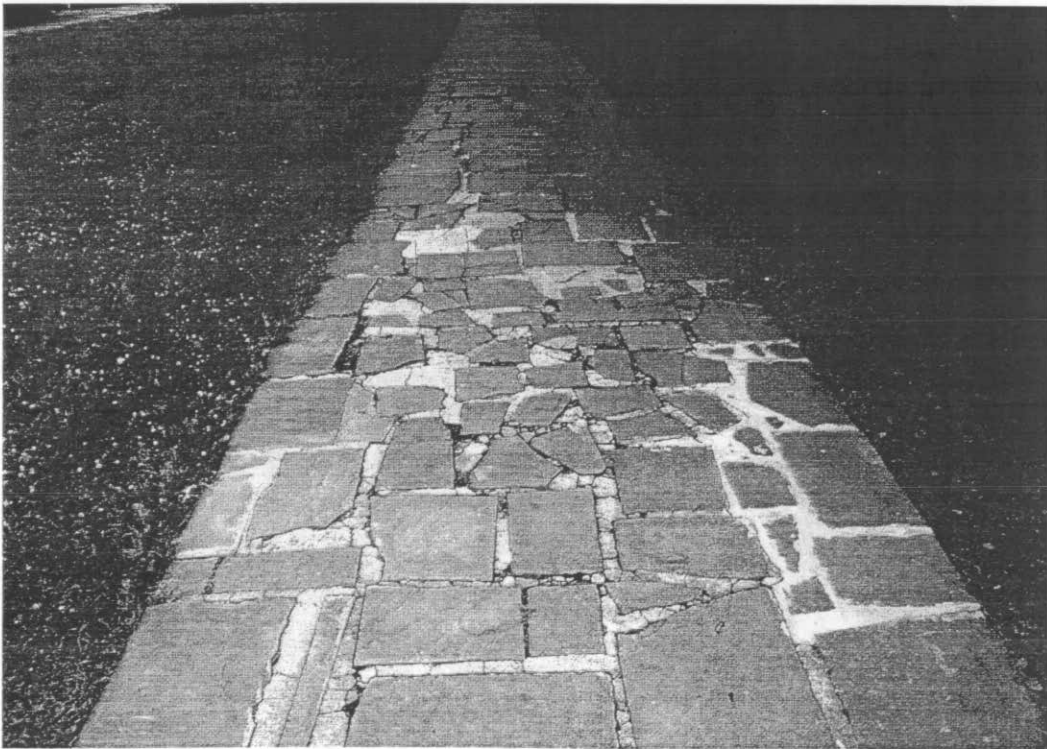
This walk was relaid with small flagstones in a slightly different pattern than original. [EDC, 2005]

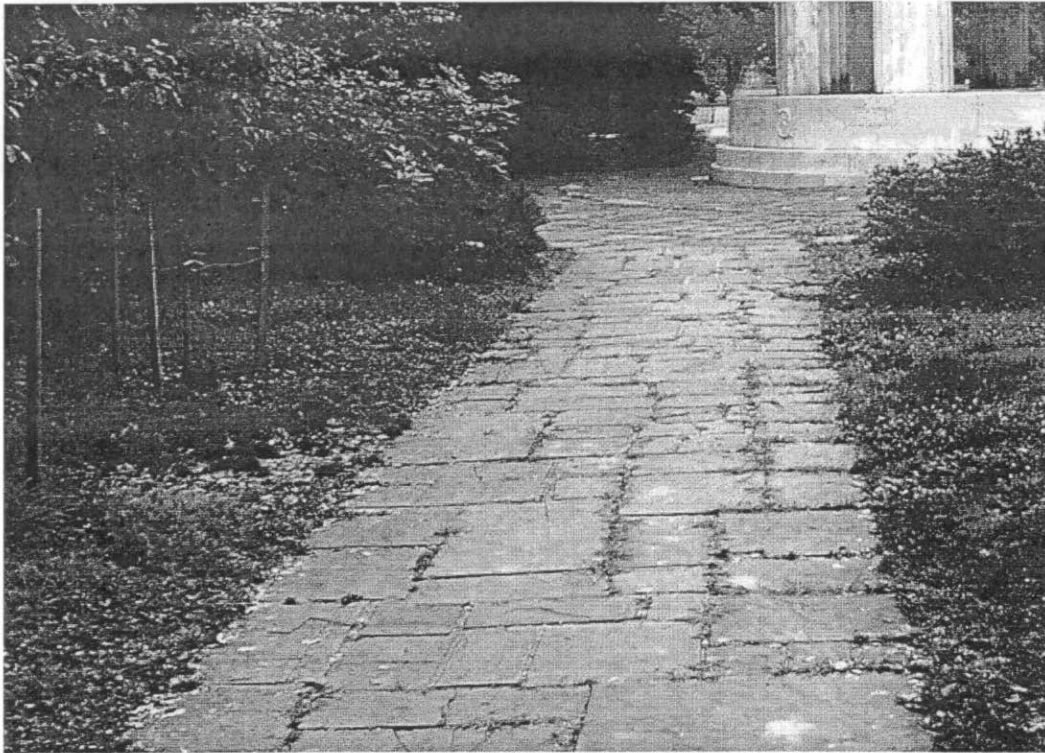
Weed infiltration along the flagstone walks. [EDC, 2005]

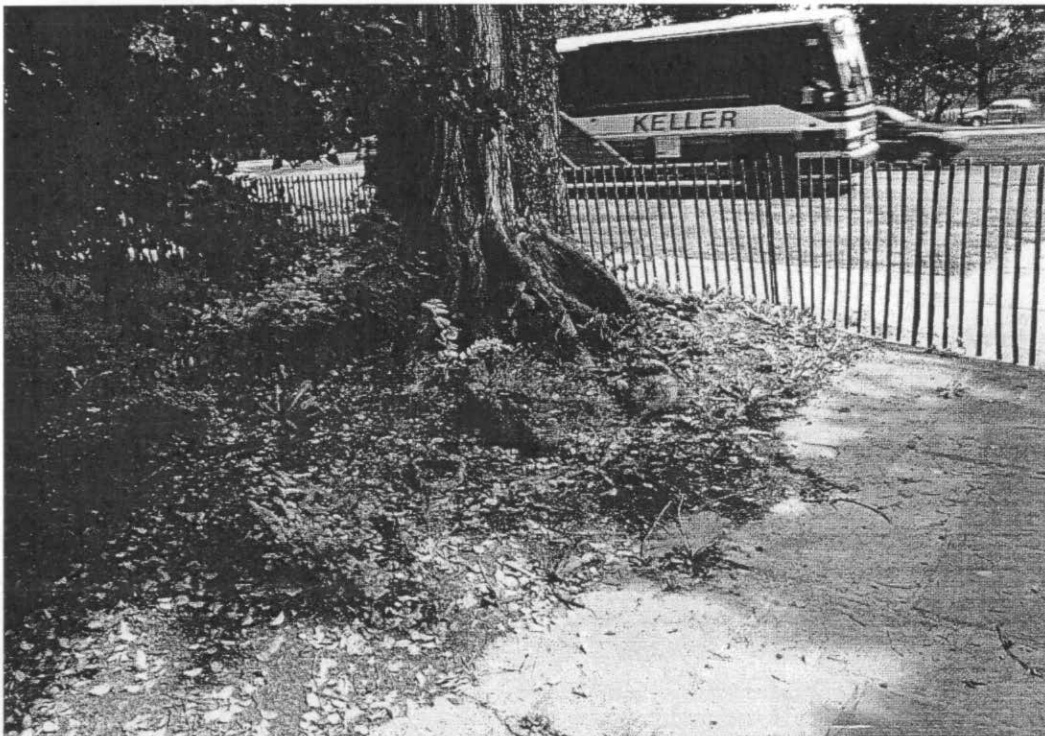
The roots of this large elm tree are starting to damage the flagstone walk. [EDC, 2005]

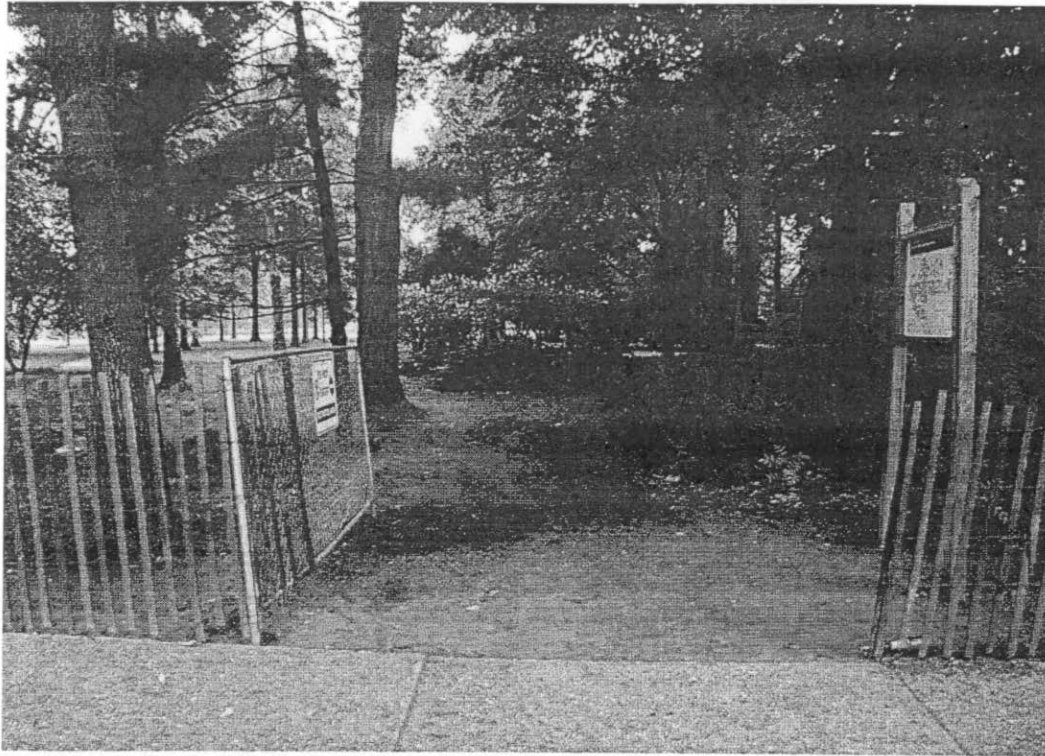
A major wear trail begins at the crosswalk along Independence Avenue and north of West Basin Drive. [EDC, 2005]

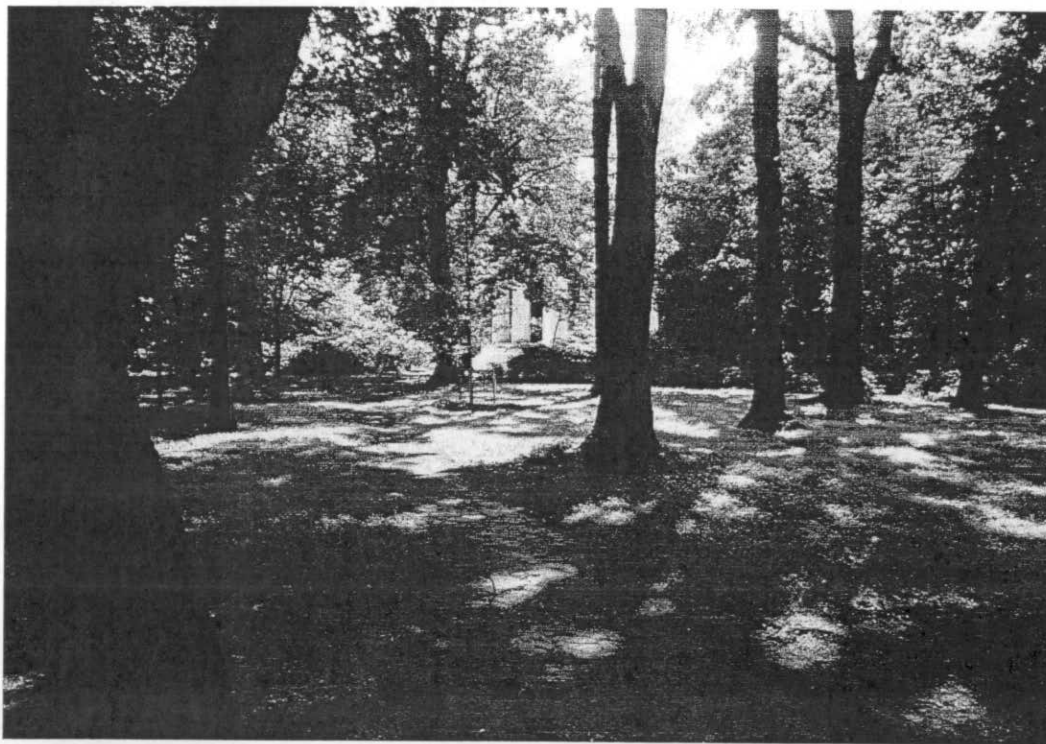
Wear trail between the Memorial and the public restrooms. [EDC, 2005]

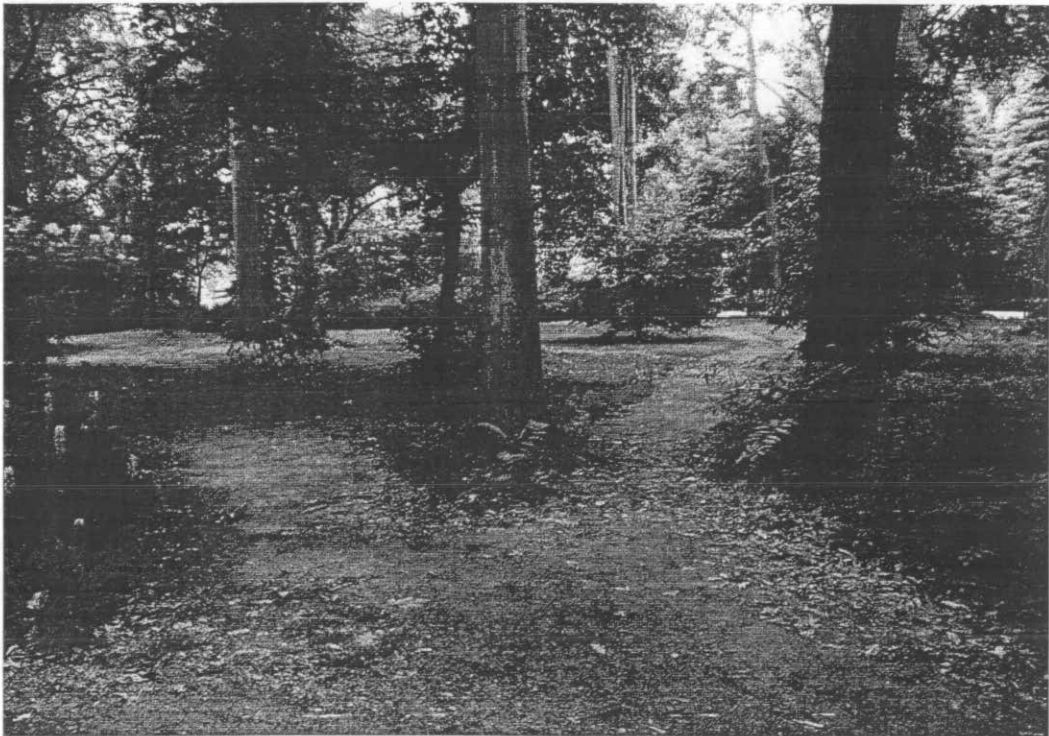
This wear trail, in the west woods, divides and goes in two directions. [EDC, 2005]

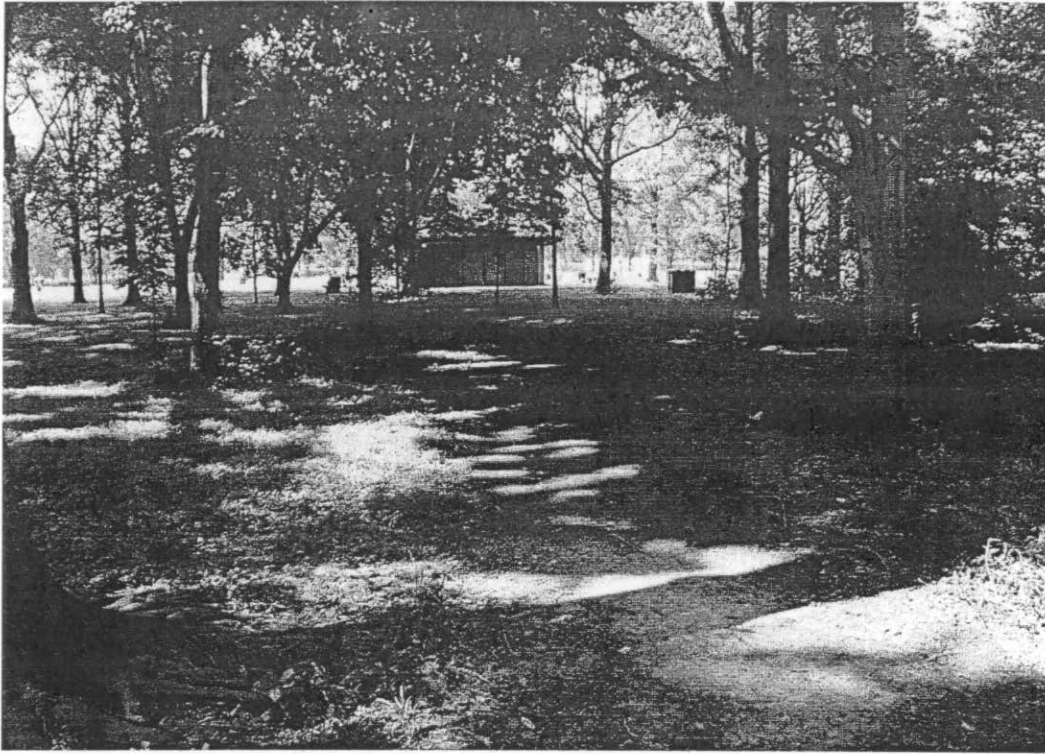
Wear trail leading to the public restrooms. [EDC, 2005]

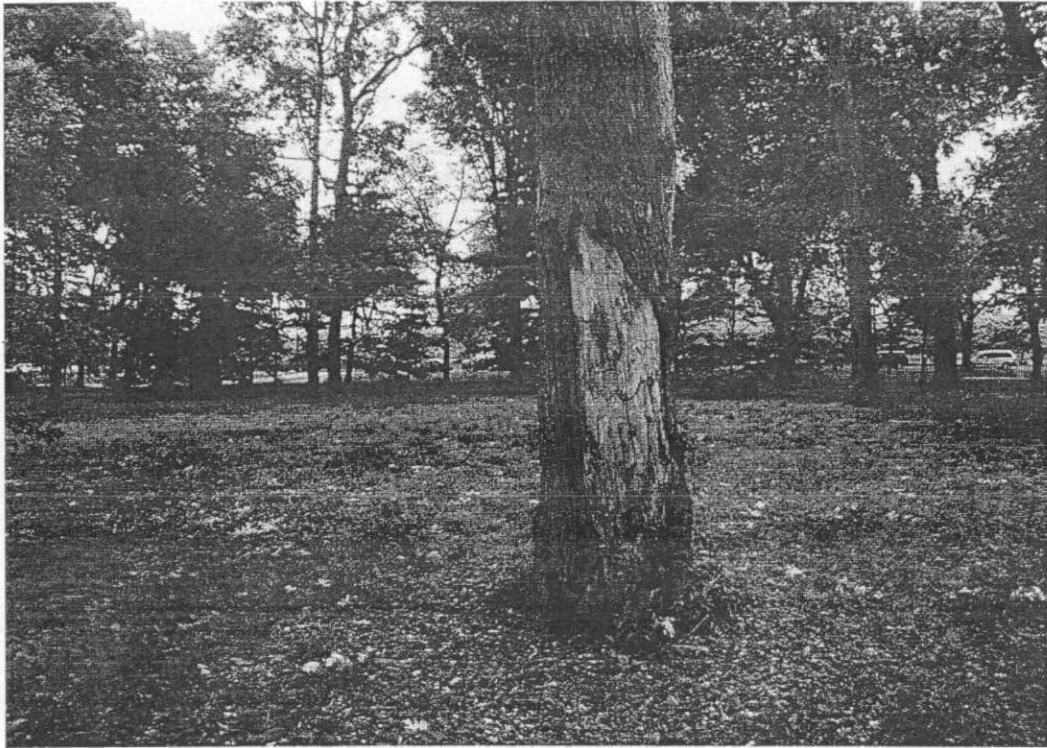
Mechanical damage to some trees does exist. [EDC, 2005]

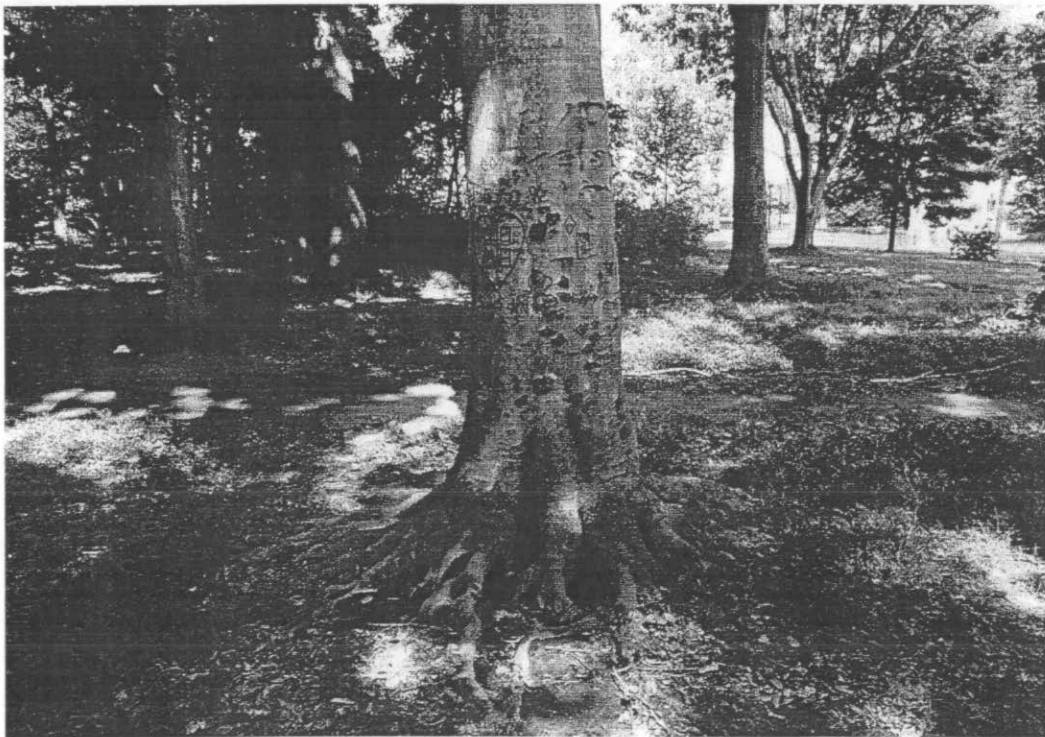
Vandals have carved graffiti into the beech trees. [EDC, 2005]

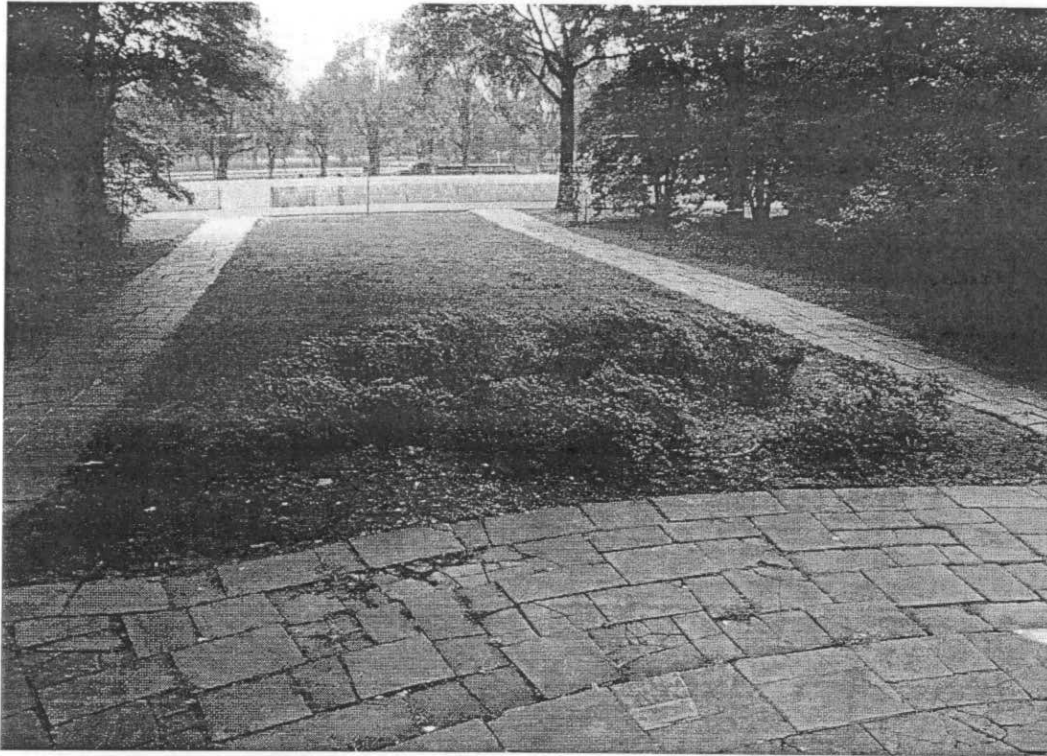
Azaleas located north of the Memorial are in poor condition. [EDC, 2005]

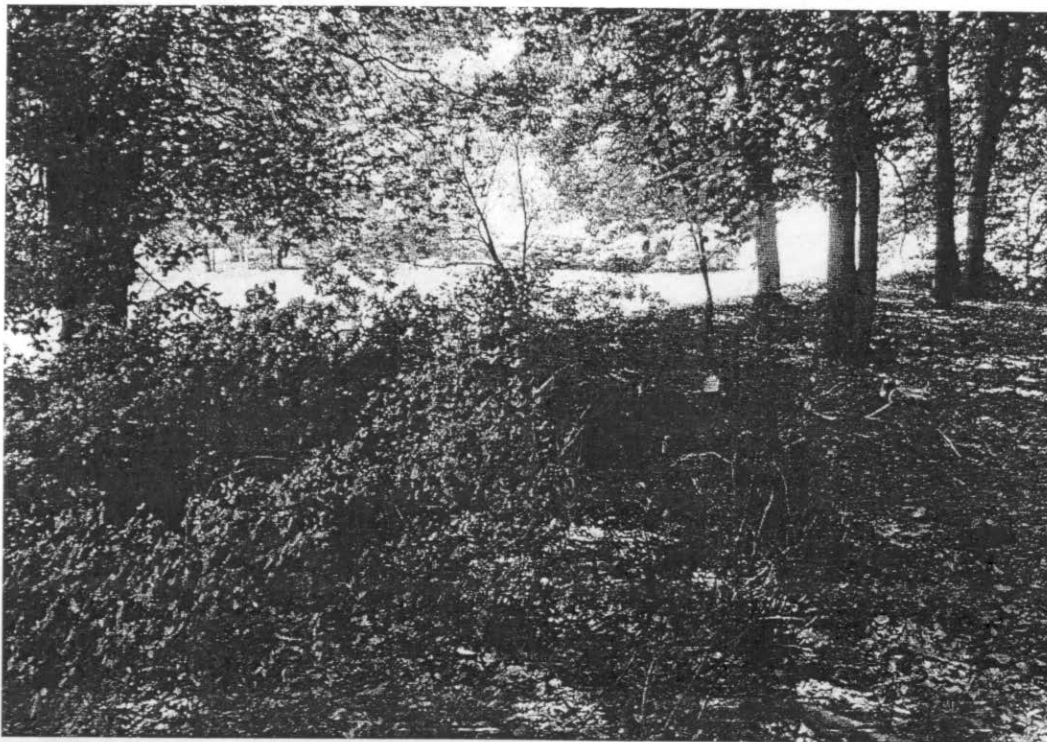
The azaleas are shaded by the trees above and are in poor to fair condition. [EDC, 2005]

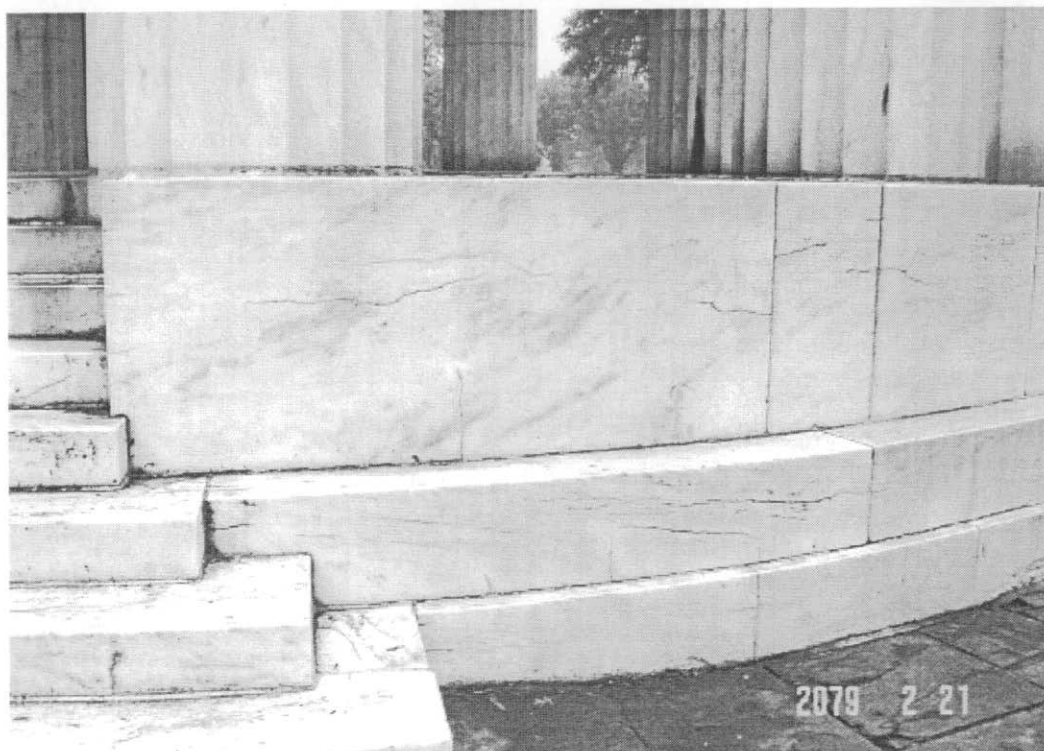
Dark-colored biological growth is present on marble in shaded areas. The blocks exhibit surface cracking. [MSSC, 2005]

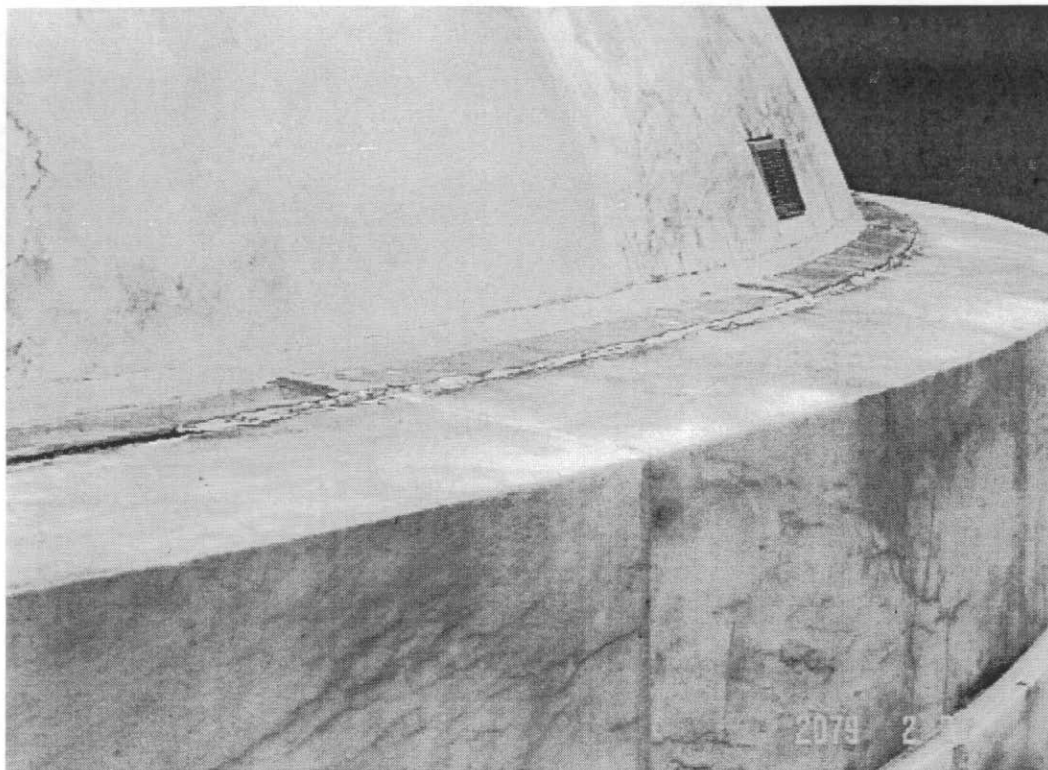
The bright orange stains on several locations on the dome exterior are below the marble surface. [MSSC, 2005]

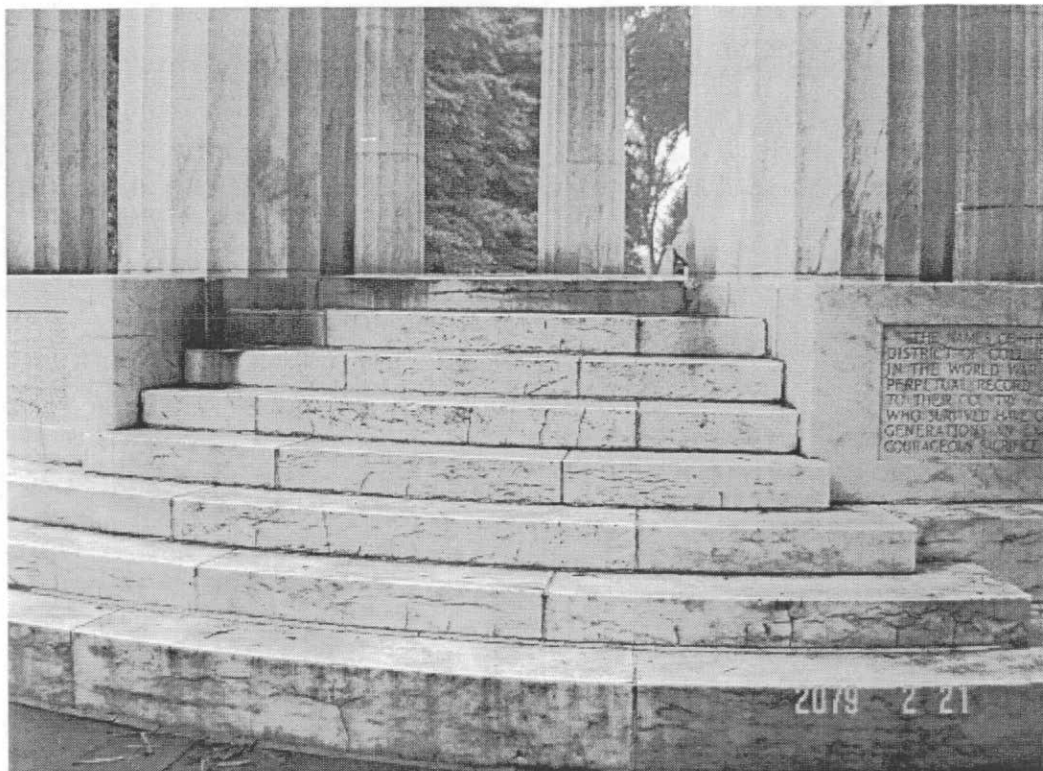
In the marble base and stairs, the cracks are predominantly horizontal. [MSSC, 2005]

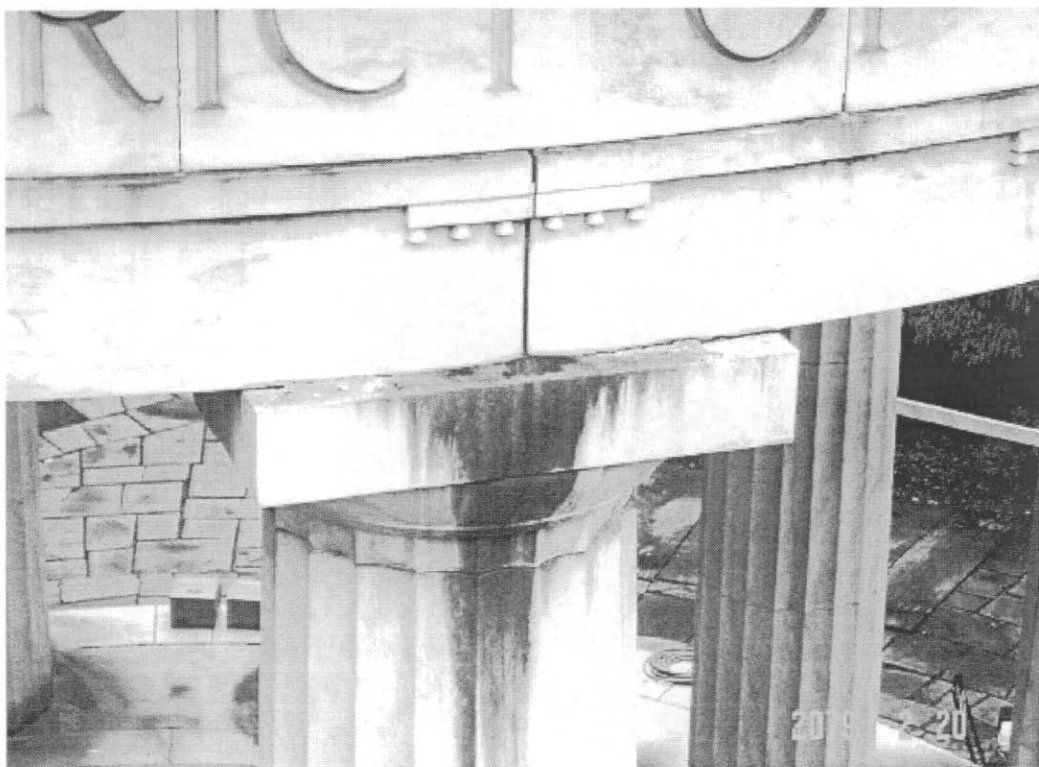
An open head joint above a column. [MSSC, 2005]

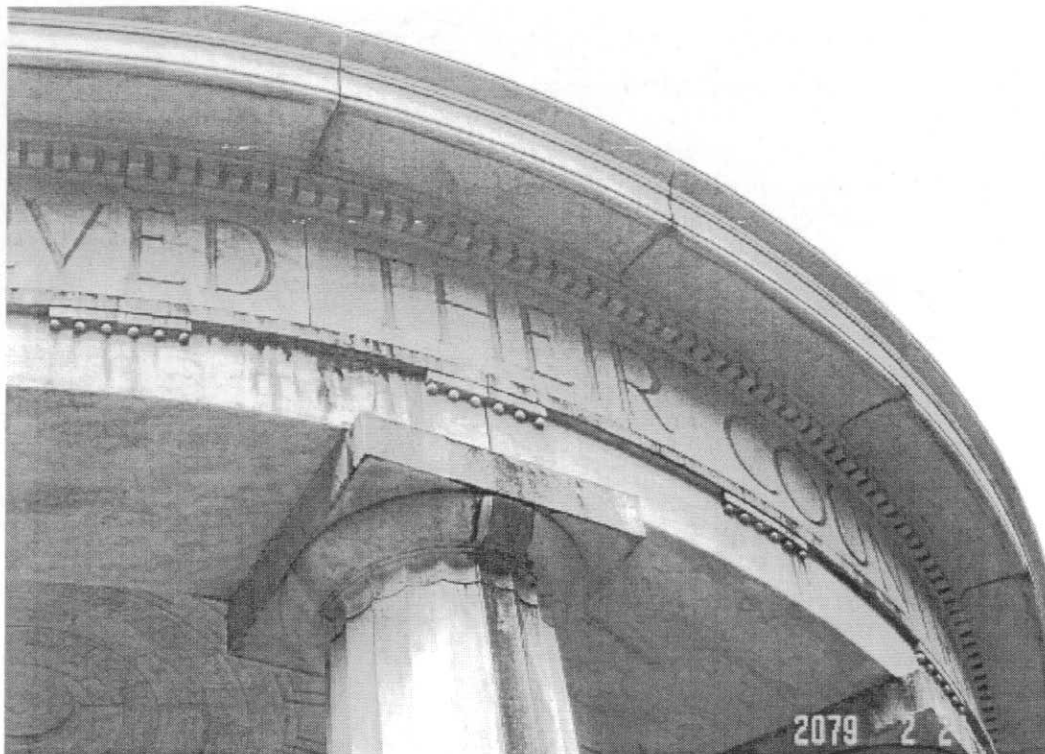
Mortar is missing and deteriorated in many locations on the entablature. [MSSC, 2005]

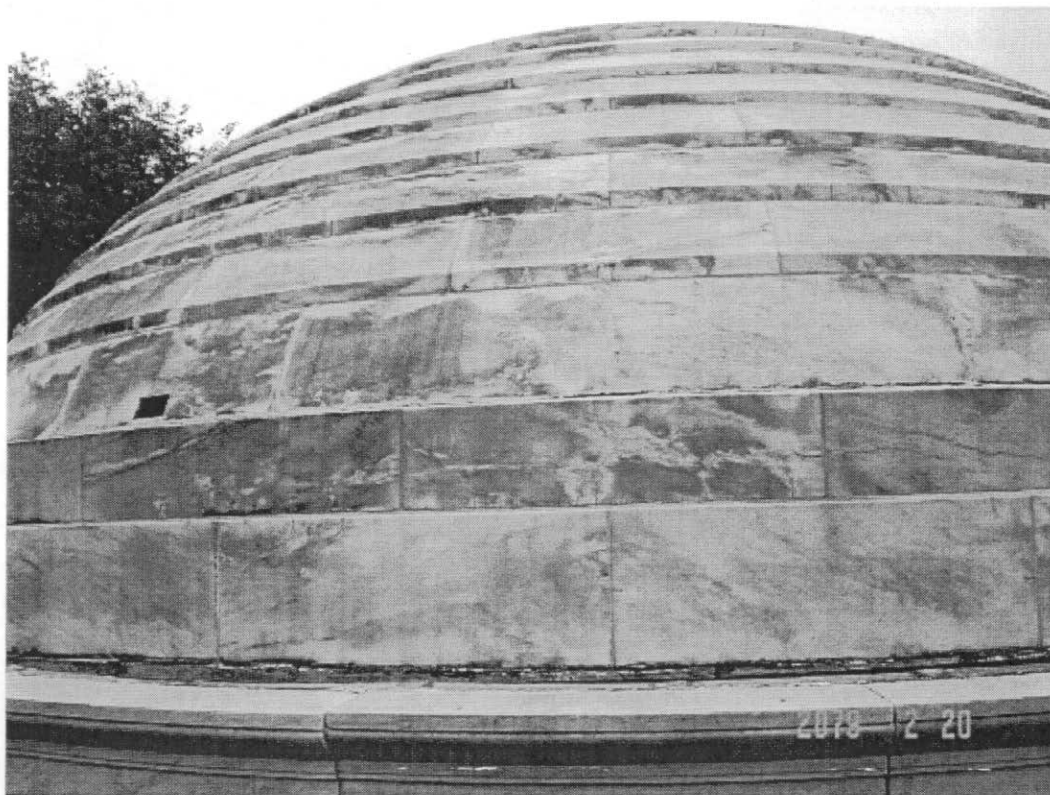
The marble of the dome exhibits dark mottling. [MSSC, 2005]

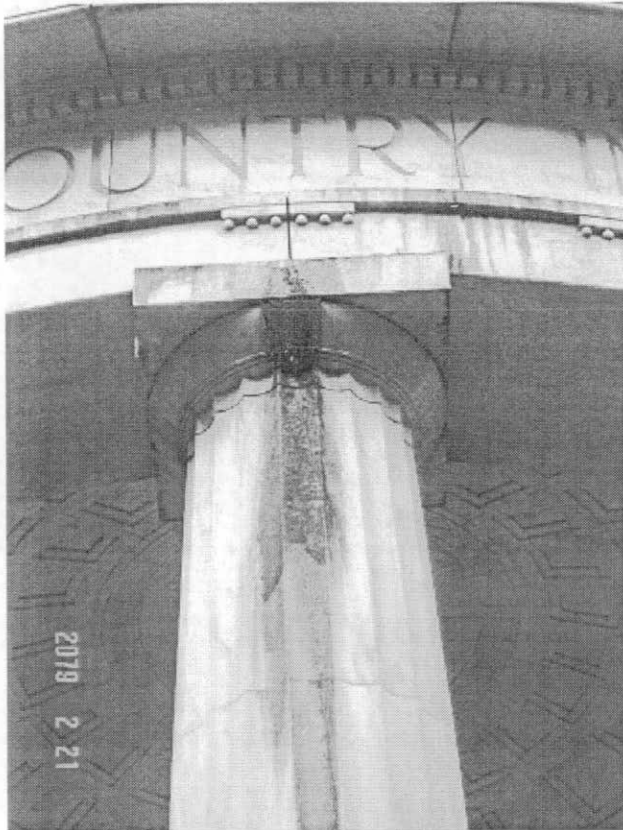
Vertical staining on exterior of entablature and column. [MSSC, 2005]

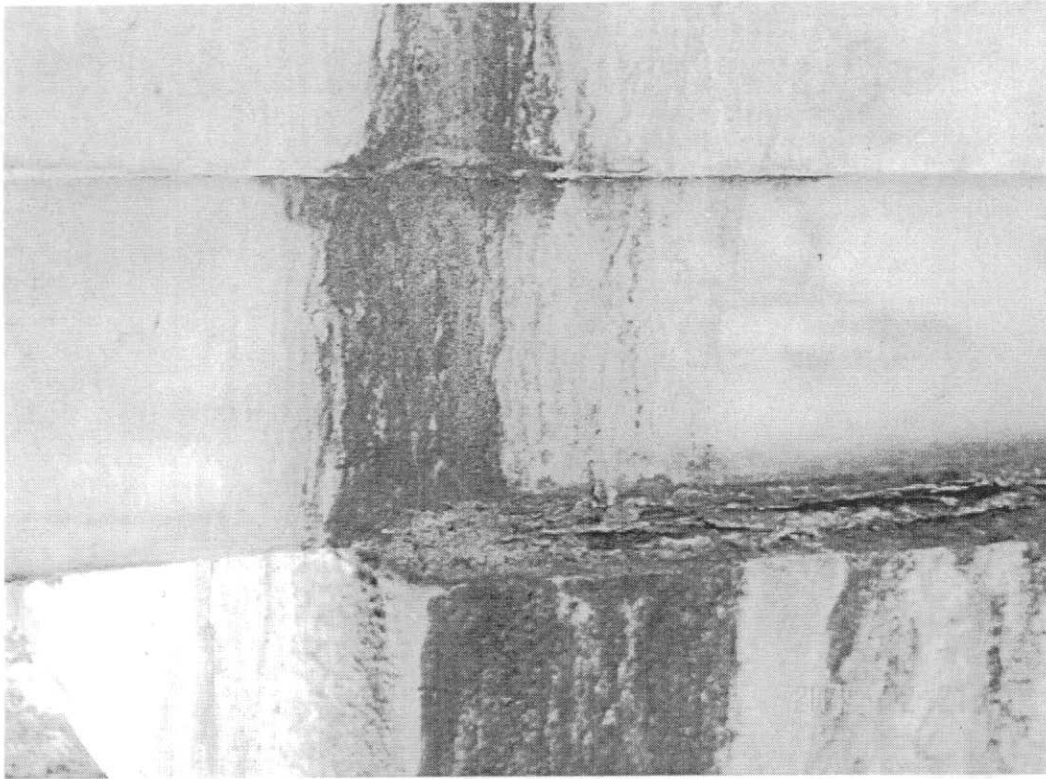
Deposit of staining material on interior of entablature and column capital. [MSSC, 2005]

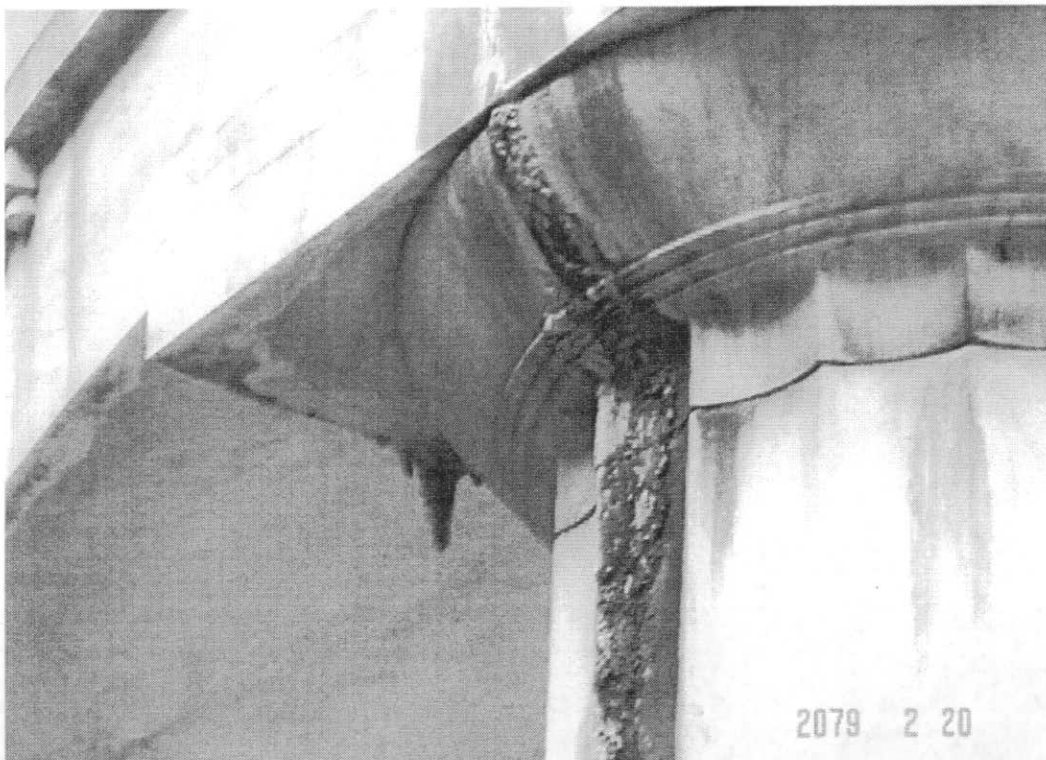
Stalactite on base of entablature. [MSSC, 2005]

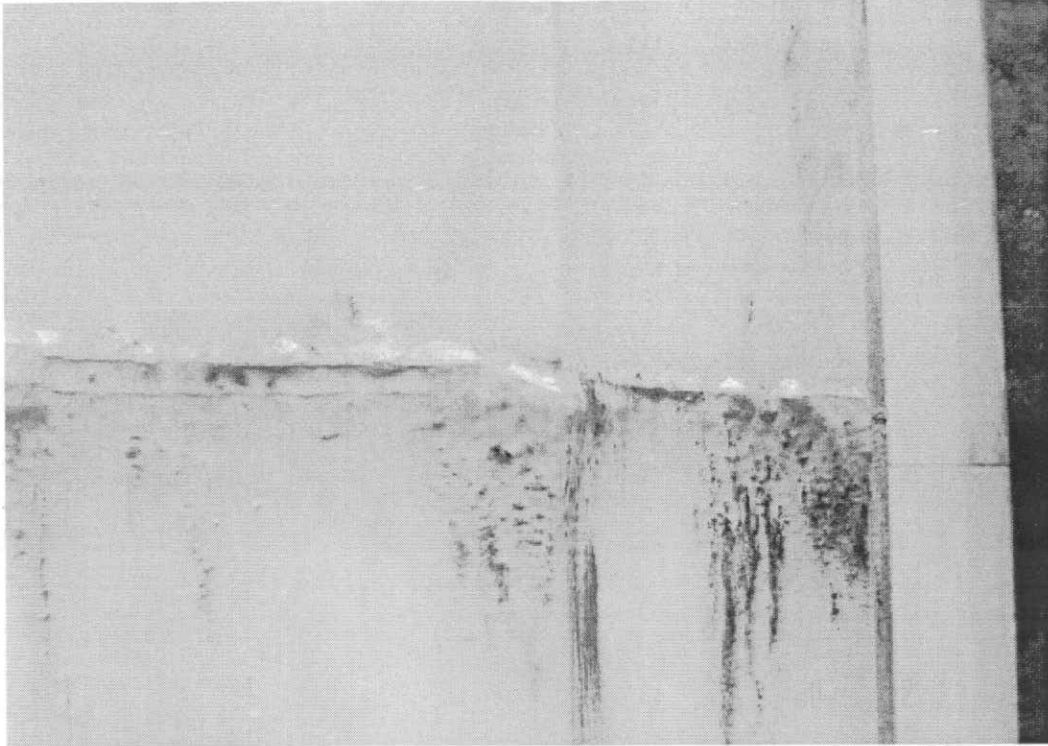
Staining material at column horizontal joint. [MSSC, 2005]

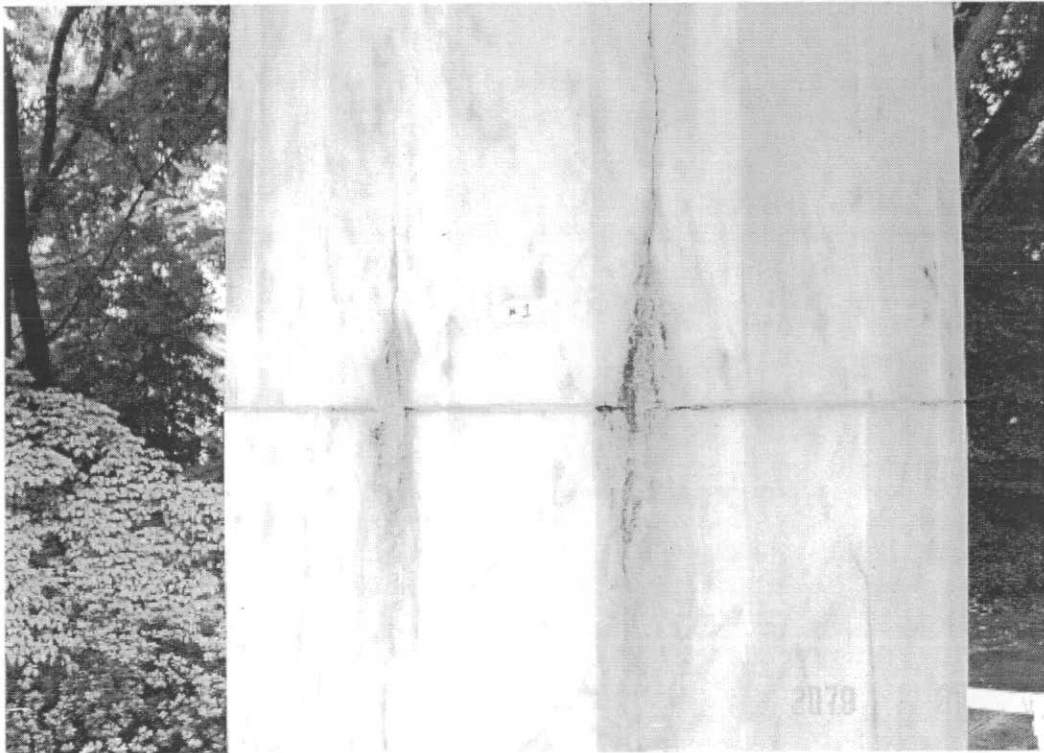
Staining material at vertical crack in column. [MSSC, 2005]

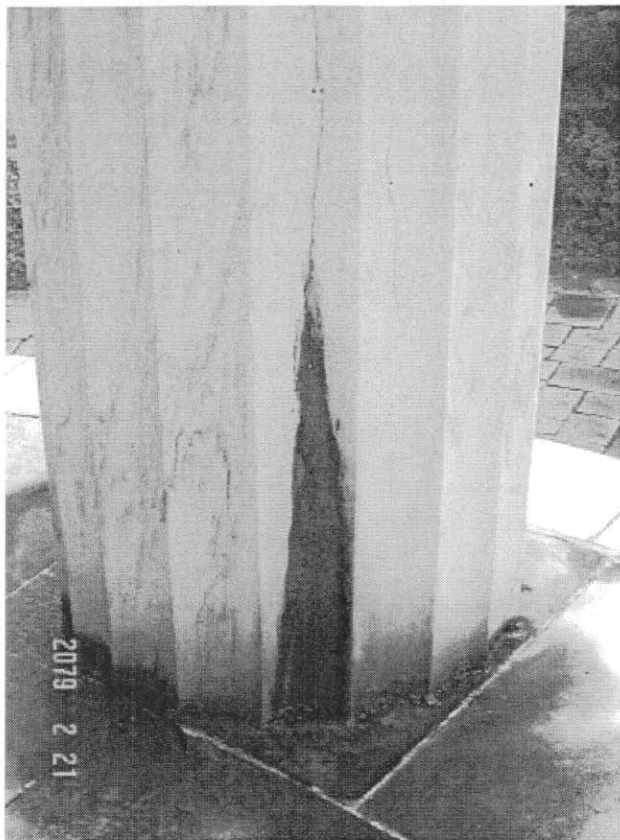
Severe dark-colored vertical stain at the base of column 4. [MSSC, 2005]

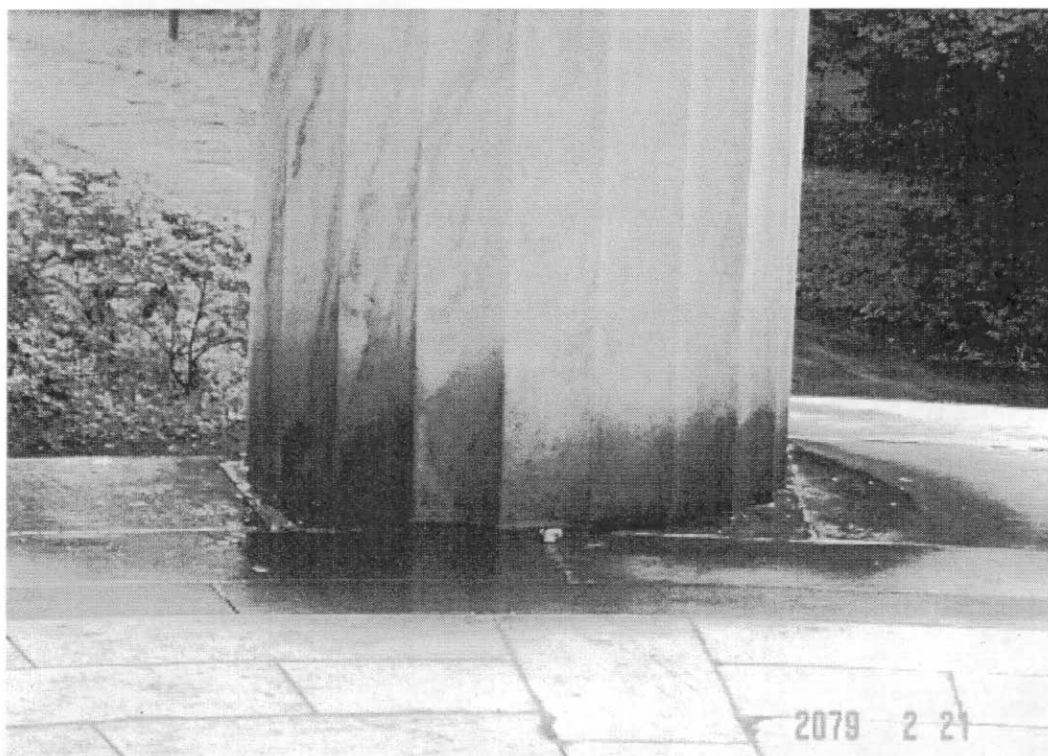
Dark-colored soiling at base of column. [MSSC, 2005]
