Nicodemus National Historic Site
Nicodemus, Kansas
Historic Structures Report
National Park Service

25 October 2002

Bahr Vermeer Haecker Architects, Ltd.
in association with
Wiss Janney Elstner Associates, Inc.

Historic Structures Report

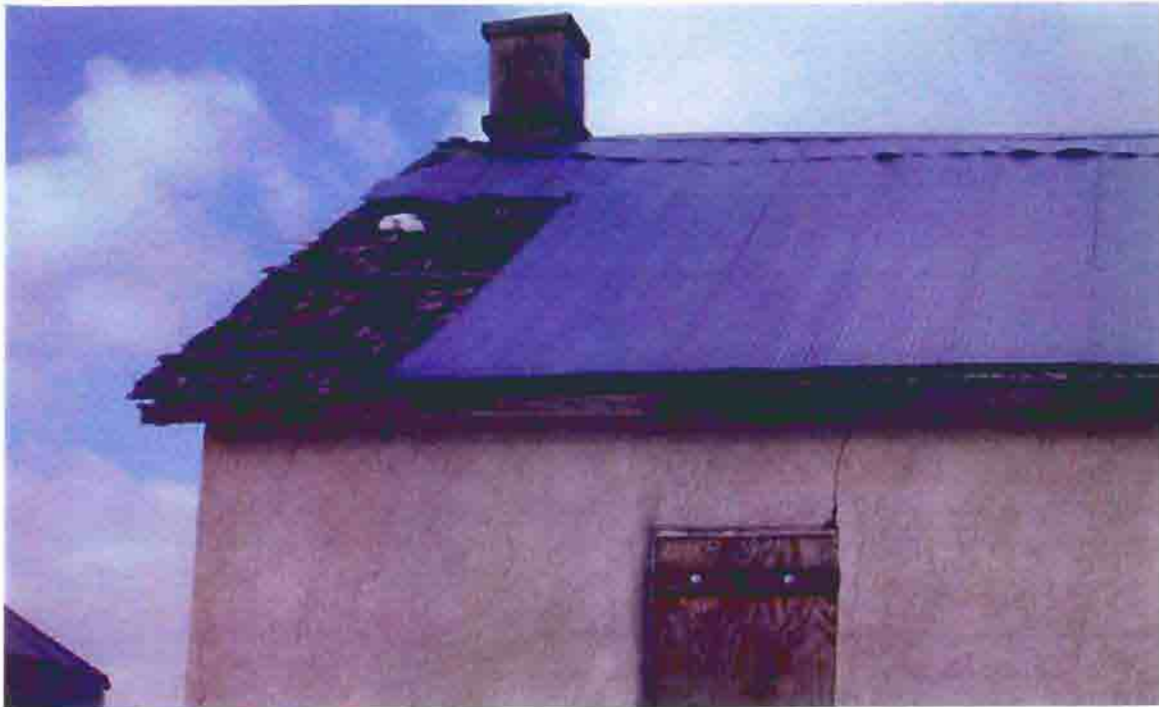
Photo A-17. The A.M.E. Church, missing metal at the west end of the roof, February 2001. Photo by Wiss, Janney, Elstner Associates, Northbrook, Illinois.

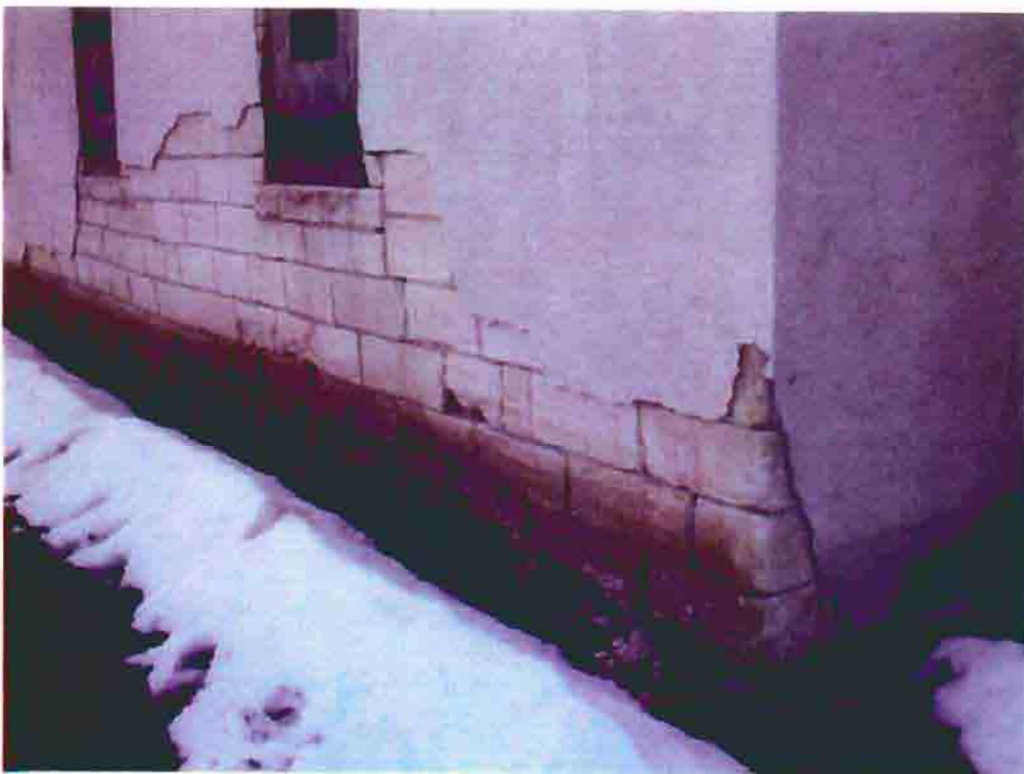
Photo A-20. The A.M.E. Church, failed stucco along the south wall, February 2001. Photo by Wiss, Janney, Elstner Associates, Northbrook, Illinois.

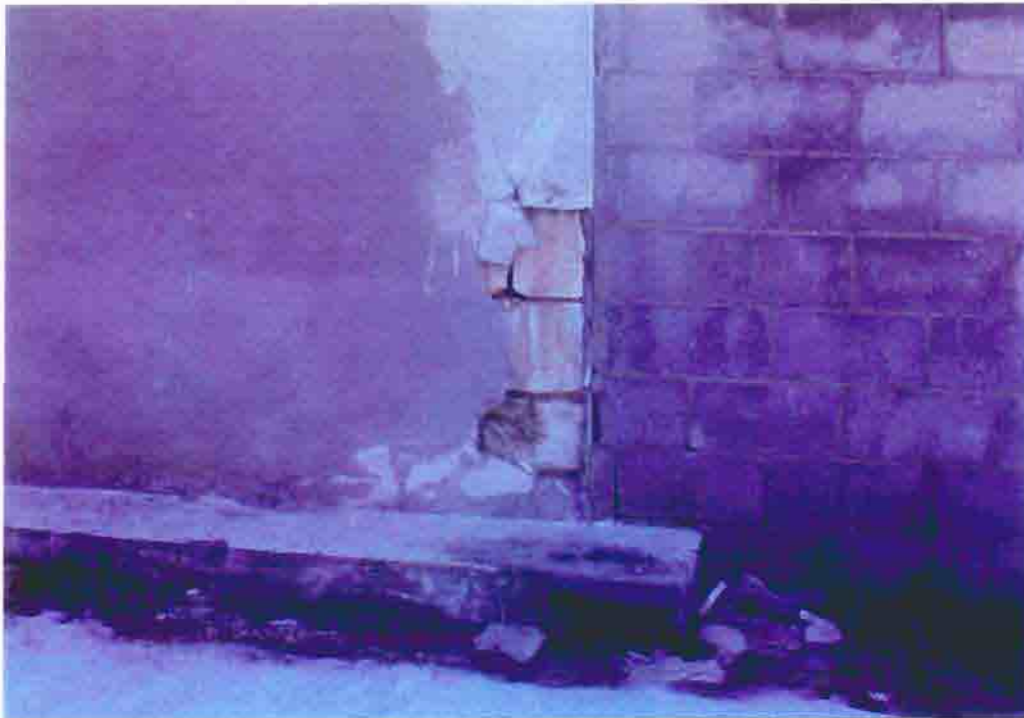
Photo B-16. The Old First Baptist Church, failed stucco on the north elevation, February 2001. Photo by Wiss, Janney, Elstner Associates, Northbrook, Illinois.

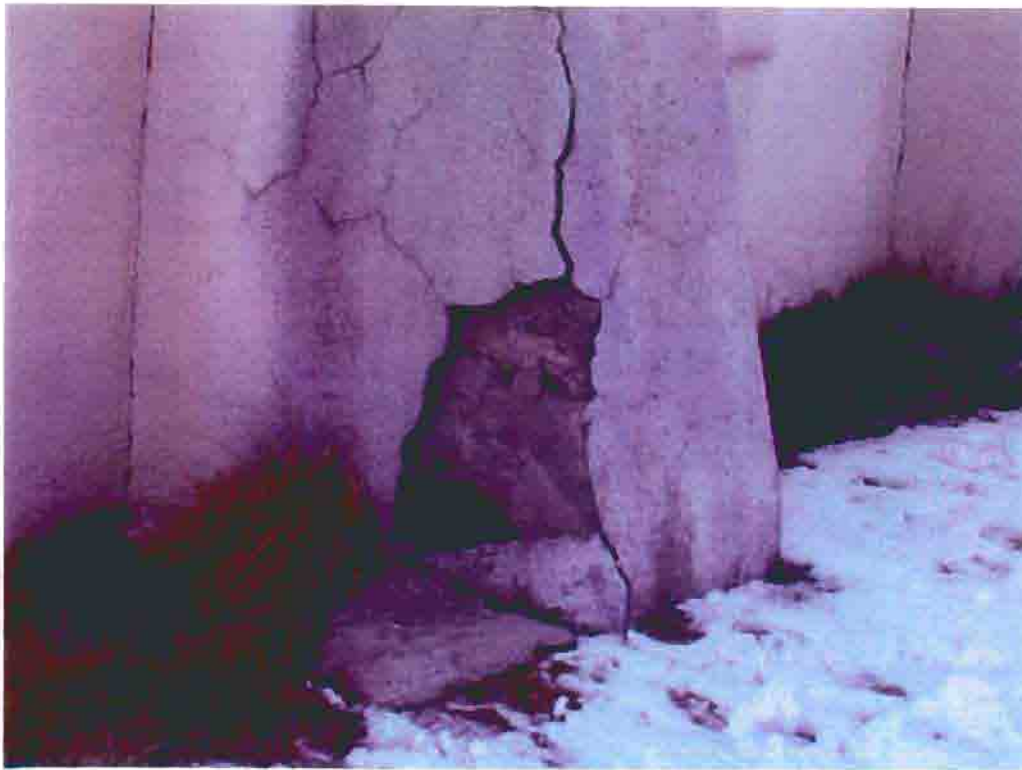
Photo B-18. The Old First Baptist Church, failed stucco on buttress, February 2001. Photo by Wiss, Janney, Elstner Associates, Northbrook, Illinois.

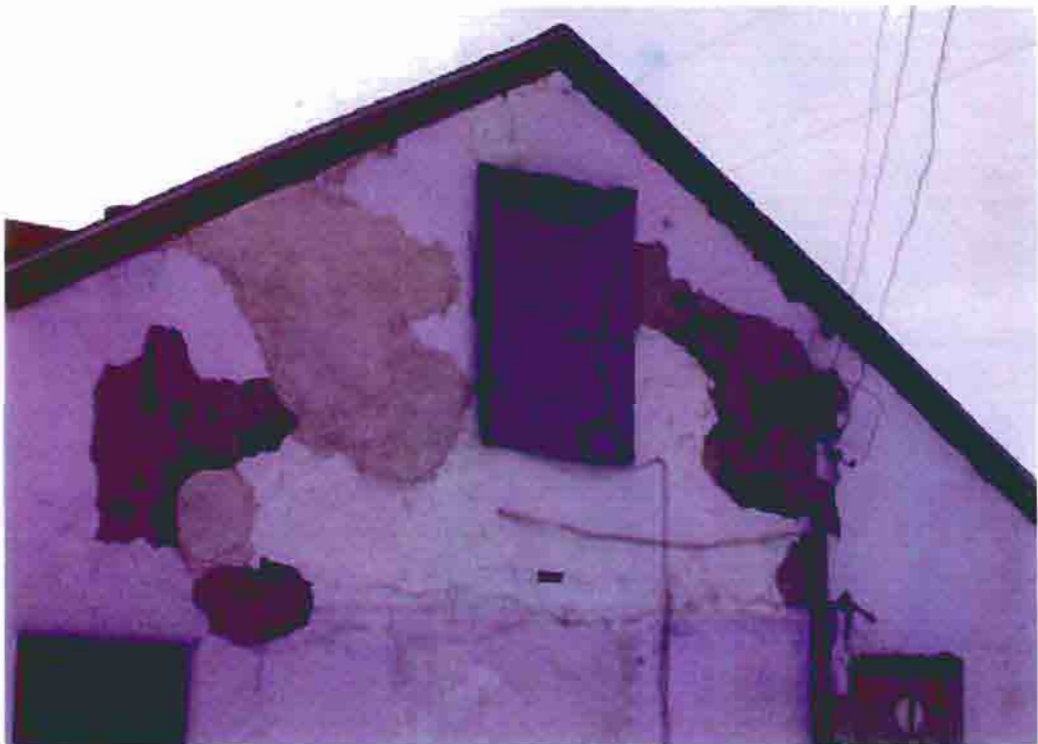
Photo F-14. The Fletcher-Switzer House, failed stucco on the east elevation,
February 2001. Photo by Wiss, Janney, Elstner Associates, Northbrook, Illinois.

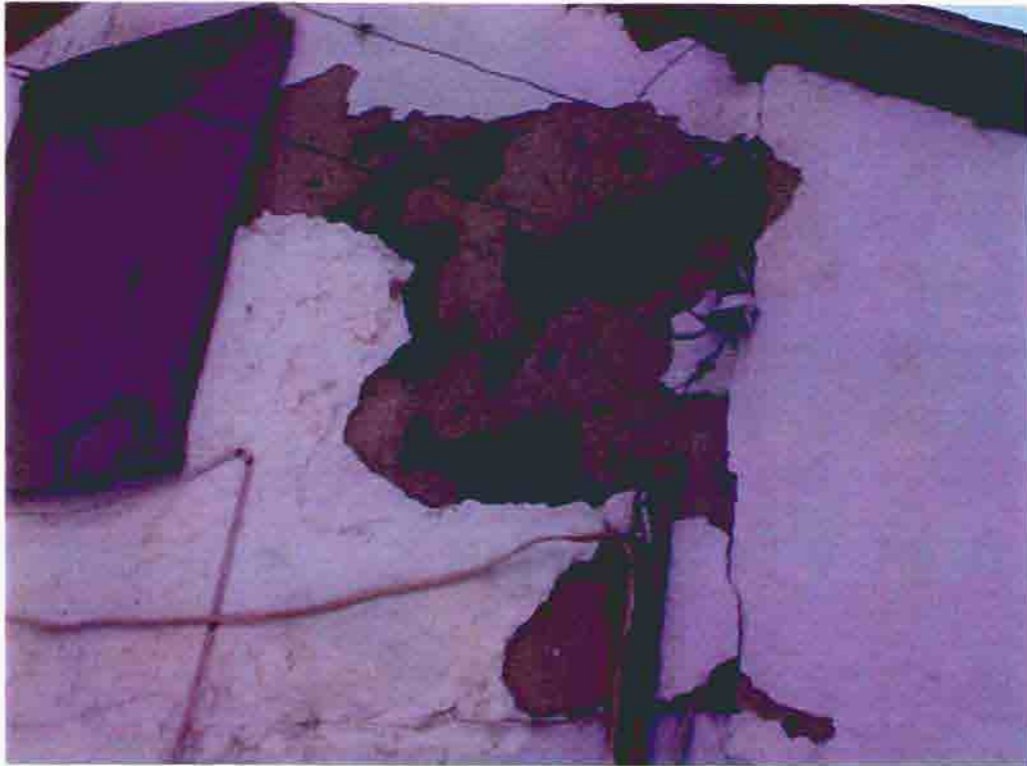
Photo F-15. The Fletcher-Switzer House, detail of failed stucco on the east elevation, February 2001. Photo by Wiss, Janney, Elstner Associates, Northbrook, Illinois.

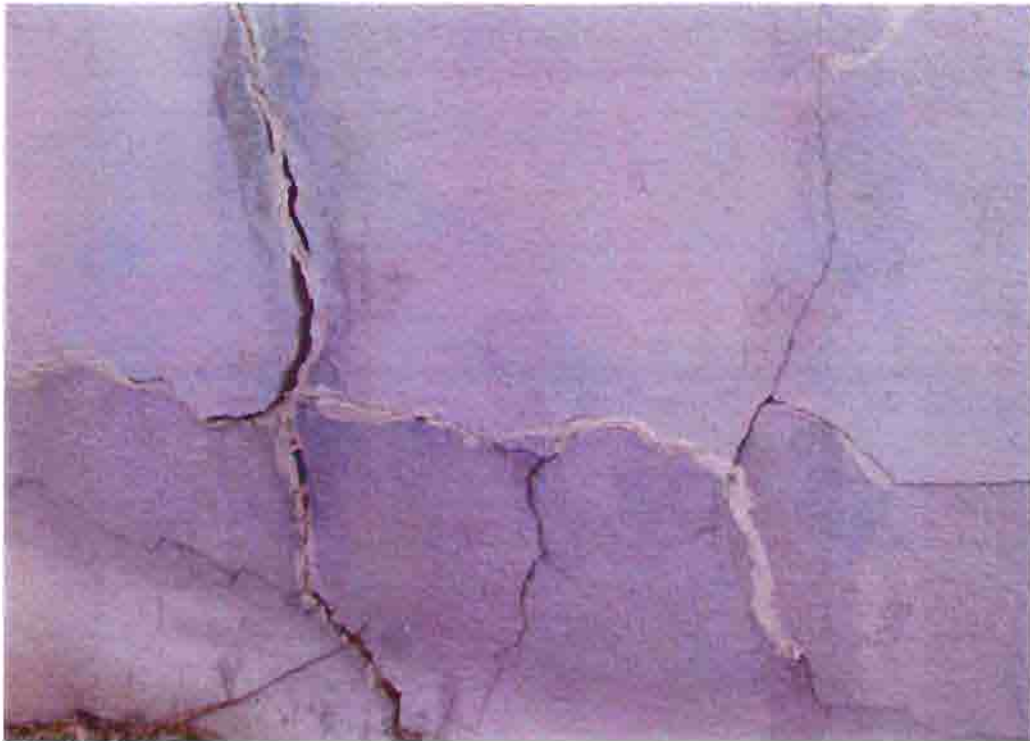
Photo F-17. The Fletcher-Switzer House, failing stucco, February 2001. Photo by Wiss, Janney, Elstner Associates, Northbrook, Illinois.

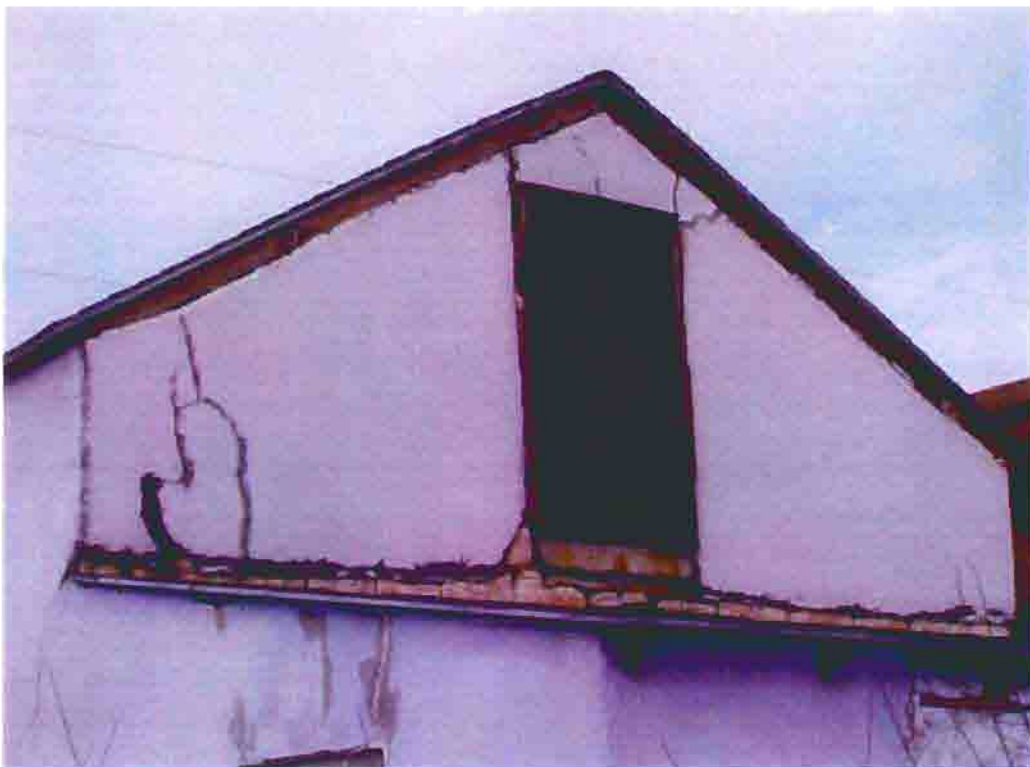
Photo F-18. The Fletcher-Switzer House, cracks at the second floor window, February 2001. Photo by Wiss, Janney, Elstner Associates, Northbrook, Illinois.

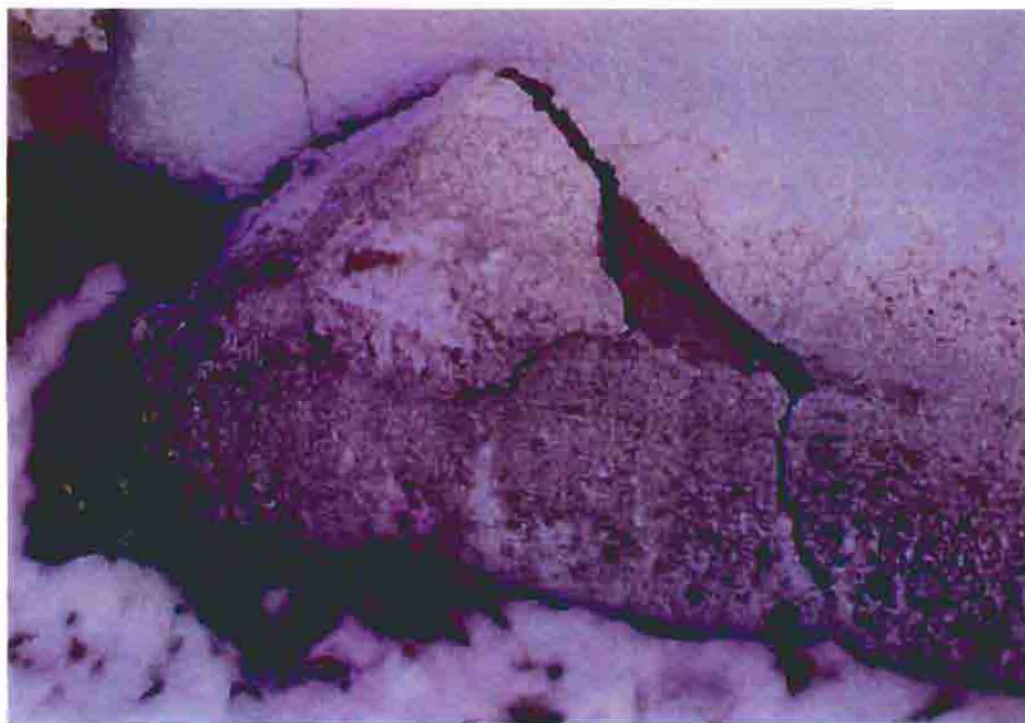
Photo F-20. The Fletcher-Switzer House, failing stucco at the foundation, February 2001. Photo by Wiss, Janney, Elstner Associates, Northbrook, Illinois.

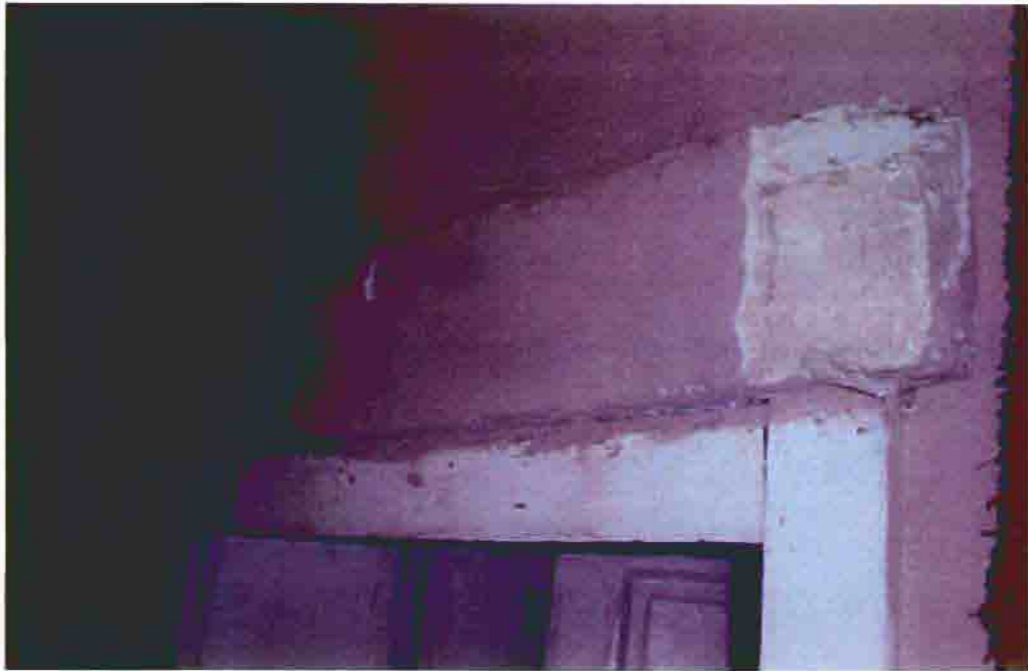
Photo F-23. The Fletcher-Switzer House, cracked stone lintel, February 2001. Photo by Wiss, Janney, Elstner Associates, Northbrook, Illinois.

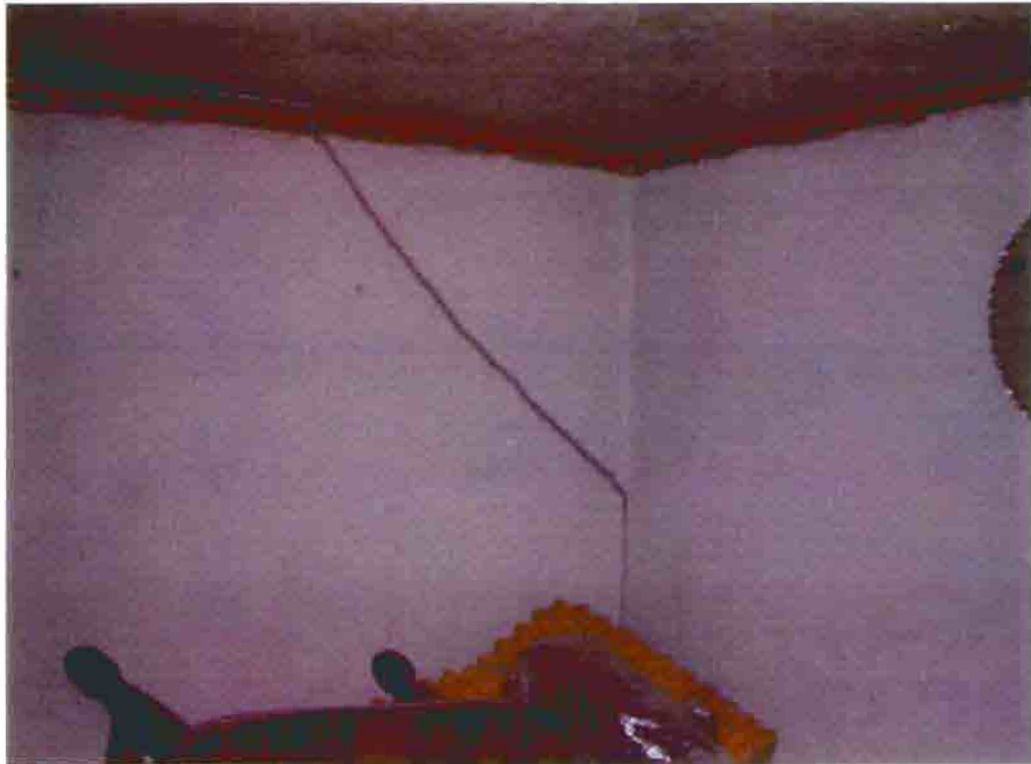
Photo F-27. The Fletcher-Switzer House, crack in interior wall, February 2001. Photo by Wiss, Janney, Elstner Associates, Northbrook, Illinois.

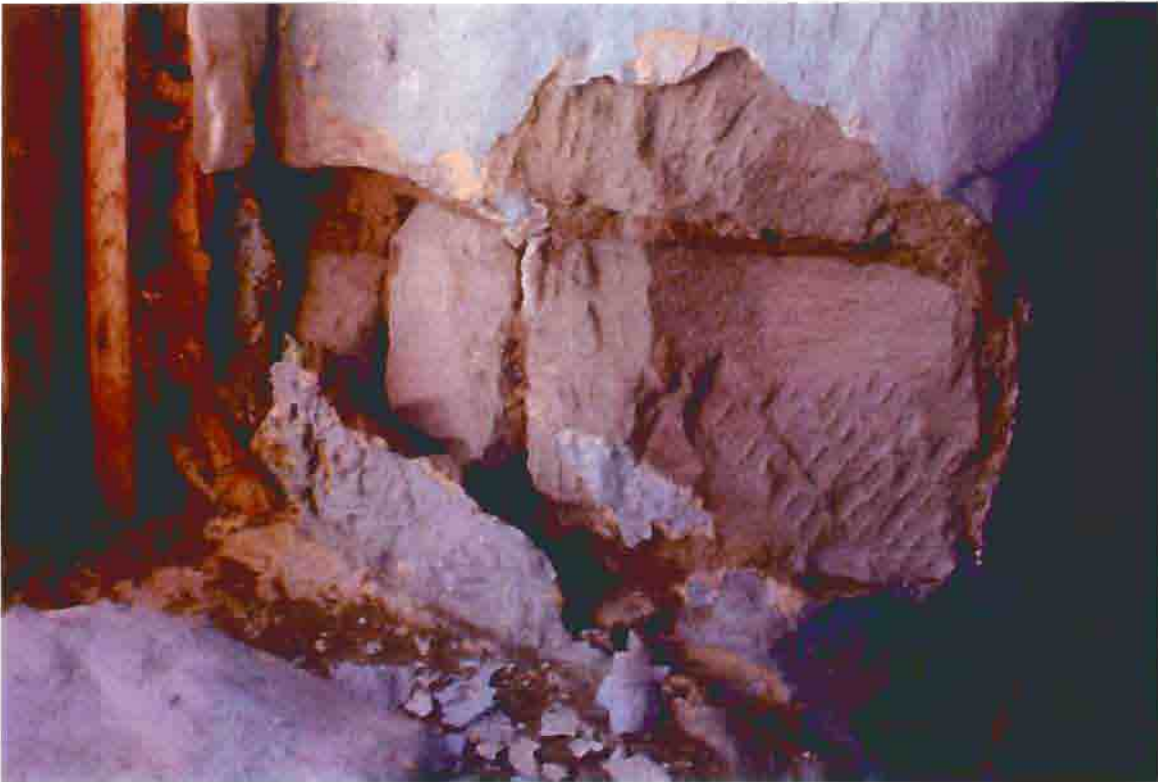
Photo F-30. The Fletcher-Switzer House, failed plaster at upstairs South Bedroom window jamb, February 2001. Photo by Wiss, Janney, Elstner Associates, Northbrook, Illinois.

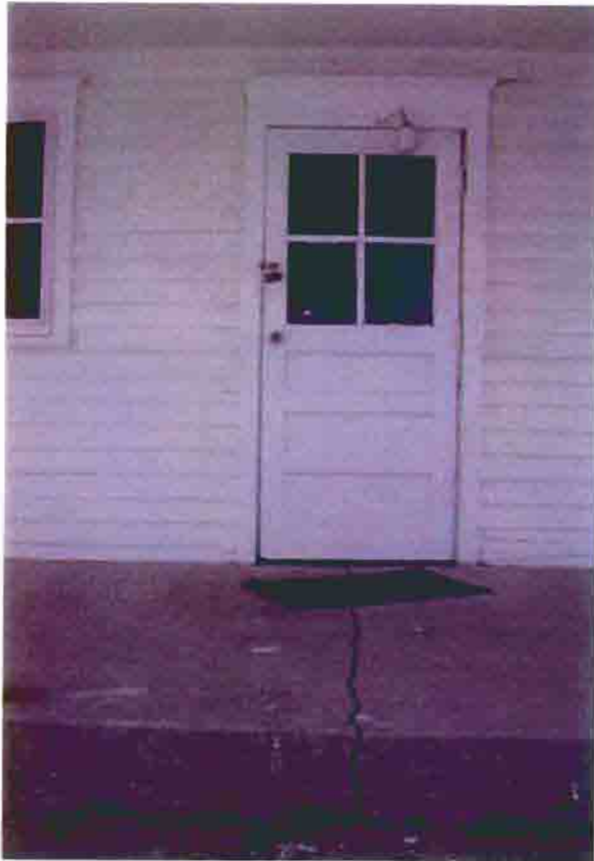
Photo S-13. The District No. 1 School, entrance door and cracked porch slab, February 2001. Photo by Wiss, Janney, Elstner Associates, Northbrook, Illinois.

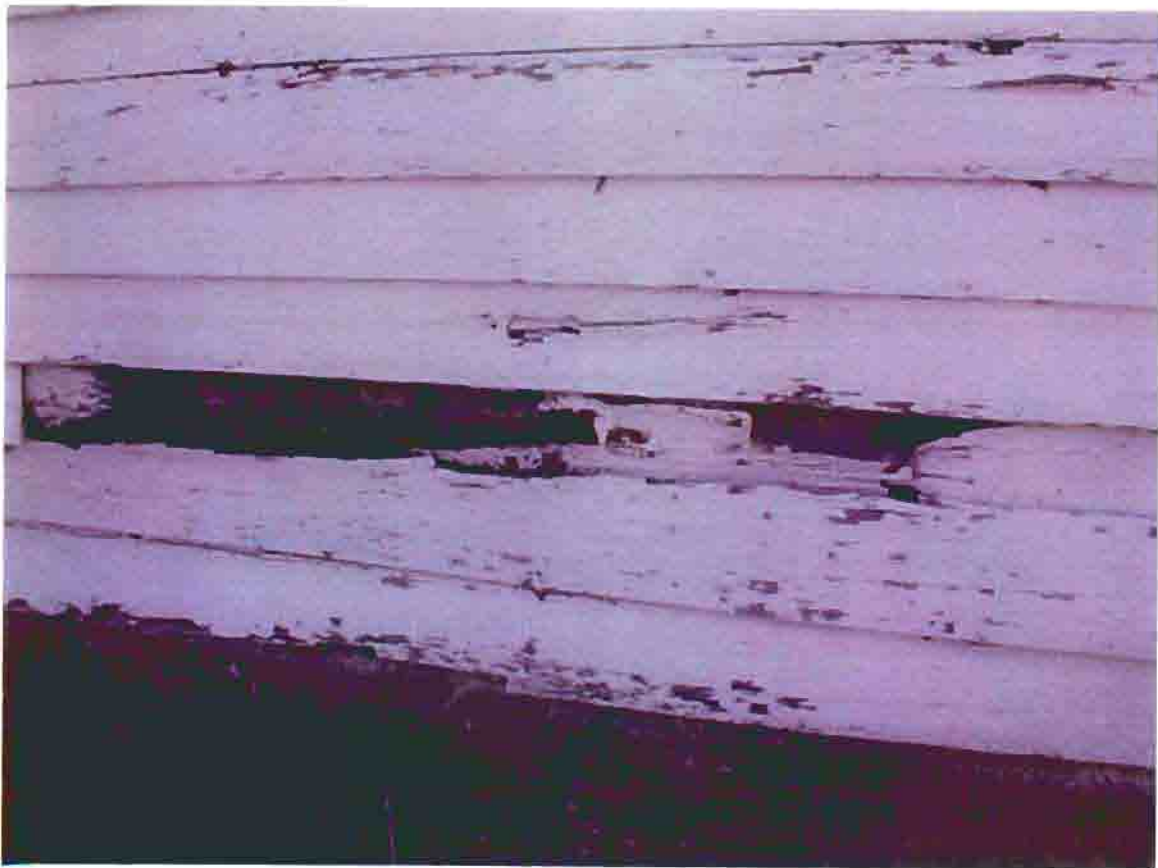
Photo S-18. The District No. 1 School, deteriorated wood siding, February 2001. Photo by Wiss, Janney, Elstner Associates, Northbrook, Illinois.

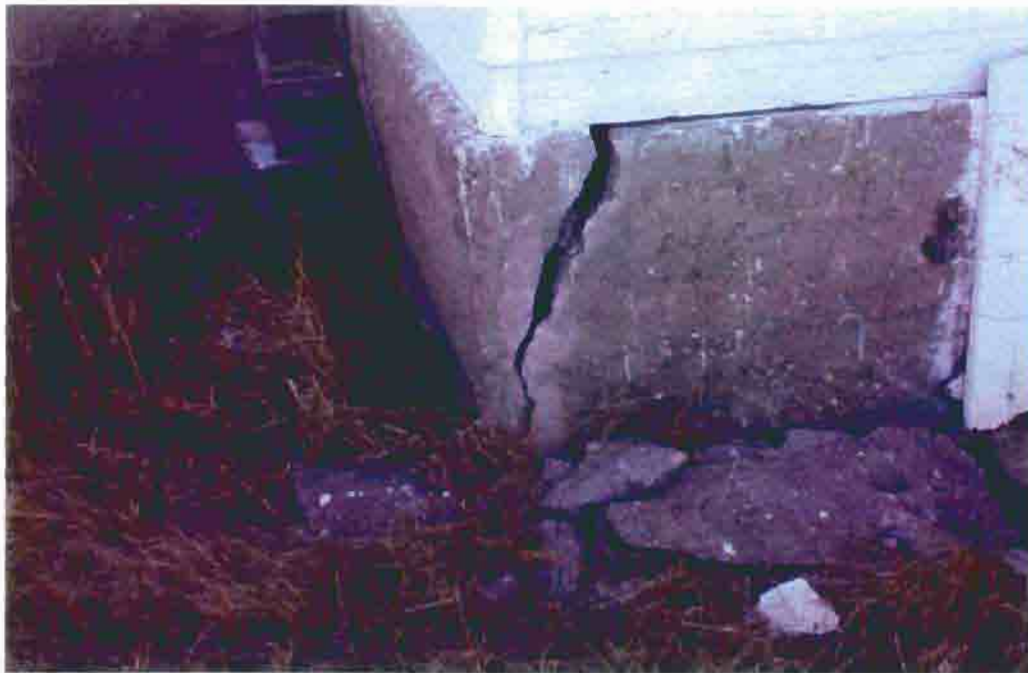
Photo S-19. The District No. 1 School, crack in foundation wall at northeast corner, February 2001. Photo by Wiss, Janney, Elstner Associates, Northbrook, Illinois.

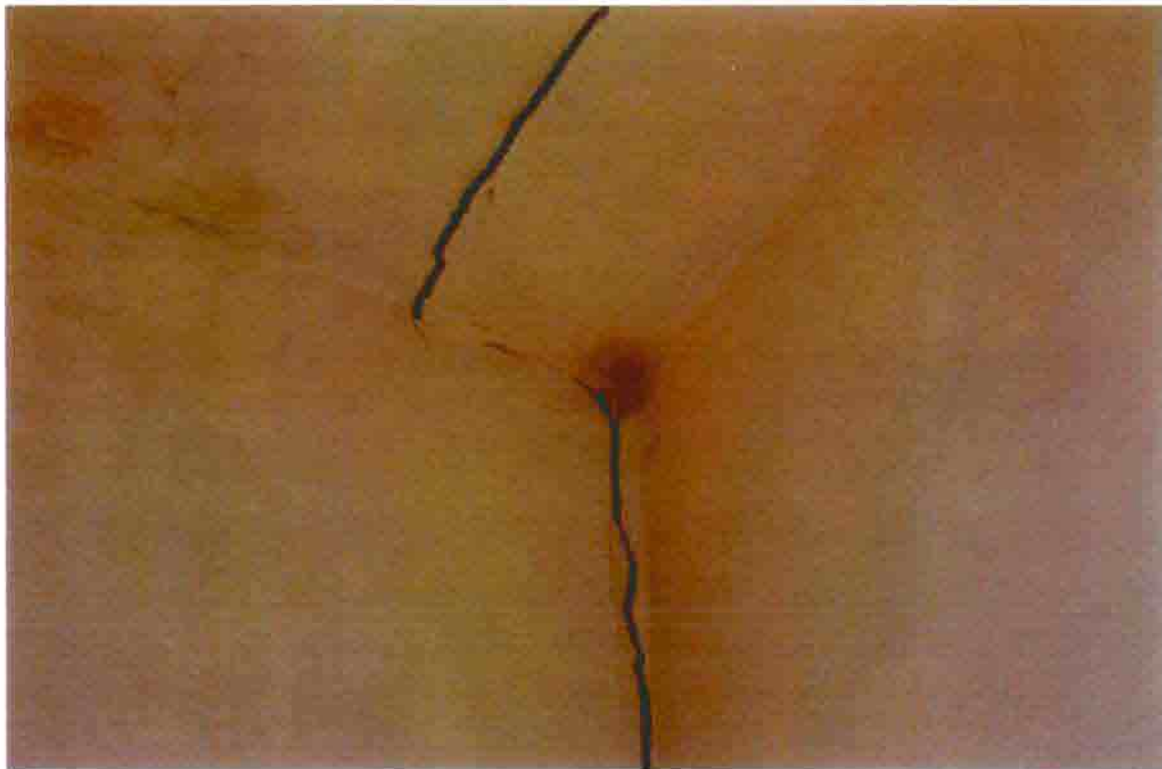
Photo S-24. The District No. 1 School, cracked plaster at wall/ceiling intersection, February 2001. Photo by Wiss, Janney, Elstner Associates, Northbrook, Illinois.

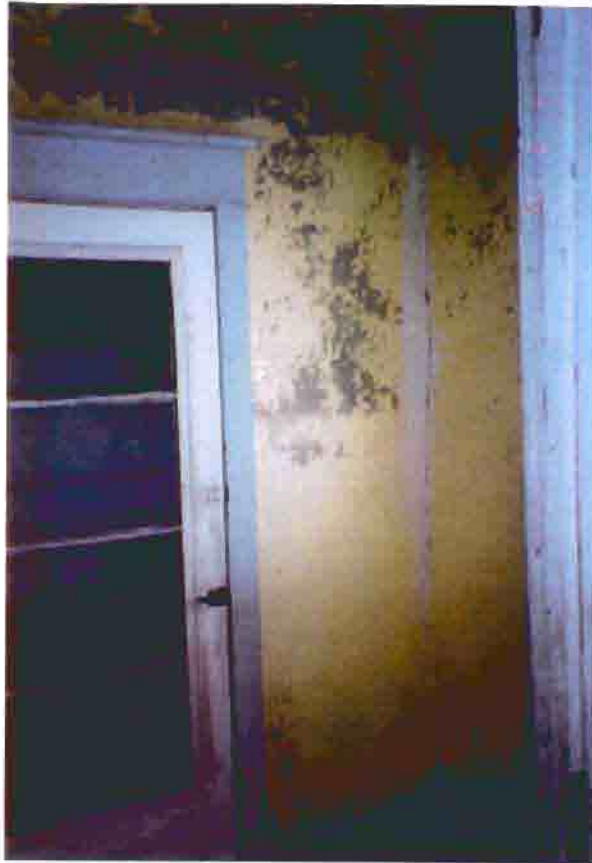
Photo S-25. The District No. 1 School, interior of the entry hall showing failing paint, cracked plaster, and the door to the kitchen, February 2001. Photo by Bahr Vermeer Haecker Architects, Lincoln, Nebraska.

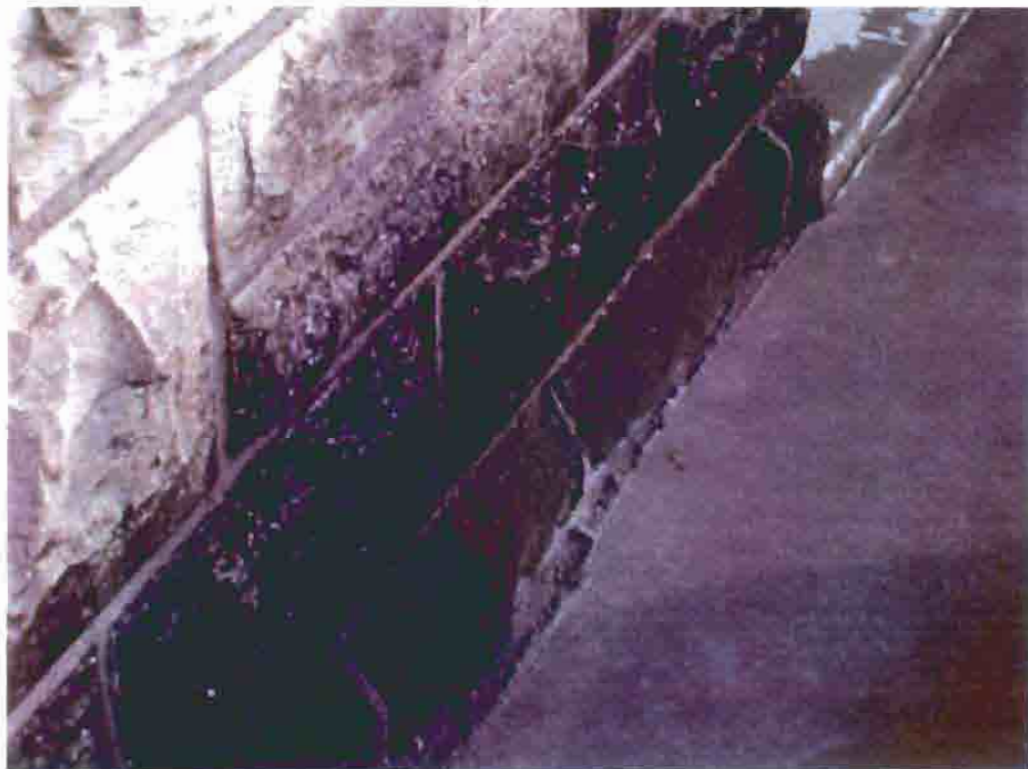
Photo T-12. The Township Hall, failure of stone at the base of the wall, February 2001. Photo by Wiss, Janney, Elstner Associates, Northbrook, Illinois.

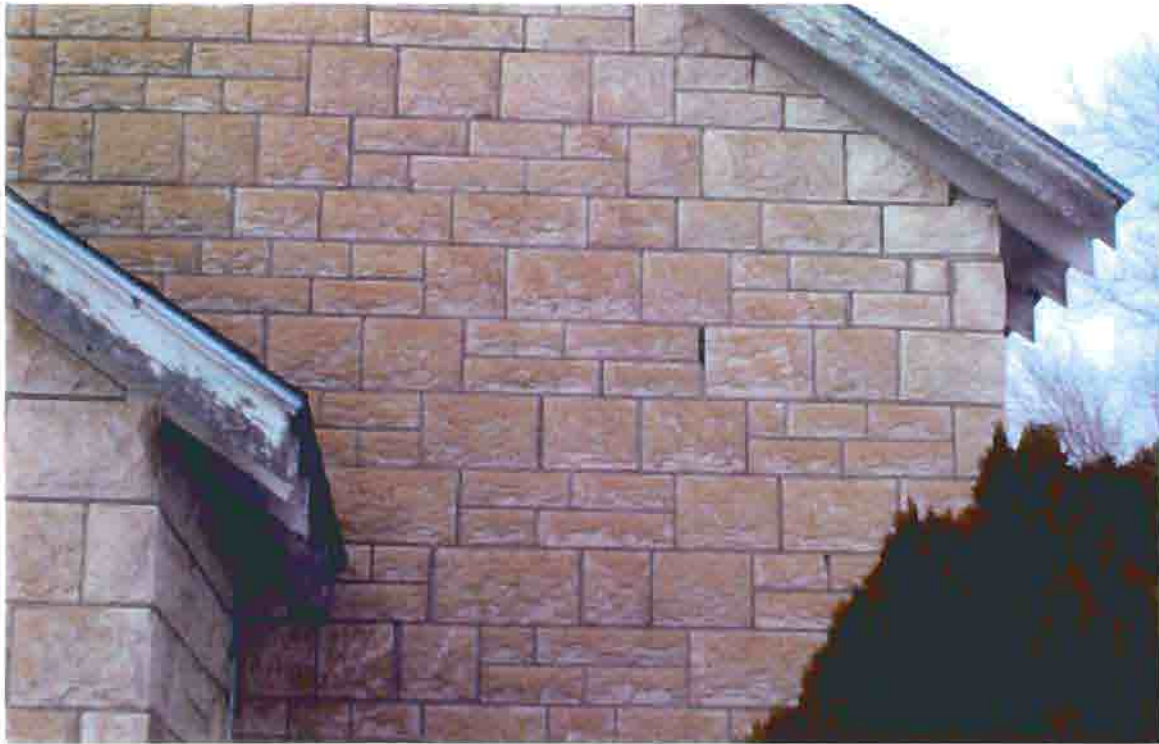
Photo T-13. The Township Hall, step cracking on the south wall, February 2001. Photo by Wiss, Janney, Elstner Associates, Northbrook, Illinois.

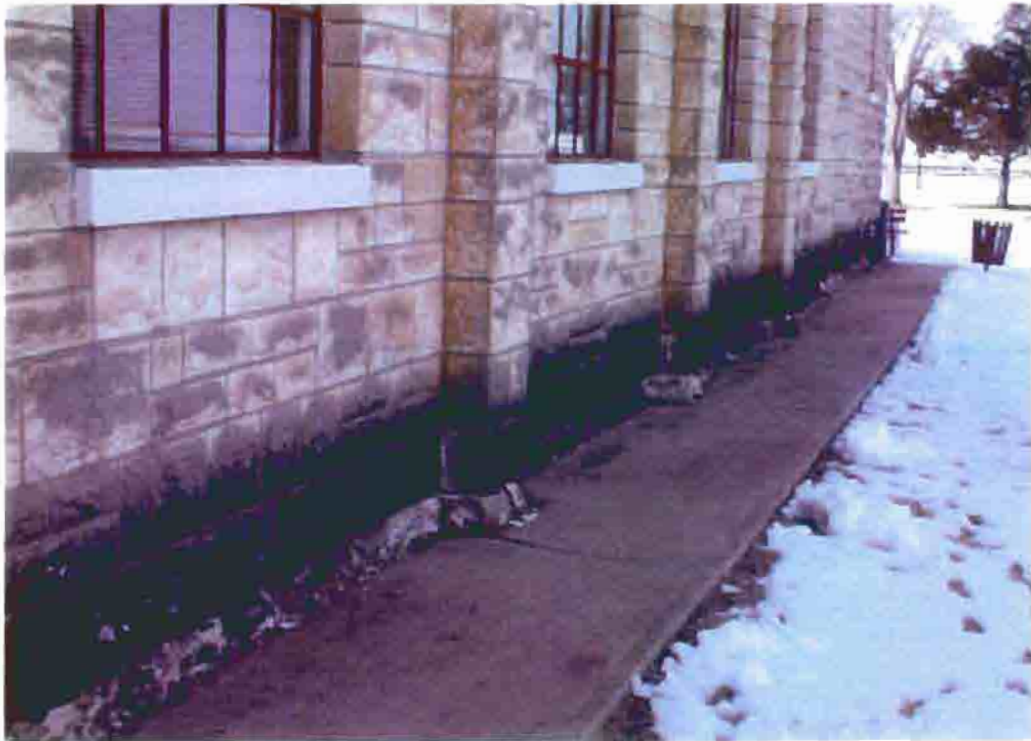
Photo T-15. The Township Hall, staining along the base of the limestone walls, February 2001. Photo by Wiss, Janney, Elstner Associates, Northbrook, Illinois.

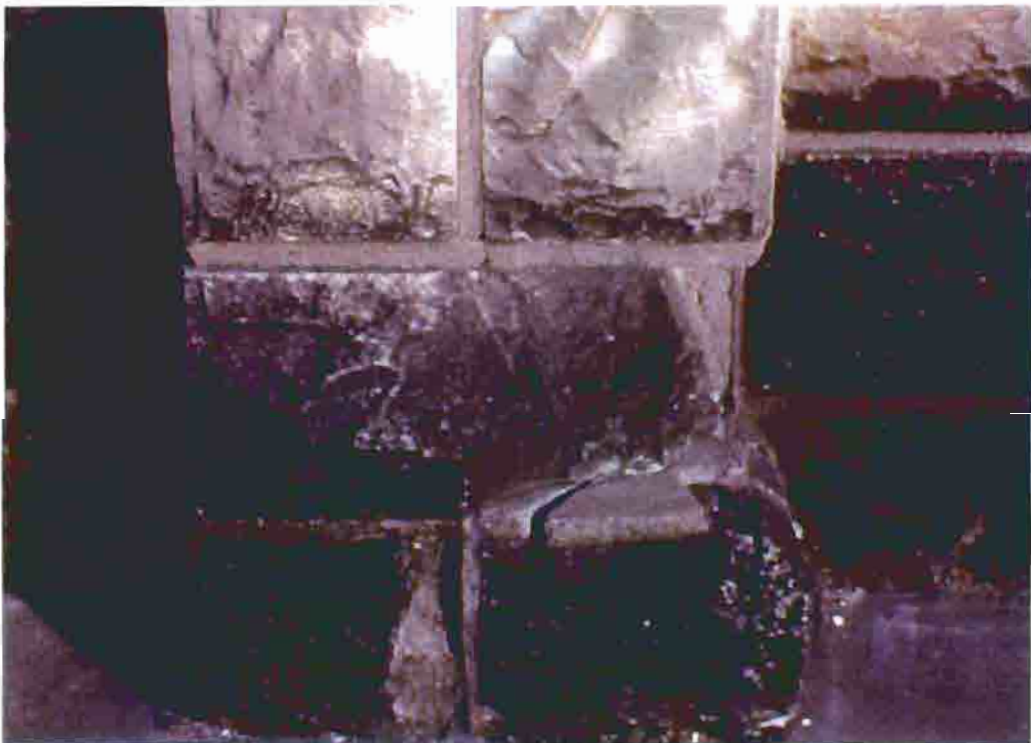
Photo T-16. The Township Hall, failed stone at the base of a butters, February 2001. Photo by Wiss, Janney, Elstner Associates, Northbrook, Illinois.

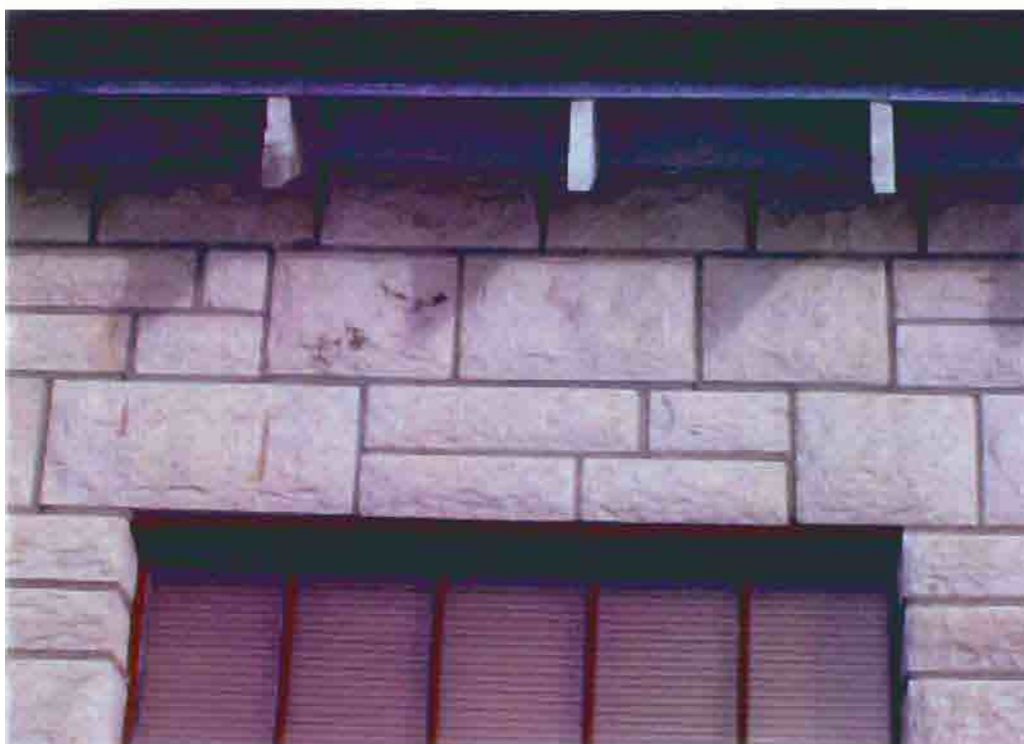
Photo T-17. The Township Hall, cracks above the window head, February 2001. Photo by Wiss, Janney, Elstner Associates, Northbrook, Illinois.

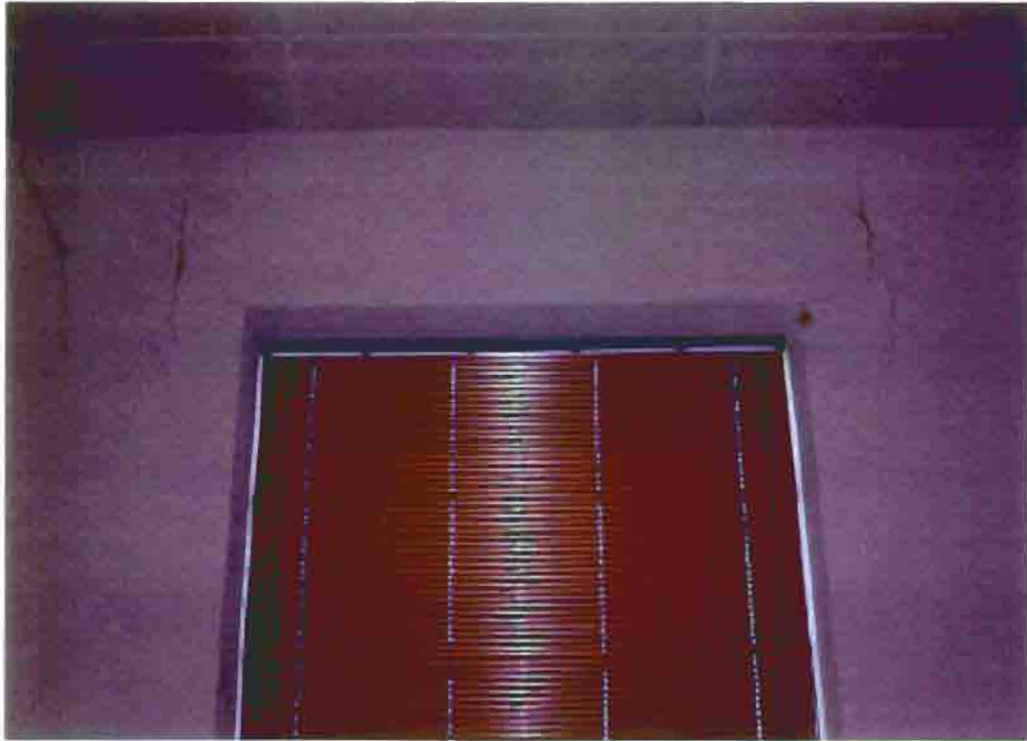
Photo T-19. The Township Hall, cracks in interior plaster around windows, February 2001. Photo by Wiss, Janney, Elstner Associates, Northbrook, Illinois.

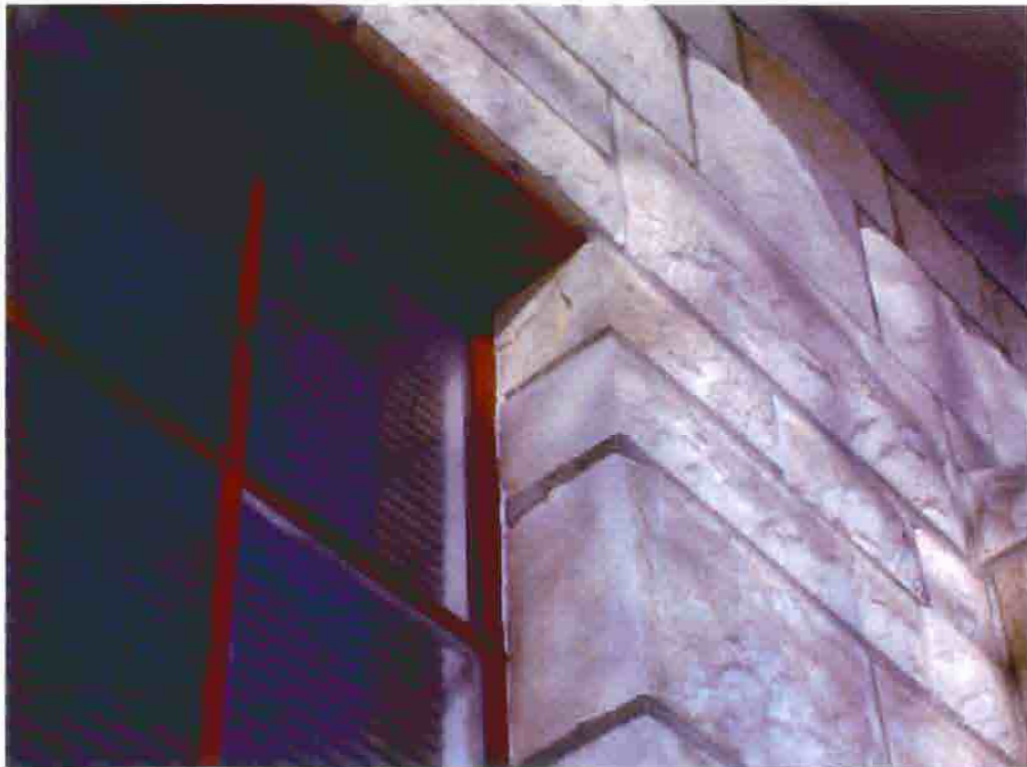
Photo T-20. The Township Hall, spalls in limestone at upper window jamb, February 2001. Photo by Wiss, Janney, Elstner Associates, Northbrook, Illinois.

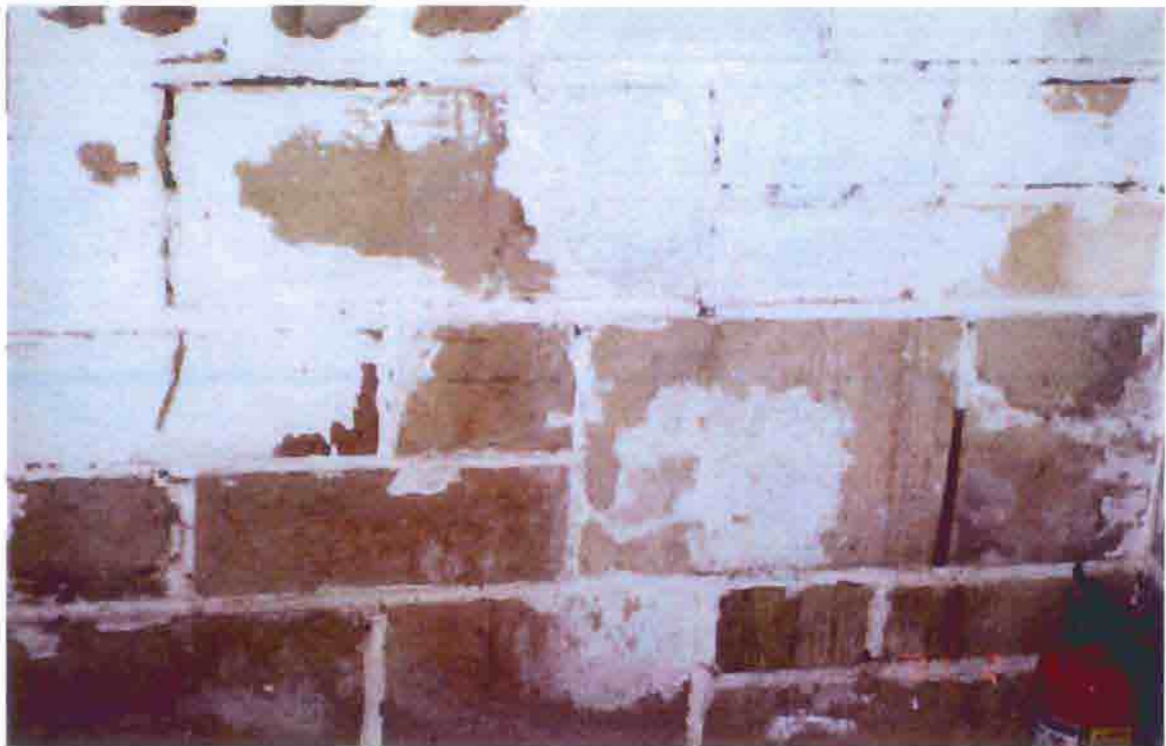
Photo T-25. Township Hall, detail of stonework in basement with failed paint, February 2001. Photo by Bahr Vermeer Haecker Architects, Lincoln, Nebraska.
