Ocmulgee National Monument
Visitor Center
Historic Structure Report

December 2008

Joseph K. Oppermann - Architect, P.A.

2008
Historic Structure Report
Visitor Center
Ocmulgee National Monument
LCS#: 091399

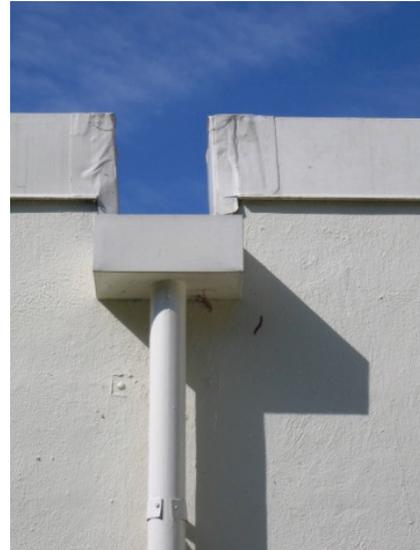
impasse resulted. The terrace continues to have problems with water infiltration.

Figure C-5. Scuppers and external Downspouts added 1999.

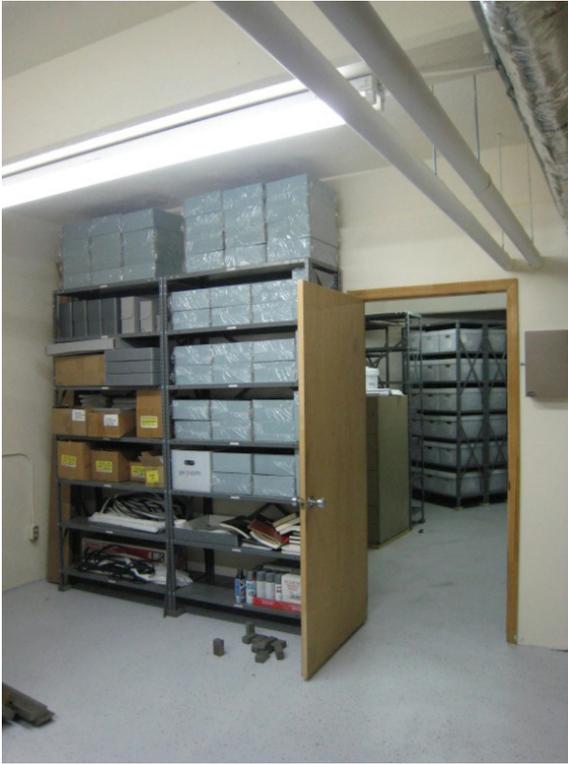
Figure C-22. Curatorial workshop and doorway to artifact storage (Room 001). Note fluorescent lighting fixture attached to bottom of beam.

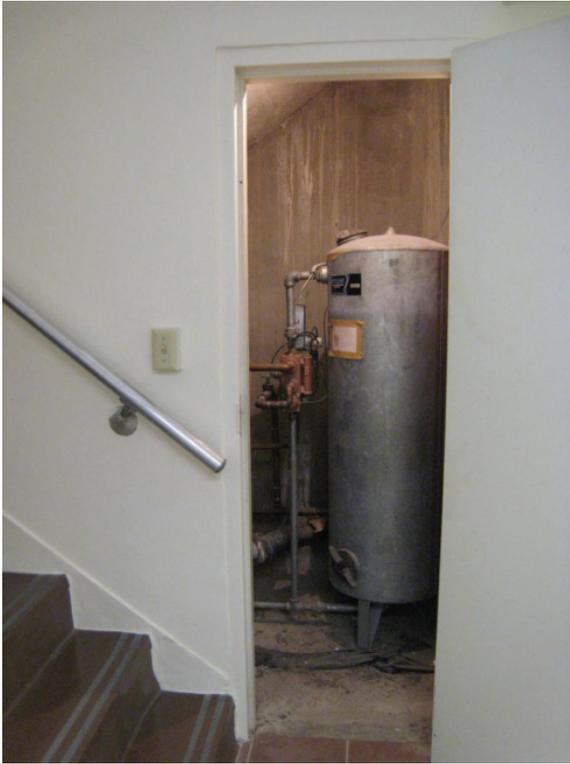
Figure C-63. Abandoned back-flush tank for solar panels.

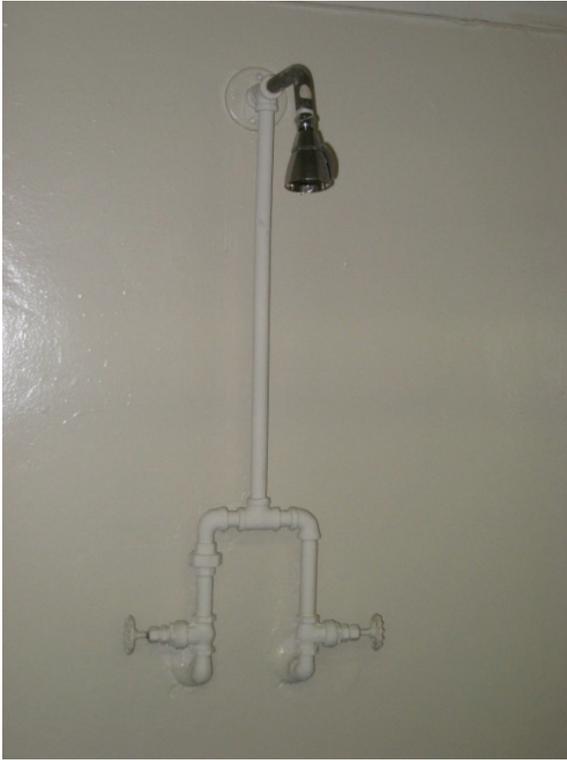
Figure C-73. Early shower with modern shower head.

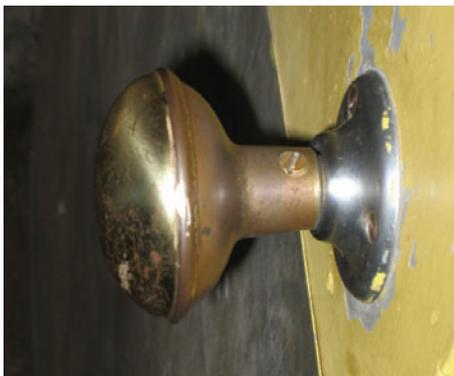
Figure C-79. Chrome, Type U escutcheon from 1950-51 era and replacement doorknob.
