HISTORIC STRUCTURES REPORT

BATES WELL RANCH

ORGAN PIPE CACTUS NATIONAL MONUMENT

A Service Learning Project of the
Preservation Studies Program
College of Architecture and Landscape Architecture
The University of Arizona

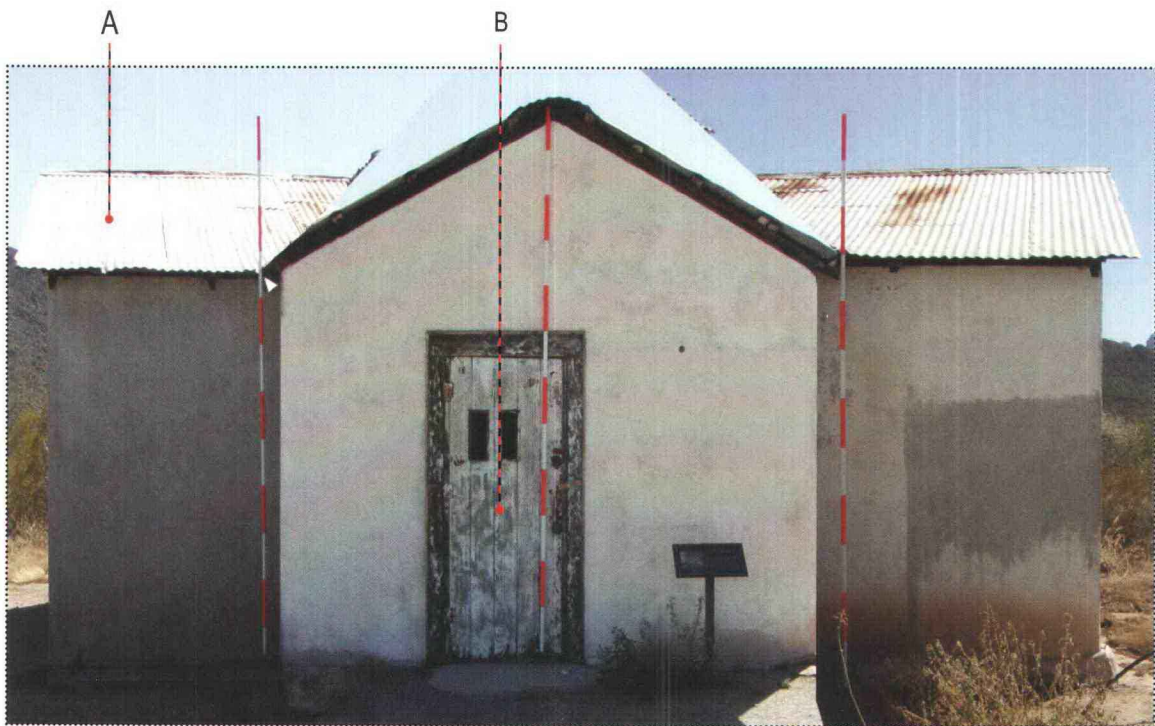
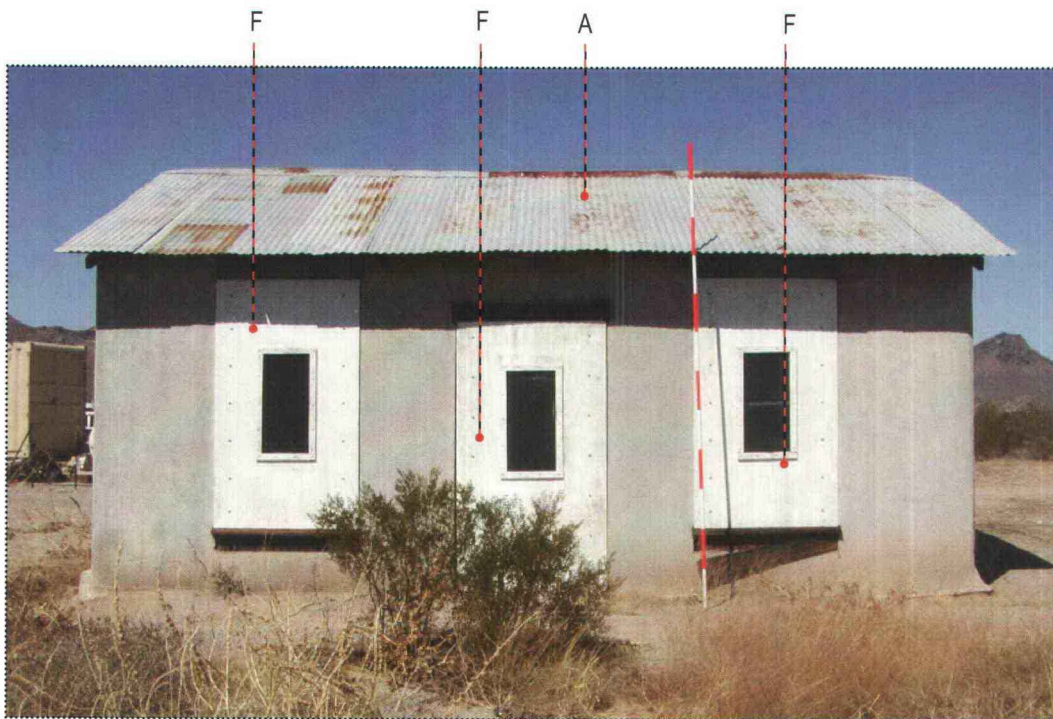
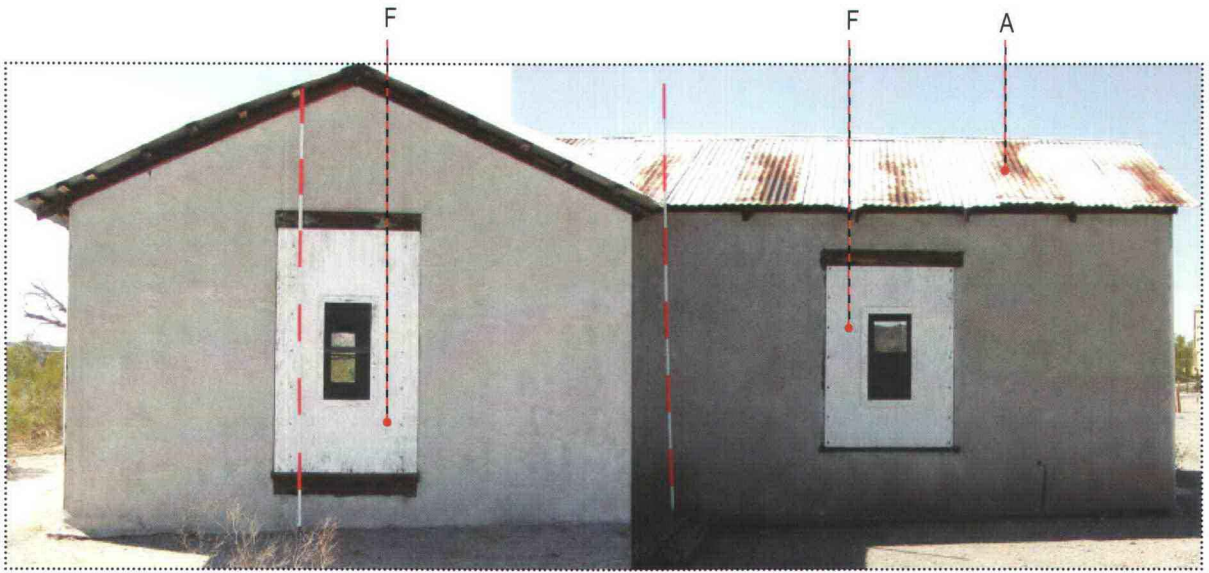
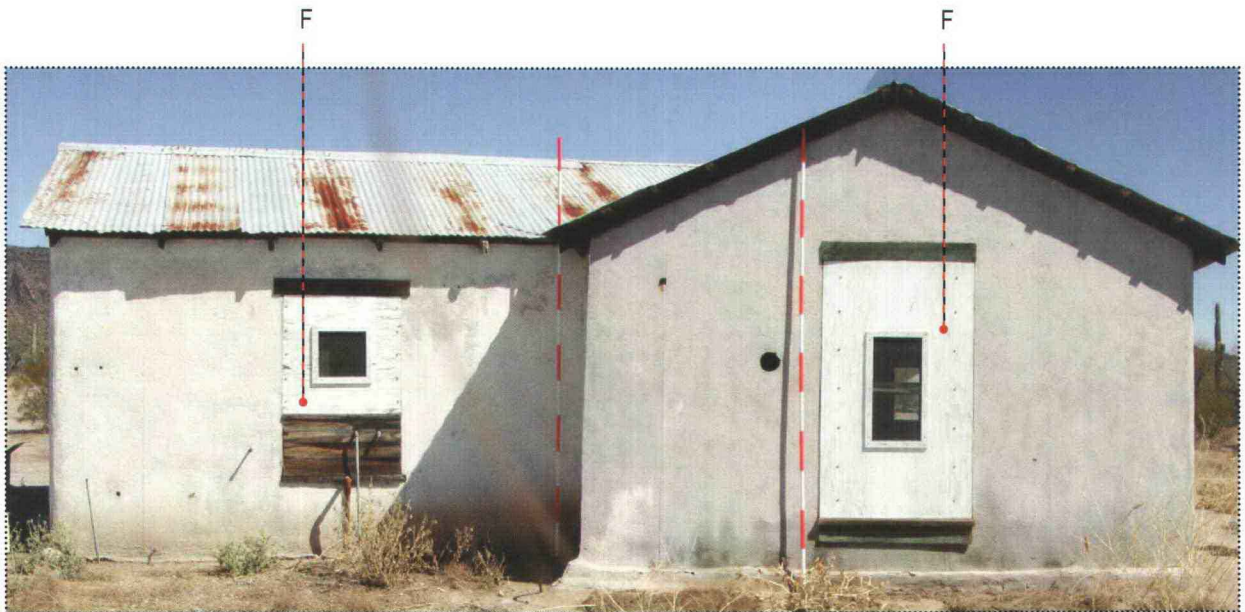
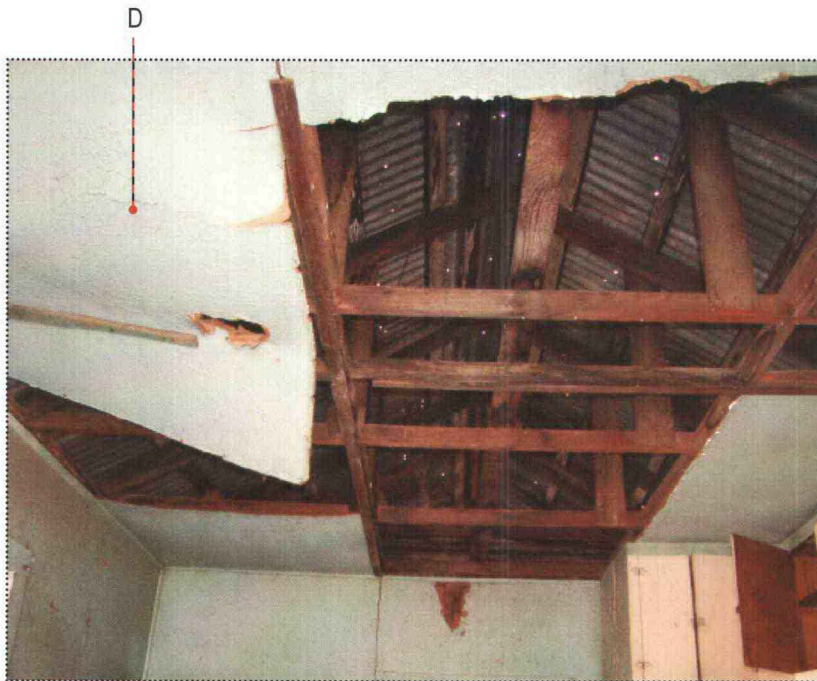
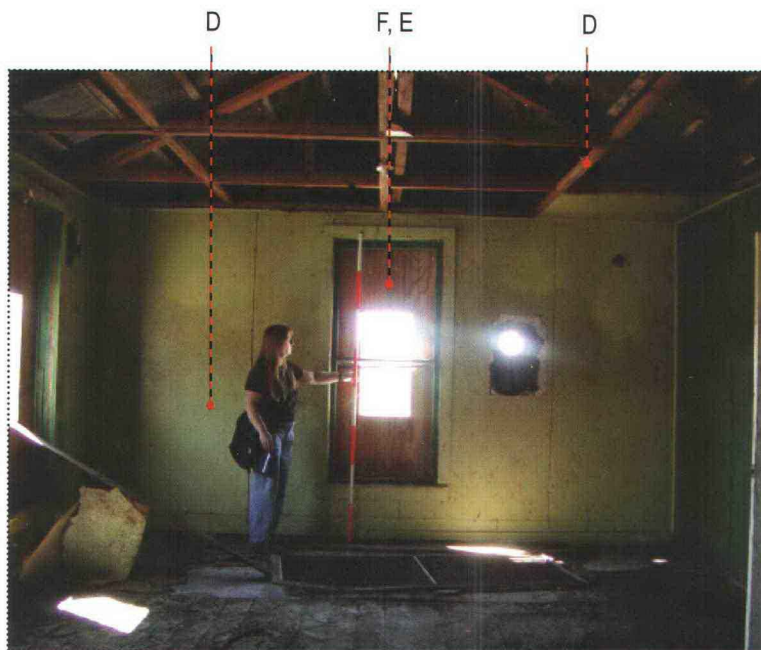
Of all the buildings that comprise the Bates Well Ranch, the Main Ranch House possesses the greatest level of integrity. The exterior is in good condition with small cracks in the stucco surface. The corrugated metal roof is in need of attention with many holes from previous nails and rusting from age. In order to deter vandalism, the window openings were boarded up in the 1990s by NPS staff from the outside with plywood, with smaller 1 foot by 2 foot openings cut into the plywood and screened with quarter inch steel mesh. The glazing is gone and many of the frames are missing as well. The ceiling material is missing in all but a few areas and there are several pieces of the wall material missing as well. The kitchen cabinets and the stove are intact. The linoleum flooring is peeling back to reveal the wood floor below from the leaking roof but there is no evidence of mold.

Deficiencies	Recommended Treatments	Priority
A	Corrugated metal roof contains nail holes and severe rust damage.	Replace roof with like material	Serious
B	Rotted/termite infested Wood	Application of biocides where severe damage.	Critical
C	Missing Components	Replace lost components with like material	Serious
D	Water Damage	Replace roof and repair or replace damaged material.	Serious
E	Broken Window Framing/glazing	Replace and repair as needed	Serious
F	Window inserts added after period of significance	Remove and return to original state	Critical

The recommended treatment for the Main Ranch House is *Rehabilitation* as defined by the Secretary of the Interior's Standards for the Treatment of Historic Properties. For more specific treatment recommendations, see the *Ultimate Treatments* section.

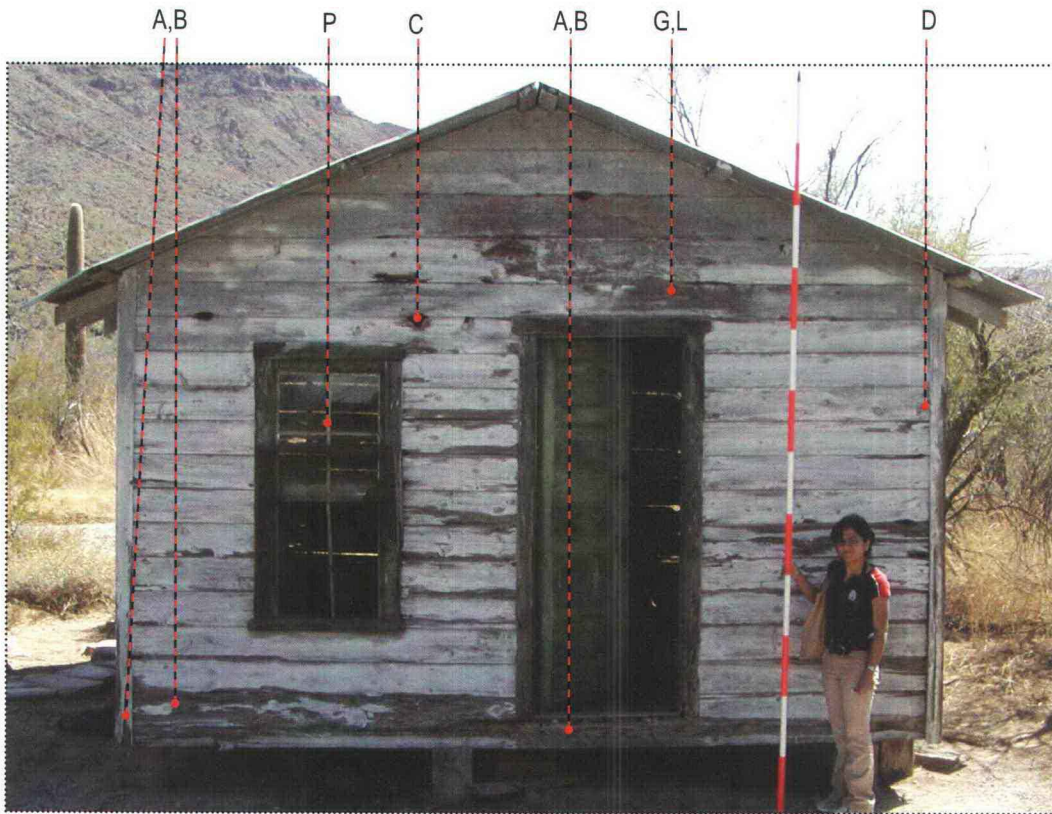
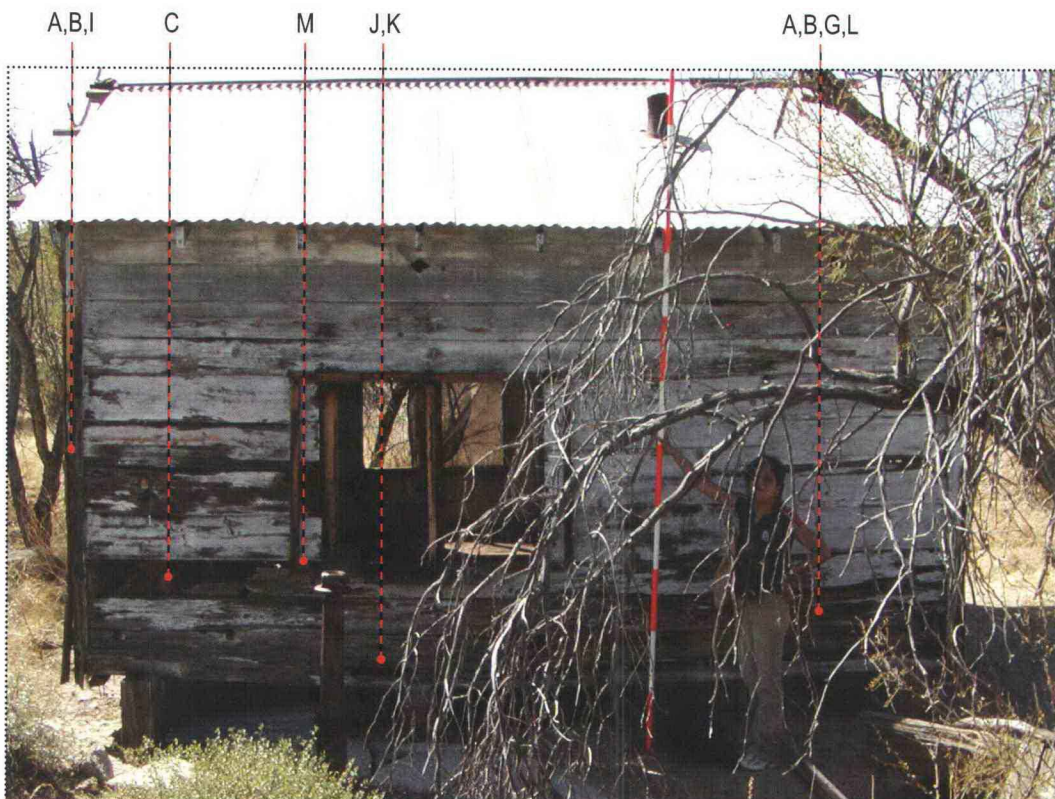
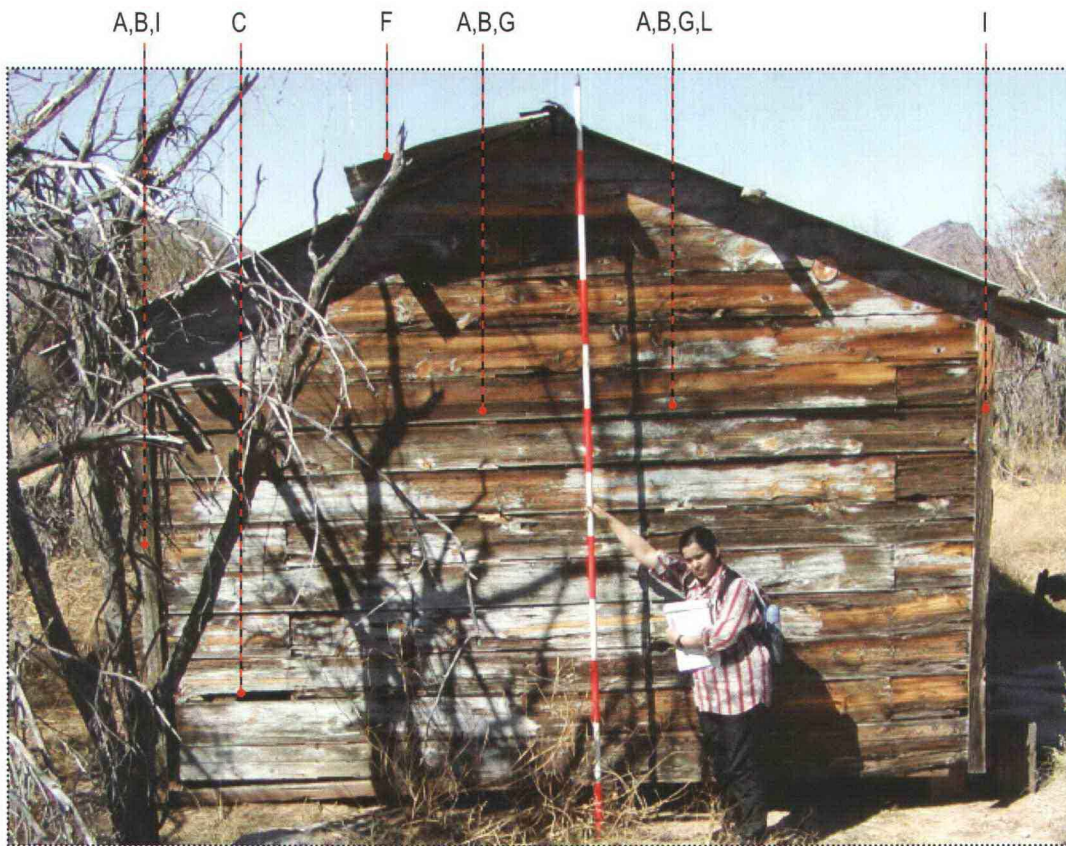
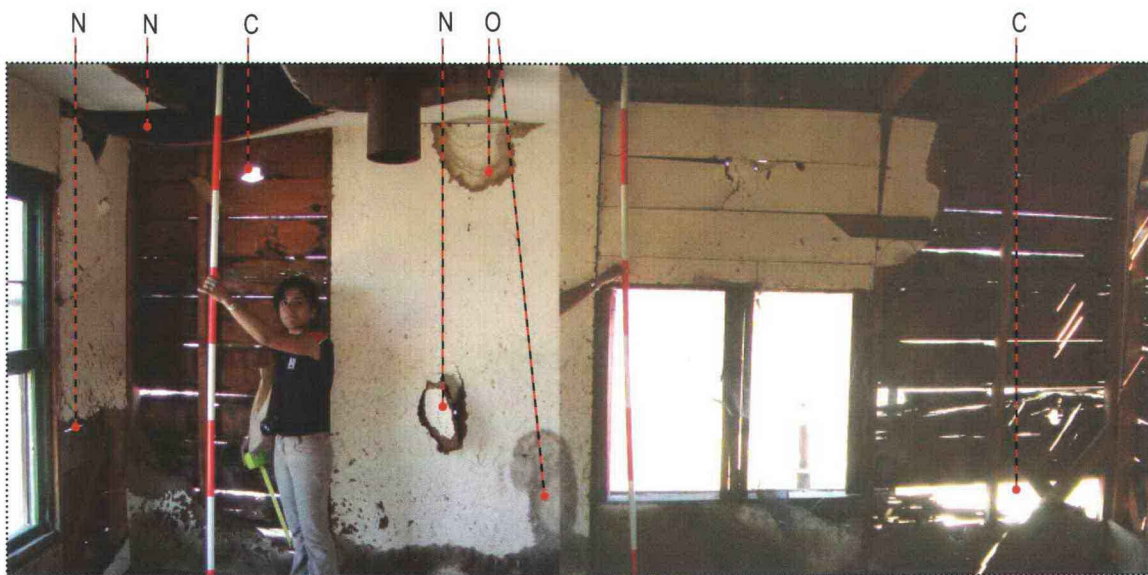
At present, the condition of the Bunkhouse has been assessed as fair relative to the condition of the other ranch structures on site. However, there are many pressing problems which need to be addressed. The structure is tilting towards the rear west corner probably due to settling of the corner pier. In addition, the floor is sagging; this can be clearly noticed on the eastern side. The wooden planks on the facades are also deteriorating due to the combined effects of the harsh climate and the impact of microorganisms. The roof sheathing is relatively new, although it displays signs of detaching itself at the rear. The interior of the building is also in a state of disrepair. The gypsum board paneling on the walls and ceiling is completely missing in parts and also suffers from damage due to water seepage. Only remnants of the original linoleum flooring are left behind.

Deficiencies	Recommended Treatments	Priority
A	Water damage to wood paneling and fascia including warping and splintering.	Remove source of water, replace wooden planks where severely damaged with like material	Serious
B	Rotting of wood due to microorganisms/ pests (also termite) infestation.	Application of biocides where damage is severe	Serious
C	Missing portions of wood planks	Replace entire plank where substantial portions are missing or structural stability is endangered.	Critical
D	Corrosion and deterioration of wood around nails.	Apply anti-rust coating on nails before replacement planks are installed.	Serious
F	Delamination of sheet metal roof	Replace/reattach portions delaminating. If pieces are missing replace with like material	Critical
G	Staining of wood due to water damage.	Remove source of water, which may be due to roof leaks or holes in the cladding.	Serious
I	Leaning of the structural wooden posts leading to instability & leaning of the shed.	Stabilize the structure by realigning the main structural posts. If necessary reassess the condition of the tie-beam and strengthen to bind the structure	Critical

J	Deterioration of planks near the base of the structure.	Missing pieces should be replaced with like material.	Critical
K	Sagging floor.	The cause of the problem should be addressed then entire floor repaired.	Critical
L	Paint cracked and peeling	Reapply paint on facades. New paint should match exactly previous in appearance & texture.	Serious
M	New screen frames nailed onto original facade	New parts should be removed after being documented	Serious
N	Missing pieces from the Gypsum-board paneling & ceiling in the interior	The paneling should be replaced if severely damaged or missing	Serious
O	Water damaged Gypsum-board	Address source of seepage & replace if extensively damaged	Serious
P	Broken window mullions	Repair or replace with like materials	Serious

The recommended treatment for the Bunkhouse is *Restoration* as defined by the Secretary of the Interior's Standards for the Treatment of Historic Properties. For more specific treatment recommendations, see the *Ultimate Treatments* section.

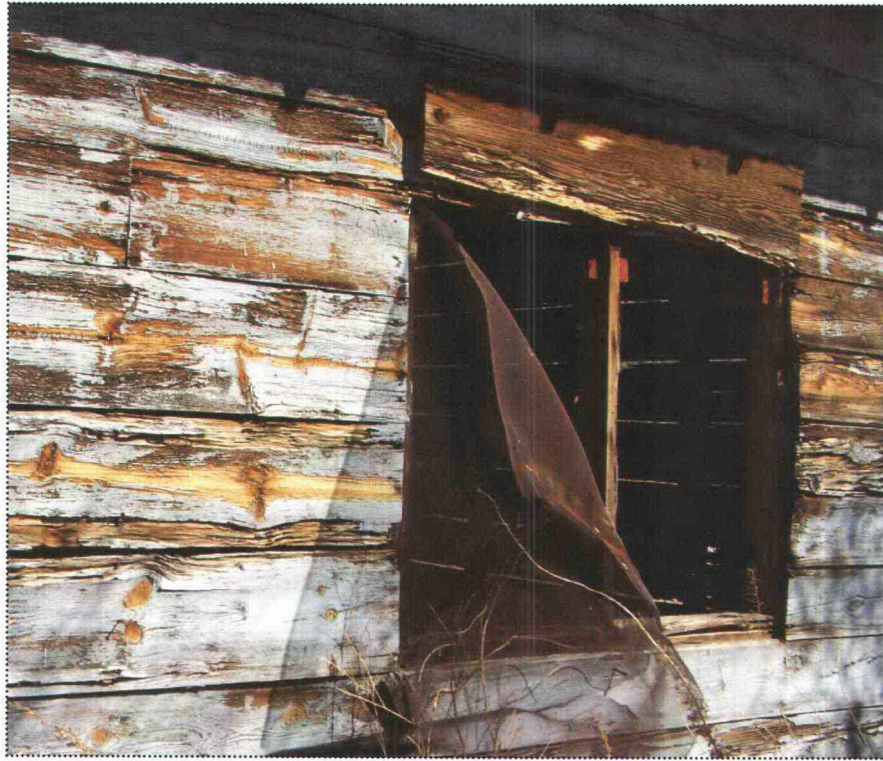
M, A, B. Detail view of window on west elevation. Note the wire mesh screen coming off & new board above opening

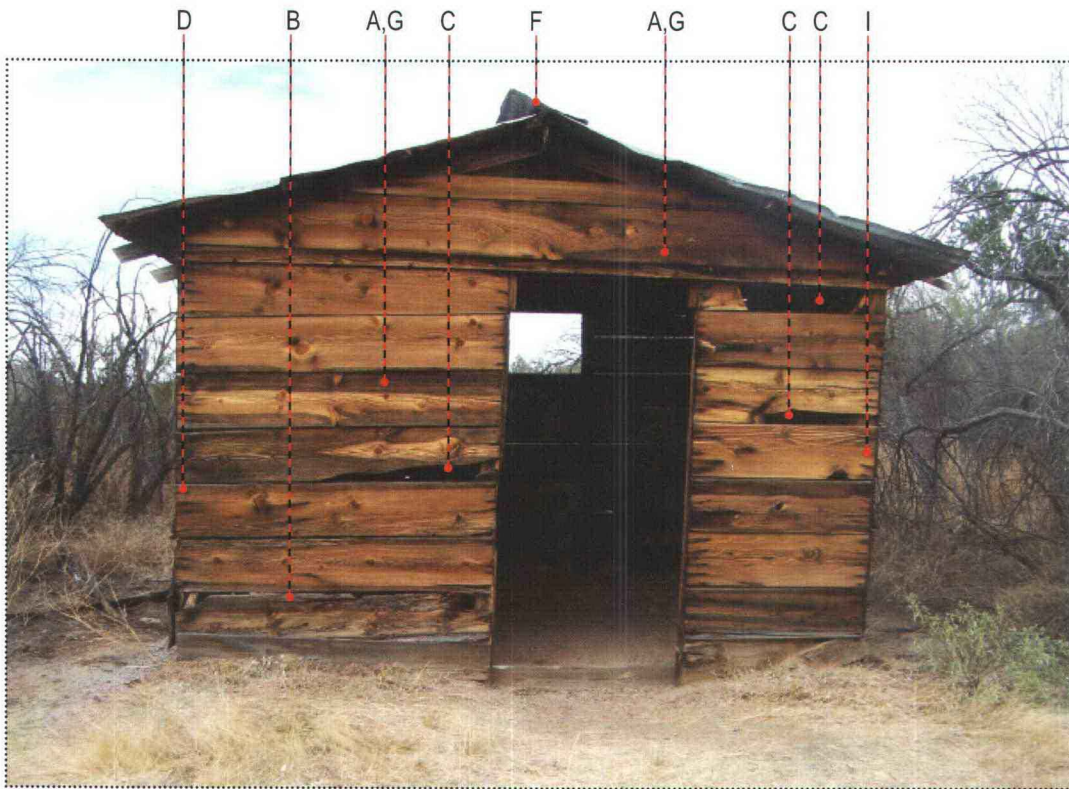
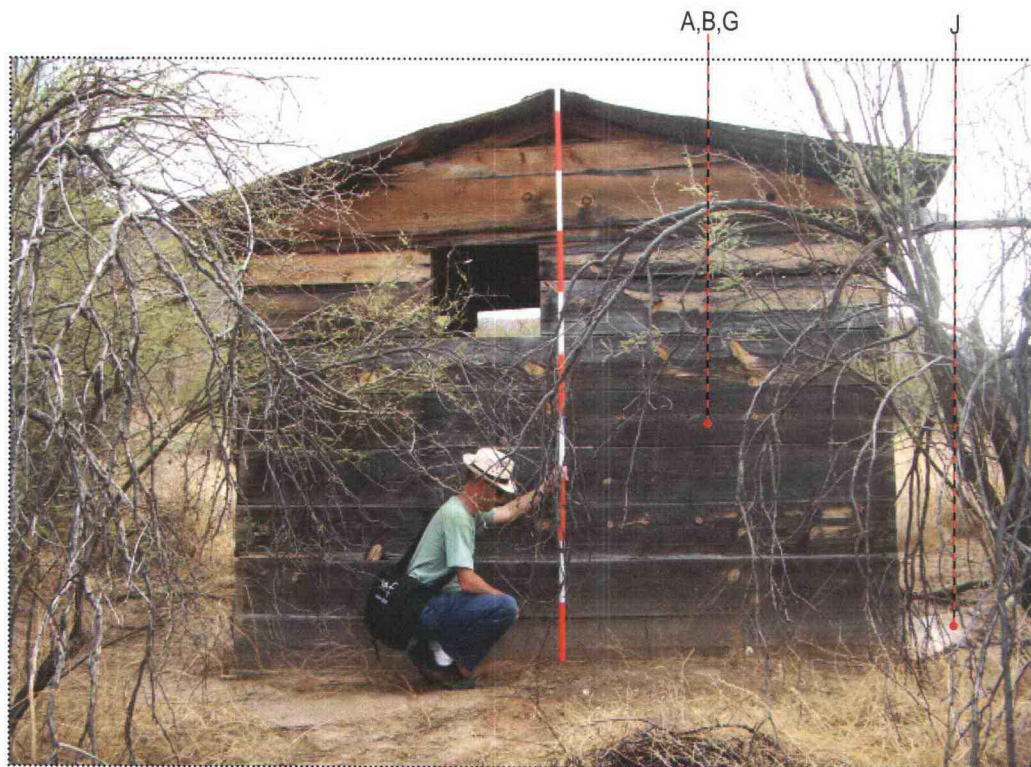
At present, the condition of the Tack House has been assessed as fair relative to the condition of the other ranch structures on site. However, there are many pressing problems to be addressed. The shed is leaning to the east and suffers from bowing of the wooden support posts, leading to instability. The wooden planks suffer from extensive rotting and staining. The major causes are animals / pests and termite infestation. The other major cause is moisture damage. As a result there is rusting at the juncture of wood & iron nails, leading to eventual corrosion of the surrounding wood. Thus either entire planks become disjointed or rotten pieces detach, causing gaping holes in the exterior facade. The corrugated sheet metal roof displays rust damage. Also, several mesquite trees in close proximity to the Tack House may pose a fire hazard.

Deficiencies	Recommended Treatments	Priority
A	Water damage to wood paneling and fascia including warping and splintering.	Correction of the source of water Replace the wooden planks where severely damaged; match the size & type of wood to existing.	Serious
B	Rotting of wood due to microorganisms/ pests (also termite) infestation.	Application of biocides where severe damage.	Critical
C	Missing parts from wood planks	Replace entire plank where substantial parts missing or structural stability is endangered.	Serious
D	Corrosion and deterioration of wood around iron nails on edges.	Apply anti-rust coating on nails before replacement planks are installed.	Serious
E	Rusting of the corrugated metal roof due to water damage	Replace the sheets which are severely rusted.	Serious
F	Falling apart of the metal sheets on the roof esp. the central ridge	Replace/reattach the portions that are coming apart. Use identical sheeting for replacement	Critical

The recommended treatment for the Tack House is *Restoration* as defined by the Secretary of the Interior's Standards for the Treatment of Historic Properties. For more specific treatment recommendations, see the *Ultimate Treatments* section.

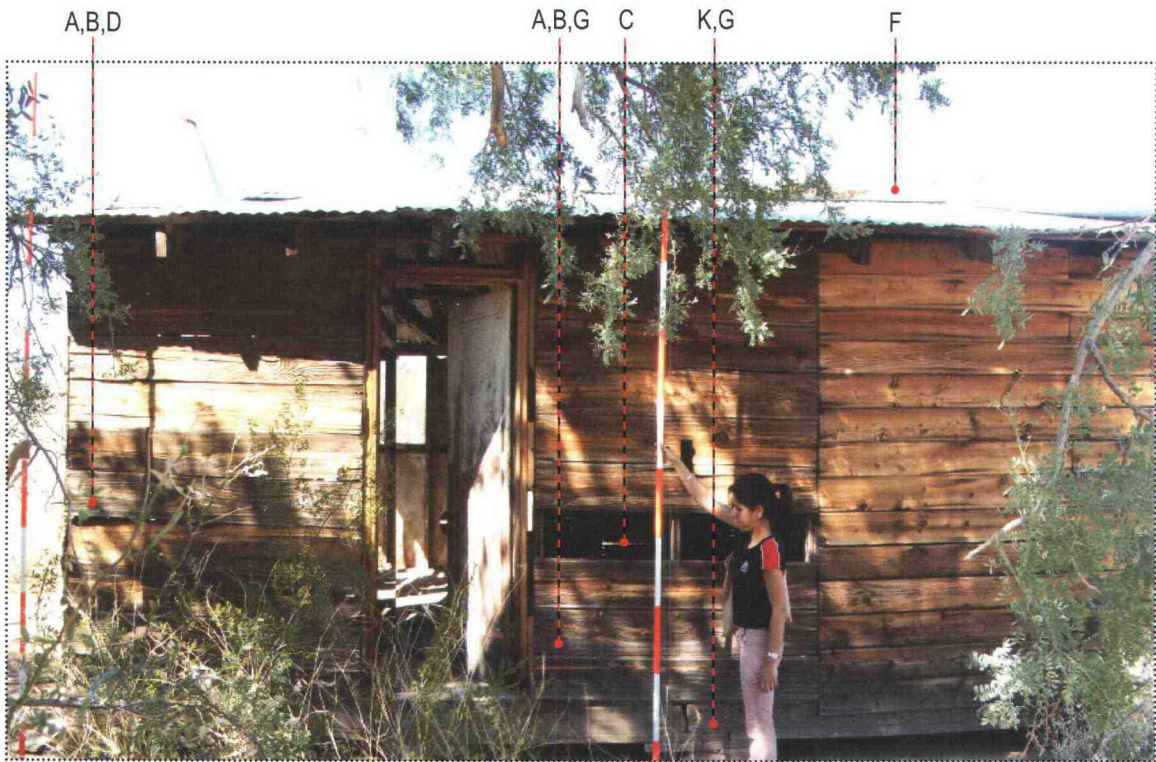
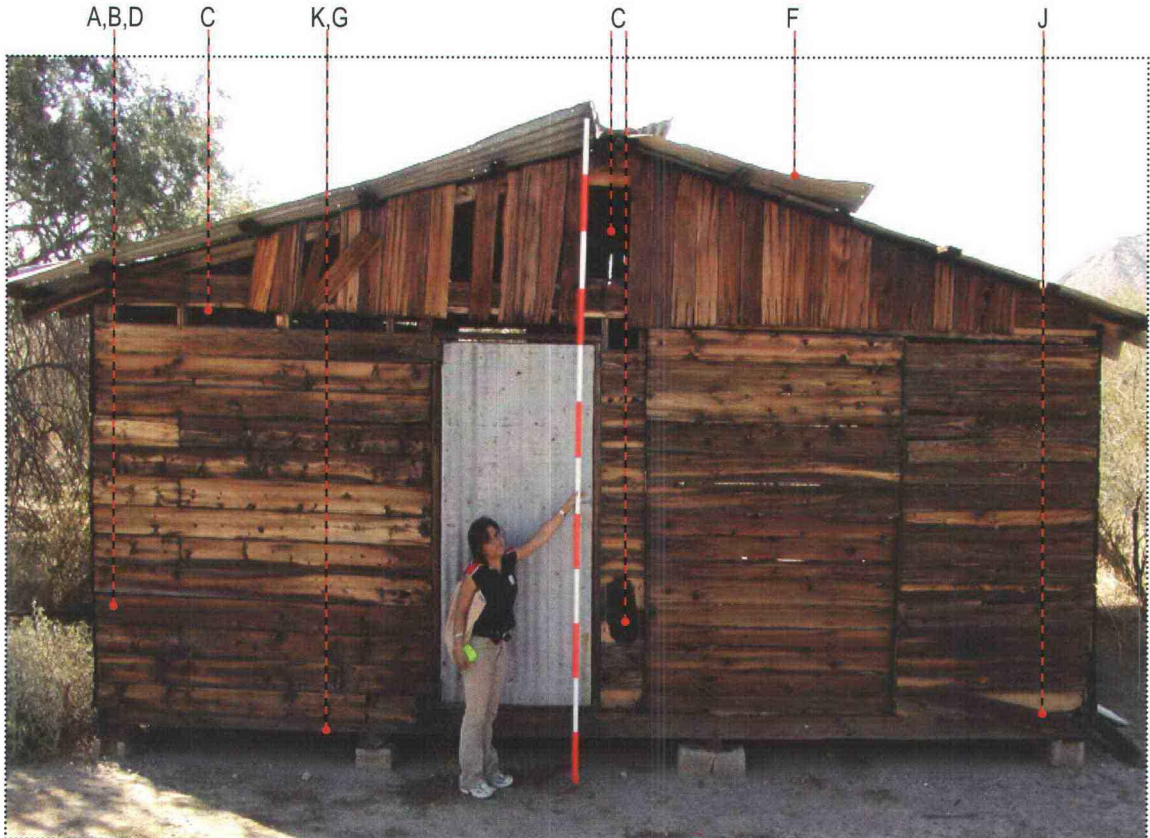
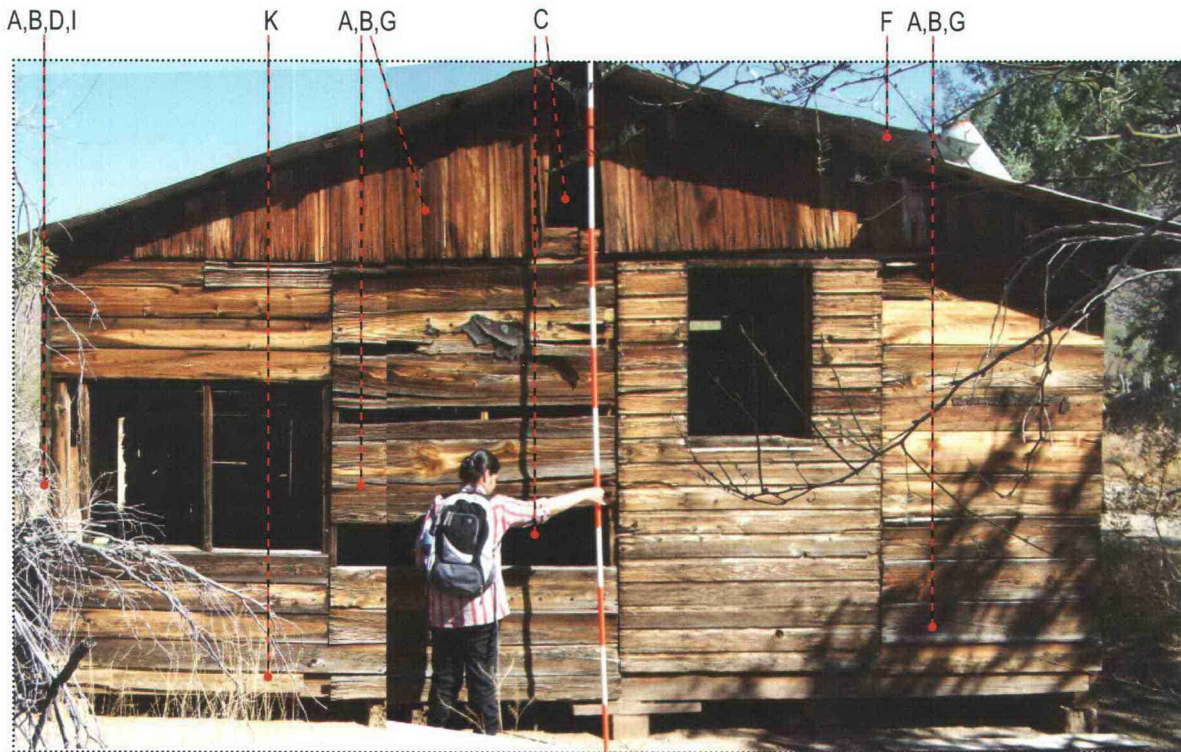
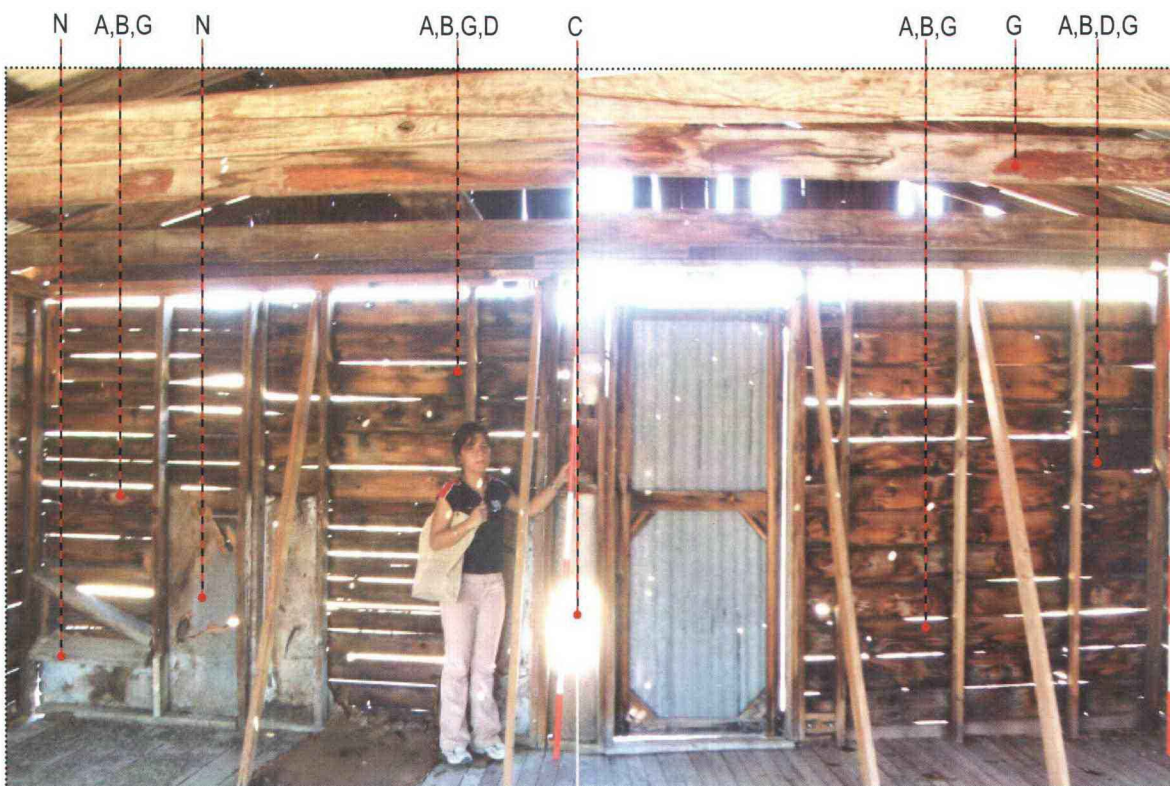
Deficiencies	Recommended Treatments	Priority
A	Water damage to wood paneling and fascia including warping and splintering.	Correction of the source of water Replace the wooden planks where severely damaged; match the size & type of wood to existing.	Serious
B	Rotting of wood due to microorganisms/ pests (also termite) infestation.	Application of biocides where severe damage.	Serious
C	Missing parts from wood planks	Replace entire plank where substantial parts missing or structural stability is endangered.	Critical
D	Corrosion and deterioration of wood around iron nails on edges.	Apply anti-rust coating on nails before replacement planks are installed.	Serious
E	Rusting of the corrugated metal roof due to water damage	Replace the sheets which are severely rusted.	Serious
F	Falling apart of the metal sheets on the roof	Replace/reattach the portions that are coming apart. Use identical sheeting for replacement	Critical

The recommended treatment for the Hay Barn / Bunkhouse No. 2 is *Restoration* as defined by the Secretary of the Interior's Standards for the Treatment of Historic Properties. For more specific treatment recommendations, see the *Ultimate Treatments* section.

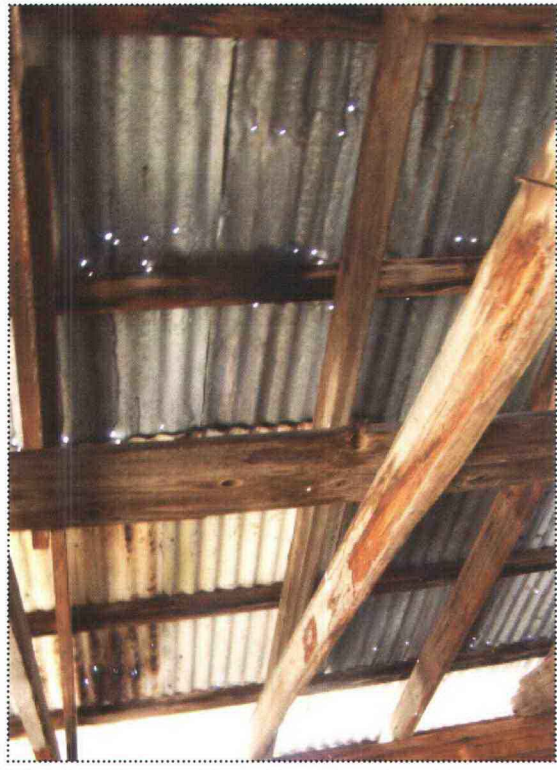
E. Detail view of metal roofing from the interior. Notice the rusting of sheets.

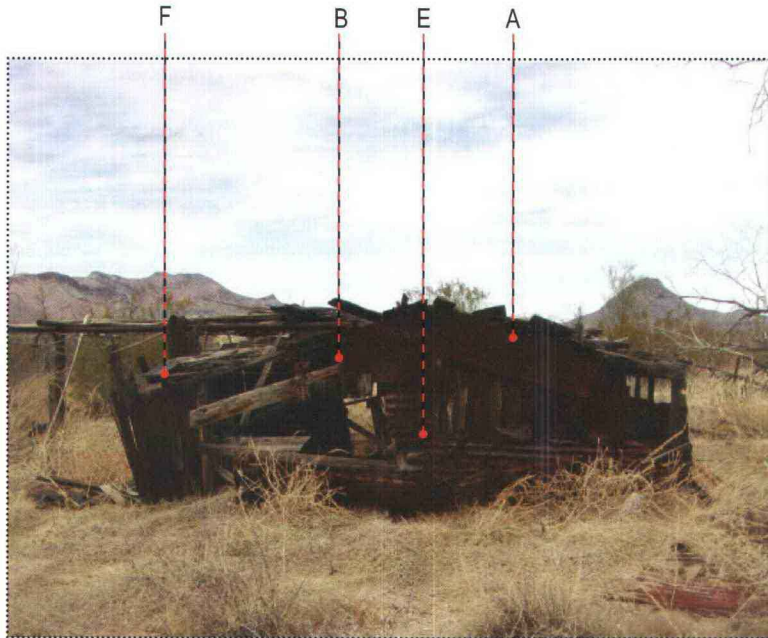
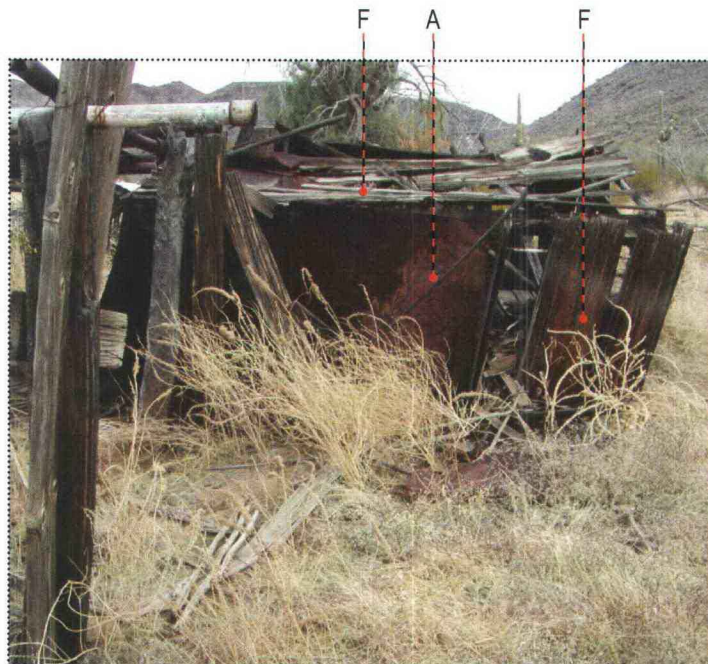
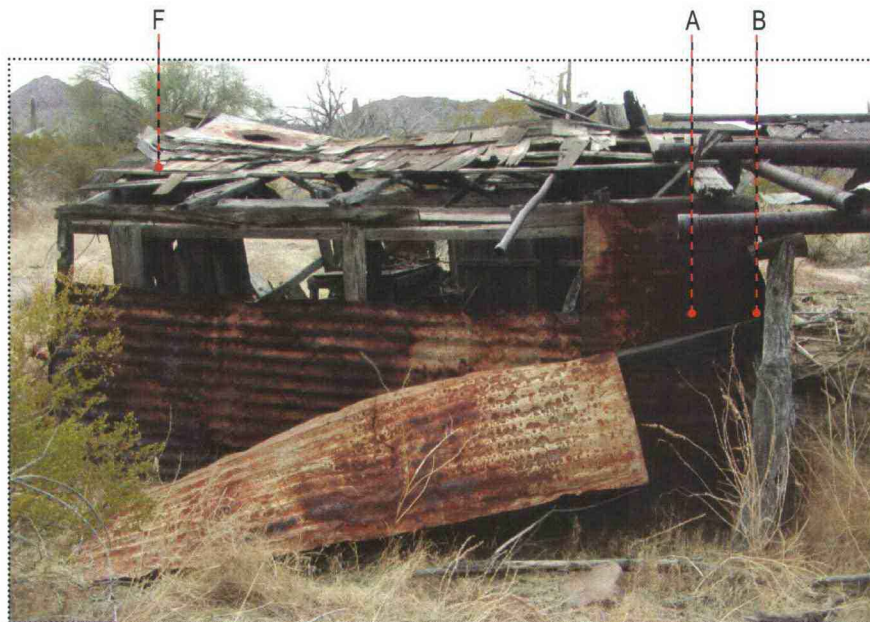
Deficiencies	Recommended Treatments	Priority
A	Corrugated metal contains severe rust damage.	Replace roof with like material	Serious
B	Rotted/termite infested Wood	Application of biocides where damage is severe.	Critical
C	Missing Components	Replace lost components	Serious
D	Water Damage	Replace roof and repair or replace damaged material.	Serious
E	Broken Window Framing/glazing	Replace and repair as needed	Serious
F	Structural Failure	Repair structural damage	Critical

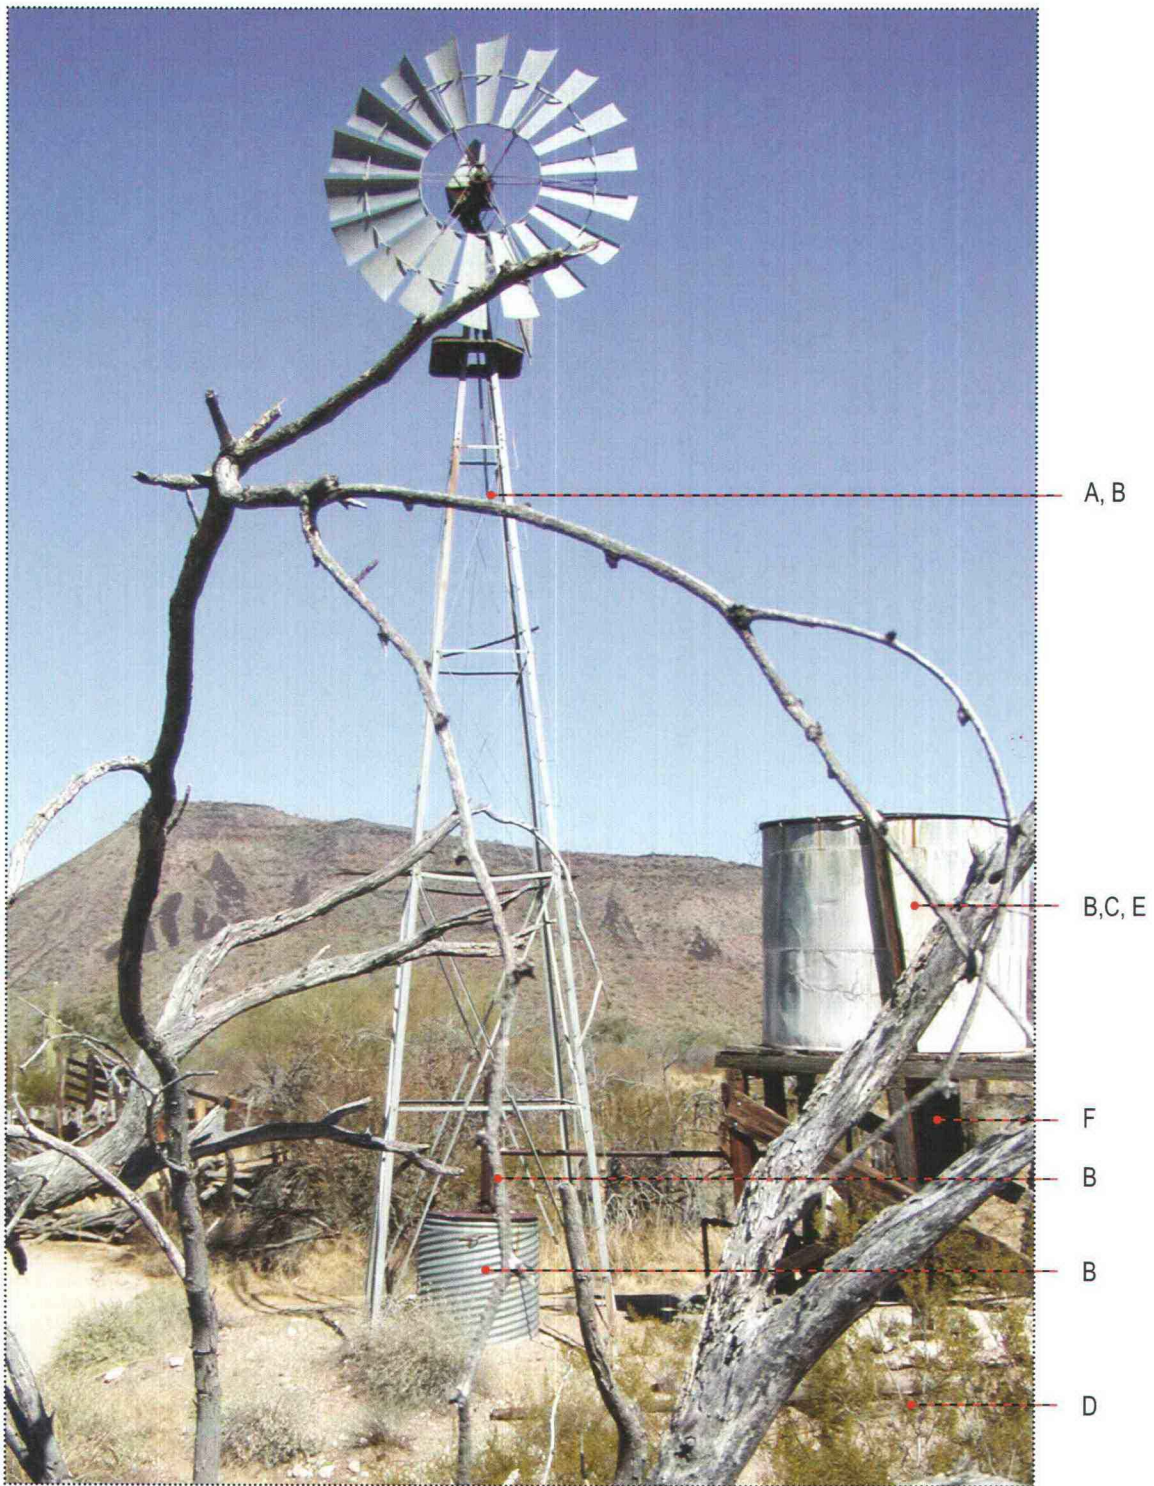
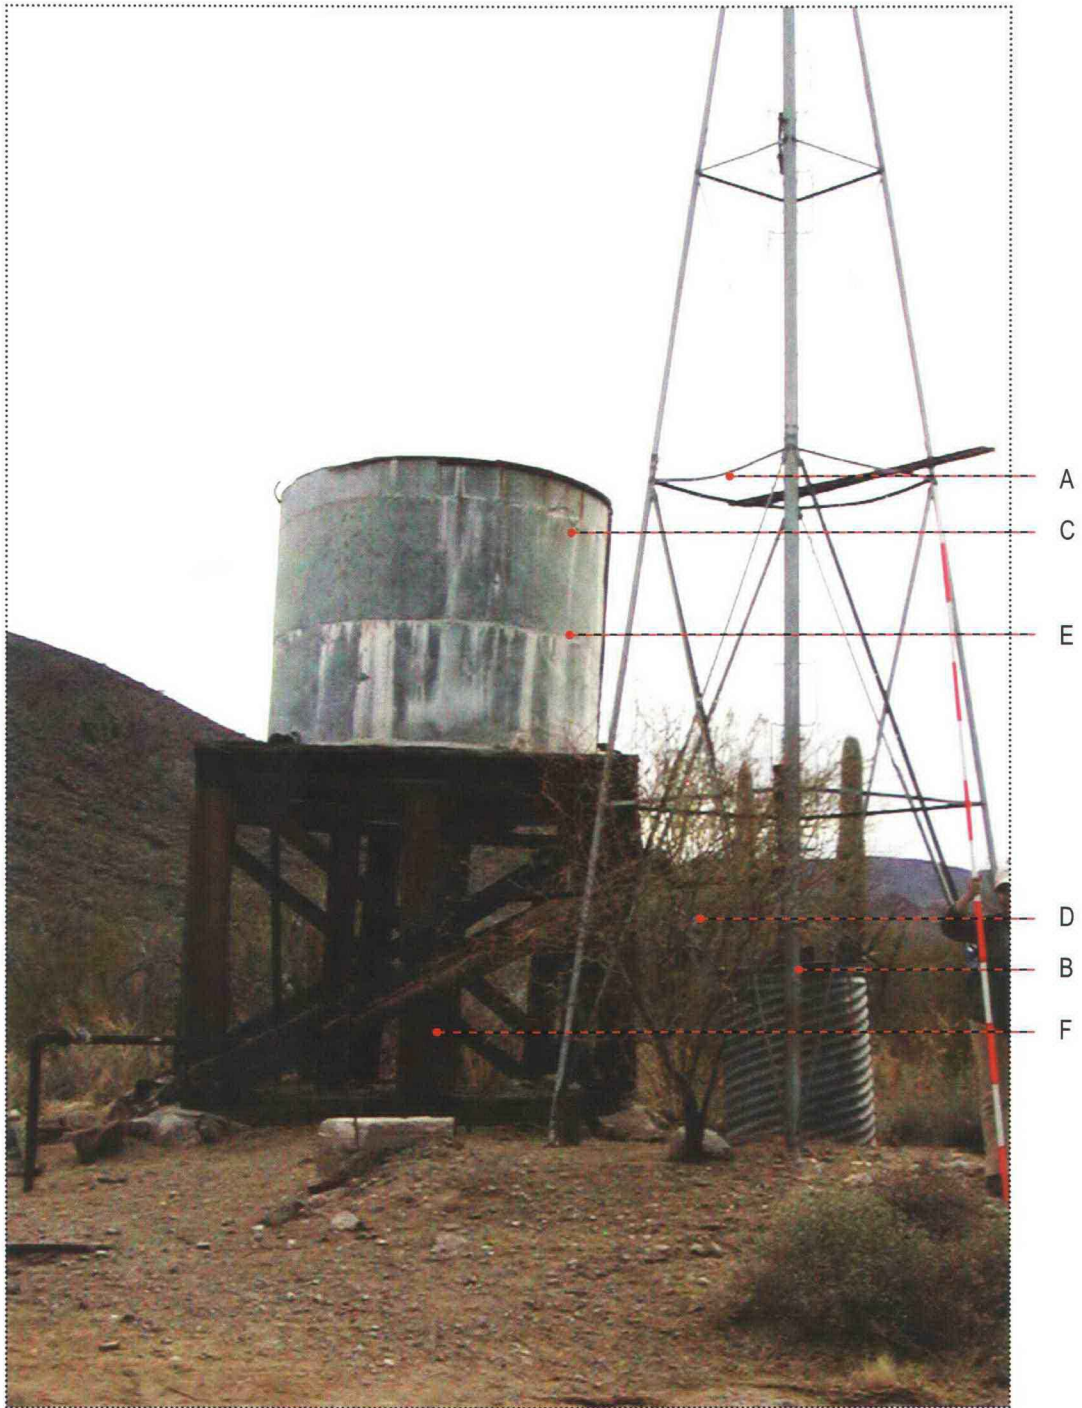
View of Windmill 2 from the west side showing existing damages and deficiencies. (letters refer to notes in condition assessment table below)

Water Tank and Base of Windmill (letters refer to notes in condition assessment table below)

The recommended treatment for Windmill 2 is *Preservation* as defined by the Secretary of the Interior’s Standards for the Treatment of Historic Properties. For more specific treatment recommendations, see the *Ultimate Treatments* section.
