HISTORIC STRUCTURES REPORT

BATES WELL RANCH

ORGAN PIPE CACTUS NATIONAL MONUMENT

A Service Learning Project of the
Preservation Studies Program
College of Architecture and Landscape Architecture
The University of Arizona

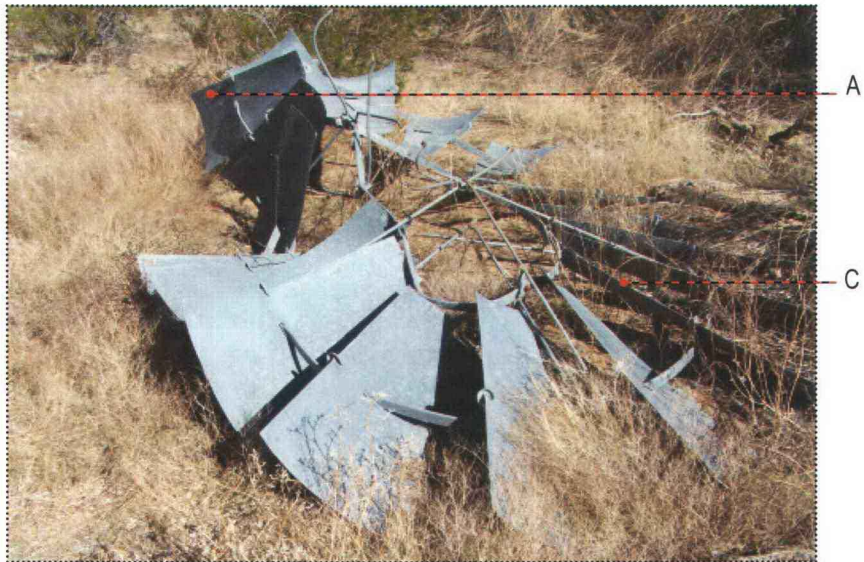
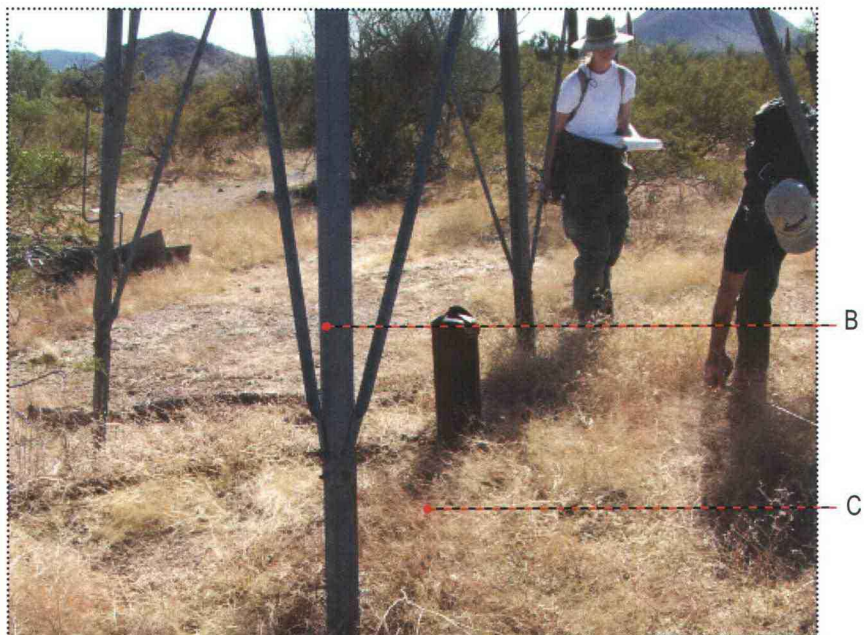
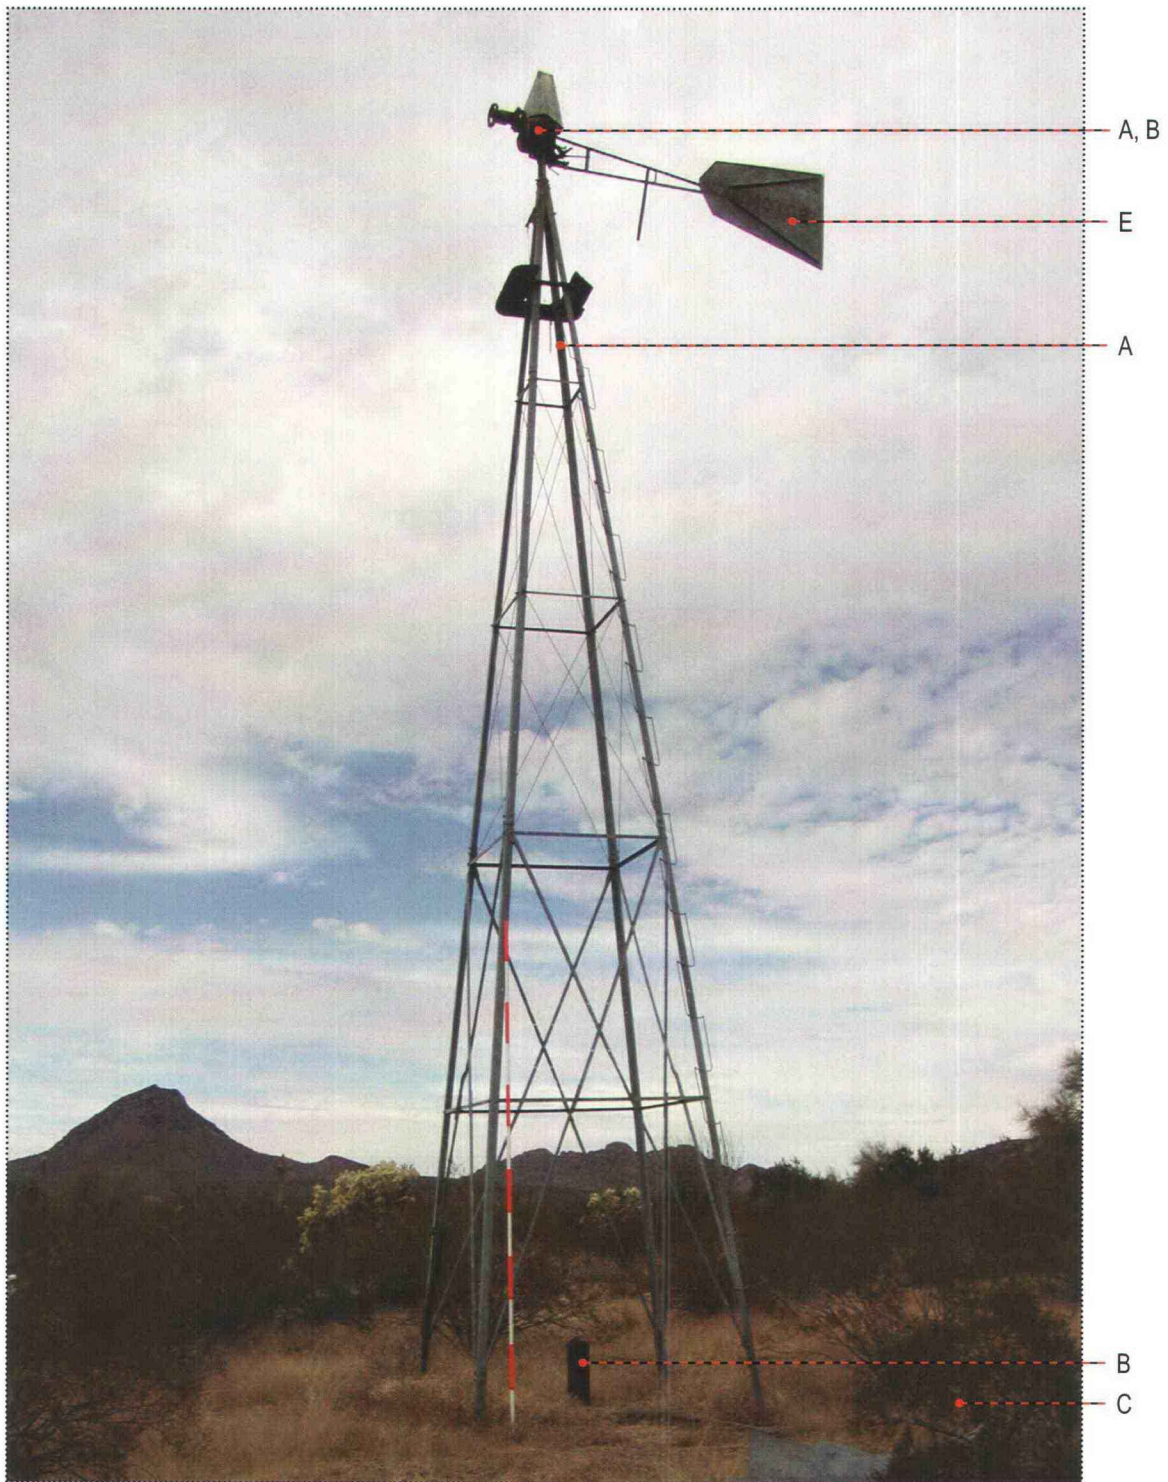
Blades from Windmill 3 lie on the ground near its base. (letters refer to notes in condition assessment table below)

View of Windmill #3 from the south-west side showing existing damage and deficiencies. (letters refer to notes in condition assessment table below)

The recommended treatment for Windmill 3 is *Preservation* as defined by the Secretary of the Interior's Standards for the Treatment of Historic Properties. For more specific treatment recommendations, see the *Ultimate Treatments* section.

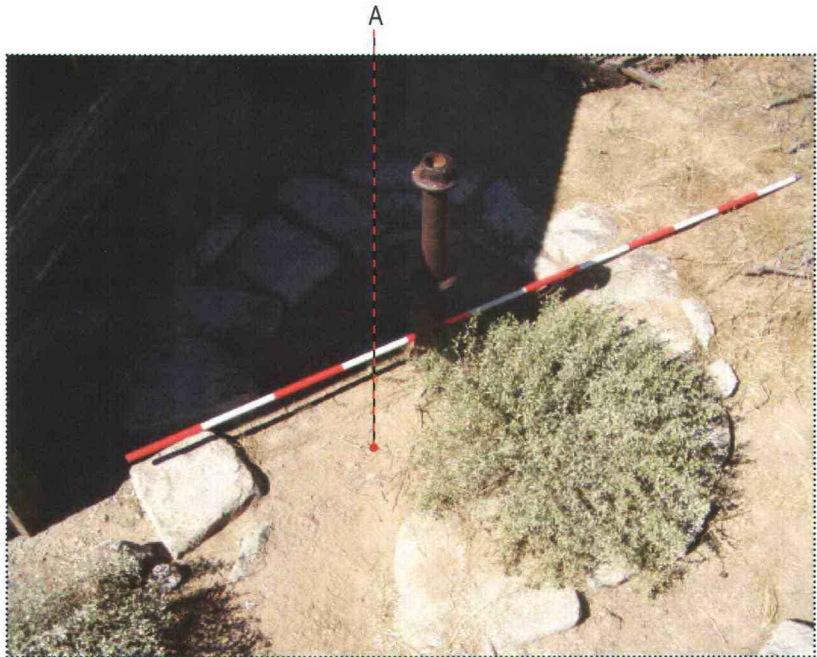
Deficiencies	Recommended Treatments	Priority
A	Missing Granite Stones	Replace with same	Medium
B	Missing arm and grinding wheel	Replace if period becomes part of significance.	low

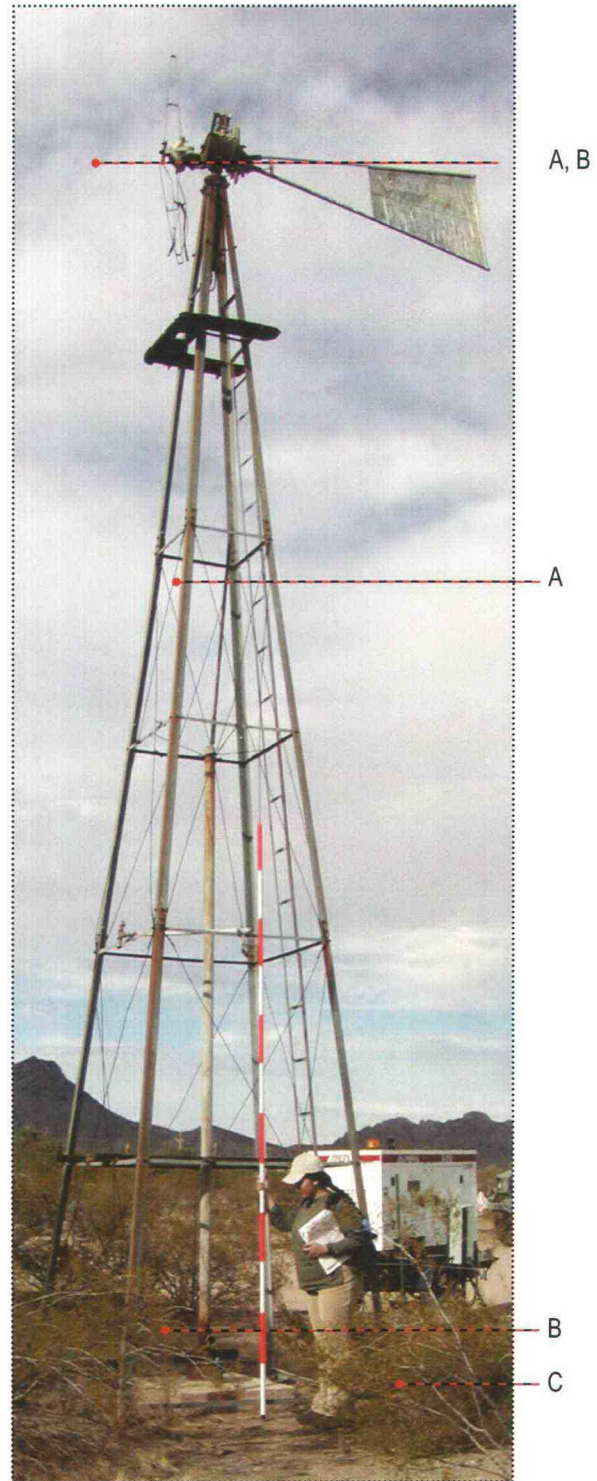
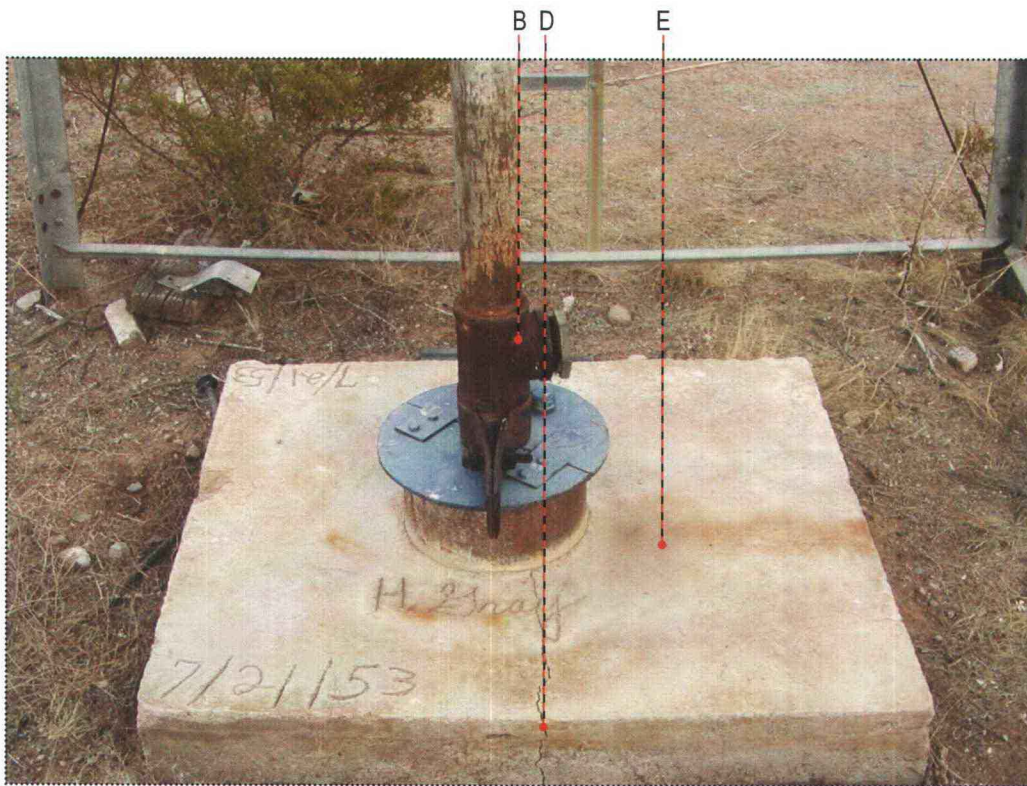
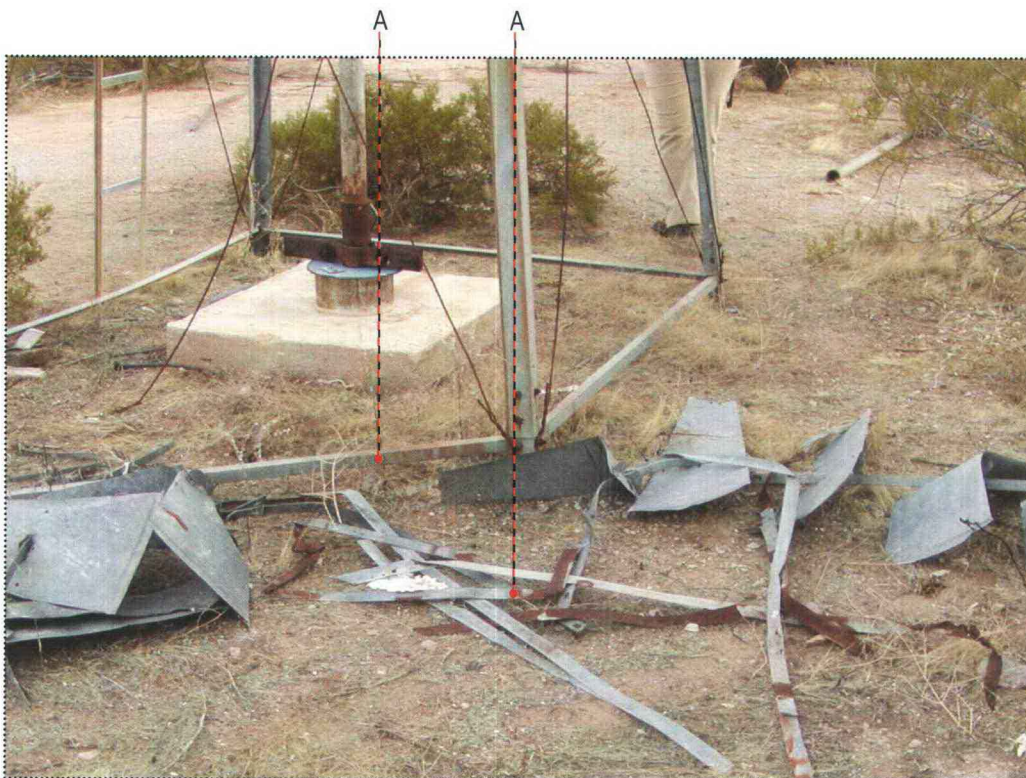
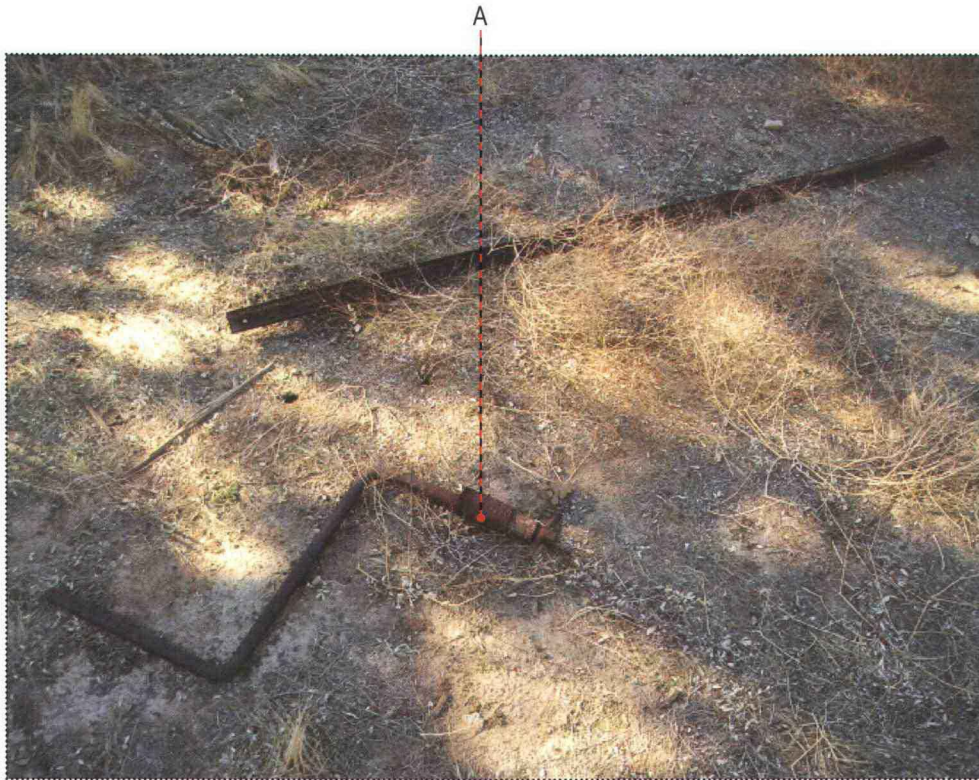
View of Windmill 1 from the south side showing existing damages and deficiencies. (letters refer to notes in condition assessment table below)

The recommended treatment for Windmill 1 is *Preservation* as defined by the Secretary of the Interior's Standards for the Treatment of Historic Properties. For more specific treatment recommendations, see the *Ultimate Treatments* section.
