historic structure report
appomattox manor

october 1982

HISTORIC STRUCTURE REPORT
PHYSICAL HISTORY AND ANALYSIS SECTION
APPOMATTOX MANOR
CITY POINT UNIT
PETERSBURG NATIONAL BATTLEFIELD
VIRGINIA

By
Richard G. Turk
and
G. Frank Williss

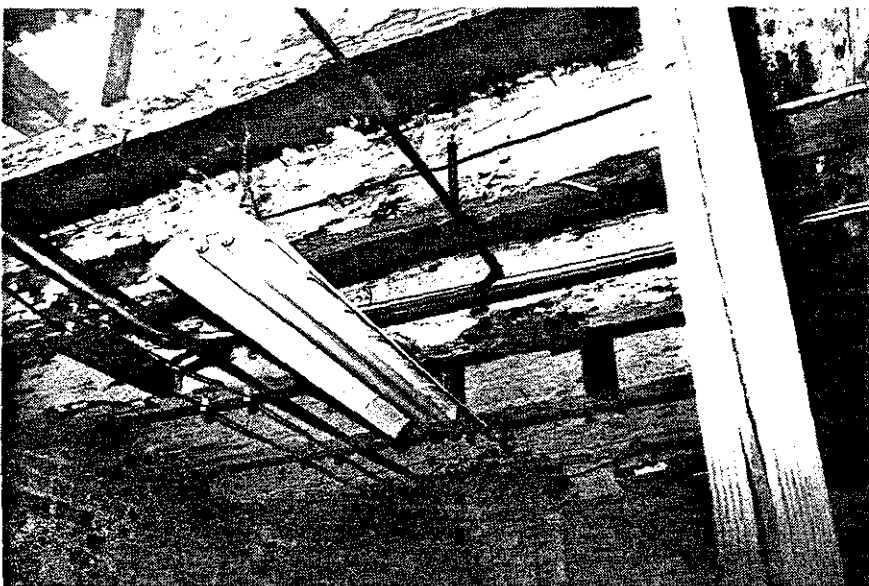
Illustration 64 1981
Manor House, basement
Interior, Room B-05
Detail first floor framing

Note: Insect damaged members

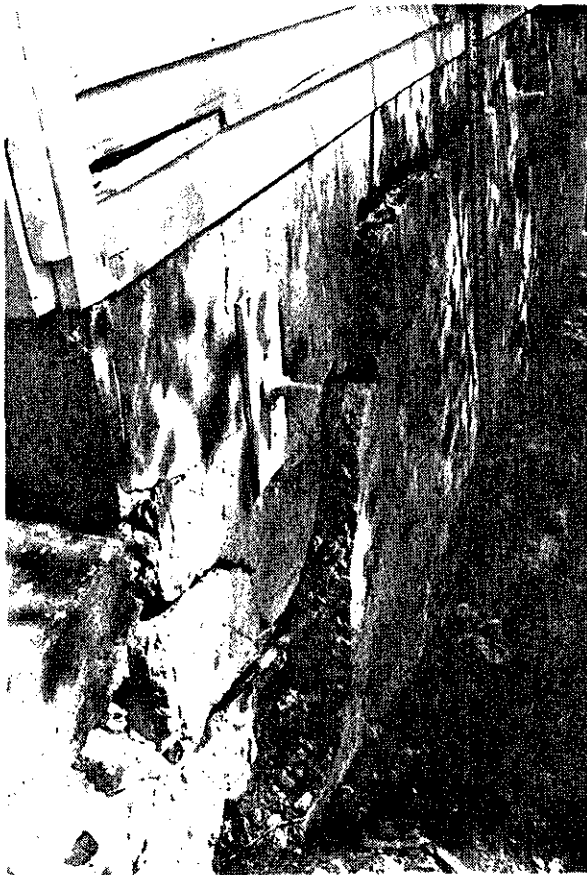
Illustration 92
Carriage House
West elevation
Foundation failure

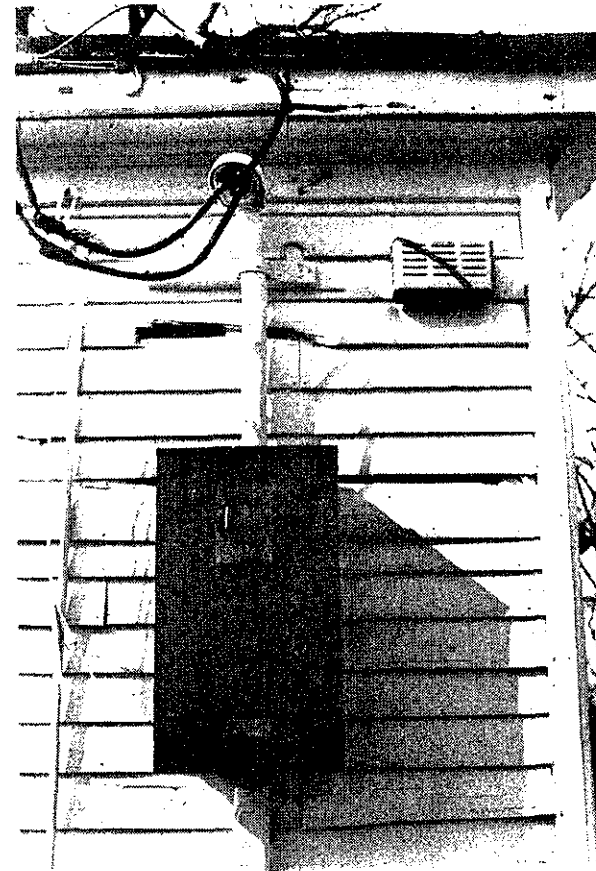
Illustration 93
Carriage House
East elevation
Damaged weatherboarding

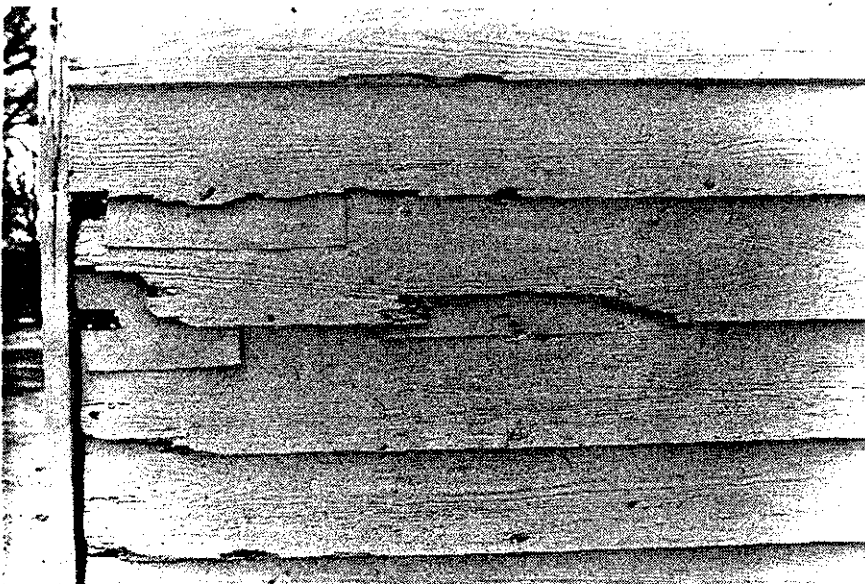
Illustration 102
Old Smokehouse
North elevation
Detail of damaged weatherboards

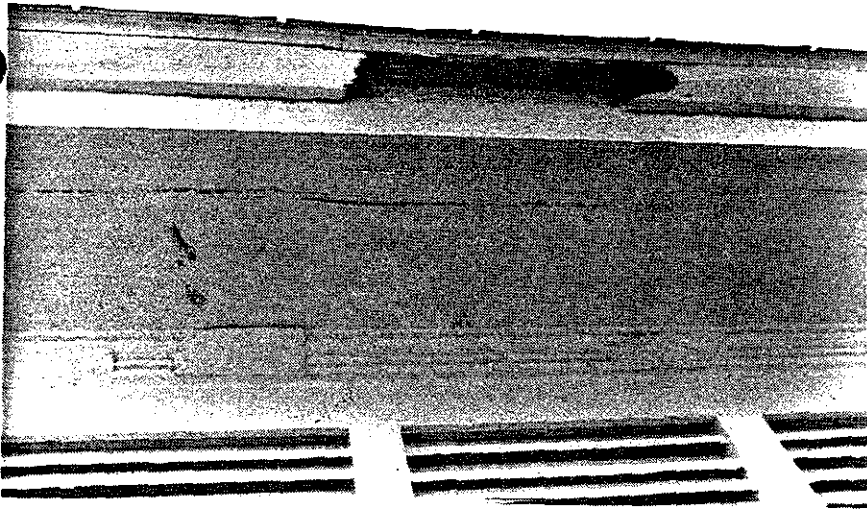
Illustration 121
Dairy
North elevation
Damaged cornice moulding

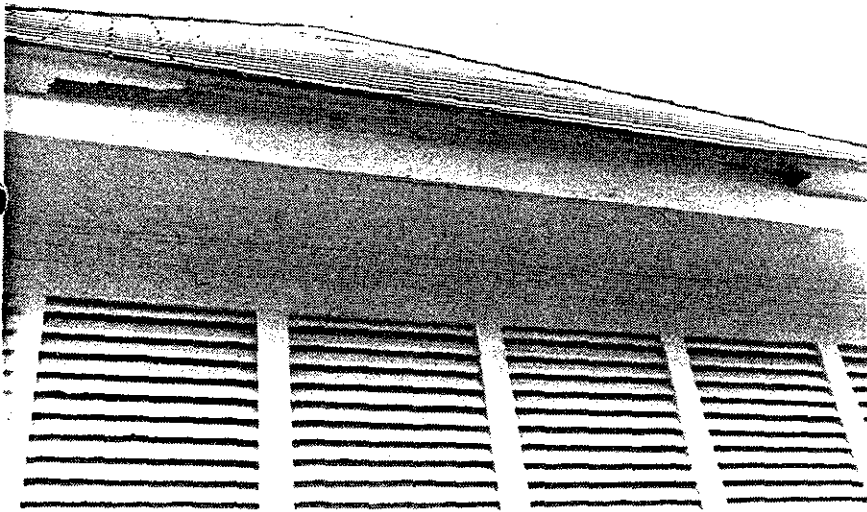
Illustration 122
Dairy
East elevation
Damaged cornice moulding
