historic structure report

administrative and architectural data

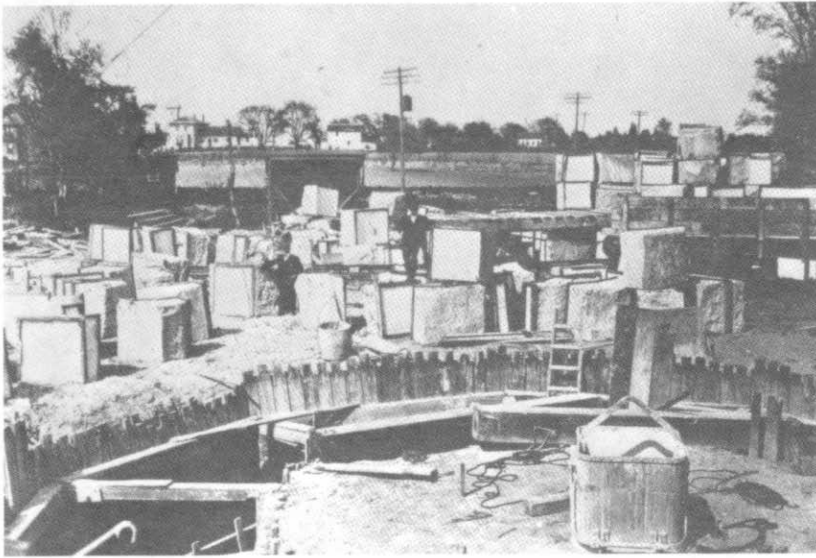
ILLUSTRATION 6. View of the repaired coffer dam, ready for forms and subsequent pouring of concrete to form the ring-shaped foundation, to extend to bedrock approximately 10 feet below foreground surface level. Bucket on center core island of excavation is to be employed to transport concrete up shaft to be raised from that spot as column construction advanced upward.

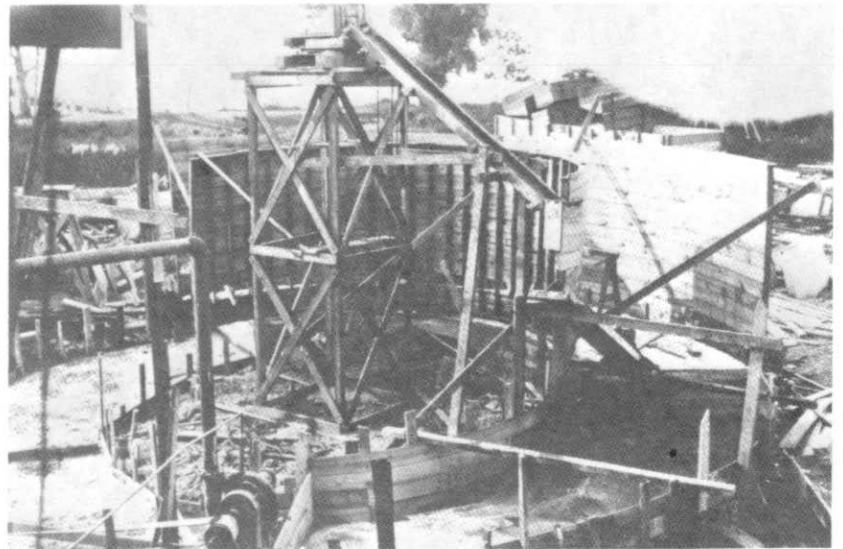
ILLUSTRATION 7. Pouring the ring-shaped foundation for the memorial column. The lower segment from bedrock to grade has been poured. Forms are being erected for pouring the upper segment from grade to the present plaza level, June 1913.

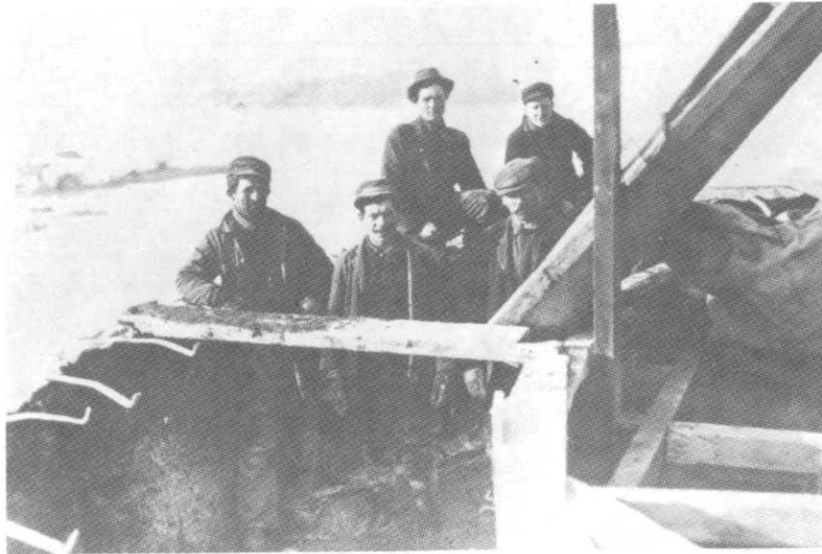
ILLUSTRATION 8. Memorial column construction progress, Aug. 15, 1913. Indiana Limestone framing interior doors and wall slabs of rotunda in place. Workman setting iron strap under granite block of partially completed fourth ("D") course of granite.

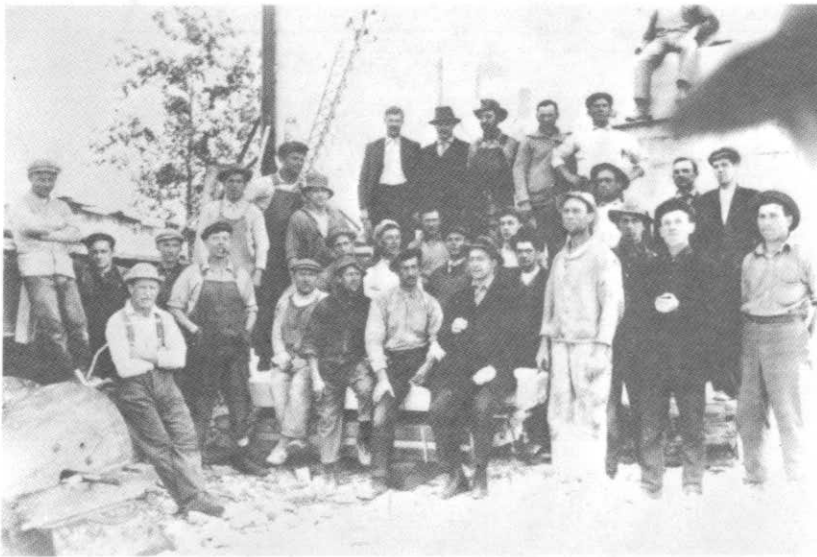
ILLUSTRATION 13. Memorial column construction crew, c. Sept. 15, 1913. Far left front, wearing derby, smoking cigar, arms folded, Mark Dunn, chief rigger. Fourth from right, first row, in light-colored clothes, soft hat, cigar in right hand, Henry Bell, the contractor's general foreman. Seated to Bell's immediate right, dark suit, is the timekeeper, name unknown.

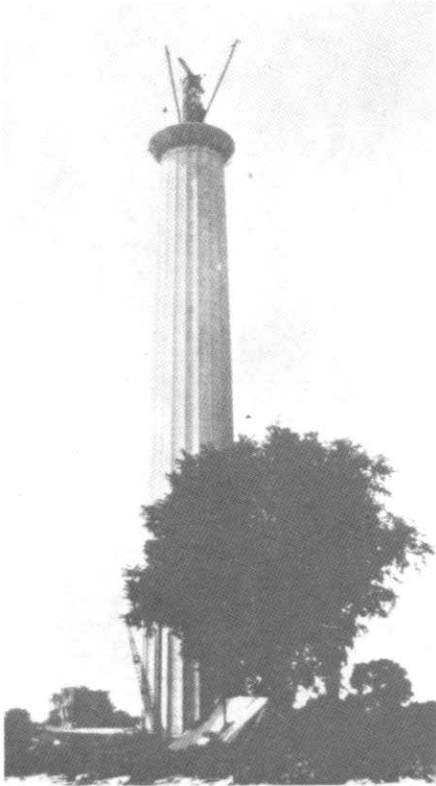
ILLUSTRATION 15. Setting the facing stones on falsework to form the soffit for the capital (cap structure) of the column, July-August 1914.

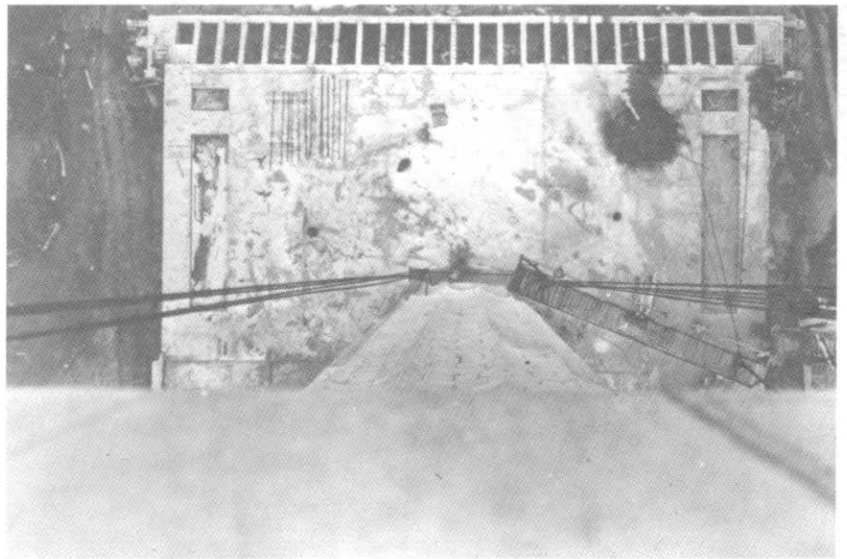
ILLUSTRATION 19. Bird's-eye view of the plaza construction, bay front, c. December-January 1914-15.

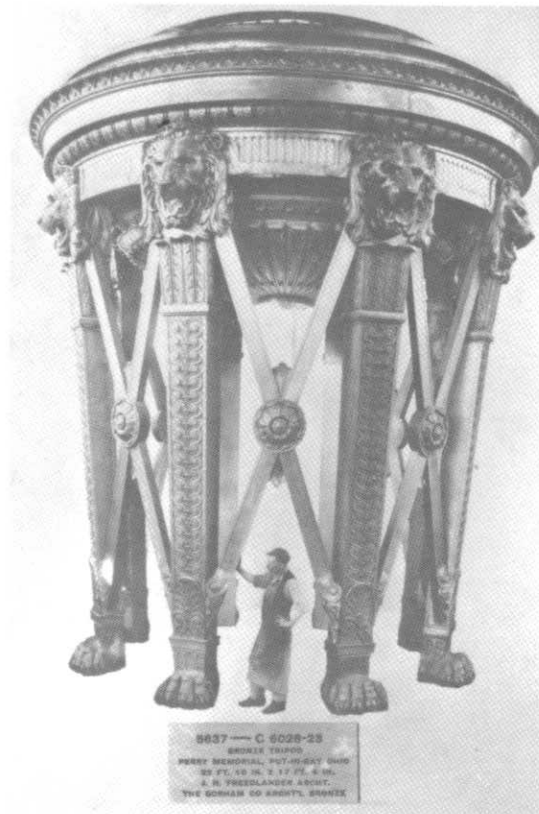
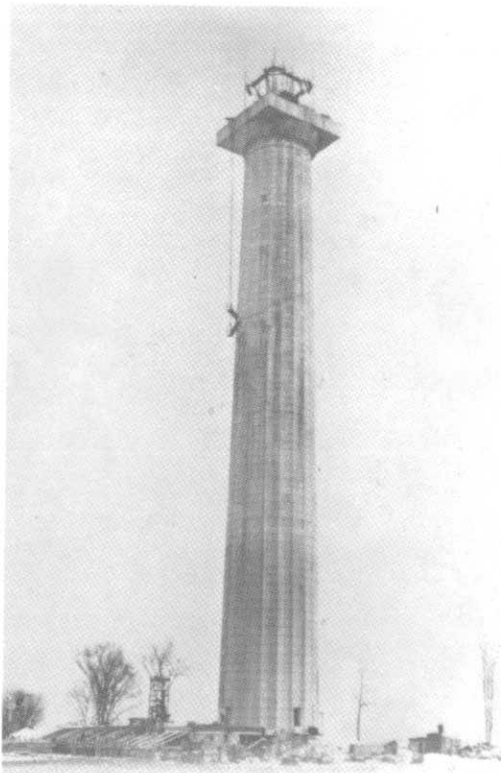
ILLUSTRATION 20. Scaffold for the lantern and framework for the plaza, c. Dec. 1914.

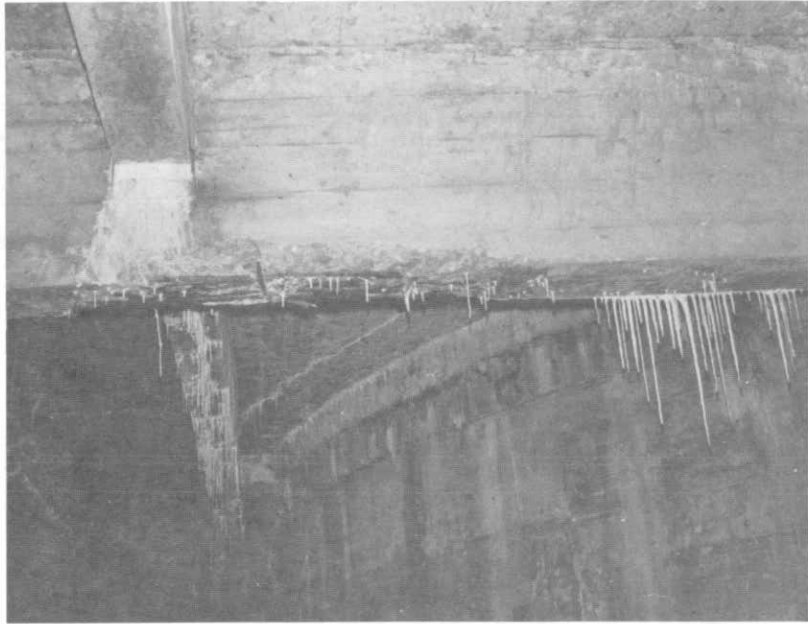
ILLUSTRATION 24. Top of column foundation at approximately southeast side, just below upper plaza.

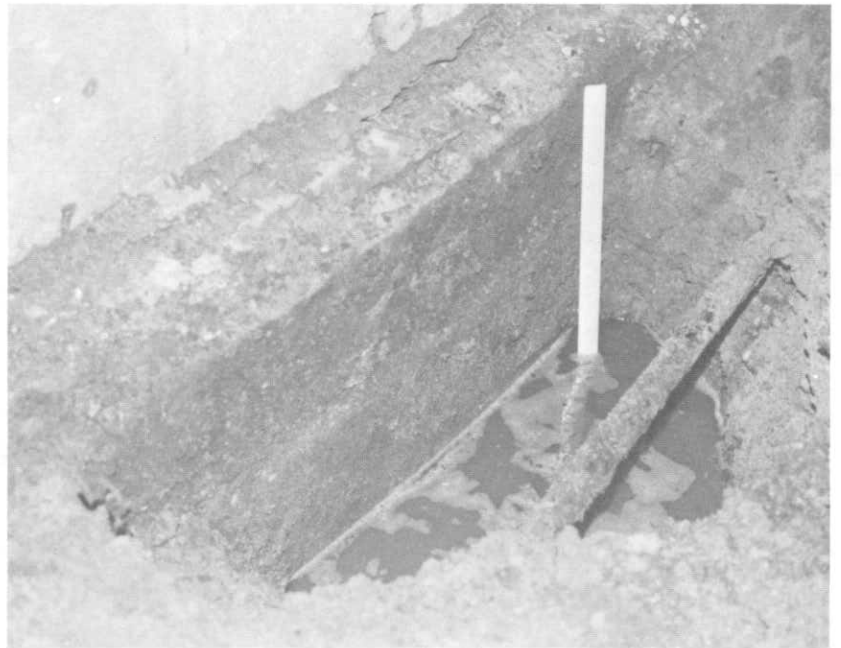
ILLUSTRATION 25. Bottom of column foundation at approximately southeast side, just below grade.

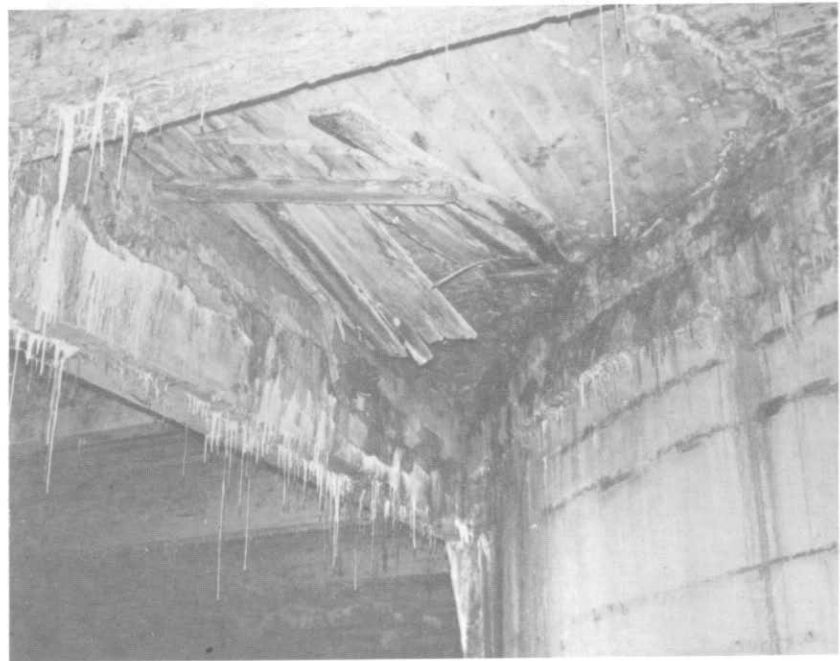
ILLUSTRATION 26. Top of column foundation at approximately northwest side, just below upper plaza.

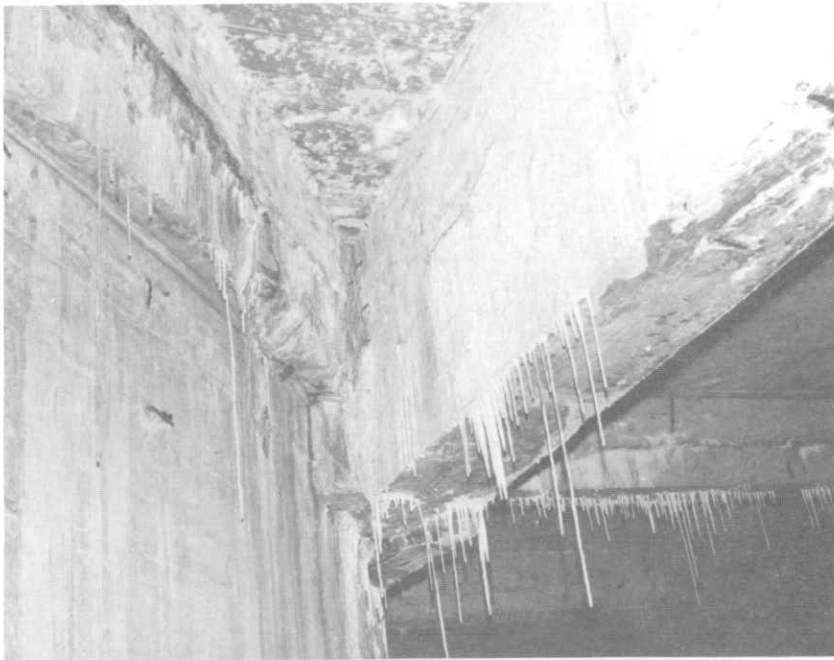
ILLUSTRATION 27. Top of column foundation at approximately northeast side, just below upper plaza.

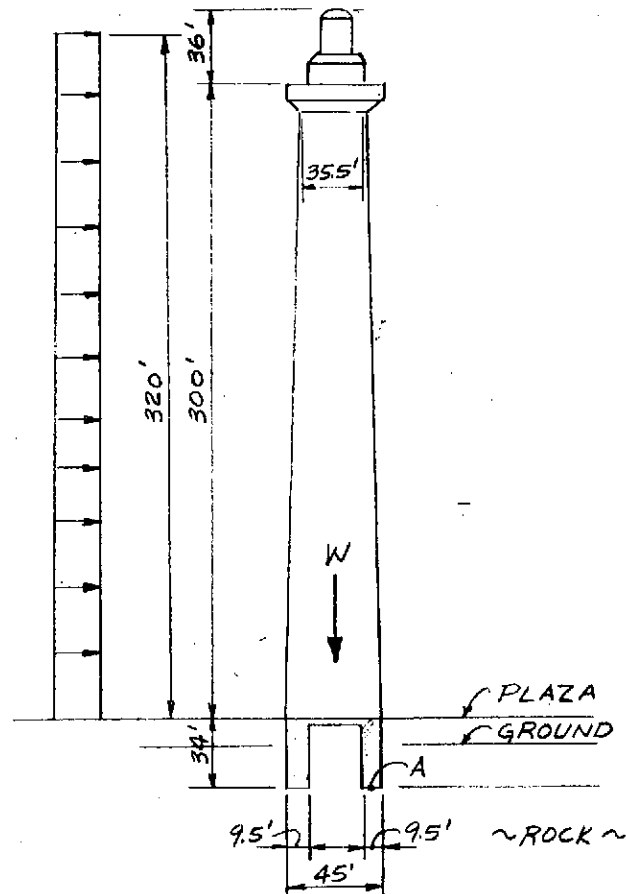
WEIGHT OF COLUMN = 36800^K

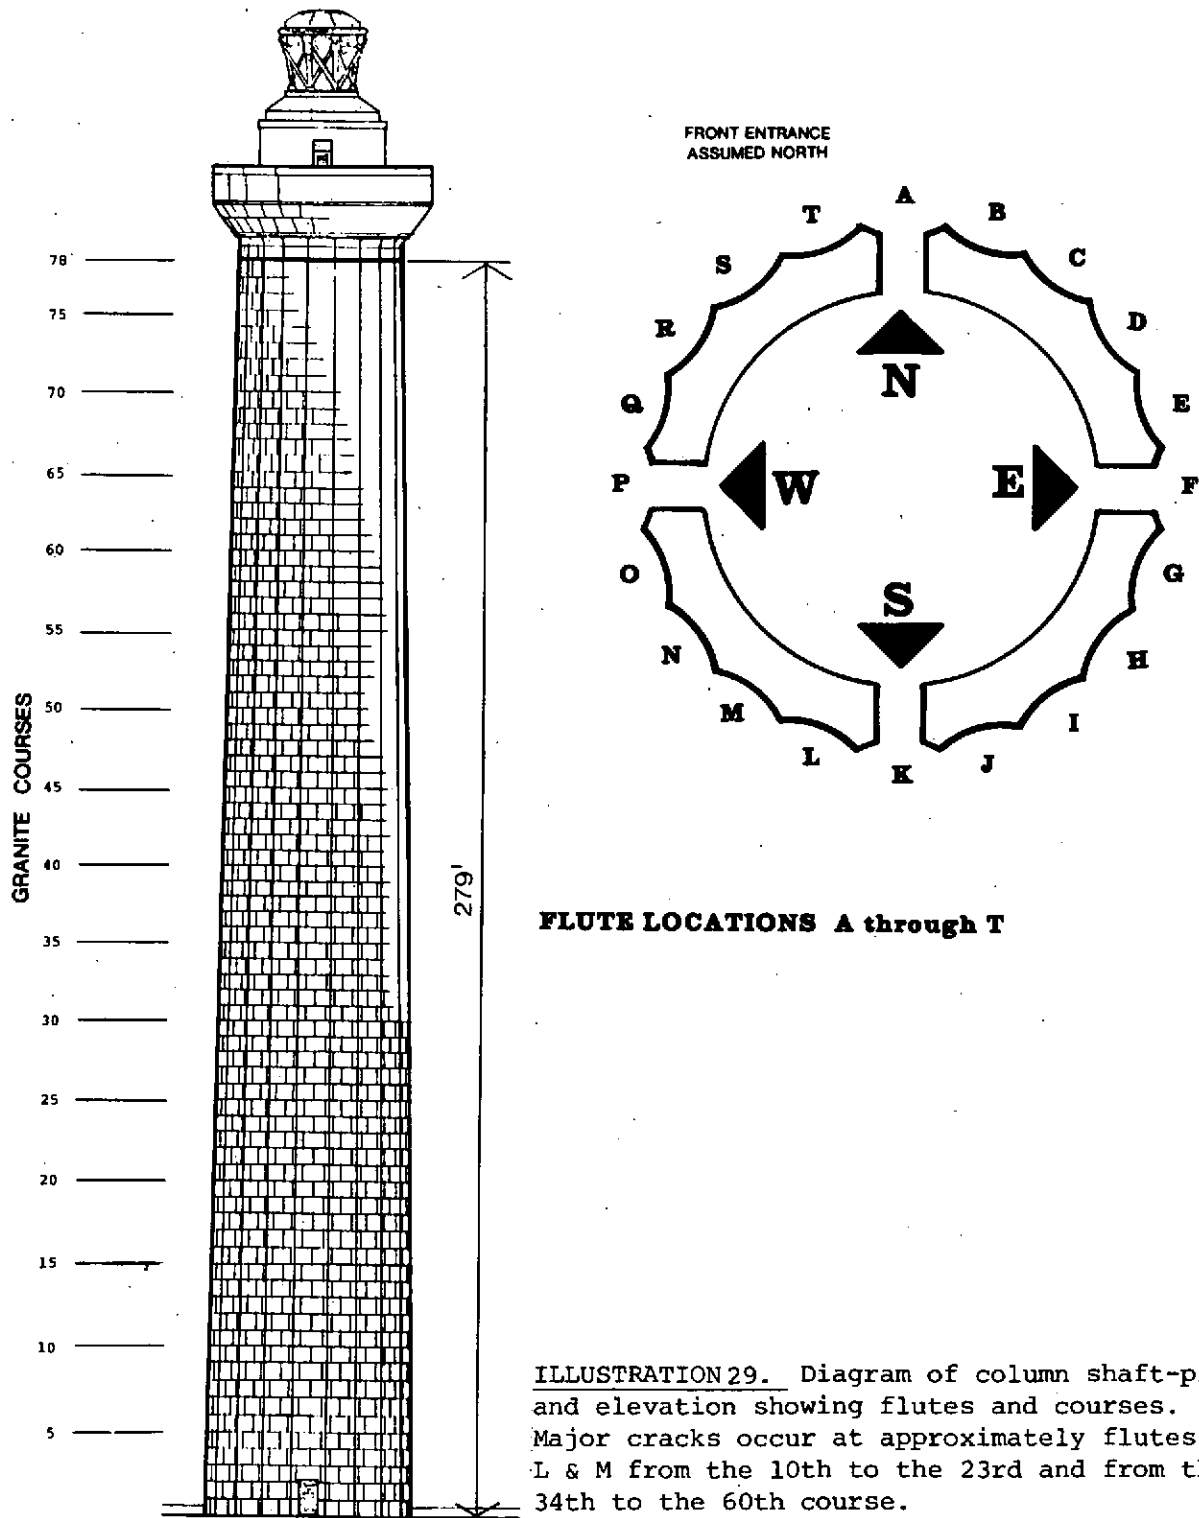
FLUTE LOCATIONS A through T

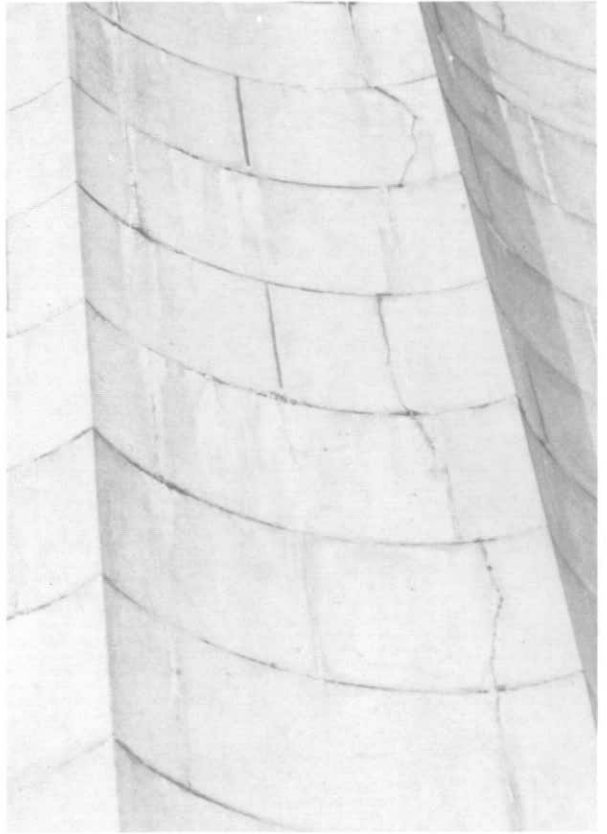
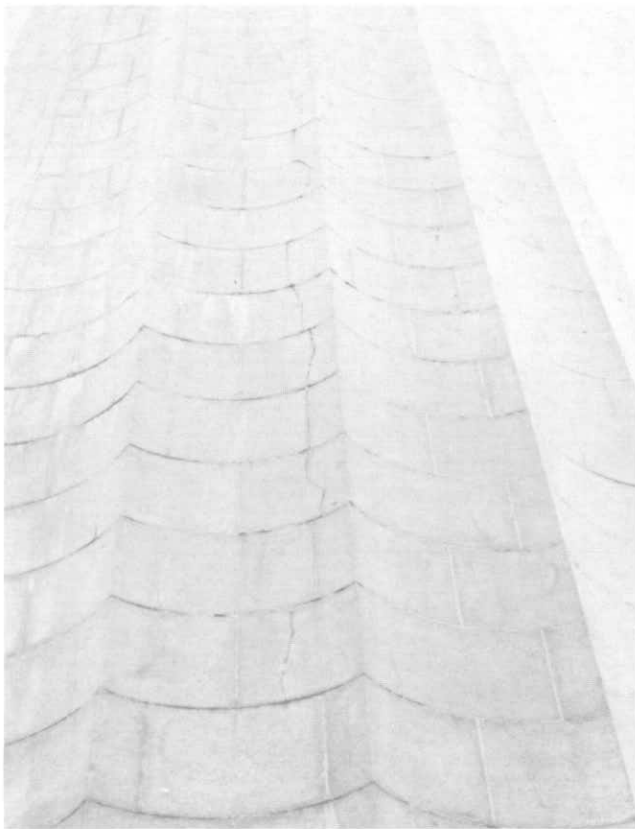
ILLUSTRATION 31. Overview of lower part of southwest side of column showing extent of major crack at flute M, courses 10 through 23.

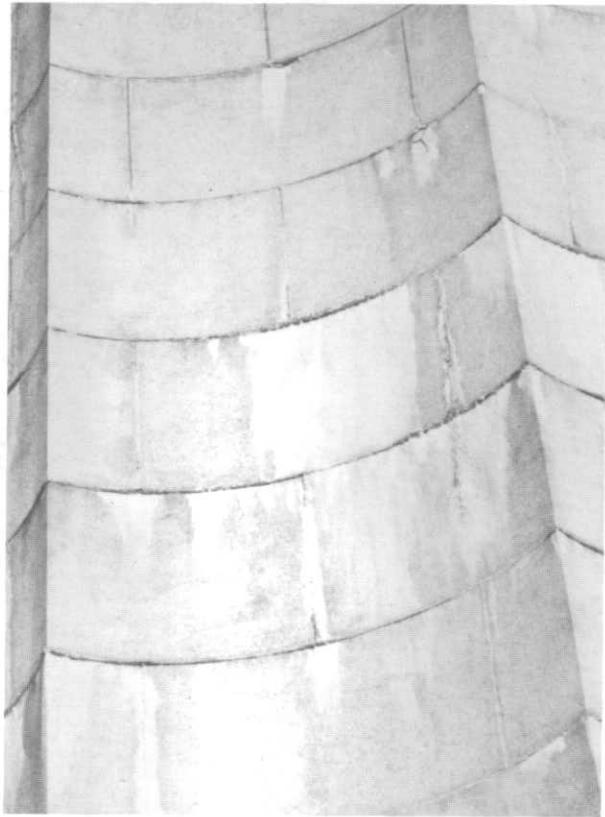
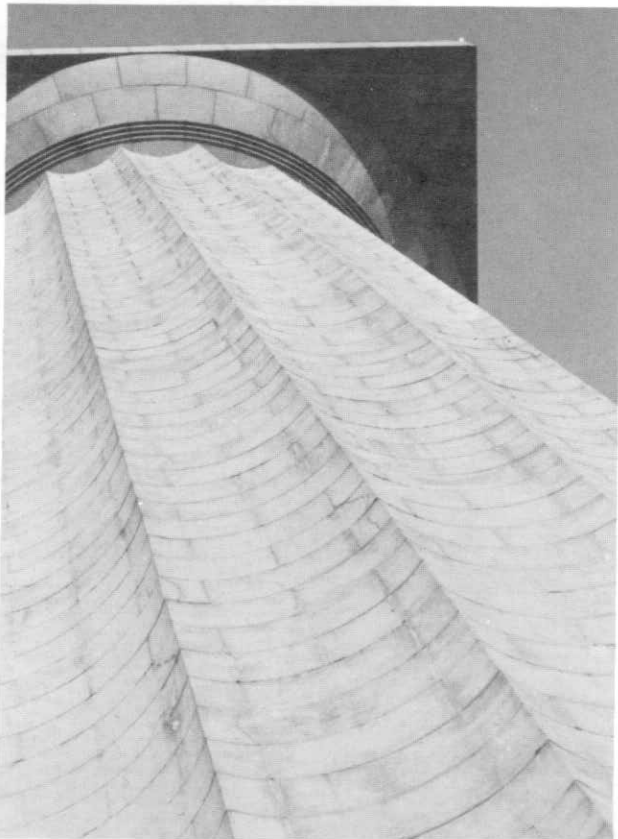
ILLUSTRATION 33. Overview of west side of column showing some typical minor cracks and spalling of face of granite block. Column capital with observation gallery above is at top of photo.

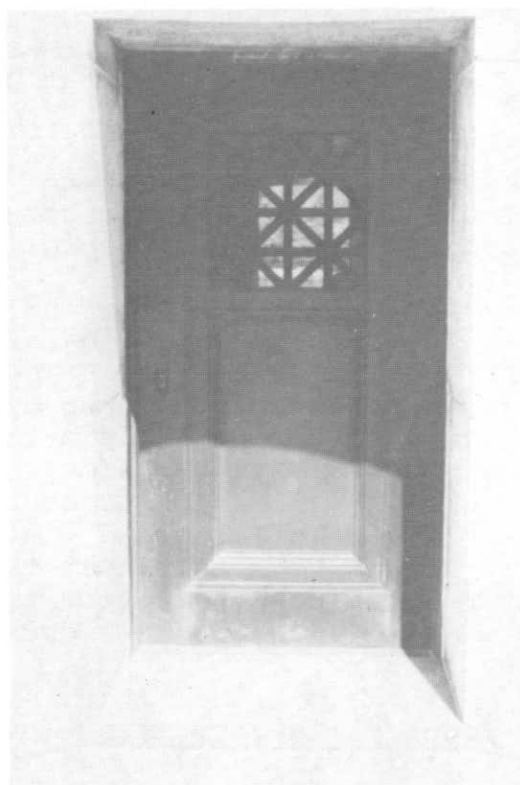
ILLUSTRATION 34. View of exterior of sliding west door to the column from the upper plaza. This is typical for the north and east doors.

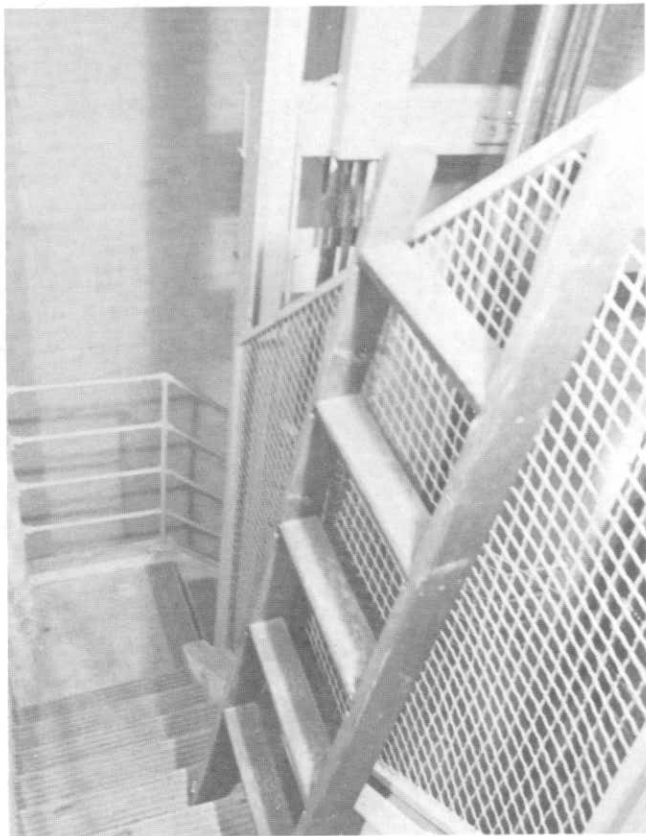
ILLUSTRATION 36. View of typical stair run and platform showing original safety treads. Mesh screen panels separate the stair run from the elevator shaftway.

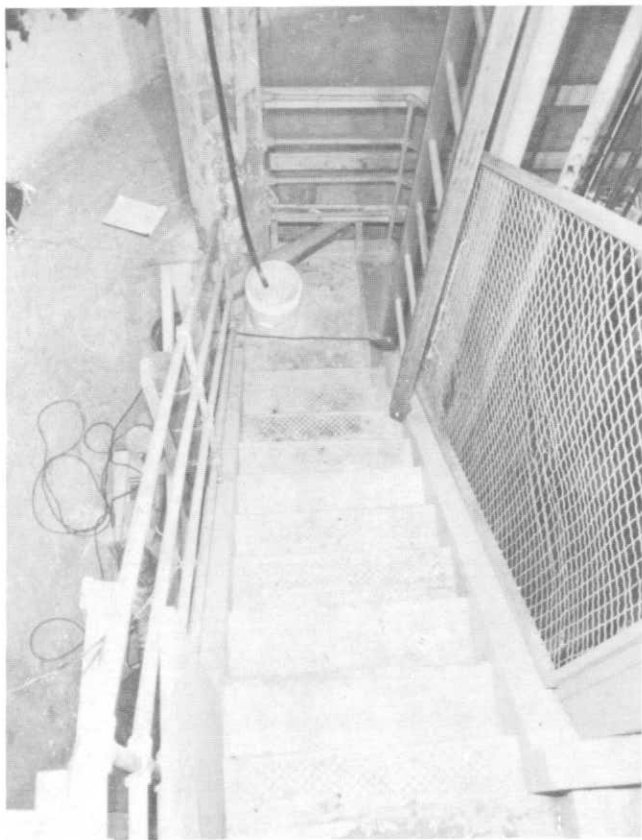
ILLUSTRATION 37. View of uppermost stair run and platform showing replacement safety tread and treads with cement wash only.

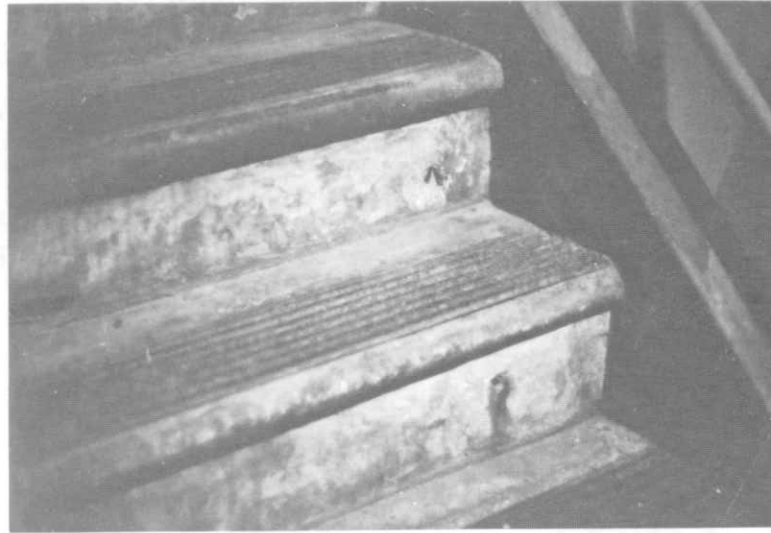
ILLUSTRATION 38. View of stair tread and riser showing the typical existing safety tread with round nosing in good condition.

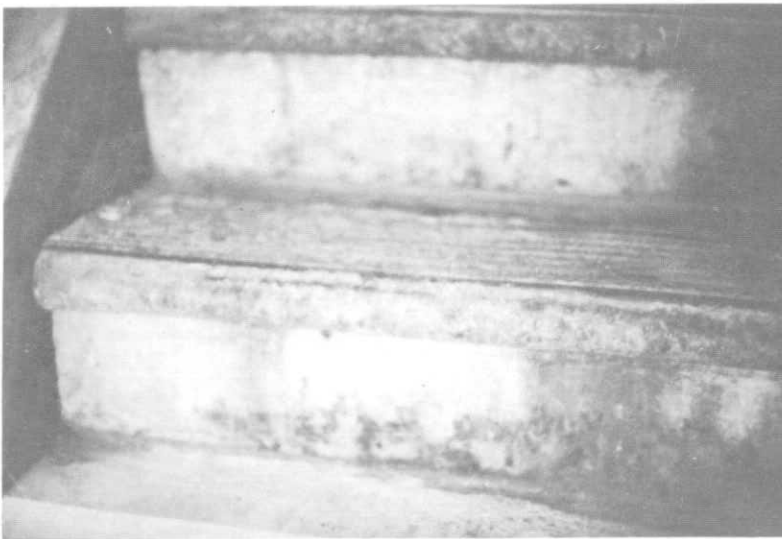
ILLUSTRATION 39. View of stair tread and riser showing the safety tread that has deteriorated due to moisture.

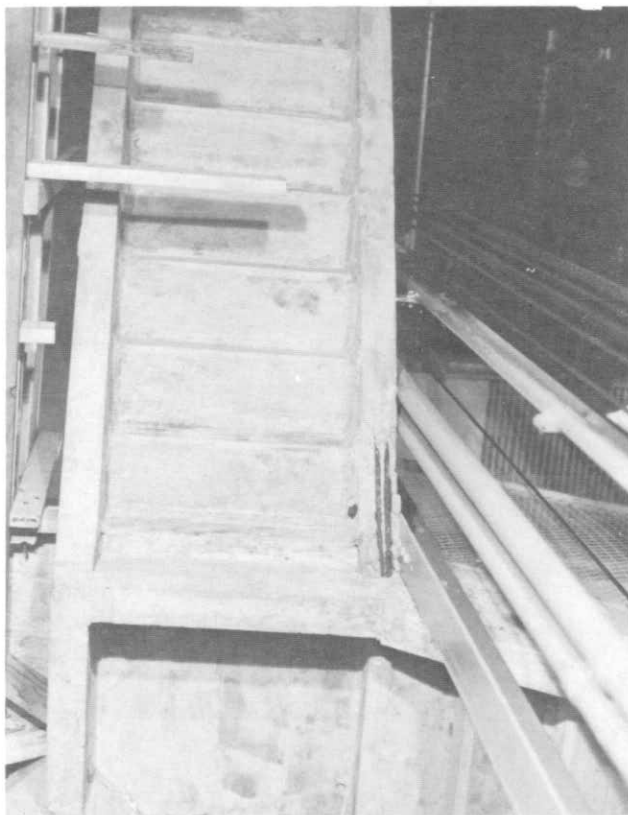
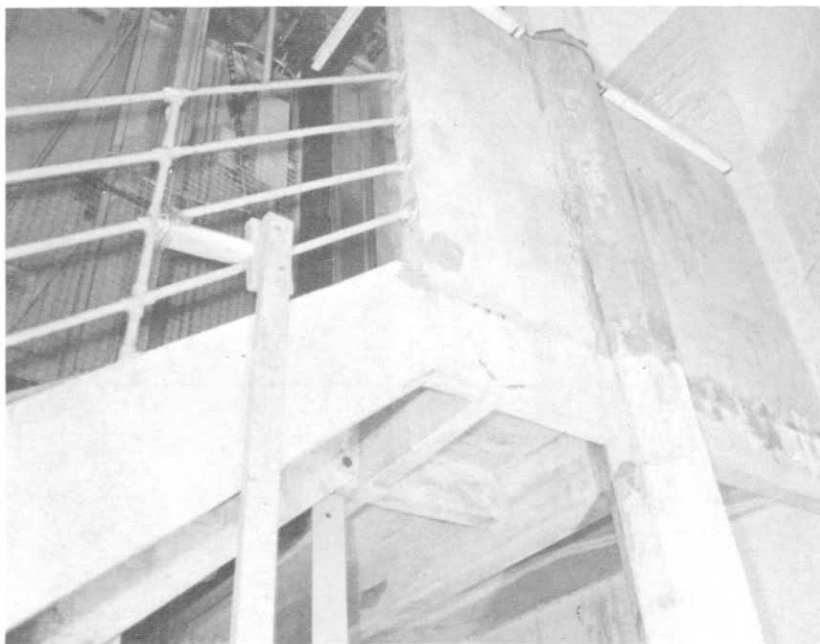
ILLUSTRATION 41. View of underside of upper elevator landing showing typical octagonal column and backside of concrete wall at landing level.

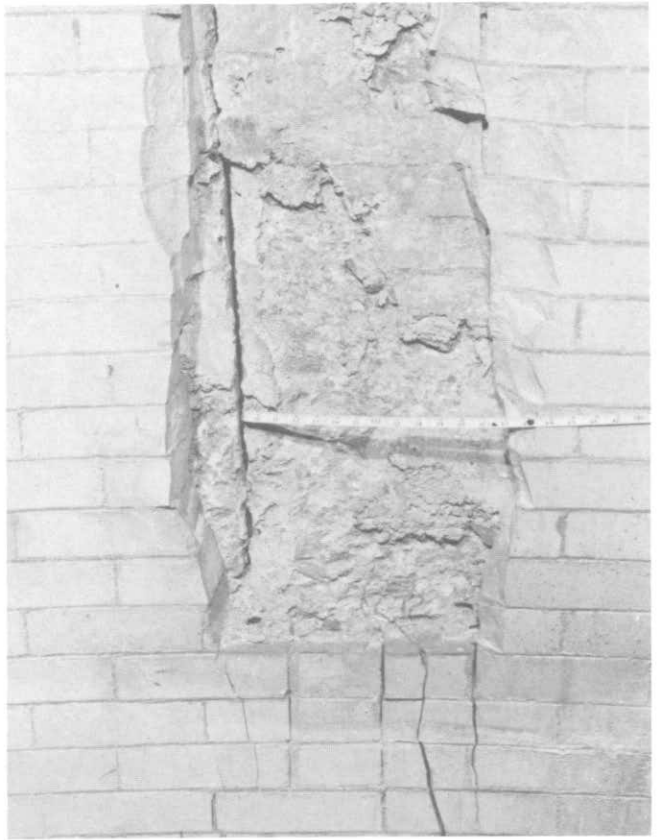
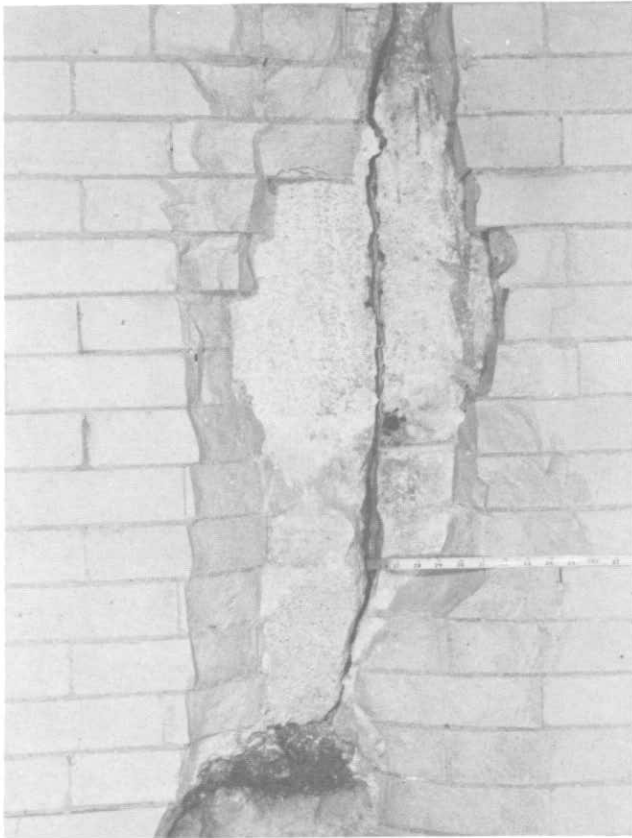
ILLUSTRATION 48. Detail view similar to Illustration 47, above, but also showing chunk of wood embedded in concrete which is an example of foreign matter which may be a cause of brown stains.

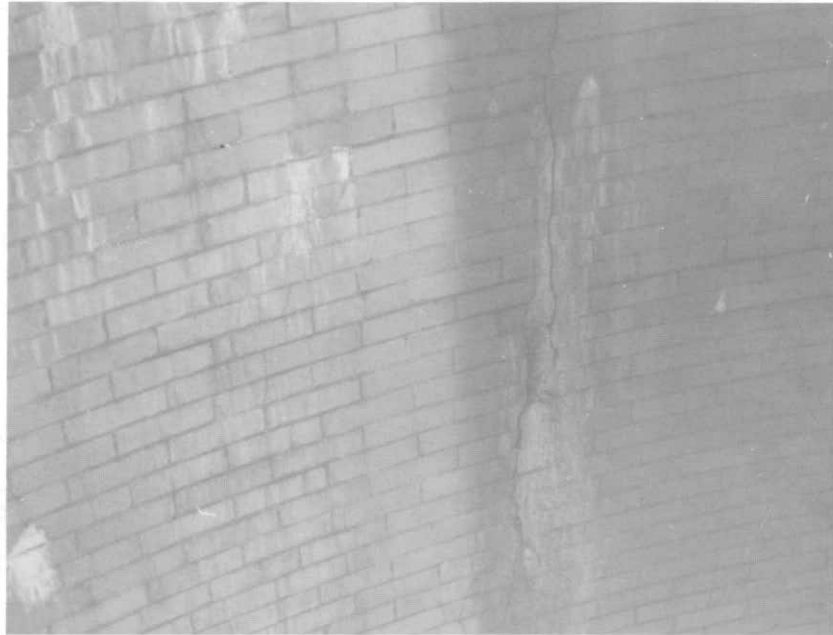
ILLUSTRATION 49. Typical efflorescence and brown stains which occur throughout shaft.

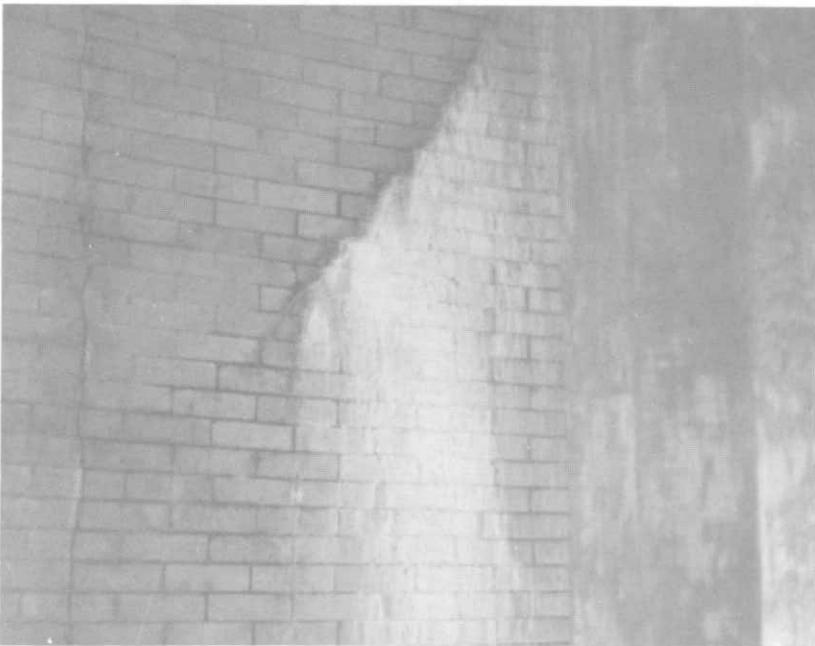
ILLUSTRATION 50. Detail of a major efflorescent stain, located in west quadrant at level 3.

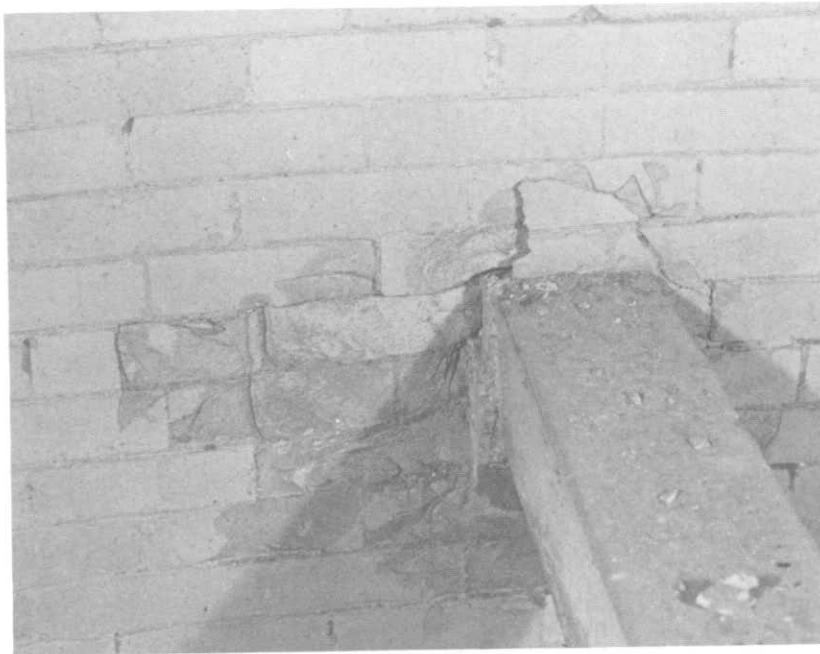
ILLUSTRATION 51. Detail of spalled brick at 6" by 6" concrete column brace and face of brick.

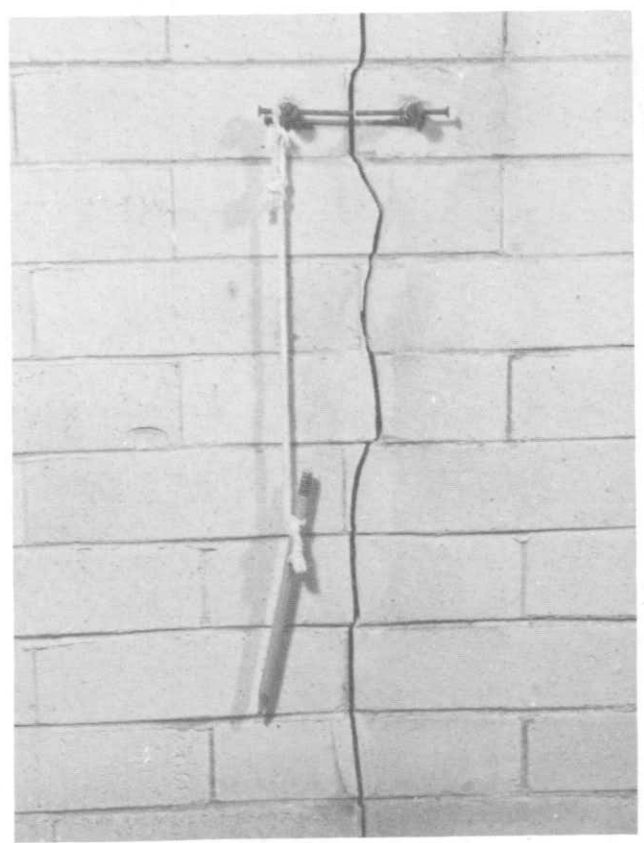
ILLUSTRATION 52. Detail of typical crack in brick lining of column shaft. Nails are a device to measure possible changes in dimension of crack width.

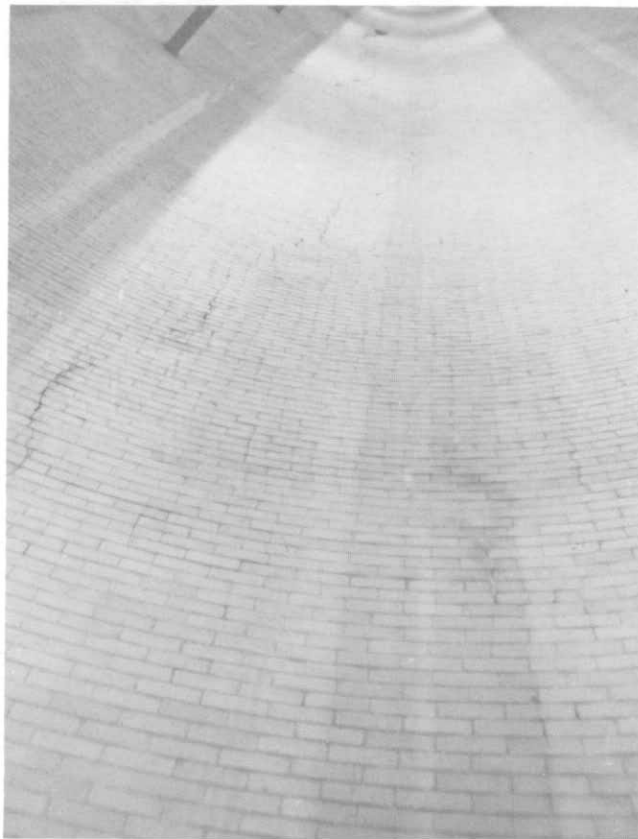
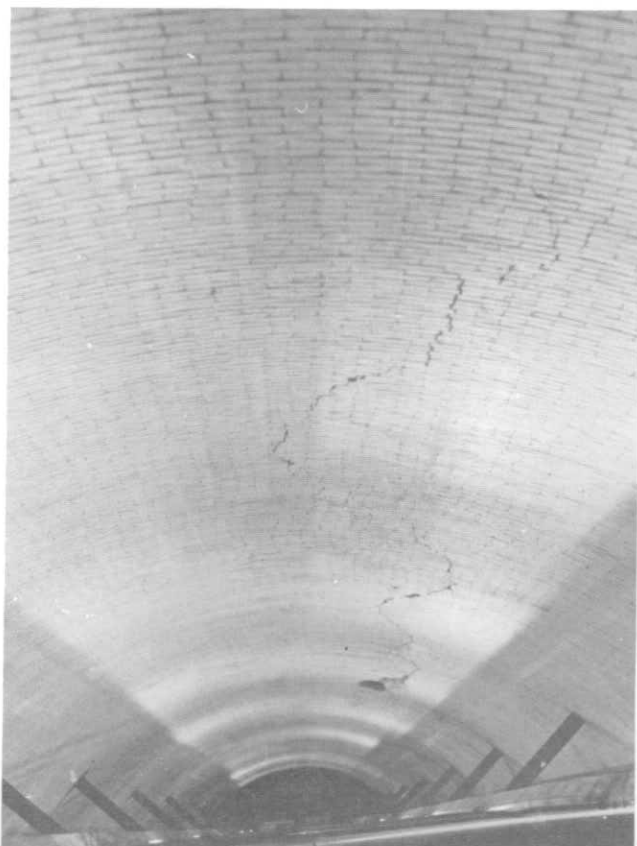
ILLUSTRATION 54. Overall view down column shaft at south quadrant showing major crack.

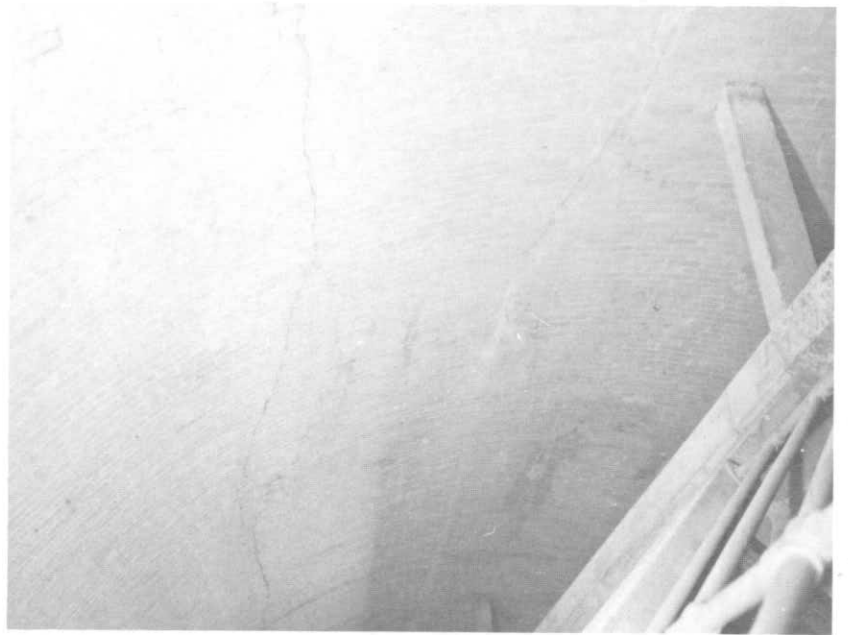
ILLUSTRATION 55. General view of brick crack in north quadrant of column shaft at approximately level 5.

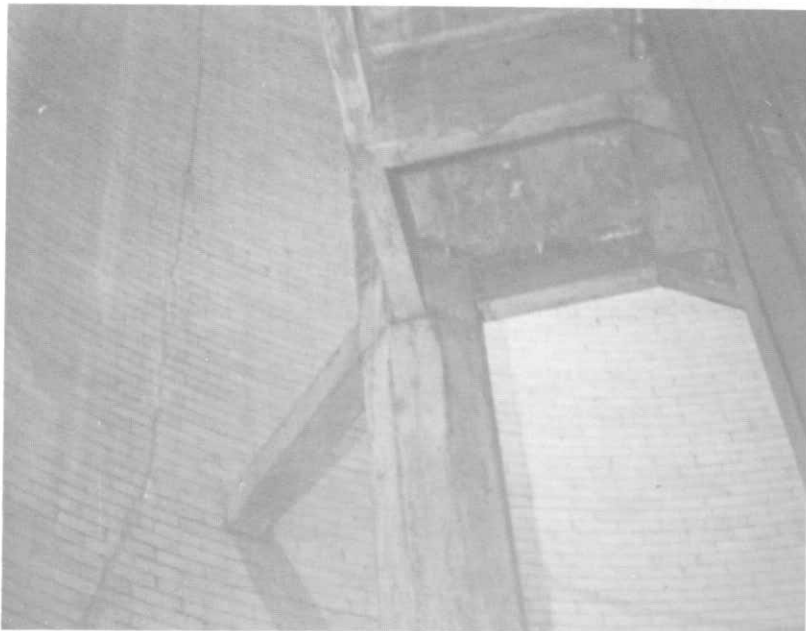
ILLUSTRATION 56. General view of brick crack in north quadrant of column shaft at approximately level 7.

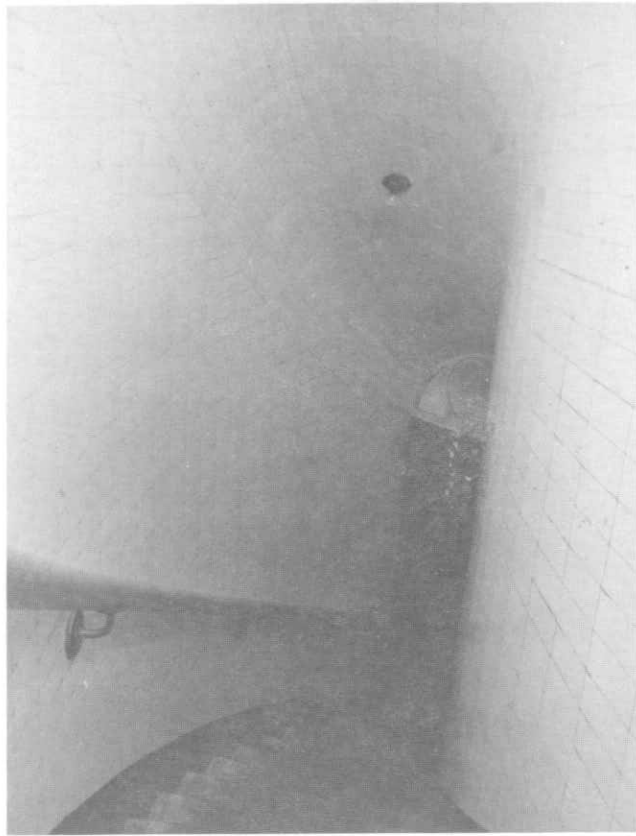
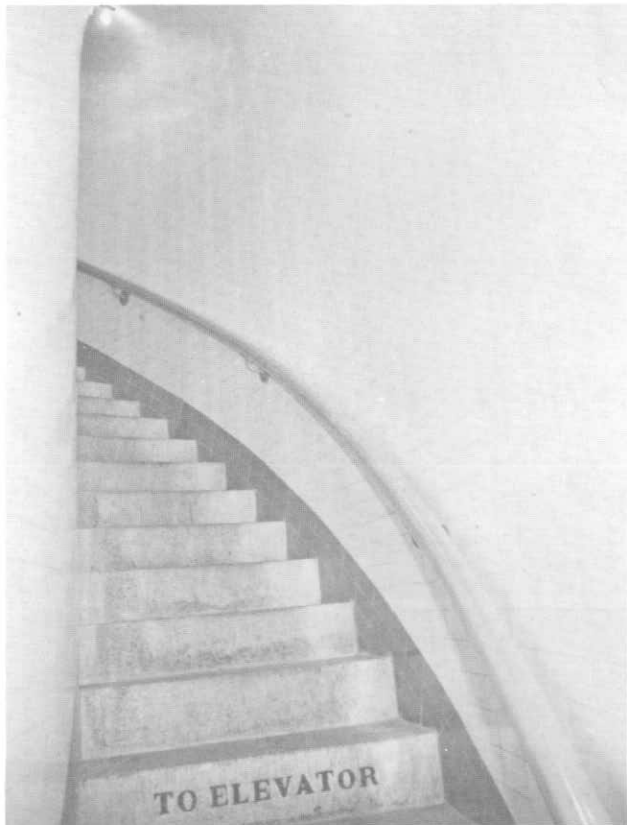
ILLUSTRATION 58. View of same entrance as Illustration 57 , but from rotunda level looking up.

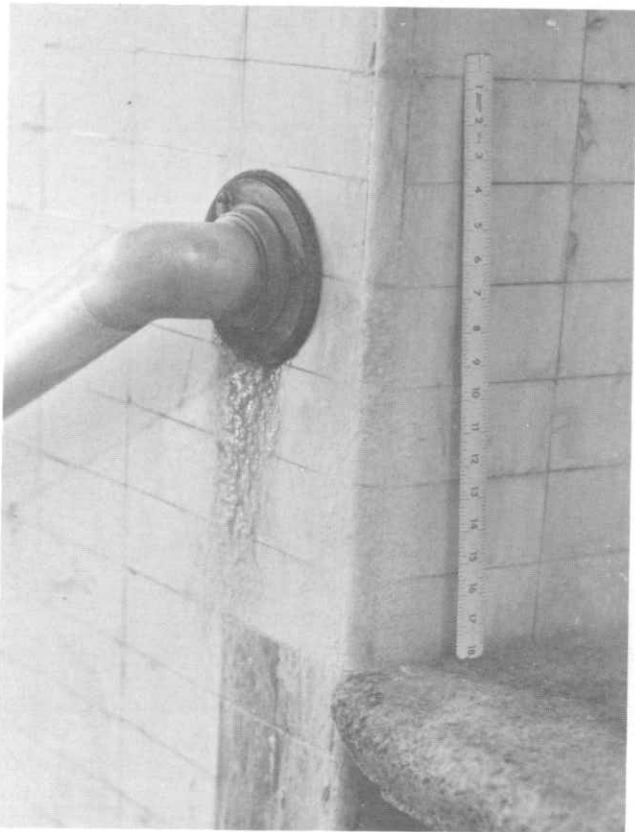
ILLUSTRATION 61. Detail view of existing condition at mid-level platform of exit stair from lower elevator landing.

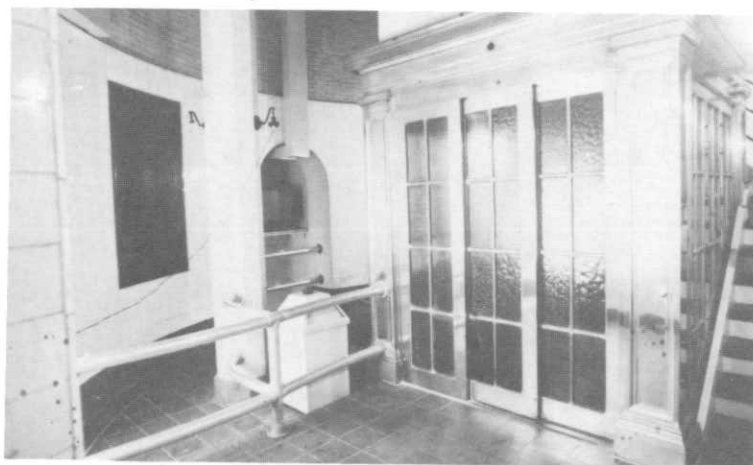
ILLUSTRATION 62. General view of lower elevator landing looking from the northwest towards the northeast.

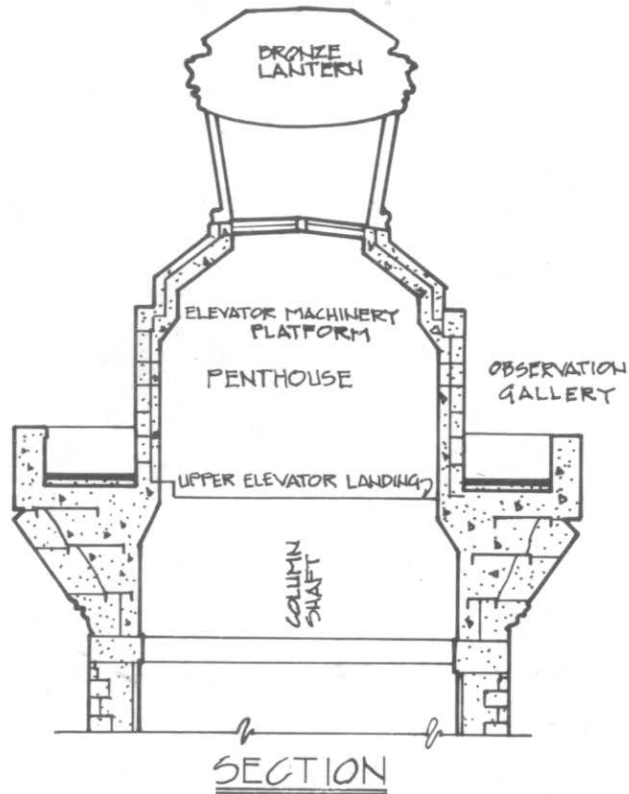
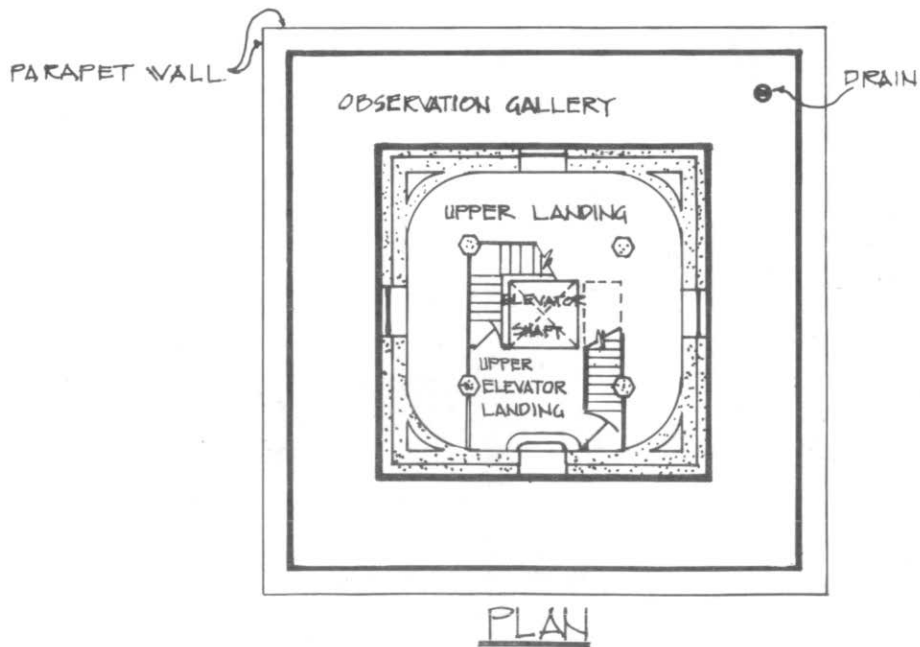
ILLUSTRATION 71. Plan and section of observation gallery and penthouse.
