historic structure report

administrative and architectural data

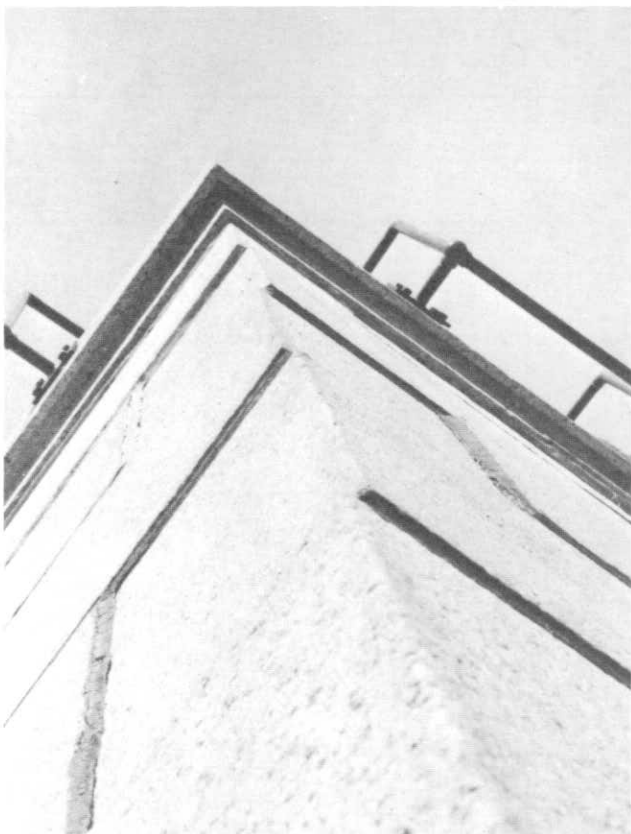
ILLUSTRATION 77. View of interior of penthouse at the southwest column showing pipe from original floor drain of observation gallery. Peeled paint is the result of moisture penetration.

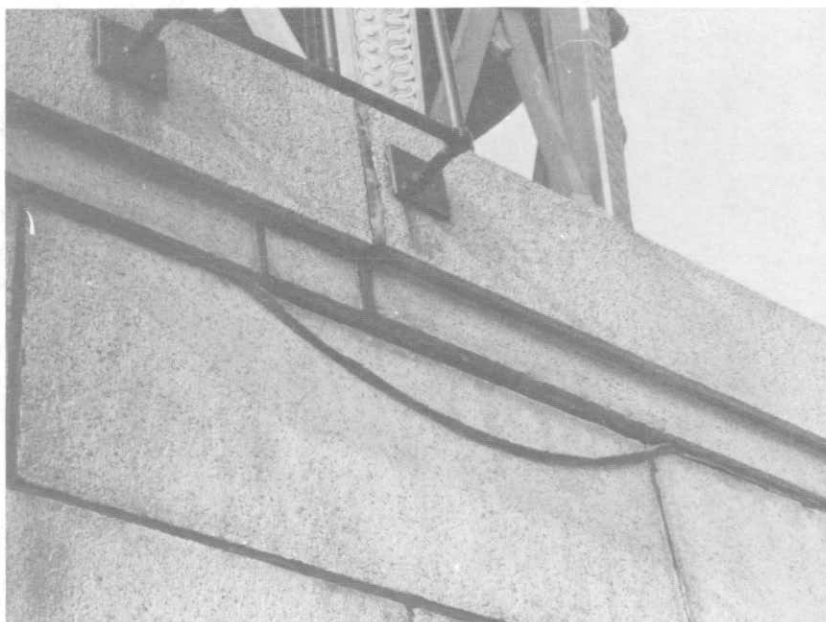
ILLUSTRATION 78. Detail at cornice of penthouse indicating sealant failure. Pipe railings were added with navigational lights at later date.

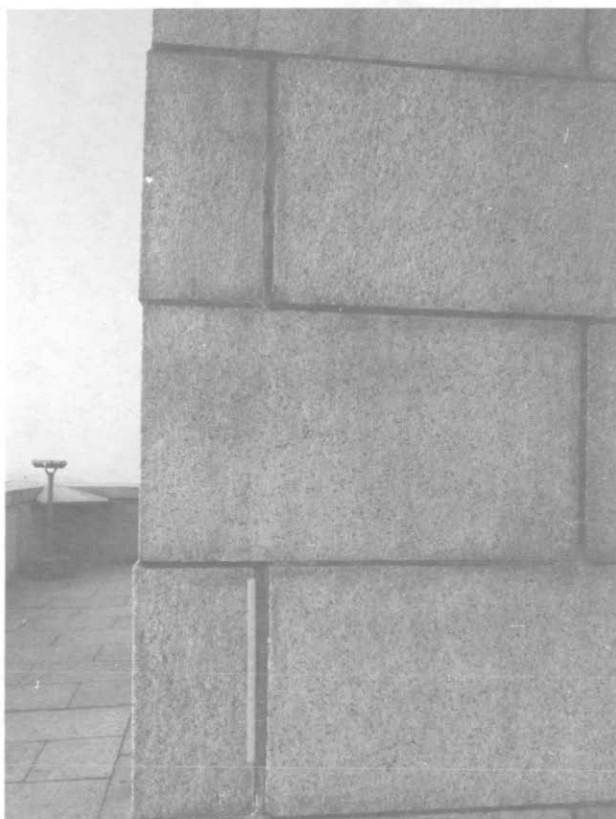
ILLUSTRATION 79. View toward southeast of observation gallery and detail of northeast corner of penthouse.

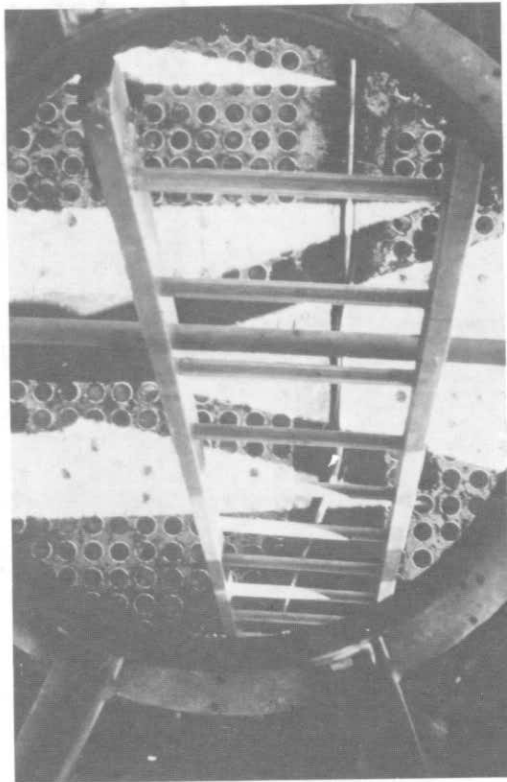
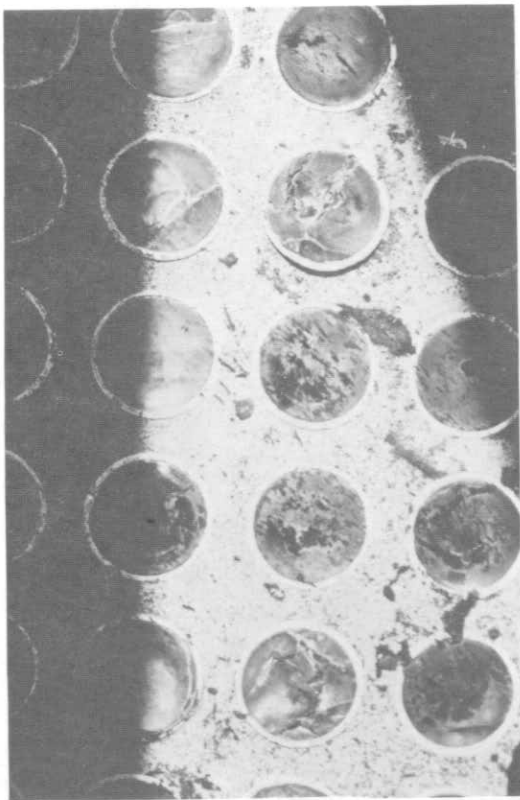
ILLUSTRATION 81. Detail of vault lights showing cracking and crazing of glass inserts.

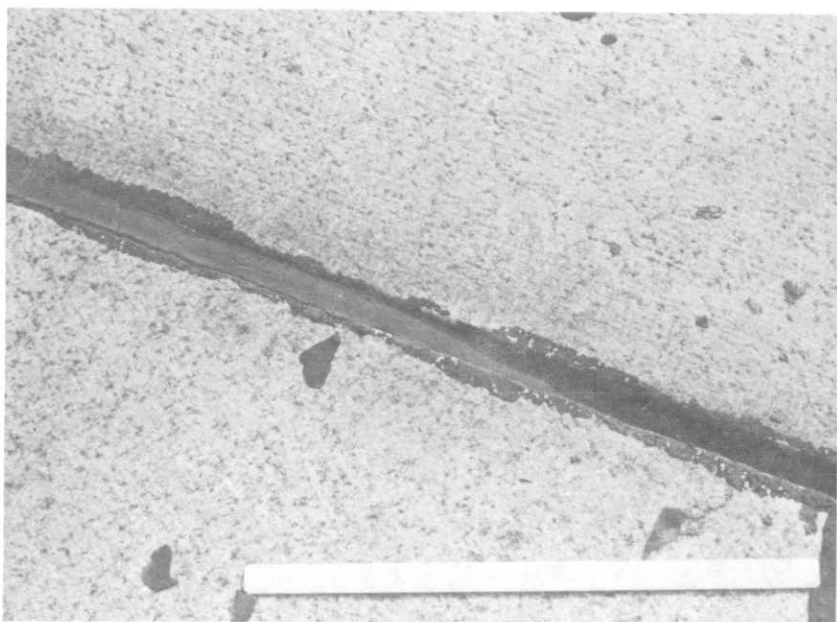
ILLUSTRATION 82. Detail of typical failure of sealant in joint on top of the penthouse.

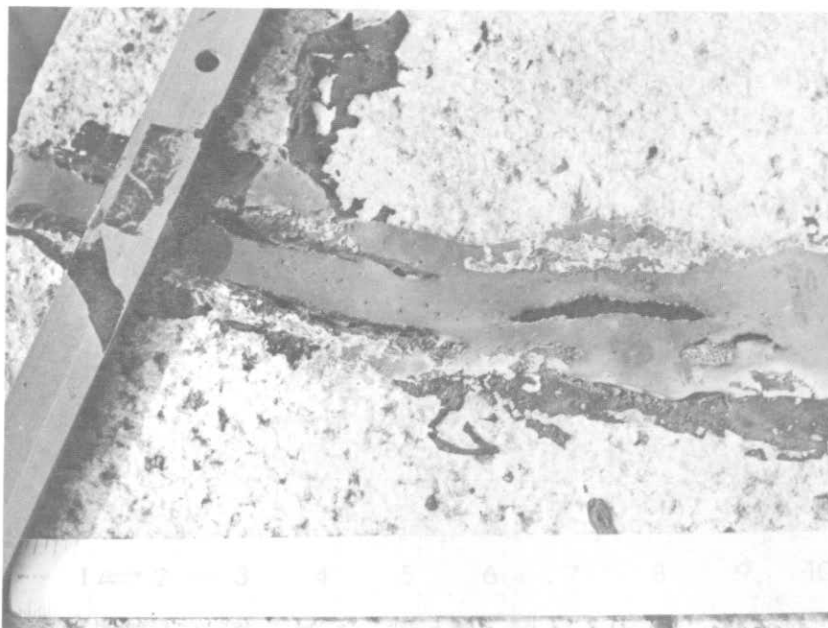
ILLUSTRATION 83. Detail of another typical failure of sealant in joint on top of the penthouse.

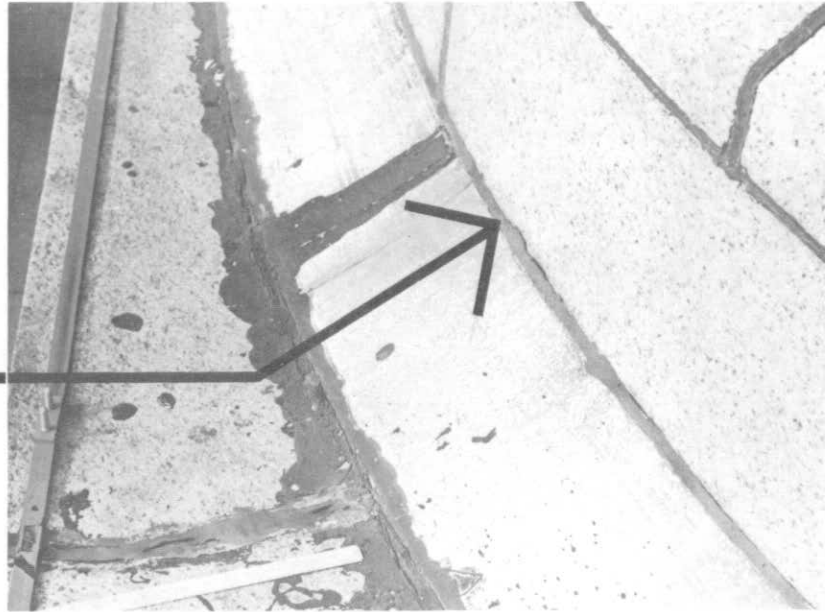
ILLUSTRATION 84. Detail of intersection of penthouse wall and round cupola-like truncated cone roof.

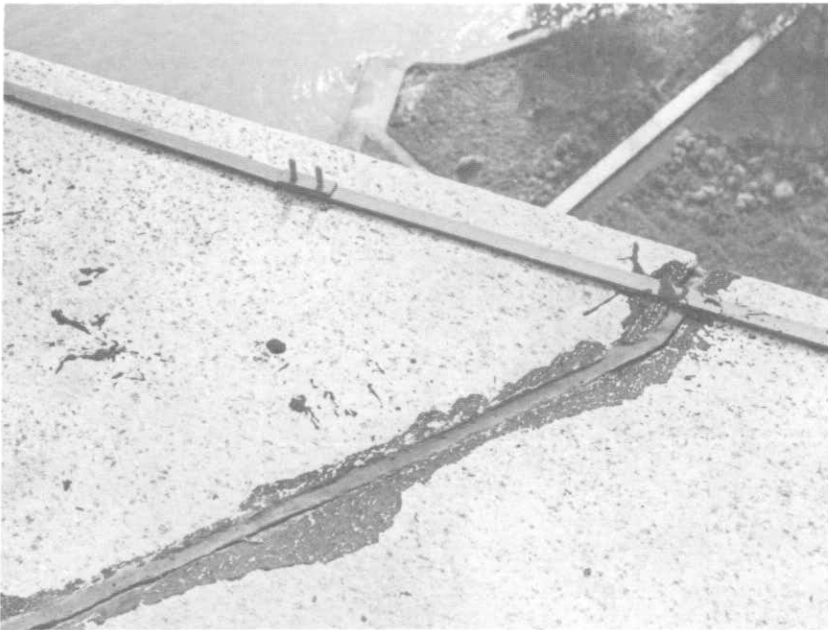
ILLUSTRATION 85. Detail of typical joint indicating improper removal of previous sealant prior to installation of new sealant. Metal bar is part of the lightning grounding system.

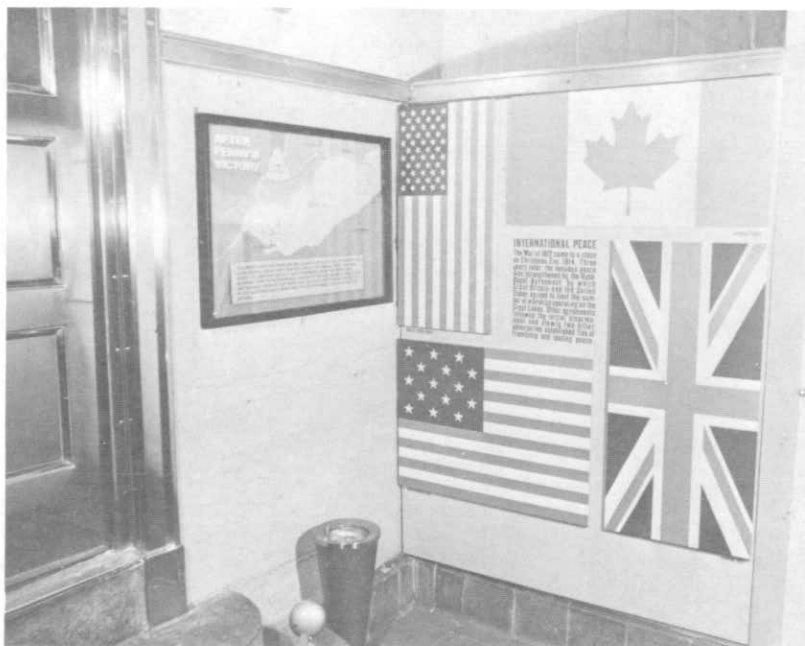
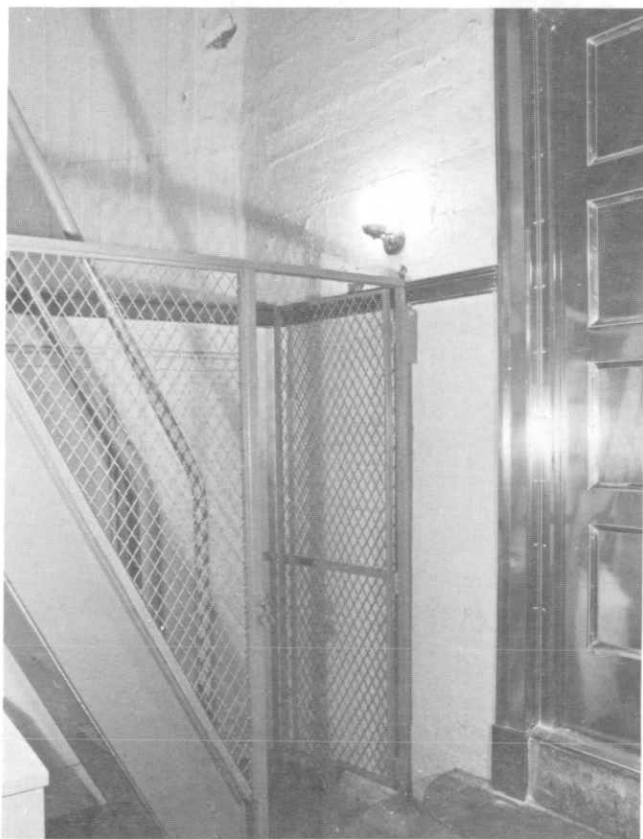
ILLUSTRATION 87. View of north wall of upper elevator landing showing bronze door to observation gallery.

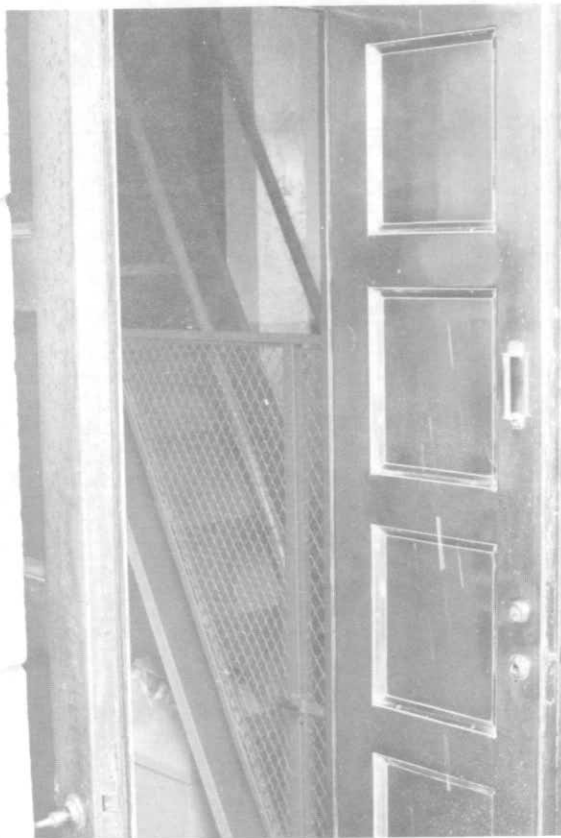
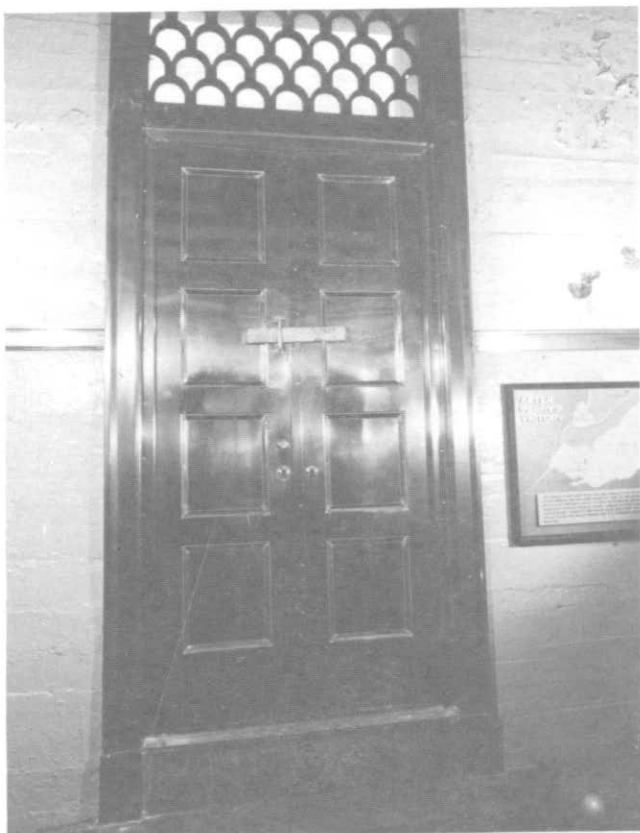
ILLUSTRATION 89. View of bronze door from observation gallery indicating faulty or missing hardware, lack of weather-stripping and dissimilar finish of bronze.

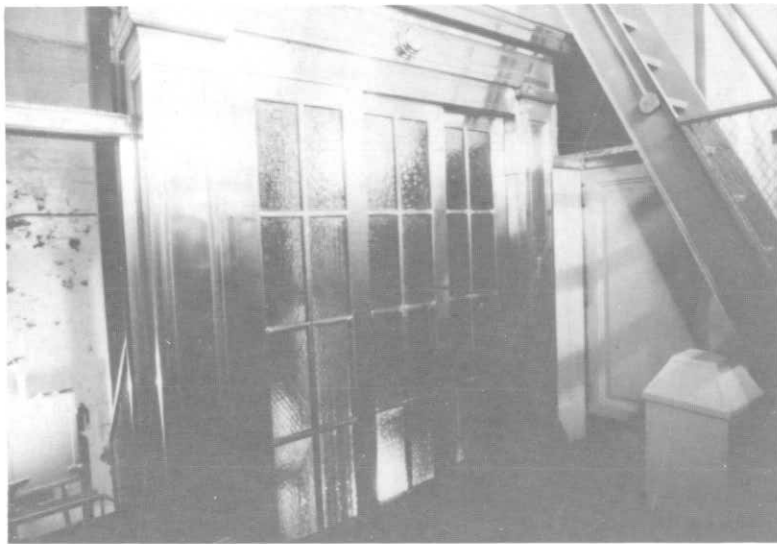
ILLUSTRATION 90. View of south wall of upper elevator landing showing bronze elevator enclosure and panelled partitions. Note panelled door to emergency exit stair in open.

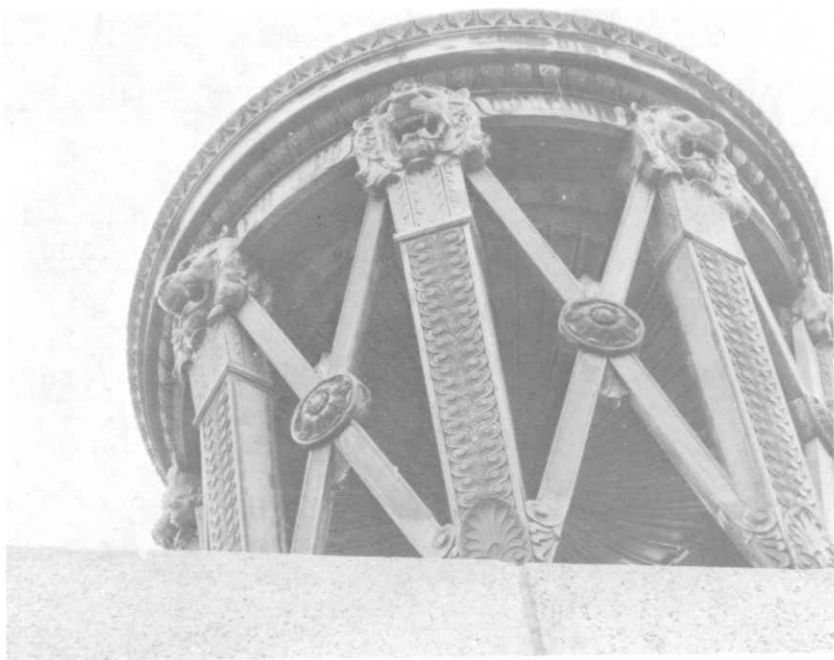
ILLUSTRATION 92. Bronze lantern on top of the penthouse,
as seen from observation gallery.

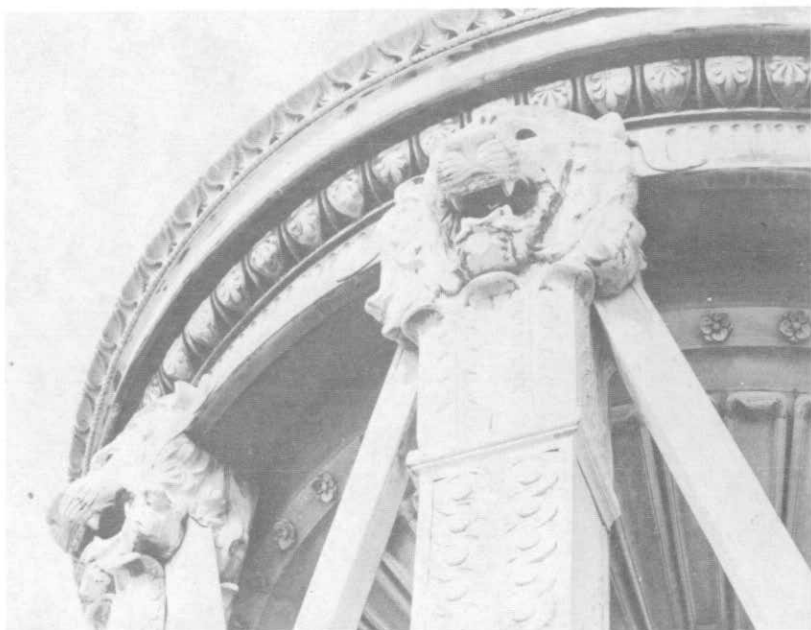
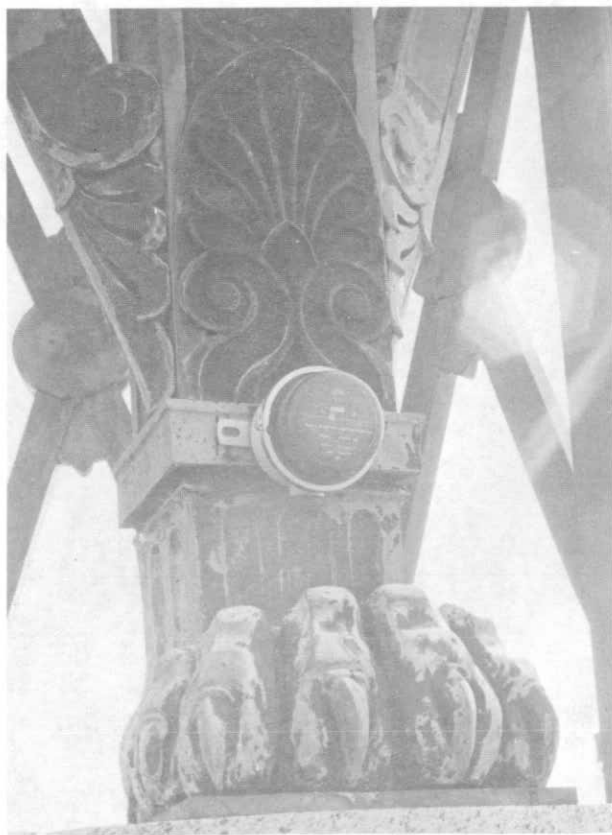
ILLUSTRATION 95. Detail of lion's foot at base of bronze lantern. Round item attached to foot is a photoelectric cell which activates navigational lights.

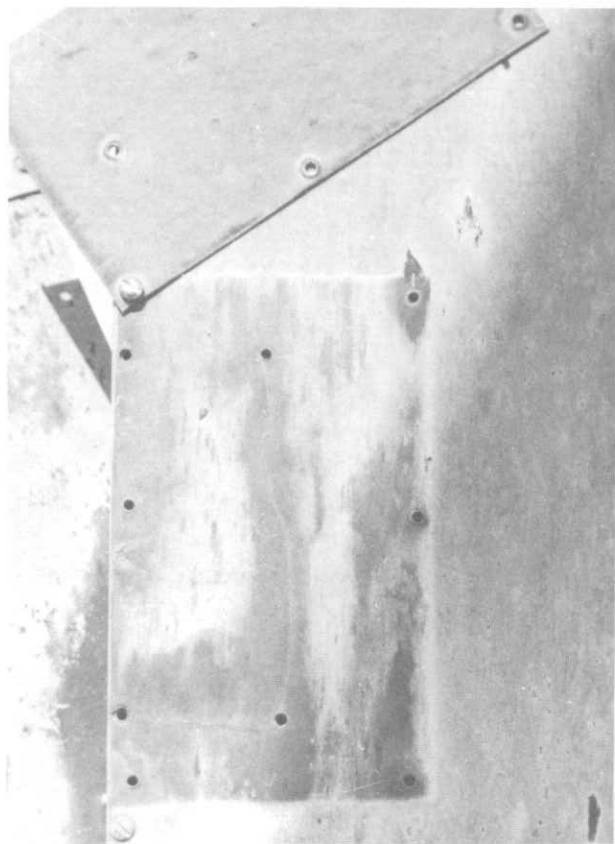
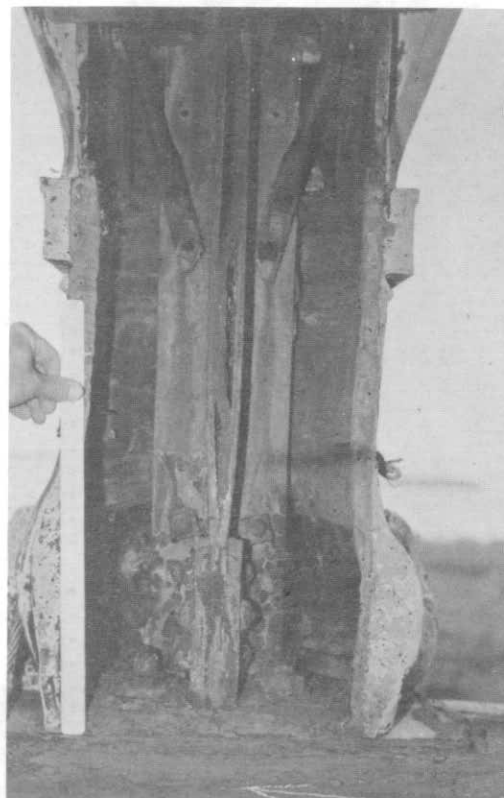
ILLUSTRATION 97. View of connection of steel structure of bronze lantern to penthouse.

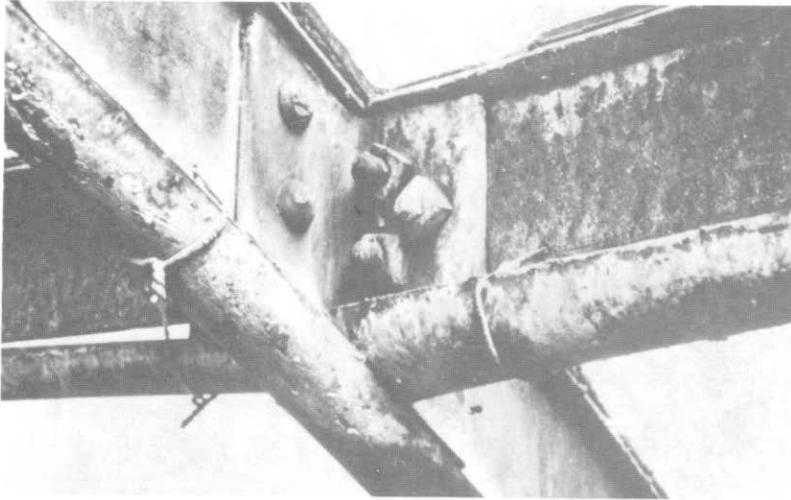
ILLUSTRATION 100. Detail of intersection of skylight steel and gutters to collect water from condensation and/or infiltration.

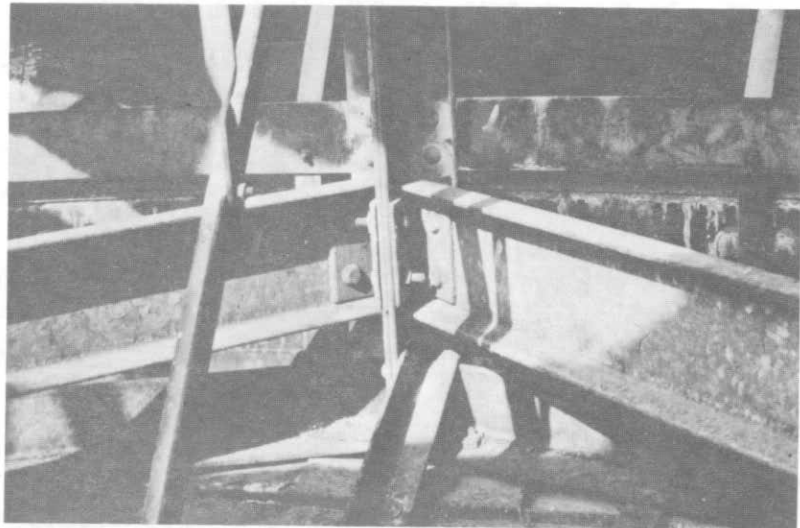
ILLUSTRATION 101. Detail of steel bracing inside of bronze lantern.

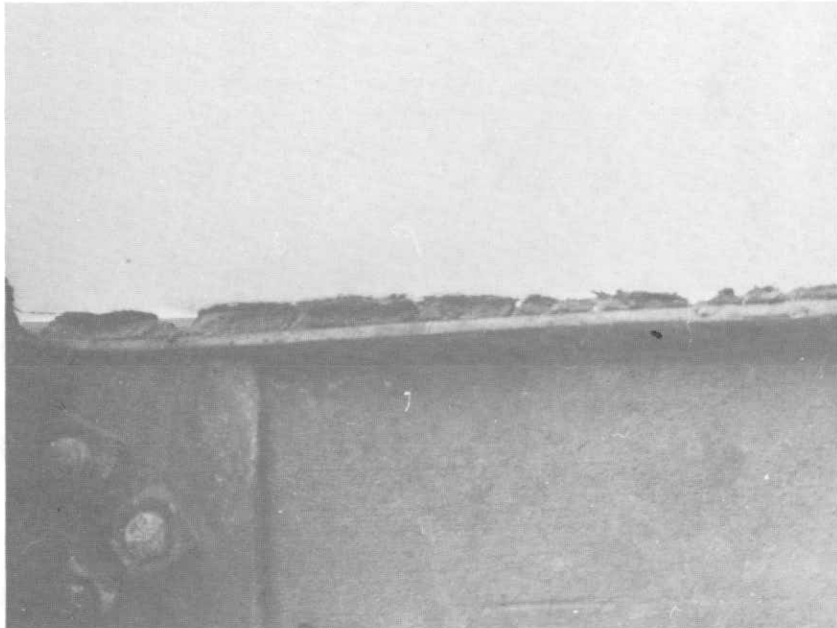
ILLUSTRATION 102. Detail of skylight glass and steel frame intersection. Note deteriorated caulking and openings in joint.

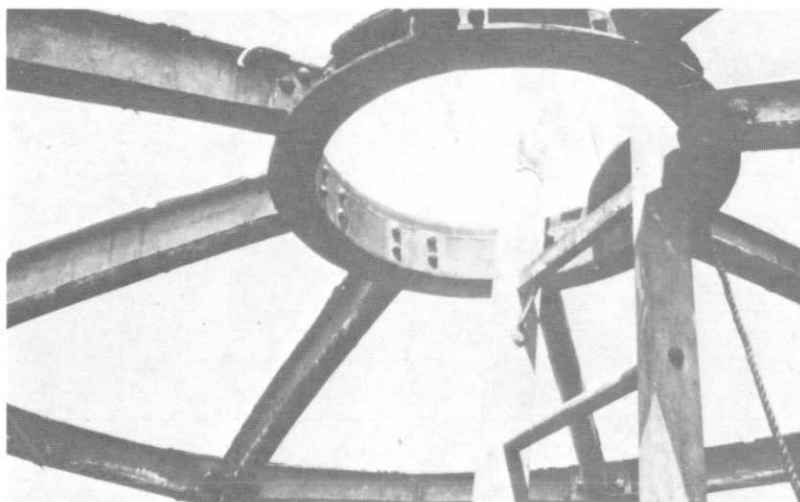
ILLUSTRATION 103. Detail of top of skylight from inside showing access hole to top of skylight.

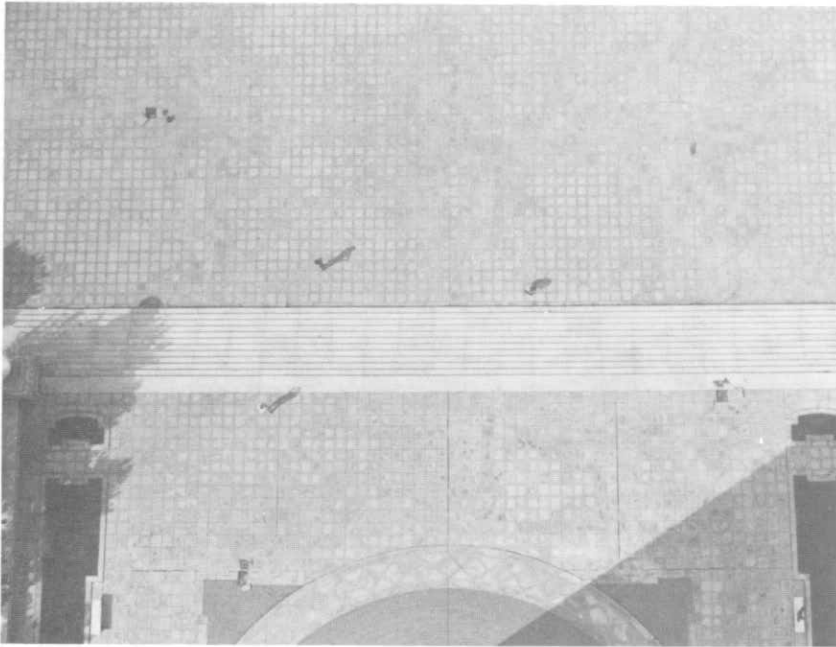
ILLUSTRATION 104. Plan view of north side of upper plaza showing granite steps to lower plaza.

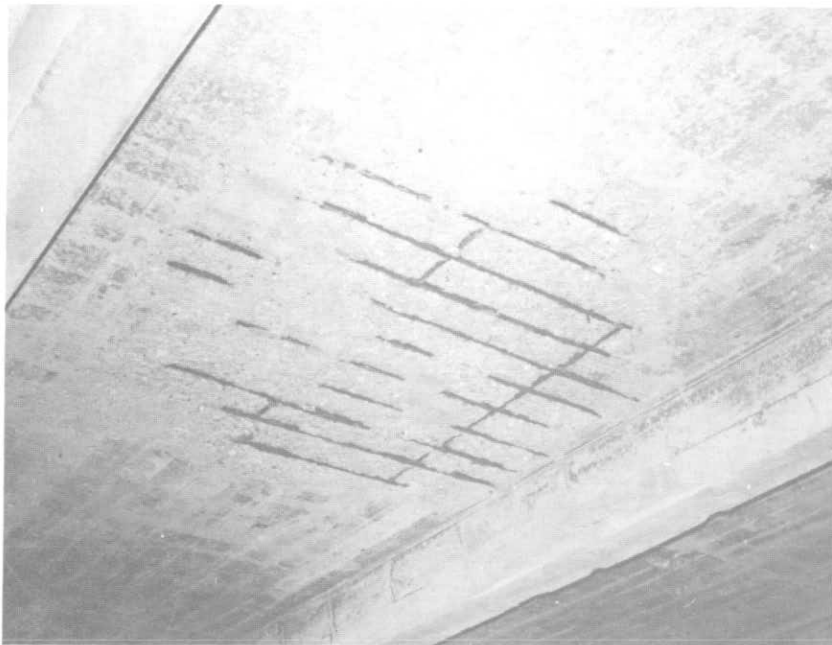
ILLUSTRATION 111. View of underside of upper plaza slab showing rusting condition of steel and spalled concrete.

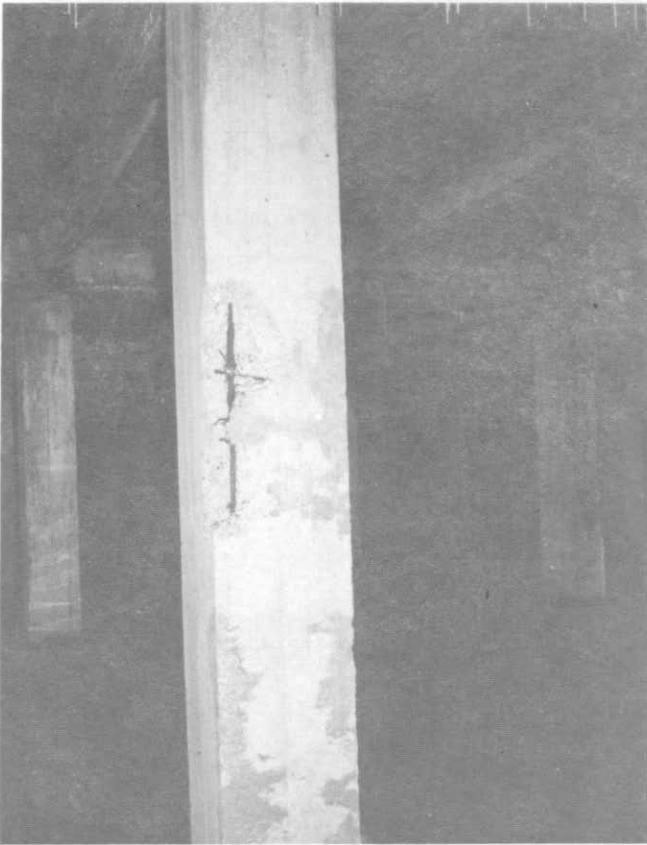
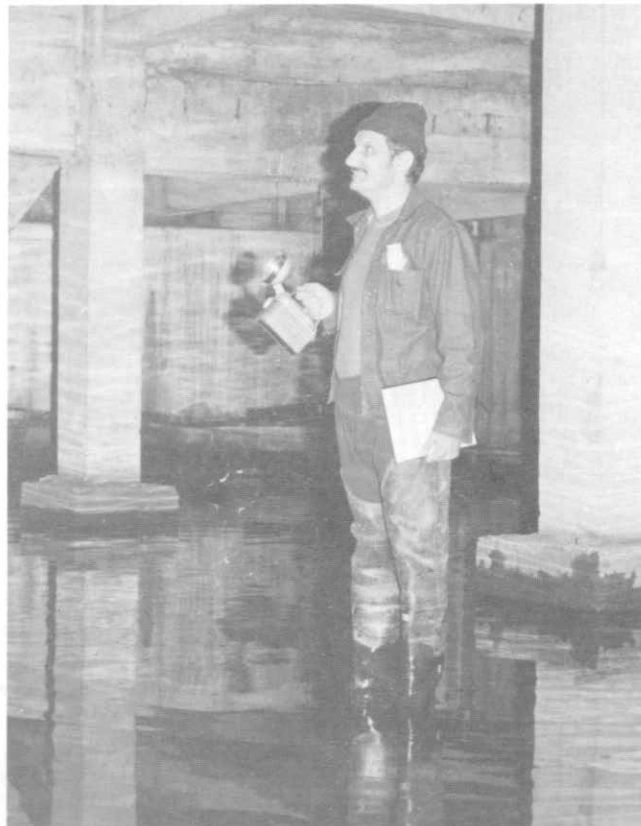
ILLUSTRATION 113. View of typical condition of standing water which covers about 75 percent of basement space below upper plaza.

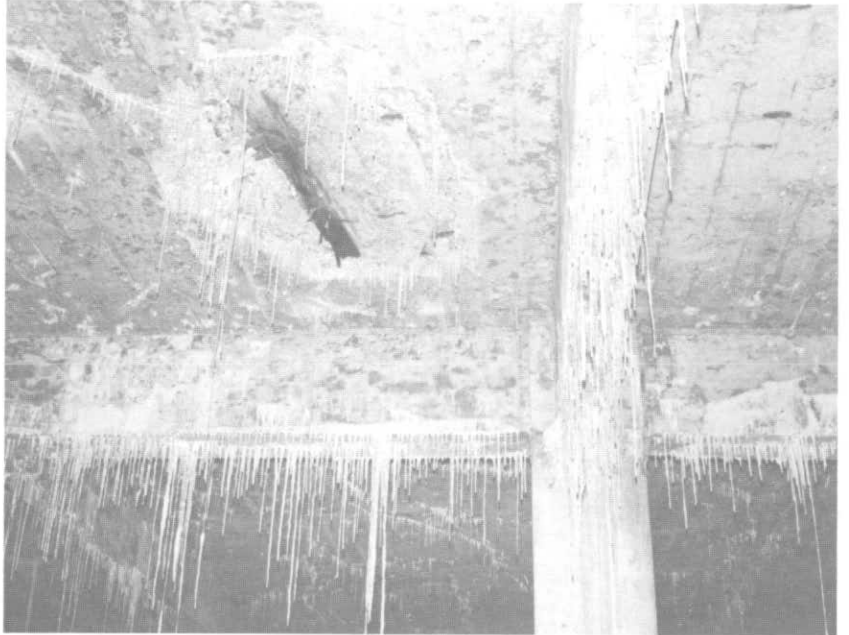
ILLUSTRATION 114. Typical condition of stalactites at underside of upper plaza slab and beams.

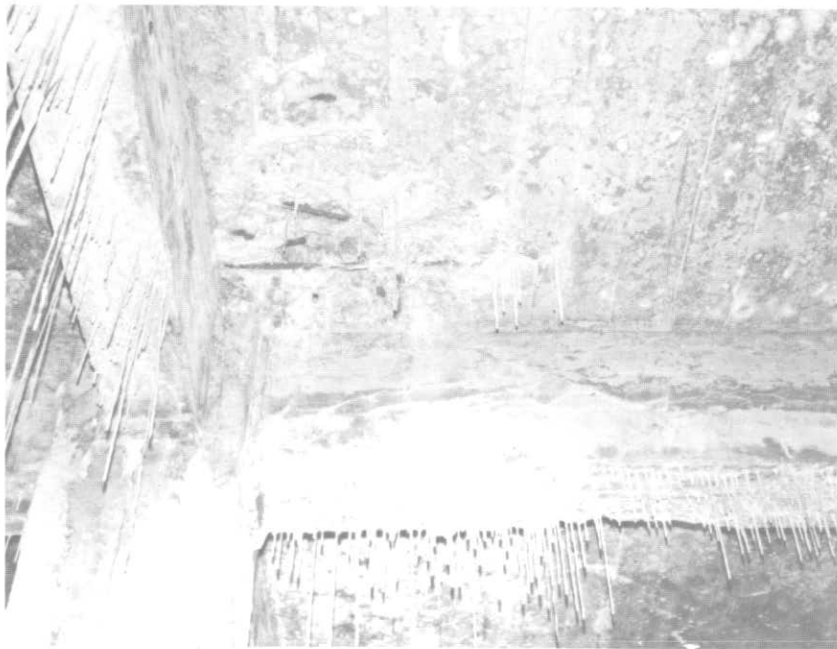
ILLUSTRATION 115. Detail view of typical beams to column intersection showing stalactites at various stages of formation.

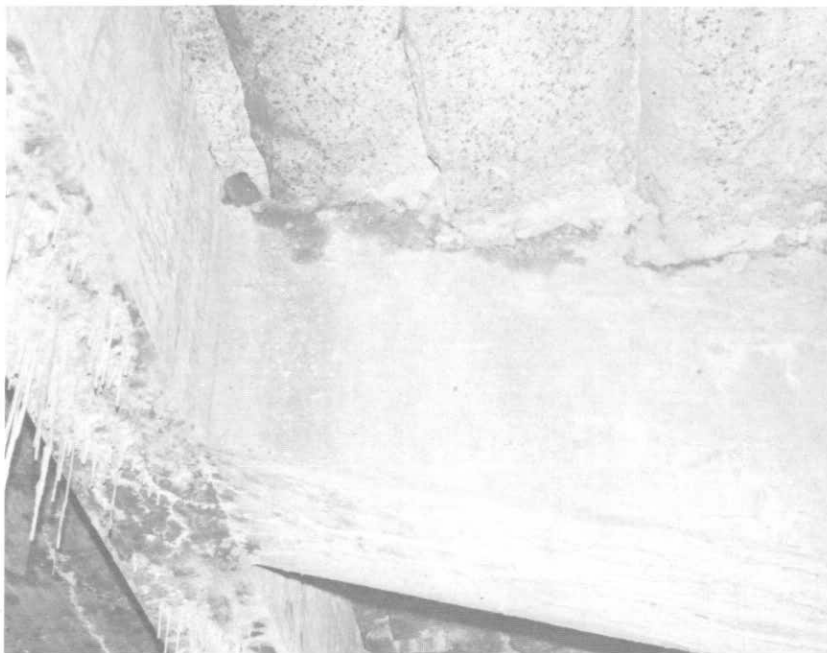
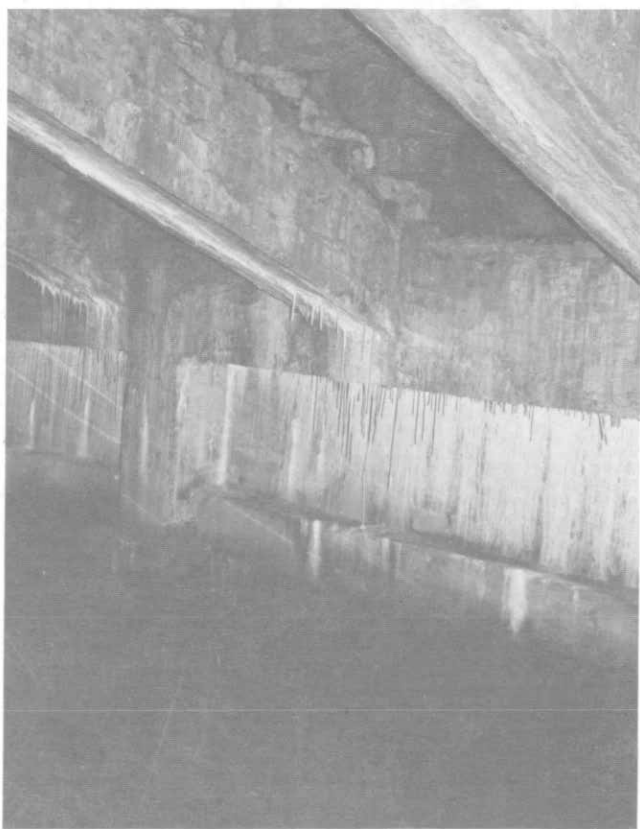
ILLUSTRATION 122. General view of stepped, sloping beams supporting granite steps.

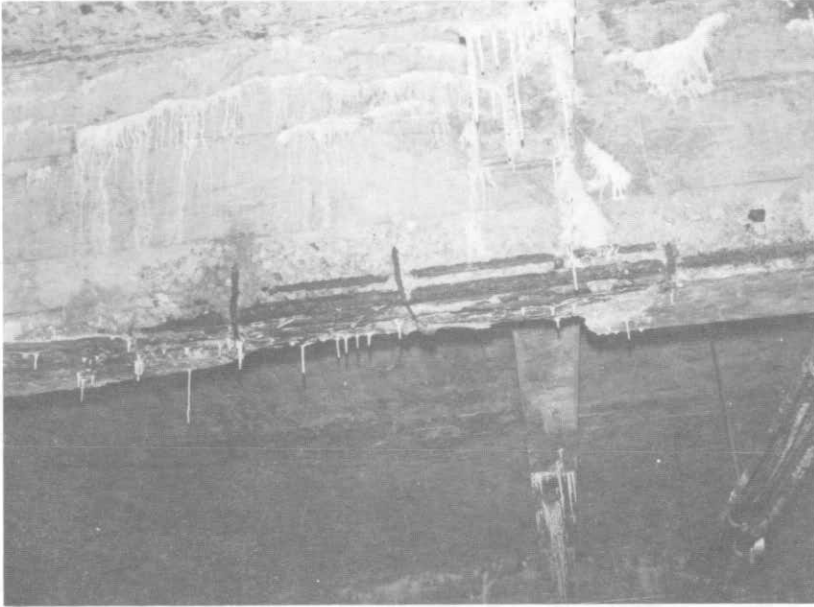
ILLUSTRATION 125. Detail of typical beam with rusting bars and spalled concrete.

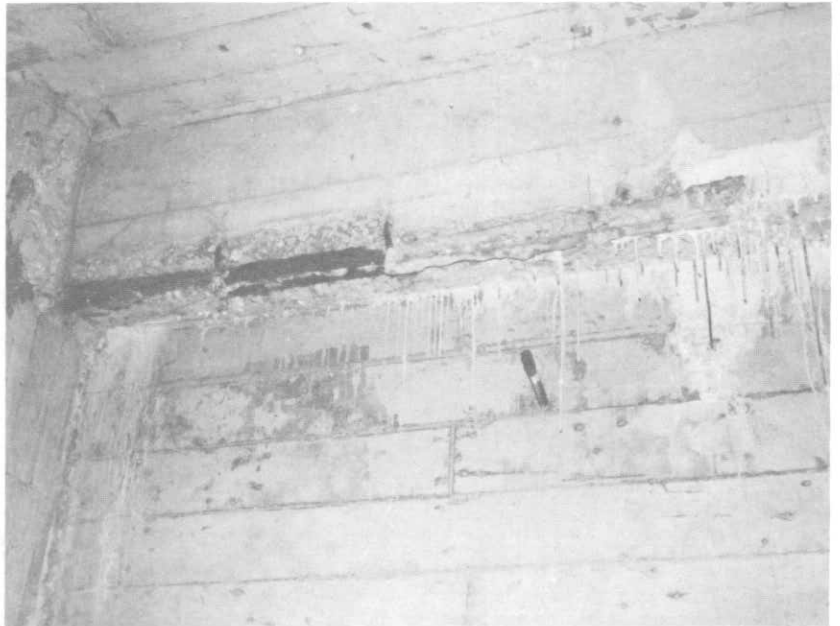
ILLUSTRATION 126. View of beam at outer wall showing rusting bars, spalled concrete and cracks of concrete about to spall from rust buildup behind.

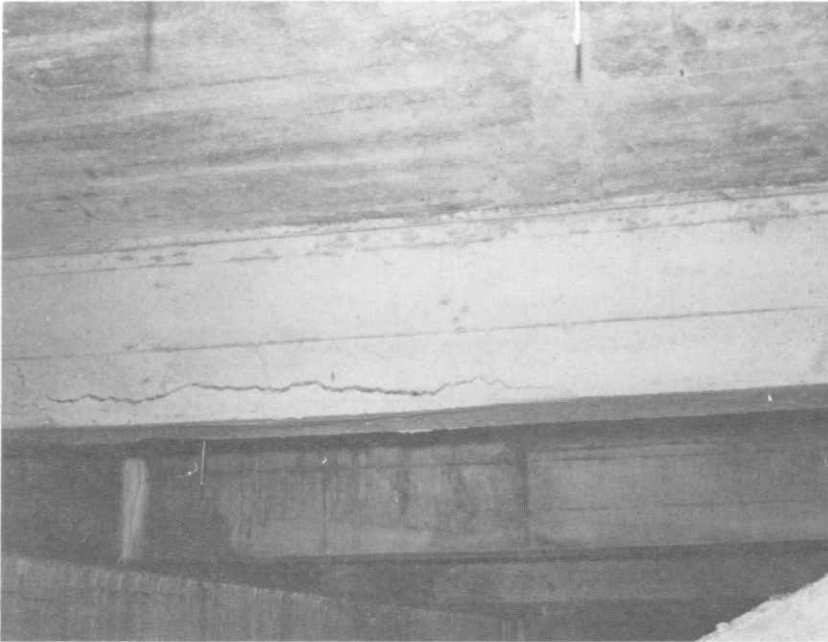
ILLUSTRATION 127. View of a typical beam with crack formed by rusting steel bars behind.

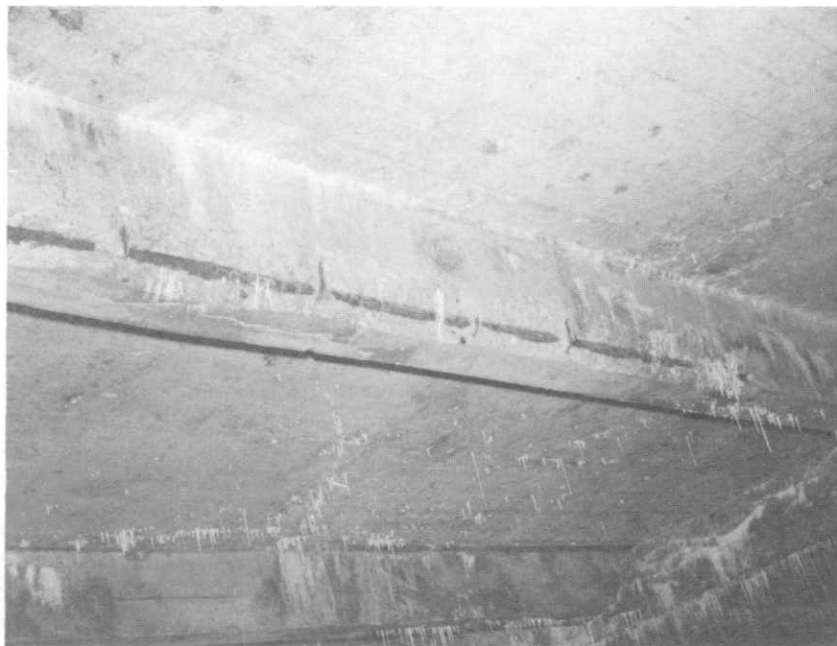
ILLUSTRATION 128. View of a typical beam after rust has caused concrete to spall.

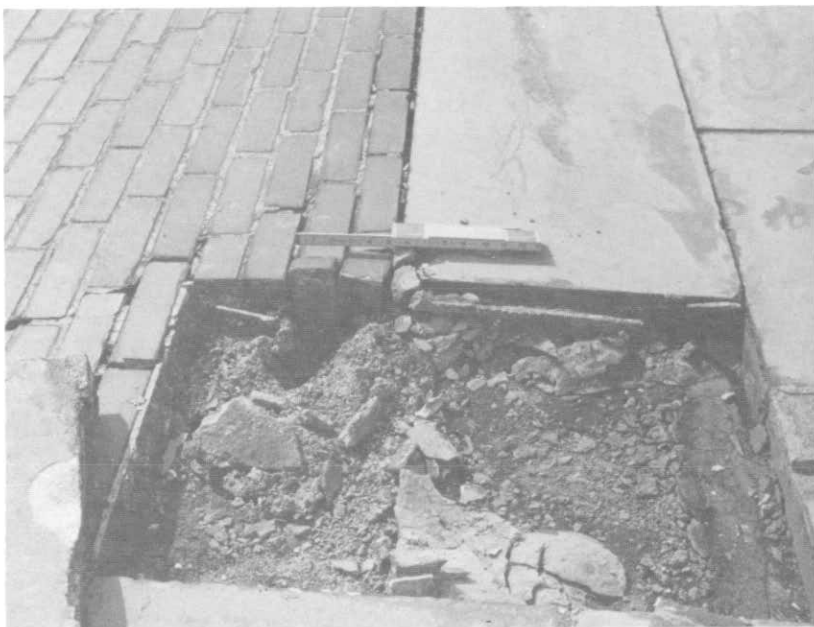
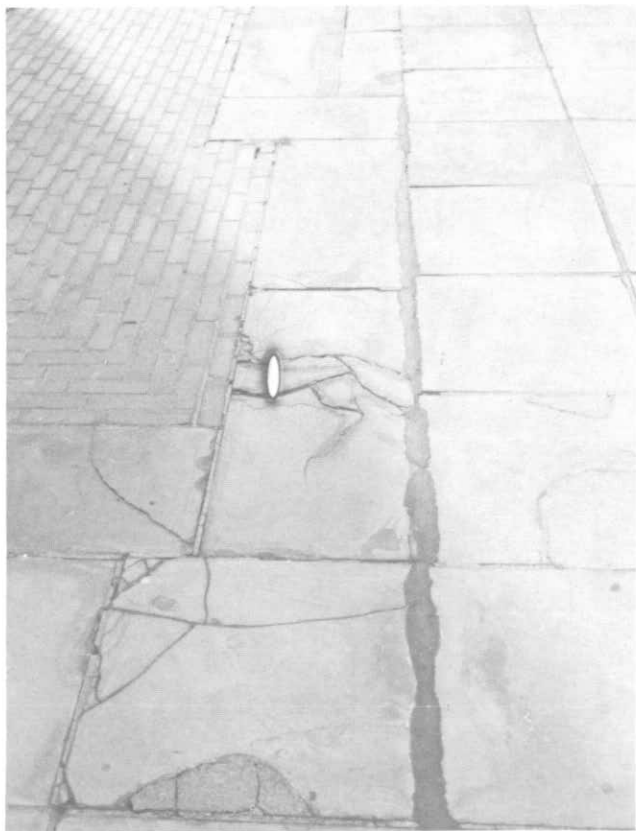
ILLUSTRATION 130. General view at northeast quadrant of upper plaza showing deteriorated joints, cracked and spalled sandstone pavers and brick paving inlay pattern.

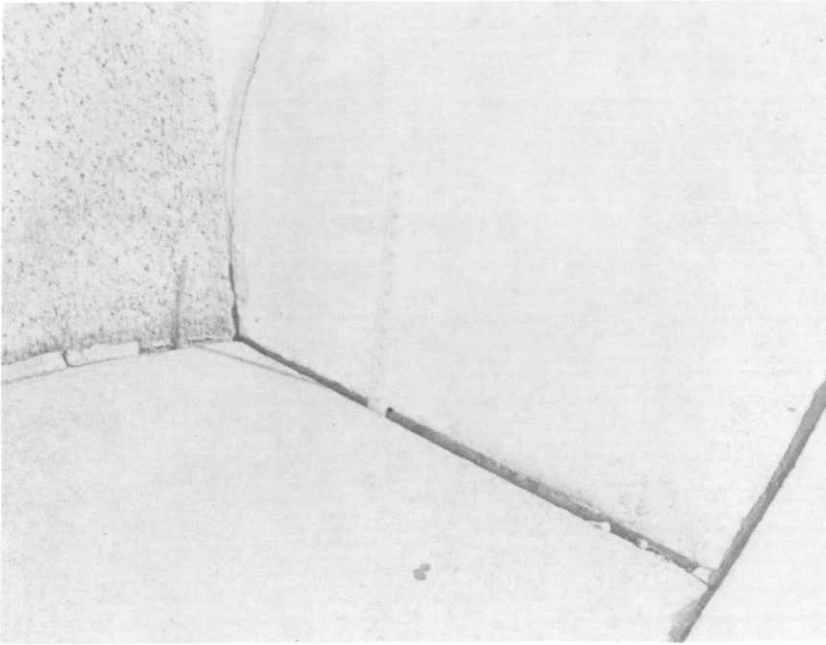
ILLUSTRATION 131. Detail of joint condition at base of column. Note lack of mortar or sealant for full depth of joint.

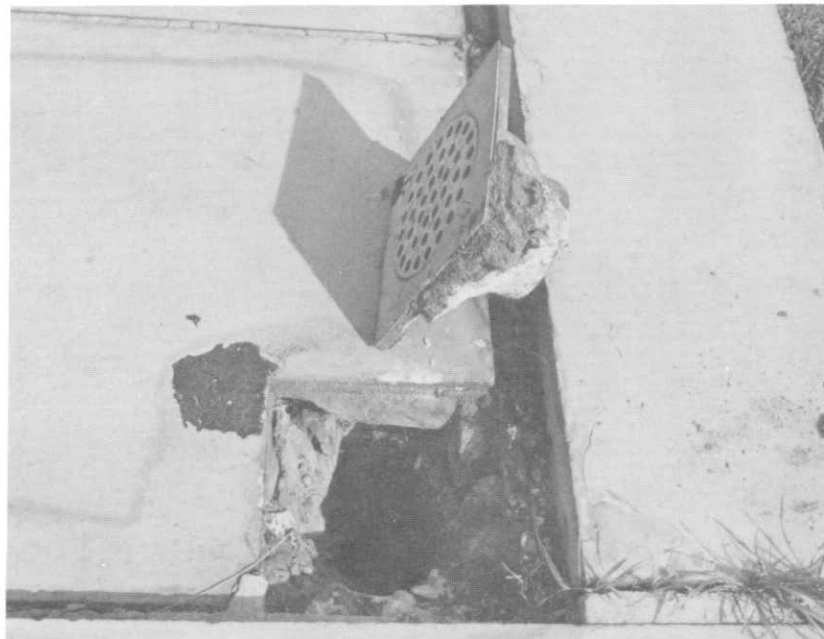
ILLUSTRATION 132. View of drain at corner of planter at south end of upper plaza. Note that drain is not connected to any pipe system. Water simply falls to basement space below upper plaza.

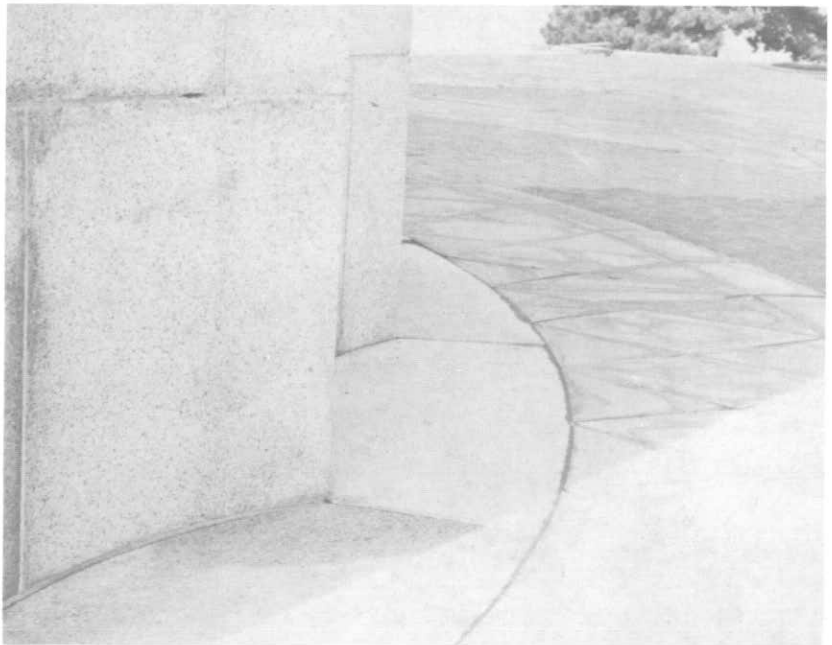
ILLUSTRATION 138. View of oil-type stain in granite paver at east side of column. Cause of stain unknown.

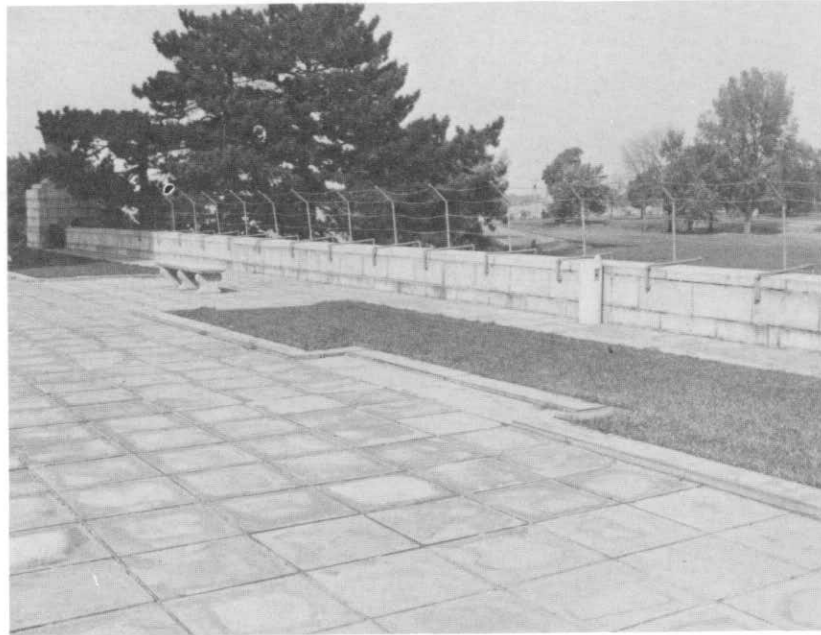
ILLUSTRATION 139. General view of east side of upper plaza. Note precast cylinder at wall which is a drinking fountain not in use.

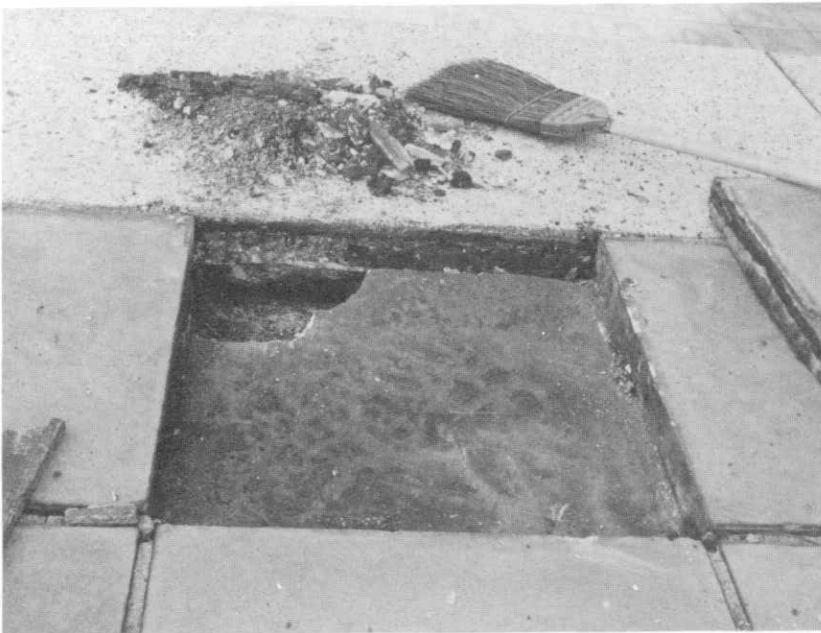
ILLUSTRATION 140. Detail view of top tread of granite steps at upper plaza and typical setting bed condition under sandstone paver.

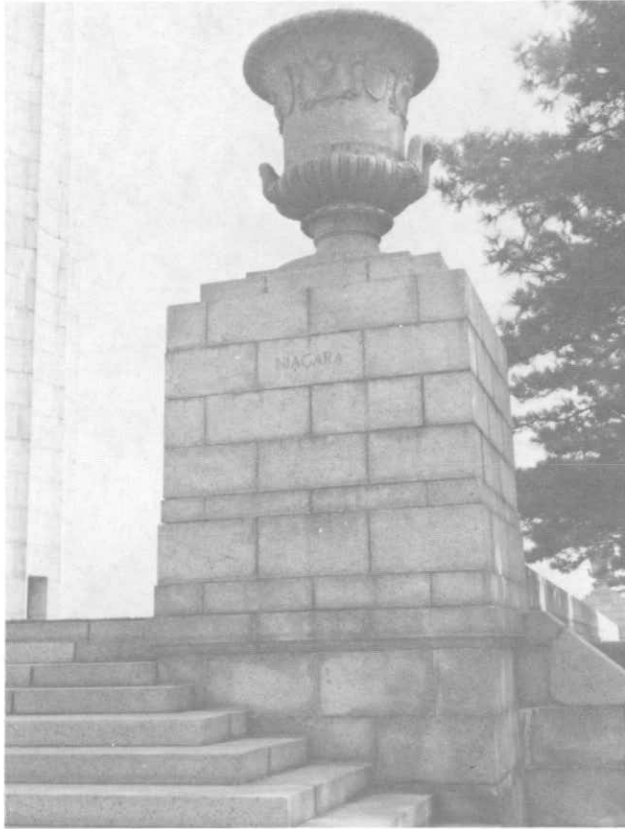
ILLUSTRATION 141. View of west end of granite steps. East end is similar, but opposite.
