historic structure report

administrative and architectural data

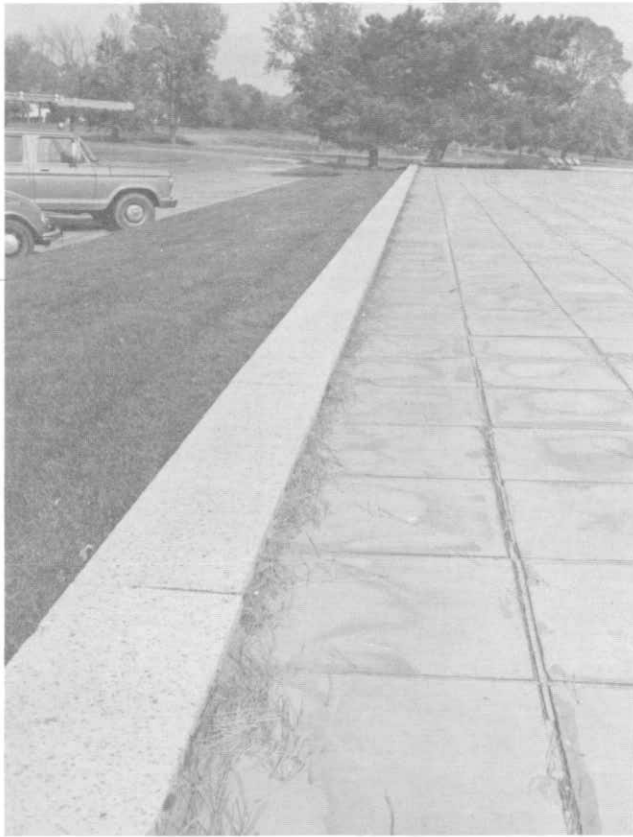
ILLUSTRATION 146. View of north edge of lower plaza, looking toward east.

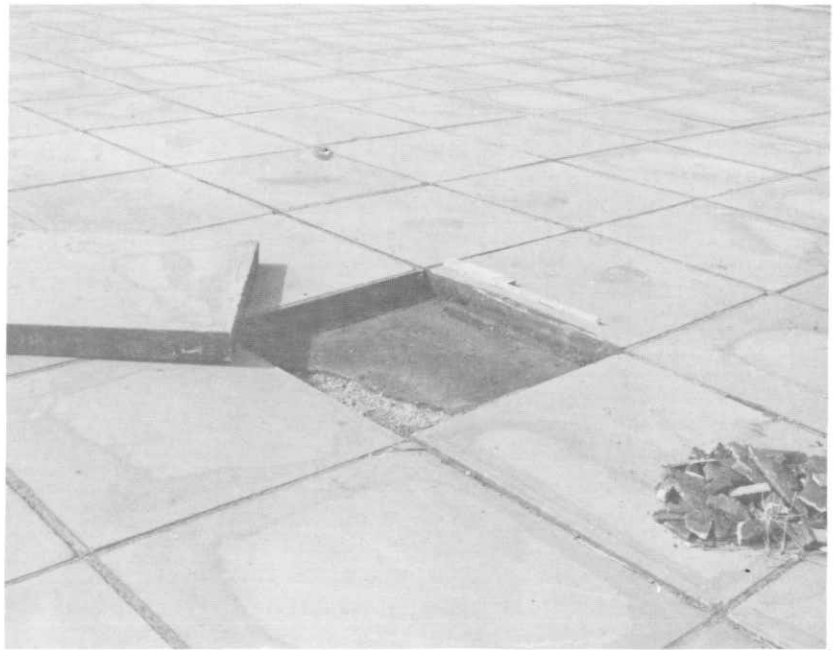
ILLUSTRATION 147.
General view of lower plaza sandstone pavers showing typical stained condition.

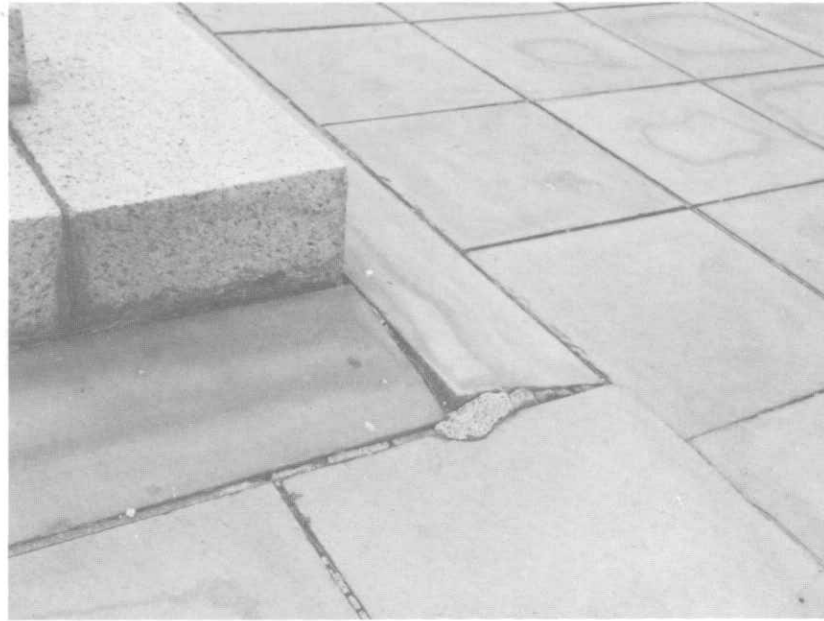
ILLUSTRATION 148. Detail view at east end of granite steps showing inclined pavers due to settling of lower plaza.

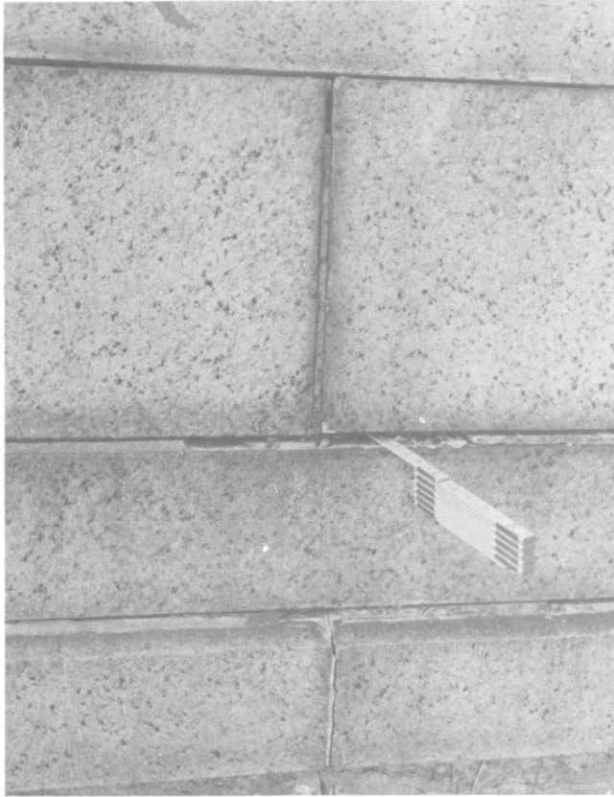
ILLUSTRATION 155. Detail view of typical mortar joints in granite retaining walls indicating poor condition of joints.

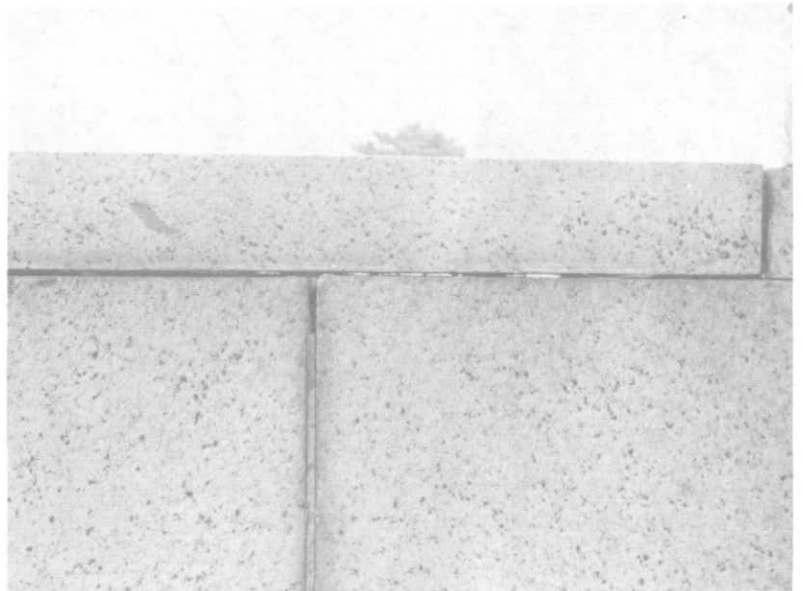
Illustration 156. Detail view of typical mortar joints in retaining walls. Note that daylight may be seen through horizontal joint indicating a lack of mortar.

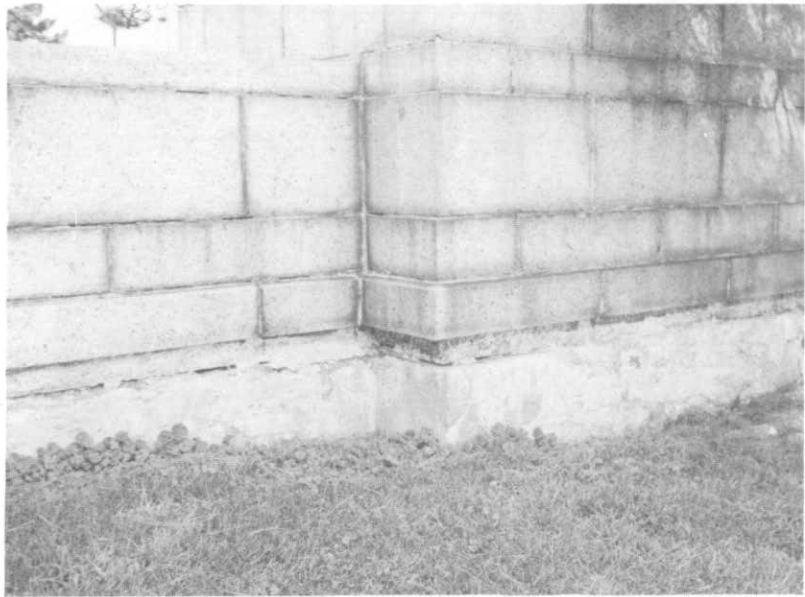
ILLUSTRATION 157. Partial view of southeast corner of retaining wall and lantern base. Note condition at intersection of concrete and granite.

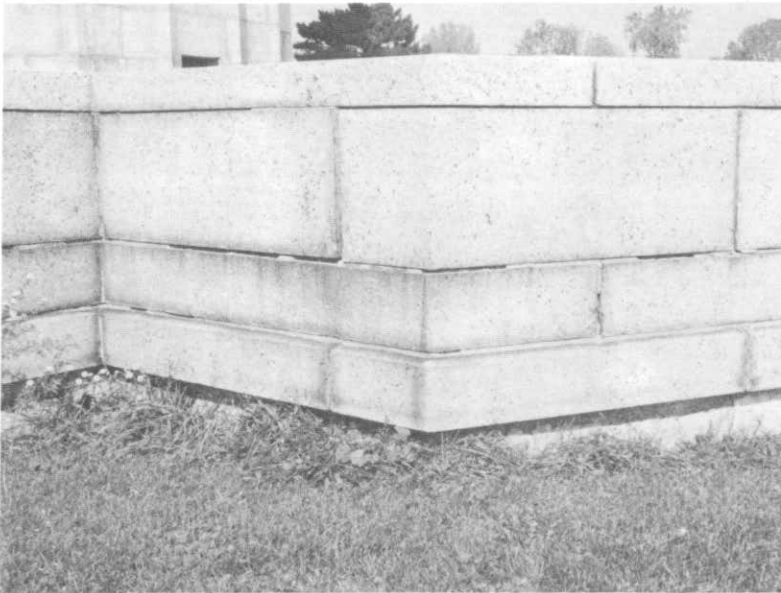
ILLUSTRATION 158. Partial view of southwest corner of retaining wall. Note lack of mortar in joints.

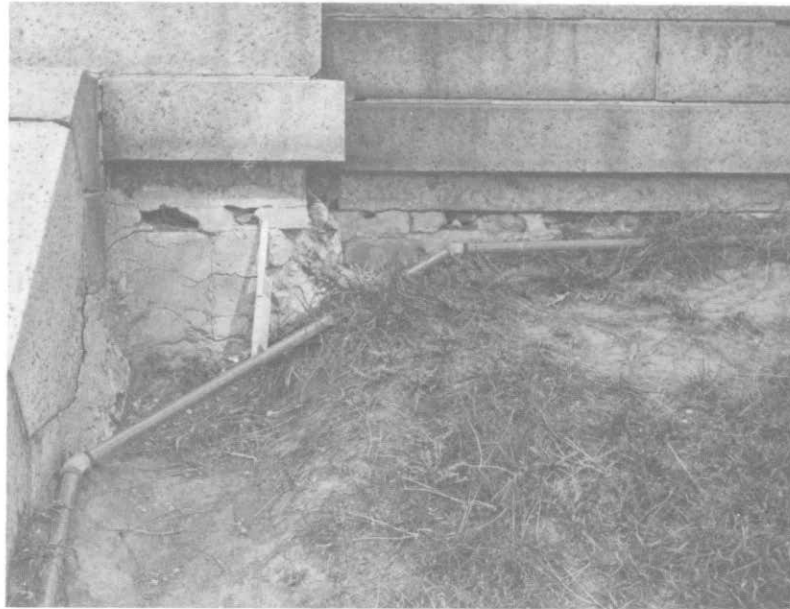
ILLUSTRATION 161. Detail view at northwest corner of retaining wall at junction of main granite steps showing deterioration of concrete. Pipe is water line for hose-bibb.

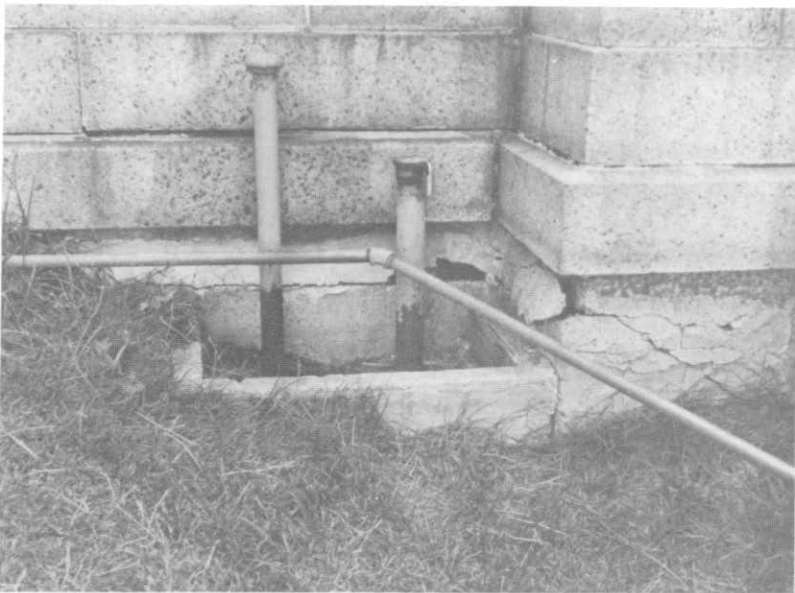
ILLUSTRATION 162. Detail view at northeast corner of retaining wall at junction of main granite steps. Horizontal pipe is water line for hose-bibb. Vertical pipes are supply and vent pipes for fuel oil storage tanks in basement.

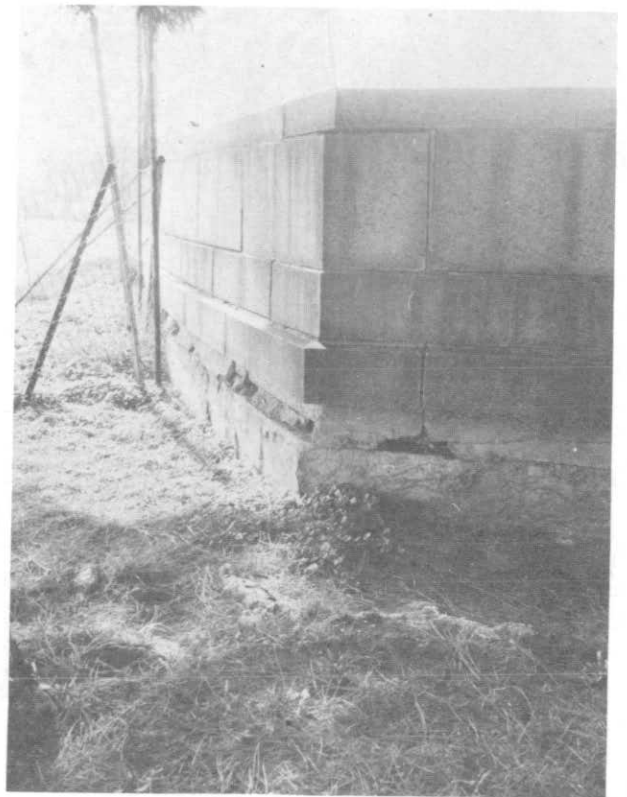
ILLUSTRATION 164. View of southeast corner of retaining wall showing concrete deterioration and lowered grade.

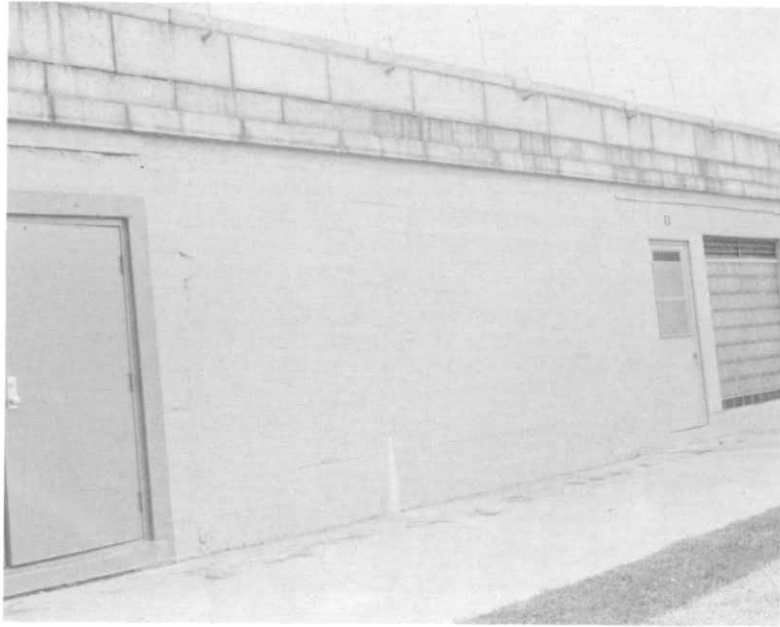
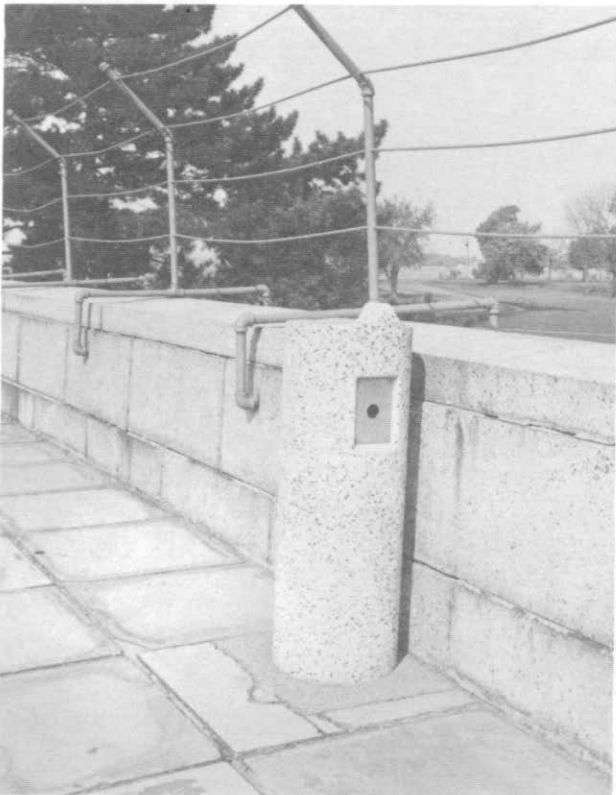
ILLUSTRATION 166. Partial view of east wall of upper plaza showing "safety fence." Concrete cylinder is the base of a drinking fountain no longer in use.

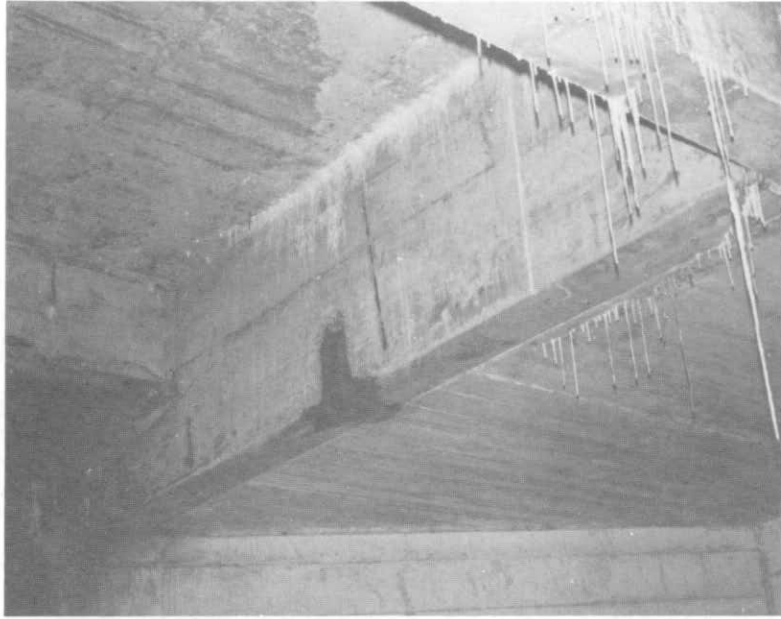
ILLUSTRATION 169. General view of underside of a planting box slab which is typically in the same plane as the bottom of the beam. Note that no drains were evident. Dark stain is probably seepage through bottom of box.

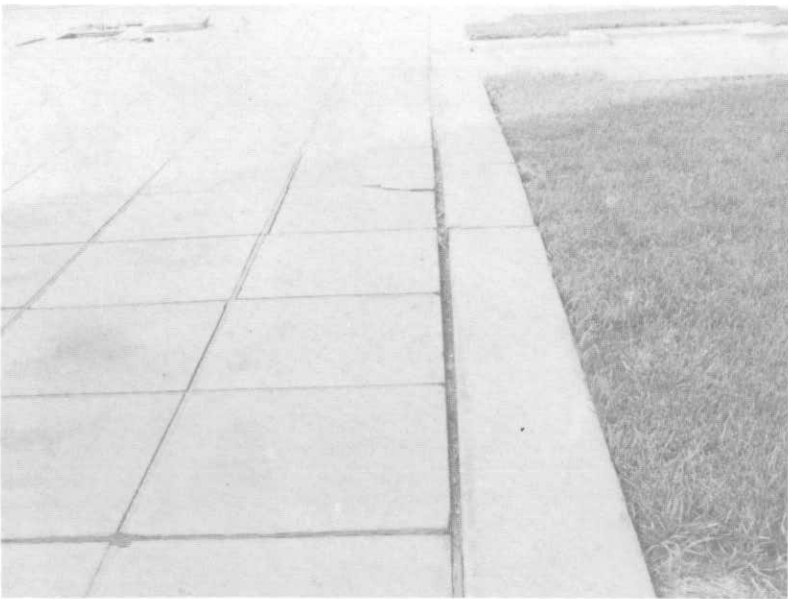
ILLUSTRATION 170. General view of upperside of a typical planting box. Note poor joints between sandstone pavers and sandstone curbstones. See Illustration 171 for section through planting box and recommended waterproofing.

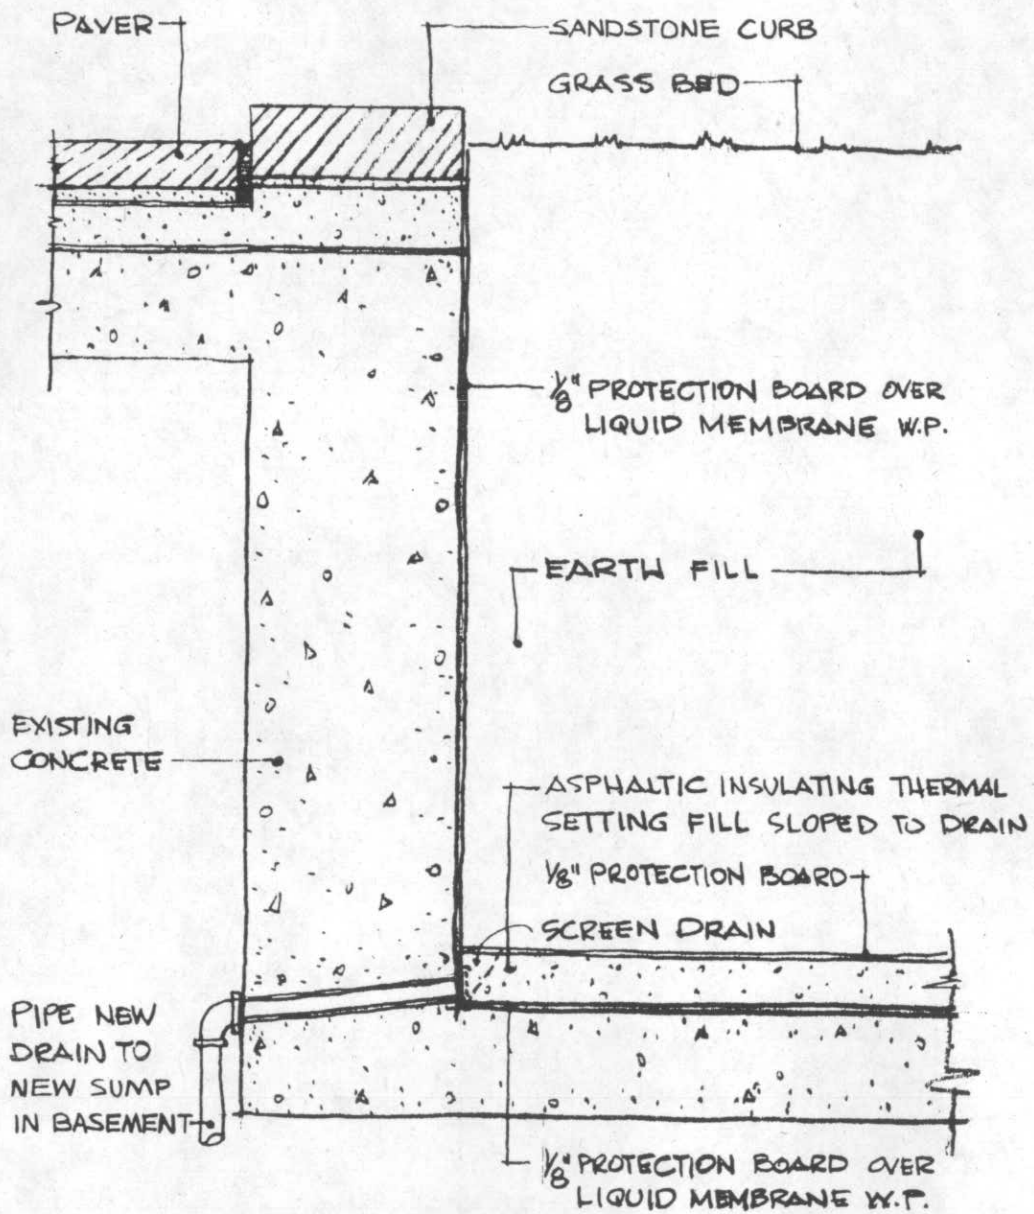
ILLUSTRATION 171. Details of recommended planting box waterproofing and drainage.

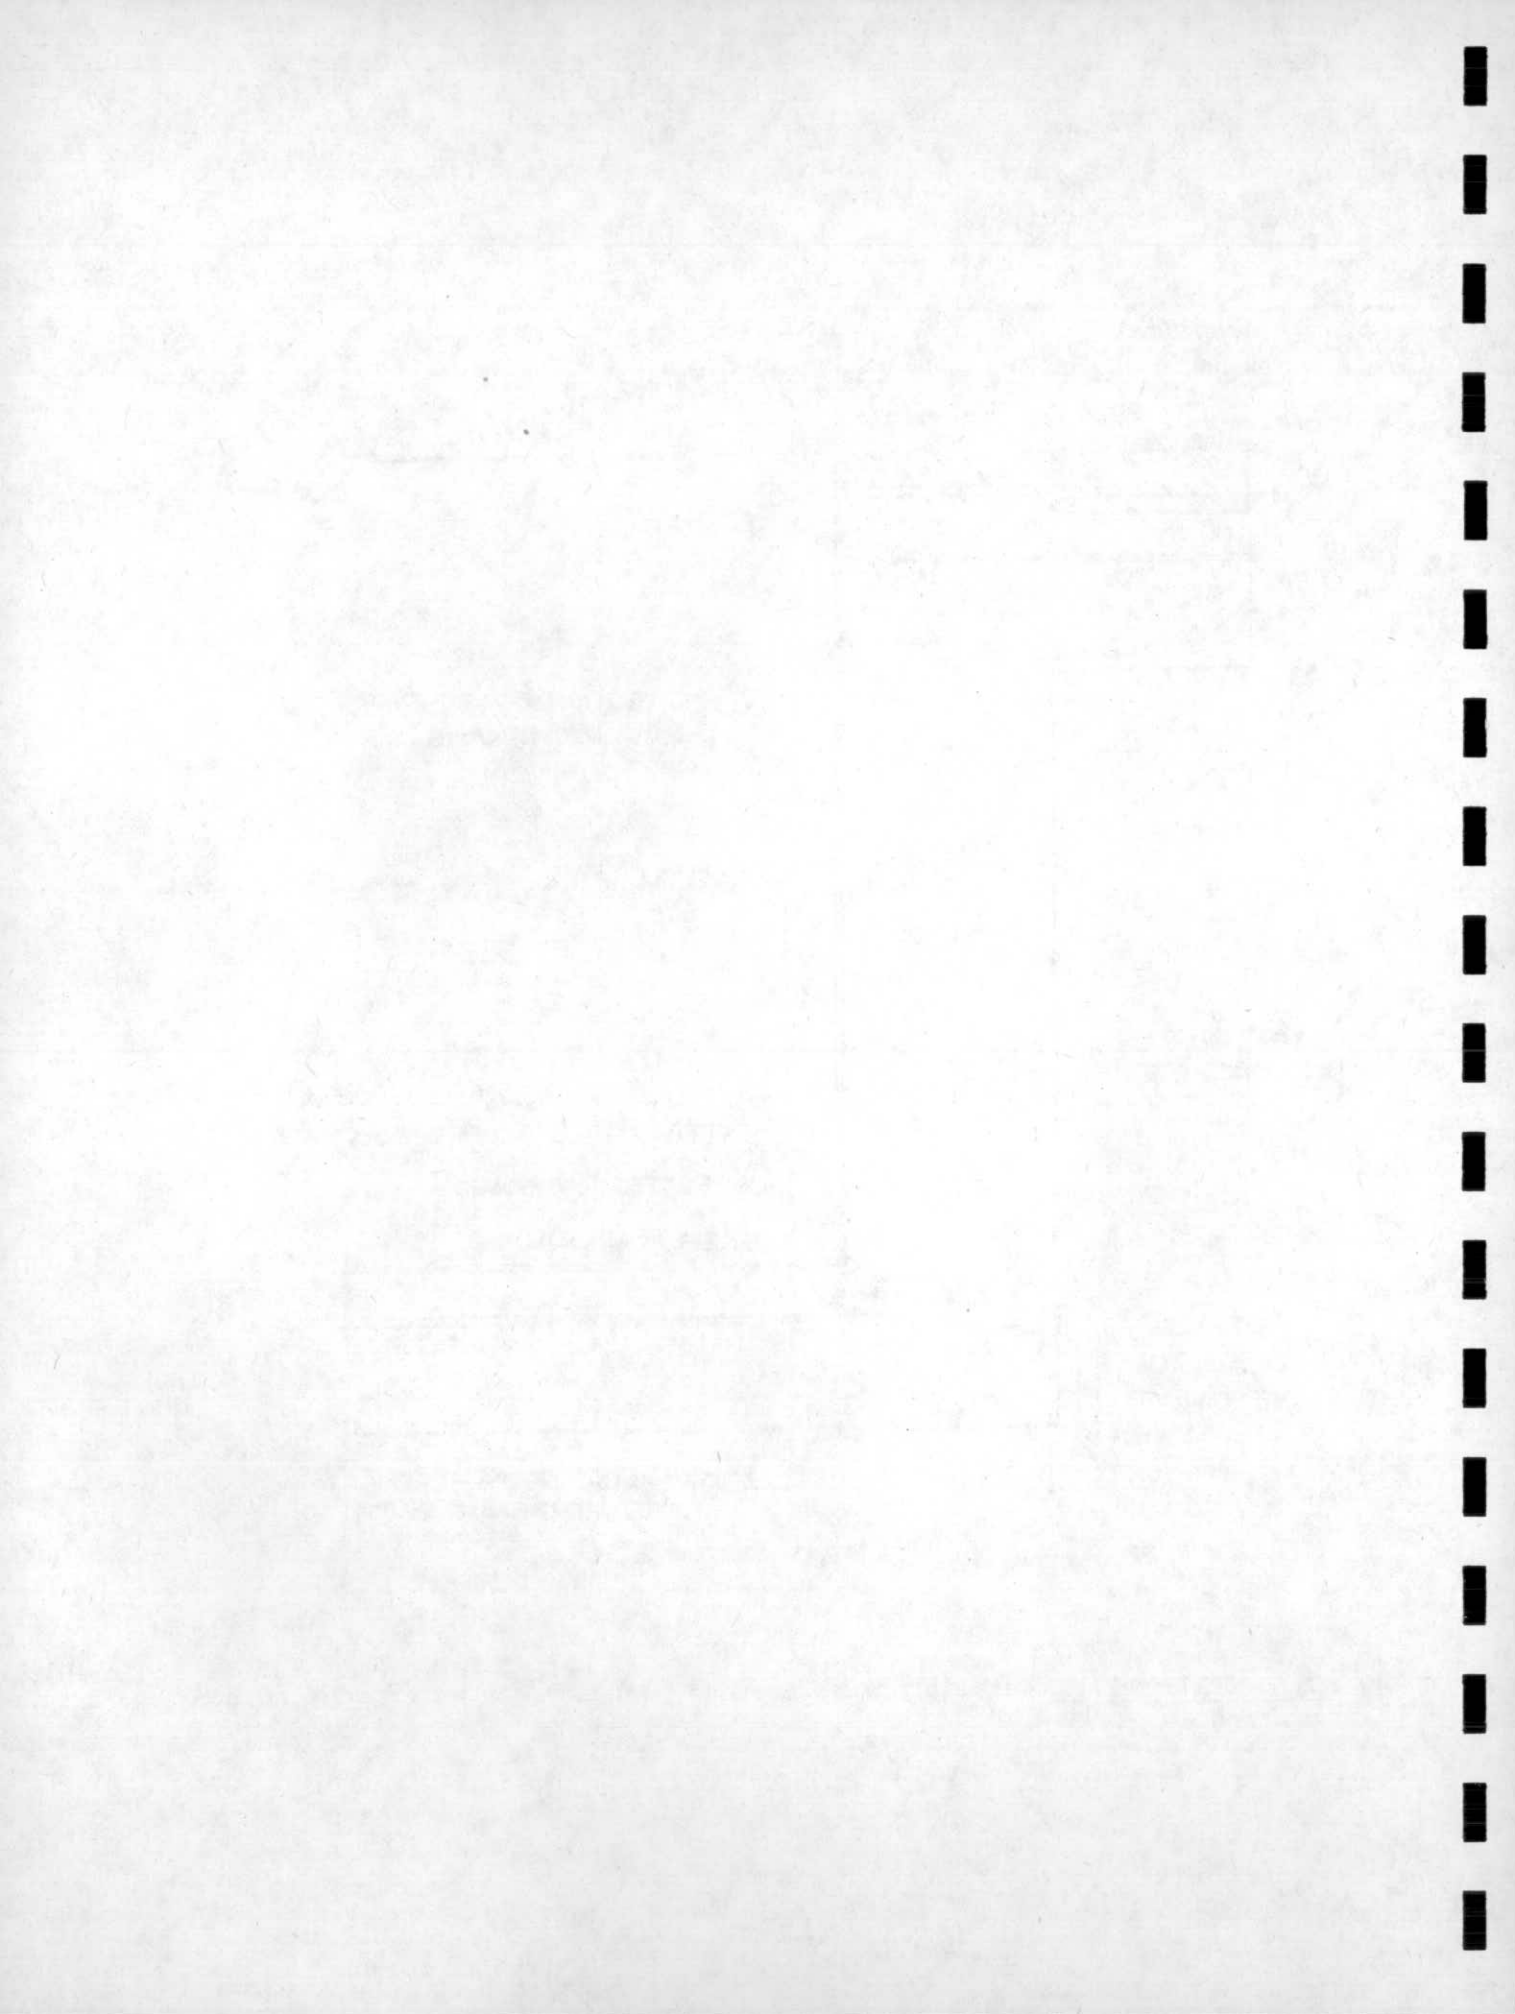
CHAPTER 8. MEMORIAL ROTUNDA

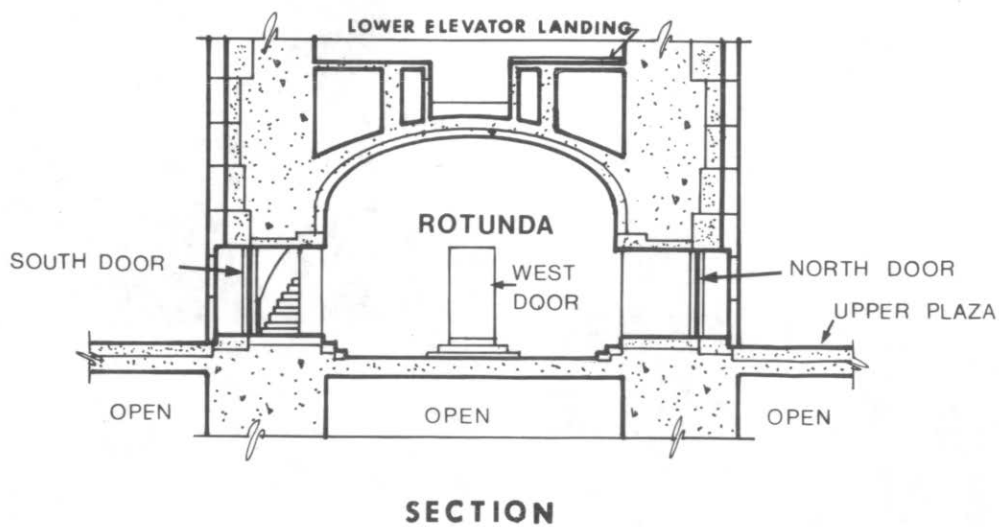
ILLUSTRATION 172. Sketch of section through memorial rotunda.

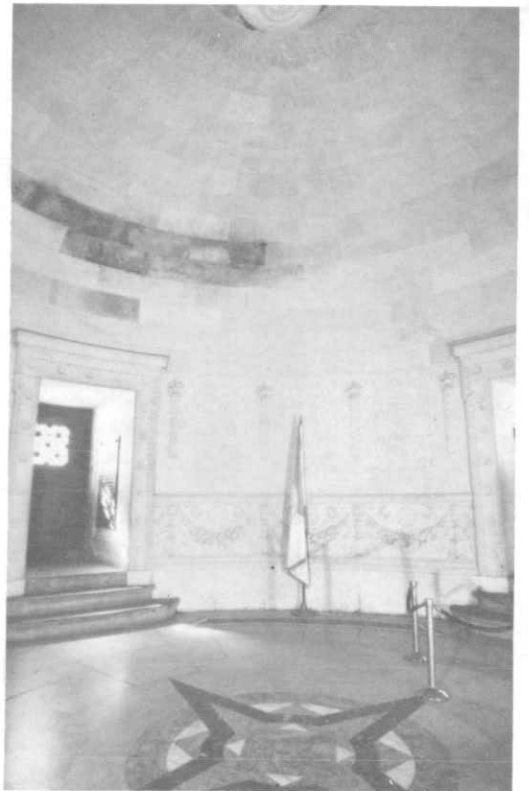
ILLUSTRATION 176. General view of northwest quadrant of rotunda.

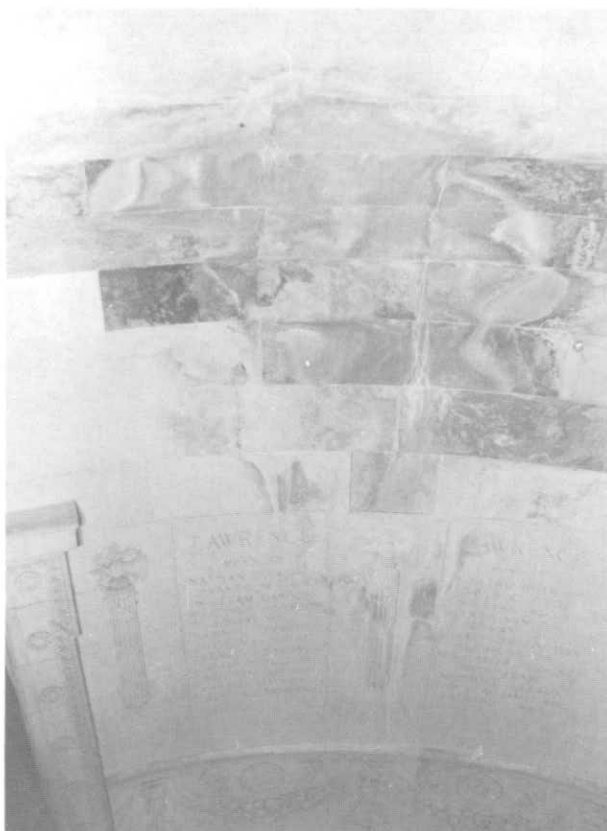
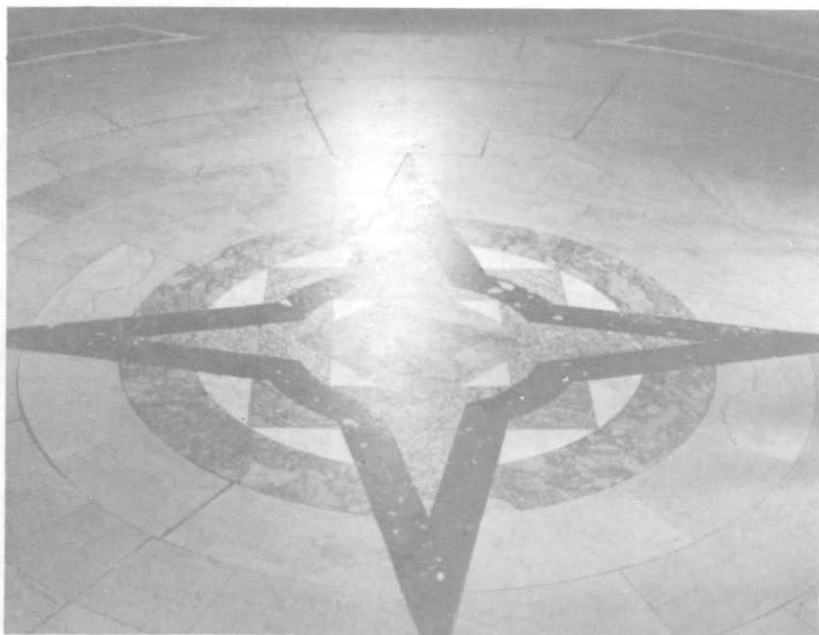
ILLUSTRATION 178. Detail view of decorative marble inlay of rotunda floor.

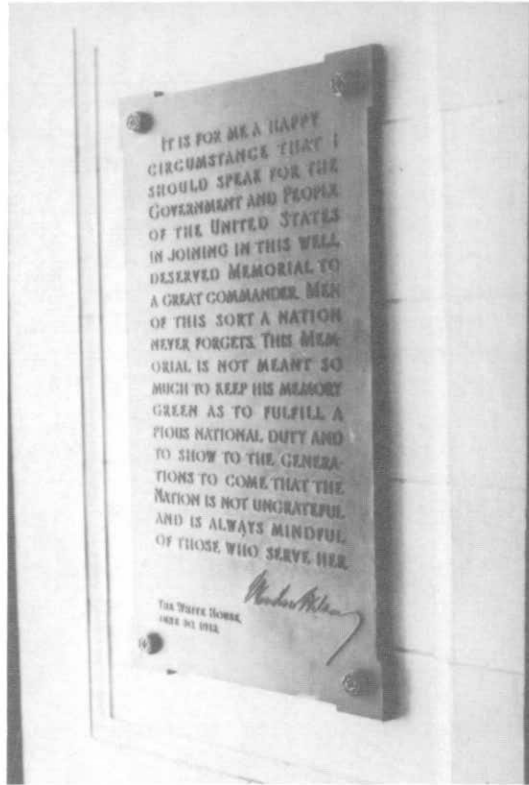
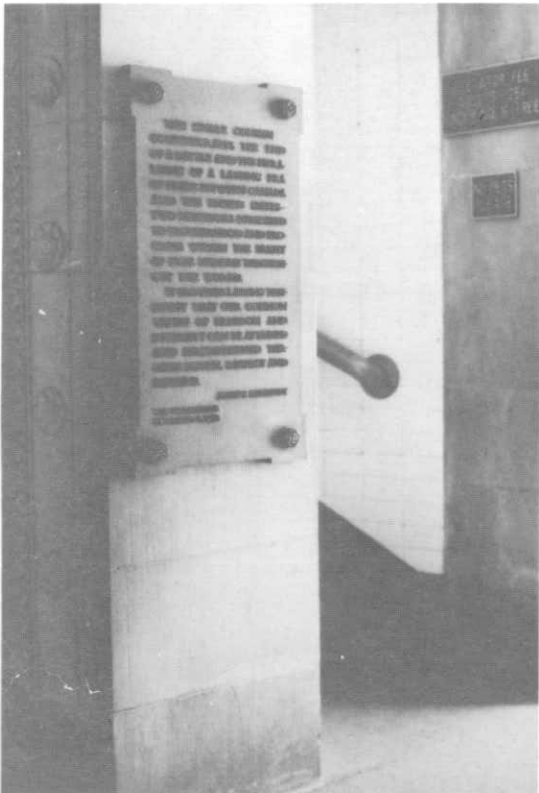
ILLUSTRATION 180. View of a bronze plaque in the niche at the south entrance door. Note the bronze signage on the wall at the entrance stair.

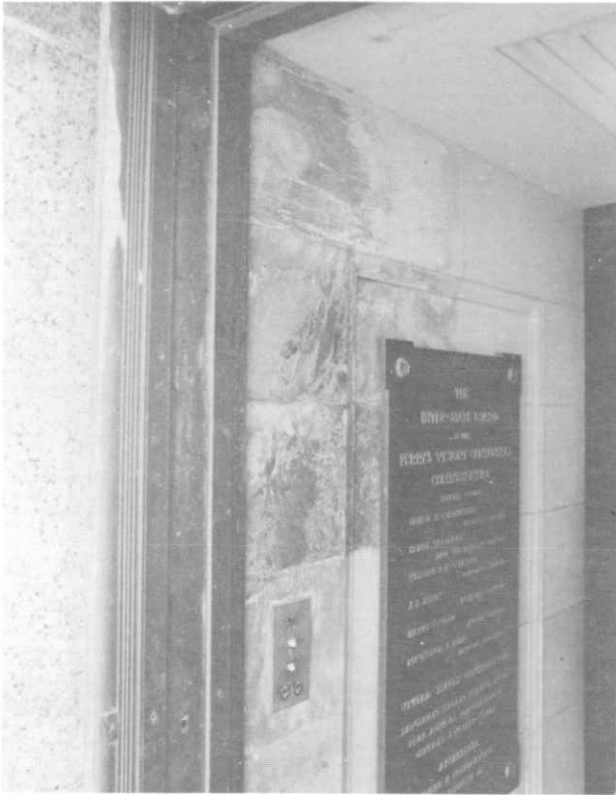
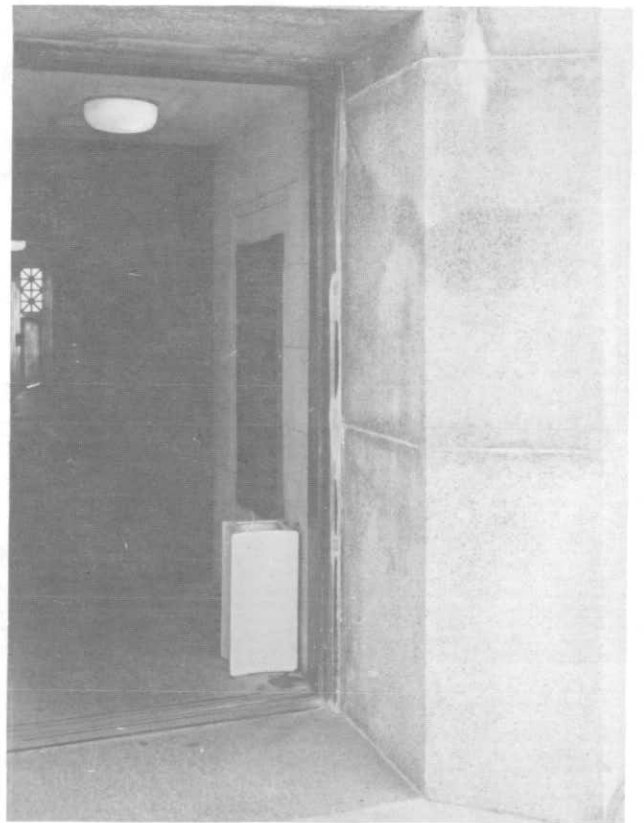
ILLUSTRATION 182. General view of north entry door. Note light fixture at ceiling of niche.

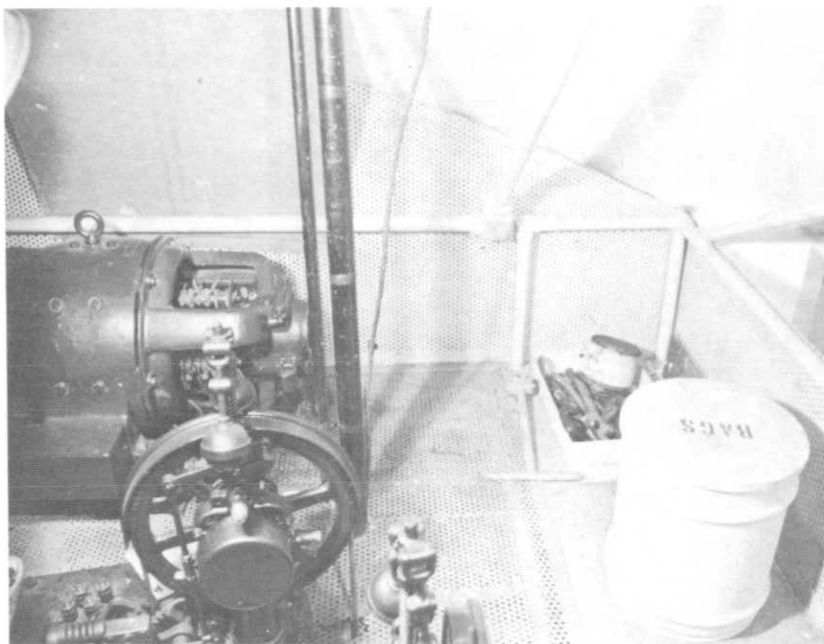
ILLUSTRATION 185. General view of elevator machine platform. Note clean appearance of equipment.

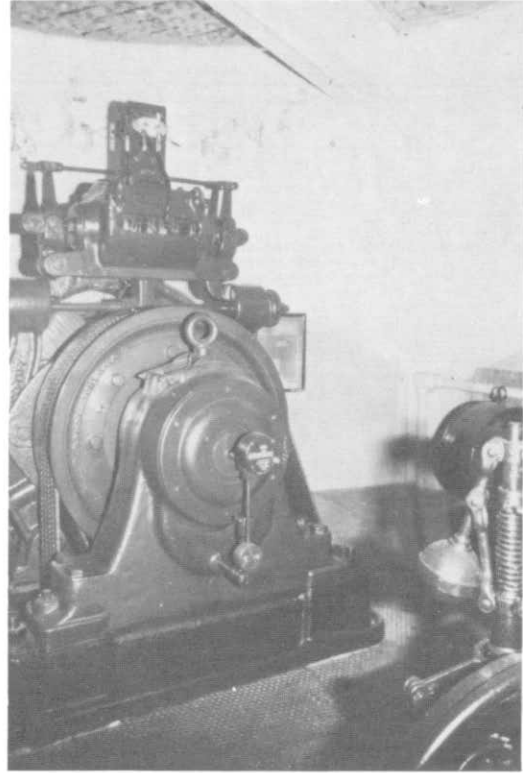
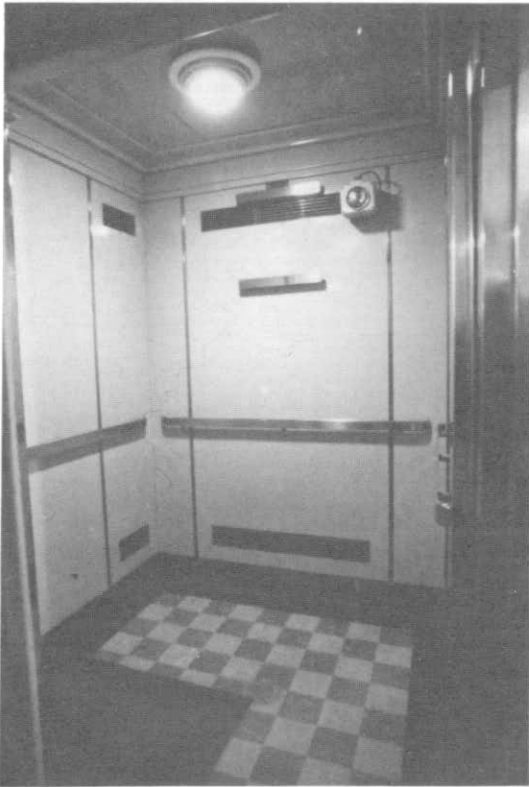
ILLUSTRATION 188. View of Otis Elevator cab showing clean appearance.

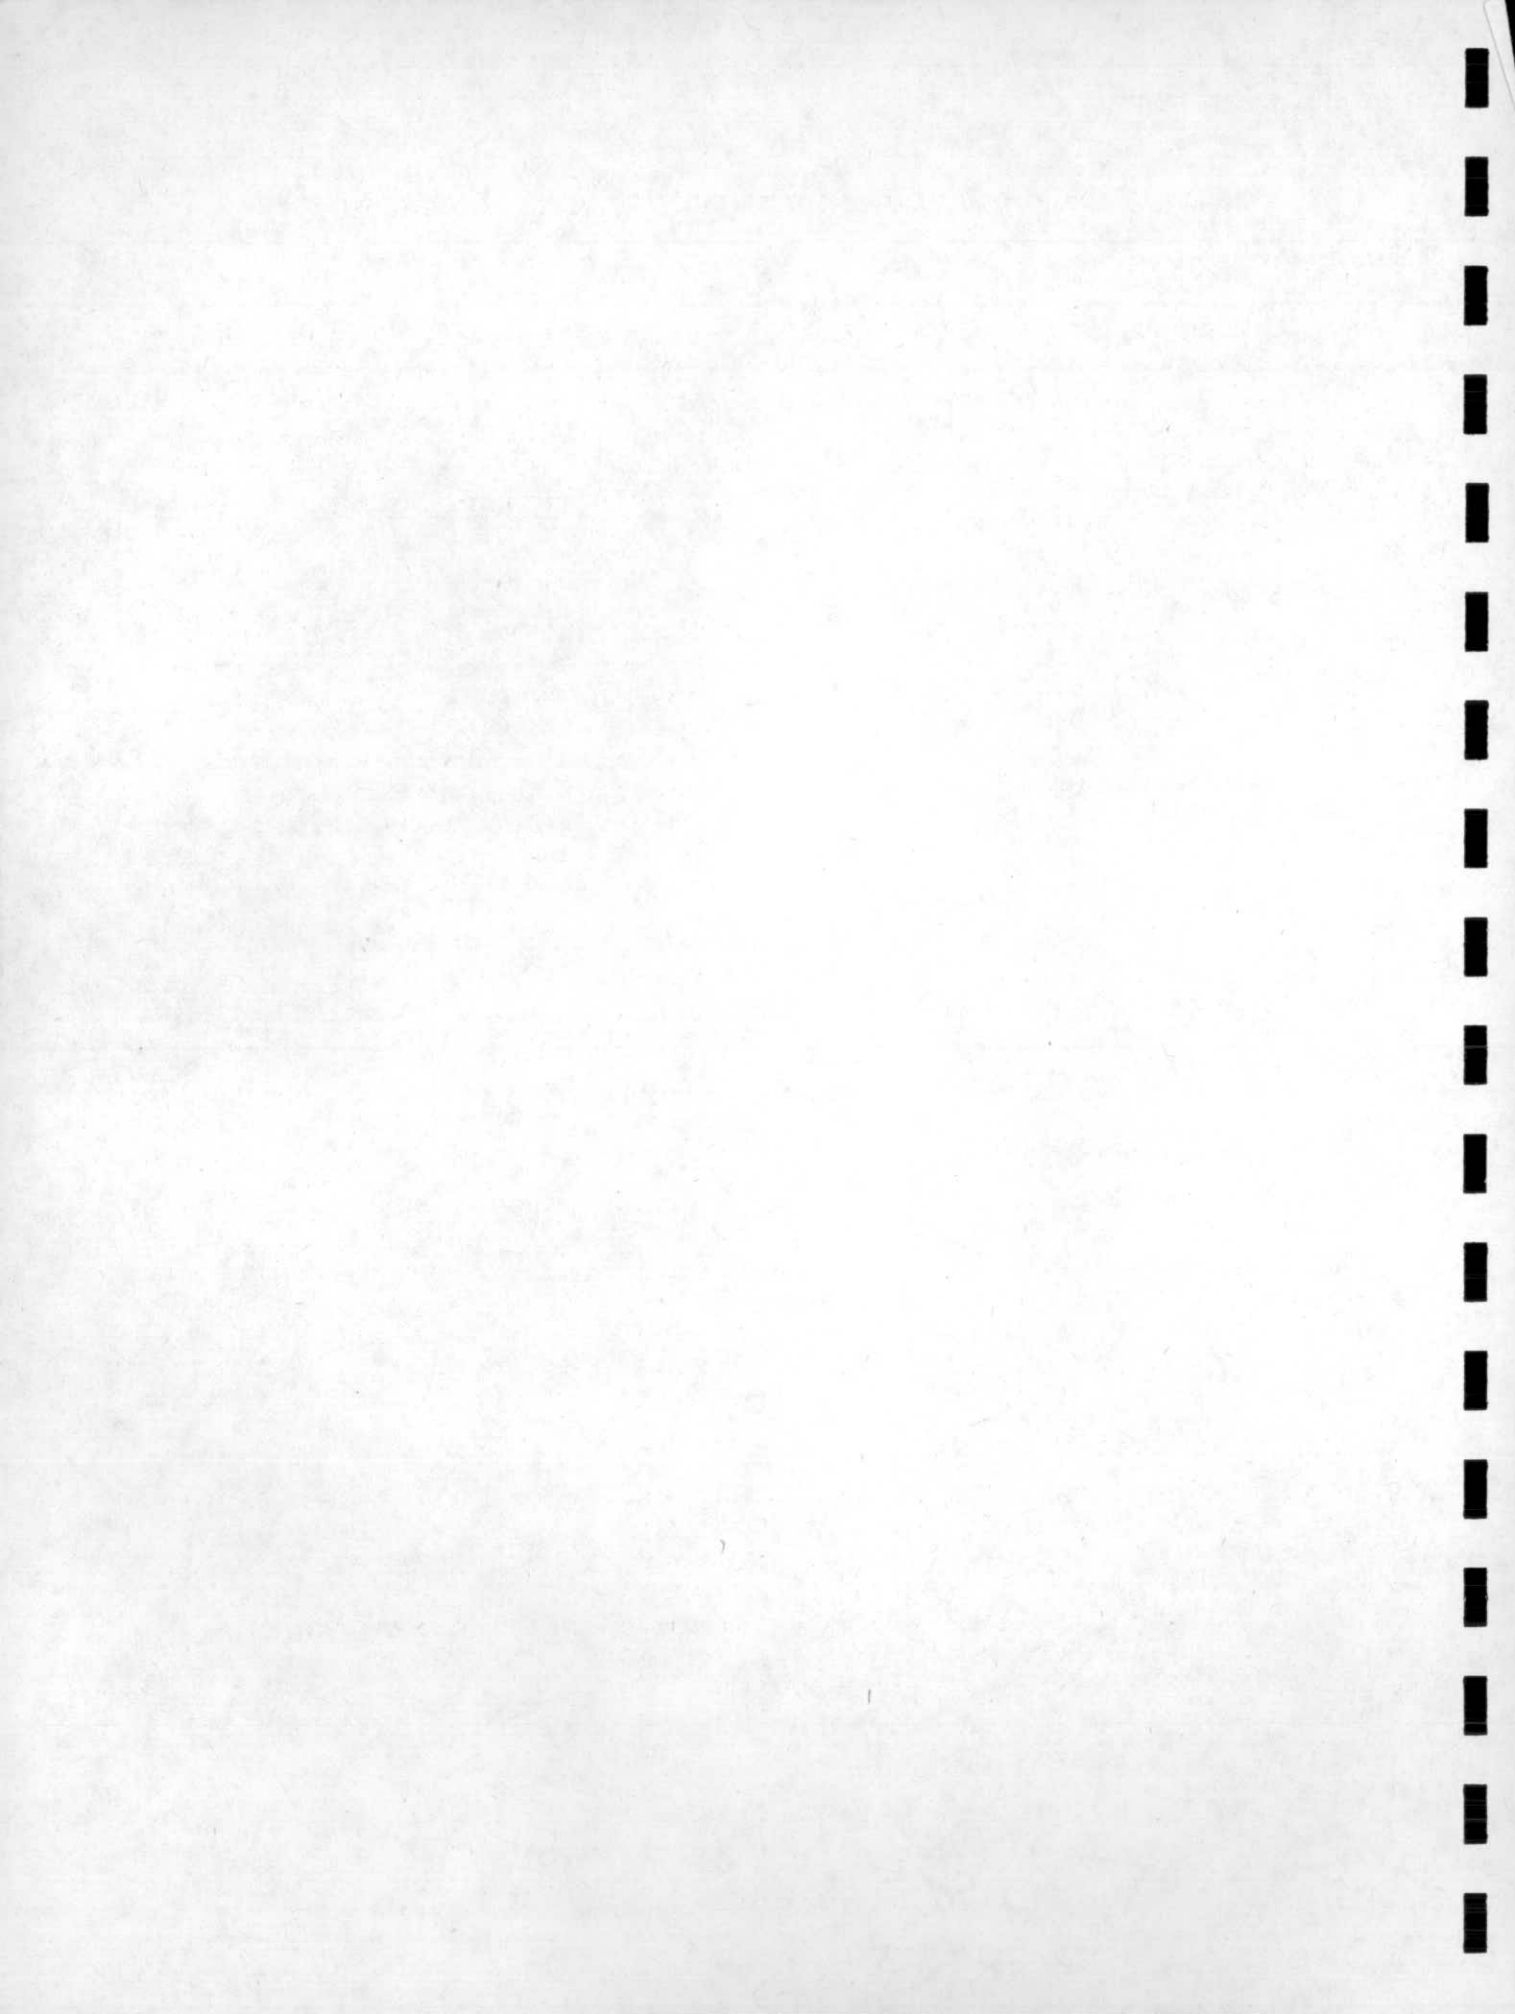
CHAPTER 10. HEATING AND DEHUMIDIFICATION SYSTEM

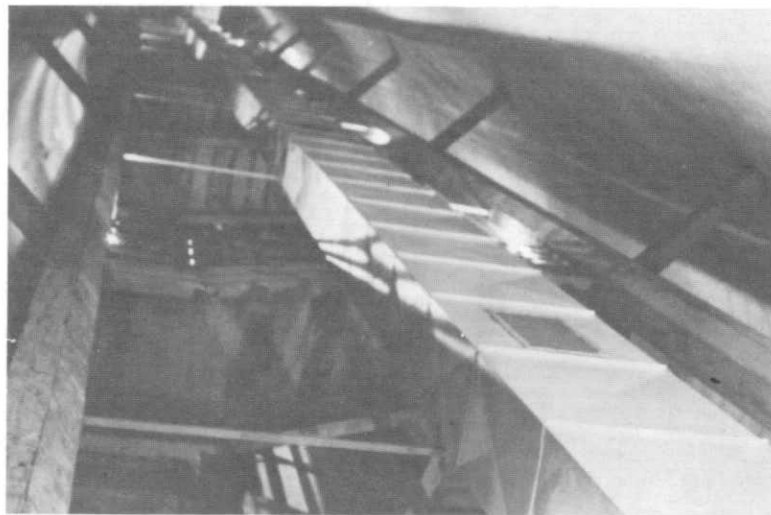
ILLUSTRATION 190. View of the return air duct within the column shaft looking up.

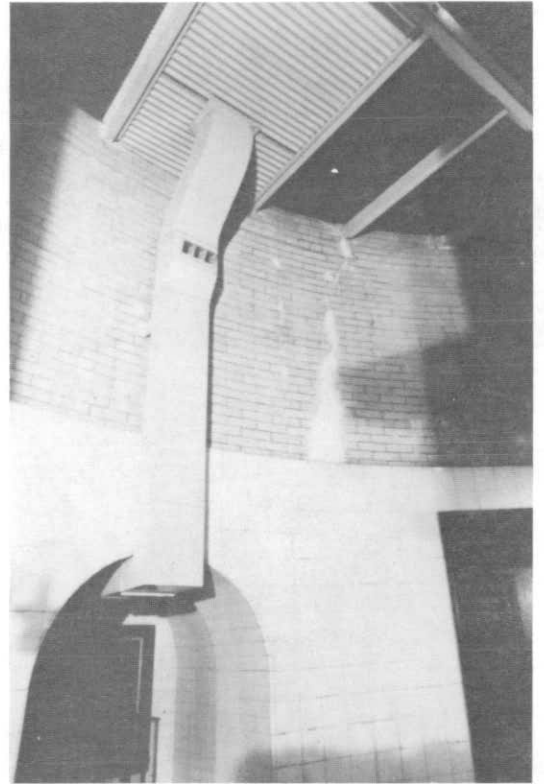
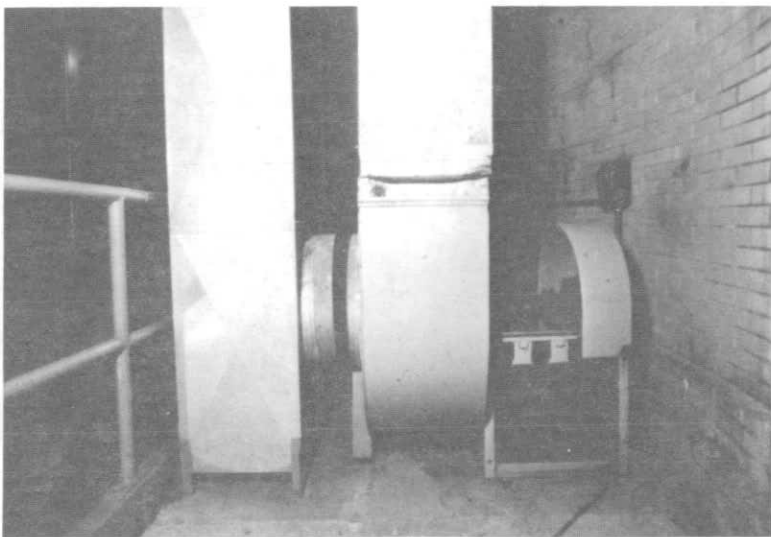
ILLUSTRATION 192. View of return fan and return air duct arrangement. Mounted on the equipment platform.

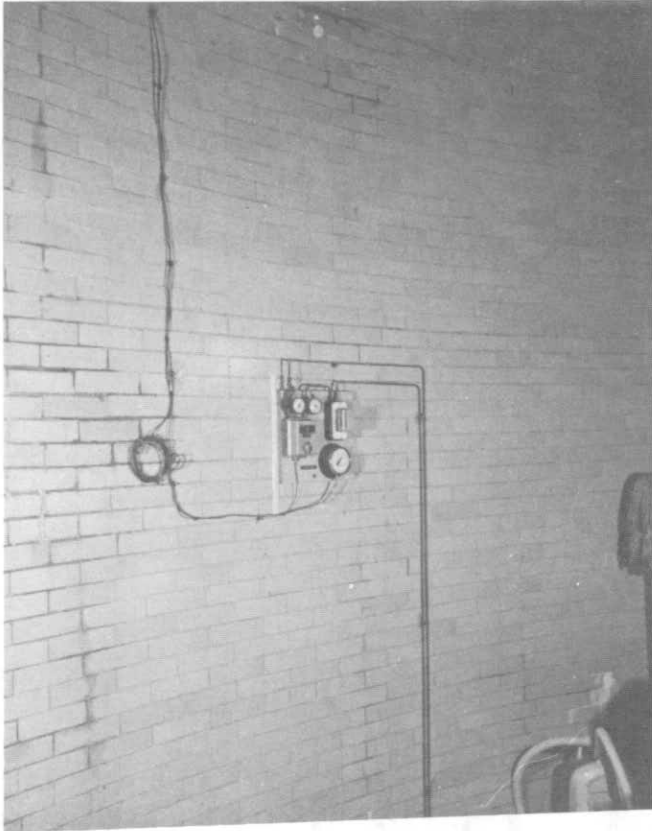
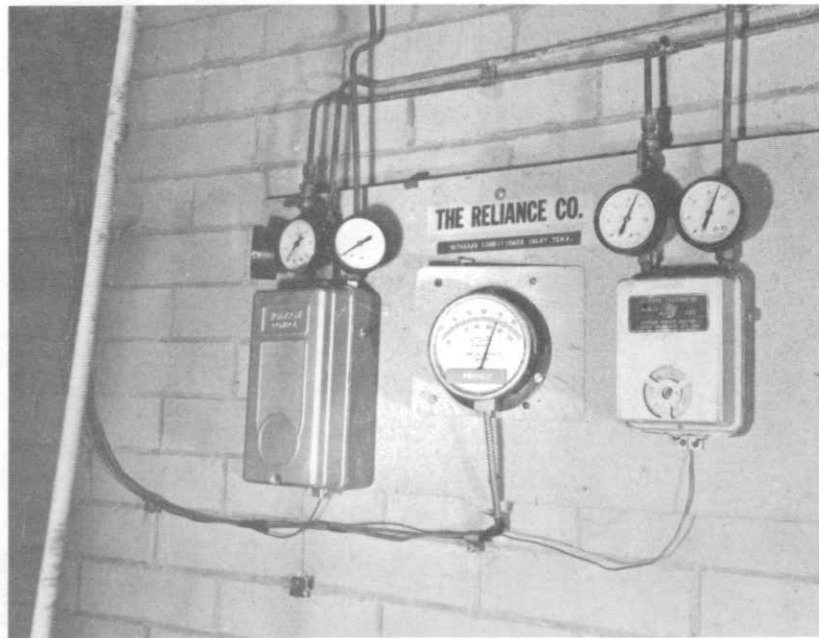
ILLUSTRATION 194. Humidity and temperature controllers located on the interior column wall adjacent the dehumidification equipment. See Ill. 196.

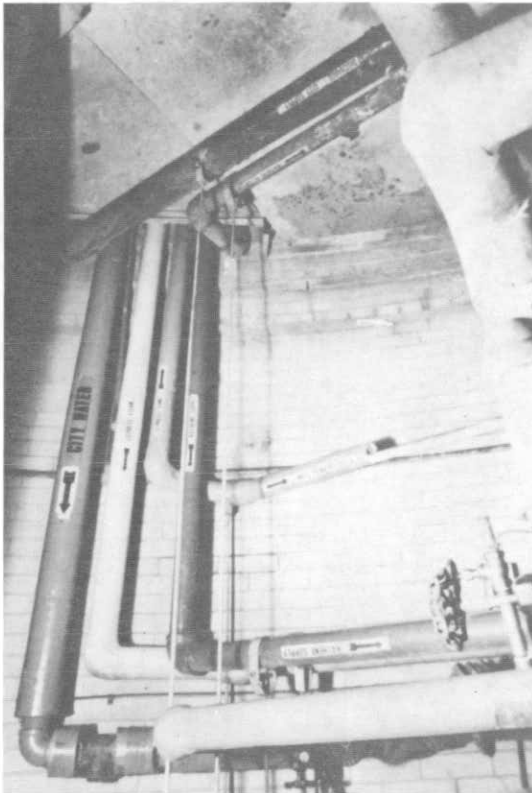
ILLUSTRATION 195. Showing condition and location of piping serving the dehumidification equipment. The pipe penetrates the equipment platform that supports the equipment located one level above the lower elevator landing. Note the condition of the insulation on the pipe in the center of the photo.
