historic structure report

administrative and architectural data

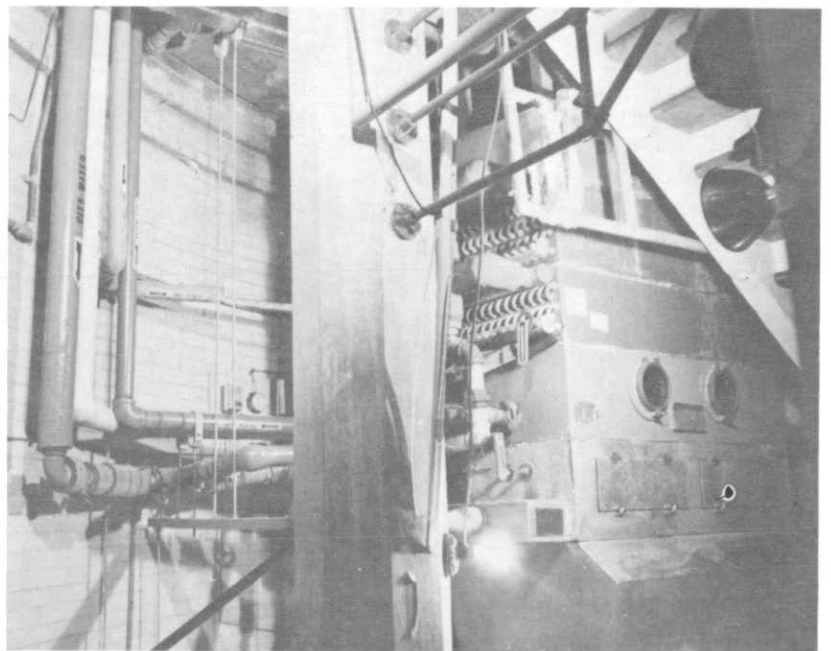
ILLUSTRATION 196. View of the conditioner section of the Kathabar unit, with piping and partial view of the master controls on the wall. See Illustration 194.

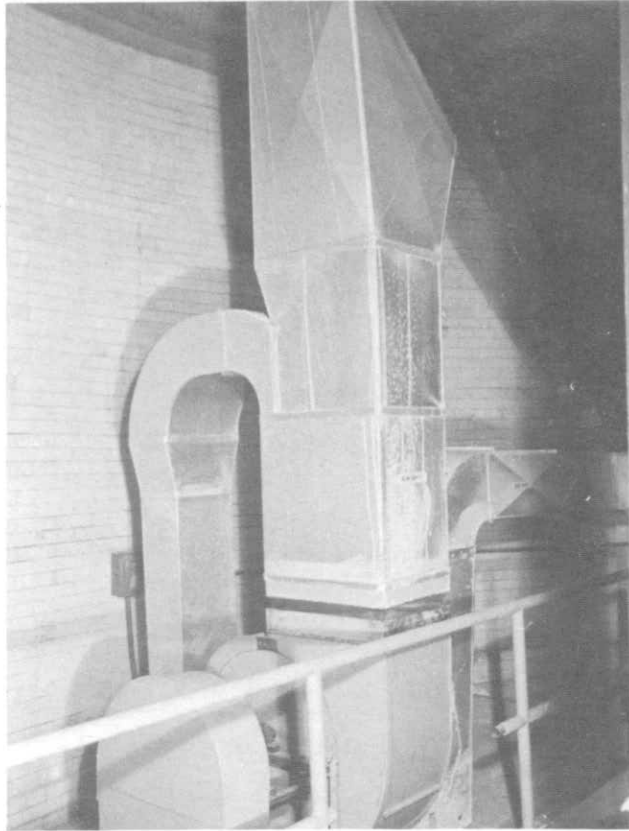
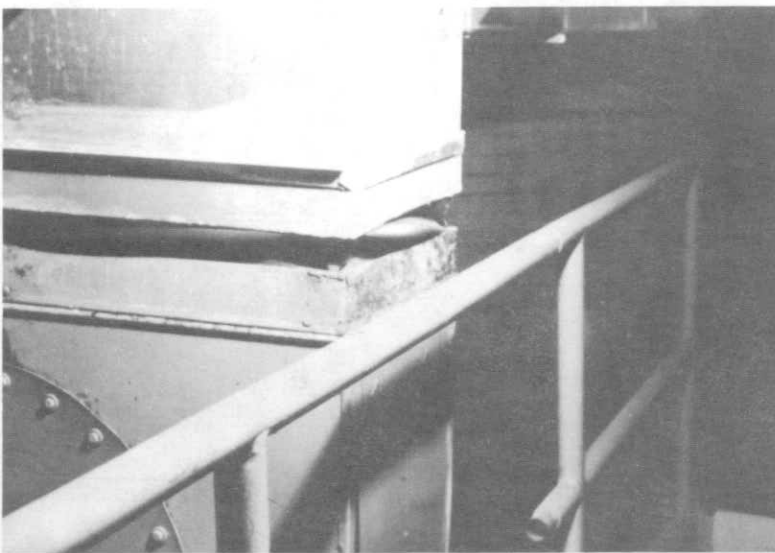
ILLUSTRATION 198. Close-up view of the supply air fan showing condition of flexible connection and slight corrosion of the metal.

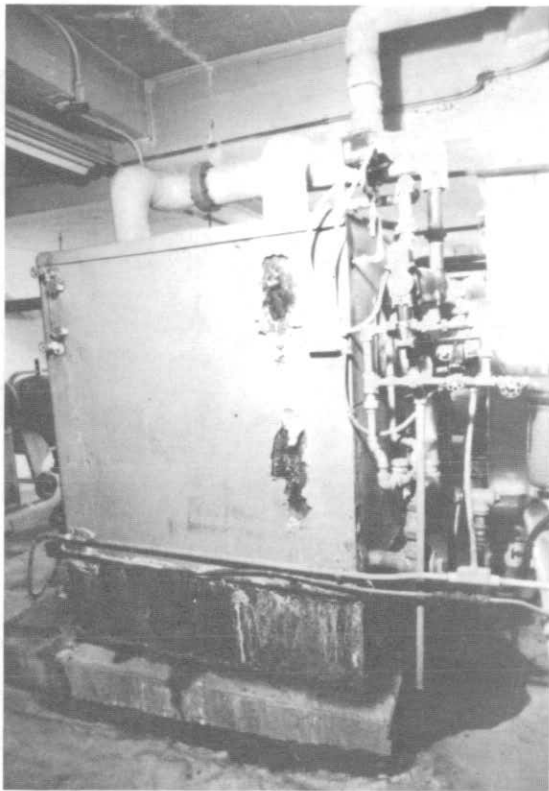
ILLUSTRATION 199. View of the boiler showing the poor condition of the insulated casing. Note the corrosion and moisture at the base of the boiler.

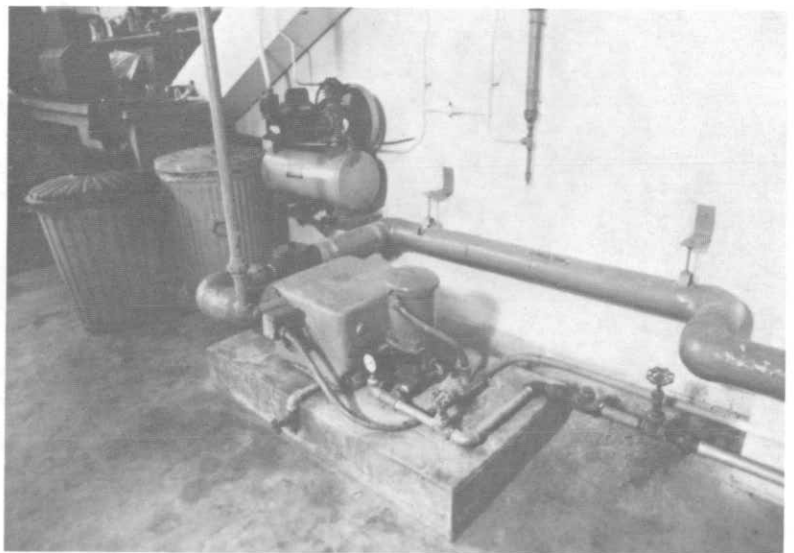
ILLUSTRATION 201. The Kathene solution tank is in the foreground with the regenerating section behind it. The tank, pumping equipment and piping in this area are all in poor condition. Scavenging air duct work is shown on top of the regeneration section. Note the controls mounted on the wall behind the solution tank. These controls serve the steam valve supplying steam for regeneration and preheat of the scavenging air.

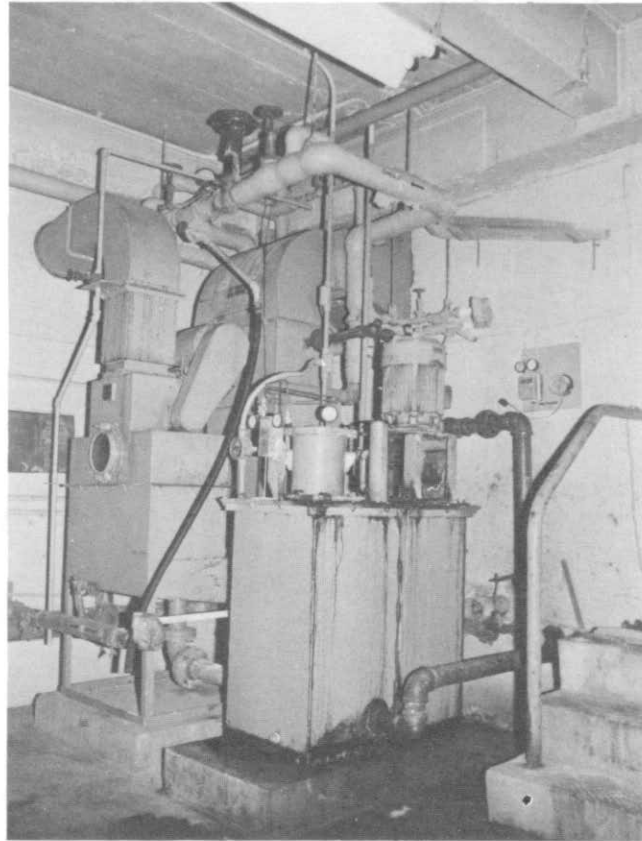
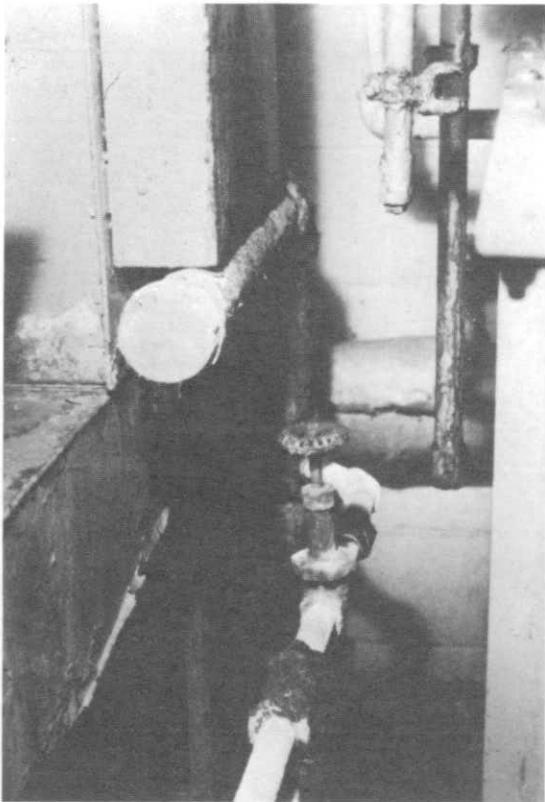
ILLUSTRATION 202. Closeup of piping located between the Kathene solution tank and the regenerating section showing the effects of corrosion.

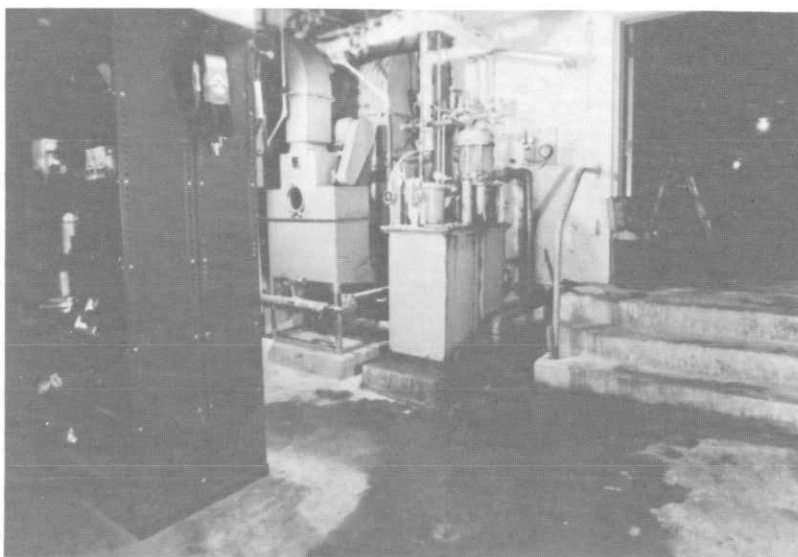
ILLUSTRATION 203. Kathene solution leaking from the tank keeps the floor continually wet.

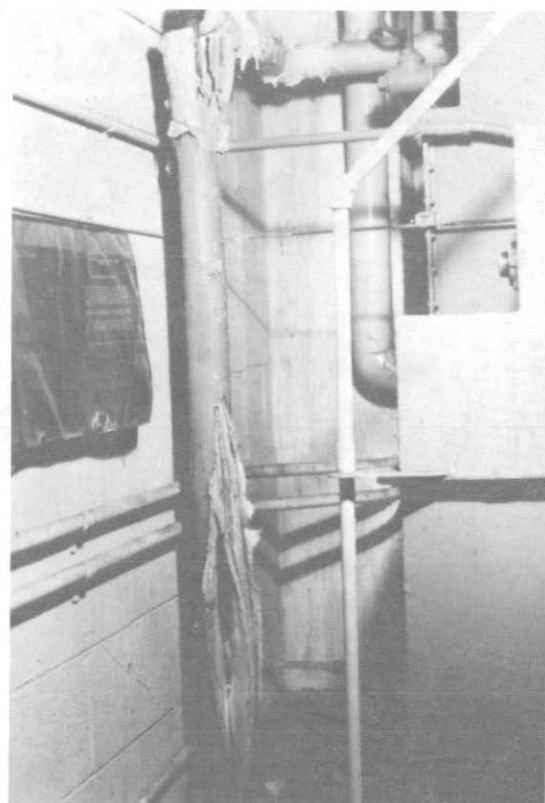
ILLUSTRATION 204. Steam pipe adjacent to the regenerating section. Note the lime-like deposit on the pipe at the top of the photo.

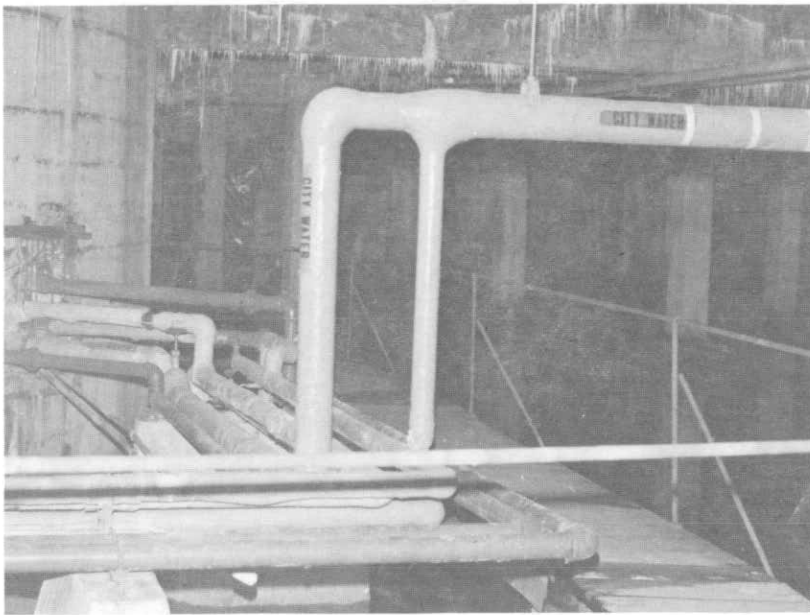
ILLUSTRATION 207. Overall view in the basement space near the north wall of the column shaft base. Note the catwalk above the standing water that covers approximately 70 percent of this area. The pipe at the left of the photo extends upward through the shaft wall to serve the dehumidification equipment located on the equipment platform above the lower elevator landing. Also see Illustrations 209 and 210.

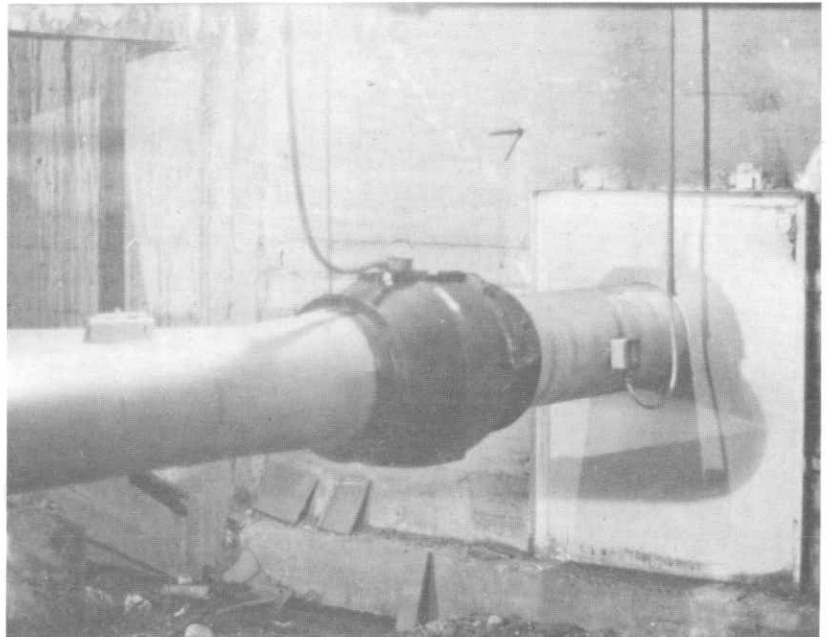
ILLUSTRATION 208. Induced draft fan for the boiler flue and the scavenging air vent located at the east wall of the upper plaza foundation. This vent passes through the wall and emerges from the embankment outside. Terminating at a built-up masonry box covered with a metal grate flush with the slope of the embankment.

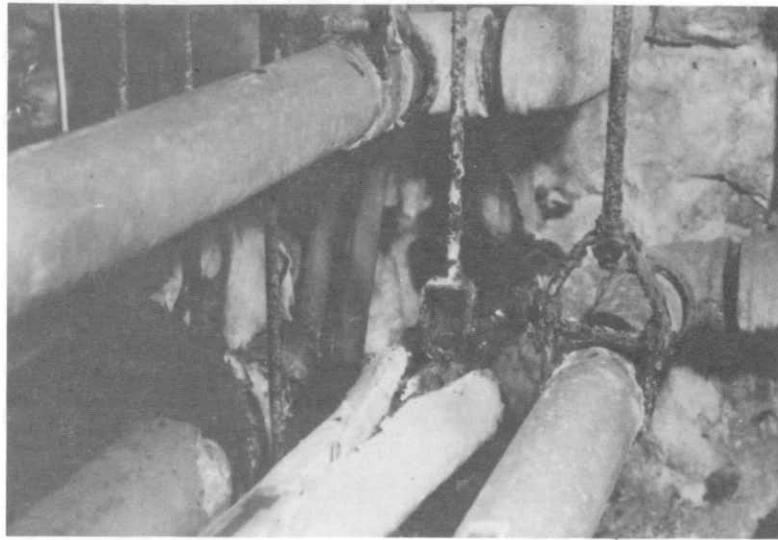
ILLUSTRATION 209. Close-up of pipe and hangers at the column shaft base. Note the poor condition of the hangers, pipe and insulation.

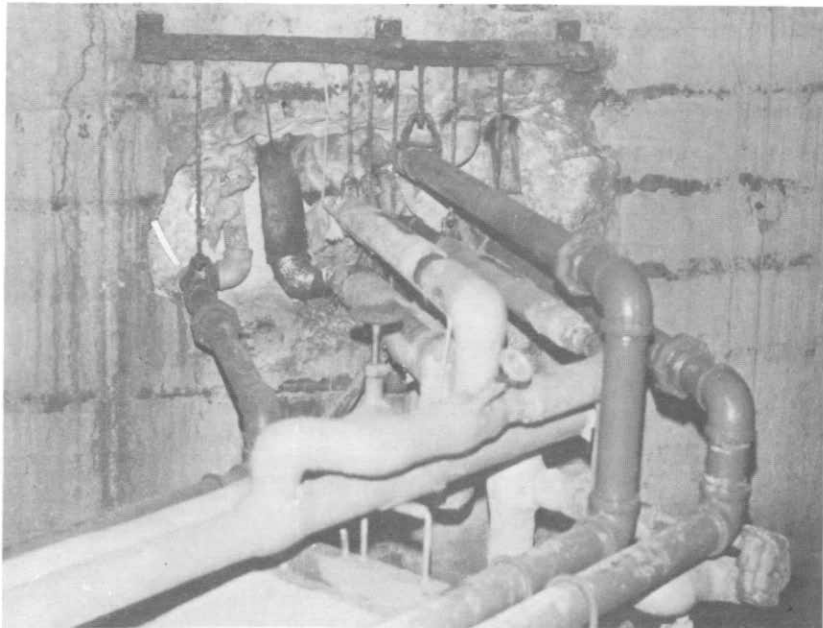
ILLUSTRATION 210. View of piping entering the base of the column shaft.

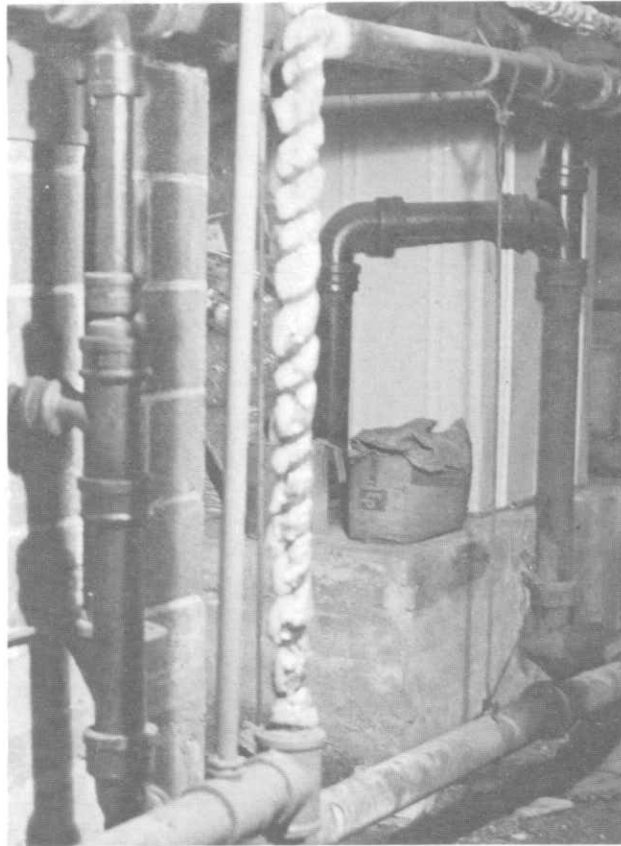
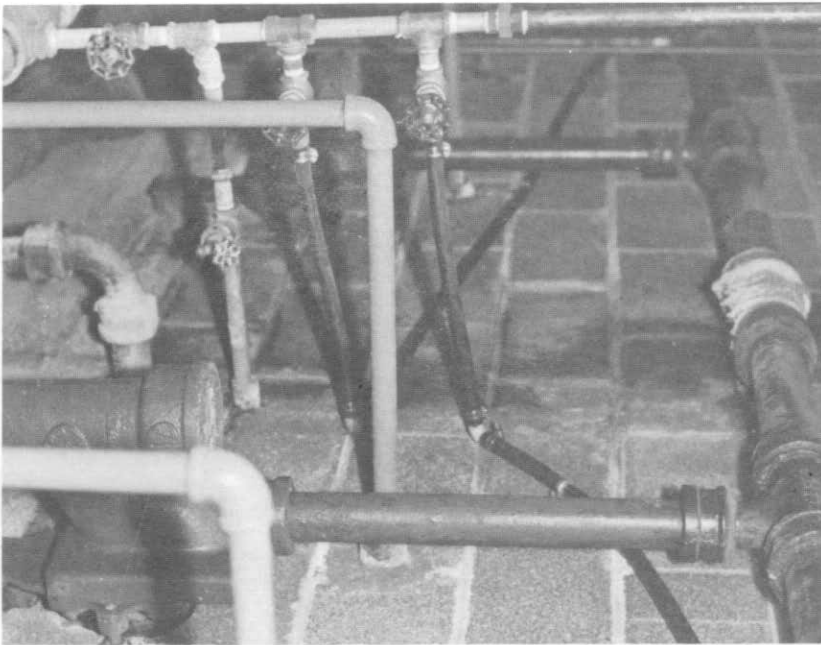
ILLUSTRATION 212. Close-up of plumbing serving the toilet rooms.

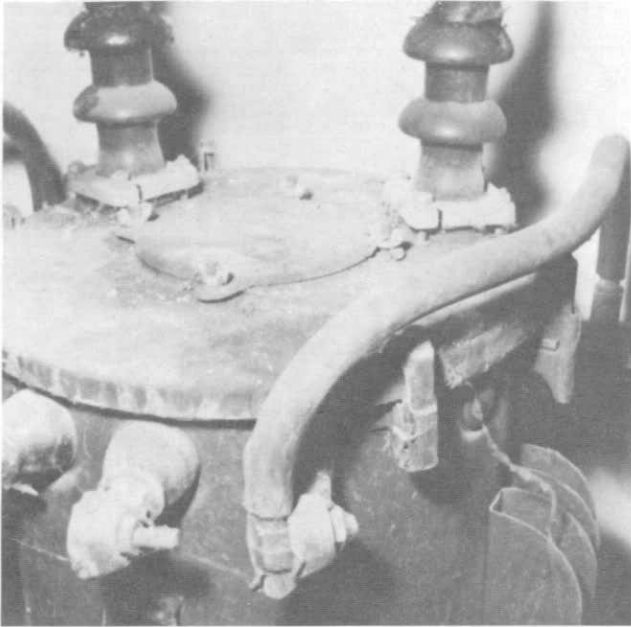
ILLUSTRATION 227. Typical transformer top. High voltage bushings are leaking and enclosures should be cleaned and painted.

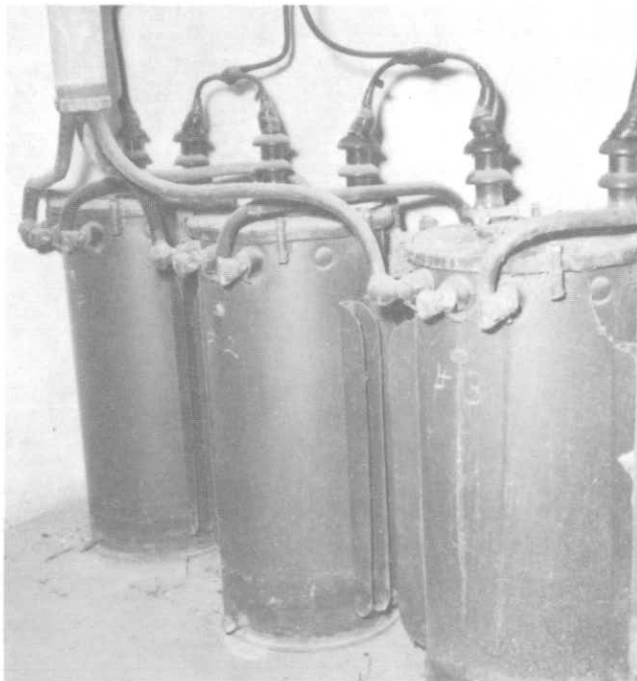
ILLUSTRATION 228. Main transformer bank. Note: Terminals in front should be tape insulated.

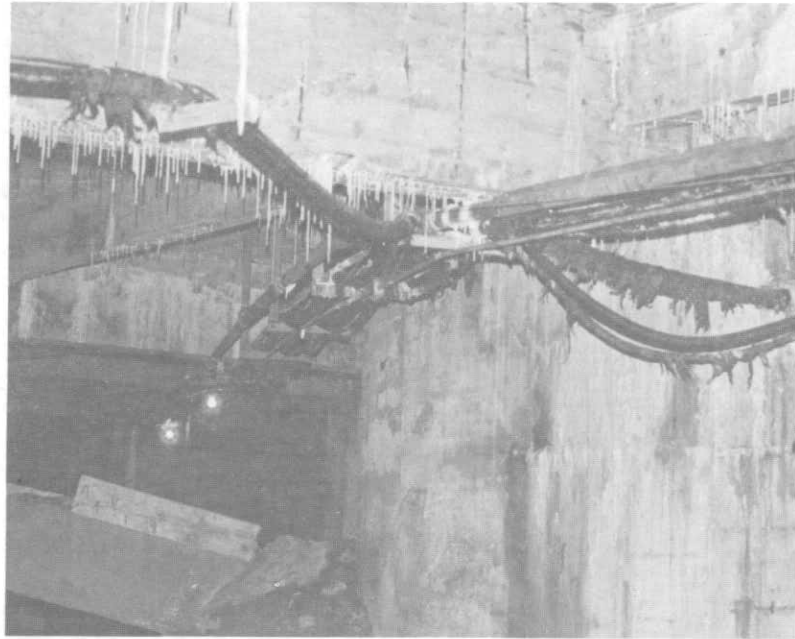
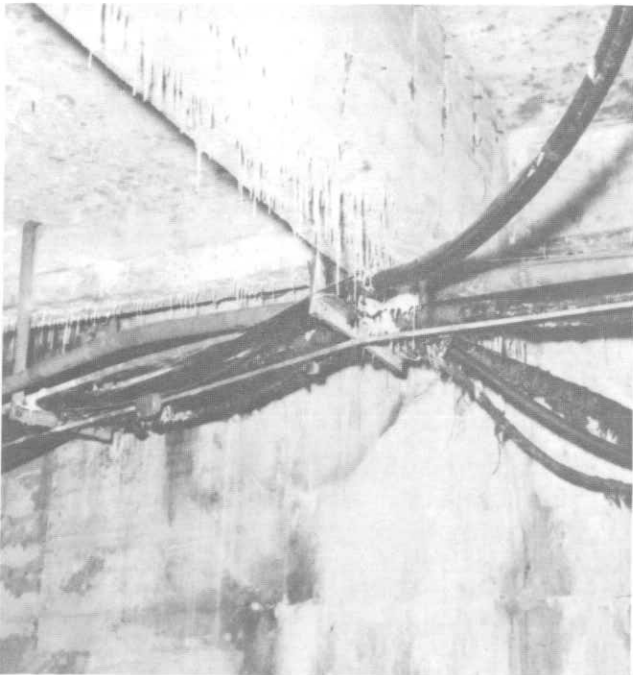
ILLUSTRATION 242. Low voltage feeder cables. Note improper cable supports.

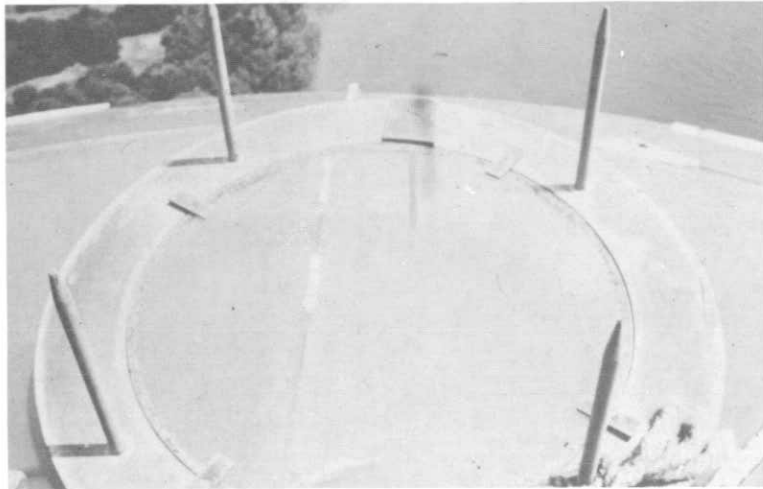
ILLUSTRATION 243. Lightning points on top of lantern hatch.

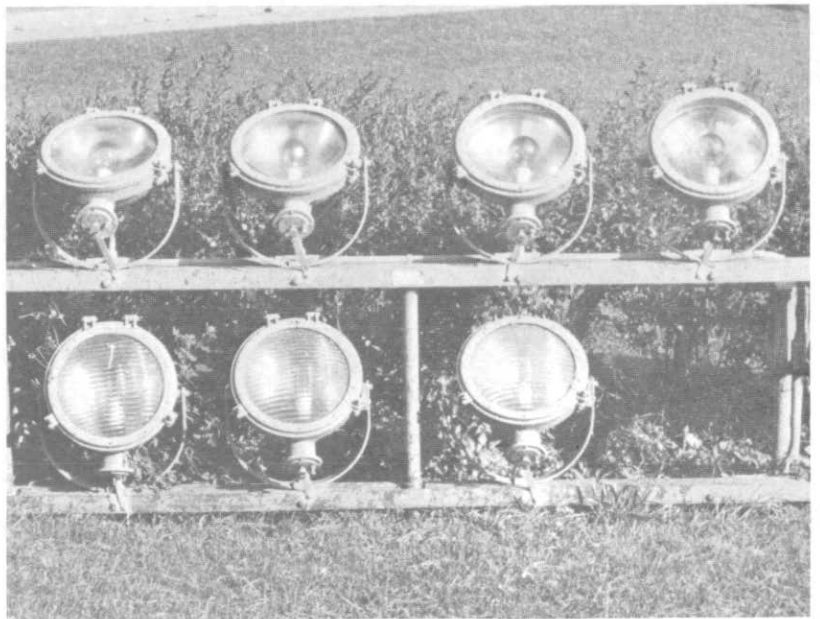
ILLUSTRATION 249. Northeast floodlight bank. Note stippled replacement lenses in bottom row.

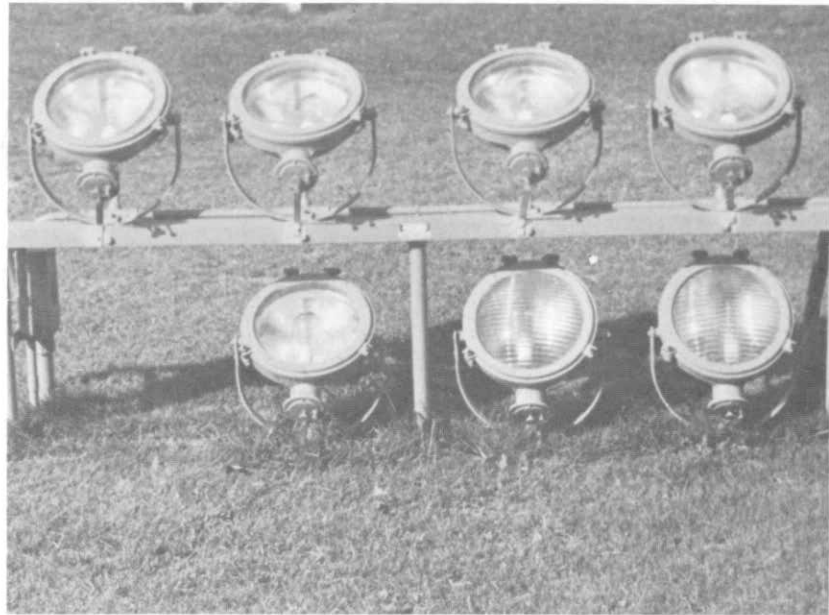
ILLUSTRATION 250. Northwest floodlight bank. Note cracked lens at top row, second from right, and stippled replacement type lenses bottom row.

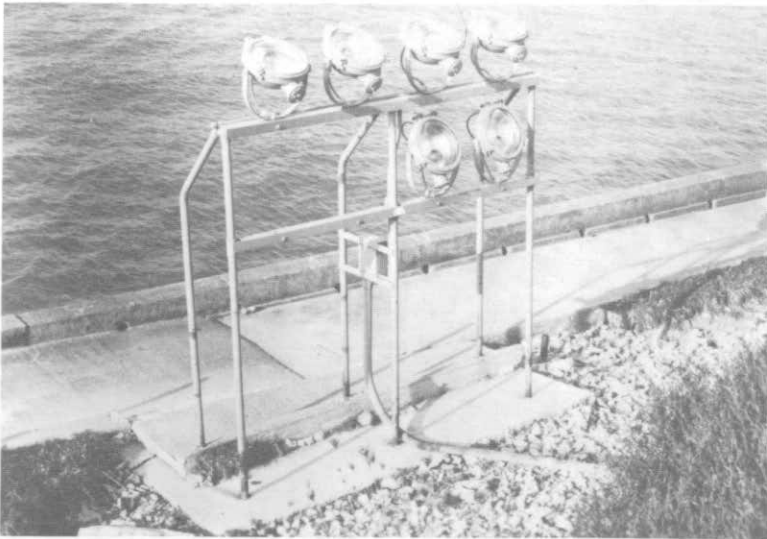
ILLUSTRATION 251. South floodlight bank.

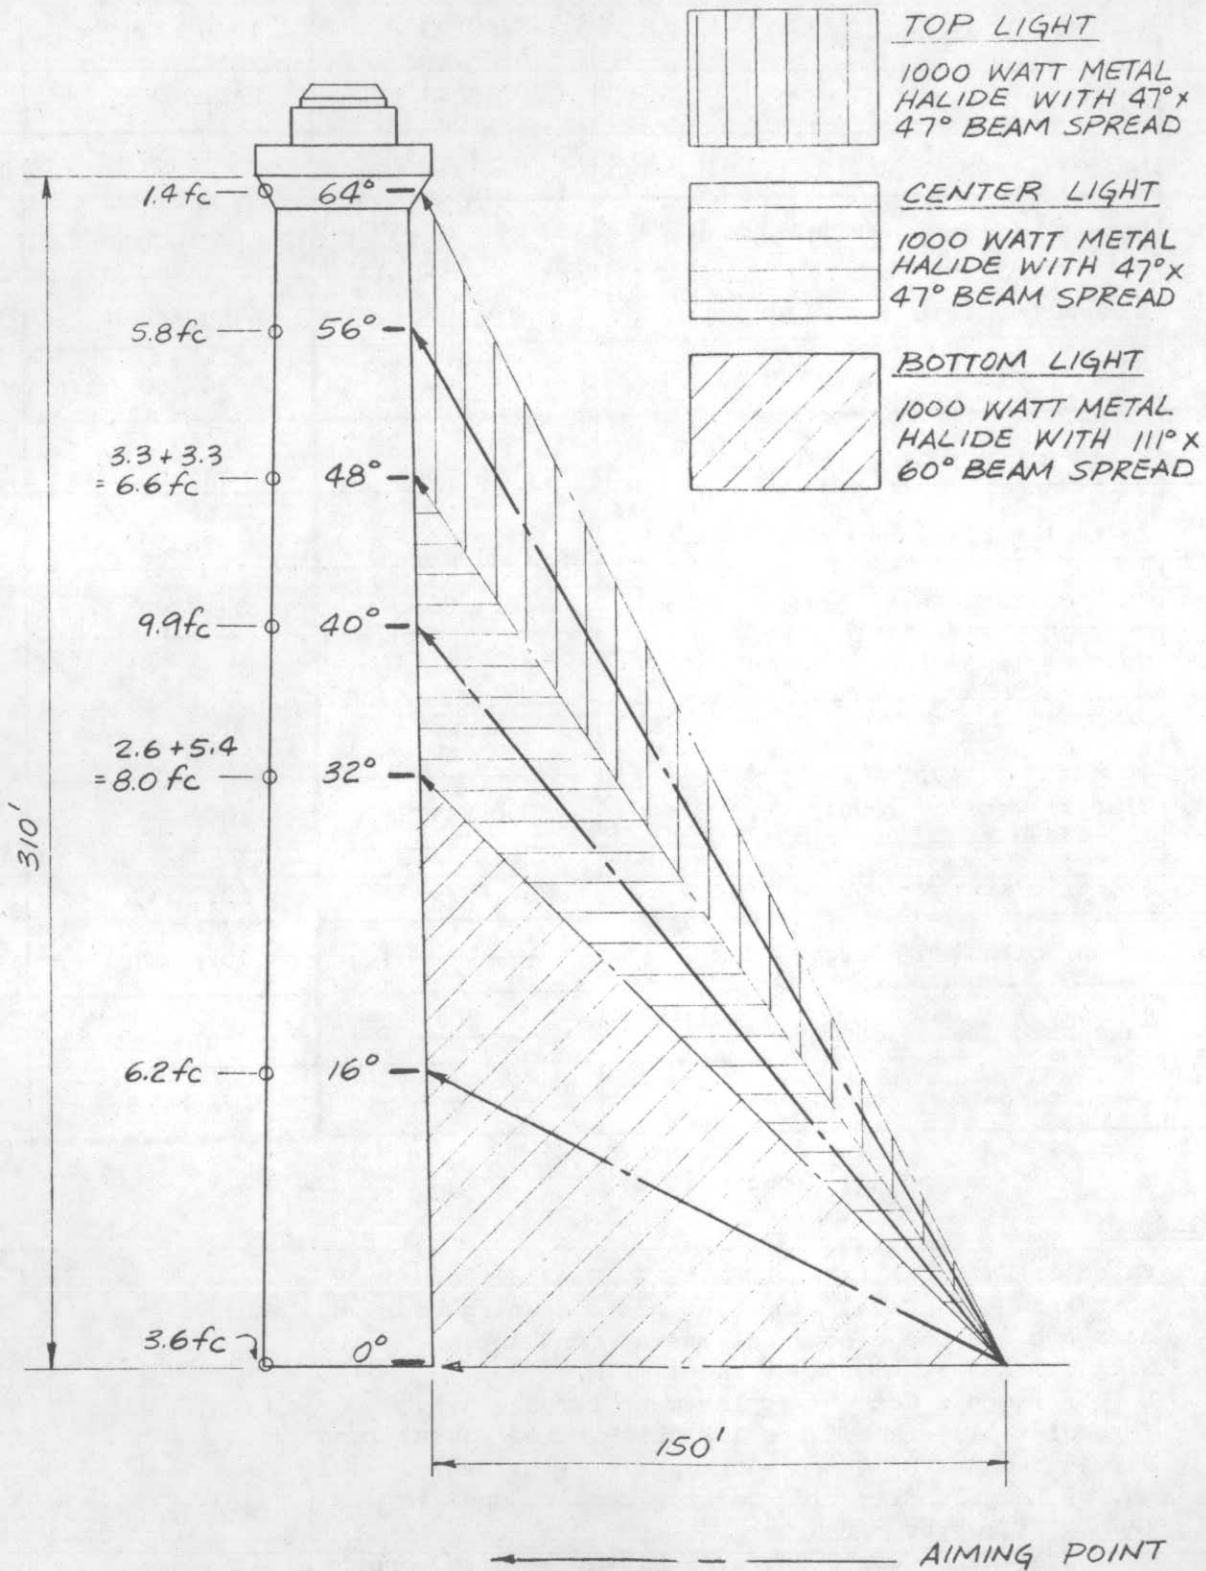
ILLUSTRATION 253. Sample lighting distribution of an H.I.D. type floodlighting luminaires.

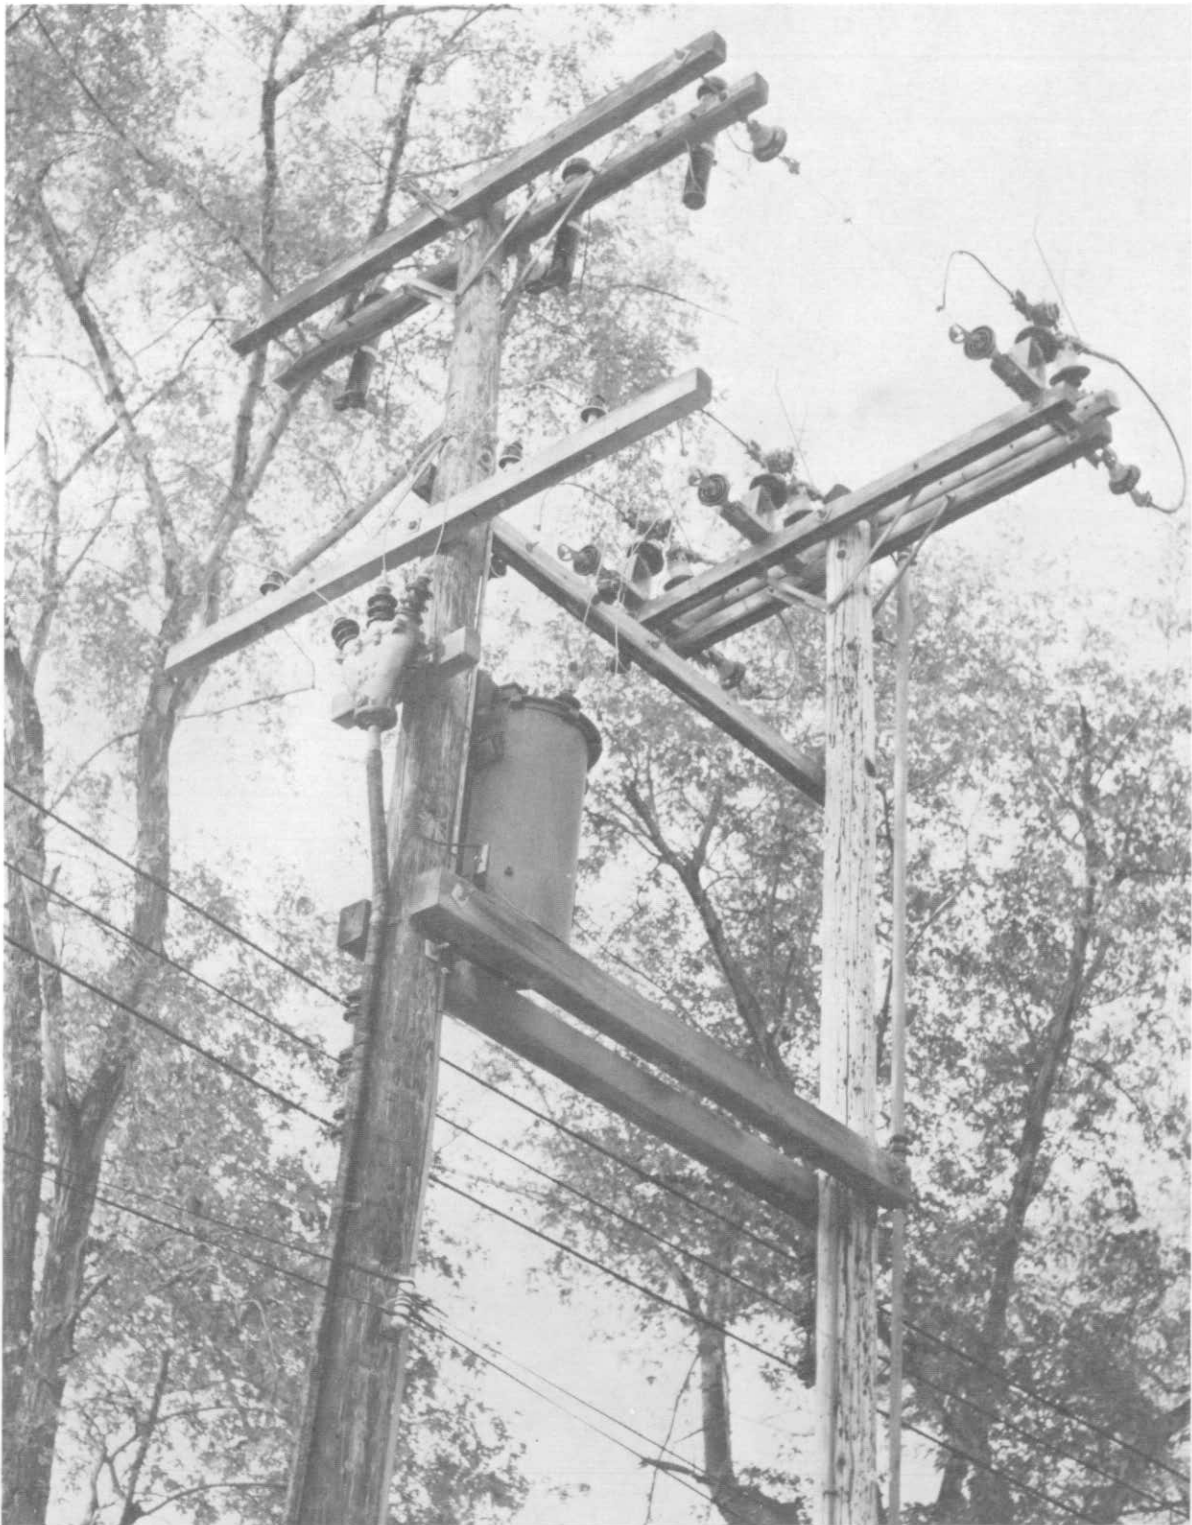
1. OHIO EDISON SERVICE The pole farthest from the transformer is in poor condition and should be replaced.

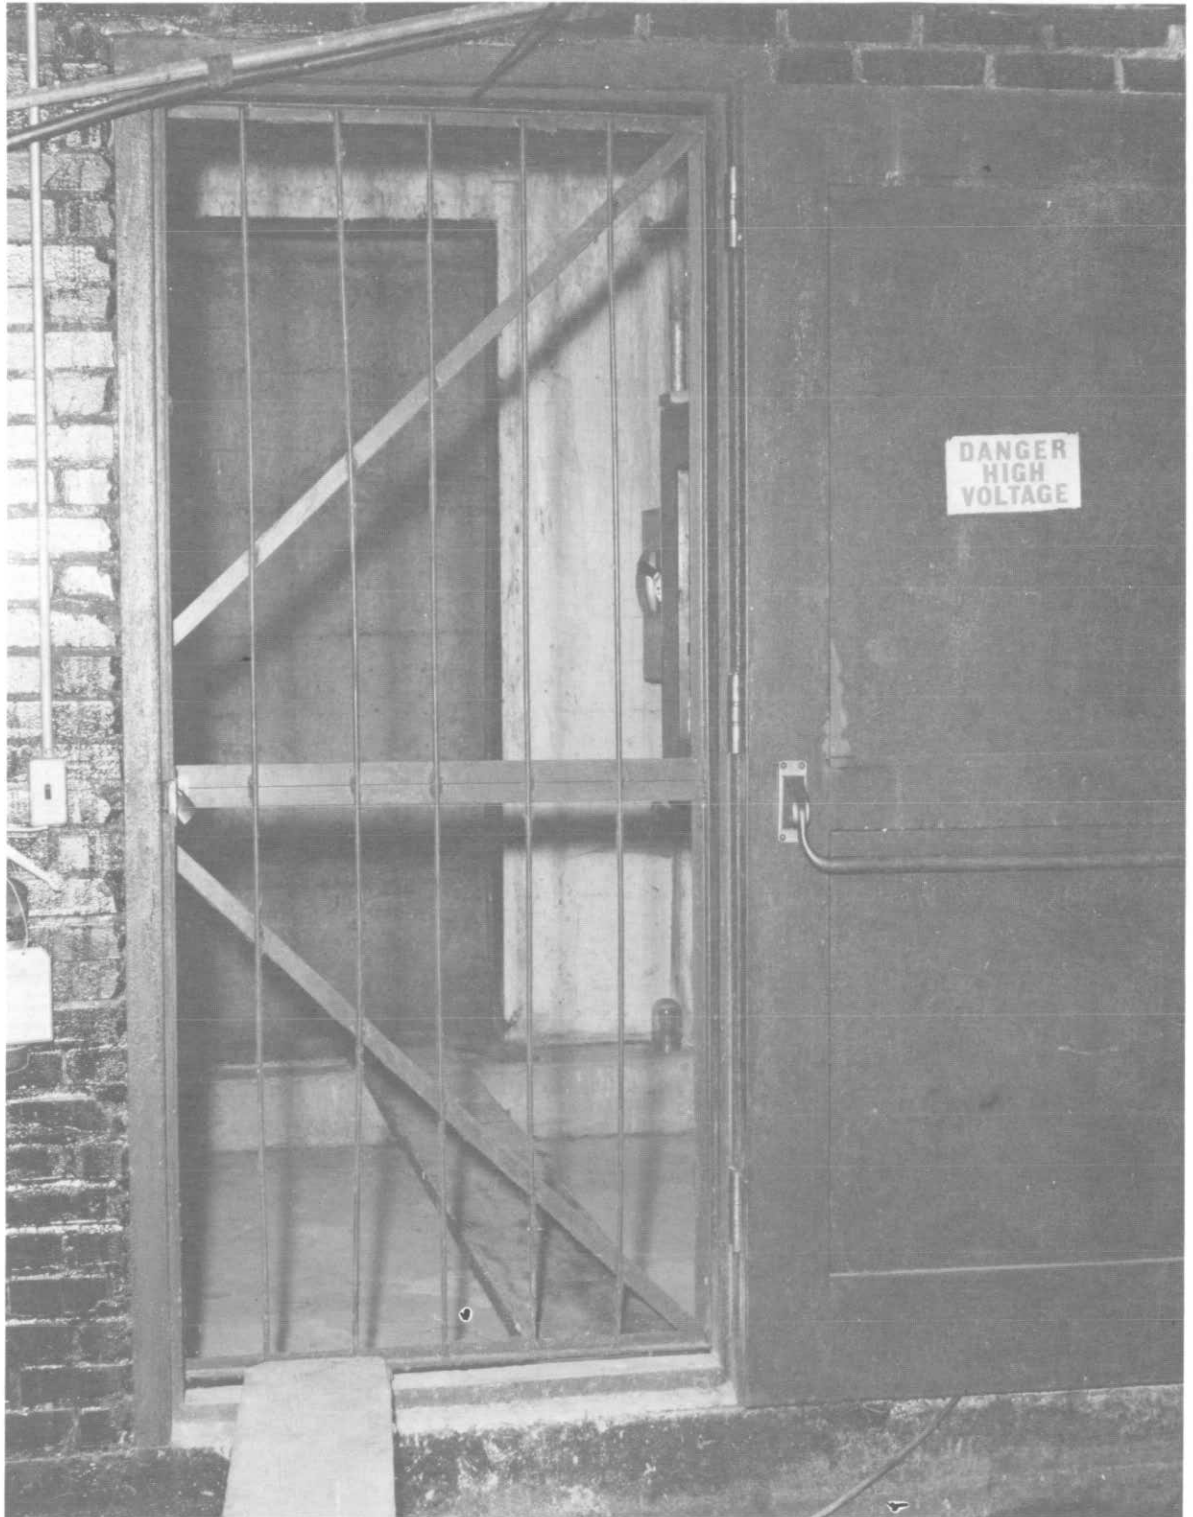
2. BASEMENT TRANSFORMER & SWITCHROOM This room serves as a ventilating corridor for the extremely damp basement. This door should be closed, and the basement should be separately ventilated to prevent rusting and possible arc over on the bus, panelboards, and switchgear.

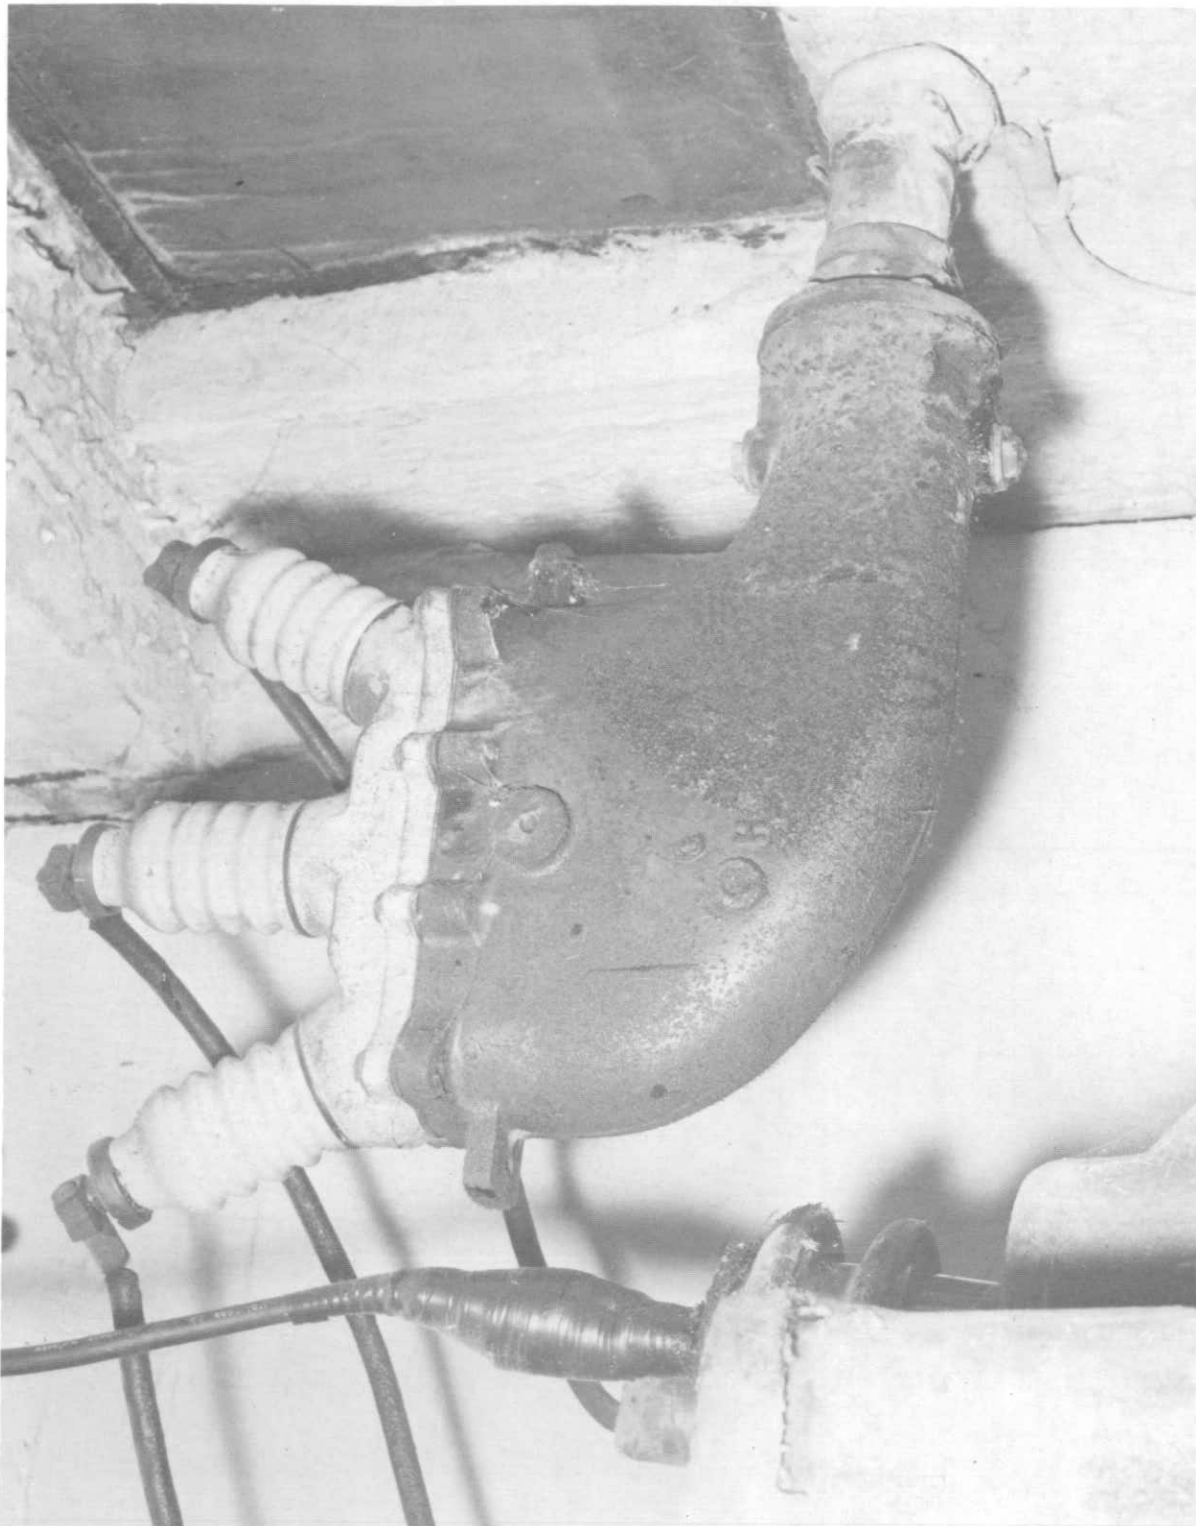
3. SERVICE ENTRANCE POTHEAD This service entrance pothead should be cleaned, and the connections should be taped to prevent birds or rodents from causing an arc over.

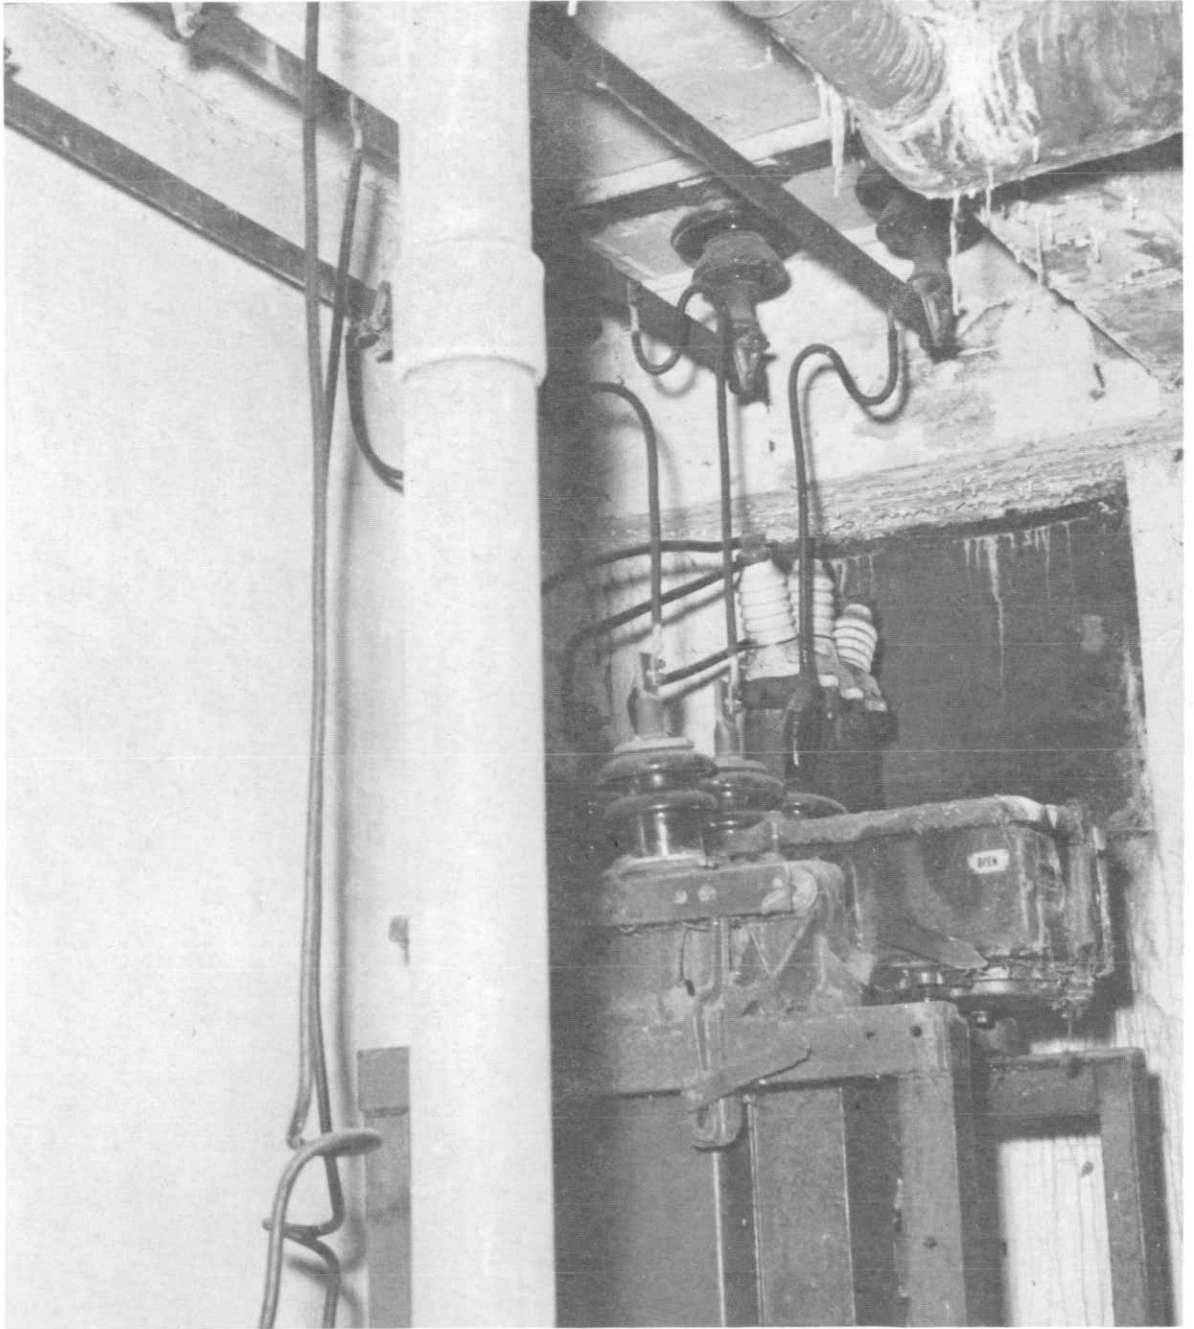
4a. MAIN SERVICE OIL CIRCUIT BREAKER This oil circuit breaker is in extremely dirty condition externally. The operating mechanism did not work due to rusting; we loosened the mechanism to permit proper tripping. This unit requires a complete mechanical and electrical cleaning and overhaul. The ceiling mounted bus and bus insulators should be cleaned and all connections tightened.

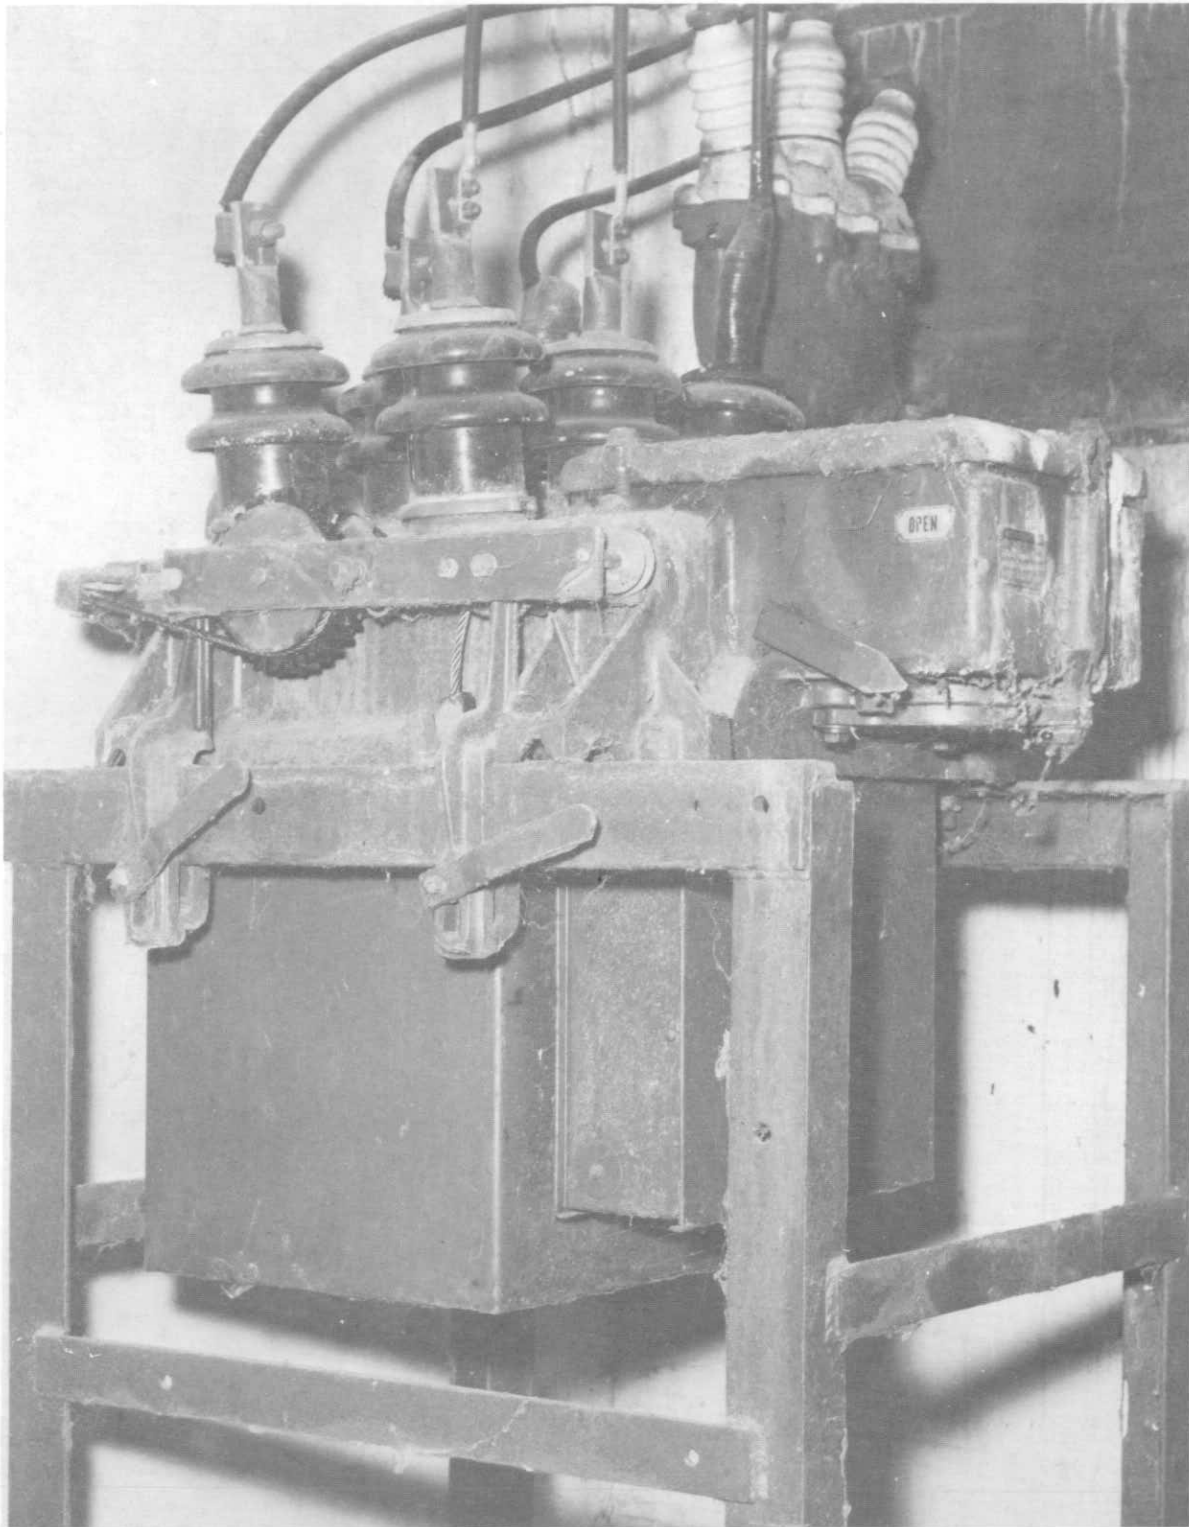
4b. MAIN OIL CIRCUIT BREAKER The line and load terminals of this oil circuit breaker should be taped to prevent bird or rodent arc over.
