historic structure report

administrative and architectural data

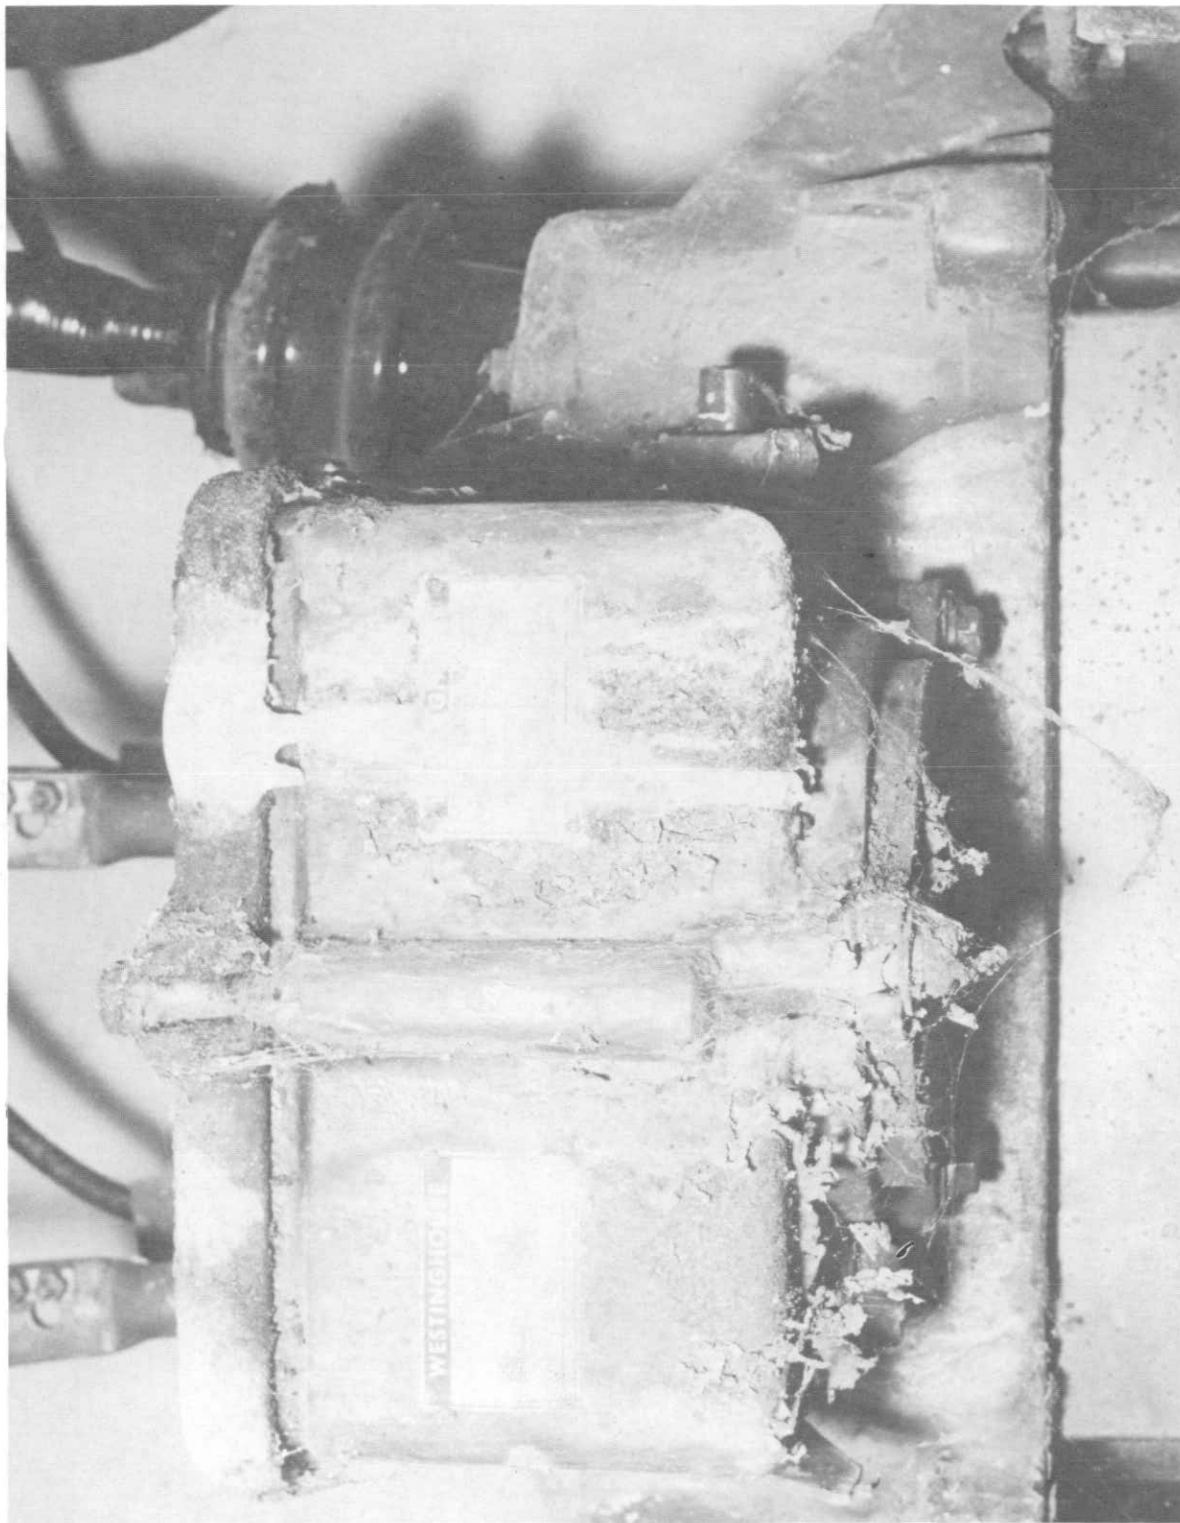
4c. MAIN OIL CIRCUIT BREAKER The entire housing and support framework of this oil circuit breaker should be cleaned and painted with a rust resistant paint.

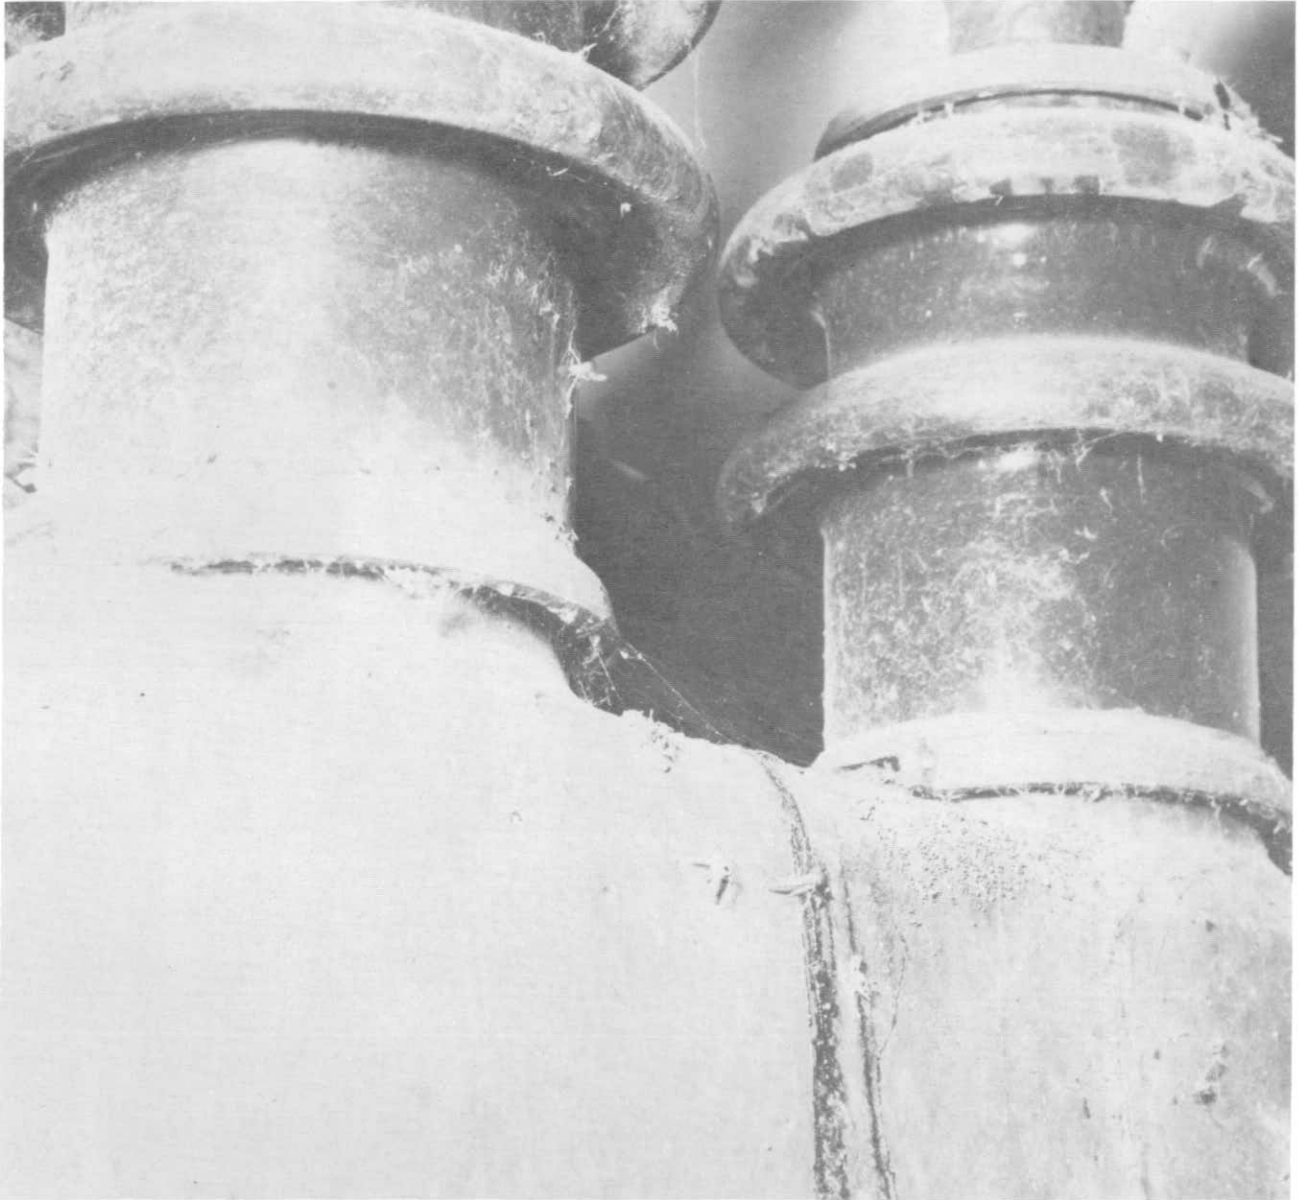
4d. MAIN OIL CIRCUIT BREAKER The extremely dirty bushings should be cleaned, and the connections tightened and insulated.

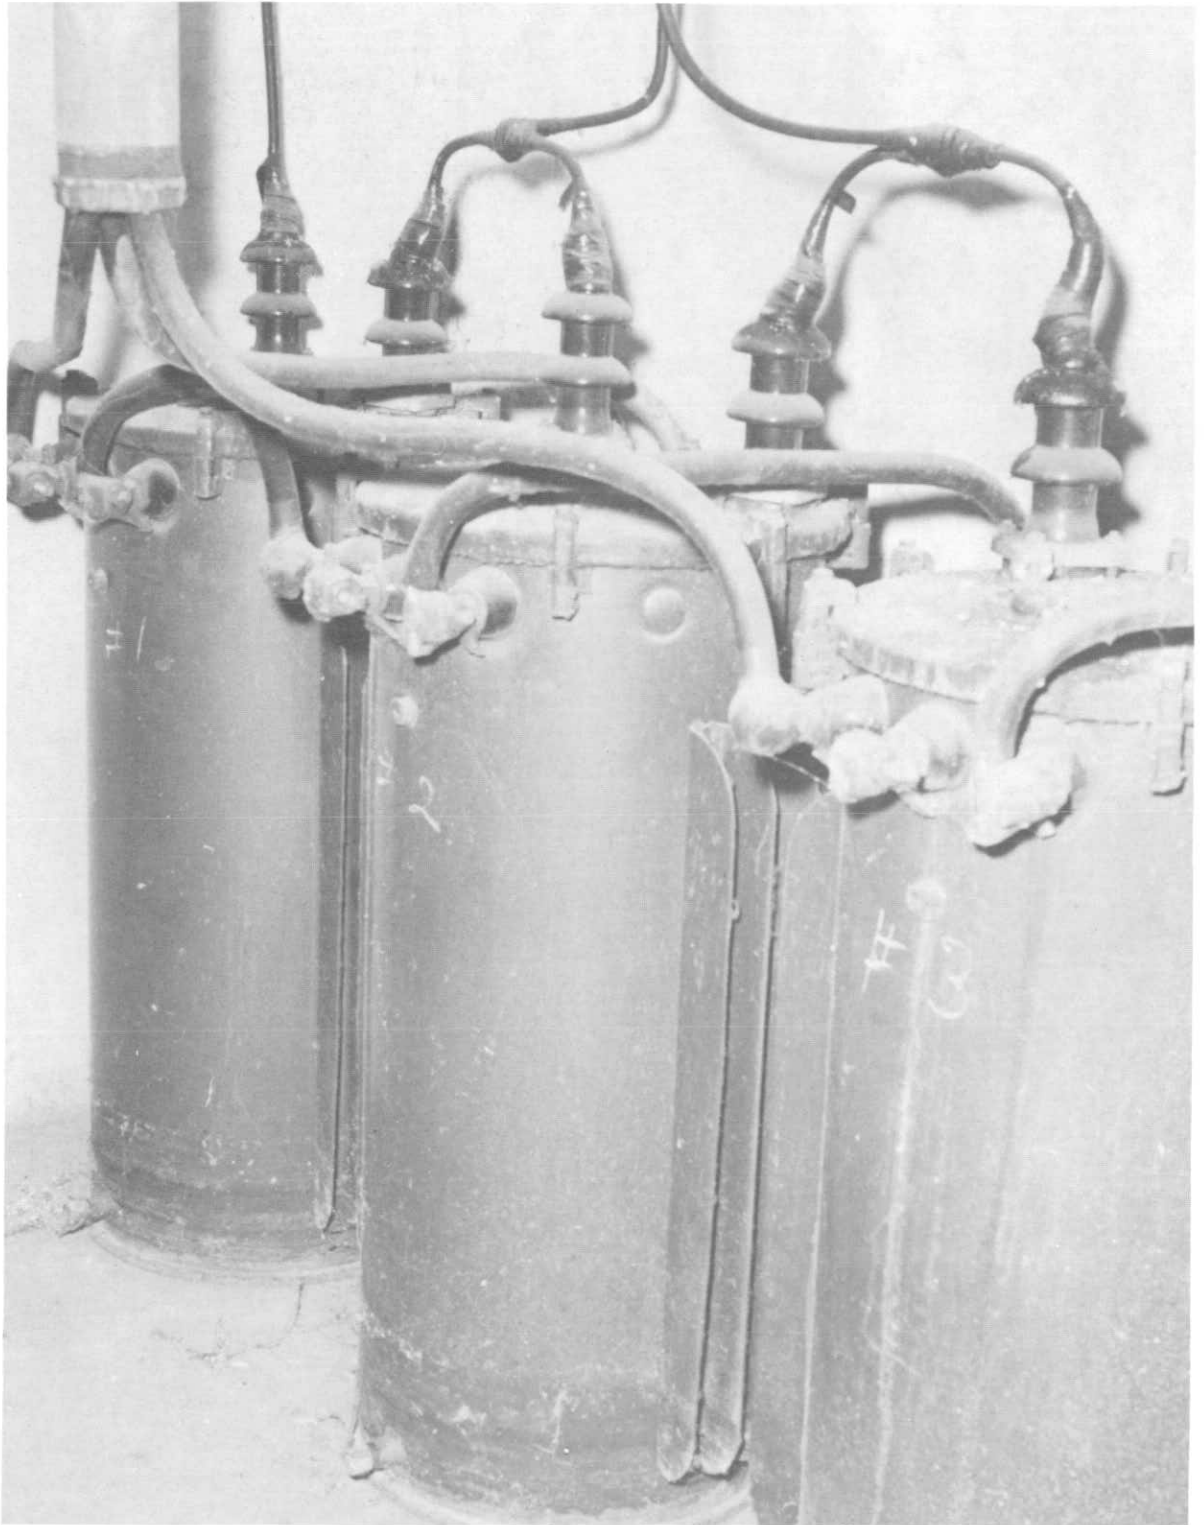
5a. 3-PHASE TRANSFORMER BANK These transformers should be cleaned, rust removed, and painted with a rust resistant transformer paint. The right side transformer tested fair. We recommend a re-test in one year.

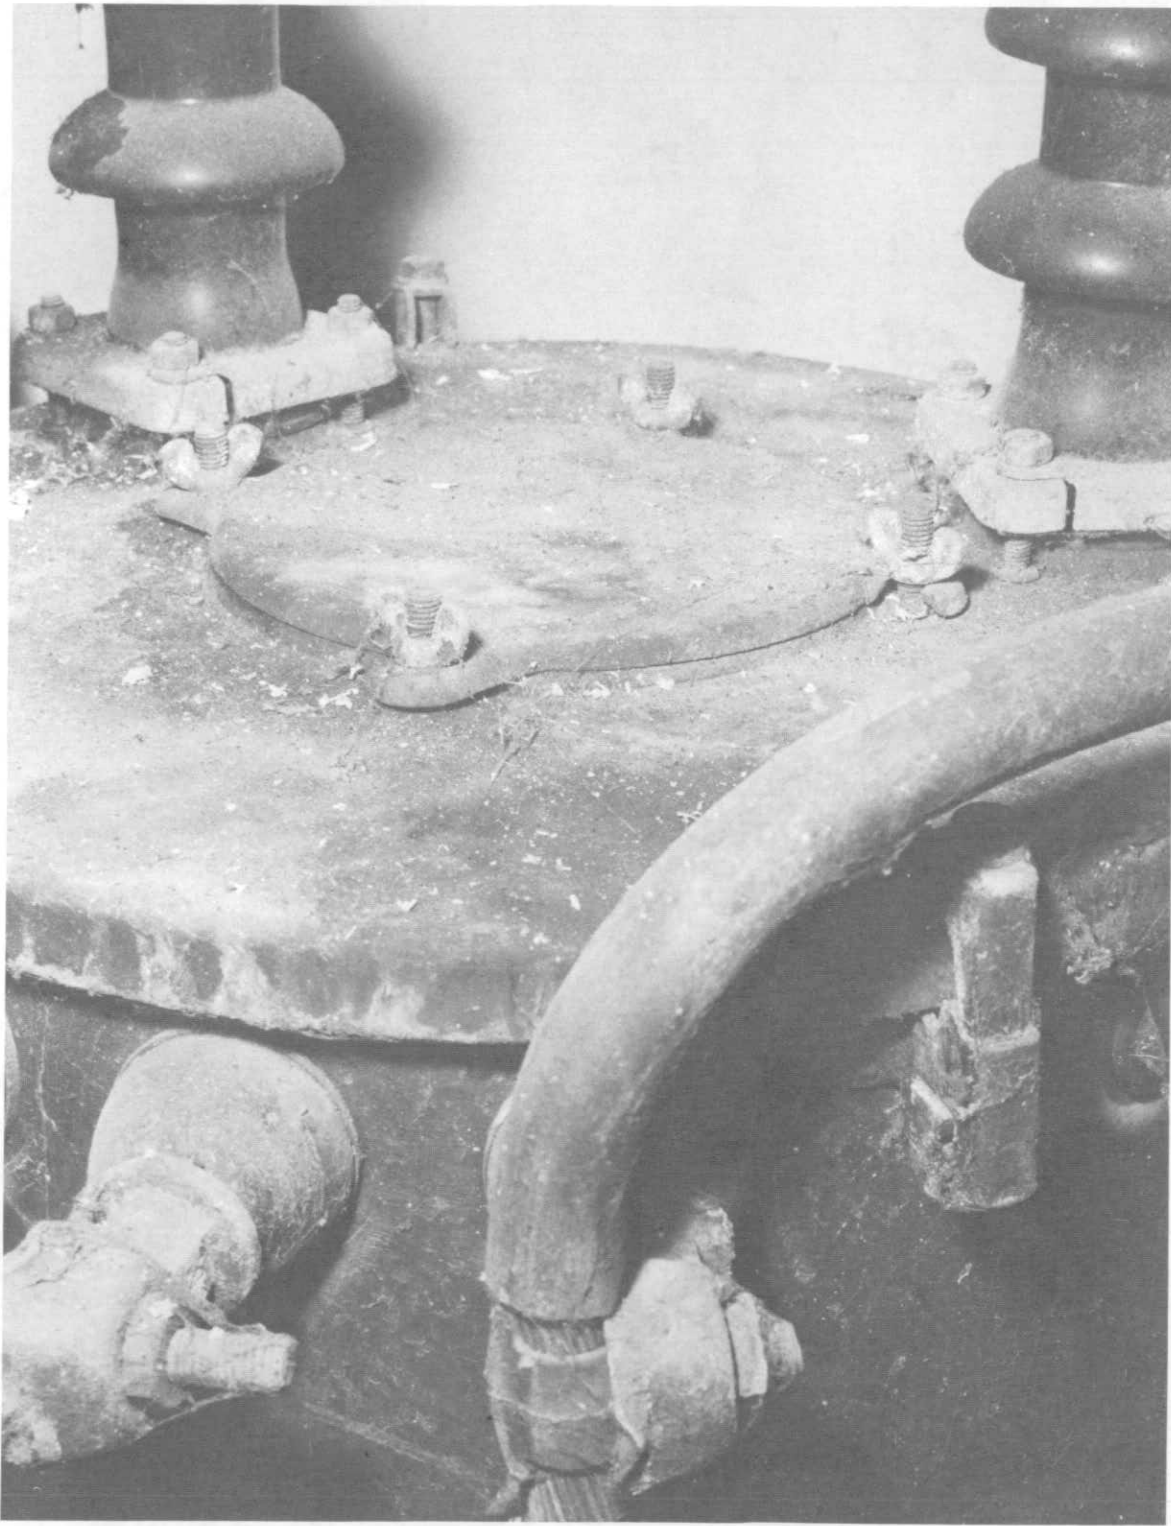
5b. TRANSFORMER The high voltage transformer bushings should be cleaned, and the connections should be reinsulated. (NOTE WET BUSHINGS FROM INSULATING MATERIAL LEAKAGE.) The low voltage bushings should be cleaned and tightened.

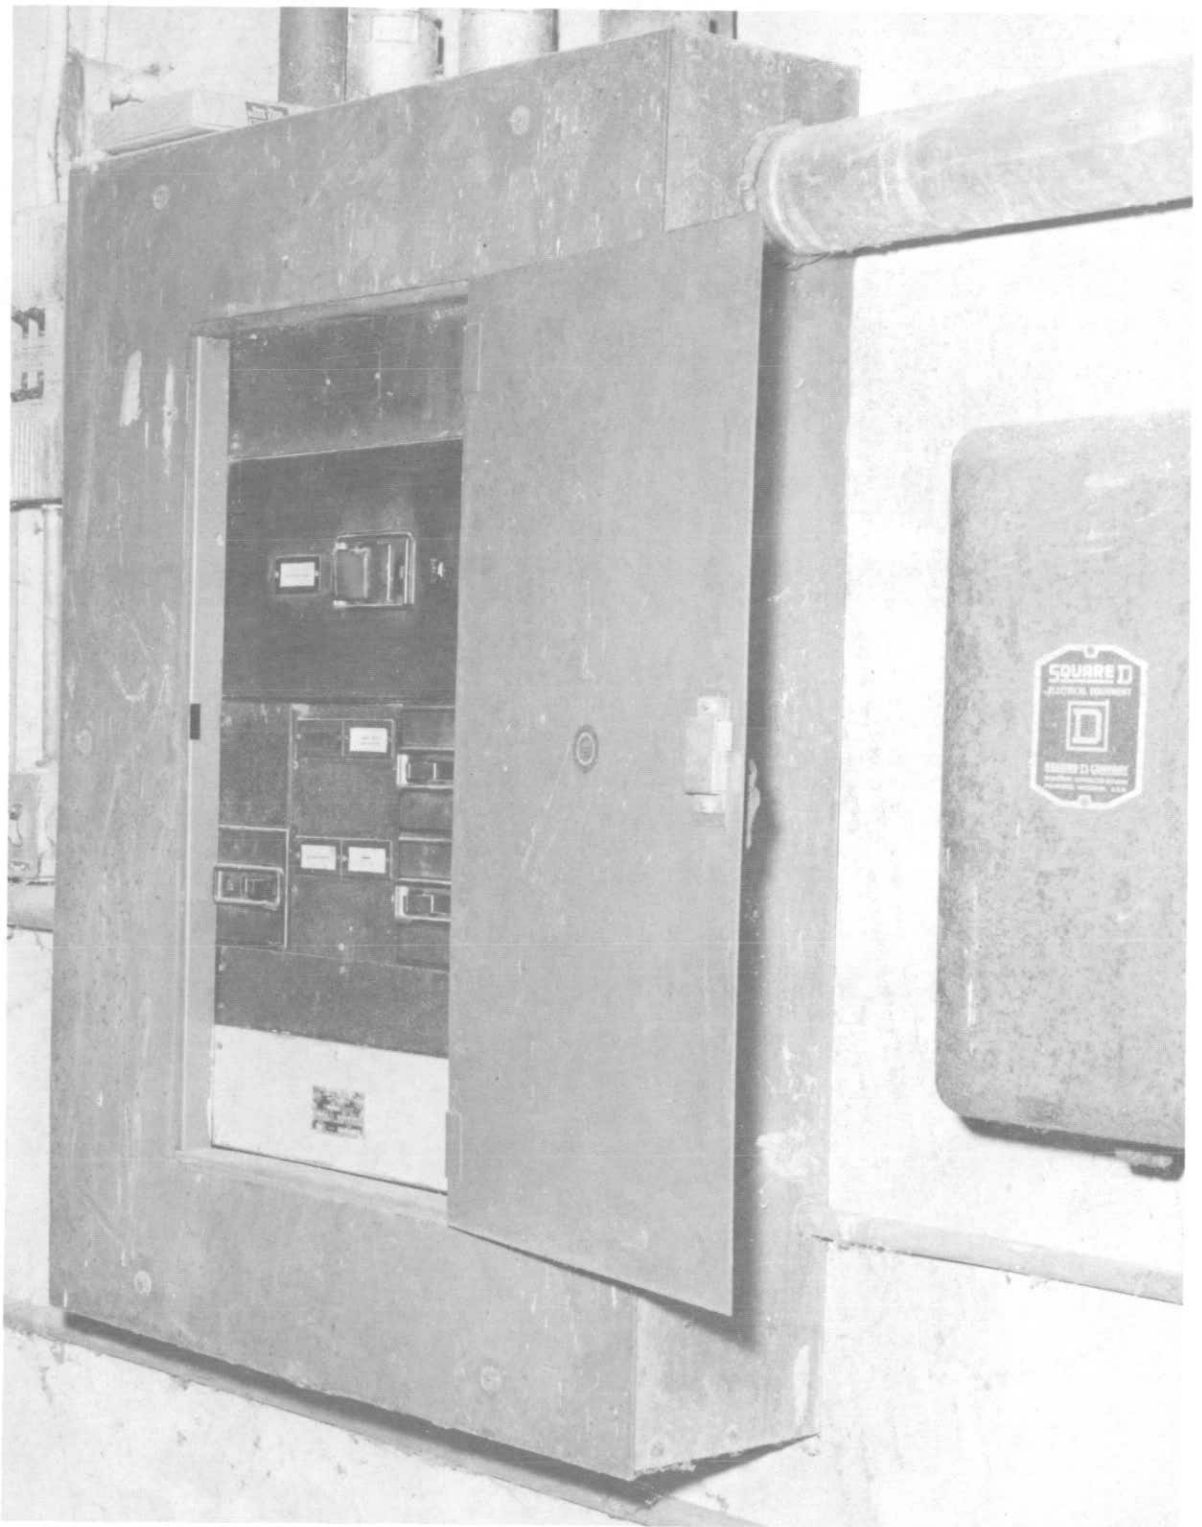
6. MAIN 208-VOLT 3-PHASE PANELBOARD This panel board should be vacuum cleaned internally, all cable connections should be tightened, and the cabinet should be dismantled and cleaned of rust inside and outside and painted with a rust resistant panelboard paint. All bus connections should be dismantled, cleaned, lubricated with conducting grease, and torqued for proper connection tightness. The Boiler Room 100-AMP, 3-pole, circuit breaker is bad and should be replaced.

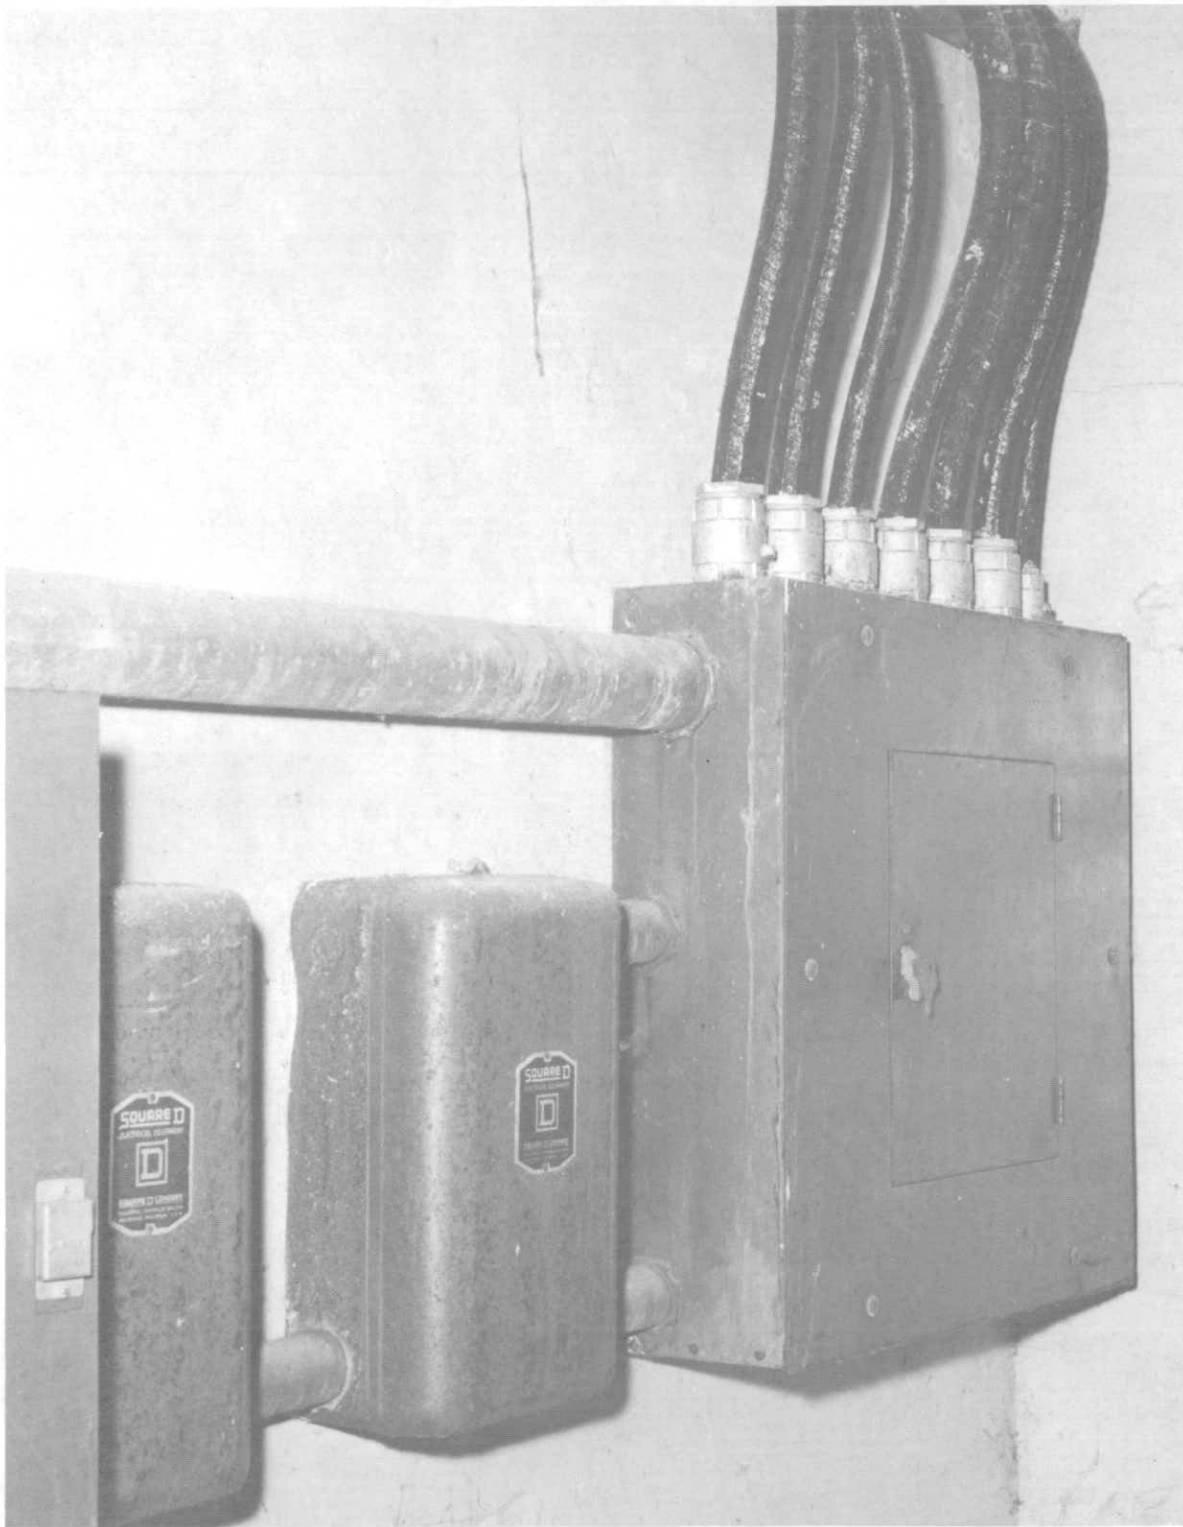
7. MAIN 120-VOLT PANELBOARD This panelboard should be vacuum cleaned internally, all cable connections should be tightened, and the cabinet should be dismantled and cleaned of rust inside and outside and painted with a rust resistant panelboard paint. All bus connections should be dismantled, cleaned, lubricated with conducting grease, and torqued for proper connection tightness.

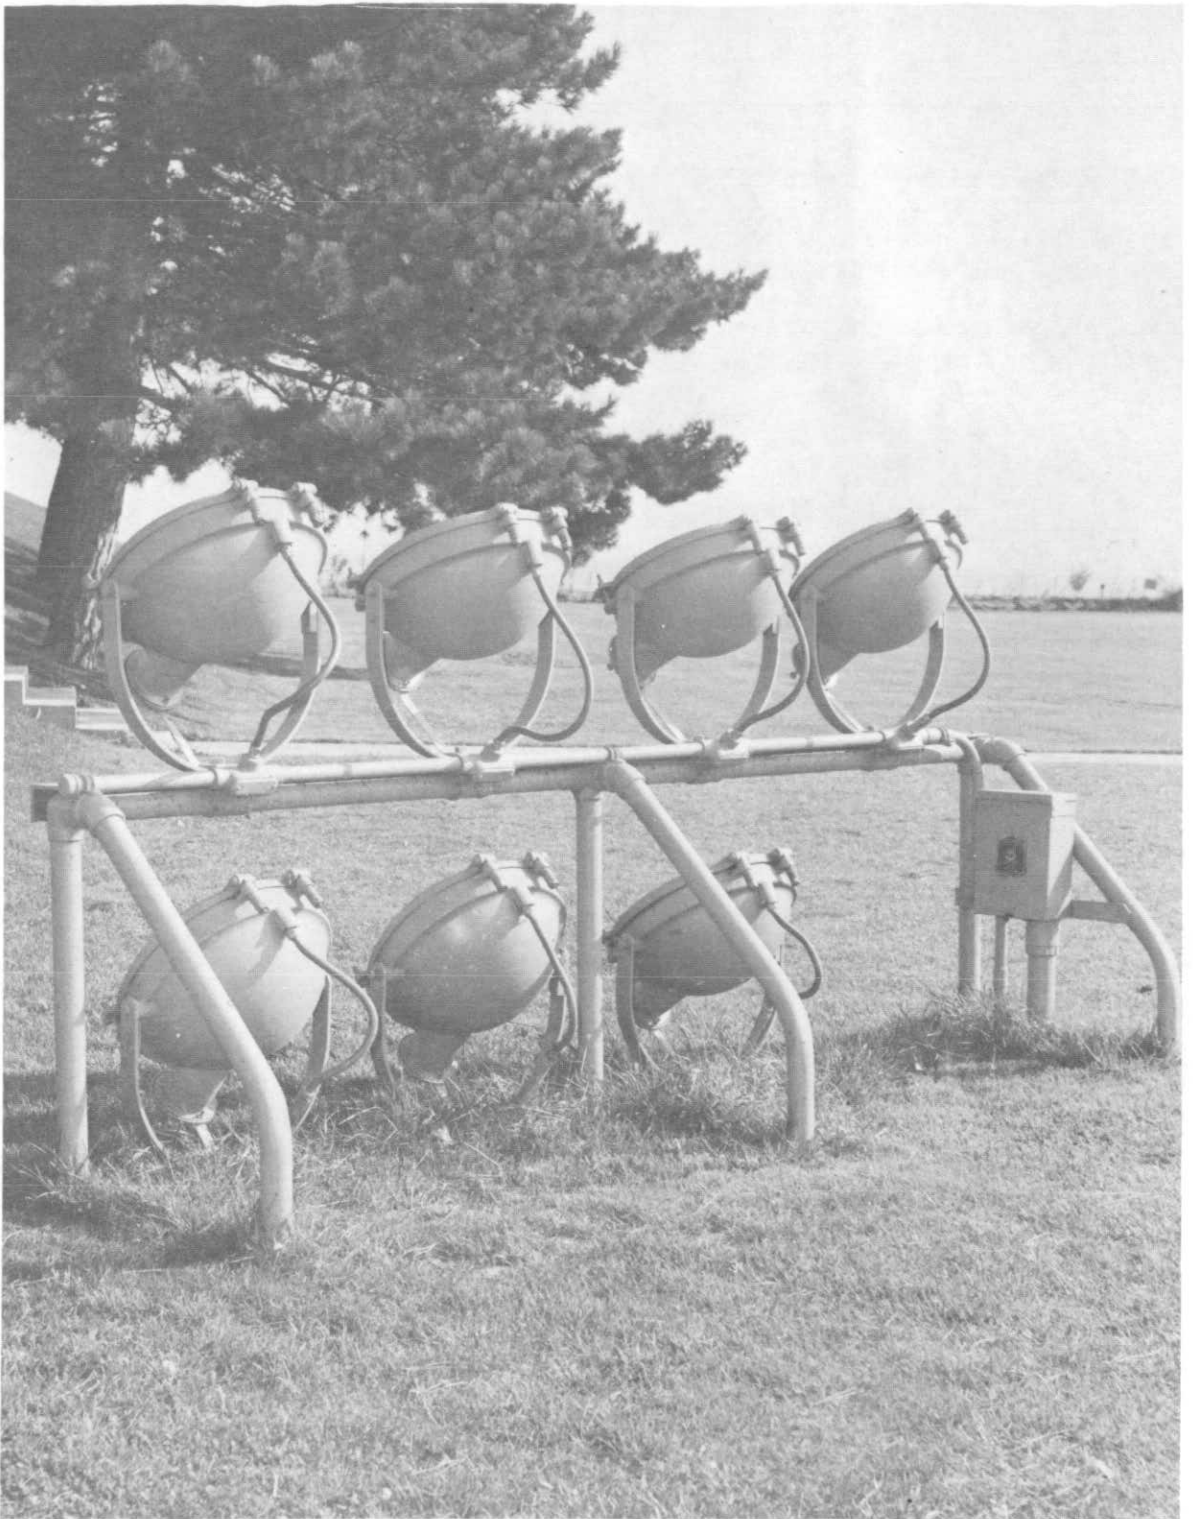
8a. OUTDOOR FLOODLIGHTING The outdoor floodlighting distribution panel-board should be replaced with a heavy-duty outdoor enclosure type panel-board. The existing panelboards are severely rusted. (SEE PHOTOGRAPH 8b.) The northeast floodlight feeder tested bad. All other floodlight feeders tested marginal or fair.

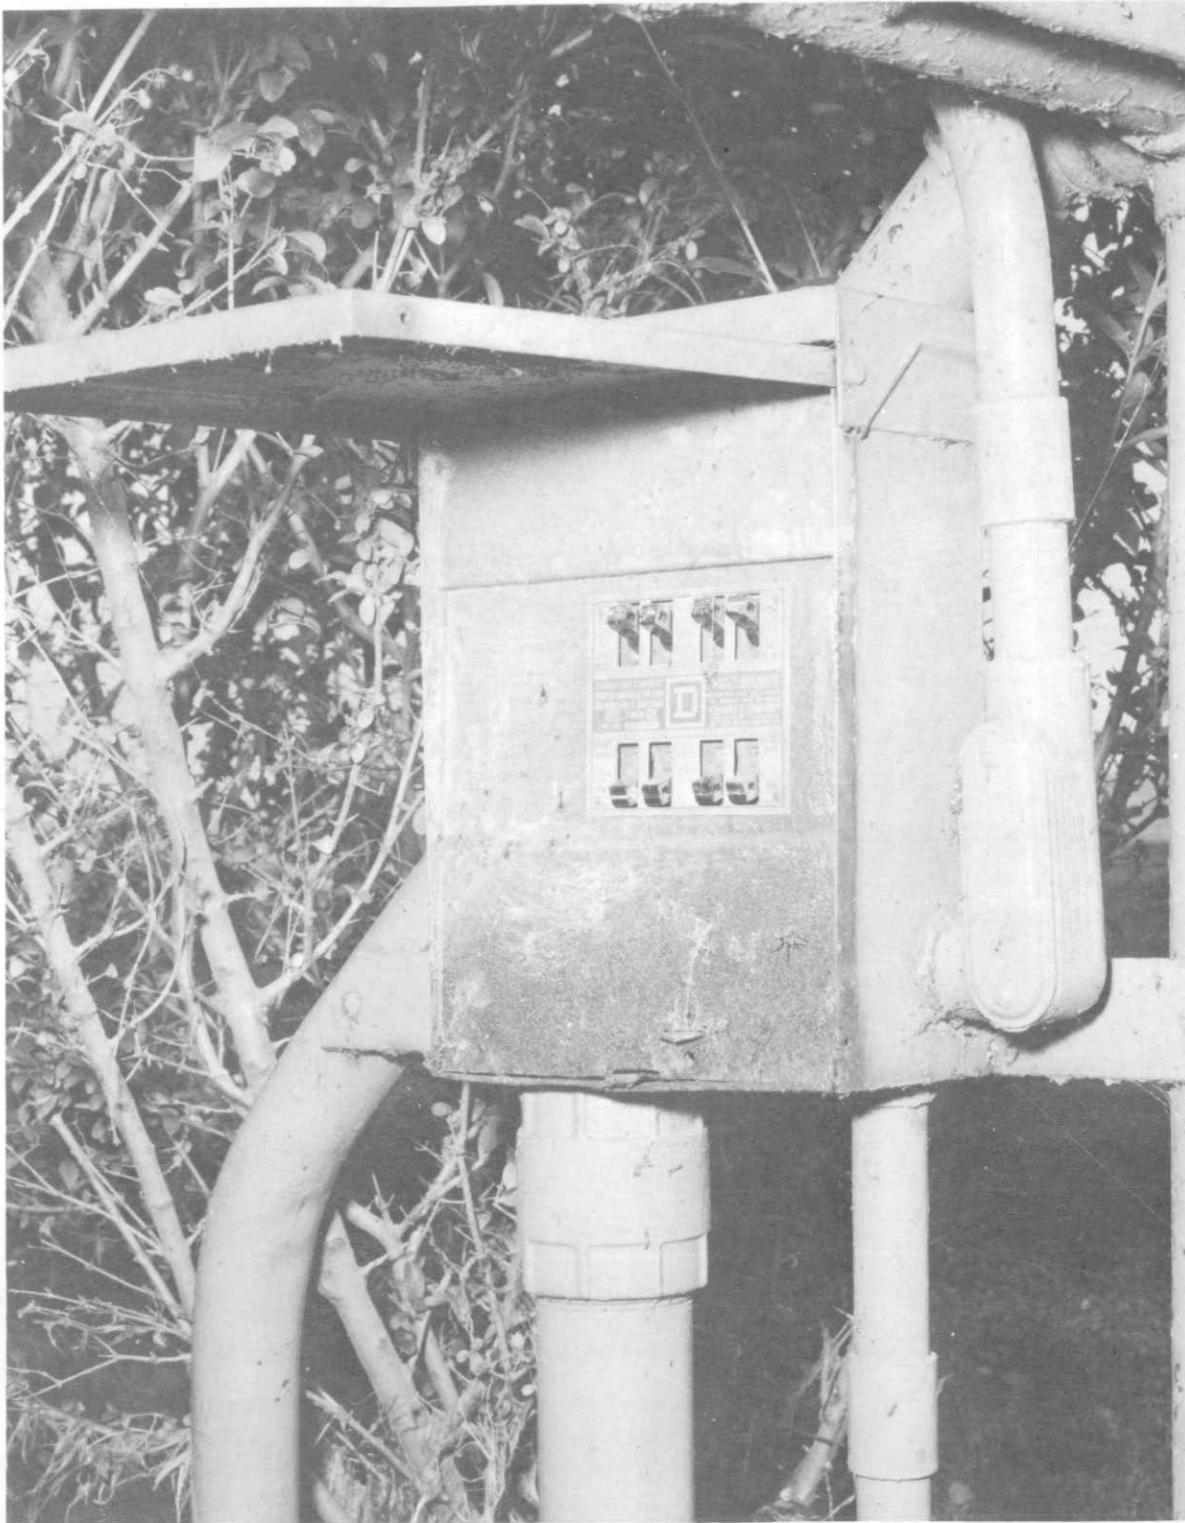
8b. OUTDOOR FLOODLIGHTING PANELBOARD The extremely rusted condition of this panelboard warrants its replacement as noted in comments on photograph 8a.

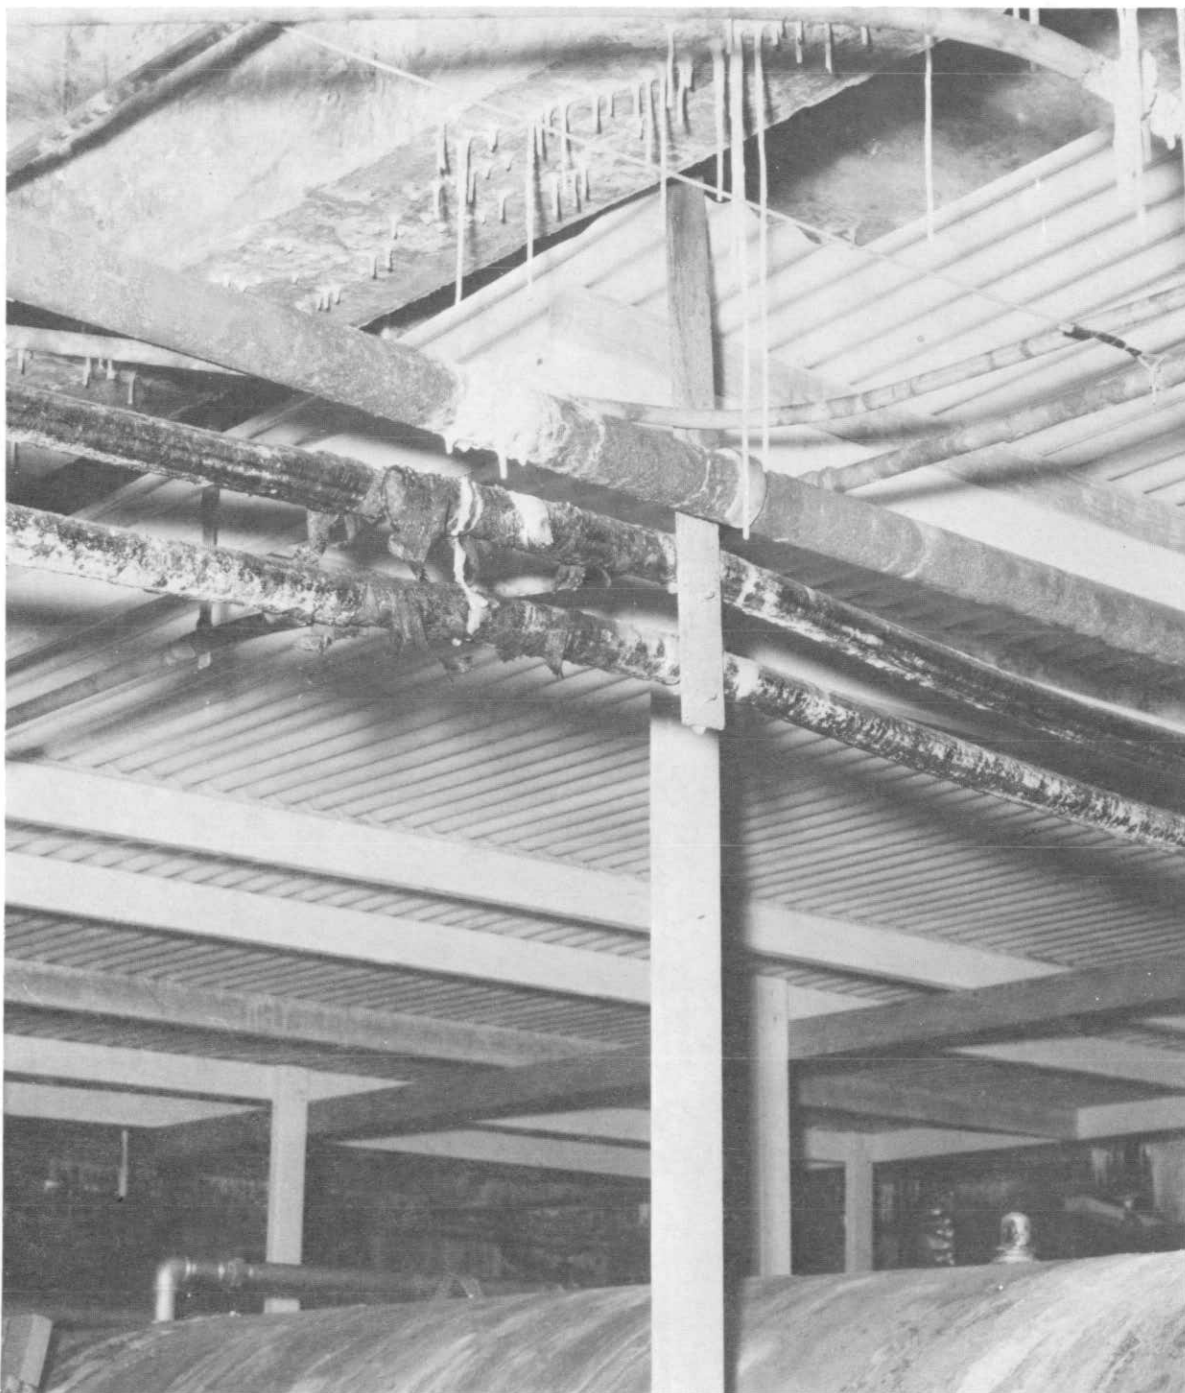
9a. BASEMENT CABLE The cables for floodlighting, elevator, and interior lighting are inadequately supported and exposed to damage and high stress concentrations at the support point. A cable tray and conduit system should be installed to continuously support these circuits. As an alternative, a stress spreading support plate should be installed at all attachment points. The outer jacket should be repaired with vinyl type tapes where the severe jacket damage and rotting are noted.

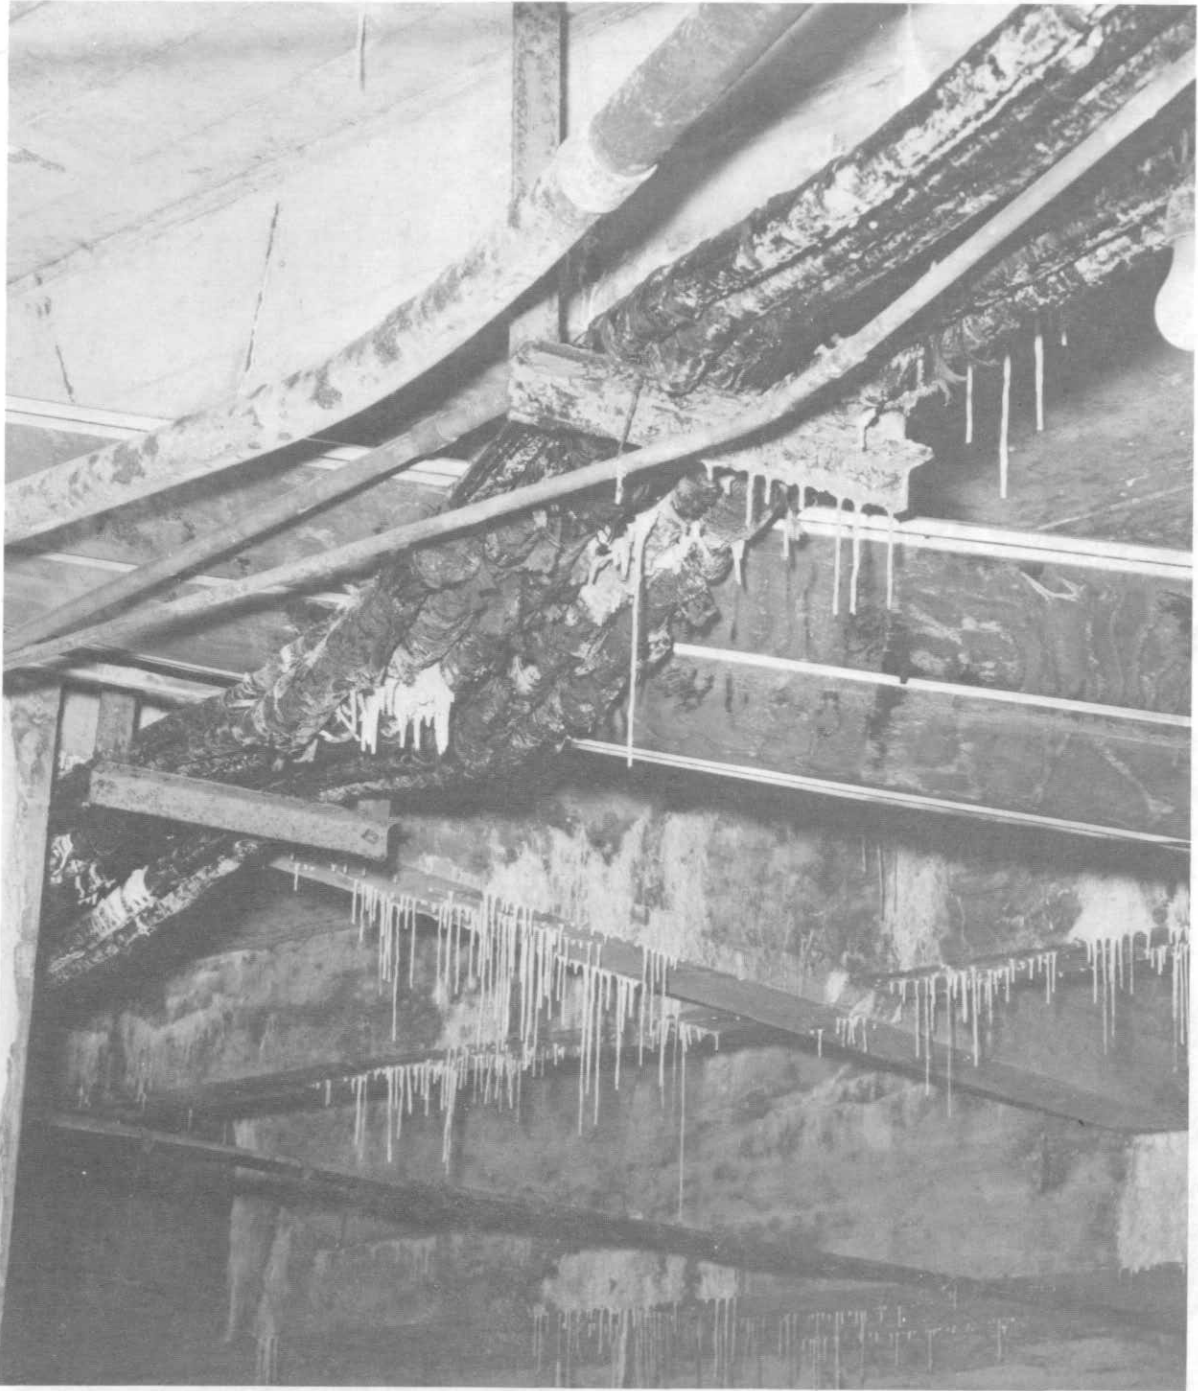
9b. BASEMENT CABLE See 9a.

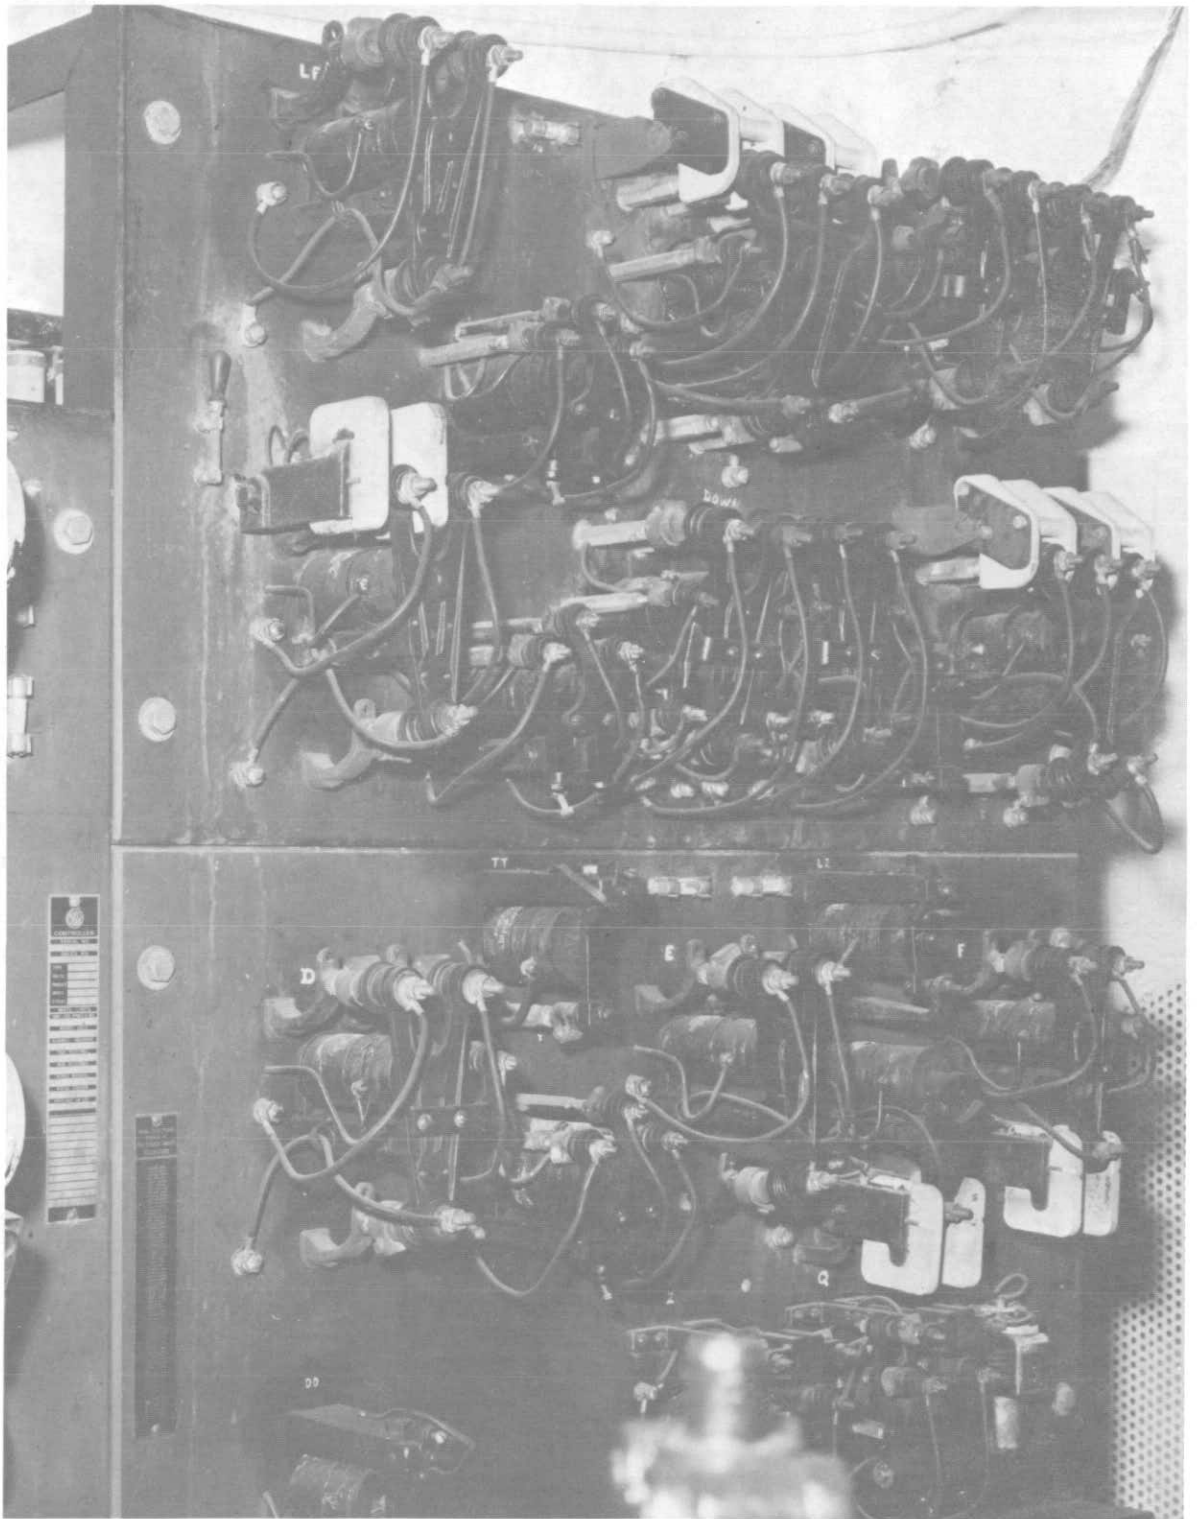
10a. ELEVATOR CONTROL PANELBOARD The elevator control panelboard should be cleaned, all contacts burnished, and all connections tightened. All solenoid and contactor coils should be painted with an insulating paint, and all inter-connecting control wiring with brittle or damaged insulation should be replaced. All backboard connections should be cleaned and tightened. A complete inventory of replacement parts should be developed, and a spare parts locker should be installed at the panelboard location.

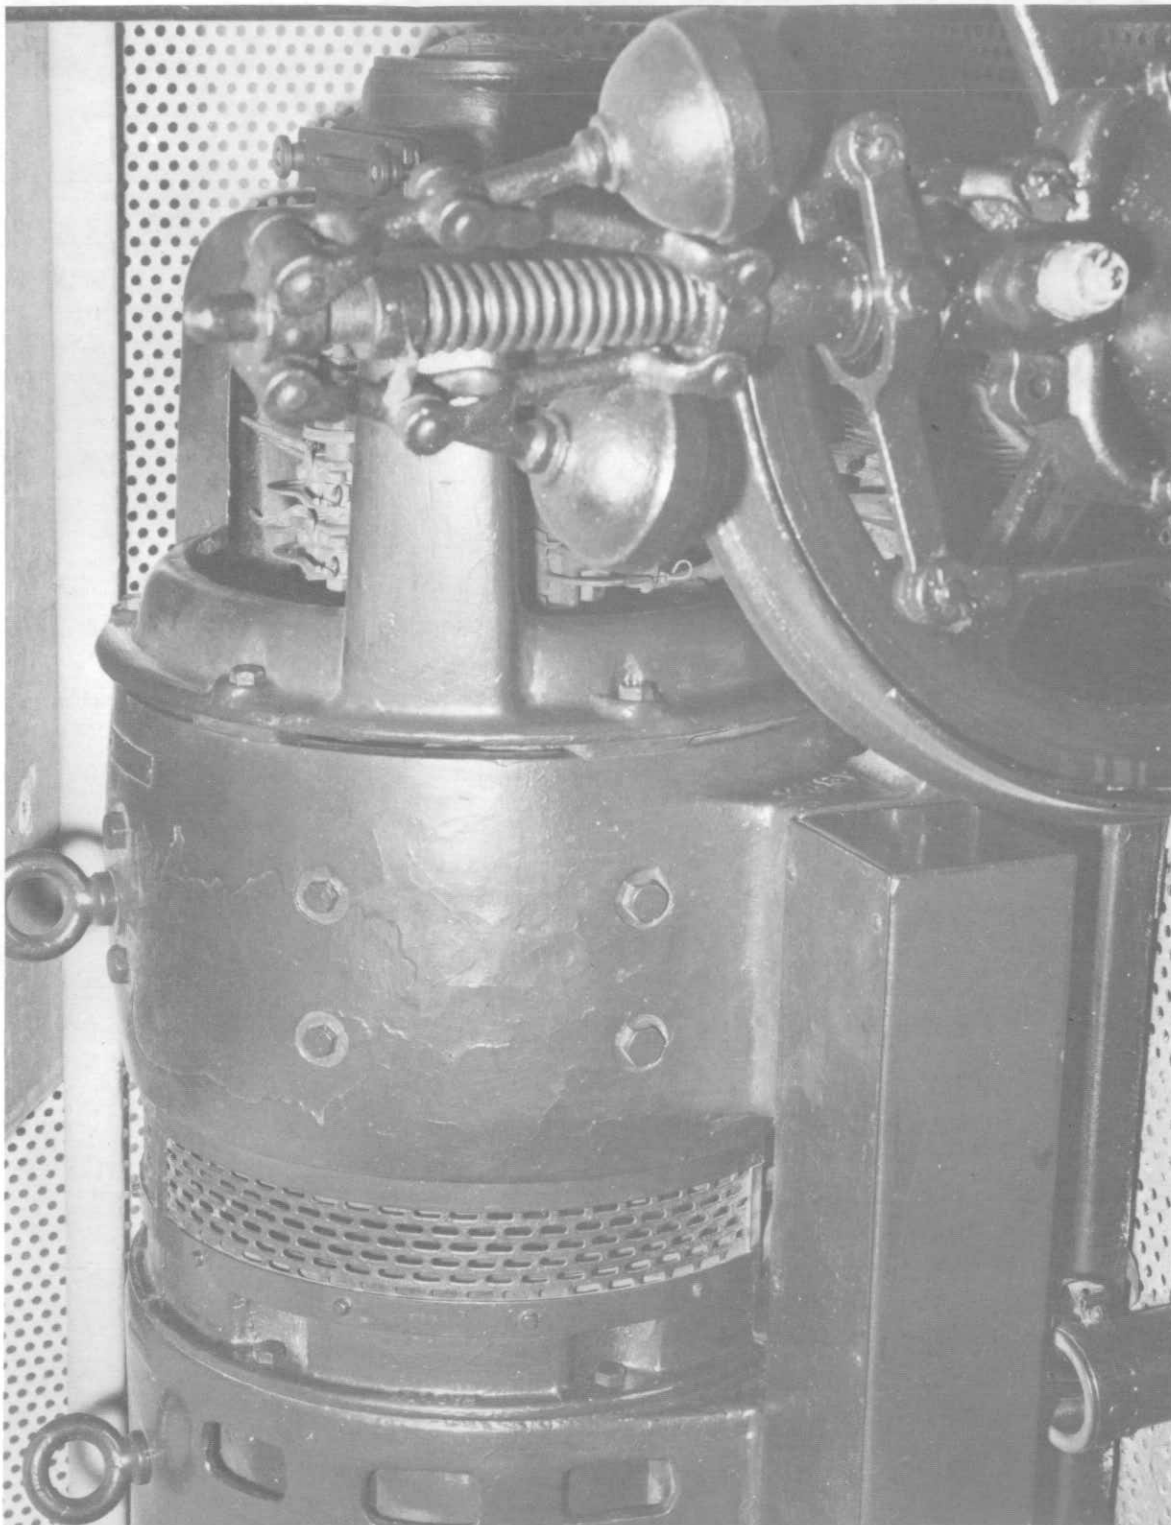
10b. ELEVATOR MOTOR GENERATOR SET This motor generator set should have the commutator section vacuumed, the brush holder boxes and connections cleaned, and the brush shunt connections checked.
