historic structure report

administrative and architectural data

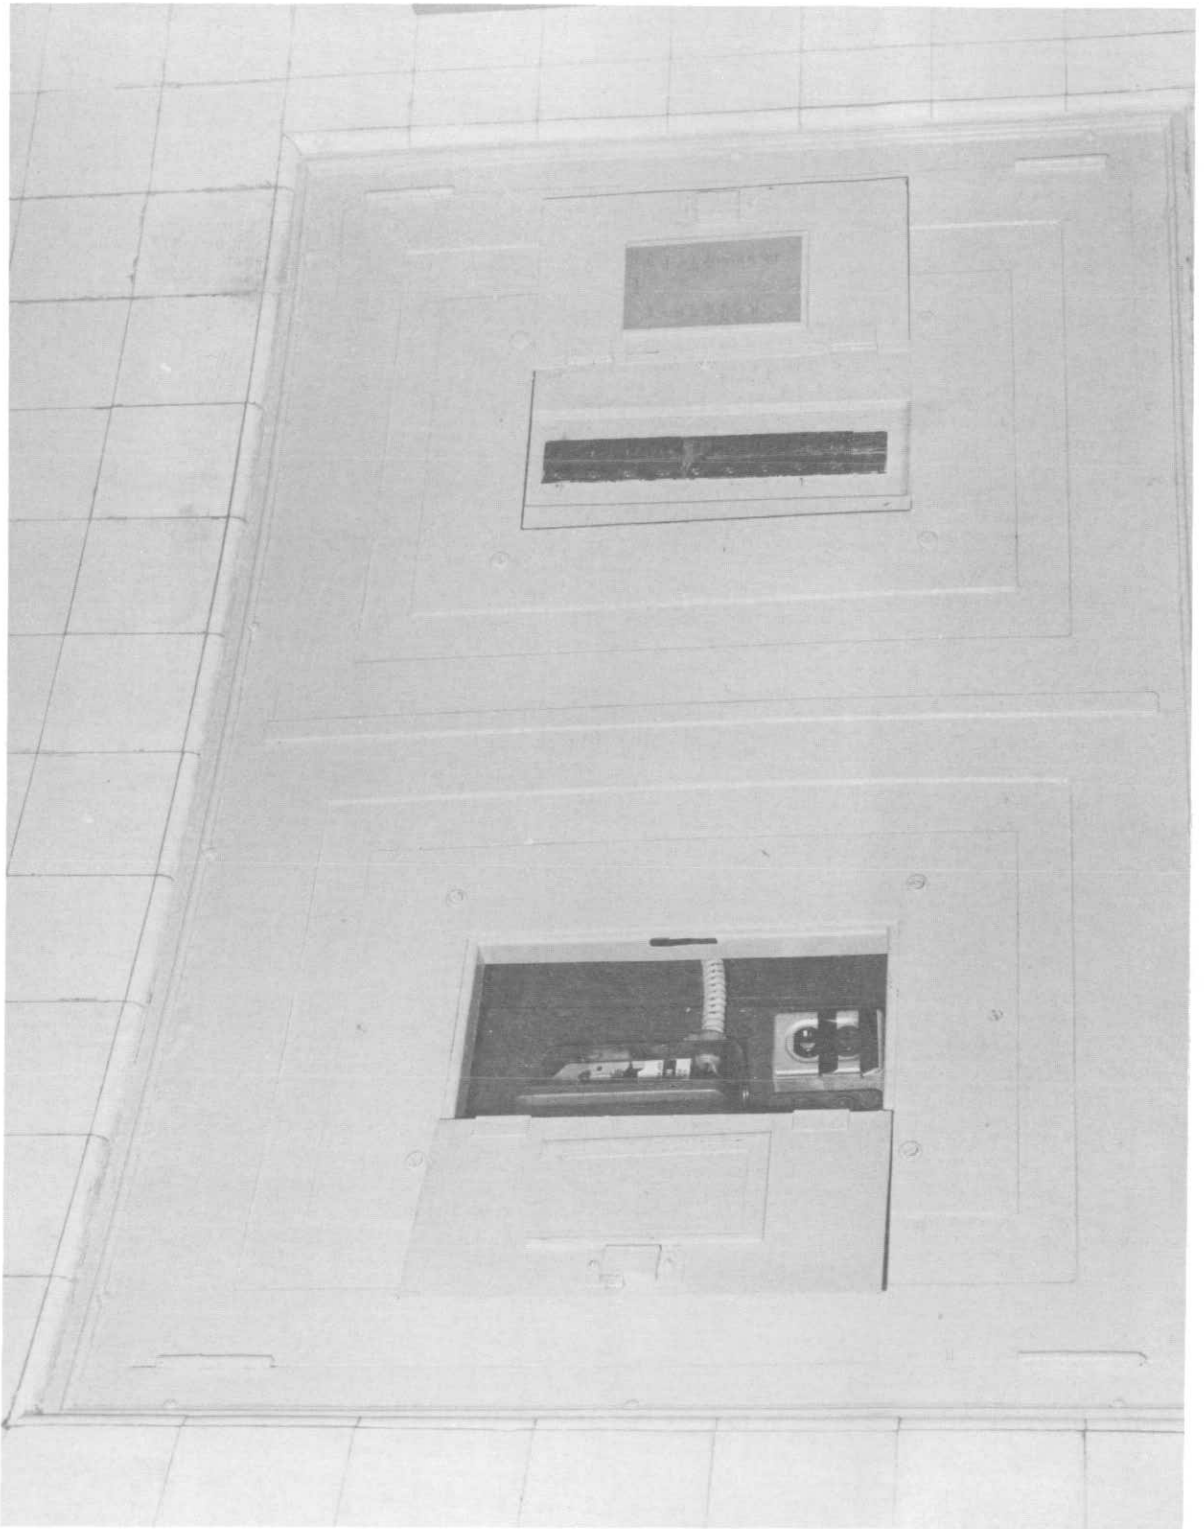
11. LIGHTING PANELBOARD This lighting panelboard is adequate for its present use. Possible future parts replacement problems may suggest the installation of a new panelboard during any present electrical modernization program.

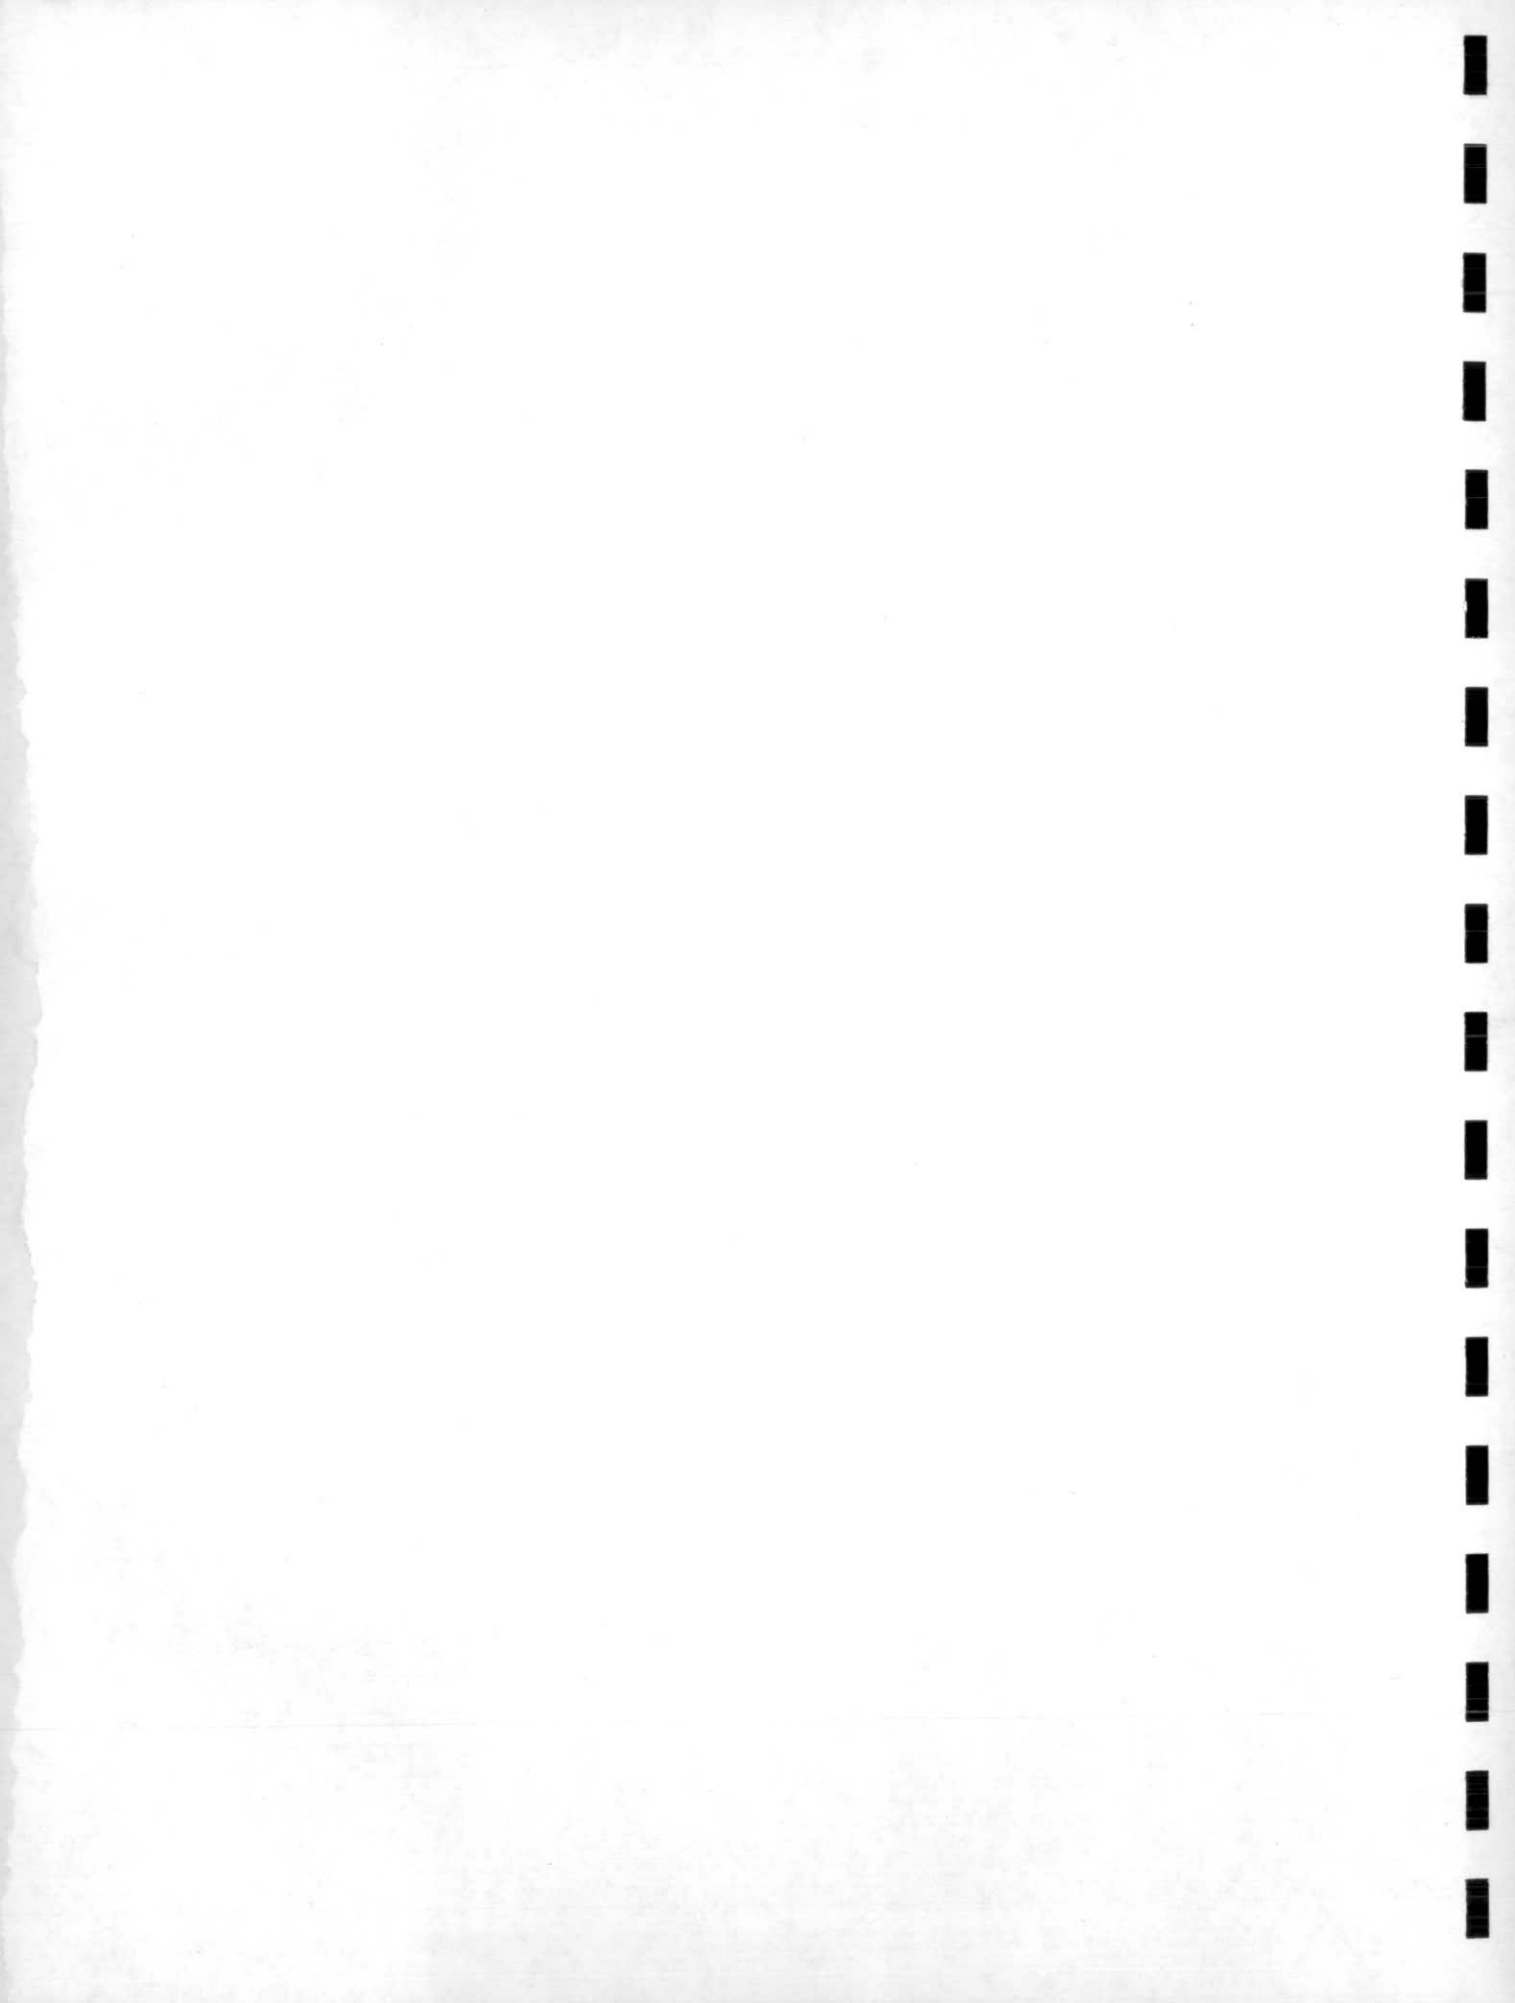
APPENDIX J: WESTERN RESERVE LIGHTNING
ROD COMPANY REPORT

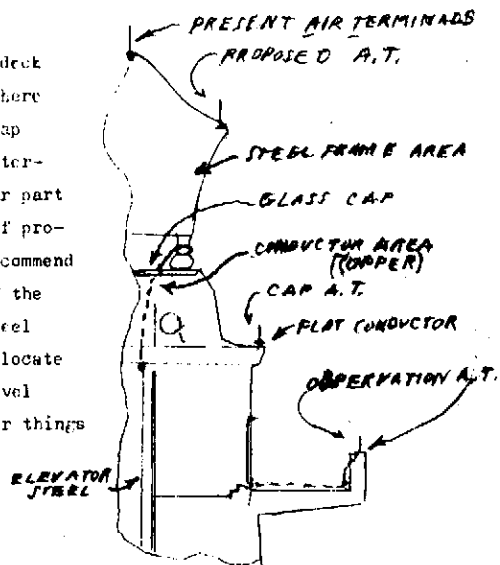
1. There are air terminals at the observation deck level that are broken and need renewing. There are air terminals right above this at the cap level which are in place. There are 4 air terminals located at the very top, at the upper part of the skylight. Due to lack of any cone of protection coverage at this height, I would recommend air terminals around the base projection of the skylight. These could be mounted to the steel framework in this area. You may want to relocate the air terminal on the observation deck level at a different spot to take safety and other things into consideration.

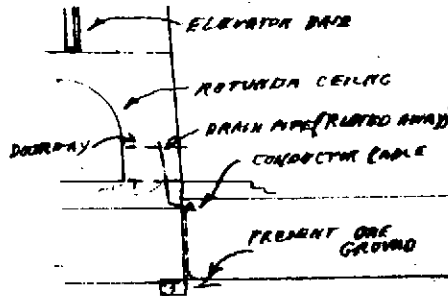
4. Common grounding or interconnection to metal parts. This has been partially adhered to, due to the use of metal parts as substitutes for the system.

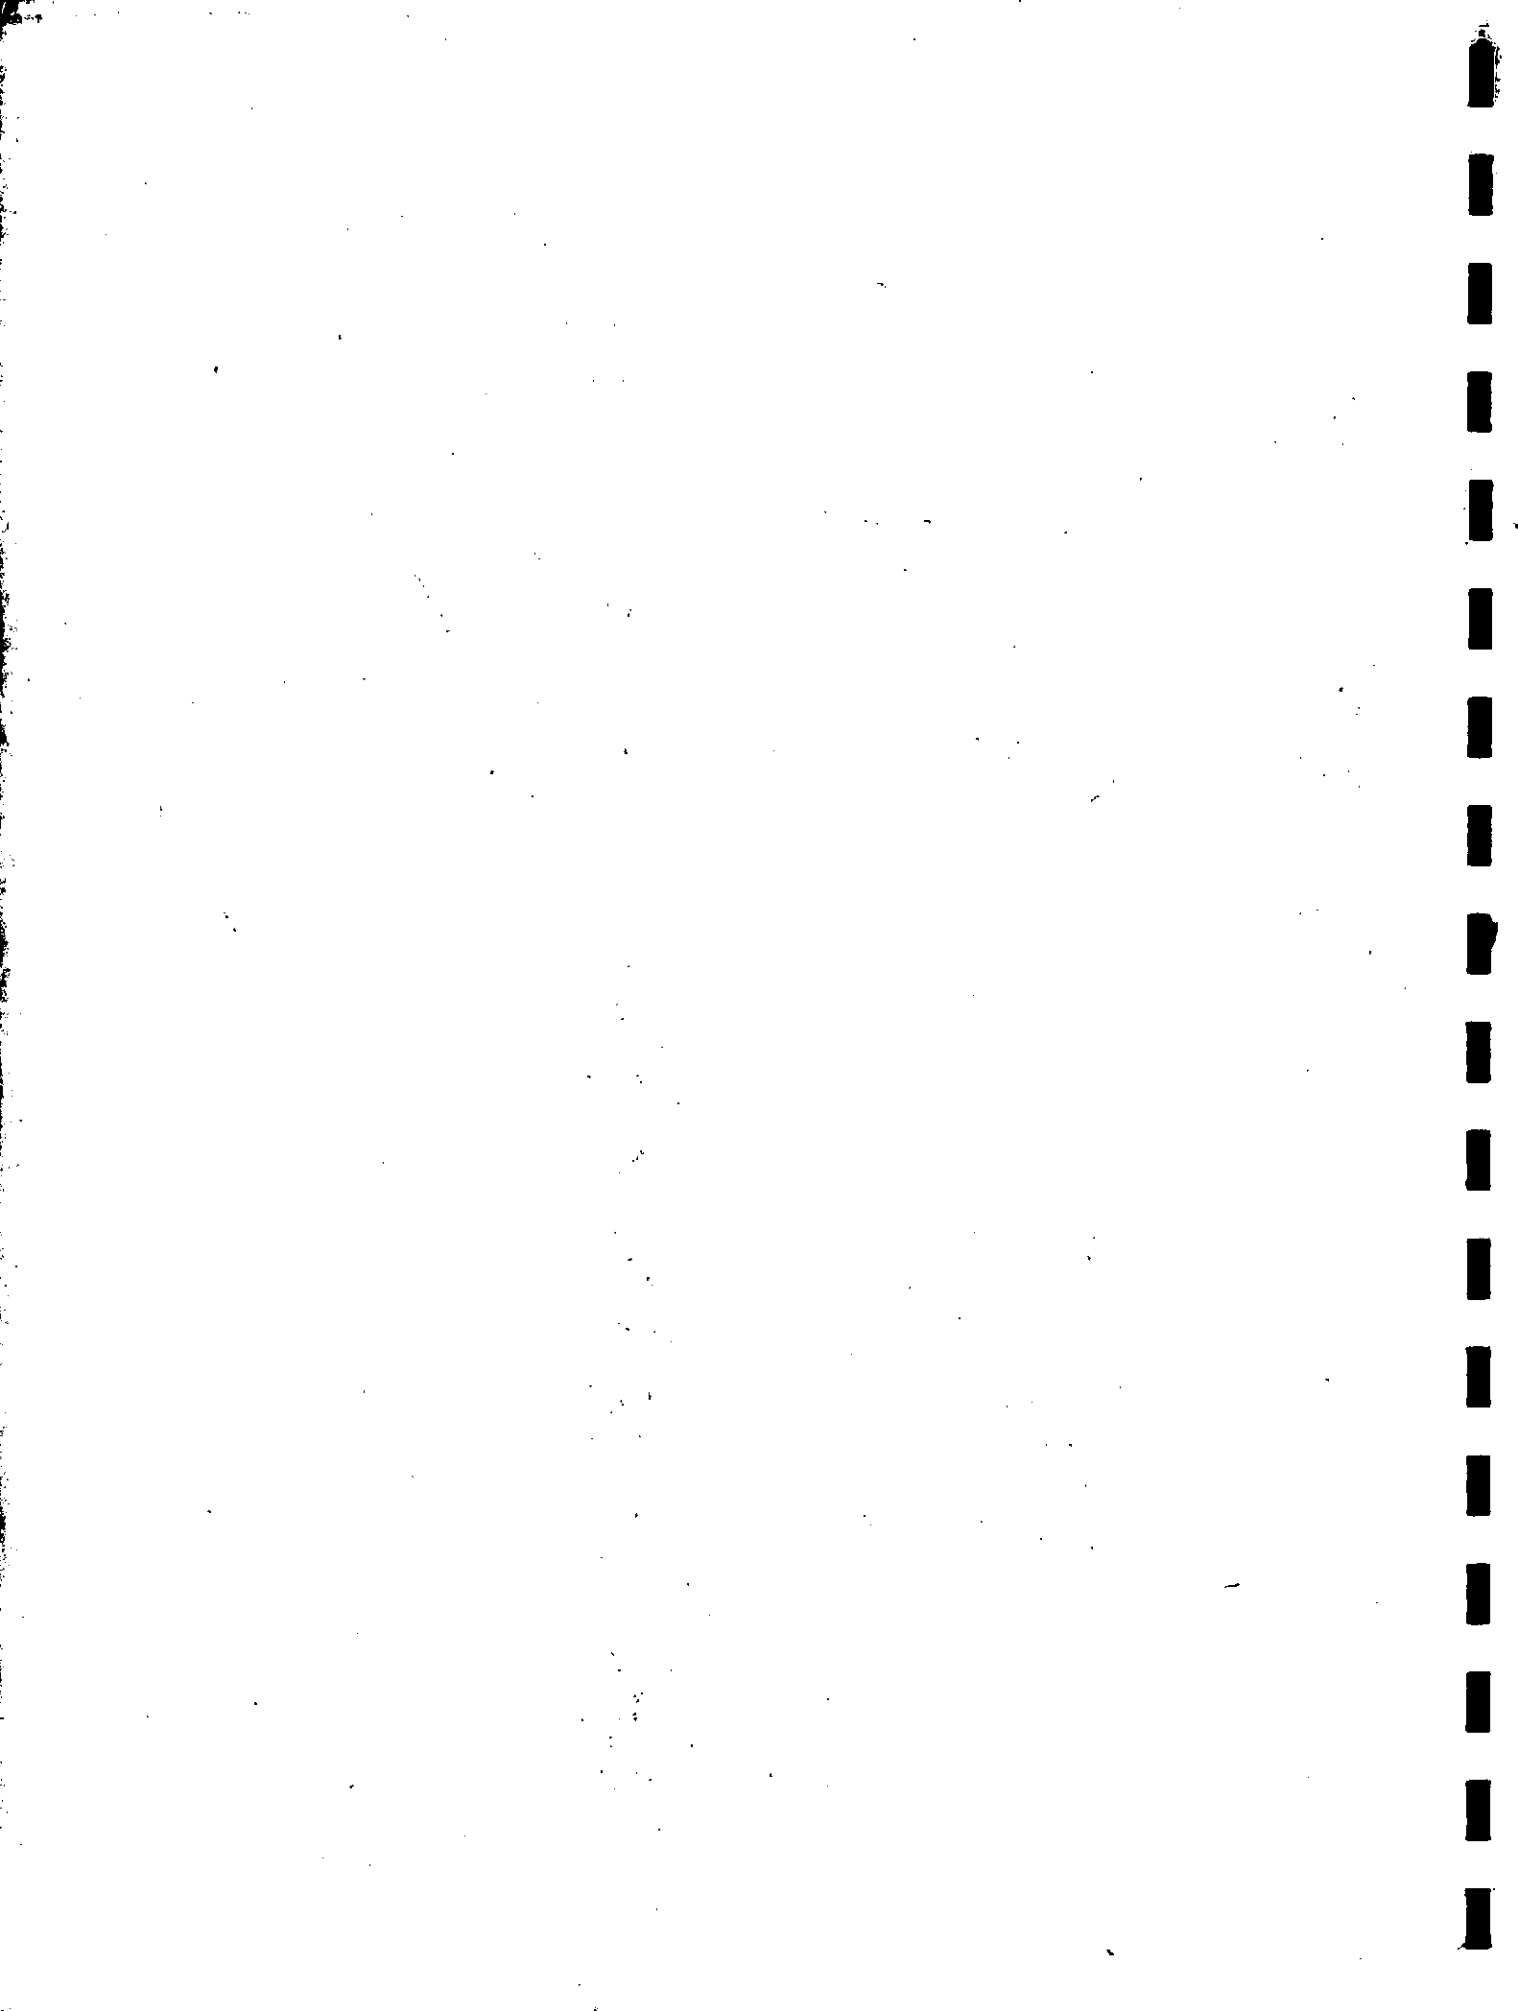
As the Nation's principal conservation agency, the Department of the Interior has basic responsibilities to protect and conserve our land and water, energy and minerals, fish and wildlife, parks and recreation areas, and to ensure the wise use of all these resources. The Department also has major responsibility for American Indian reservation communities and for people who live in island territories under U. S. administration.
