HISTORIC STRUCTURES REPORT

Tallgrass Prairie National Preserve

Tallgrass Prairie National Preserve
Strong City, Kansas

January 2005
Final Submission

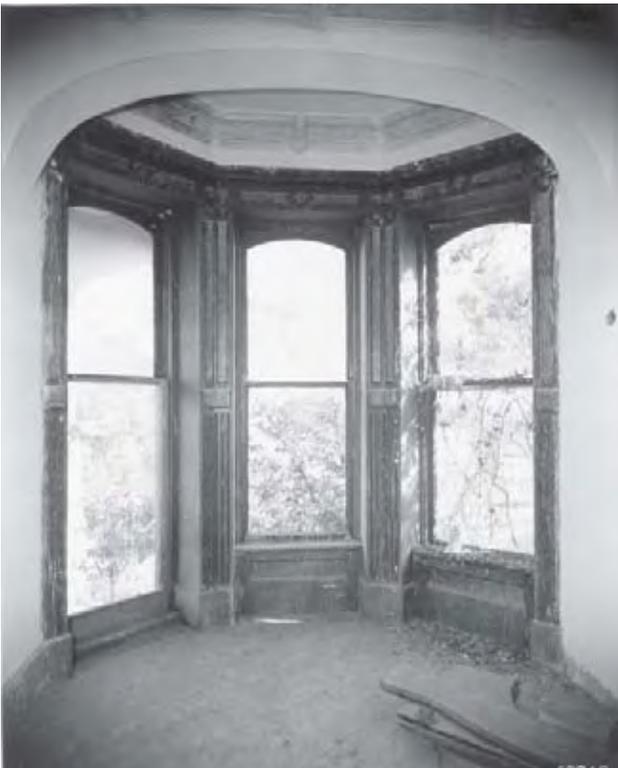
Figure A2-21: South parlor 102, looking southeast, Kinucan collection, ca. 1935.

The room, with vines growing in through the windows, dirt, droppings and debris, appears abandoned in this photograph. Base molding and possibly two lights on either side of the bay window are missing. Crown molding was originally decoratively painted throughout the house, which is evident in this room.

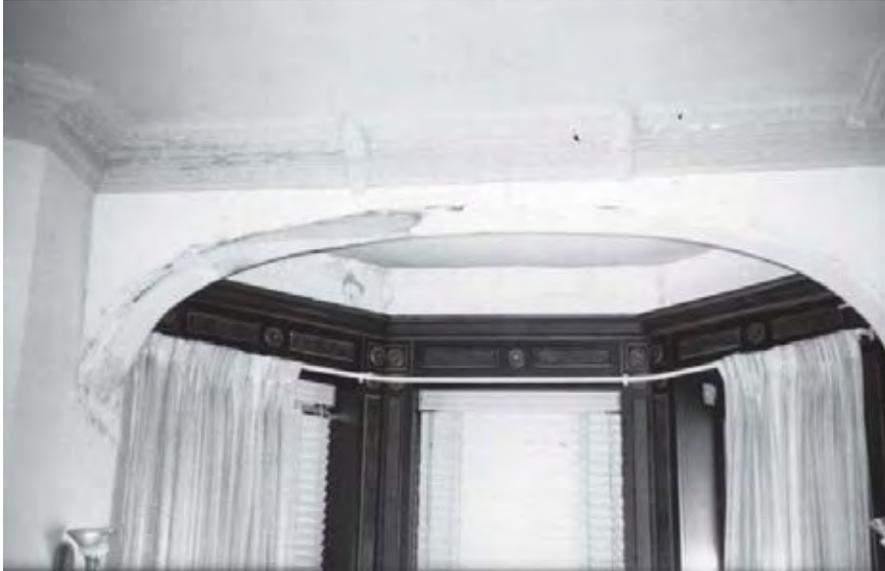
Figure A2-34: North parlor 103, facing northeast, Burtis (Tax Credit) collection, ca. 1983.

The arch leading to the north bay window suffered repeated water damage. At the north bay window, there is crown molding at the decorative arch only on the north parlor side, as opposed to the "bay" side. At the south parlor bay window, there is crown molding on both sides of the arch.

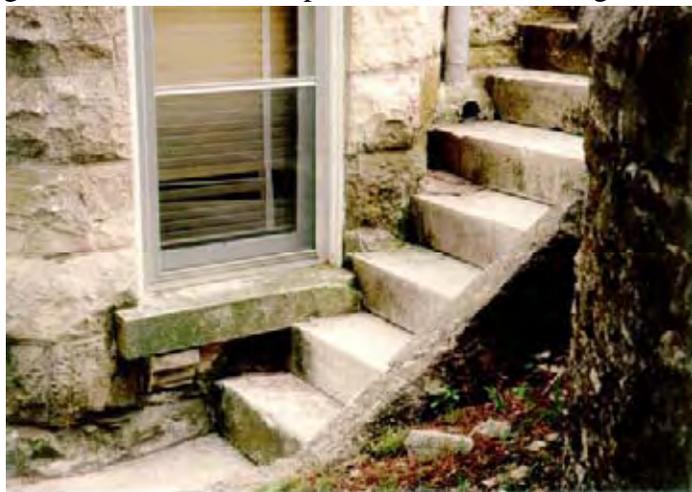
Figure C2-4: Northeast downspout draining onto steps, QEA, 01/22/02.

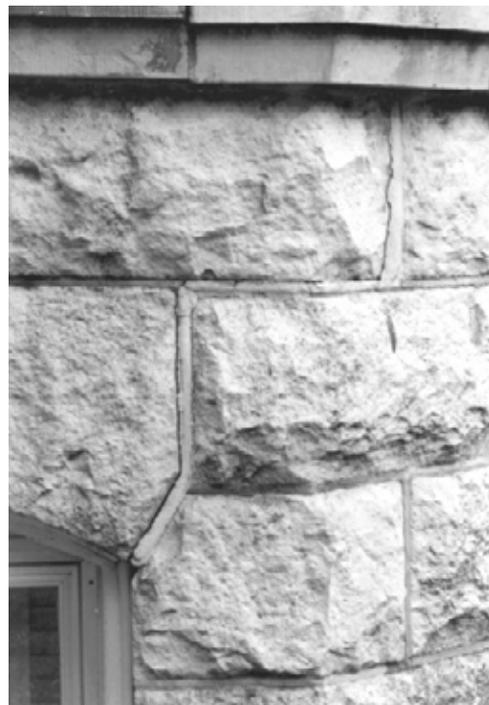
Figure C2-6: Ranch house, north pavilion, window 108, repointed mortar, QEA, 07/07/98.

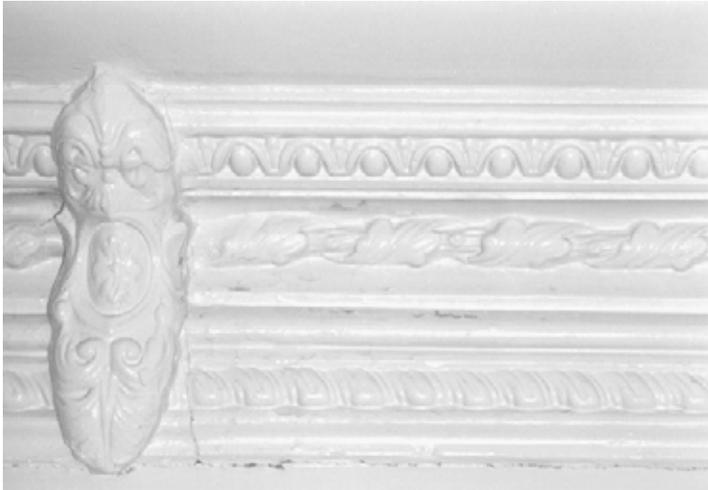
Figure C2-31: Ranch house, north parlor 103, west wall, cracked and peeling cornice moulding, QEA, 07/08/98.

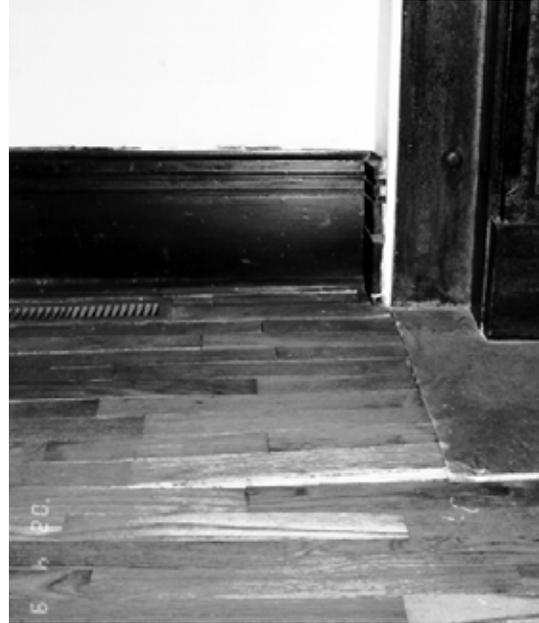
Figure C2-48: Buckled finish flooring south of fireplace hearth in north parlor 103 at first floor level; also note cracked base board beyond, Fitzpatrick Structural Engineering, PC; April 2002

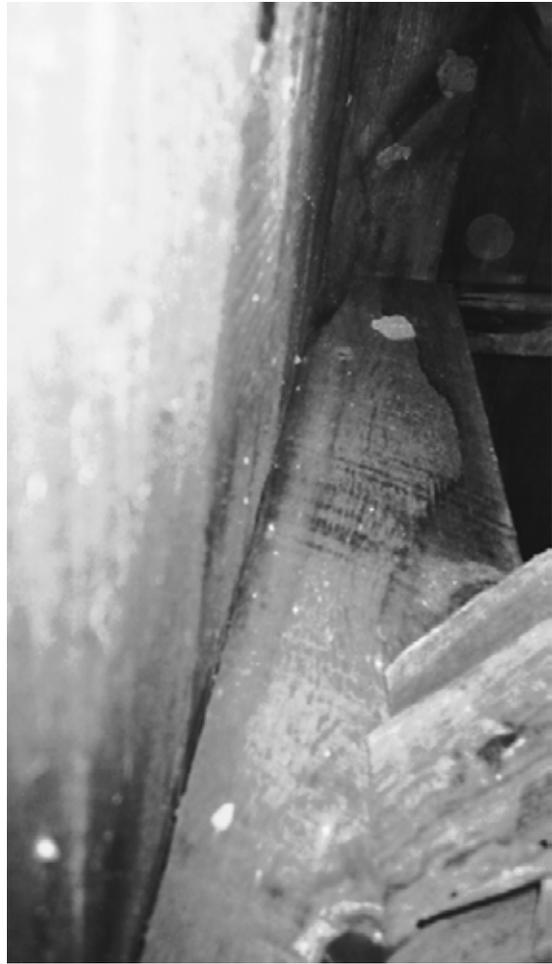
Figure C2-54: Continuation of sloped rafter/stud up for framing of upper mansard roof, note water staining and wasp nests, note top plate and upper roof rafters at top of figure, Fitzpatrick Structural Engineering, PC; April 2002

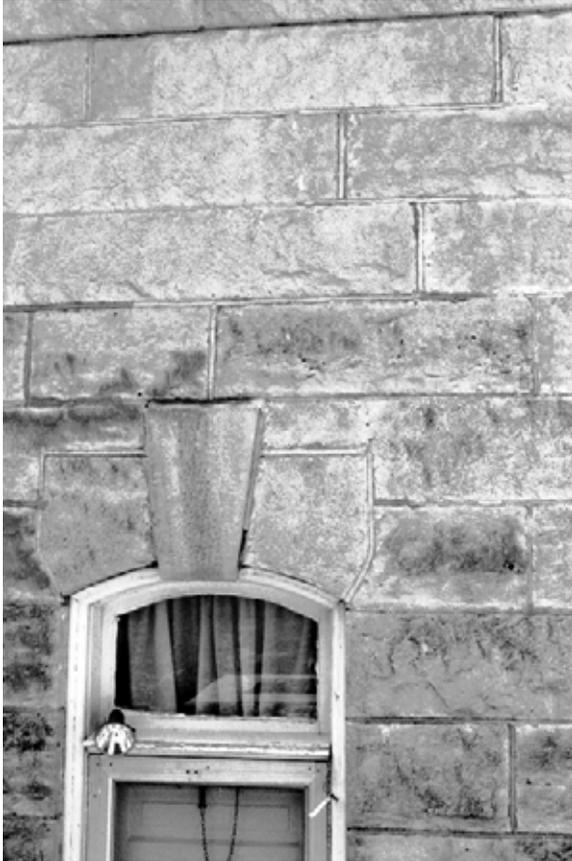
Figure C2-57: Continuously repointed cracks in north wall above door 206A, note large joint above keystone indicating that the keystone has dropped, Fitzpatrick Structural Engineering, PC; July 1998

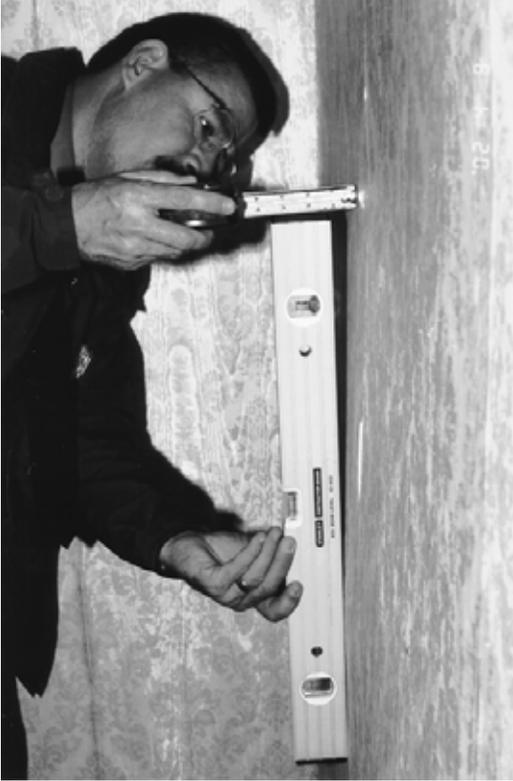
Figure C2-59: Maximum measurement recorded when measuring the plumbness of the walls, the top of the wall is leaning 1-1/4" in the nearly 2'-0" length of the level at the central stair at the third floor level, Fitzpatrick Structural Engineering, PC; April 2002

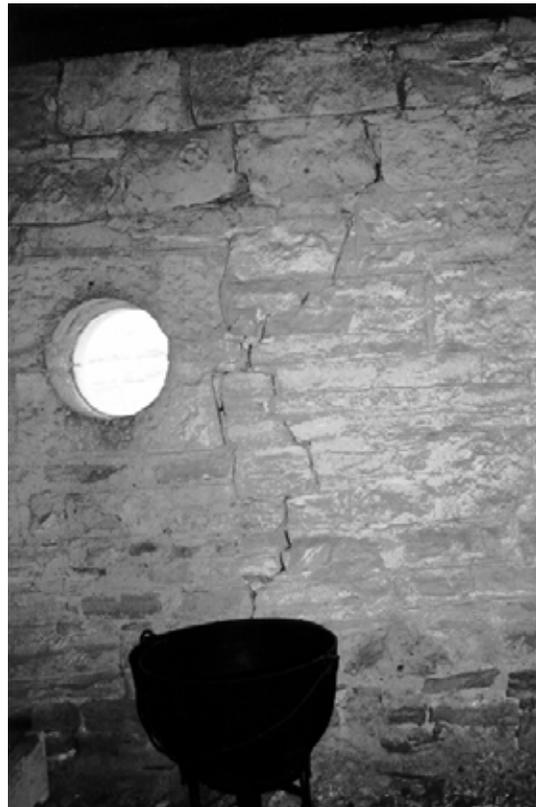
Figure C2-64: Most severe crack inside curing room 208 on west end of south wall, Fitzpatrick Structural Engineering, PC; January 2002

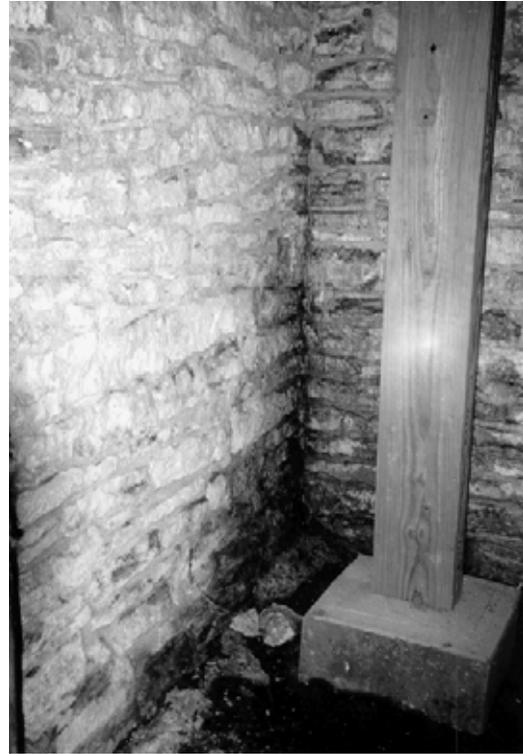
Figure C3-19: Barn, first floor, west wall, bay 1, water damage, QEA, 07/08/98.

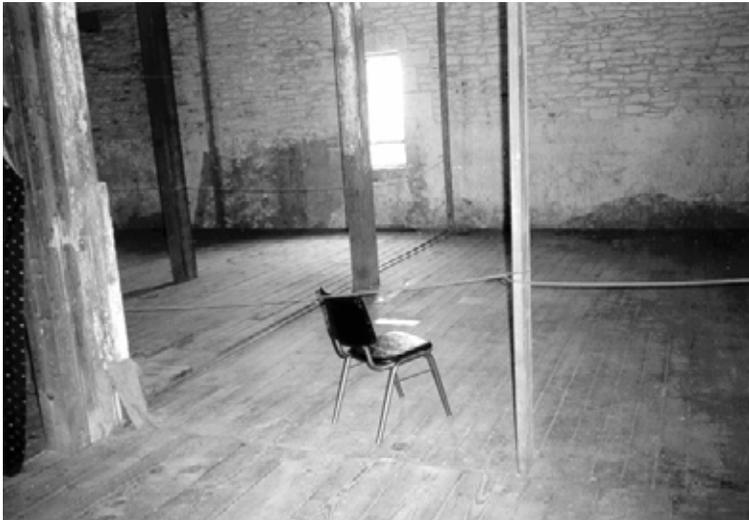
Figure C3-28: Barn, second floor, interior bays, floor misalignment at column line "D", QEA, 07/09/98.

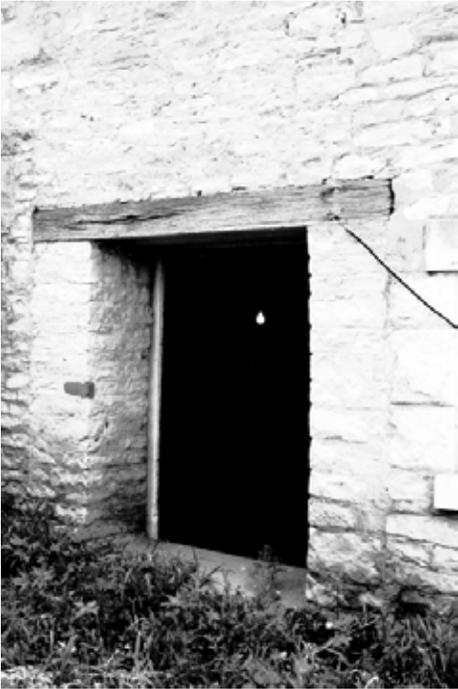
Figure C3-49: Newer door 101 to stable in west wall of barn. Note jambs are rebuilt. Note wood lintel over door, Fitzpatrick Structural Engineering, 1998.

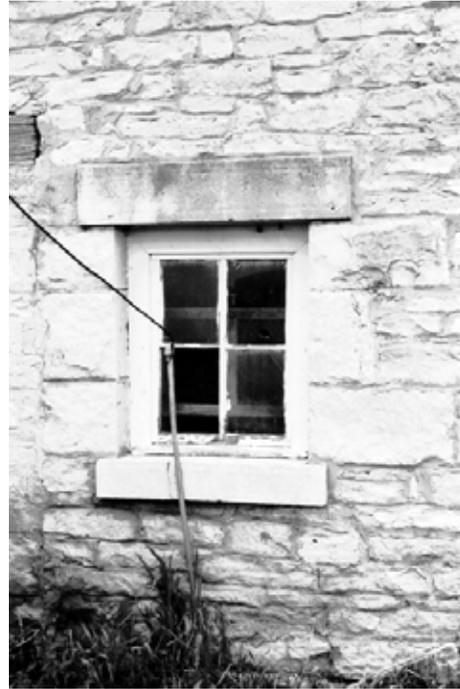
Figure C3-50: Window 103 at south side of west wall of barn. Note sill through stone crack, Fitzpatrick Structural Engineering, 1998.

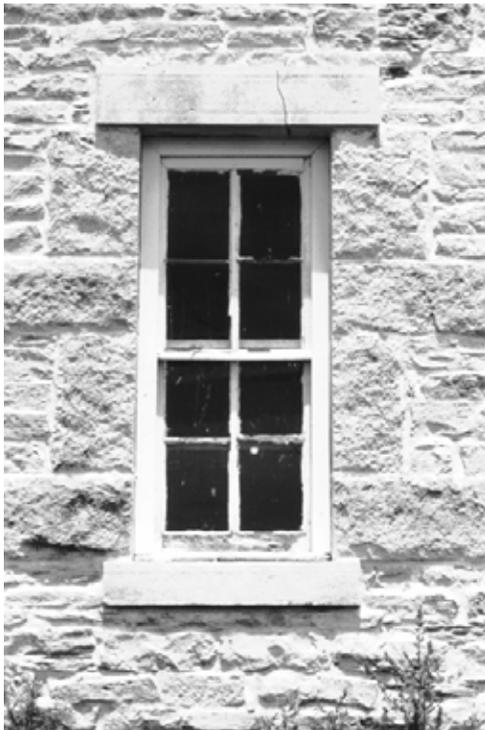
Figure C3-52: South wall east window 109 at stable level of barn. Note through stone crack at lintel, Fitzpatrick Structural Engineering, 1998.

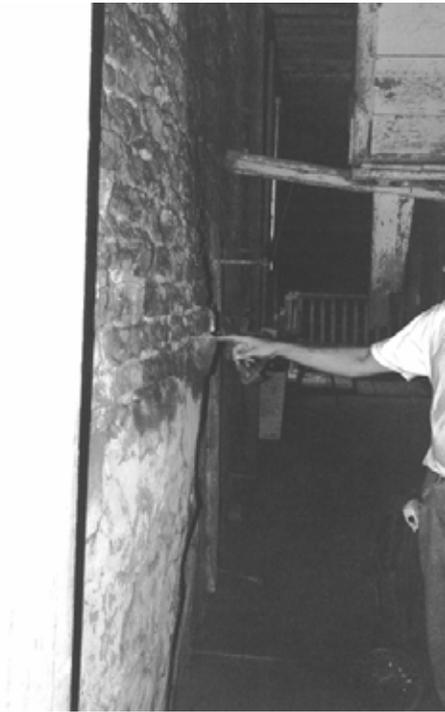
Figure C3-58: Bulge in the north wall of barn at juncture with the east cistern wall, Fitzpatrick Structural Engineering, 1998.

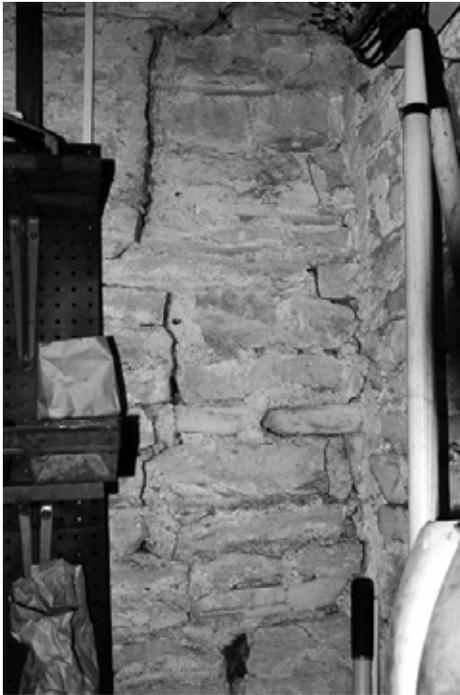
Figure C6-4: Vertical cracking in north end of west interior wall of icehouse, Fitzpatrick Structural Engineering, 1998.
