HISTORIC STRCUTURE REPORT THEODORE ROOSEVELT BIRTHPLACE NATIONAL HISOTRIC SITE

CONTRACT No. 1443CX2000, PMIS 16068

NATIONAL PARK SERVICE DENVER SERVICE CENTER

JOHN MILNER ARCHITECTS, INC. 104 LAKEVIEW DRIVE CHADDS FORD, PA 19317

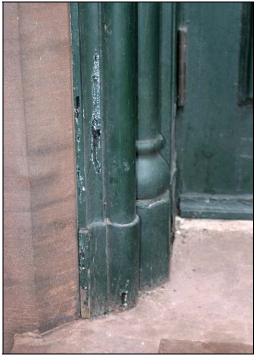
Detail of flaking and lost paint on the formal entrance door frame, JMI, 2006.

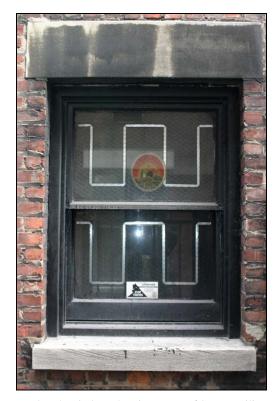
Wood sash window showing areas of heavy soiling on the lintel and weathering on the sill, JMI, 2006.

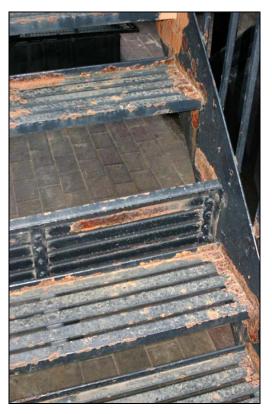
Missing tread from the exterior fire escape on the south elevation, JMI, 2006.

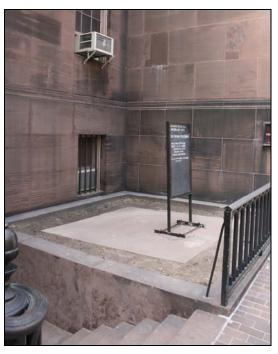
There are two soil beds, one in front of each building section. These beds have periodically been planted with vegetation, but are currently void of plantings. The western bed also contains a concrete slab which is in good condition; however the purpose of this slab is unclear. The slab and soil within the bed are sloped towards the building. The western and the eastern bed appear to have no means of proper drainage and may be contributing to interior moisture issues at the basement level.

Concrete pad and soil bed on west side of Theodore Roosevelt Birthplace north facade, JMI, 2006.

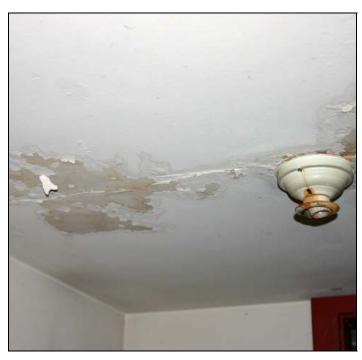
<u>LIGHTING:</u> There is one light suspended from the ceiling that is missing the globe and bulb.

Detail of deteriorated ceiling finishes and rusted fixture, JMI, 2006.

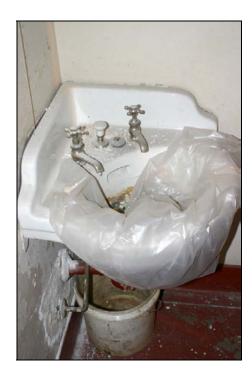
Detail of inoperable sink, JMI, 2006.

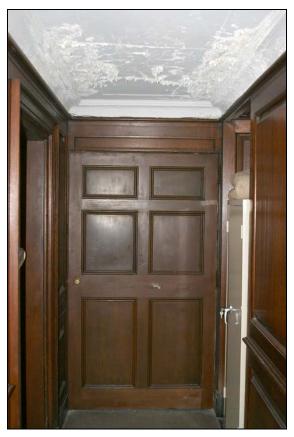
View of ceiling paint and plaster deterioration at the south end of the hall outside of room 109, JMI, 2006.

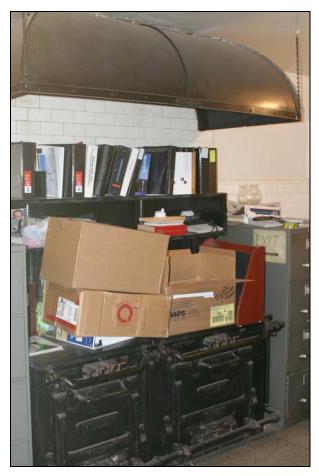
View of the inoperable Vulcan stove and fume hood on the north wall of the kitchen, JMI, 2006.

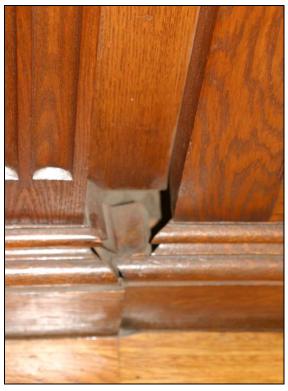
Detail of damage along the baseboard, JMI, 2006.

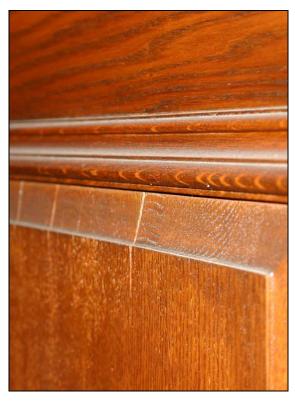
Example of cracks in the wall panels, JMI, 2006.

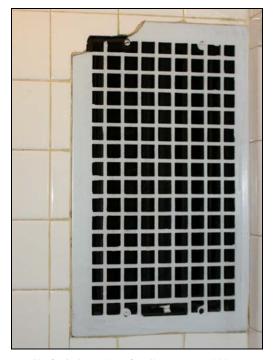
Detail of missing edge of wall vent, JMI, 2006.

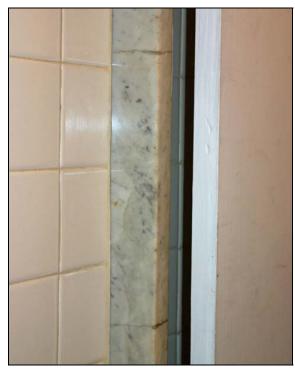
Detail of two cracks in the proper right marble stall jamb, JMI, 2006.

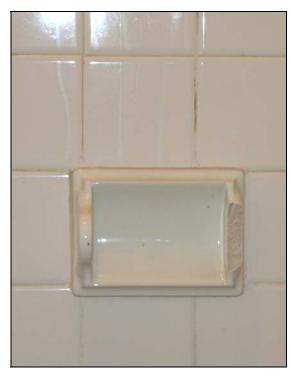
Detail of broken toilet paper dispenser, JMI, 2006.

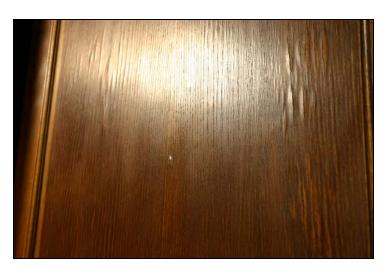
Detail of blistering and cracks in the wall paneling, JMI, 2006.

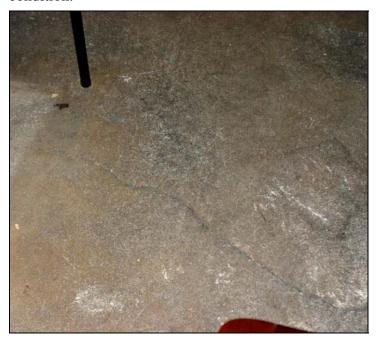
Detail of the crack in the concrete floor, JMI, 2006.

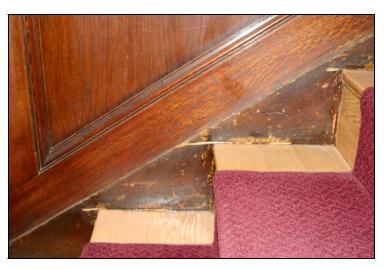
Detail of damage on baseboard and lighter stained oak stairs, JMI, 2006.

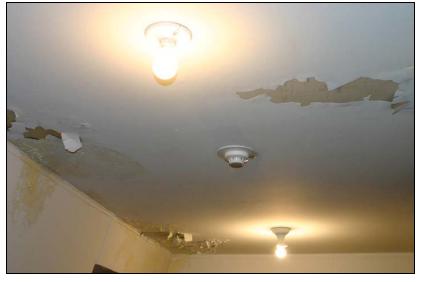
View of flaking and paint loss throughout the ceiling, and plaster deterioration in the far corner, JMI, 2006.

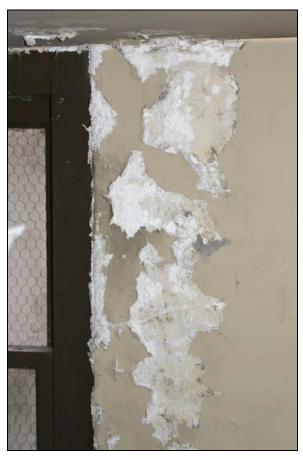
Detail of plaster and paint deterioration, JMI, 2006.

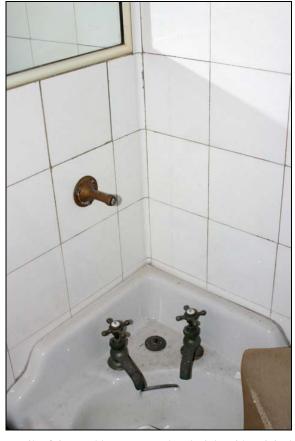
Detail of inoperable corner pedestal sink with original faucets, JMI, 2006.

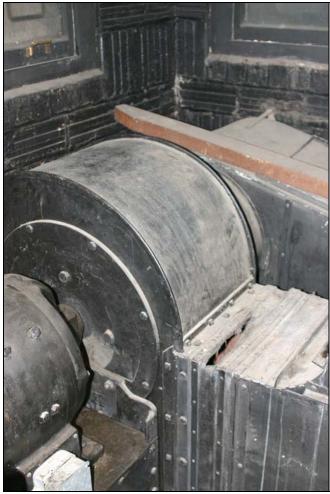
The blower motor requires maintenance, JMI, 2006.

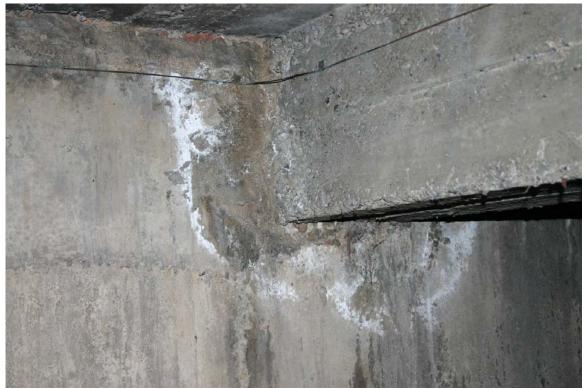
Photo 15. Efflorescence staining on the east wall of the under floor space at the beam seat

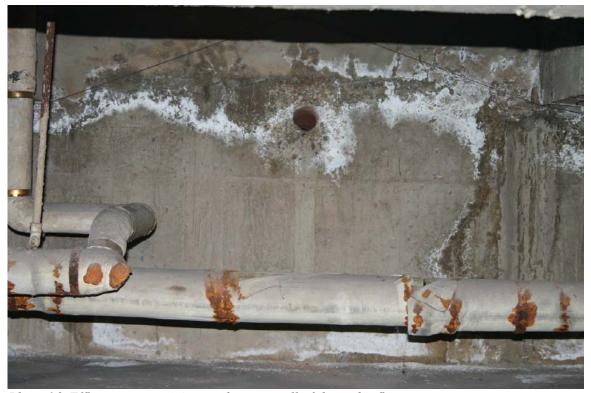
Photo 16. Efflorescence staining on the west wall of the under floor space

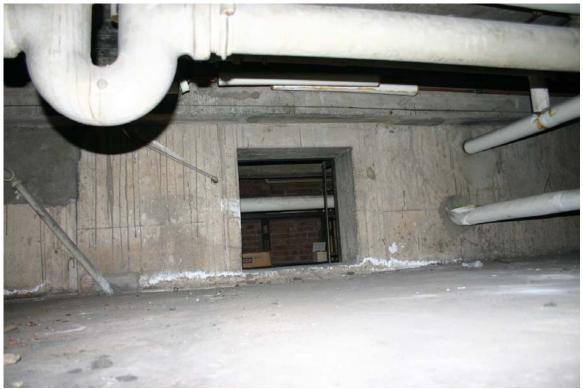
Photo 17. Efflorescence staining on the center wall of the under floor space

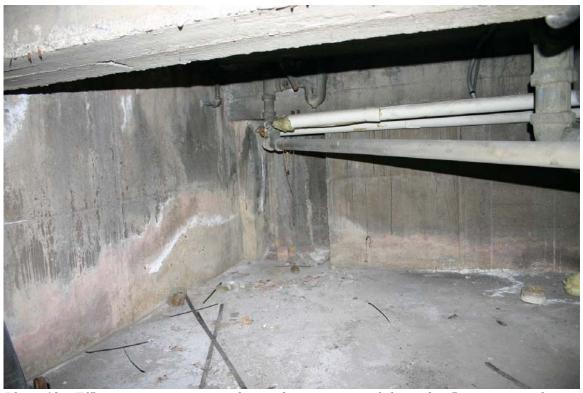
Photo 18. Efflorescence staining on the south east corner of the under floor space with pipe chase on the south wall

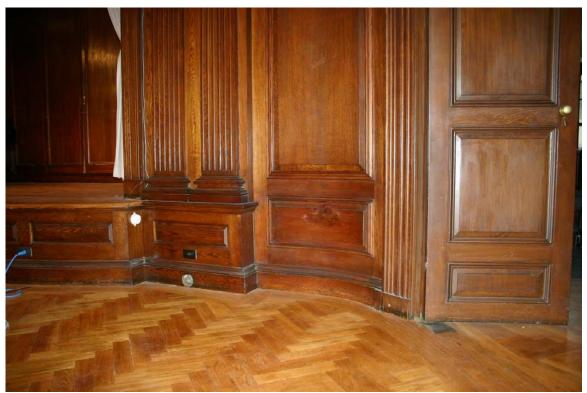
Photo 65. Water damaged decorative wood paneling in Room 406 Auditorium from the piping for the toilet and sink in Room 402 Restroom

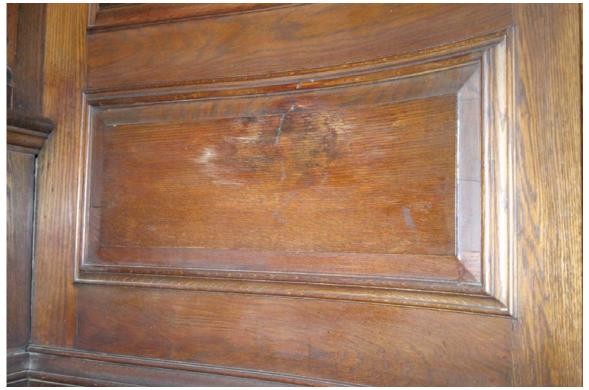
Photo 66. Close-up of water damaged decorative wood paneling in Room 406 Auditorium from the piping for the toilet and sink in Room 402 Restroom

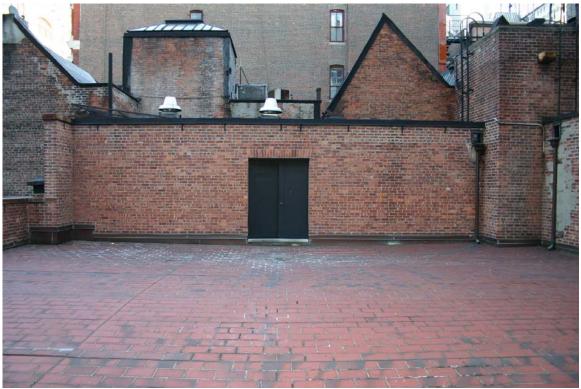
Photo 67. Open joints in the exterior brick masonry of the roof top penthouse

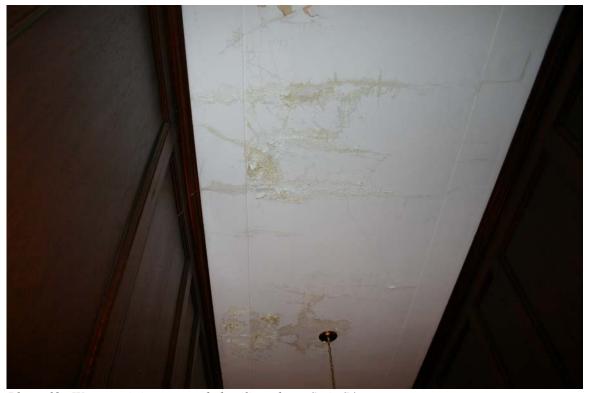
Photo 68. Water staining suspended ceiling above Stair S4

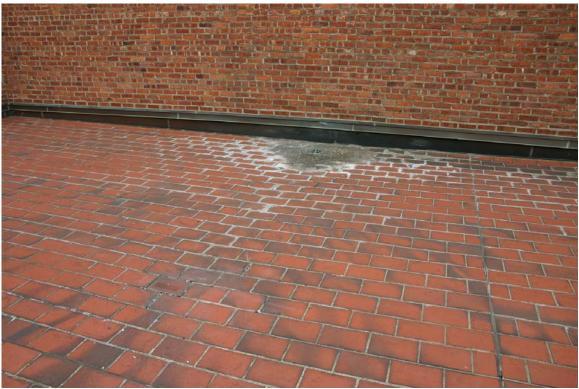
Photo 69. Open joints in the roof top terrace pavers with silt accumulation at the roof drain

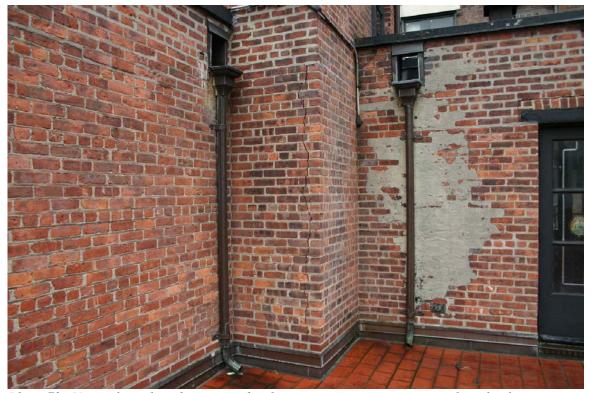
Photo 72. Vertical crack in the exterior brick masonry encasing a structural steel column

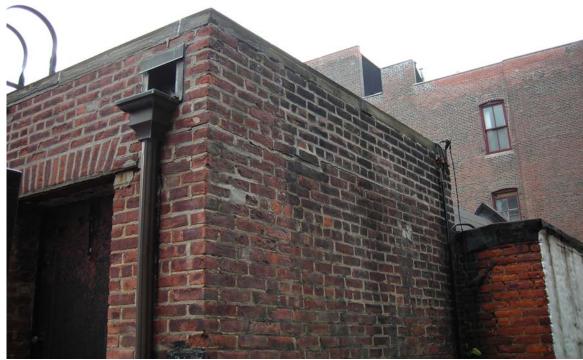
Photo 73. Open joints in the exterior brick masonry of the roof top penthouse with repointing near the top of the wall

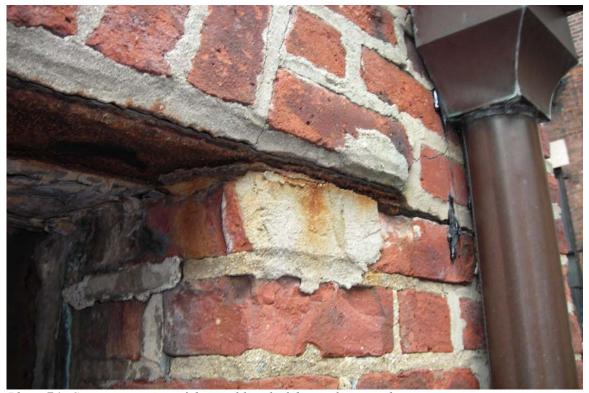
Photo 74. Severe corrosion of the steel lintel of the roof top penthouse
