**Timucuan Ecological and Historic Preserve**

**Napoleon Bonaparte Broward House**

**Historic Structure Report**

March 2010

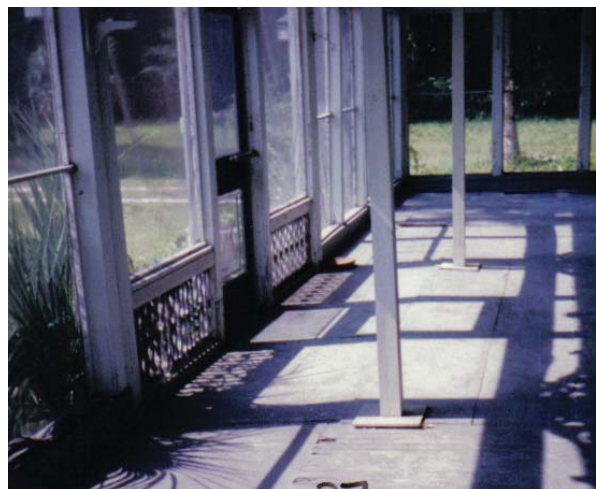
For some years before, the second-floor porch was thought to be unsafe and the door from the hall to the porch was kept closed. While the large screened porch below remained the center of activity, the upstairs porch was of questionable stability. Decades earlier when the first-floor porch was extended, its original corner posts had been removed and installed at the new corners. Eventually the upper porch sagged due to the lack of direct support, the condition worsening until, in the late 1980s, a row of four-by-four posts was installed within the lower porch to provide temporary support for the second-floor porch (Figure 17).

**Figure 17,** Interior of the screened porch in 1996 showing 4-by-4s supporting second-floor porch. (Zillgitt)

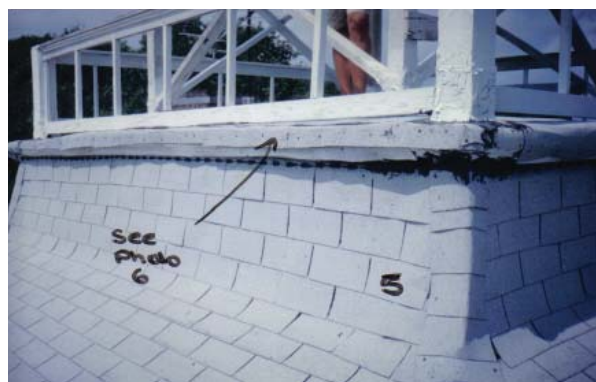
**Figure 18,** Cupola railing, floor, and shingled base in 1996. (Zillgitt)

The cupola was also in trouble. By 1994, water damage had caused severe deterioration to the canvassed wood floor. To protect it from rain, the

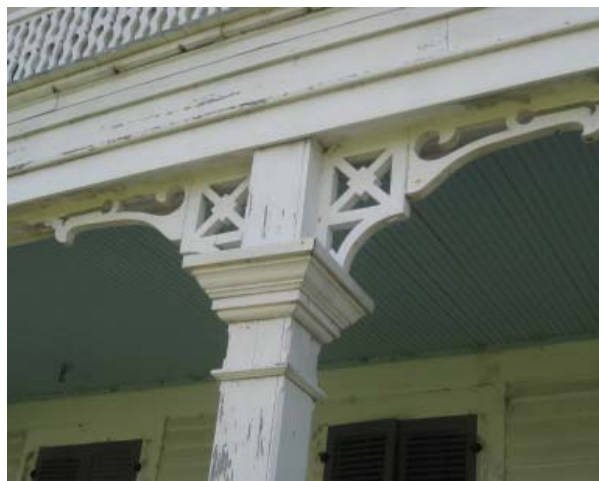
According to interviews with Karl Zillgitt, the decorative sawn brackets on the porch posts were repaired with portions replaced. In most of the brackets, the center straight pieces (those forming the X within a square) were in poor condition and replaced with reproductions. The scroll-cut pieces of the post brackets were in better condition and were reused (Figure 21).

Figure 21, Porch post brackets showing replaced straight “X” pieces and repaired scroll-cut elements.. (Oppermann, 2009)

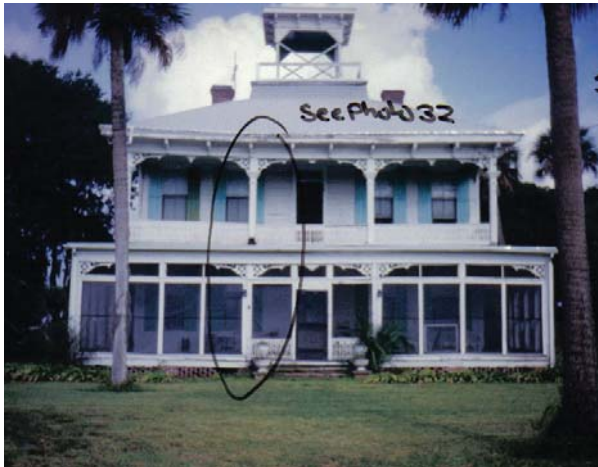
Figure 22, Porches in 1996 showing sagging roof. (Zillgitt)

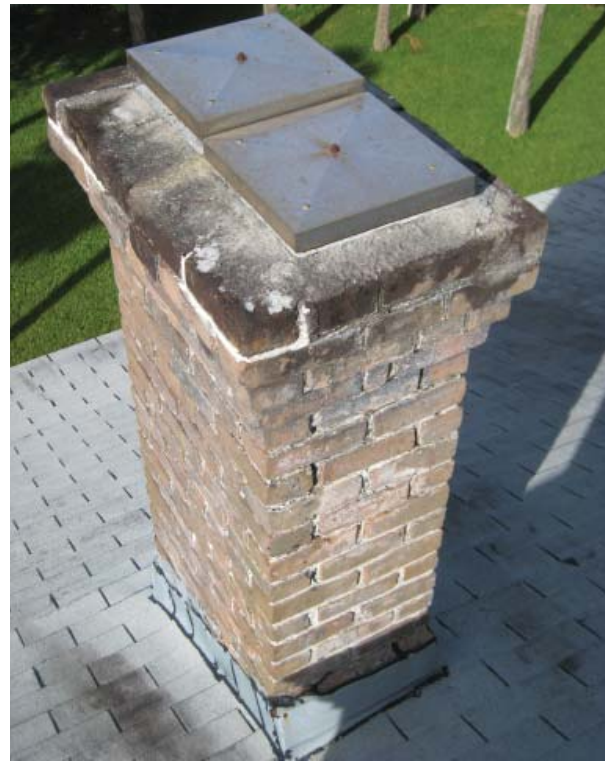
The Main Block has two matching chimneys, one on the north roof hip and the other on the south. Both chimneys are of brick and measure approximately 2'-7" by 1'-5½" in horizontal section above the roof line. The chimneys are centered on the Main Block, not including the area of the front porches. Each chimney is divided into two flues connecting to fireplaces at the first and second floors. There are four wood burning fireplaces within the house, two on each floor in the east rooms. Both chimneys have been capped and are inoperable.

Figure 19, Chimney at north roof hip.

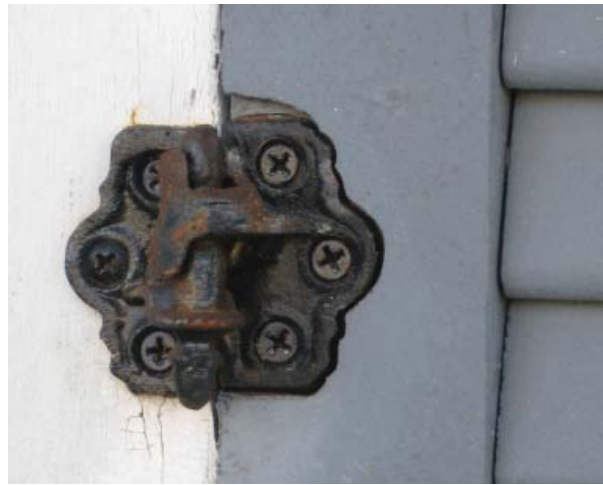
**Figure 29**, Inaccurate replacement shutter hinges on shutters of the east elevation of the Main Block.

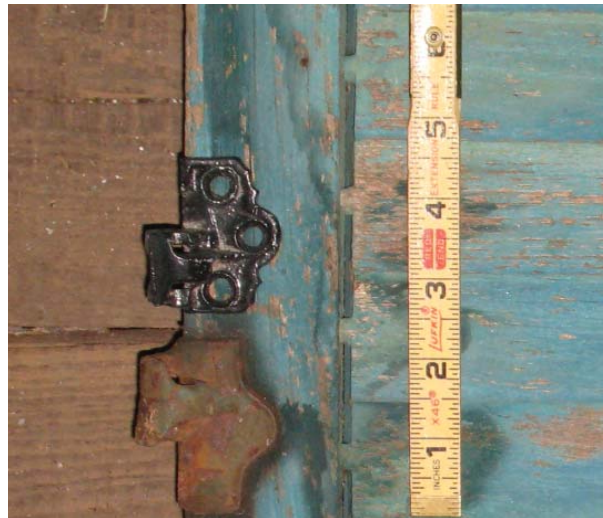
**Figure 30**, Salvaged louvered shutter stored in Attic, showing different size of early hinge compared to replacement hinge above (Figure 29).

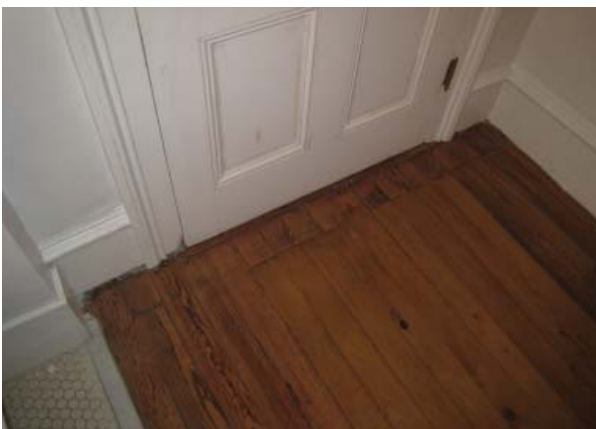
Figure 62, Room 105-Bathroom flooring patch at southeast corner.

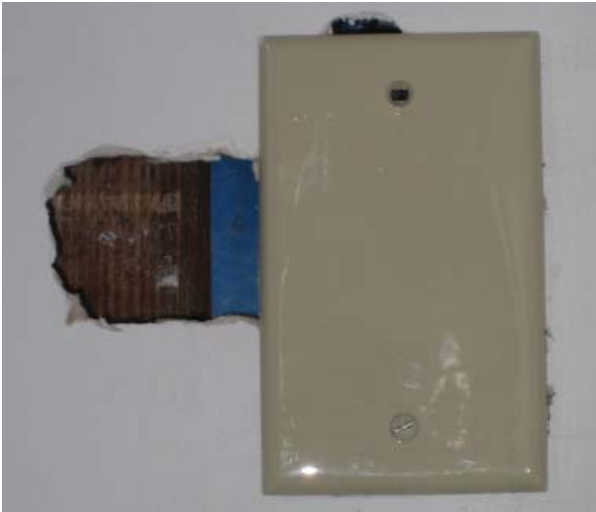
**Figure 71**, Area of gypsum board removed to reveal an original stud, which shows lime stains and nail holes. This indicates the wall had plaster on lath at one time, probably originally.
