**WASHINGTON MONUMENT AND ASSOCIATED STRUCTURES
HISTORIC STRUCTURE REPORT**

VOLUME II – MONUMENT LODGE

FINAL REPORT

PREPARED BY
John Milner Associates, Inc.
ARCHITECTS • ARCHEOLOGISTS • PLANNERS • LANDSCAPE ARCHITECTS
535 NORTH CHURCH STREET
WEST CHESTER, PENNSYLVANIA 19380
(610) 436-9000

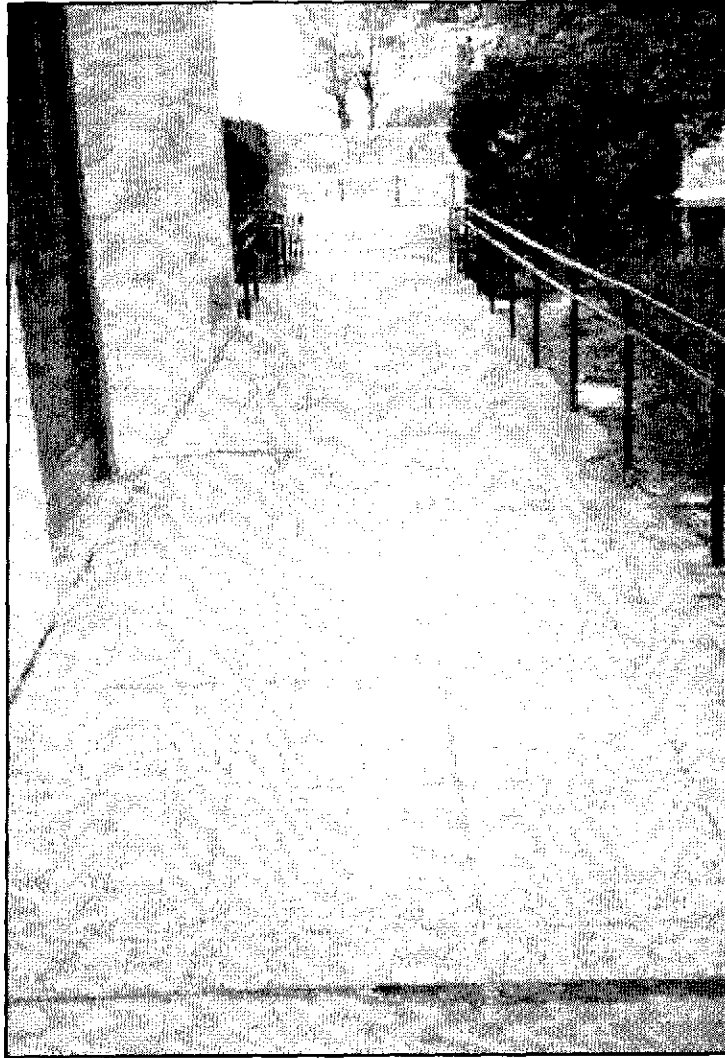
Figure 5.3: Monument Lodge, Concession Addition, south façade, note deteriorated sidewalk.

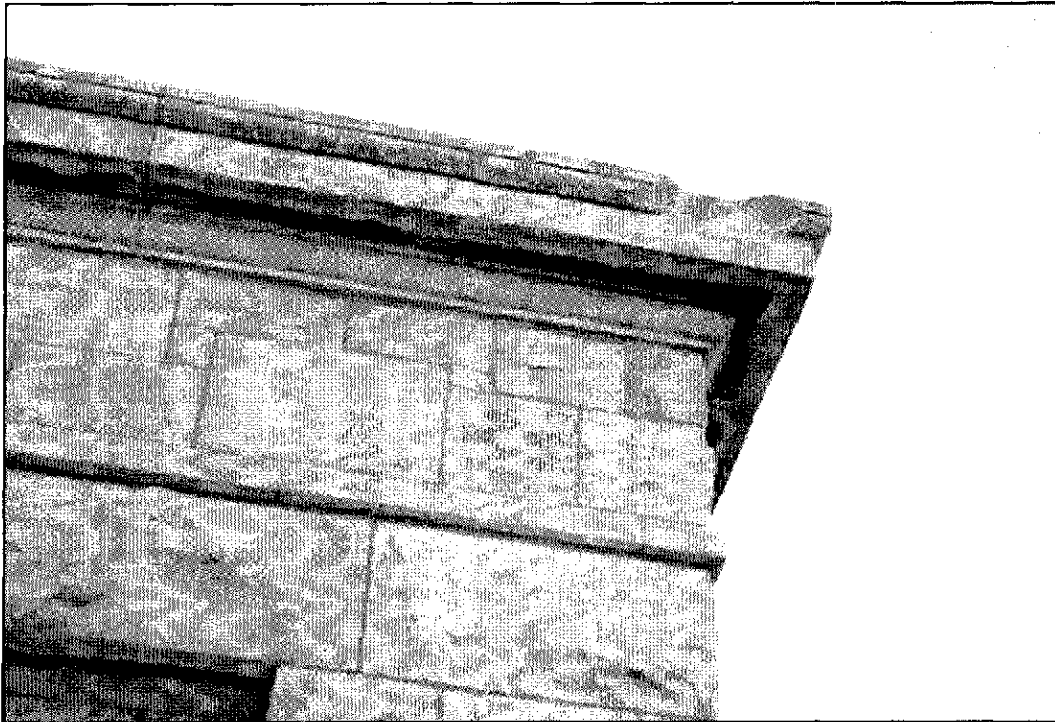
Figure 5.4: Monument Lodge, east façade, old damage at northeast corner of cornice.

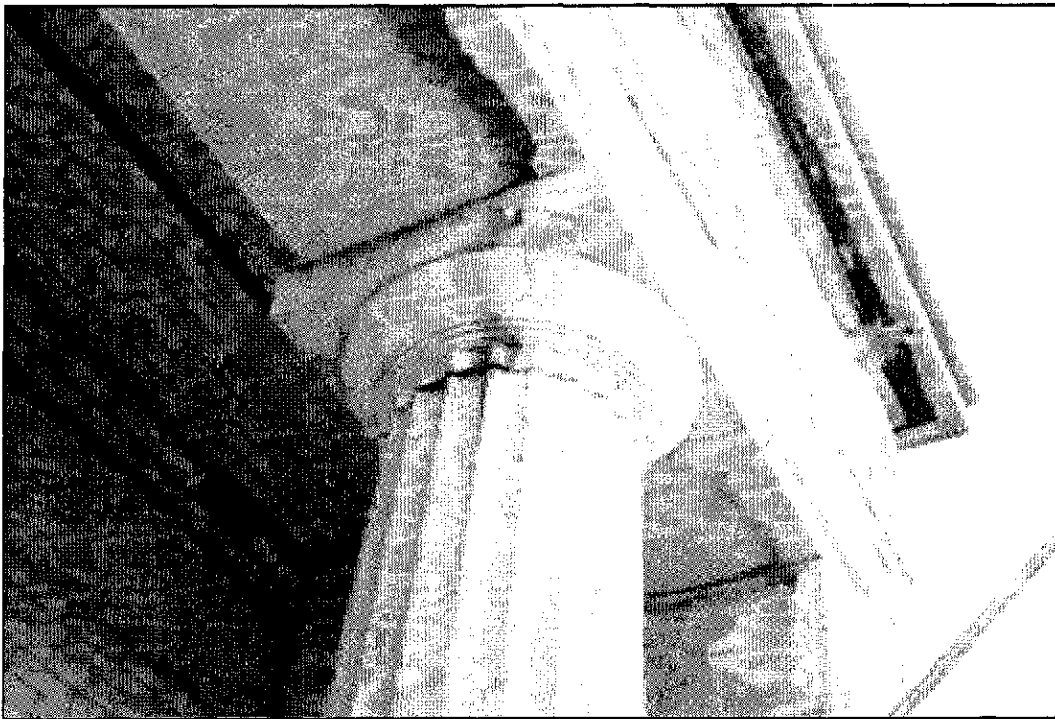
Figure 5.5: Monument Lodge, east façade, underside of portico, note gypsum crusts.

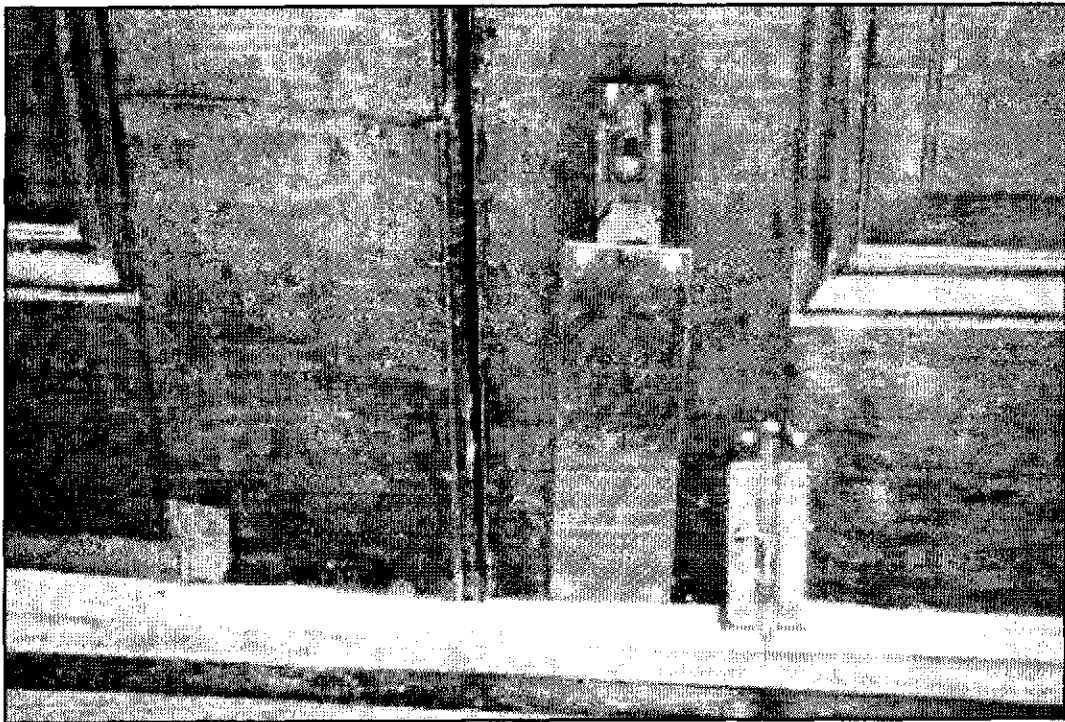
Figure 5.7: Monument Lodge, interior, souvenir shop, east entrance doors, note modern hardware and damage at base.

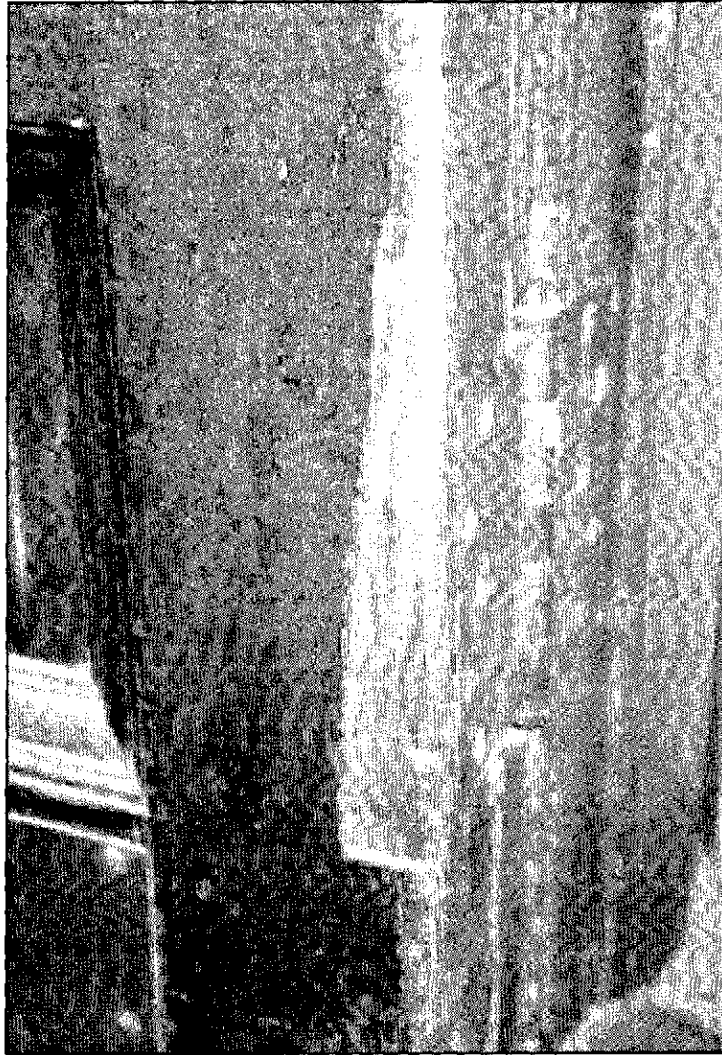
Figure 5.8: Monument Lodge, interior. souvenir shop, east entrance doors, note damage to wood and finish.

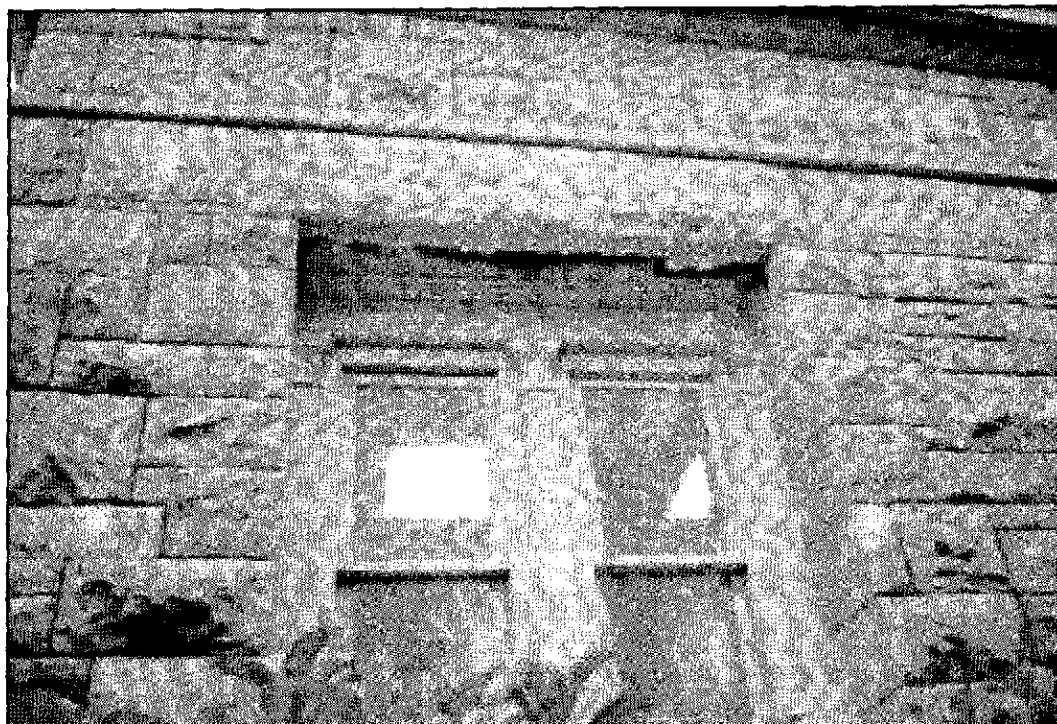
Figure 5.9: Monument Lodge, exterior, detail of gypsum crusts at north window to mens' rest room.

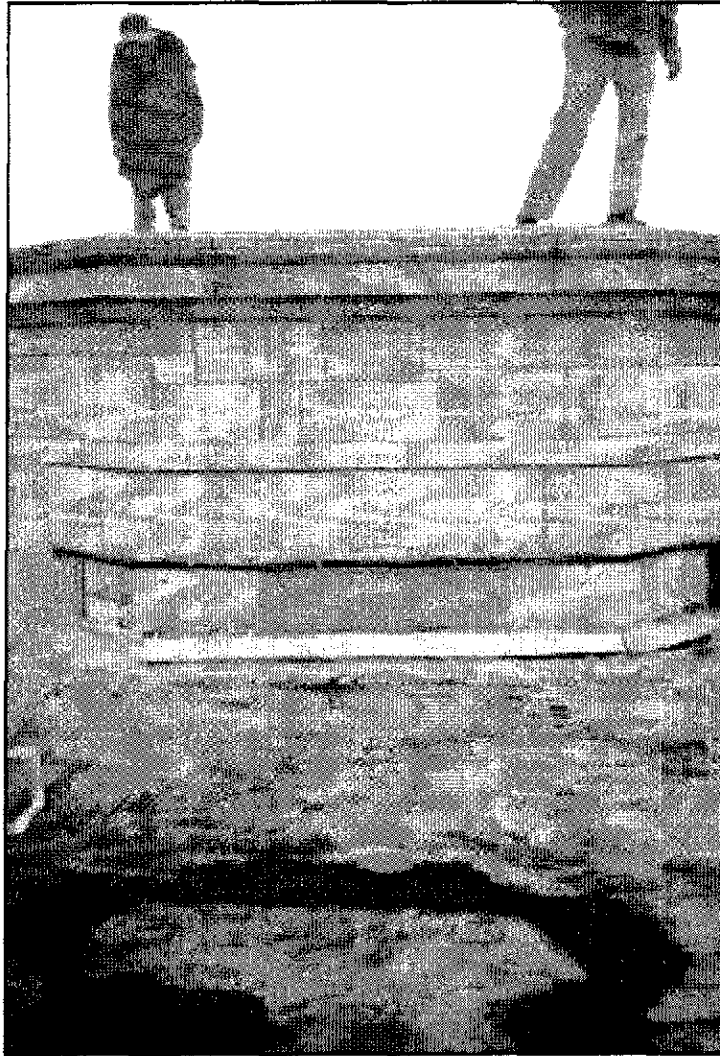
Figure 5.10: Monument Lodge, Concession Addition roof, projecting west bay, note crack through cornice.

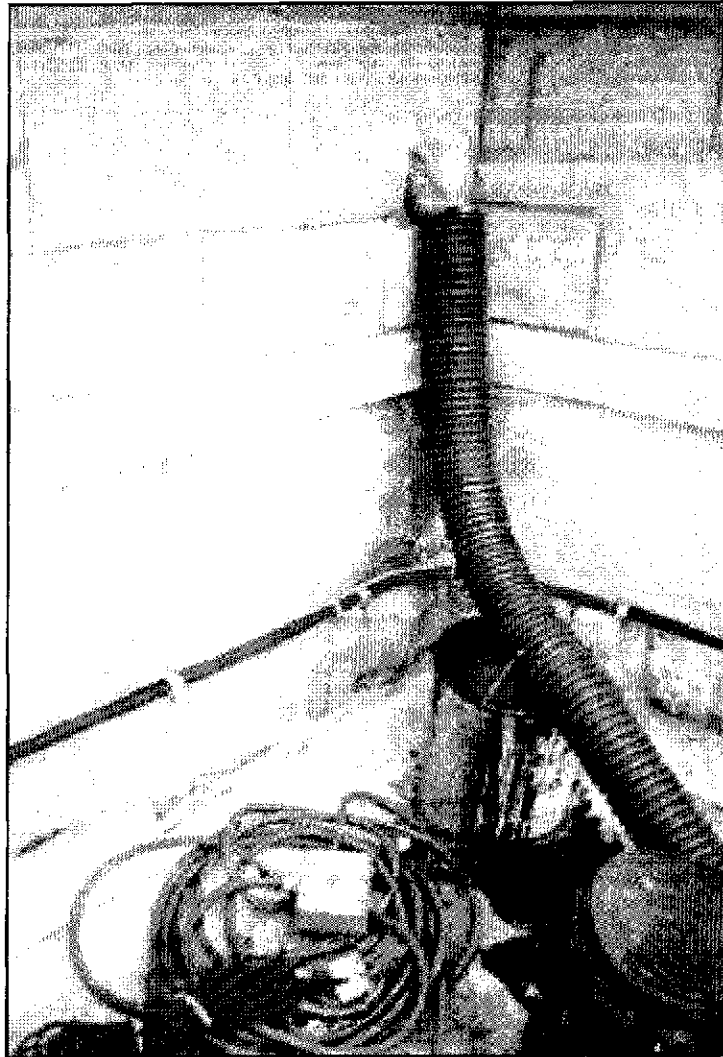
Figure 5.11: Monument Lodge, west facade, northwest downspout, note rust staining.

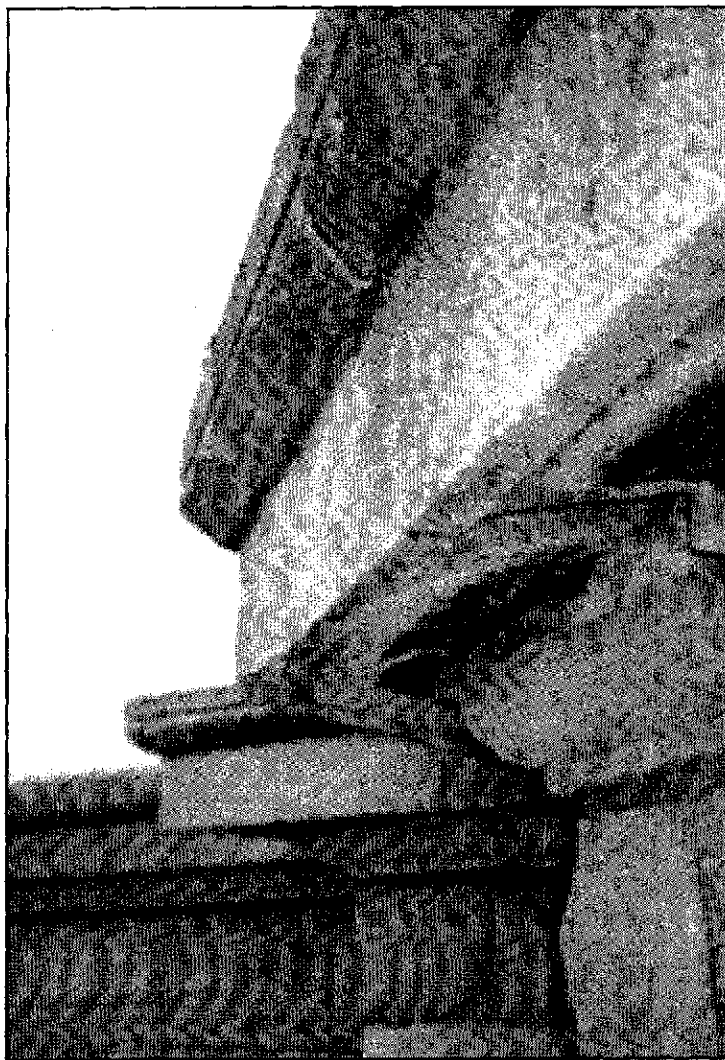
Figure 5.12: Monument Lodge, west facade, detail gypsum crust on underside cornice.

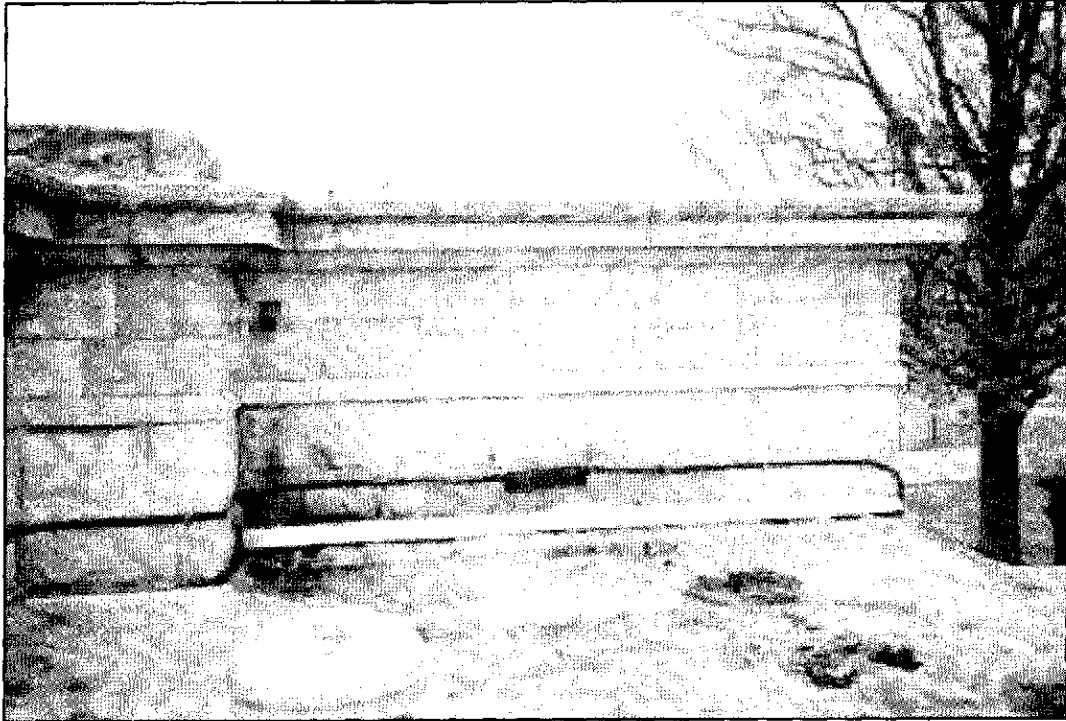
Figure 5.13: Monument Lodge, west facade, southwest end, note rusting plates.

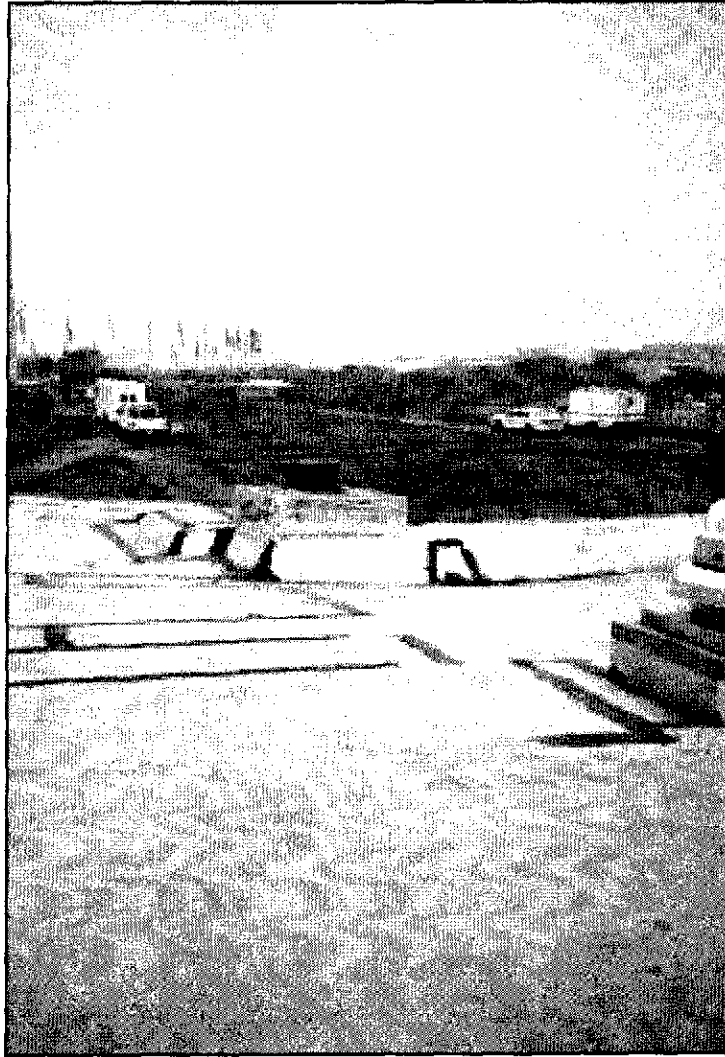
Figure 5.15: Monument Lodge, roof, northwest chimney with terracotta pipe, note seam repairs.

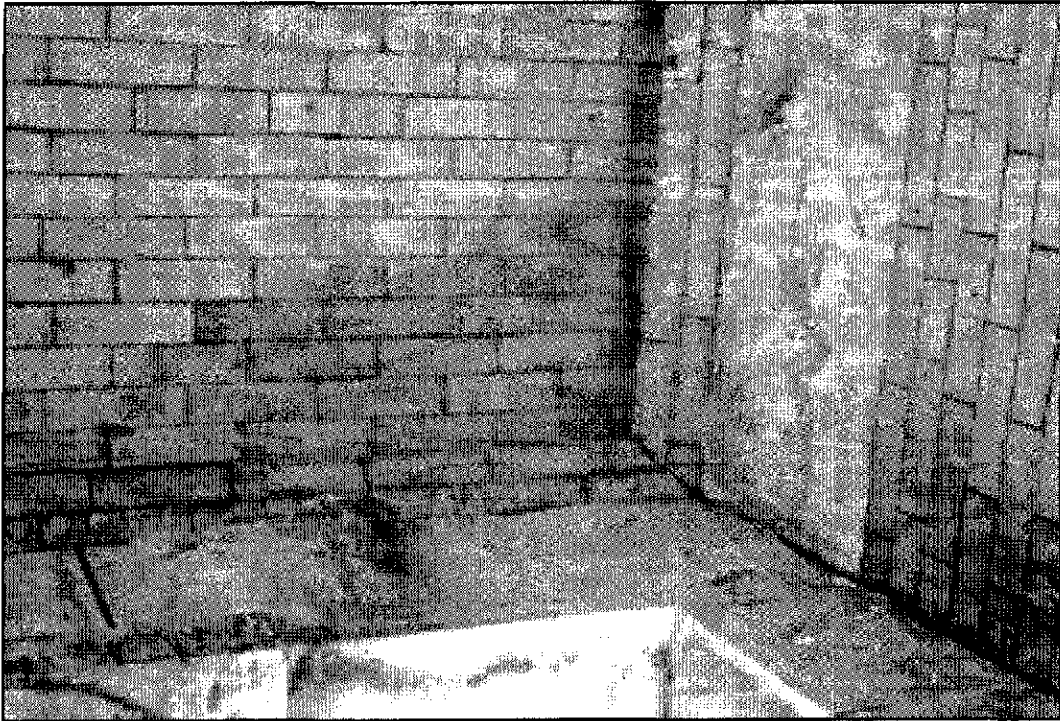
Figure 5.16: Monument Lodge, east façade, south end of vault over portico, note water infiltration.

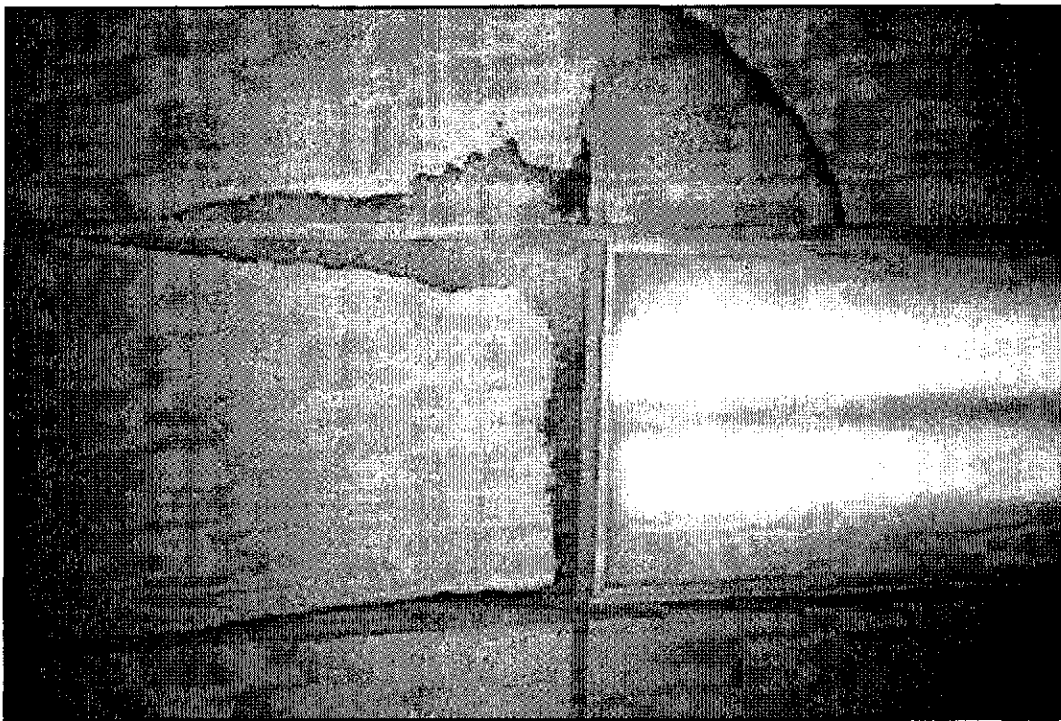
Figure 5.17: Monument Lodge, interior, souvenir shop, drop ceiling, note recent water damage.

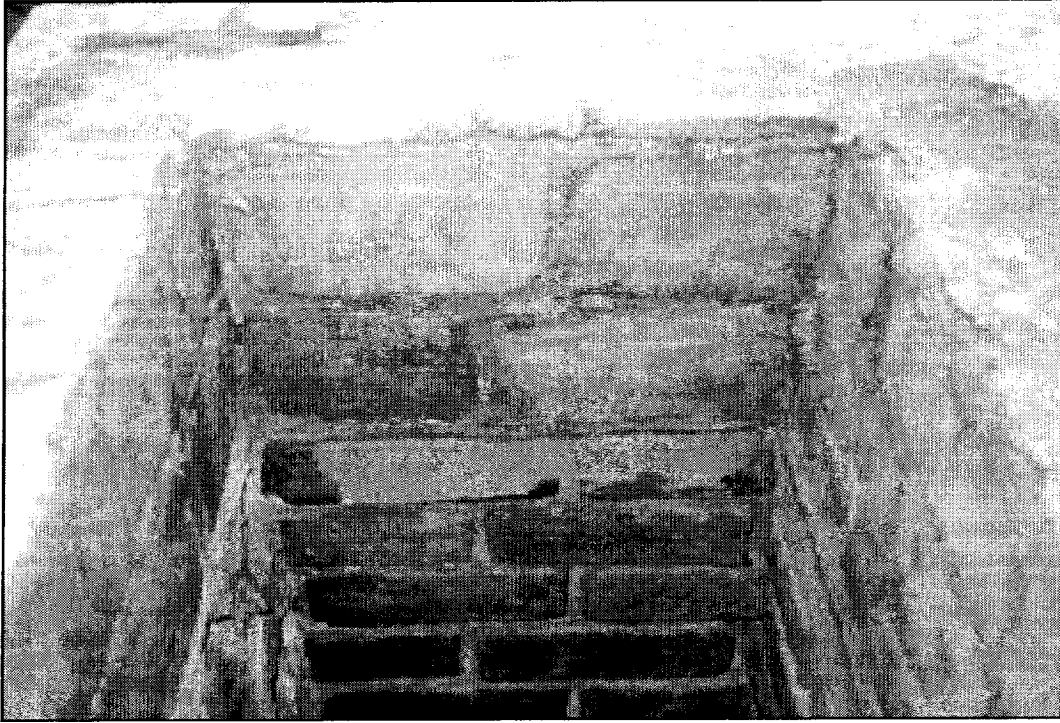
Figure 5.18: Monument Lodge, roof, note rusting through flashing at southwest chimney.

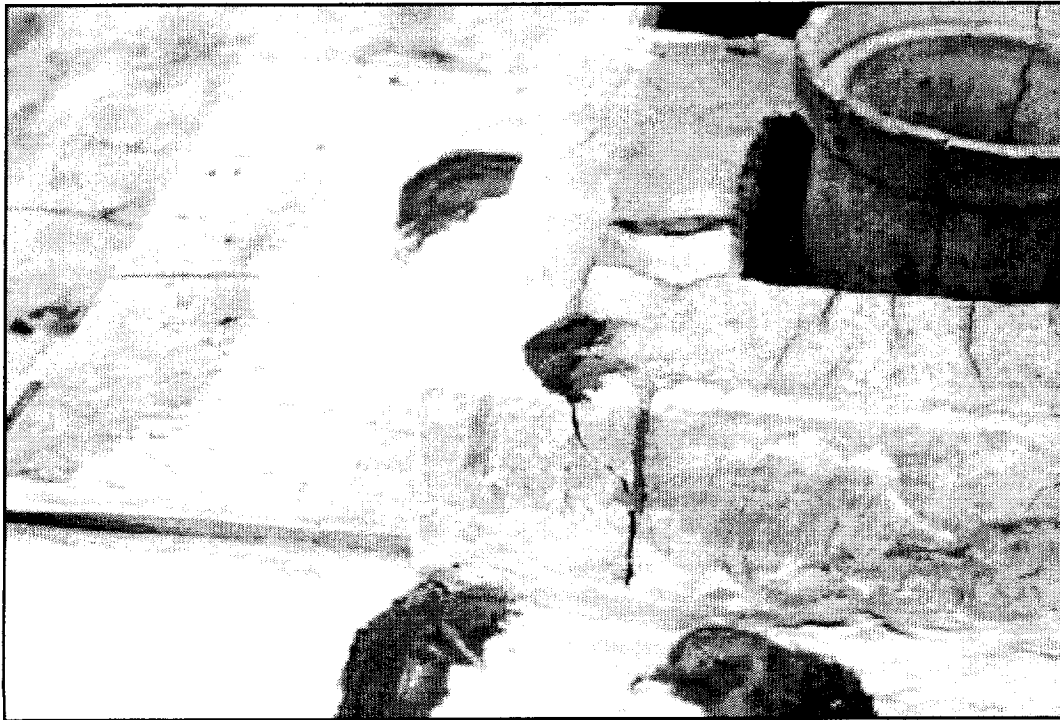
Figure 5.19: Monument Lodge, roof, detail of cracks at northwest chimney.

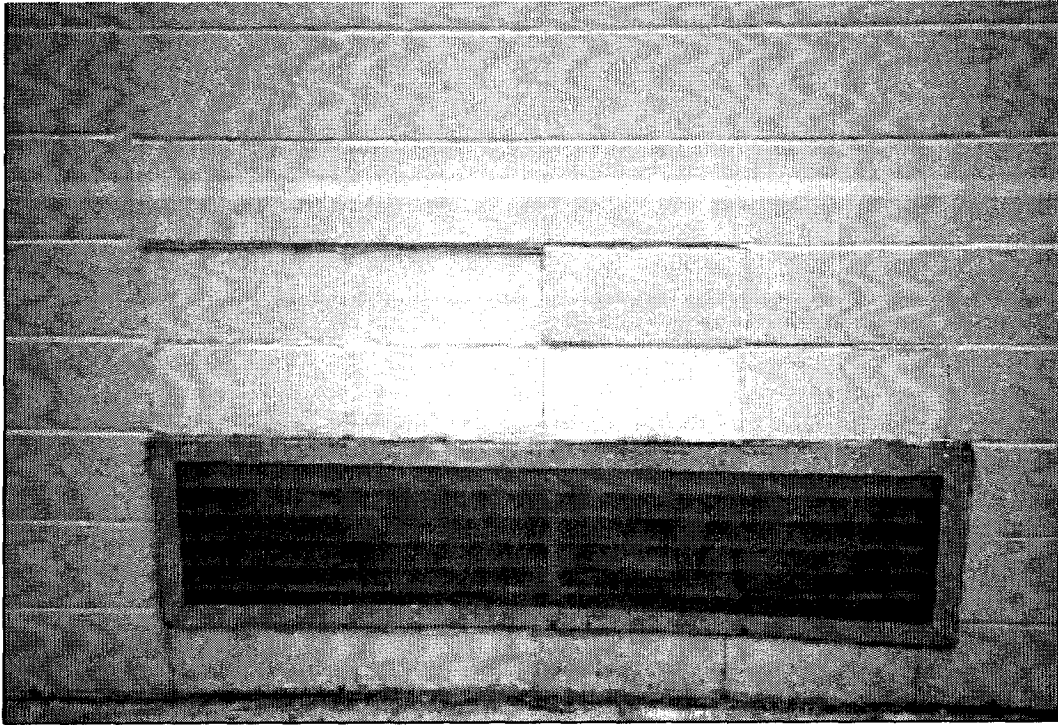
Figure 5.20: Monument Lodge, concession addition, south façade, detail of movement in CMU wall.

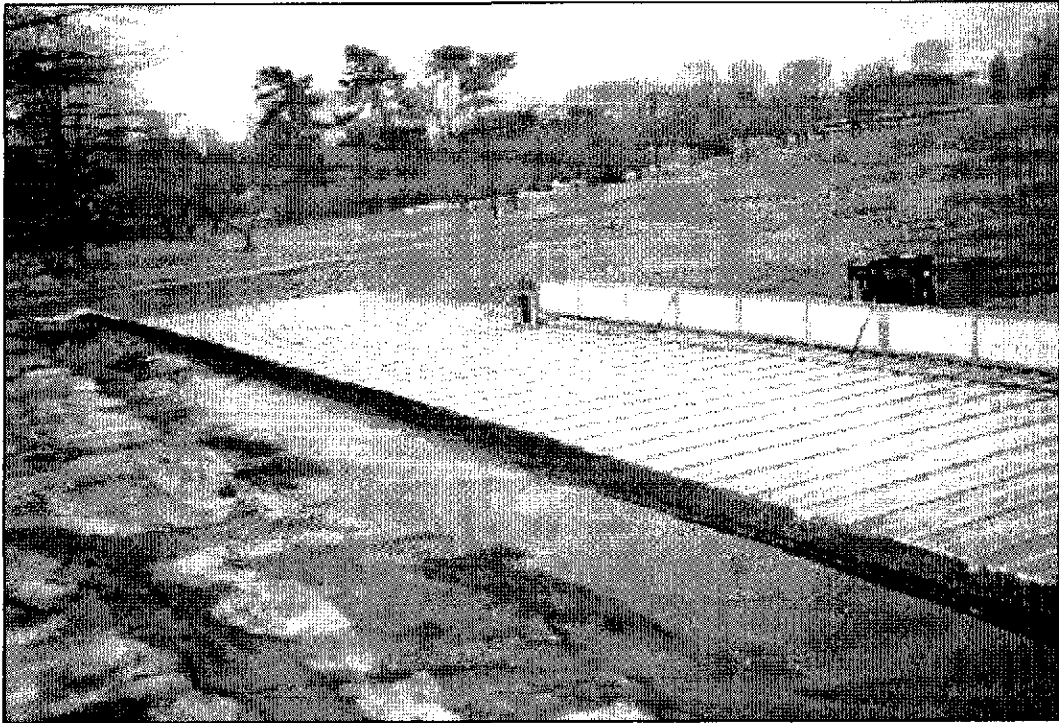
Figure 5.24: Monument Lodge, Concession Addition roof, note pooled water at west edge.

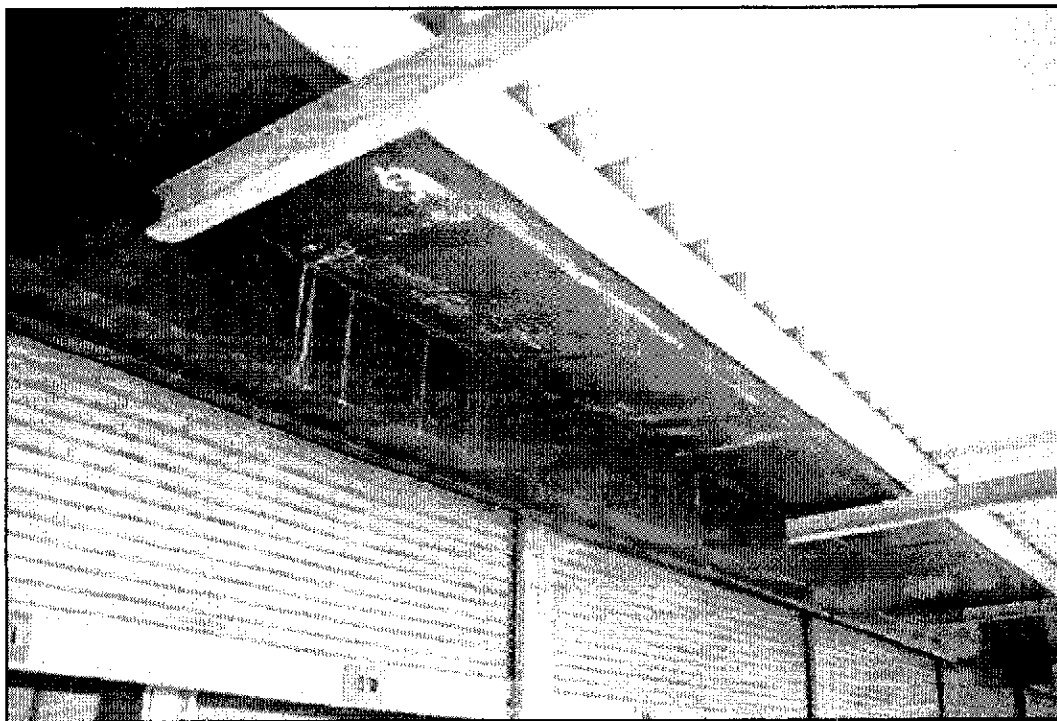
Figure 5.25: Monument Lodge, west façade, note damage at underside of porch roof.

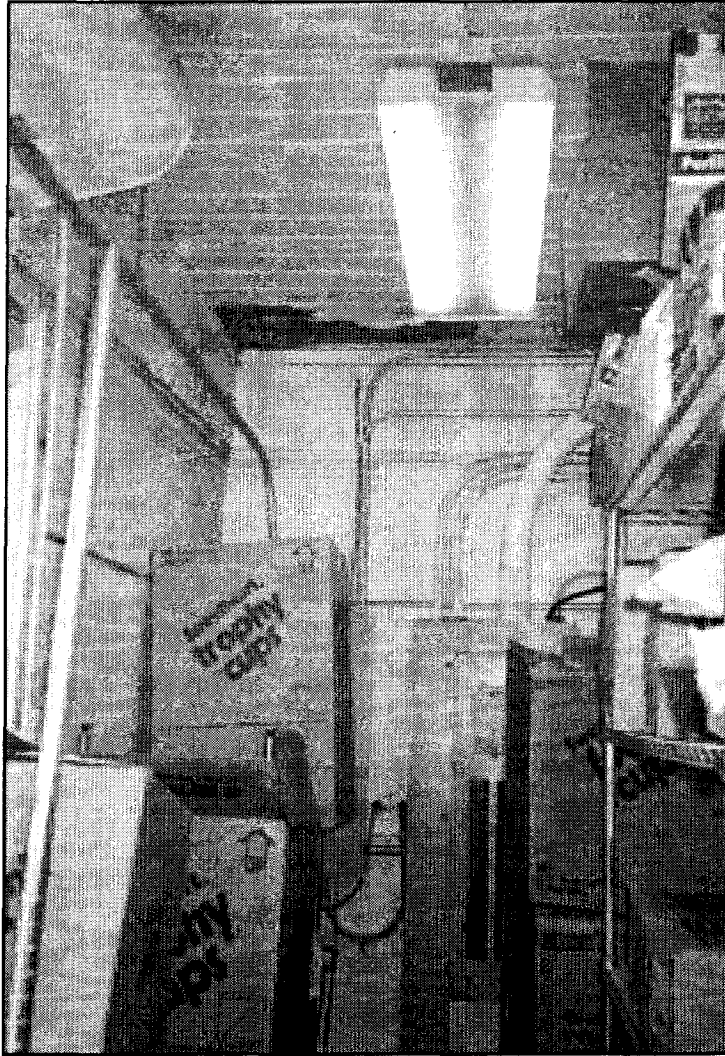
Figure 5.26: Monument Lodge, interior, Concession Addition, storage, southwest corner, note damage at ceiling.

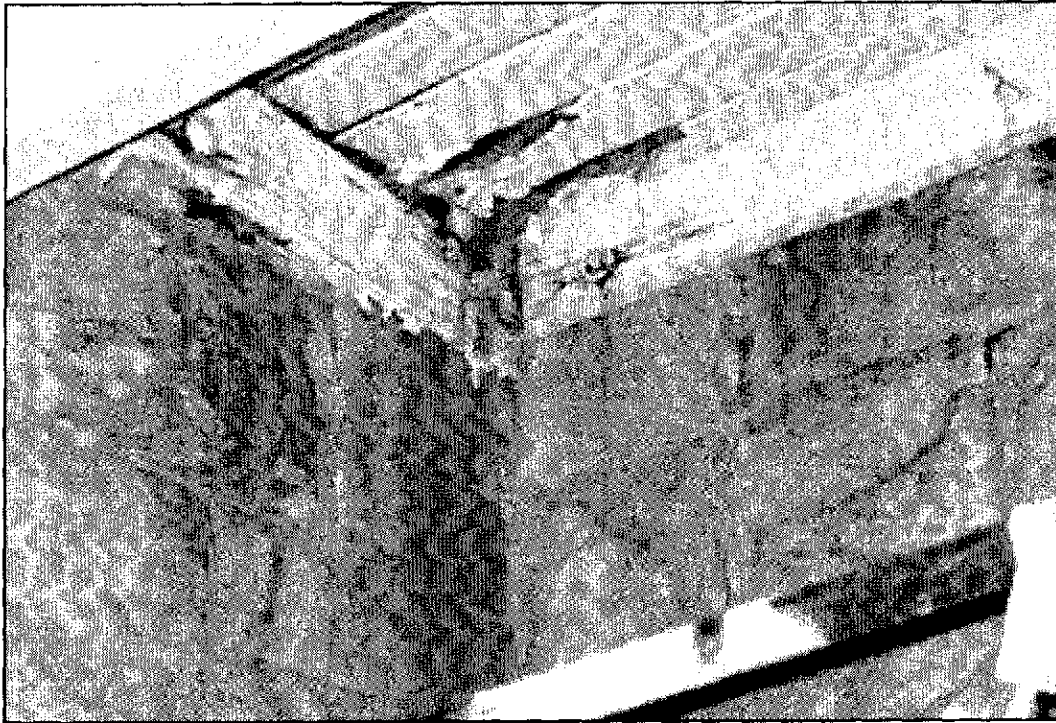
Figure 5.27: Monument Lodge, interior, Concession Addition, mechanical room, note damage to ceiling below lodge downspout.

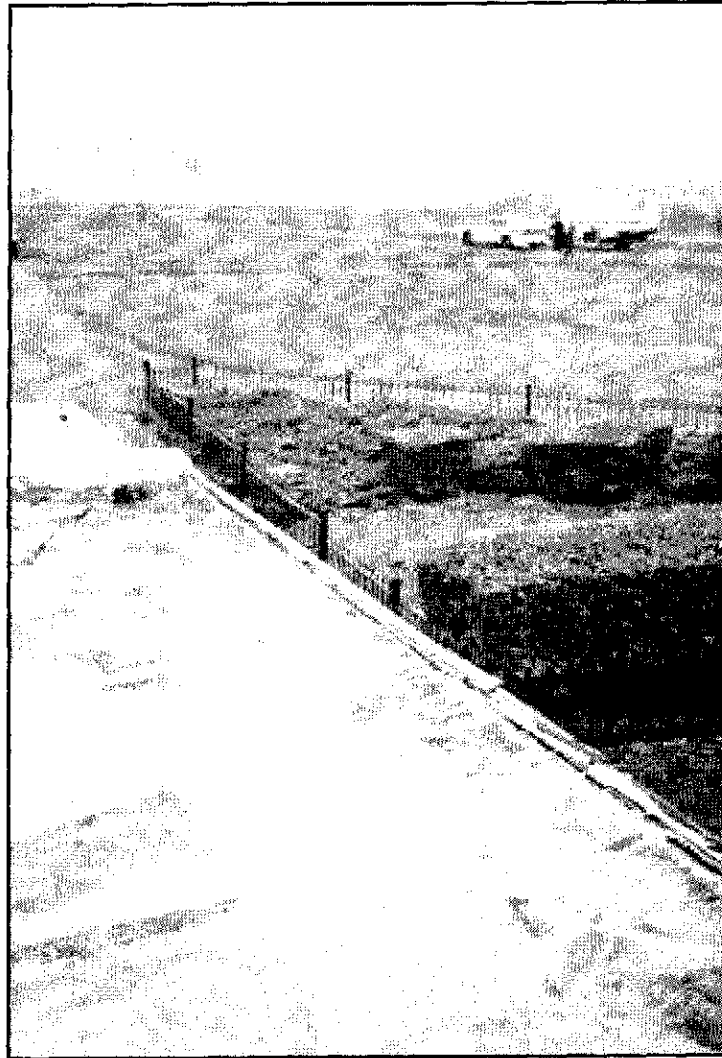
Figure 5.28: Monument Lodge, Concession Addition roof, note disrupted termination bar at south edge.

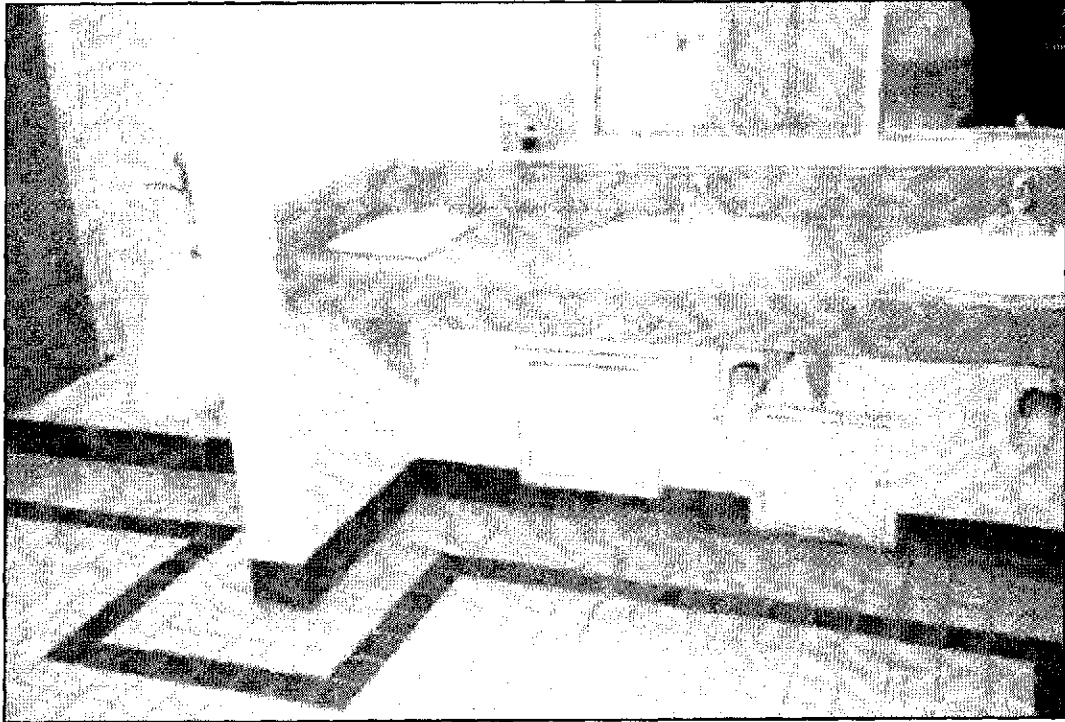
Figure 5.32: Monument Lodge, interior, mens' rest room, looking south, note rusting utility panels.

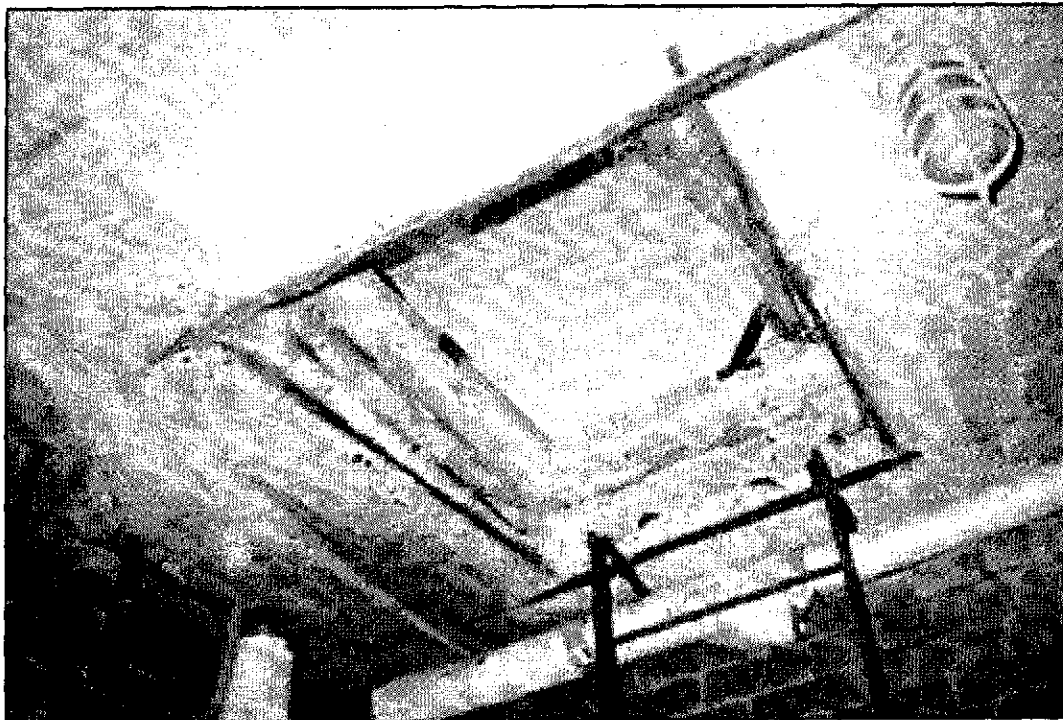
Figure 5.33: Monument Lodge, interior, boiler room, note rusting reinforcing bar at concrete ceiling near trap door entrance.

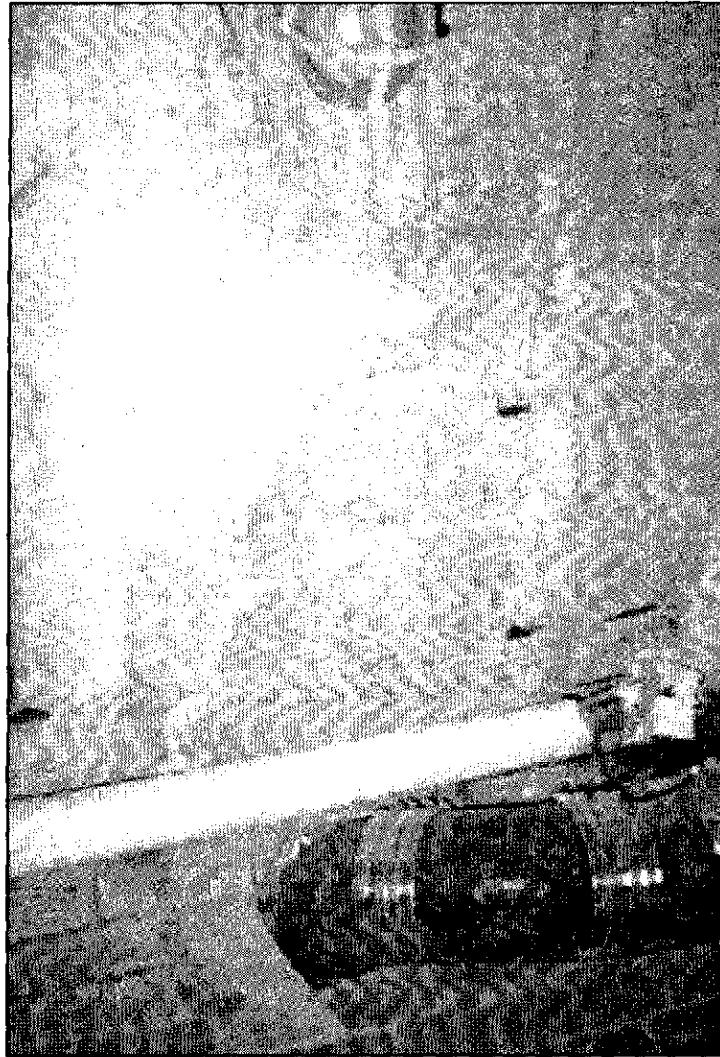
Figure 5.34: Monument Lodge, interior, boiler room, note concrete delamination at southeast ceiling.

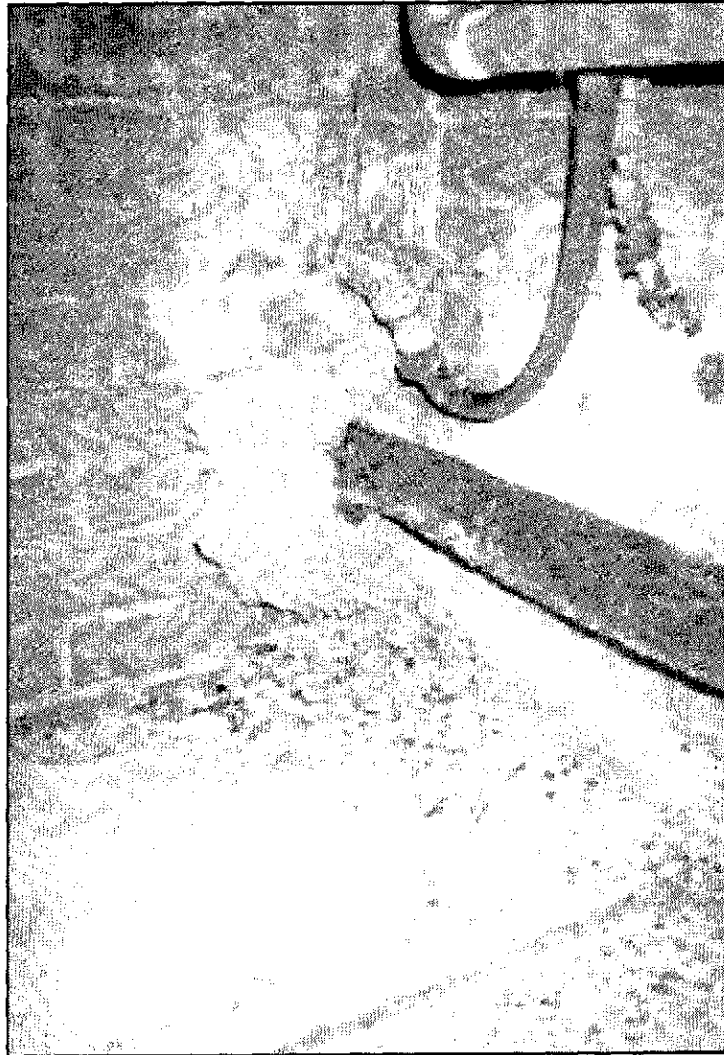
Figure 5.35: Monument Lodge, interior, boiler room, note deterioration of concrete at northwest ceiling.
