VILLAGE HALL

Women's Rights National Historical Park

Historic Structure Report

VILLAGE HALL
HISTORIC STRUCTURE REPORT
Women's Rights National Historical Park
Seneca Falls, New York

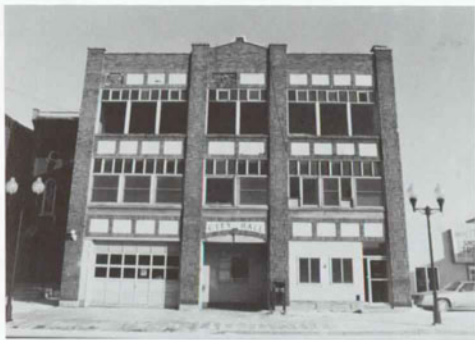
Fig. 13. Exterior South Facade [1988].

Brick Surface. The brickwork at first-story level is in good condition. It is chipped at midpoint on the east side of the garage doorway, and the east side of the central bay (which originally also was a garage doorway.) It is possible that both chipped areas are the result of vehicles passing through the doorways.

The parget on the back side of the parapet is also in poor condition. It is cracked and has spalled, exposing the underlying brick masonry to weathering.

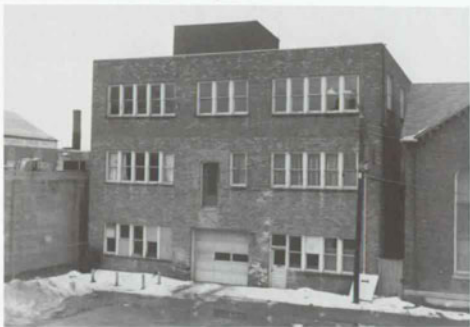
Fig. 15. Exterior North Wall [1988].

The overall condition of the north wall is poor. There are no obvious structural dangers (e.g., areas of bowing or eminent collapse). However, the surface conditions of the bricks and mortar are among those that contribute to eventual structural failure. These conditions are most severe at first-story level. For example, surface loss in the form of spalling occurs most extensively at first-story level. There are also localized areas of efflorescence, specifically on either side of the garage doorway to a height of about 4 feet. The brickwork directly below the second-story doorway is stained with a white haze. This may be the result of mortar being exposed by the deteriorated and missing brickwork below the doorway (see below).

Brick Cracks. The north wall displays three areas of extensive cracking, all located between the first- and second-story levels. The east end of the east bay contains a vertical crack that ascends, from a point about level with the first-story windows' meeting rail, to the east end of the second-story window opening's sill. The crack runs mostly along and through the mortar joints, but does traverse a few bricks (approximately 5 out of 40 courses). The crack's greatest width--approximately 1/4 inch--occurs next to the lintel of the first-story window opening. The east bay also displays a vertical crack below the middle window at

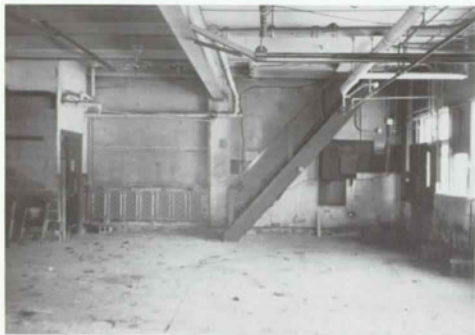
Fig. 32. Room 106 (Garage), Looking West [1988].

Floor. The concrete floor has no finish. It is marked with oil and water stains. A trap door sits along the east wall north of the elevator; its function may relate to automobile repairs.

inal, judging by the former's characteristically smooth texture. The plaster is in poor condition, being cracked throughout. At the north end of the wall, where a steam radiator is attached, the plaster has spalled extensively.

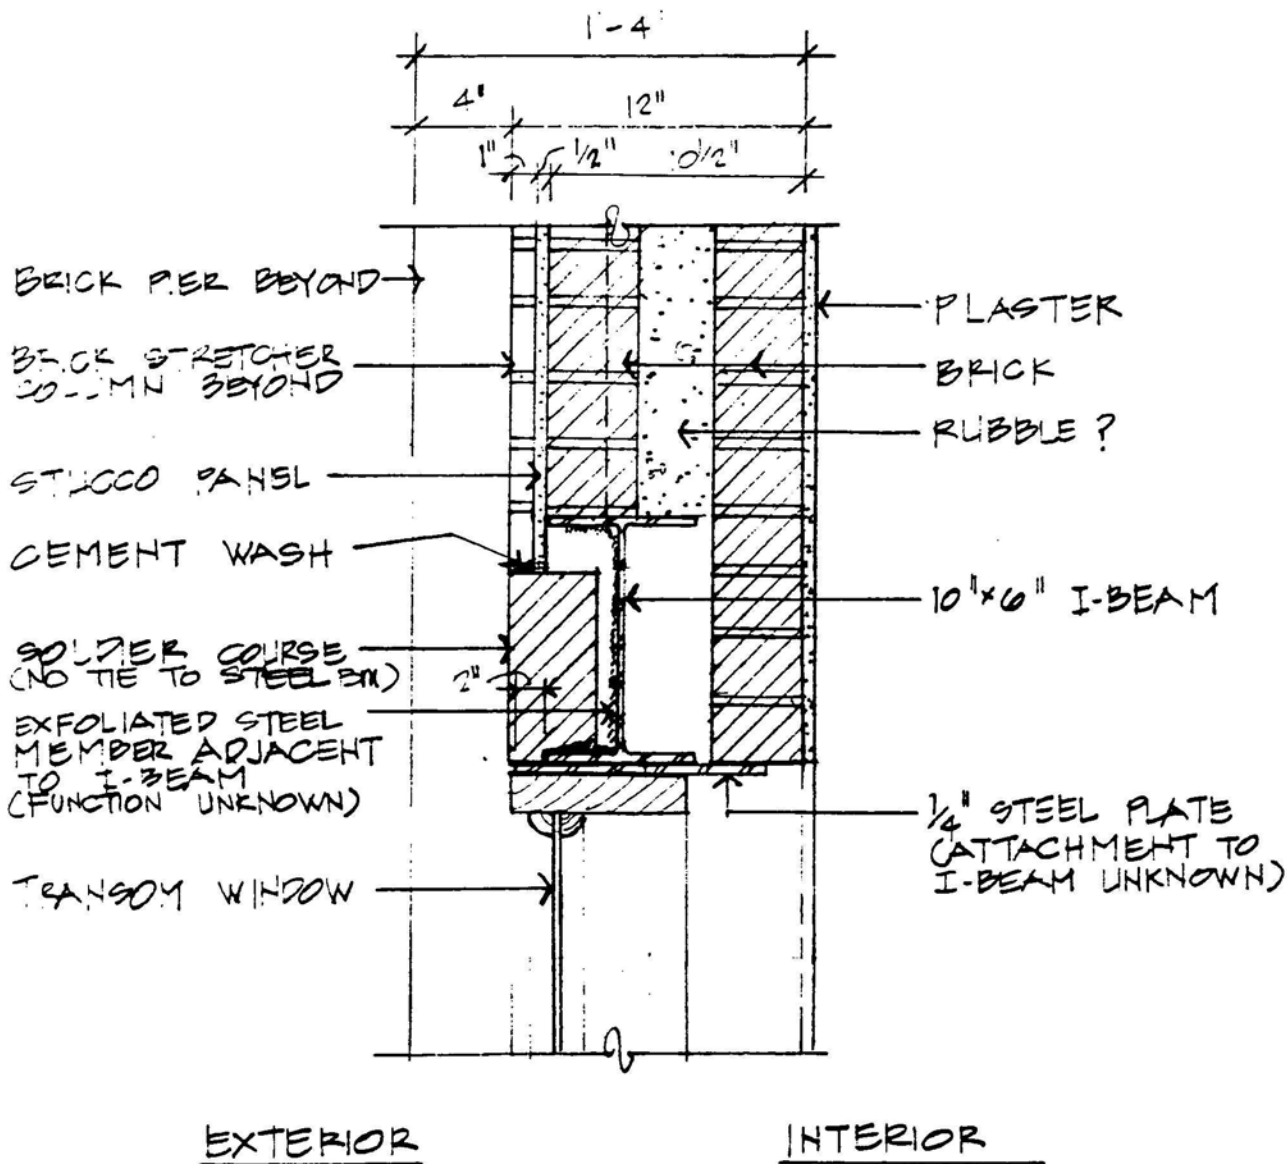
SOUTH WALL SECTION
 SCALE: $1\frac{1}{2}'' = 1'-0''$

NOTE: BOWED SOLDIER COURSE ABOVE 2ND STORY WINDOWS (EAST END) REMOVED & STORED. NAME ON BRICKS - "CALEDONIAN".
 SOLDIER COURSE ABOVE 3RD STORY WINDOWS ALSO EXHIBITS MOVEMENT.
