**WRIGHT BROTHERS NATIONAL MEMORIAL  
VISITOR CENTER**

**HISTORIC STRUCTURE  
REPORT**

2002  
Historic Structure Report  
Wright Brothers  
National Memorial Visitor Center  
Kill Devil Hills, North Carolina  
LCS#: 91645

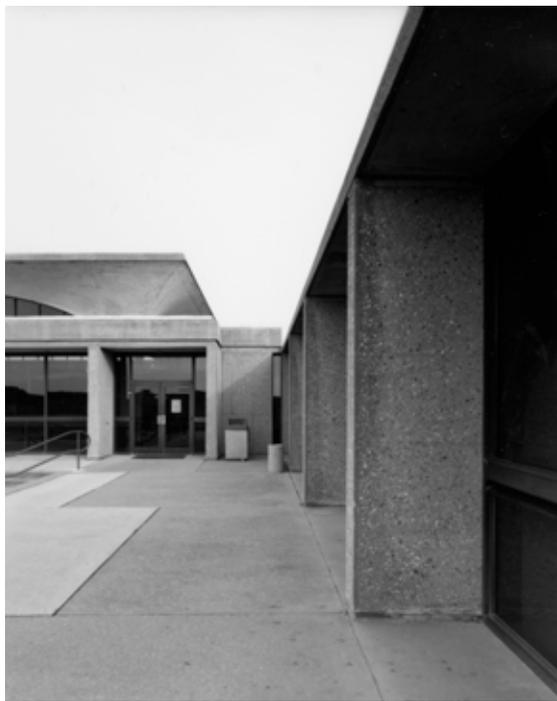
**Figure 20** Above, view of concrete paving of Ceremonial Terrace, showing original exposed-large-aggregate panels to right, and the brush finish of modern repairs at left (National Park Service, 2000)

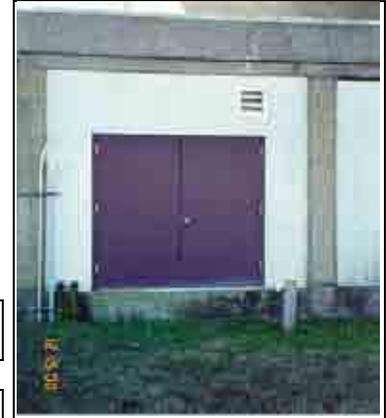
**Deficiency:** Original design plans have been significantly altered with this addition. However, it will not be possible to remedy if the HVAC systems are not revised.

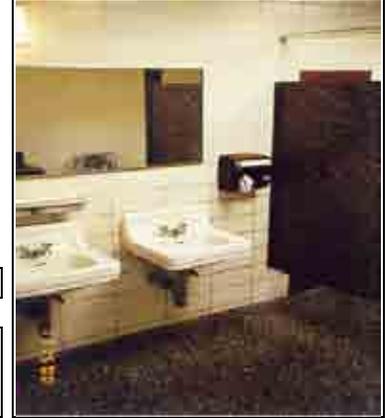
**Deficiency:** Penetrations for mounting non-original fixtures in the restroom.

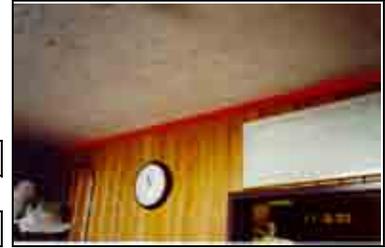
**INTERIOR****4220****Interior Ceiling Surface/Flight Room Dome****Feature Description:** Exposed Concrete with Spray-on Acoustical Finish - The ceiling finish is exposed concrete with sprayed on, non-asbestos containing acoustical finish. Documents on past work on the structure indicate that the dome originally had a sprayed-on, asbestos containing acoustical finish applied to the cast in place concrete.**Feature Notes:****Feature Condition:** Excellent to Good**Total Inventory:** 1,600 SF**Historic Rating:** N**Priority:** Critical**Deficiency:** Non-contributing finish due to the loss of the texture of the acoustical material and the exposure of the board form pattern on the underside of the dome.**Recommendation:** Apply spray-on acoustical material to underside of dome with texture, color and finish to match original.**Materials:** \$912.00**Labor:**

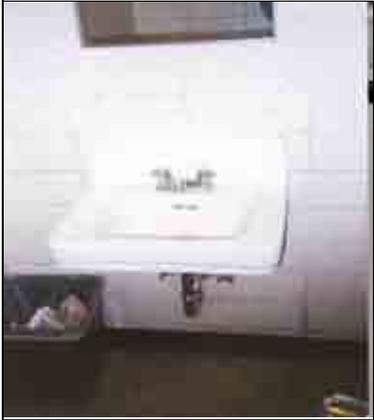
**Deficiency:** Not handicapped accessible

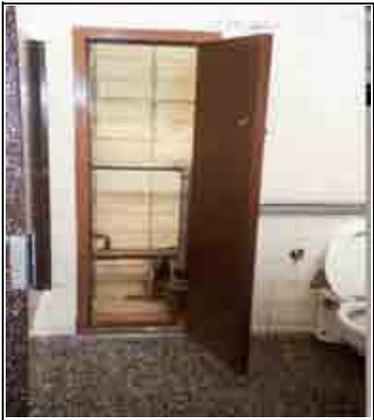
**Deficiency:** Water closet designated for handicapped is not mounted at proper height for handicapped accessibility.

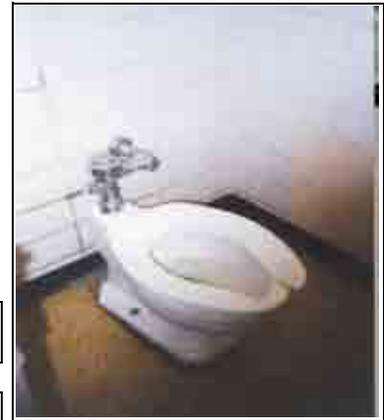
**Deficiency:** Not handicapped accessible proper height for handicapped accessibility.

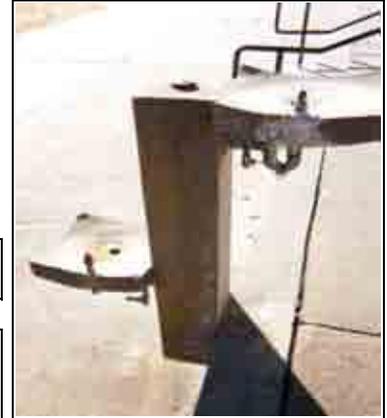
**Deficiency:** Working parts are missing, concrete parts are cracked and broken out.

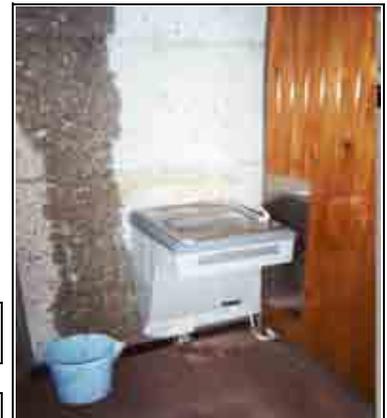
**Deficiency:** Too close to wall for handicapped access out,
