THE STILLWATER ROAD (SHEA) BRIDGE Cumberland, Rhode Island

Tech Notes

METALS NUMBER 4

Rehabilitating a Historic Iron Bridge

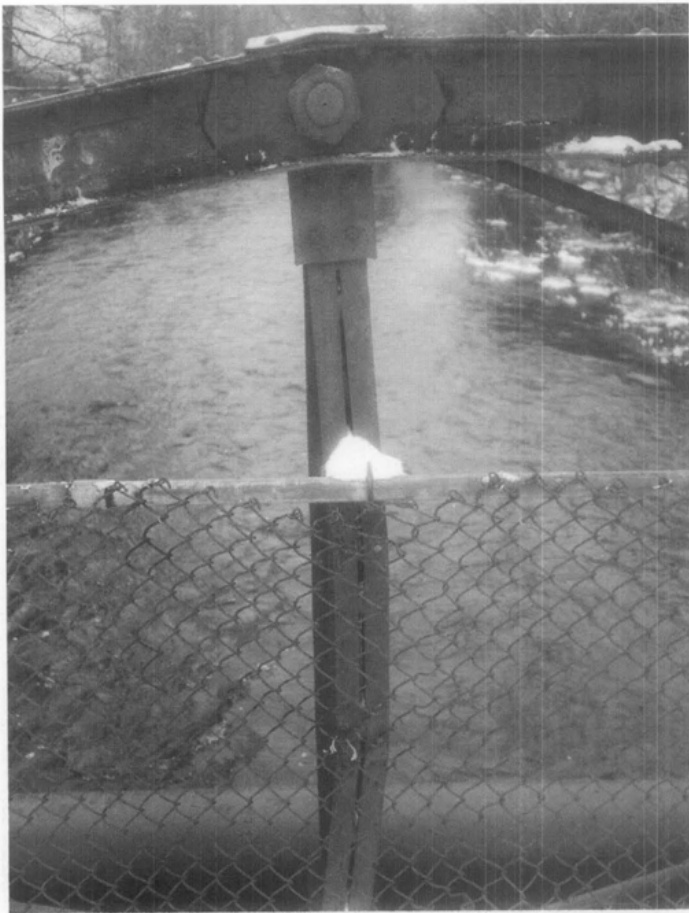
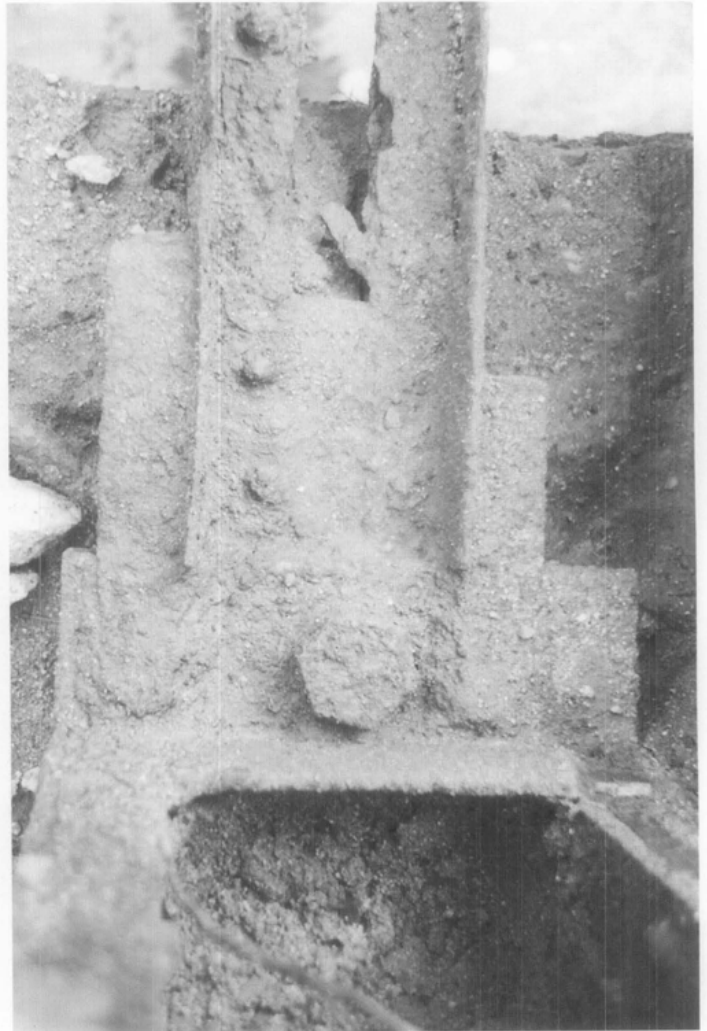
After a century of use, the bridge showed signs of major deterioration. Three of the four upright posts were bent from automobile collisions. The U-bolt floorbeam hangers had rusted, the result

of moisture and dirt collecting on the flange. The lattice girder stiffeners (zero-force members which serve to prevent "racking" or lateral movement) had lost their latticework and were severely corroded. In addition, the endposts of the bridge showed signs of serious decay (see figures 2 and 3).

Figures 2 and 3. The extent of damage can be seen in the bent vertical post member (below, left) and the heavily corroded end post (right). Similar problems existed throughout the structure. Photo: Beta Engineering.

Some parts were so deteriorated that they could not be preserved and re-used as planned, including the end posts, lattice girder stiffeners, and all four vertical (lattice girder) stiffeners. This was somewhat disappointing, as the original specifications called only for the removal of the floorbeam hangers, and the intent was to save as many of the original parts and fasteners as possible. The new, matching members would be more cost-effective and actually stronger than repairing the original pieces. The other drawback was that the new elements would need to be fabricated of steel, rather than higher-priced wrought iron. Once completed, however, the

Meanwhile, the endposts, lattice girder stiffeners, and vertical posts were being fabricated from steel (see figure 8). The original end posts had been constructed as a box section; one plate and two angle iron pieces were riveted together to form a column with one lattice side.

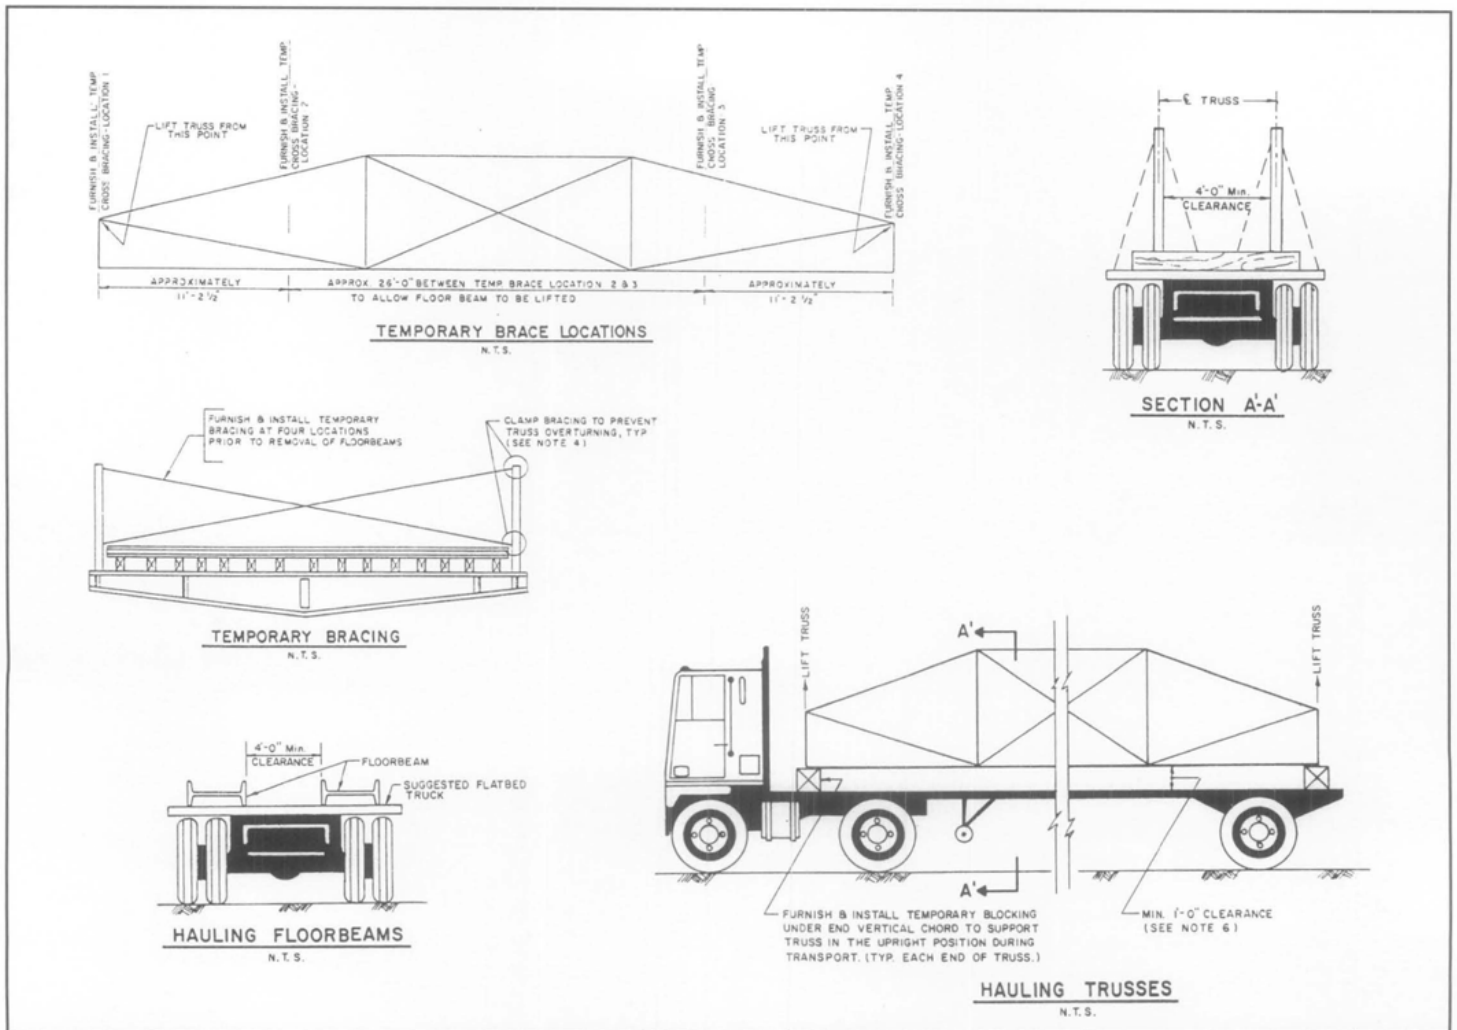
Figure 5. A temporary bracing system assured the protection of the bridge during disassembly.

At this point, a temporary bracing system was built to stabilize the trusses before construction work proceeded (see figure 5). This wooden system was extremely important—without it, the trusses might have twisted or overturned during the remaining disassembly work.

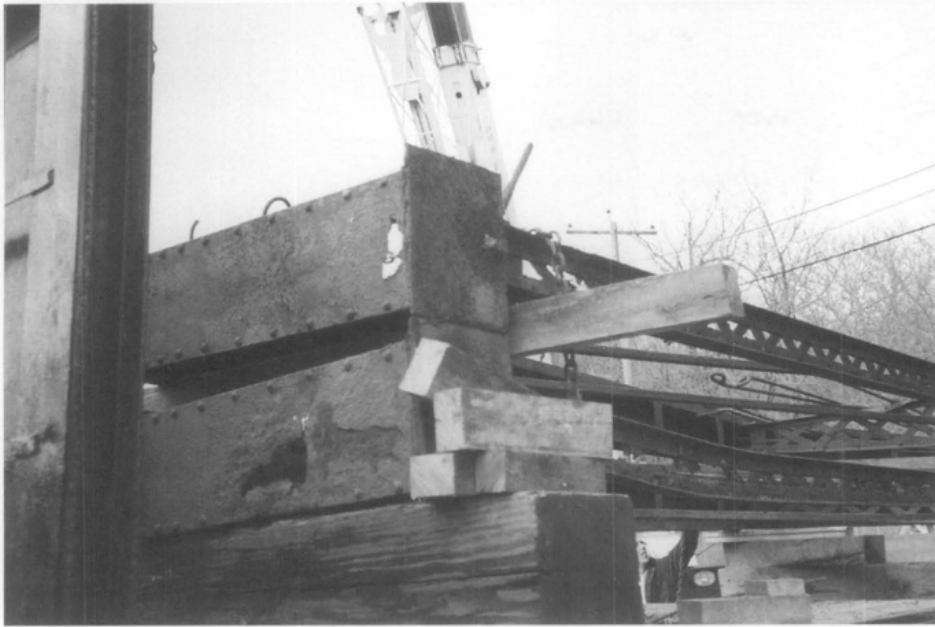
With the trusses stabilized, the deteriorated floorbeam hangers were removed. The floorbeams themselves were lifted, one at a time, by crane onto a flatbed truck, and transported to the shop. With the temporary bracing removed, the trusses were then attached to the crane and lifted in one piece, then placed on their sides on the truck (see figure 6). The plans had specified that the trusses be placed on the truck in an upright position, with protective bracing. But when the first truss was mistakenly laid on its side, the deteriorated lattice girder stiffener was severely bent. Fortunately, this lattice girder was slated for disposal before the damage occurred. The other truss was removed without damage.

Figure 6. Although plans specified that the trusses be placed in an upright position, they were placed on the truck on their sides (left). The lower truss was damaged during the loading operation. Photo: Beta Engineering.

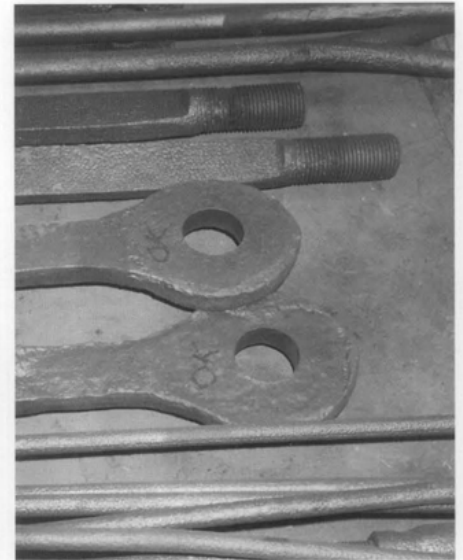
Figure 7. The pieces were disassembled in the shop, then cleaned of rust and paint. The worn condition of the eye bars can be seen in the center of the photograph. Photo: Beta Engineering.

The salvageable parts were placed in a Wheelbrator, a machine which removes rust through repeated vibration. The iron members were then sandblasted to remove paint and any remaining rust, then subjected to magnetic particle testing to determine which pieces had unseen damage or decay. The test was useful in determining wear in some of the parts, particularly the eyebars of the lower chord and the middle panel tension rods. In addition, some of the pins had worn by more than 1/4" over time.

In order to reuse as much of the historic material as possible while ensuring sufficient structural integrity, it was decided to "build up" through welding those pieces that were worn down. In order to match the metallurgical composition of each part, a chemical test was undertaken. This testing allowed for an exact metallurgical match between the new built-up welds and the original metal of each part. Such a match reduced the possibility that a harmful physical or chemical reaction would take place between the weld and the wrought iron.

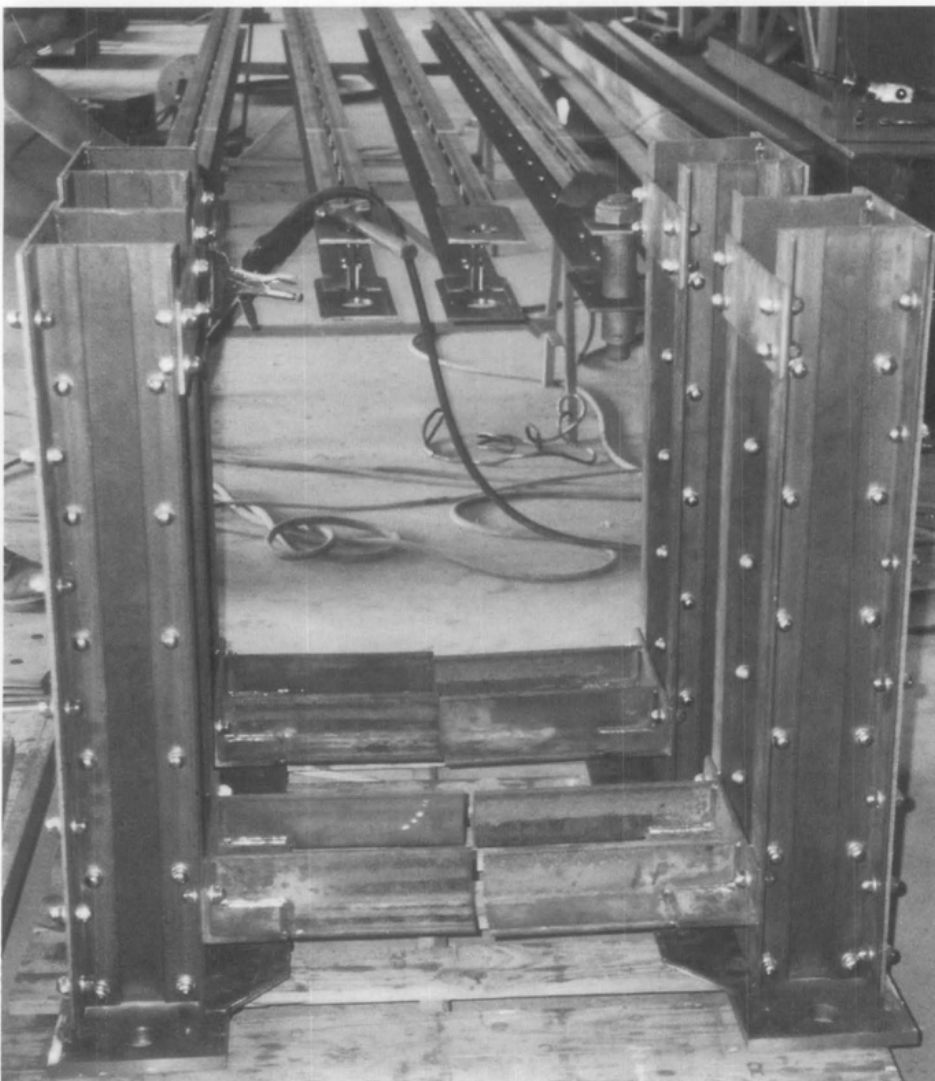
Figure 8. New endposts (foreground) and lattice vertical posts (background, center) were fabricated from steel. The rivets are actually threaded; hidden bolts help keep the pieces together. Welding provides additional strength. Photo: Beta Engineering.

Only the rivet heads could be found, and there seemed little use for them. But after some thought, a creative solution was formulated. The shanks of the rivet heads were threaded, and the plates screwed together. For structural strength, the pieces were also welded, but this weld is invisible from the outside. The result is a welded box girder that looks, from the outside, like an authentic riveted member. Had no rivets been found, a similar procedure could have been followed using hack bolts. (These are bolts with heads that look like rivets but have nut fasteners.)

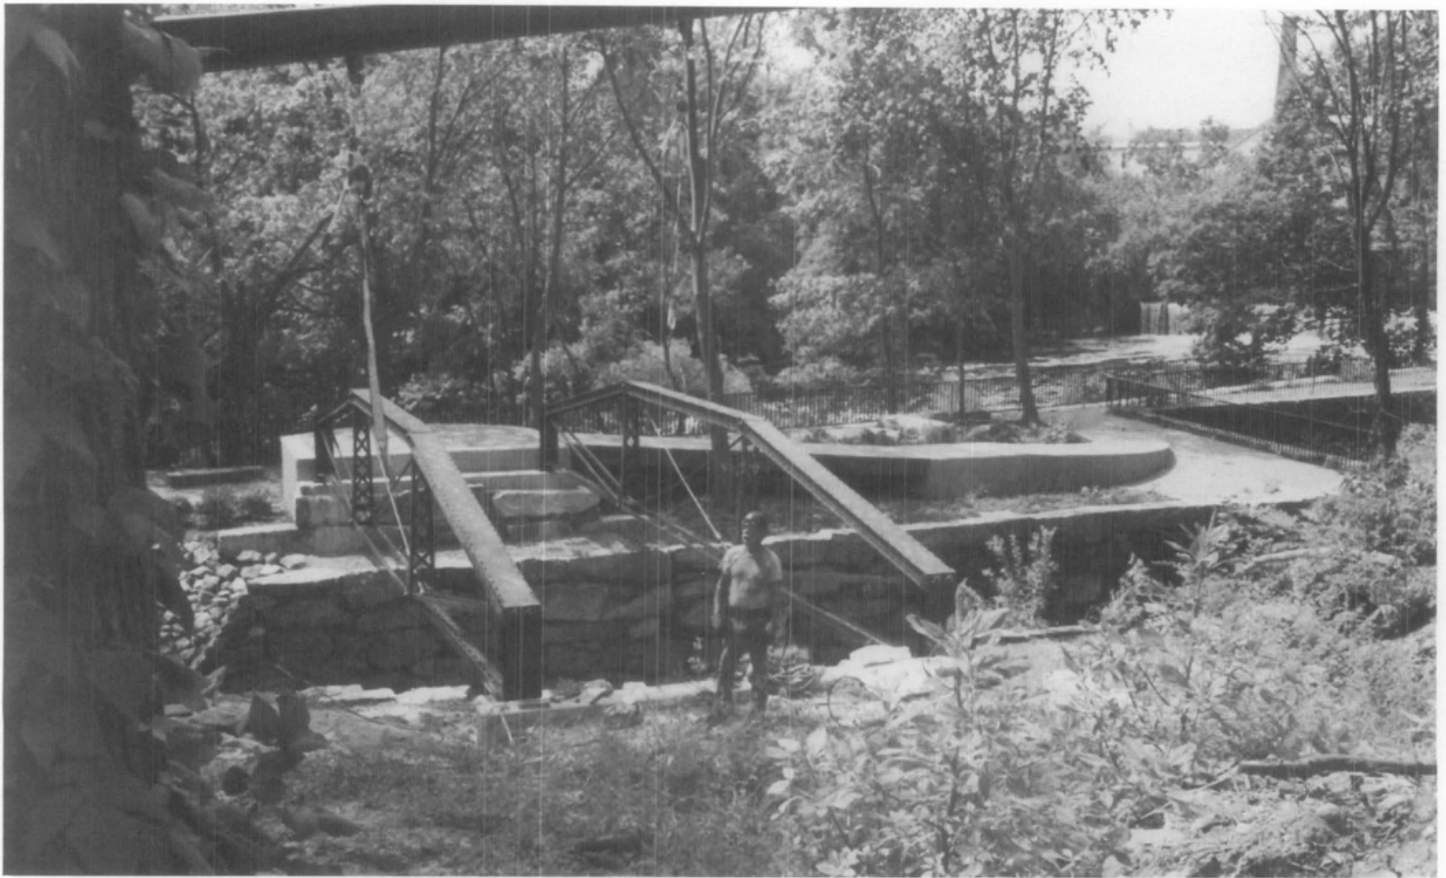
Figure 9. The trusses were lifted by crane and set into position on the new site. Photo: Beta Engineering.

When the new foundation was completed, the trusses were lifted by crane to the site, installed in place, and secured with temporary wooden bracing (see figure 9). The rest of the bridge (floor beams, hangers, stringers, etc.) was then

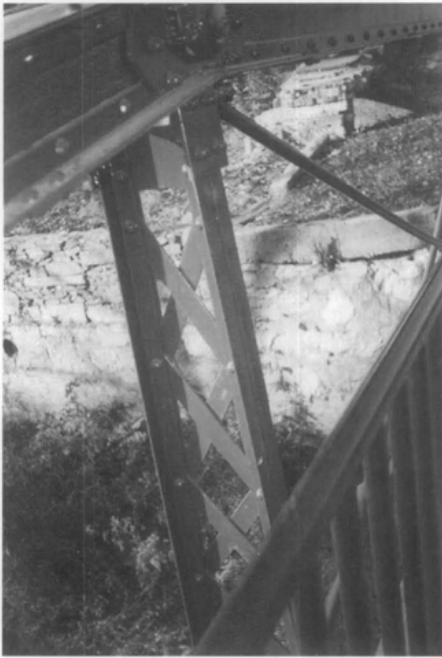
Figure 10. The new lattice girders are shown as installed on the bridge. Photo: Joseph P. Saldibar, III.

assembled, in the reverse of the dismantling process (see figure 10), and a new hardwood deck was installed.
