Tech Notes

WINDOWS

NUMBER 8

Thermal Retrofit of Historic Wooden Sash Using Interior Piggyback Storm Panels

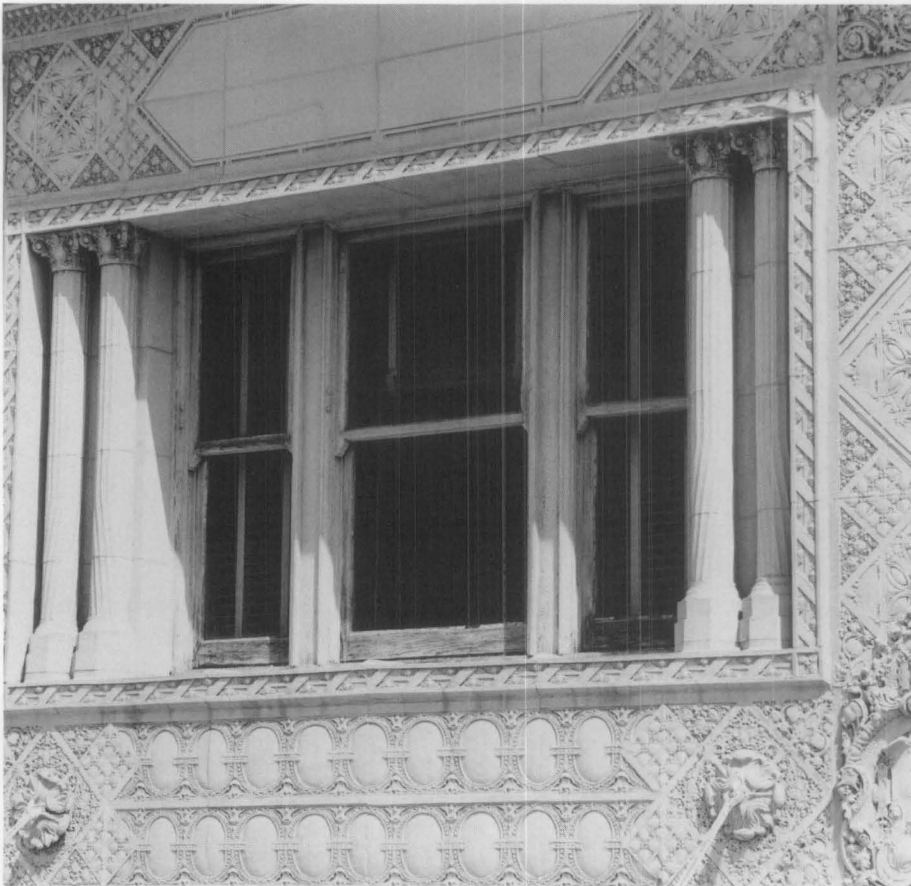
The need to seek a cost-effective and yet compatible solution quickly eliminated two common options. The first was the use of an exterior storm window since it would have altered the deep setback which was a character-defining feature of the building. The second alternative was the use of a modern replacement window. The cost of replicating 507 double-hung windows out of wood and installing thermal glazing was beyond the budget of the owner. A much less expensive solution, which was investigated, involved the replacement of all windows with a metal frame, fixed sash and solar grey heat absorbing insulating glass. While the cost estimate of \$300 per unit was within budget, the architect felt that such a solution was unacceptable since it would have drastically changed the building's historic appearance.

Figure 1. Deeply recessed windows with ornamental terra-cotta surrounds were character-defining features of the building which the owner wanted to retain. Photo: Jack Graves, AIA

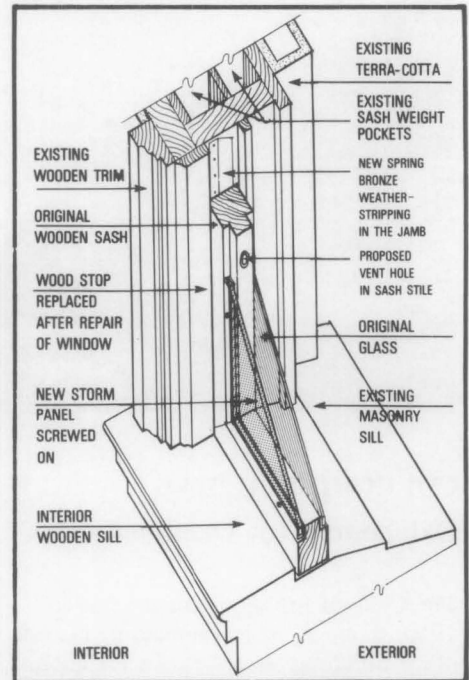
This approach would necessitate routing or cutting out a portion of the historic wooden sash and would add to the weight of the sash due to the attached storm panel. The sash rails and stiles measured 1-7/8" deep by 2" wide and were in sound condition. They were therefore capable of tolerating the required cut—3/8" deep by 1/2" wide. The issue of the additional weight of the storm panels was directly related to the choice of materials selected for the piggyback units. Since acrylics are purported to be 40% lighter than glass and 15% more thermally efficient for the same thickness, the architect investigated their use. Because of expense and the tendency of acrylic to bow or discolor due to sun

Figure 2. Cutaway view of the proposed retrofit solution showing how the historic sash would receive a recessed storm panel through routing or cutting an inside rabbet. Drawing: Sharon C. Park, AIA

While researching new window units, the architect found a commercially available wooden replacement window that incorporated a removable storm panel piggybacked onto the single glazed sash. This second layer of glazing was recessed on the inside of the primary wooden sash, allowing the double-hung window to operate without interference from the applied panel. The architect applied this concept to the Colcord Building's windows and proposed to retrofit a recessed storm panel to each existing sash, provided it would not structurally weaken the sash in the process (see figure 2).

The use of interior storm panels affixed to a sash can create a potential problem of trapped condensation. To avoid this possibility, the architect specified two features. The first was a neoprene gasket as an air seal between the wooden sash and the aluminum frame of the storm panel; the second was the creation of ventilation holes in the wooden sash stiles. The vent holes, drilled laterally through the stiles, were to provide a minimum of air circulation should moist air condense between the layers of glazing.

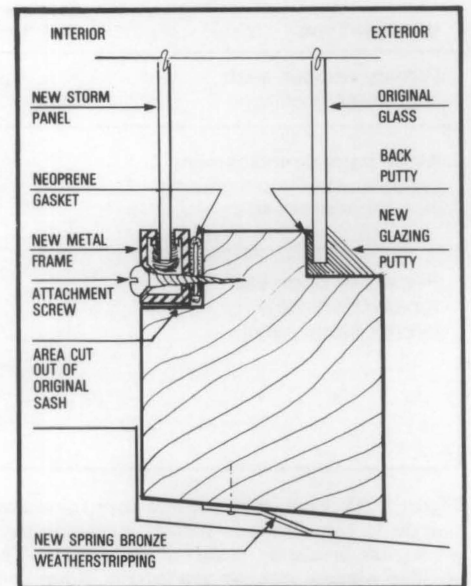
Figure 3. The completed retrofit shows the storm panel screwed onto the historic window. Photo: Tamara Coombs

As the panels would only be removed for maintenance purposes, the architect determined that the panels simply could be screwed in place, using a neoprene gasket set on the back side of the panel as a seal (see figure 3). Should the panels ever need to be removed, an electric screw gun would do the job quickly (see figure 4).

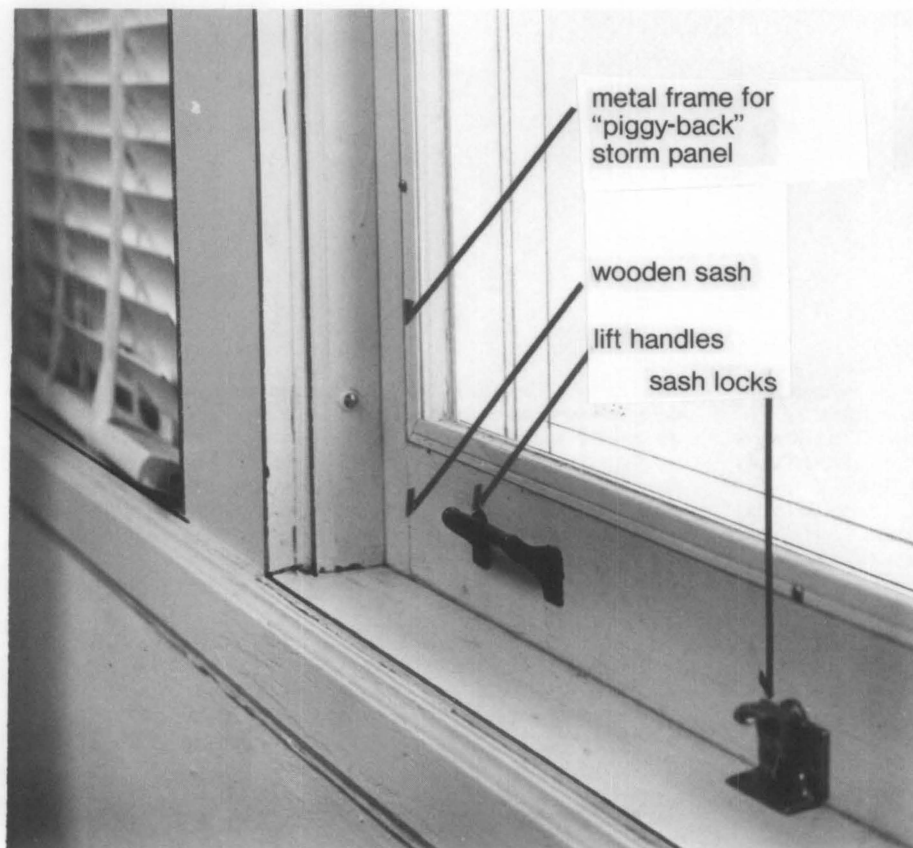
Figure 4. The applied interior storm panel was screwed in place. Note the use of the neoprene gasket, which provides an air seal between the storm panel and the historic wooden window. Drawing: Sharon C. Park, AIA

The method for mounting the storm panels posed the final problem for the architect. The commercially available storm panels used concealed retractable clips to hold the panels in place. These clips allowed for the easy removal of the storm panels for cleaning. However, because the clips would have added substantially to the cost of the storm panels and would have required deeper routing of the historic sash, it was determined that an alternate attachment method was needed.
