## CHALMERS UNITED CHURCH

# Tech Notes

### NUMBER 14

## Reinforcing Deteriorated Wooden Windows

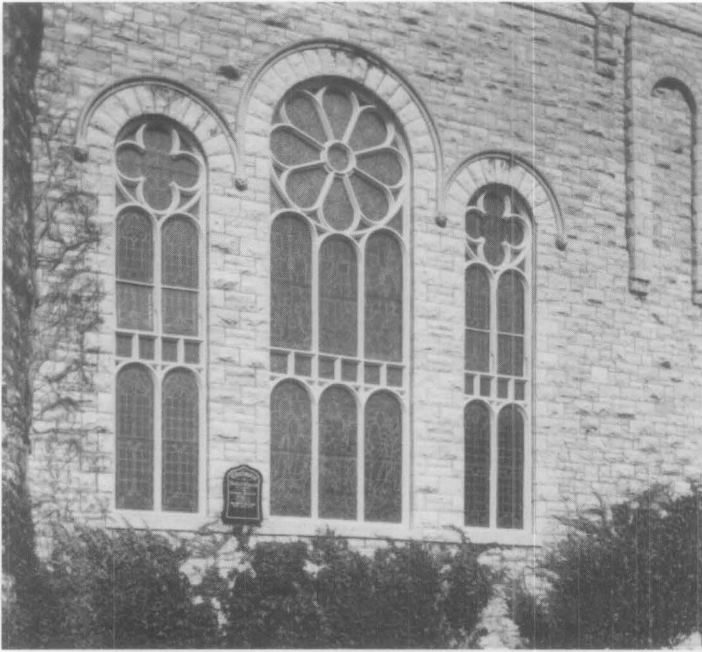
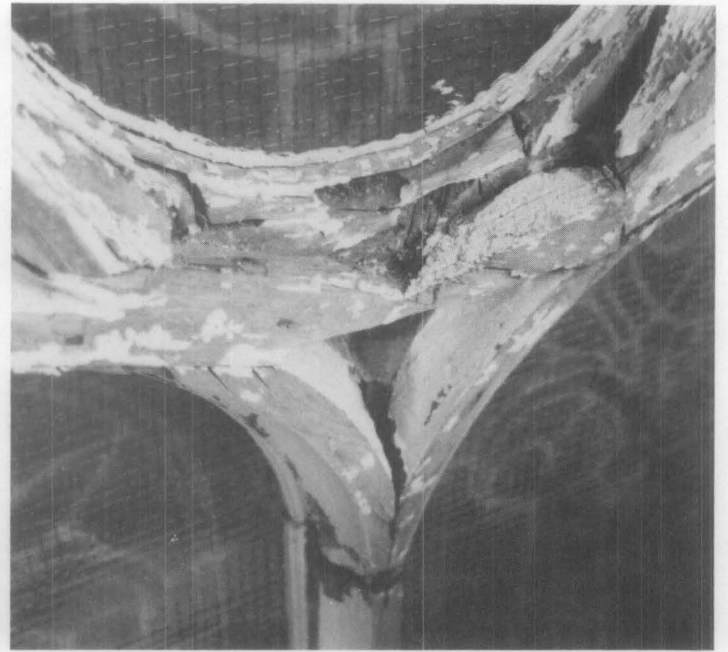
Over time the windows had suffered severely on the southern facade of the church, which is exposed to sun and constant strong winds blowing in from nearby Lake Ontario (see figure 1). This wind not only carries dust and dirt, but also has a high moisture content. Because of weathering and the lack of regular maintenance, the wooden frames which secured the stain glass panels had gradually deteriorated. The decay finally became so acute that by 1982 the windows were in imminent danger of collapsing. The parishioners at that point had no choice but to ar-

**Figure 1.** Considerable deterioration had occurred to the tripartite windows as shown in the close-up view of a portion of the mullion. (The stained glass is protected by individual sheets of wire glass set within the wood mullions)

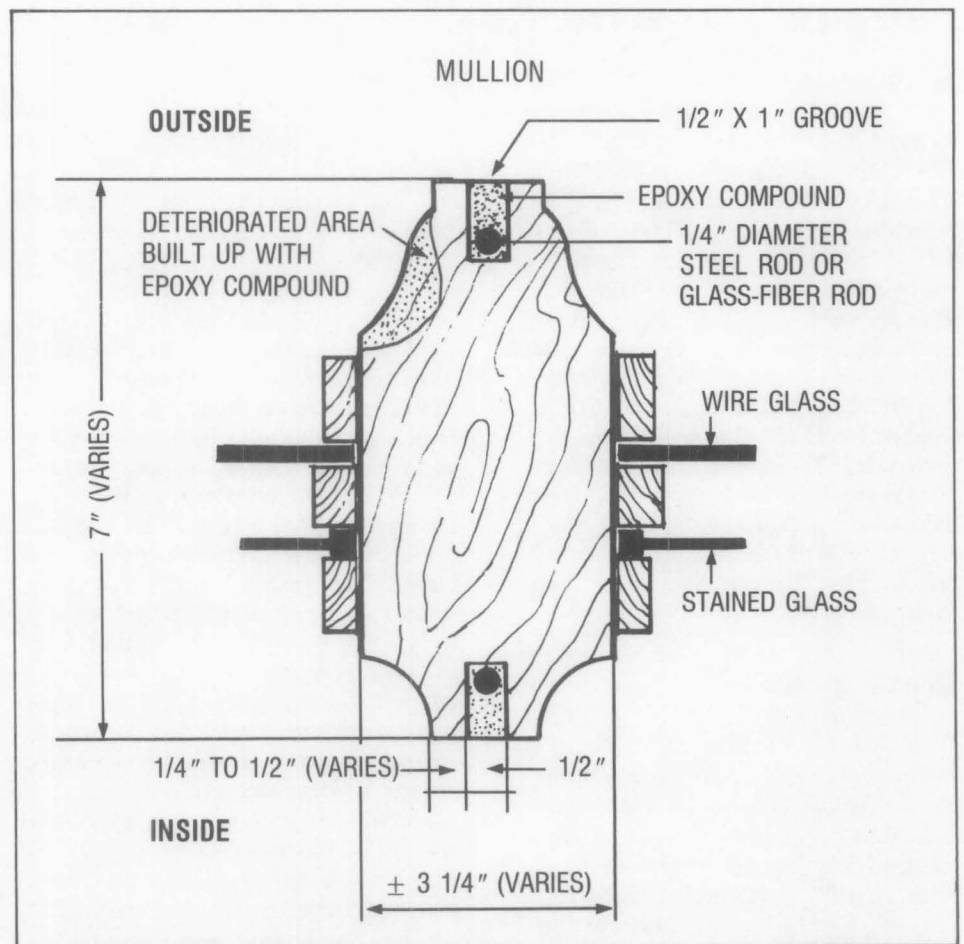
**Figure 2.** Cross section of the historic mullion shows the manner in which the pre-formed steel reinforcing bars were inserted in order to strengthen the windows. The grooves that were cut for the steel bars were filled with an epoxy compound.

Next, a 1/2" wide groove was cut into the mullions on opposite faces to receive a steel reinforcement rod. The depth of this groove ranged from 3/4" to 1 1/4", depending on the location. This delicate exercise was carried out with utmost care. After some experimentation was carried out on scrap wood, a hand-held electric router was adapted for the job. Special rollers were installed to guide the rotating cut-

For reinforcement, 1/4" diameter steel bars (the same type used to reinforce concrete) were painstakingly bent to match the curves of the mullions. The shape of the bars had to be accurate, within a tolerance of 1/8" in any direction, in order to fit comfortably in the 1/2" wide grooves which followed the complex curves of the windows (see figure 5). Because of the deteriorated condition of the wood, the steel bars could not be forced into the grooves without the danger of splitting the frames apart. In a few instances where the steel rods could not be suitably shaped, braided fiberglass strands were used instead.

With the reinforcement in place, the grooves were filled with an epoxy compound, thus completely embedding

the steel in epoxy. The epoxy used for this project — the high-modulus, thixotropic Sikadur gel in which some Union Carbide phenolic microballoons had been added for more firmness and improved workability — had the consistency of a stiff paste. This mixture had the advantage of remaining in position and retaining its shape wherever it was placed. If a fluid epoxy had been used on these vertical windows, special molds would have had to be fabricated and positioned to prevent the liquid from spilling out before it hardened. After this paste epoxy cured, it achieved a strong adhesive bond with the wood of the mullions and the reinforcing steel bars, creating a sturdy composite window frame.

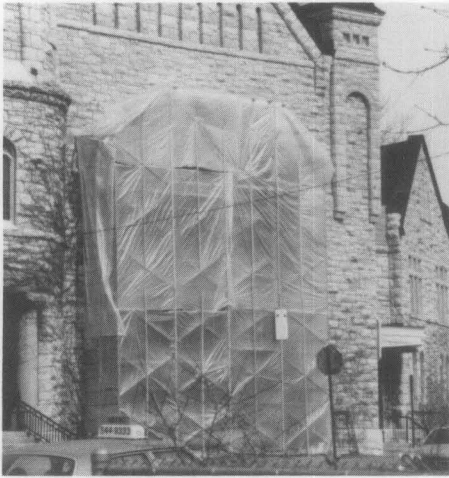
Figure 3. A vinyl cocoon placed over the windows allowed the repair work to be carried out even in inclement weather.

of damage during removal and transportation. Instead of making new mullions, the decayed frame was reinforced in an unusual manner, using a method developed by Paul Stumes, the consulting engineer for the project. The method involved the use of epoxy consolidants along with steel reinforcement rods (see figure 2). To permit the work to take place undisturbed by the weather, a "cocoon" formed out of vinyl sheet was attached to the temporary bracing installed to stabilize the windows while the restoration work was underway (see figure 3).

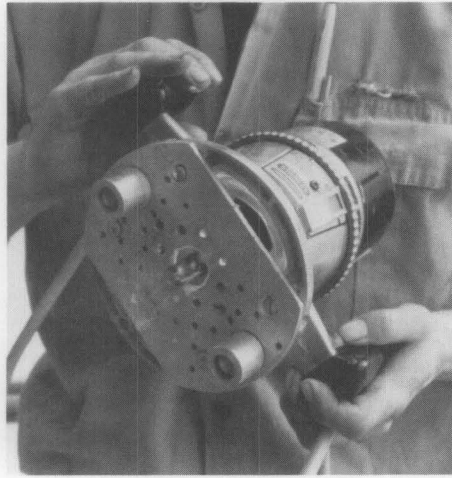
Figure 4. Once the old paint had been carefully removed, grooves were cut in the mullions using an electric router fitted with special guide rollers.

ting bit (see figure 4). Notwithstanding the usefulness of this apparatus, the real success of the operation can be attributed to the skill of the craftsman who guided the tool. The wooden mullions varied in size; on a typical 3 1/4" wide mullion, the outer edge where the groove was cut was 1 1/2" wide. In cutting a 1/2" groove on the outer edge, only 1/2" of wood remained on either side. A slight deviation of the tool could have seriously damaged the mullions.

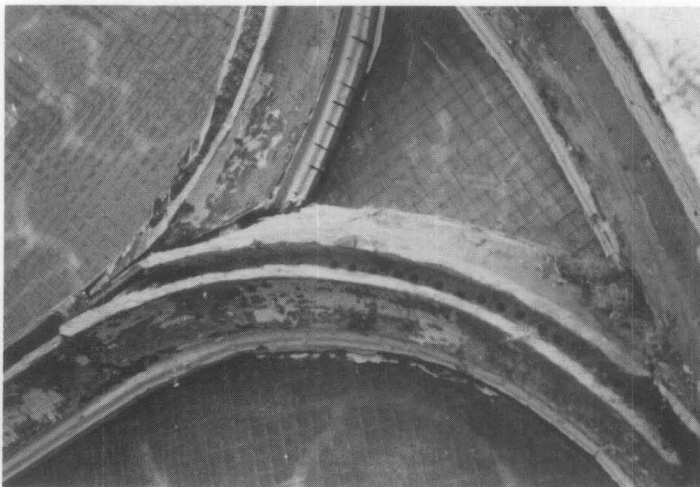
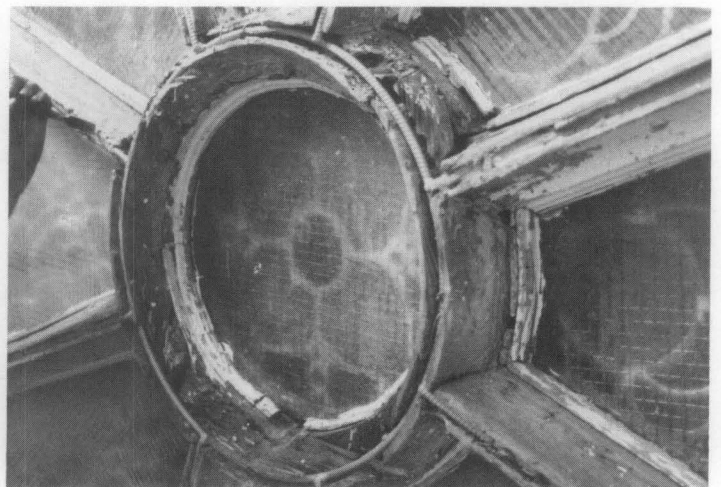
Figure 5. Details of the mullions as the strengthening process was carried out. Left: The grooves had to be carefully cut both because of the deteriorated condition of the wood and due to the relative thinness of the outer edge of the mullion. Right: Reinforcing bars are positioned in the grooves prior to being encased in an epoxy compound.

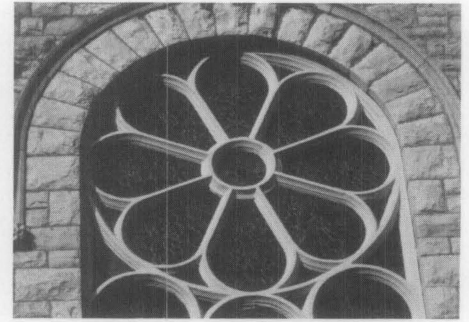
**Figure 6.** Repairing the historic frames resulted in a 25% savings over fabrication of new ones. The work included paint removal, reinforcing of the mullions, consolidation of the deteriorated wood, and repainting.

paste like modeling clay. Skillful hands of the craftman sculpted fill-ins which blended perfectly into the curvature of the wooden mullions. After the epoxy paste hardened, only the color was different from the wood; the shape and the texture were the same. To complete the work, the windows were then primed and painted (see figure 6).
