**Sears Roebuck and Company Mail Order Store
(Landmark Center)
Boston, Massachusetts**

Preservation
Tech Notes

WINDOWS
NUMBER 20

**Aluminum Replacement
Windows for Steel
Projecting Units with
True Divided Lights and
Matching Profiles**

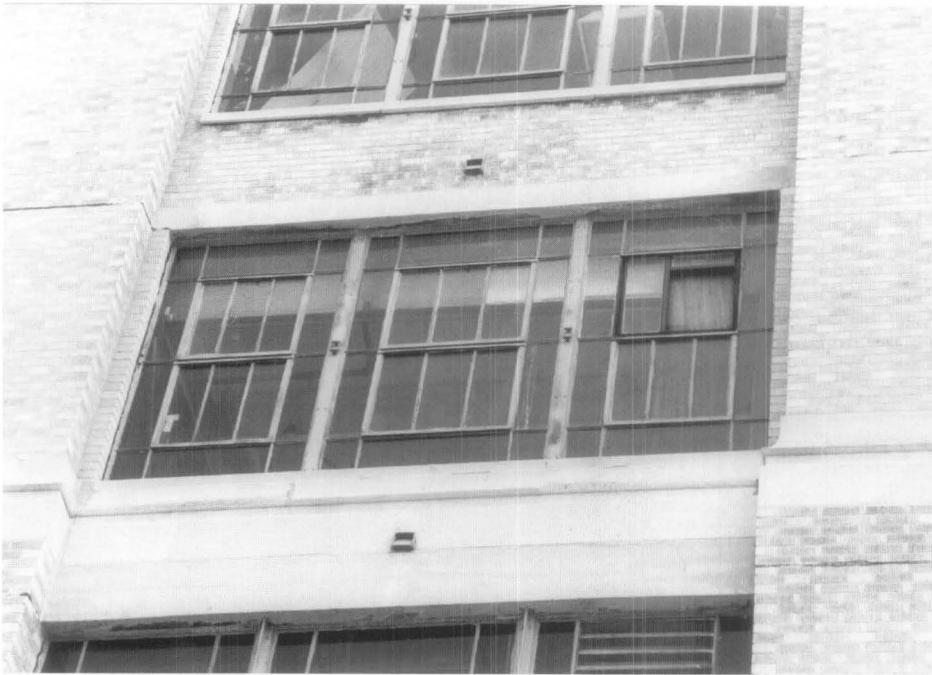
Figure 1. Many of the original Lupton windows incorporated a pair of stacked ventilators that projected outward. The vents were centrally located within a multi-light frame each of which was set either individually or in groups of two or three. Photo: Bruner/Cott & Assoc., Inc.

tor (or ventilators) framed by a group of fixed lights (*see figure 1*). Details such as muntin patterns, muntin widths and profiles, and the profiles of the operable vent were integral to the look of the windows and the building as a whole (*see figure 2*). Because of the distinctive character and prominence of the windows, any treatment plan required careful regard for the historic appearance of the original units.

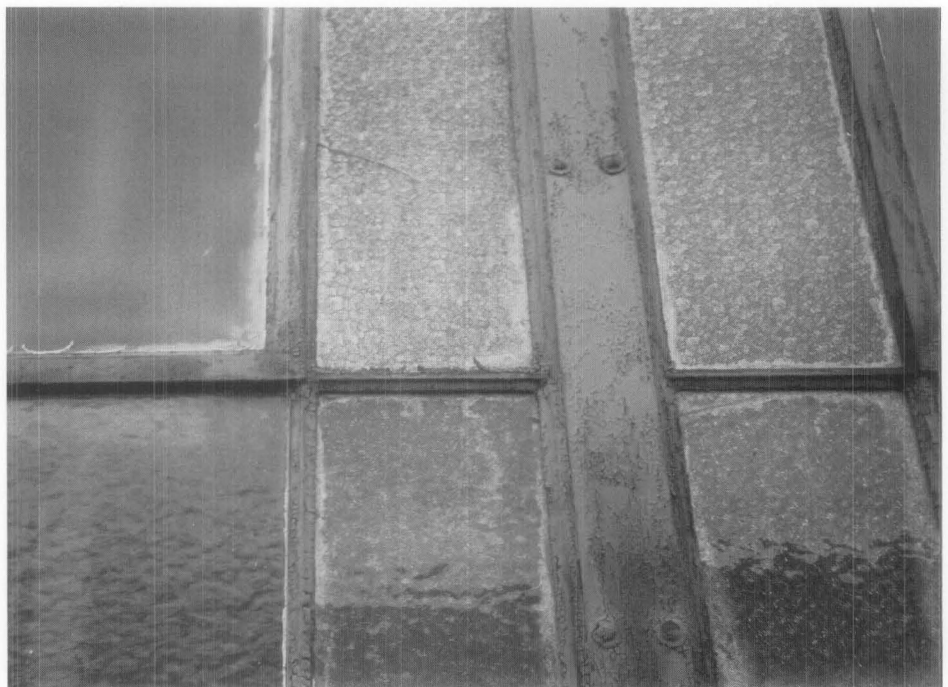
Figure 2. Narrow sightlines, ventilator weathering flanges and mullion boltheads were all distinguishing features of the original steel windows. Photo: Bruner/Cott & Assoc., Inc.

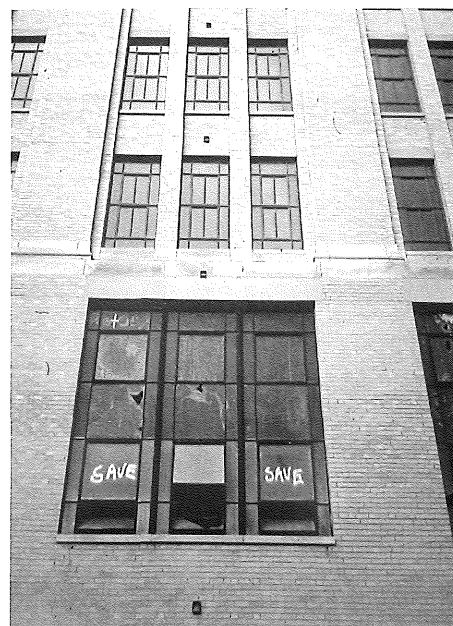
Figure 4. Among the retained and repaired original windows were these large units on the second floor level. Photo: Bruner/Cott & Assoc., Inc.

Existing historic windows in areas that were not to be continuously occupied, such as common lobbies and fire stairwells, were retained and repaired in situ. In addition, all of the tall windows on the second level (which would be devoted to retail functions) were repaired and reglazed where needed with historic glass salvaged from other locations in the building (see figure 4).

While the new windows were being manufactured, a local contractor began the three month long process of stripping, repairing, repainting and reglazing the historic second floor windows and other retained units in stairwells and other non-office locations. As the new windows began to arrive in Boston, the general contractor removed the original units that were slated for replacement and a team of eight to ten workers started installing the new windows.

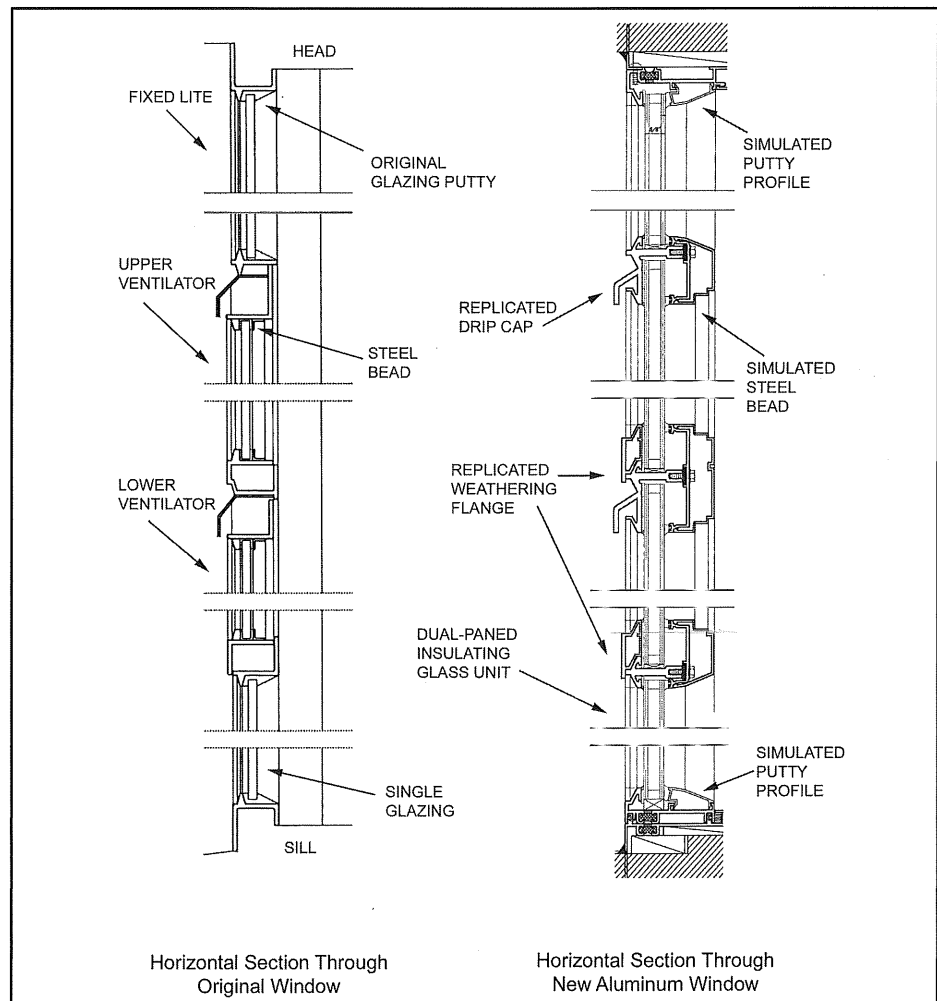
Figure 6. Sections of original and replacement windows. Drawings: Bruner/Cott and Custom Window.

the original interior putty profiles, the fixed-light muntins were tapered to the same 1/8" thickness of the original sections while stepped muntins were used in the central vent where steel beads had originally secured the glazing. Jambs in the replacement units were also beveled to recall the shape of the old glazing putty (see figure 6).

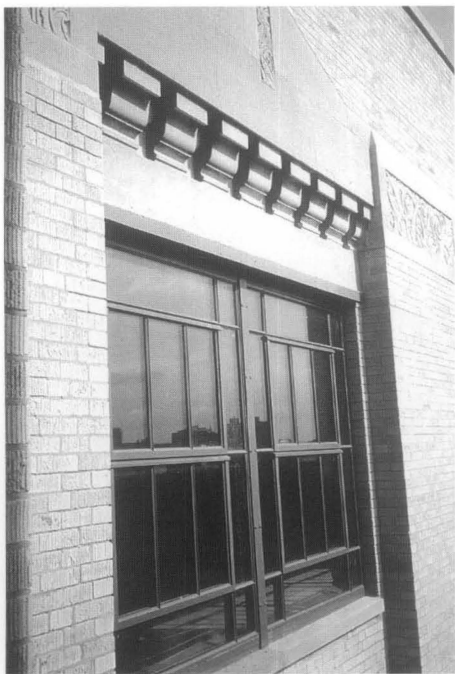
Figure 7. Installed replacement window. Photo: Bruner/Cott & Assoc., Inc.

Decisions involving the treatment of the original Sears building windows were reached after understanding the significance of the windows' historic appearance and by evaluating their condition and the requirements imposed by the rehabilitated building's new function. Various proposals were explored to determine how well they reconciled these factors. The process suggested that the most appropriate solution was to retain approximately 18% of the original windows while replacing the remainder with aluminum true divided light units that carefully matched the originals in both detail and general appearance (see figure 7).

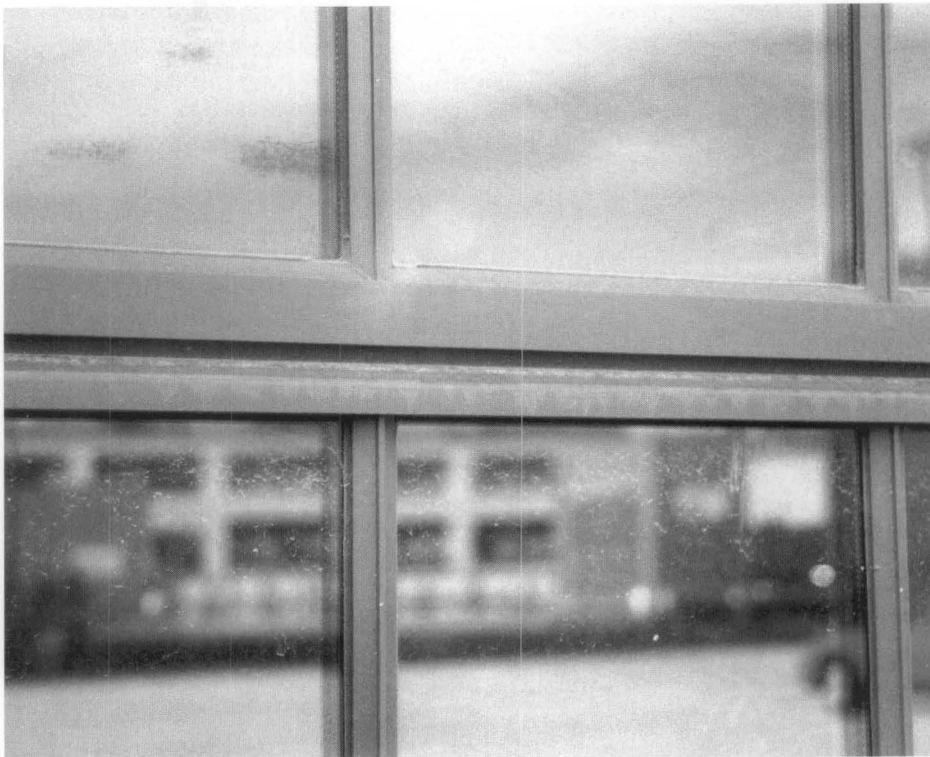
Figure 8. A close up view of the replacement window showing the replicated ventilator drip cap and narrow muntins. Photo: Bruner/Cott & Assoc., Inc.

as drip caps and the interior appearance of the window proved crucial to the success of the replication effort (see figures 8 and 9). This understanding led to a new engineered window that met the challenge of combining narrow muntins with insulating glass units and true divided lights.

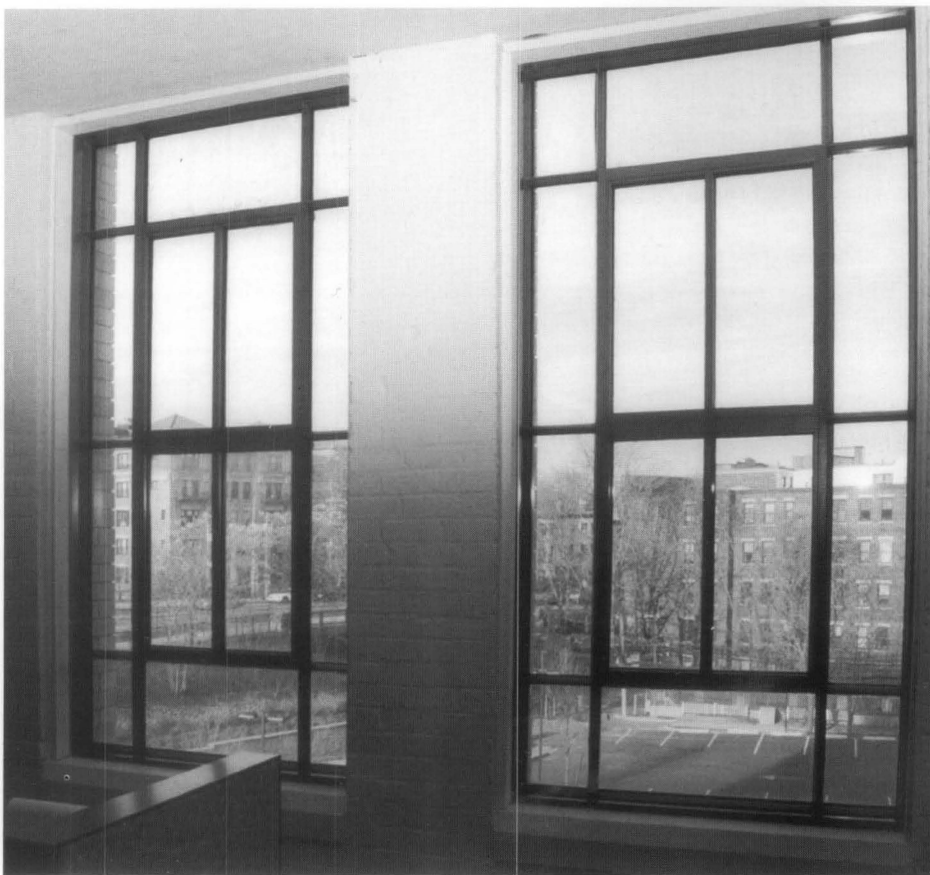
Figure 9. The interior profiles of the original windows were accurately reproduced in the aluminum replacement units. Photo: Bruner/Cott & Assoc., Inc.

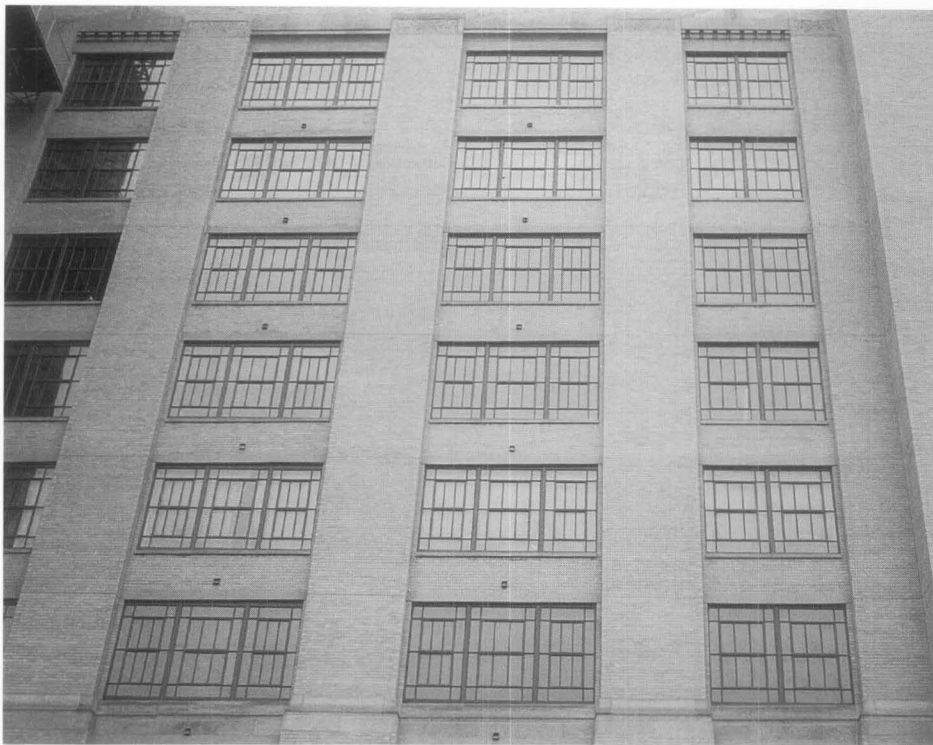
Figure 10. The replacement windows designed for the Sears building rehabilitation met energy efficiency and aesthetic goals while providing for the continued historic appearance of the structure. Photo: Bruner/Cott & Assoc., Inc.

The Sears project illustrates that a combined approach of window repair and replacement with a custom window designed to match the historic unit is a viable alternative when large-scale building rehabilitation is undertaken (see figure 10). Such a solution provides the opportunity to retain significant historic fabric and a wholly authentic original appearance in the most visible locations. In areas where the original windows have experienced significant deterioration, are in less prominent locations and where there are no suitable alternative means of enhancing thermal performance, replacement windows that are intended to match the originals in detail and appearance are acceptable. The window solution devel-
