**552-554 BROADWAY**  
New York, New York

# Preservation Tech Notes

## **HISTORIC GLASS** NUMBER 2

### **Repair and Rehabilitation of Historic Sidewalk Vault Lights**

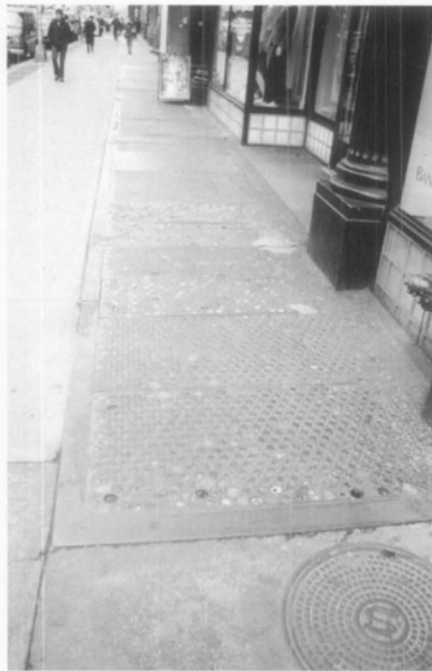
Figure 2. At the outset of the restoration project, the original cast-iron and glass vault lights in front of the building's storefront were in poor condition.

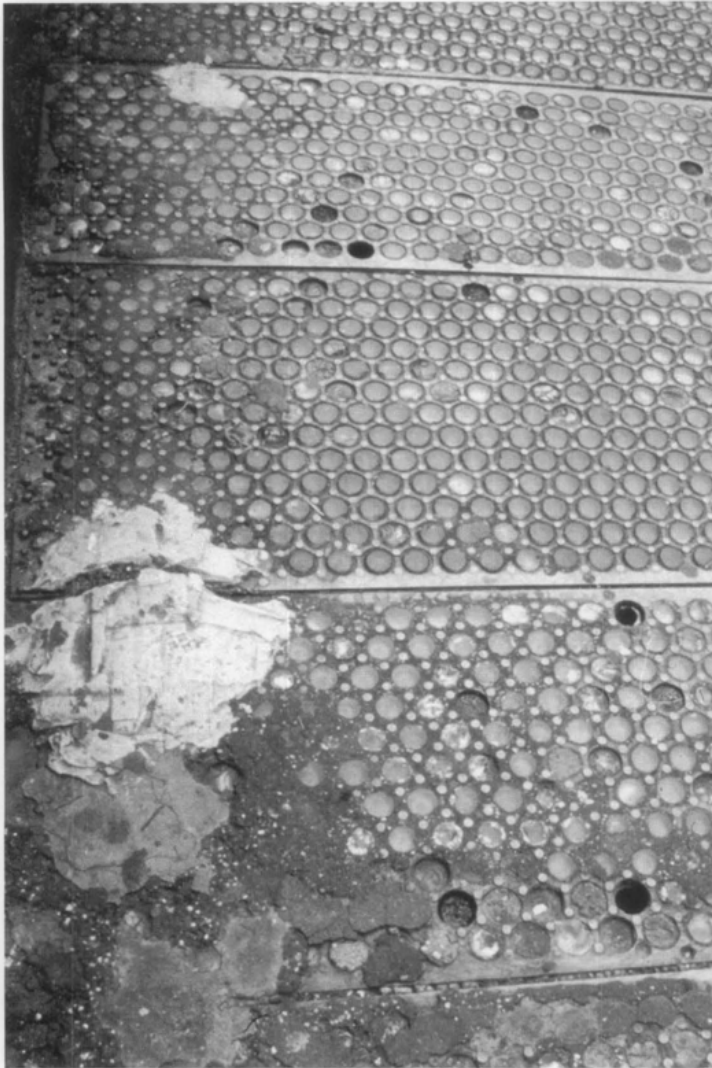
At the outset of the project, the vault lights at 552-554 Broadway were in poor condition (see figure 3). As with many old vault light installations, broken glass lenses and deteriorated seals allowed considerable water infiltration through the individual panels and the surrounding framework. A majority of the glass lenses were either cracked, missing or replaced with a variety of materials including wood, concrete and asphalt (see figure 4). Of the twenty-one cast-iron panels, six sections had areas which were cracked or missing altogether. Two original vault light panels had been replaced with steel diamond-plate hatchway doors to the basement and a variety of materials had been applied over the remaining panels in repeated attempts to prevent further leaks. Worn and lacking a protective coating, the cast-iron panels

Displaced panels and uneven asphalt and concrete patches presented trip hazards at sidewalk level.

Figure 3. The individual cast-iron panels were displaced and coated in some areas with asphalt and concrete. A number of glass lenses were missing, allowing water to enter the basement of the building.

To facilitate treatment and allow the sidewalks to remain unobstructed, the panels were removed and temporary steel plates were installed over the vaults. In the cast-iron contractor's workshop, the surviving deteriorated glass lenses were removed, the cast iron stripped, cleaned and repainted, and new lenses set into the openings. Replacement lenses were cast by a specialty glass manufacturer, Blenko Glass Company. The company had created glass molds for a vault light restoration several years prior and were now a regular supplier of various sized lenses for similar projects. A cast-iron foundry was contracted to fabricate two new panels to match the missing historic panels. Both new and repaired panels were delivered to the building site where the cast-iron specialist reinstalled them.

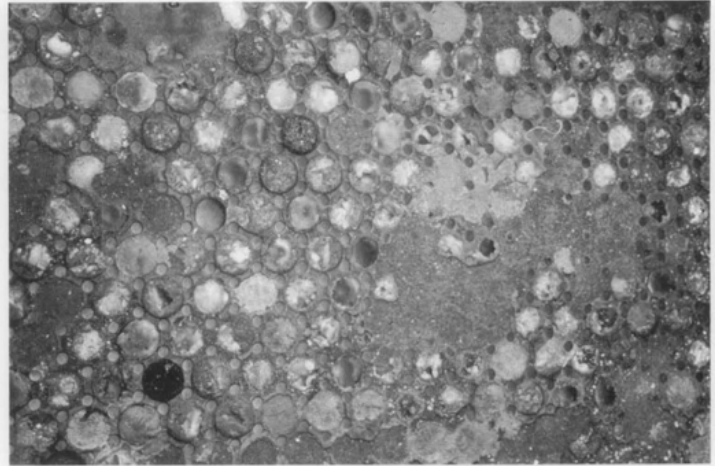
Figure 4. A detailed view of one of the panels illustrates the typical conditions prior to work. Although the original cast-iron knobs were still visible through the asphalt and concrete, many of the round openings were covered over or infilled. Nearly all of the remaining glass lenses were cracked.

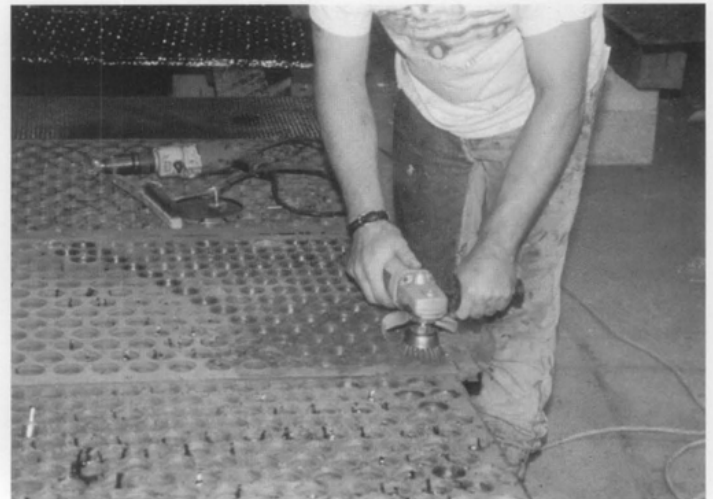
Figure 5. Workers removed any remaining corrosion, grout and other contaminants with hand chisels and power-operated wire brushes.

cleared off the paint, chewing gum, tar, asphalt, concrete, corrosion, grout and other grime that accumulates on a New York City sidewalk over the course of a century, without pitting or otherwise damaging the cast-iron. Then, workers cleaned each of the panels with small chisels and drills fitted with wire brush attachments to remove any material missed during sandblasting (see figure 5).

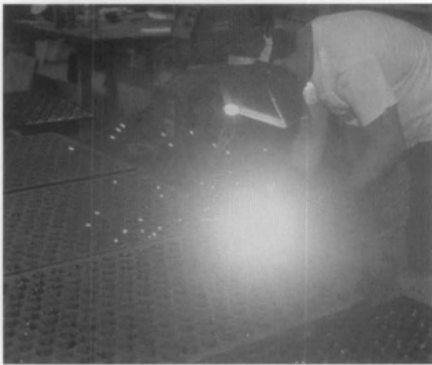
At the outset of the restoration program, six of the twenty-one vault light panels were found to be cracked. Rather than replace them with newly cast panels, the contractor chose to repair the damaged units using two different techniques: welding cracked sections and splicing in replacement

pieces. Due to inconsistent heating and the presence of impurities in the blast furnace mixture, historic cast-iron is a notoriously brittle material. This brittleness makes historic cast-iron susceptible to cracking and a challenge to weld properly.

Figure 6. Cracked panels were repaired by welding in new material from a stock of salvaged panels maintained by the cast-iron contractor. The welded seams were then ground down before repainting.

The contractor had developed a system for repairing cracked or damaged vault covers. Primary considerations were to ensure that the pieces to be welded were correctly positioned and level and that the cast-iron was properly preheated. Then, using a wire-feed MIG (metal inert gas) welder, the two pieces were joined together (see figure 6). The welded seam was ground down to the level of the adjacent panel

surface so that the repair would not be visible after painting. The result was a strong, durable and complete cast-iron panel. When replacement sections were required, the contractor drew from a small stockpile of salvaged panels identical to those at 552-554 Broadway.
