Tech Notes

MASONRY

Substitute Materials: Replacing Deteriorated Serpentine Stone with Pre-Cast Concrete

SIX LOGAN CIRCLE Washington, D.C.

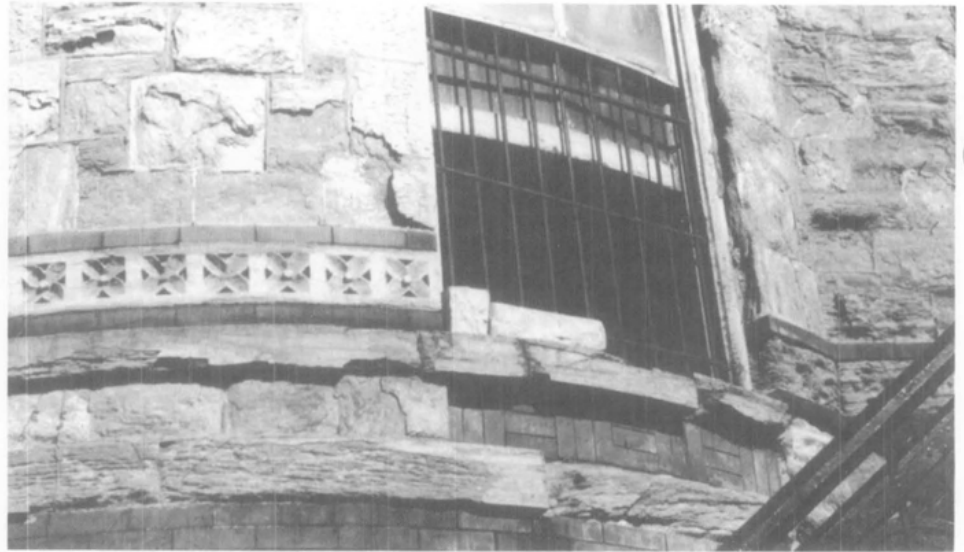
A stone consultant was retained to assess the condition of the serpentine stone and to recommend remedial work. The consultant conducted an in-depth visual inspection and evaluation and concluded that the serpentine stone was spalling extensively, due to the inherent softness and poor quality of the stone and the chemical forces interacting with the stone. The deterioration had been further exacerbated by the general lack of maintenance the building had received for the last forty years which had allowed large amounts of moisture to penetrate the stone. Moisture, laden with acids, had entered the stone through open mortar joints and the delaminated surface, accelerating the stone's deterioration. In this case, the problem was compounded by additional moisture spilling onto the surface of the serpentine from clogged, leaky, and inoperable gutters, downspouts and drains. Given the inherent problems with serpentine stone as an exterior building material and its overall advanced deterioration on Six Logan Circle, the consultant recommended that the serpentine stone, which was used as a veneer covering structural brickwork, be replaced rather than attempting a repair using traditional patching techniques. This conclusion was supported by a survey undertaken to determine how many of the stones

Figure 1. Close-up view of the deteriorated serpentine stone facade showing substantial surface delamination. Photo: Anne Grimmer

retained their integrity (i.e., how many remained substantially free of fractures and crumbling and retained their surface tooling, texture, and shape). The survey showed that 868 of the original 946 face stones which made up the facade no longer retained their integrity. In fact, many were so deteriorated that they could literally be pulled apart by hand (see figure 1).

Because only 78, or less than nine percent, of the stones remained intact, total replacement of the historic stone was justified in this particular case. However, the replacement material needed to closely match the historic stone in size, shape, dimension, texture and color in order to preserve the historic character of the facade. To meet these requirements, three replacement alternatives were considered:

Therefore, the material that offered the most potential for use as a replacement material was pre-cast concrete. This material had recently been used to replace extensively deteriorated brownstone on the Renwick Gallery of the Smithsonian Institution in Washington, D.C., and it was determined by the consultant (who had worked on the Renwick Gallery restoration), that the same technology could be successfully applied to replace the serpentine stone at Six Logan Circle.

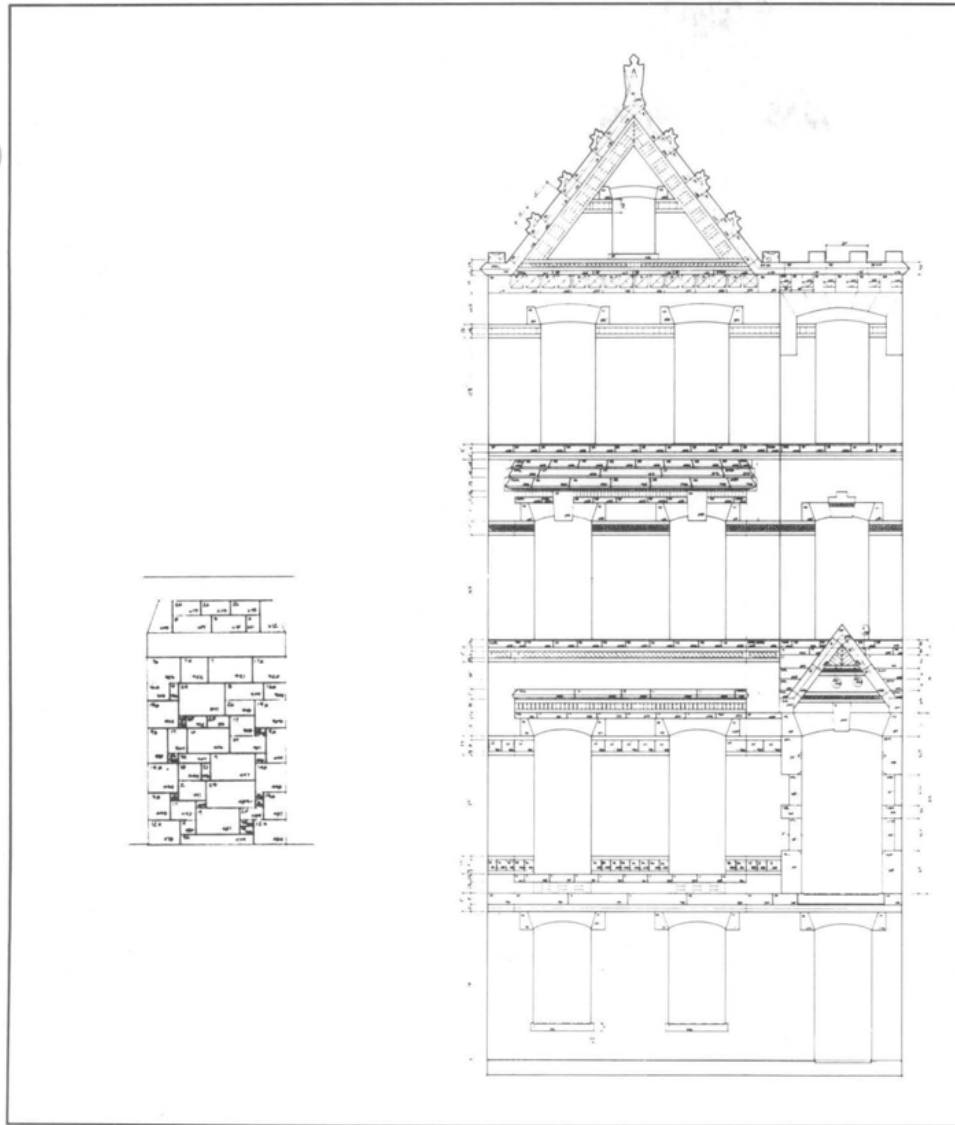
Figure 2. Two measured drawings were made of the facade, one showing the individual field and jamb blocks, and the other, the decorative trim stones. The identification number and the shape and size number of each stone were marked on the drawings. Drawings: Rich Layman

Before the new cast stone could be manufactured, the existing serpentine stone facade had to be recorded. An architecture student was hired to measure each existing stone on the facade and prepare precise drawings of the elevation, showing the size and location of each stone. Each stone was assigned two numbers—an individual identification number and a number indicating the stone's shape and size. These key numbers were marked directly on the measured drawings. Drawings were prepared for the plainer stones that made up the major portion of the facade as well as the decorative trim stones (see figure 2). From these drawings, a master list of all the stones and their sizes was compiled, which was used to guide the casting and manufacturing processes. Later, as each new stone was fabricated, it was noted on the drawings so that an up-to-date inventory could be maintained.

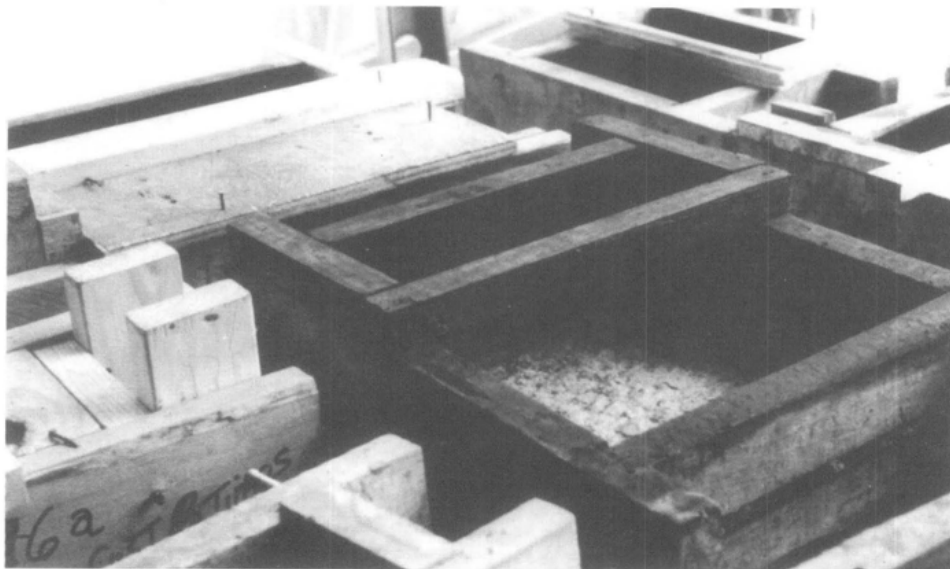
Figure 3. Concrete was poured into these wooden forms which were specially constructed, and reinforced with steel rods and bolts, to hold the built-up molds of the original stones. Once placed in the wooden forms, the built-up molds thus served as the casting models. Photo: Robert Powers

1. A release agent was sprayed on each stone of the facade to be reproduced.
2. Latex molding rubber was then brushed-on in layers to the surface of the stone, still *in-situ*, to obtain an impression of the stone's surface. From these latex molds, the surface qualities of the individual blocks of the serpentine facade could be faithfully reproduced in the casting process.
3. The latex mold was removed from the stone and in the workshop the mold was built up with plaster to increase the crispness of the details.
4. This built-up mold, when placed in a specially constructed wooden framework reinforced with steel rods and bolts, became the casting mold.
5. A release agent was applied over the formwork and the built-up mold. Then the concrete was poured into the casting mold (see figure 3).

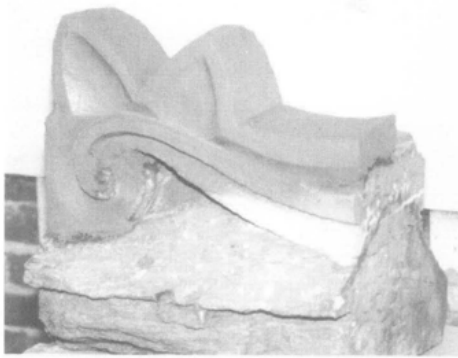
Figure 4. Most of the rubber castings could be made directly from stones still in place on the facade, but the more deteriorated stones first had to be removed from the wall. After their removal from the wall, a bonding agent was applied to the deteriorated stone surface, and a new stone surface was created replicating the original design details with concrete. Photo: James Smith

1. A bonding agent was applied to the surface of the stone to be reproduced.
2. Using the more intact stones as models, the stone's surface was built up with a mixture of portland cement and sand to approximate as closely as possible the stone's original surface, shape, and texture.
3. After the built-up stone was dry, the same process described earlier was followed to create molds of these stones (see figures 4-6).

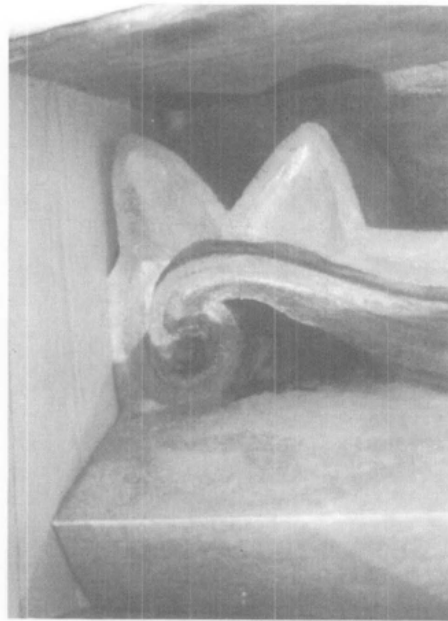
Figure 5. A latex casting mold was made from this recreated "built-up" stone surface by brushing on layers of latex molding rubber. Photo: James Smith

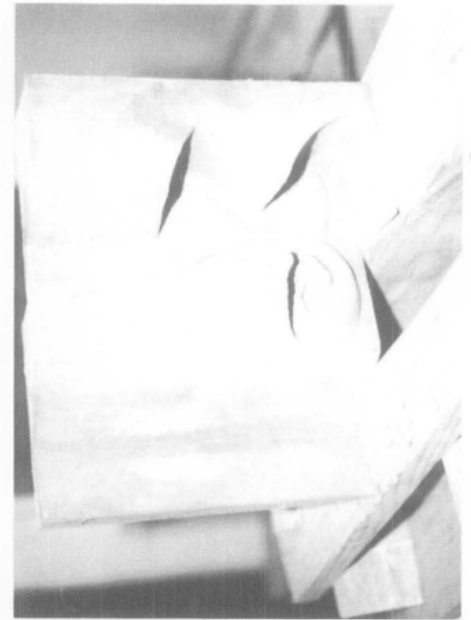
Figure 6. A rubber impression made from this latex casting mold then provided the mold into which the concrete was poured to create the new pre-cast units. Photo: James Smith

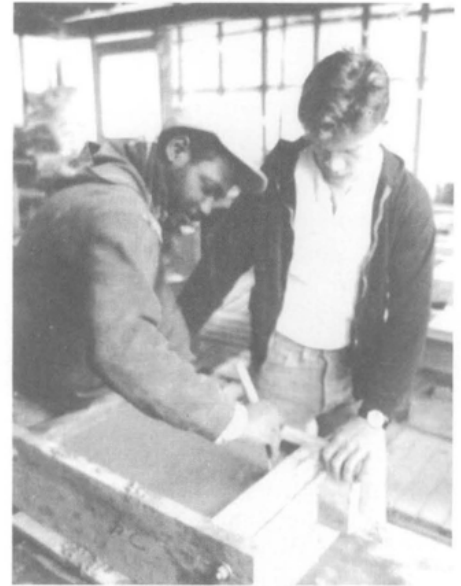
Figure 7. The workmen shown here are cutting the air bubbles from the sides of the mold using a cake spatula during the first 10 seconds of the vibration process. Photo: James Smith

The consolidated and homogeneous concrete mix was poured from the mixer into the specified mold which had already been placed on the vibration table. The vibrating process forces the entrained air and surface air out of the mold, eliminating in most cases the possibility of surface imperfections from air bubbles. Proper vibration of the newly poured concrete was extremely important to obtain a high quality pre-cast concrete. The vibration table operated at a rate of 2,600 vibrations per minute and could accommodate all the castings from a batch within thirty minutes after mixing. Small cast units required approximately sixty seconds of vibration and the larger ones required approximately ninety seconds. A cake spatula was effective in cutting many of the air bubbles from the surface of the sides of the mold during the first ten seconds of the vibration process (see figure 7).

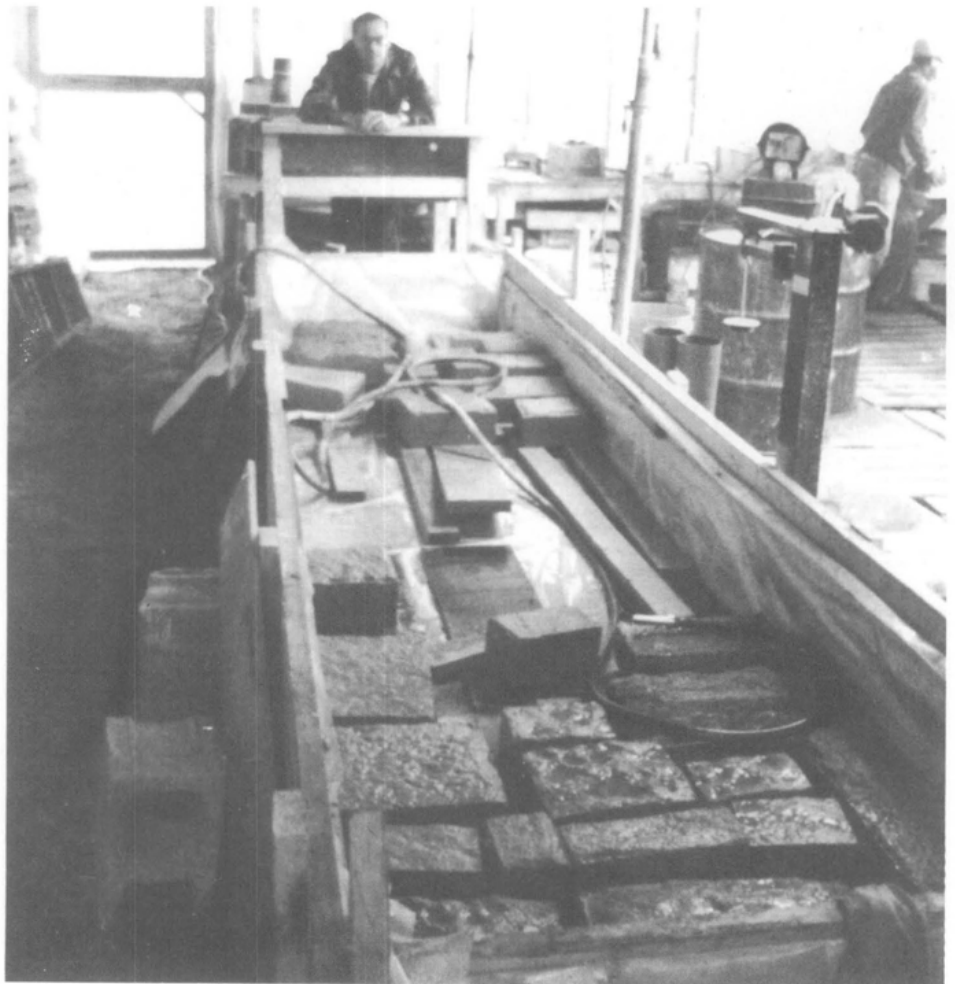
Figure 8. After soaking for 6 hours to remove soluble salts in a polyethylene-lined wood water tank, the pre-cast units were allowed to dry for another 6 hours. This process was repeated 3 times for each pre-cast unit. Photo: James Smith

The final step in the manufacturing process was essential to the successful outcome of the product. In this step, the stones were submerged in a water tank for a period of six hours, then removed and dried for six hours (see figure 8). The drying process forced soluble salts inherent in the concrete mix to the surface of the stone. An application of a weak solution of muriatic acid with a thorough water rinse was used to wash away the leaching salts. This procedure of soaking and drying was repeated three times for every stone. After completing this process, each stone was transferred to the base-mat for storage on wooden skids.

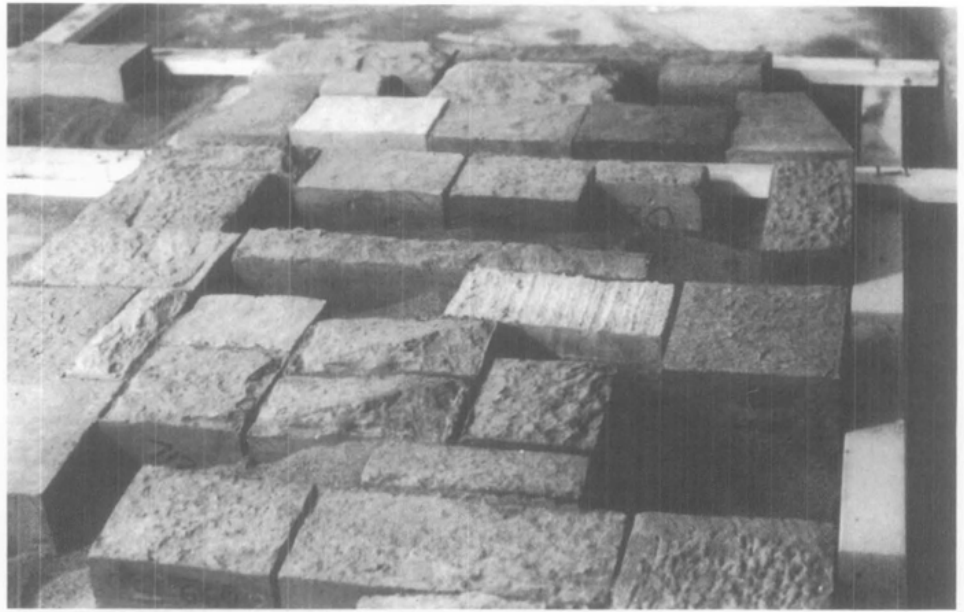
Figure 9. Using the measured drawings as a guide, the pre-cast units were assembled in the staging area on top of 4 inches of sand prior to their installation on the facade. Photo: Robert Powers

“staging area” in the basement. Using the measured drawings and numbering system prepared earlier, the blocks of cast stone were assembled on the basement floor on top of 4” of sand. Assembling them in the staging area allowed for a final inspection of the blocks and also allowed the master mason to arrange the new stones during a “dry run” prior to the actual installation on the building, thereby minimizing problems once the work on the building began (see figure 9).

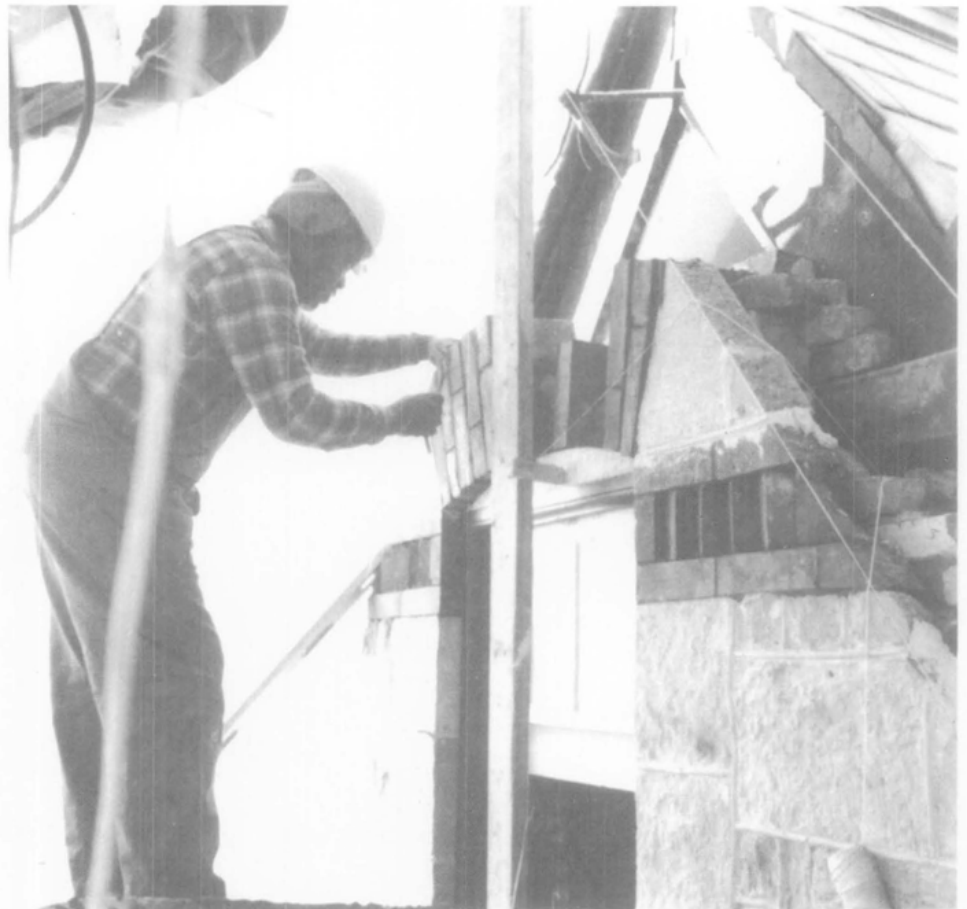
Figure 10. The new pre-cast units were hoisted up the scaffolding on wide belt slings with an electric winch, and installed in place using a portland cement-based mortar appropriate for cast-concrete. The original bricks were relaid with a more traditional lime-based, dark-colored mortar. Photo: James Smith

With the front elevation fully scaffolded, sections of the serpentine stone and ornamental brick were removed. Because the brick trim was in excellent overall condition and was to be reused in the new facade, it was carefully removed with hand tools, inventoried, and stored for reinstallation. With the serpentine and face brick removed, necessary repairs were made to the structural brick, and stainless steel anchors for the new pre-cast veneer were installed. The new cast stones were hoisted up the scaffolding on wide belt slings with an electric winch and installed in place (see figure 10).

Since the new pre-cast concrete blocks are much harder than the original serpentine stone, a mortar mix containing a large proportion of white portland cement was used. However, other than the composition, the new mortar joints match the light-colored, raised mortar joints used on the original stone facade. The walls were then backfilled with a parging material.

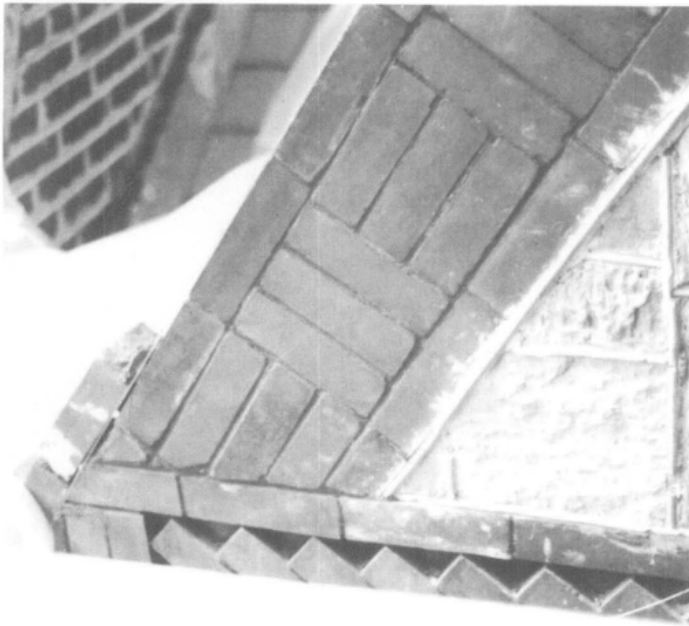
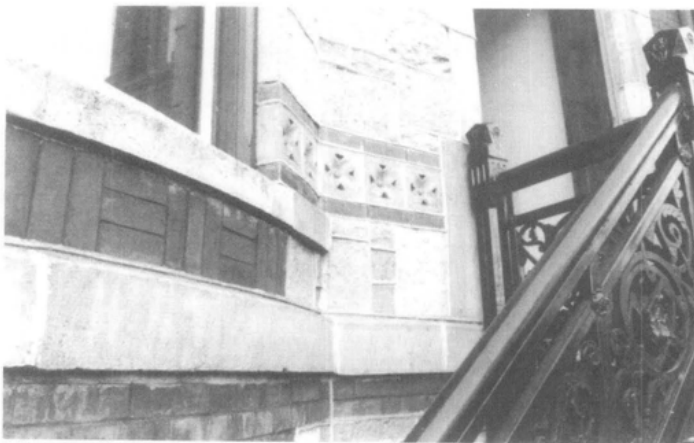
Figure 11. Close-up views of the newly installed pre-cast concrete units and the reinstated original brick. Photo: James Smith

The original bricks were individually cleaned with bristle brushes and water before being reset into the new facade. The new brick mortar was based on an analysis of the original, dark-colored brick mortar and matched it in composition, color, texture, joint width and profile. (see figure 11).

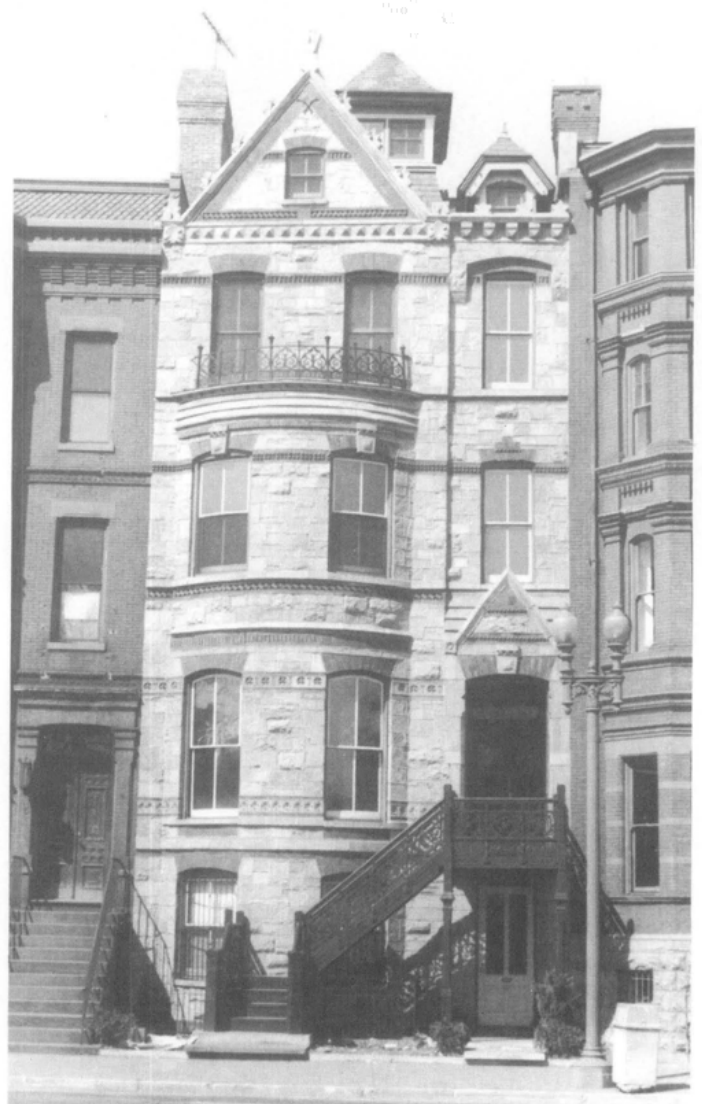
project was considered a success by all the participants; the stated goal of removing the crumbling serpentine veneer and replacing it with a new material that returned the facade to its original appearance was met. The building has a renewed presence with its pre-cast concrete units molded to match the form of the original stone, and exhibits a crispness of detail, texture and color that had been absent for many years (see figure 12).

Some of the trim pieces, in particular the floral blocks as well as units in the belt coursing and window sills, do have noticeable surface imperfections when

viewed up close, such as indentations caused by air bubbles and in a few instances the aggregate is exposed, indicating a poor concrete mix. Ideally, each of these units should have been rejected during the inspection stage. However, the small number of such pieces does not detract from the overall appearance of the rebuilt facade.

Figure 12. The house after rehabilitation. Photo: Anne Grimmer
