Tech Notes

NUMBER 1

Replicating Historic Elevator Enclosures

GUARANTY BUILDING Buffalo, New York

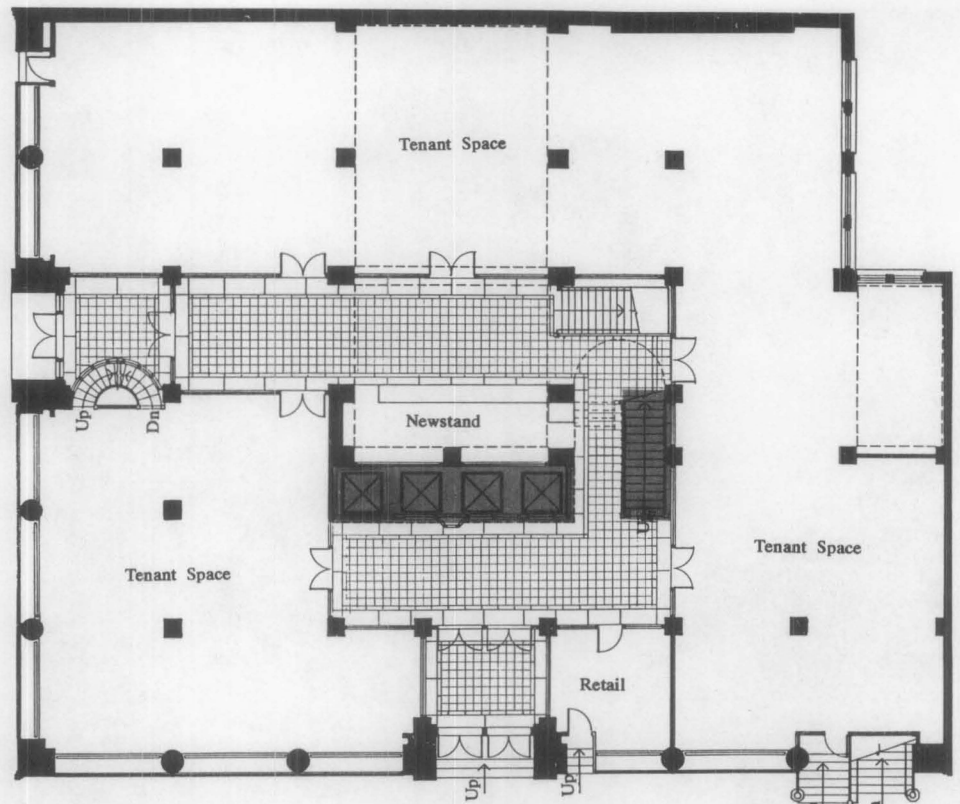
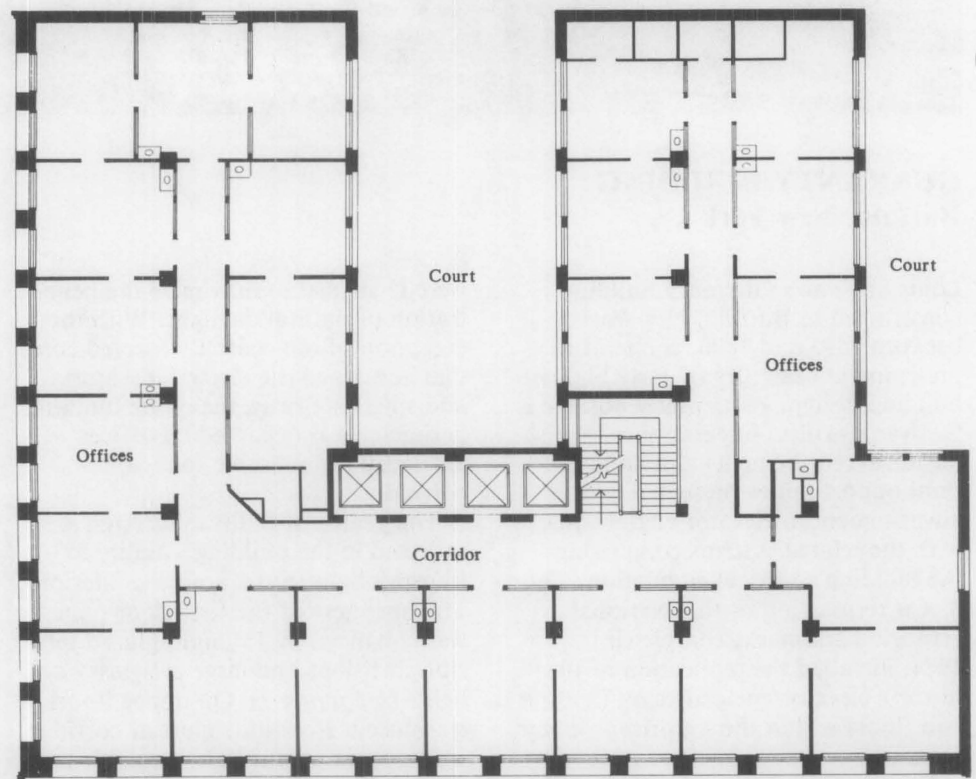
The genius of Sullivan's design is reflected in the building's ability to transmit light throughout the interior. The openness of the first floor plan was enhanced by 15' high, glazed interior partitions and large art-glass skylights (*see figure 1*). On upper floors, translucent florentine glass at corridor walls maximize the light available to the corridor and offices as well as to the elevators and stairs.

Figure 1. First and typical upper floor plans, 1897. Extensive skylit circulation area on the first floor and glazing at corridor partitions contributed to the building's openness and transparency. Drawing: Cannon, Javier Salazar.

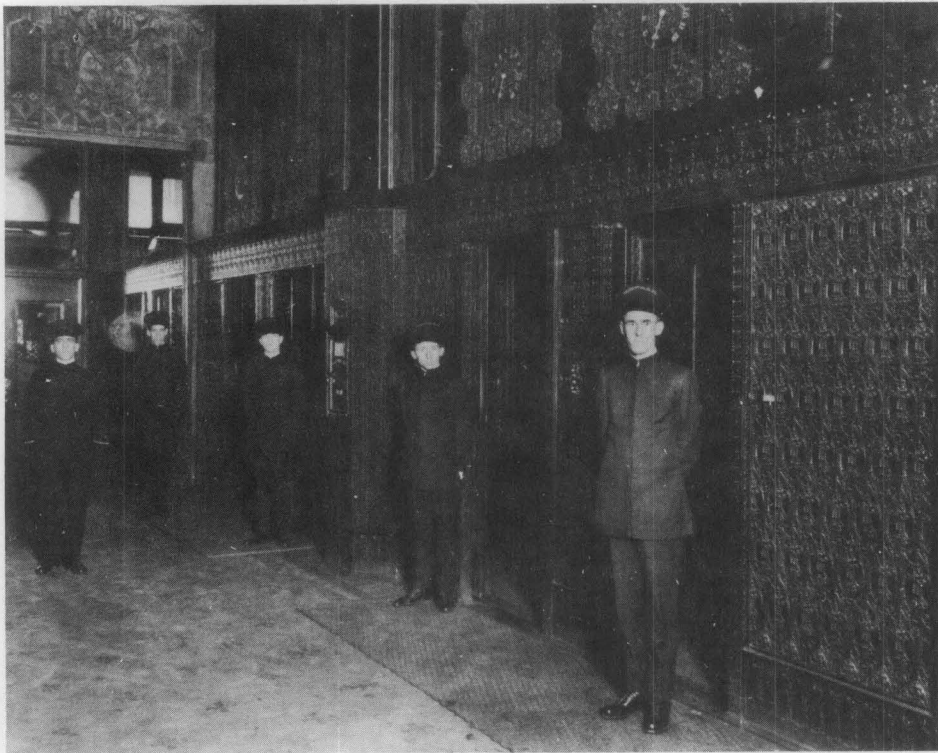
The elevator doors and walls that enclosed the elevator shaft and faced the elevator lobbies were part of a cast iron enclosure assembled from vertical and horizontal members: posts, friezes, cornices, base moldings, and pierced infill grilles. All were detailed with an ornate organic pattern based on the growth and emergence of a germinating seedpod, and finished with electro-plated bronze (see figure 2).

Figure 2. First floor elevator lobby, c. 1897, from northwest. Photo: United Founders Life Insurance Company of Illinois.

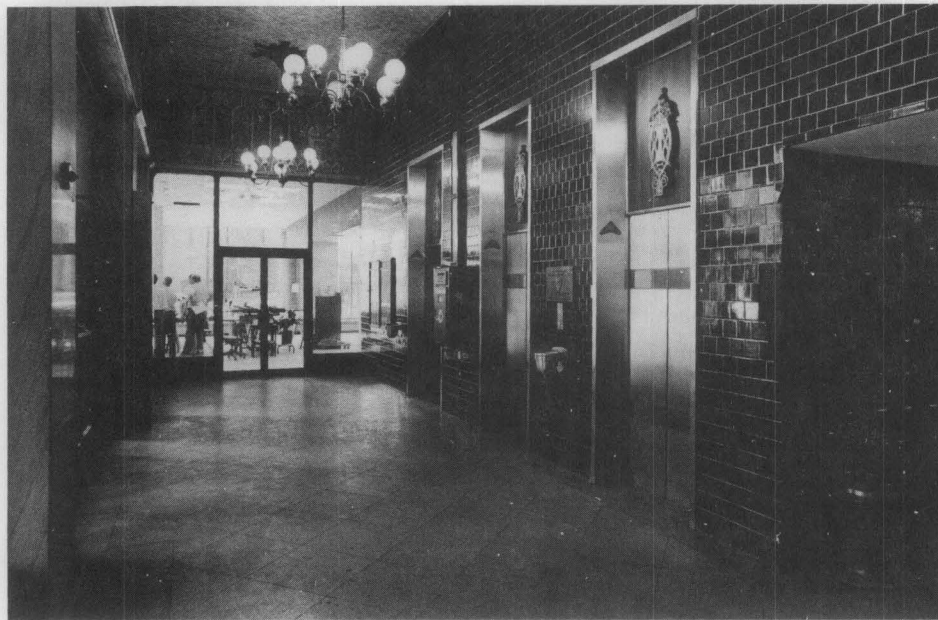
The 1962 changes had a major impact on Sullivan's original design. The four 1903 cabs were replaced with a 3-cab, electrically powered system, with the remaining shaft left vacant for future use. The glazed elevator cabs were replaced with fully enclosed ones, and the open elevator shaft and single stairway were enclosed with two-hour, fire-rated masonry walls (see figure 3). Throughout the building, almost all elevator ornament was removed, leaving only a small piece of the elevator framework exposed within

Figure 3. First floor elevator lobby, c. 1962. Modifications included reduction in number of elevators and addition of masonry enclosure around open elevators and main building stair. Photo: Cannon.

the stair to the west of the elevator bank. Window openings within the elevator shaft were infilled with concrete block, and the shaft's skylight was removed to provide space for a new elevator penthouse.

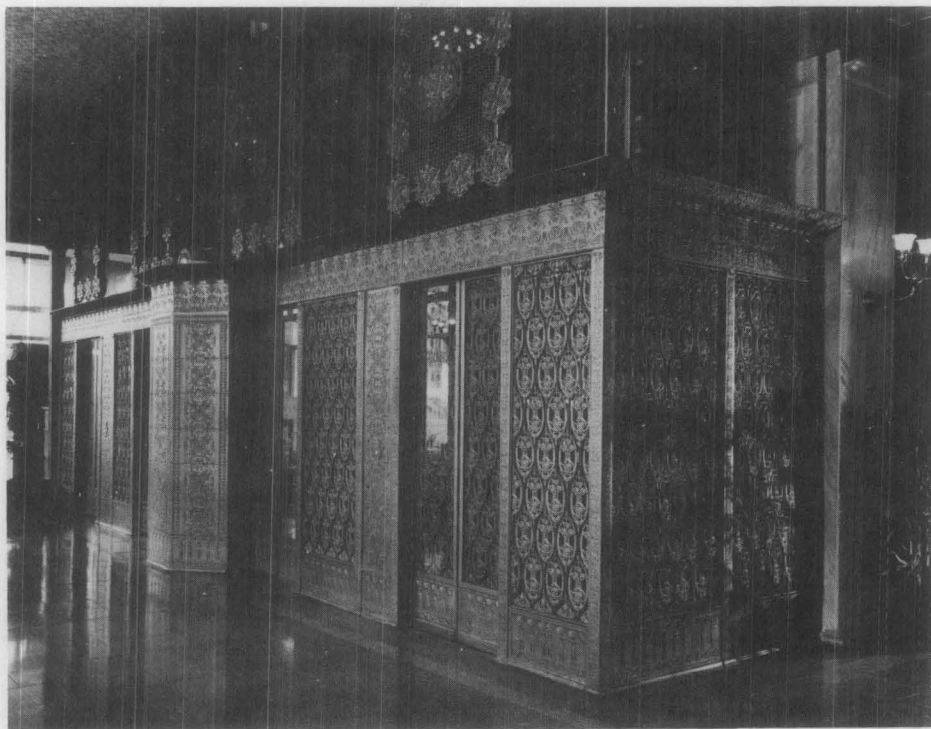
Figure 4. First floor elevator lobby as restored, 1984, showing the replicated cast ornament on the elevator enclosure, with sprinkler heads discreetly placed to protect elevator cabs. The elevator door far left (number 4) is inoperable since the cab and equipment had been removed in 1962. Photo: Patricia Layman Bazelon.

At the first and second floor levels, the elevator enclosures and original lobby floor plans were restored (see figure 4). Replication of all elements comprising the enclosures required the recasting of new elements in molds taken from original samples. Cast iron was used (as had originally been specified by Sullivan), and throughout the casting and finishing processes the architects worked closely with the artisans at the foundry. Only a few surviving elements were able to be refinished and reused.

coverage was used at the elevator and first floor where glazing was installed or retained in lieu of solid fire-rated walls (2 hours). Sprinkler heads were located 6' on center (o.c.), selected and located to minimize their impact on the elevator enclosure. At the elevator shaft, two heads were placed at each 6' o.c. location, one directed upwards to protect the glazing above, and the other directed horizontally to protect the lobby area below. Sprinkler heads were connected to piping located in the elevator shaft. To ensure an unobtrusive installation, sprinklers and piping on the lobby side of the enclosure were finished to match the decorative metal; piping within the shaft was painted black to match the shaftway walls.

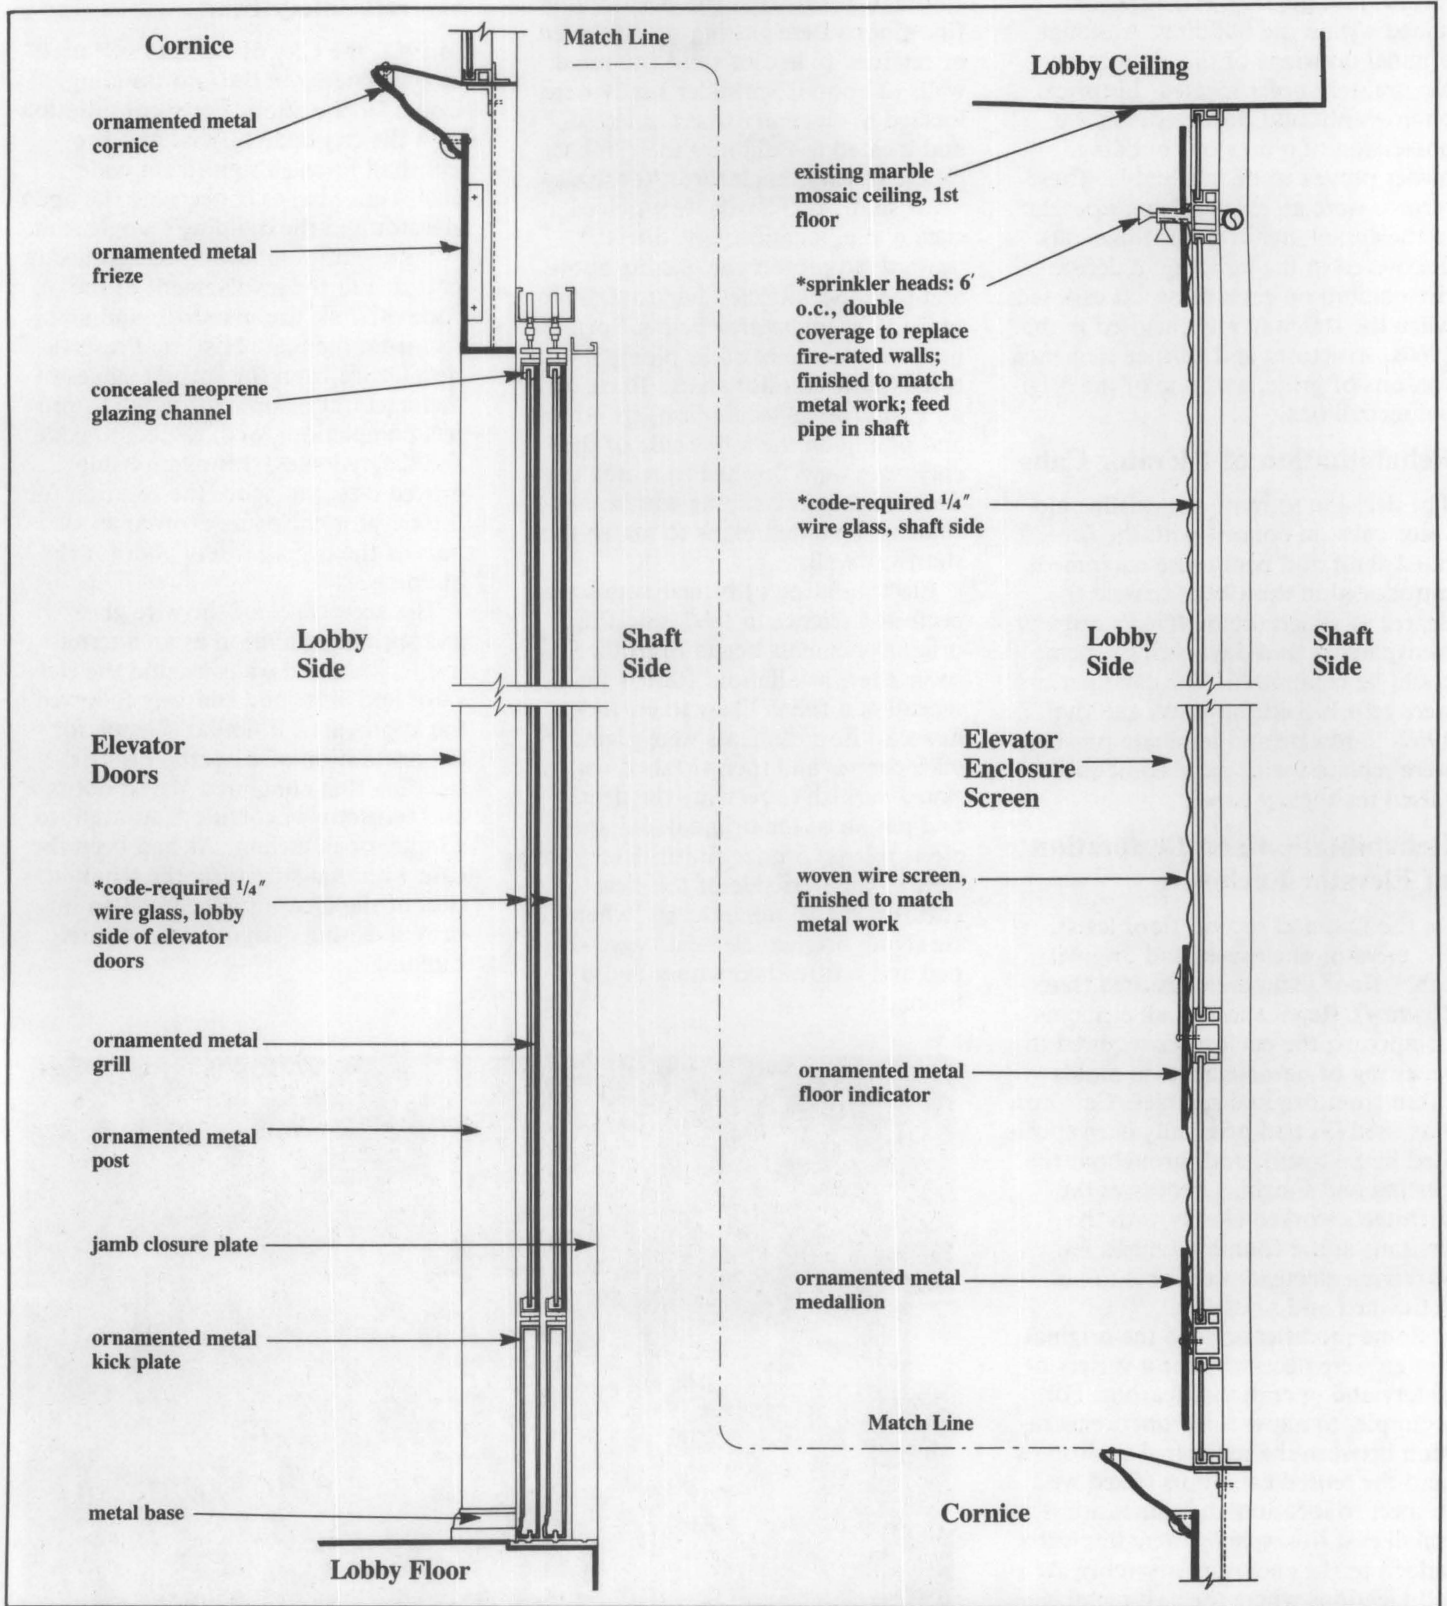
Figure 5. The reconstruction of the elevator enclosures was a complex integration of code-required features (marked by an *) and architectural elements. Wire glass and double-coverage fire sprinklers replaced fire-rated walls while retaining the quality of light in Sullivan's original design. The metal ornament was reproduced in copper-plated cast iron and finished with a tinted varnish to match the original bronze electroplated finish.

Some modifications to the original design were necessary for a variety of safety and operational reasons. For example, to allow for proper registration between the replicated enclosures and the reused cab doors (fixed with respect to location and dimensions), small cast iron spacers were discreetly added to the enclosure assembly. At all locations where the cast metal elevator enclosures was fixed, 1/4" wire glass was installed on the shaftway side with a specially designed, concealed glass gasket. The portion of the enclosure that opened with the elevator doors was double faced with wire glass installed on the lobby side as added protection (see figure 5).

Electroplating of bronze was not a perfected science in 1897, and the original elements began to oxidize soon after installation. Rather than repeating a finish likely to corrode, new cast iron elements were plated with copper and then finished with a tinted varnish to recreate the depth and patina of the original and aged electroplated bronze finish. Exceptions were at the west side of the elevator enclosure at all upper levels, where the surviving original elements were stripped and refurbished with a liquid bronze.

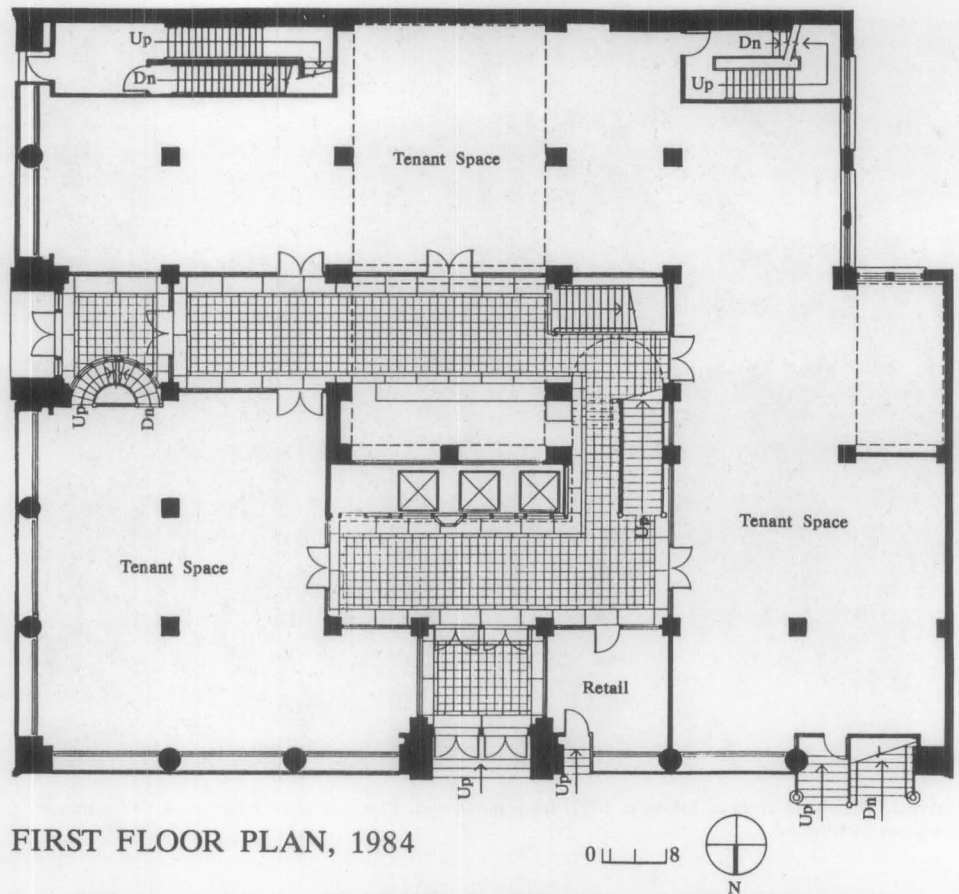
FIRST FLOOR PLAN, 1984

Figure 6. First floor as restored, 1984. With the exception of two new exit stairs added at southeast and southwest corners, the first floor has been faithfully restored to its 1897 appearance, including the 4-bay elevator enclosure. Drawing: Cannon, Javier Salazar.

New stairs exiting directly to the outside were unobtrusively added at the southeast and southwest corners of the building (see figure 6). The stairs at the southwest connected to the building's original open stair; at

the south wall of the open stair's intermediary landing between the second and third floor, a fire separation and door to a new half-flight of stairs were added. This half-flight was considered part of the new fire-rated corridor that

led directly to the southwest exit stair. Other fire safety elements added to the building included a fire detection annunciator and alarm system, stand-pipes, and a sprinkler system throughout the building.
