Tech Notes

NATIONAL PARK SERVICE
U.S. DEPARTMENT OF THE INTERIOR
WASHINGTON, D.C.

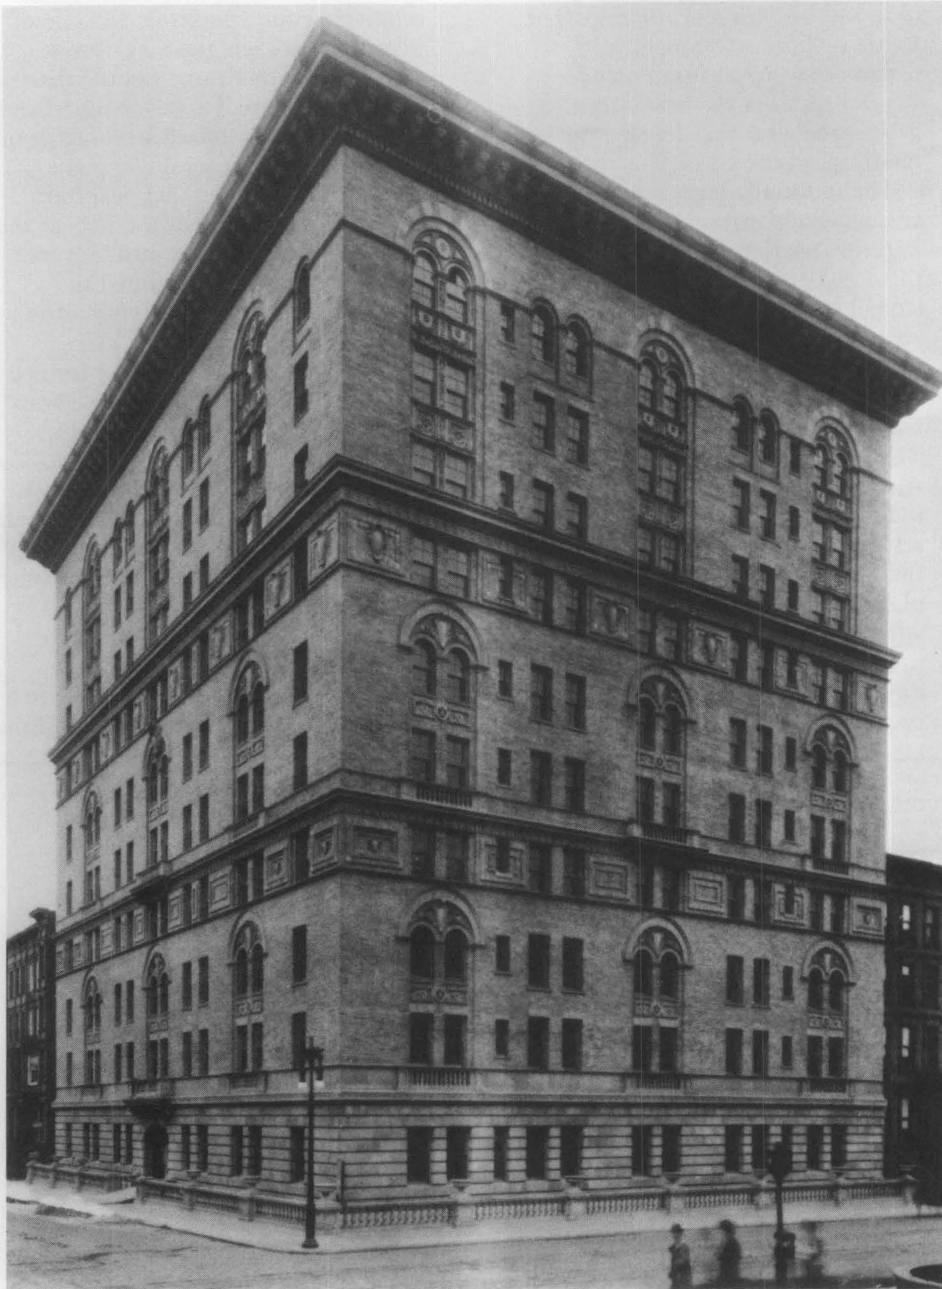
32 EAST 64TH STREET New York City

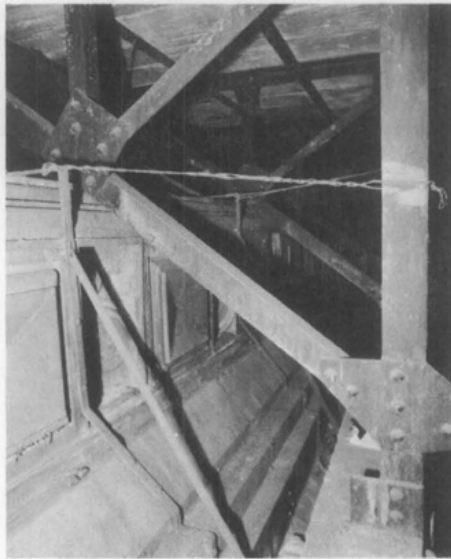
Figure 1. Large steel trusses cantilever out from the masonry parapet to support the cornice. Metal facing of the cornice was bolted to small iron or steel ribs (as at left). Wire ties helped to pull the center of the cornice tight to the bottom member of the truss. Photo: Richard Pieper.

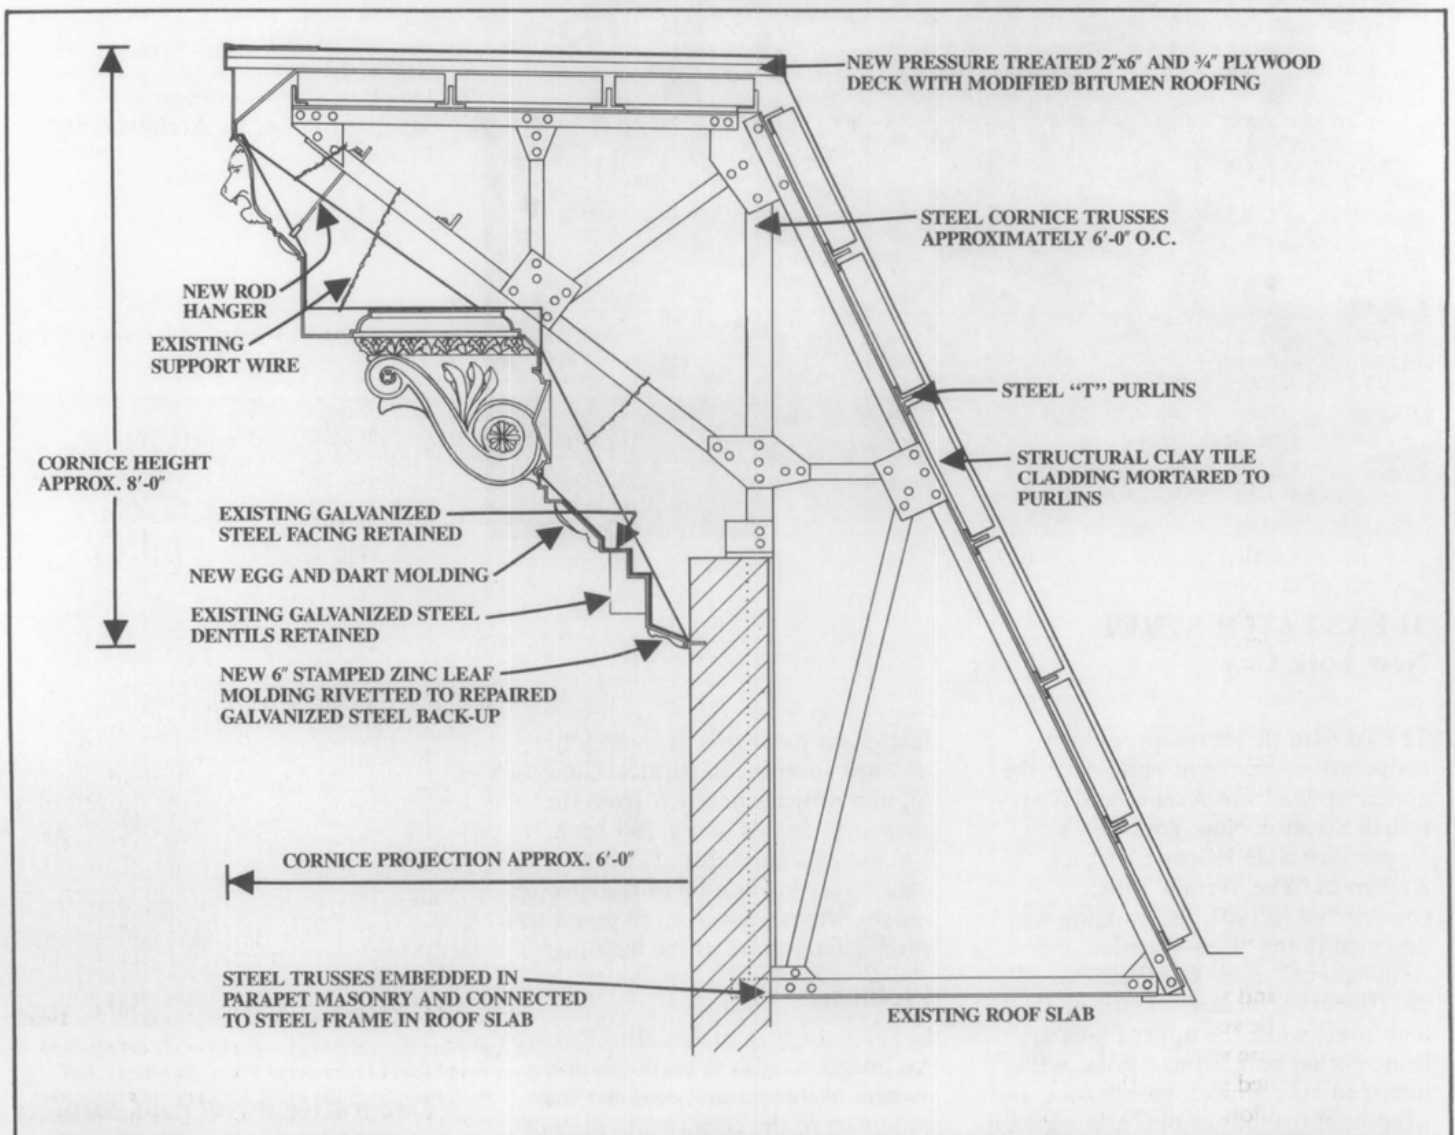
Figure 2. Cornice section shows the manner in which the cornice was supported and attached to the building. Drawing: Michael Devonshire.

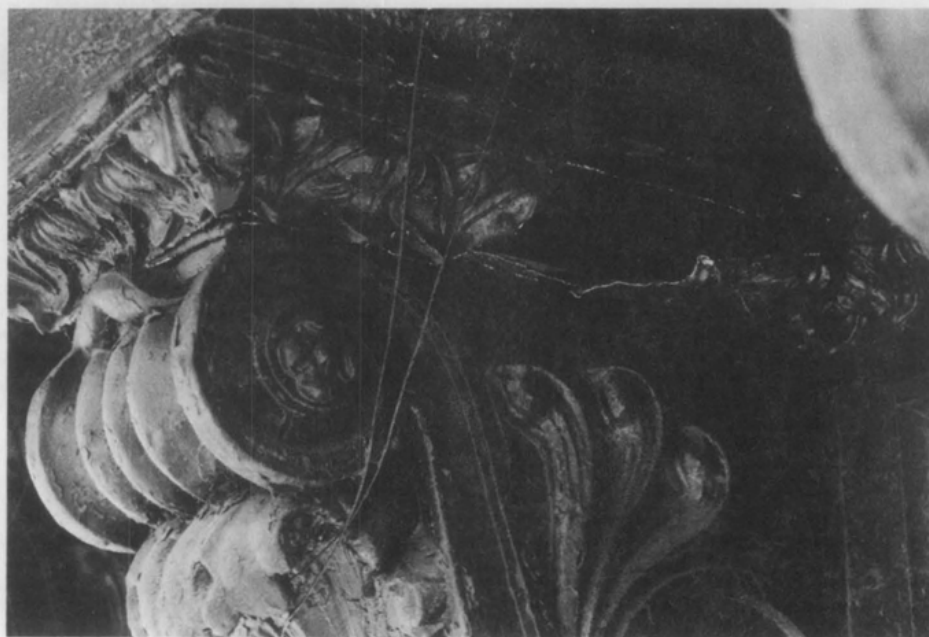
Figure 4. As shown in this view, the molding applied to the modillions was extremely deteriorated. A more serious problem was that most of the zinc modillions had fractured where the integral leaf moldings met the scrolled sides, allowing them to separate from the soffit. As a previous temporary safety measure, holes had been cut in the soffit panels to pass supporting wire beneath the modillions. Photo: Richard Pieper.

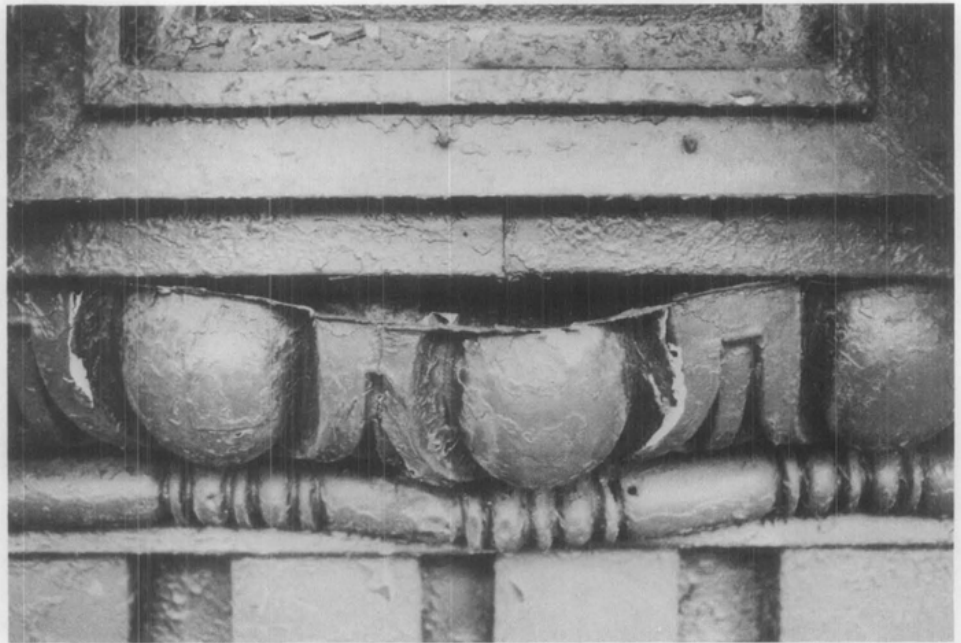
Figure 5. Most of the egg and dart molding on the cornice had deteriorated over the years and required replacement. Photo: Richard Pieper.

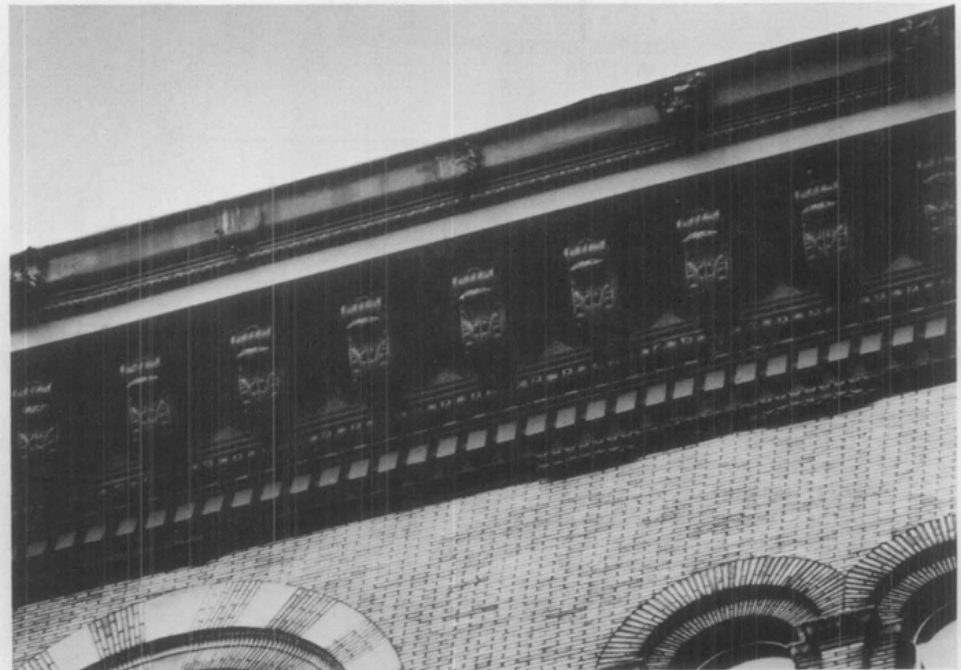
Figure 6. Three of the components of the metal cornice which required replacement because of serious deterioration are shown in this view. They are the lions' heads on the crown molding (several are missing due to failed soldered joints), modillions, and the egg and dart molding at the base of the cornice. The brake-formed galvanized steel that comprised the lineal moldings of the cornice, the soffit and dentil band were in sound condition. Photo: Richard Pieper.

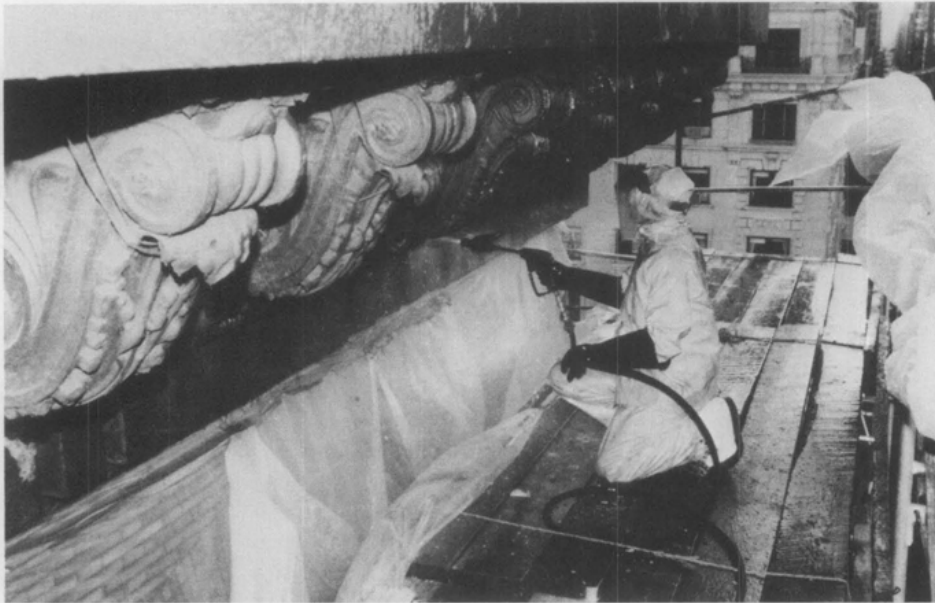
Figure 7. A water spray was used to remove most of the paint from the components of the cornice that were being retained. With the more delicate egg and dart molding, care was required to avoid possible dimpling of the metal. Steps were taken to keep water from collecting inside the cornice. Photo: Michael Devonshire.

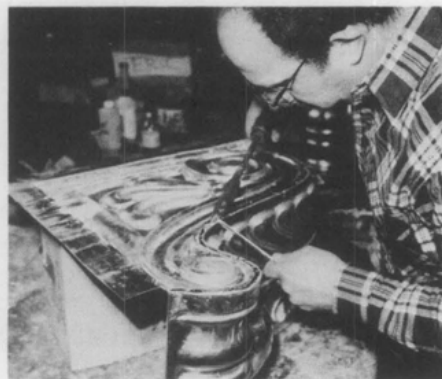
removal was dismissed because of environmental and public safety considerations and potential problems of the residue soiling the exterior masonry. Tests of water spray removal techniques showed that successful cleaning was achieved with a rotating tip spray device, which removed nearly all paint without harming the metal substrate (see figure 7). Care was required when spraying the zinc molding that was to remain, since the water pressure required to remove the paint was sufficient to dimple the projecting metal of the ornament. Water and paint chips were collected in troughs of sheet plastic. Paint residue was gathered to the extent possible, but the spray effluent was difficult to control and some spilled onto the building and sidewalk bridging. In some areas it was necessary to supplement water removal with light hand scraping, using a flat scraper after most paint had been removed.

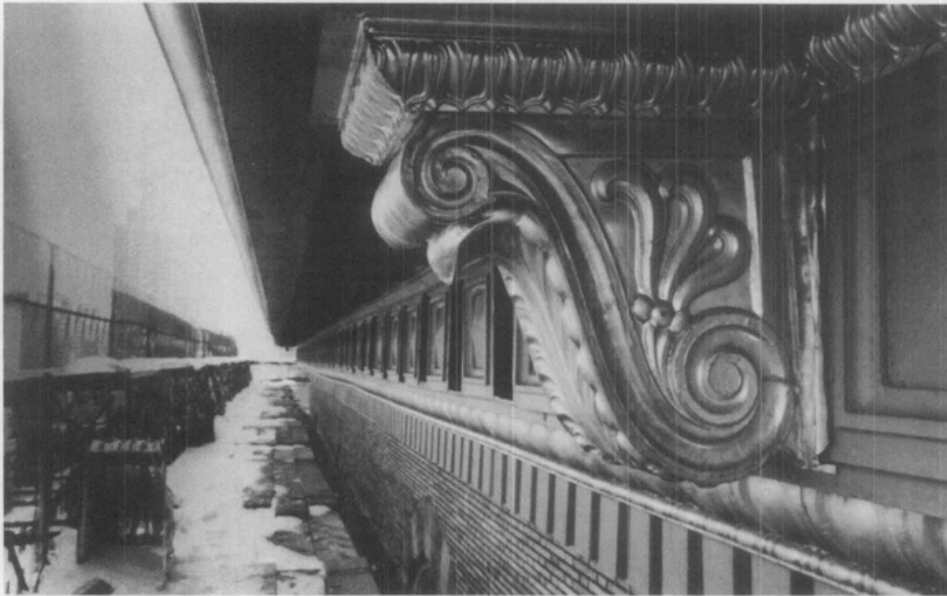
Figure 9. The new modillions, shown here in an installation test, were the same size as the originals but not precisely the same design. Had the difference in appearance been discernible from the street below, matching pieces could have been manufactured at an additional cost. Photo: Michael Devonshire.

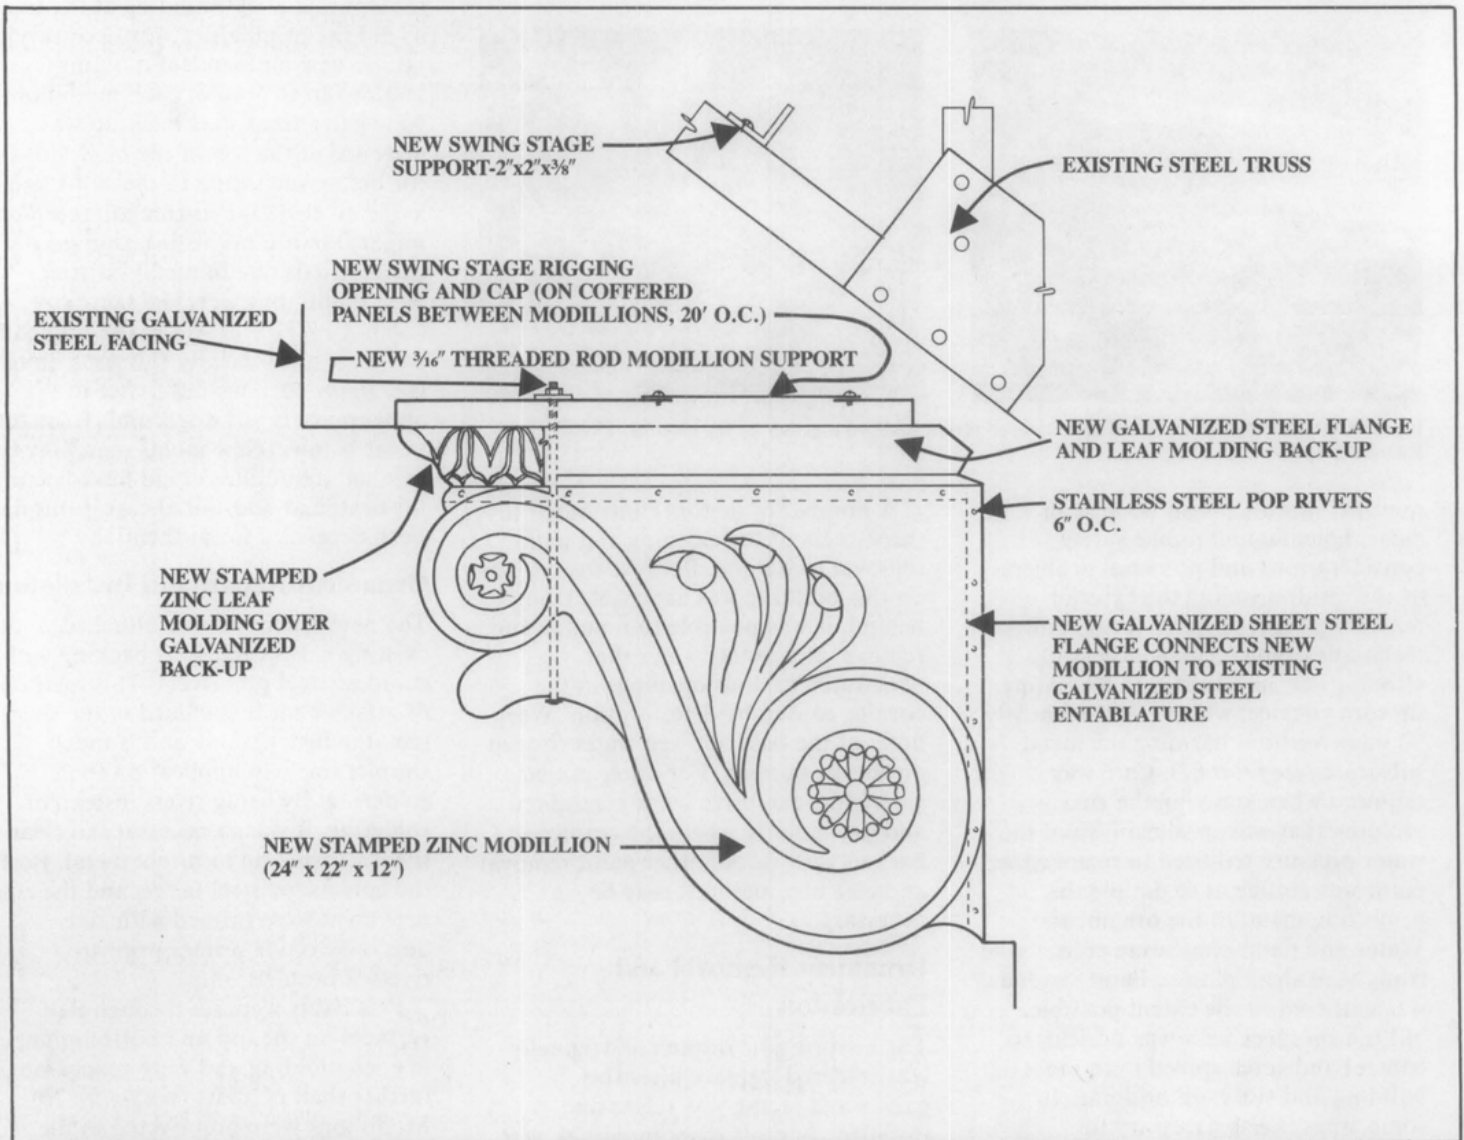
Figure 10. Detailed section shows the supporting technique for the new modillions, which consisted of riveted galvanized steel flanges and threaded rods. Drawing: Michael Devonshire.

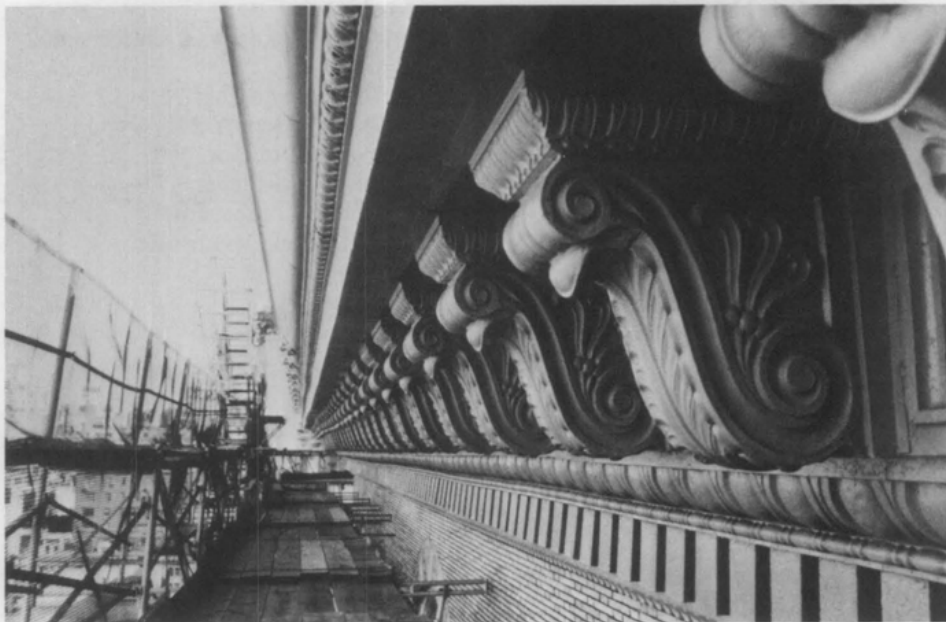
Figure 11. The completed cornice is shown after painting and immediately prior to removal of the scaffolding. Photo: Richard Pieper.

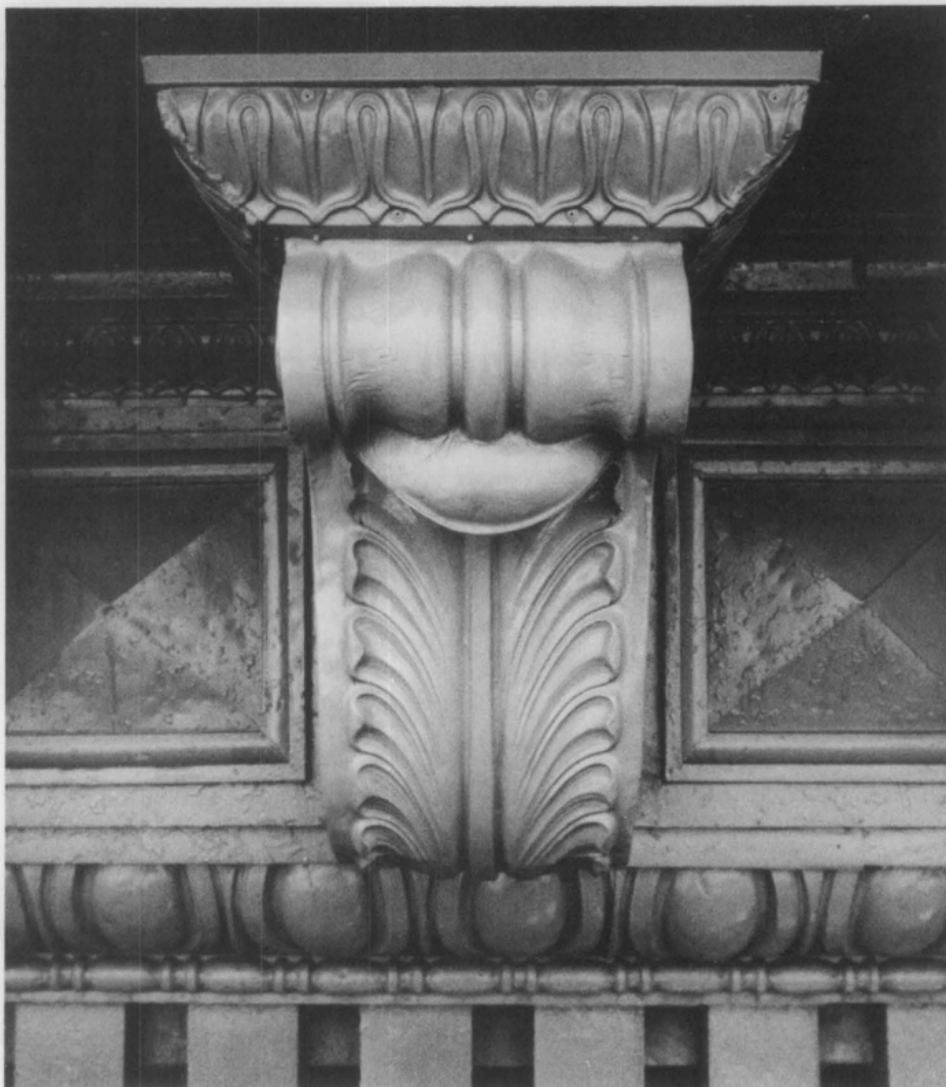
Figure 12. Detail of the completed cornice shows the new zinc modillion and the leaf and egg and dart moldings attached to the historic cornice. This repair approach, which involves in-kind replacement of deteriorated components, is the recommended treatment for such distinctive features as this cornice. Photo: Michael Devonshire.
