# Tech Notes

## WINDOWS

### Planning Approaches to Window Preservation

## MARQUETTE BUILDING

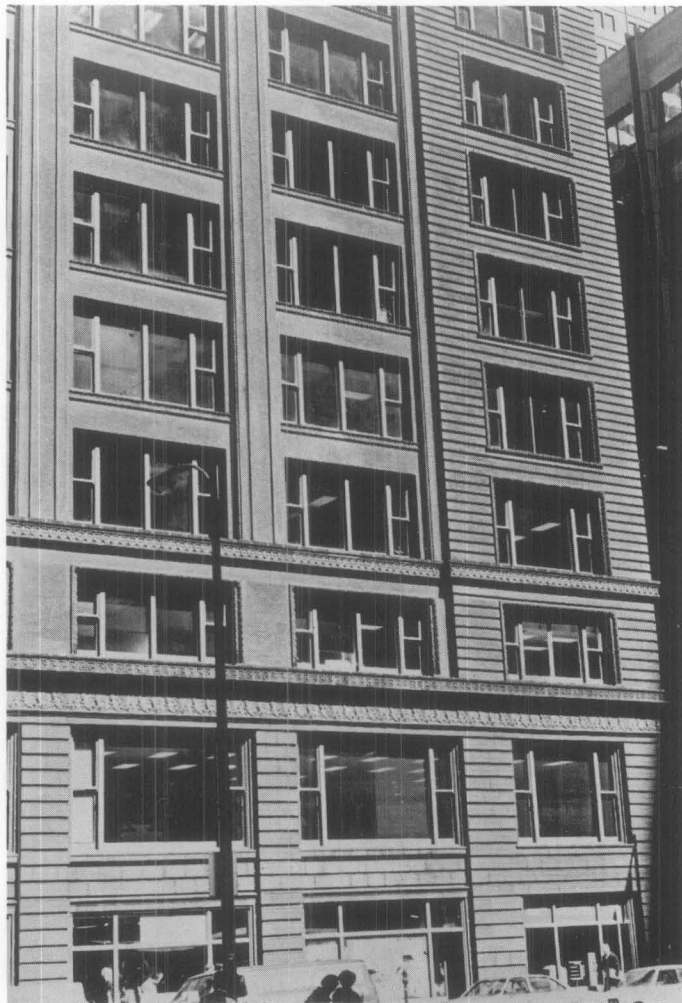
ing on an alley, the 182 Chicago style windows are of greatest interest here because of their style, prominence, and large size. Although the windows vary in size, most measure about 12' wide by 8' high (see figure 1).

**Figure 1.** The Marquette Building has both Chicago-style windows, as shown above on the second floor, and a modified Chicago-style window consisting of two fixed lights in the center section. Photo: Charles E. Fisher

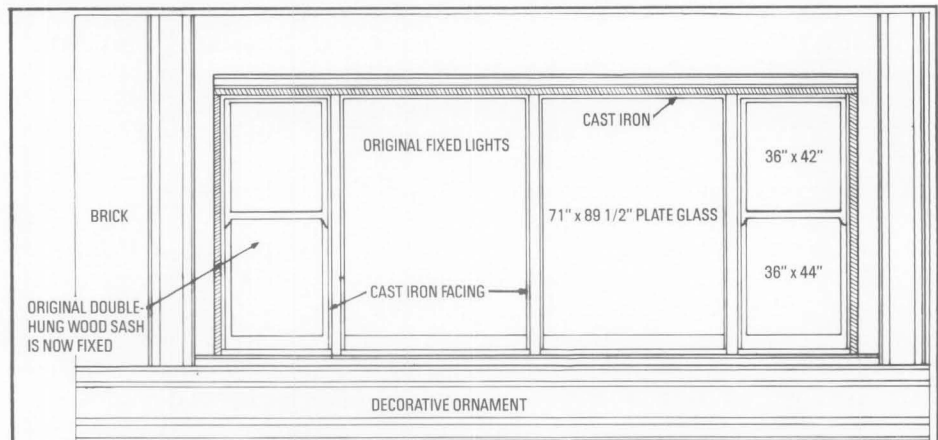
Constructed out of good quality mahogany, the windows were still in sound physical condition despite over ninety years of exposure to Chicago's winter weather and years of neglect due to deferred maintenance (see figure 2). While some of the sills needed repair, the windows primarily needed to be repainted and to have some interior trim replaced. Recaulking around the frames was necessary, but otherwise there was very little air infiltration. The windows had already proven to be very durable and, except for periodic painting, long-term maintenance was expected to be minor. The project architect, Walker C. Johnson, AIA, of Holabird and Root, estimated the life of the windows to be in excess of another ninety years. Even with this information, the architect and owner still had other factors to consider in examining alternatives for the repair or replacement of the windows.

**Figure 2.** The window sash were well-constructed of mahogany and the frames were faced on the outside with cast iron trim. Drawing: Martha L. Werenfels

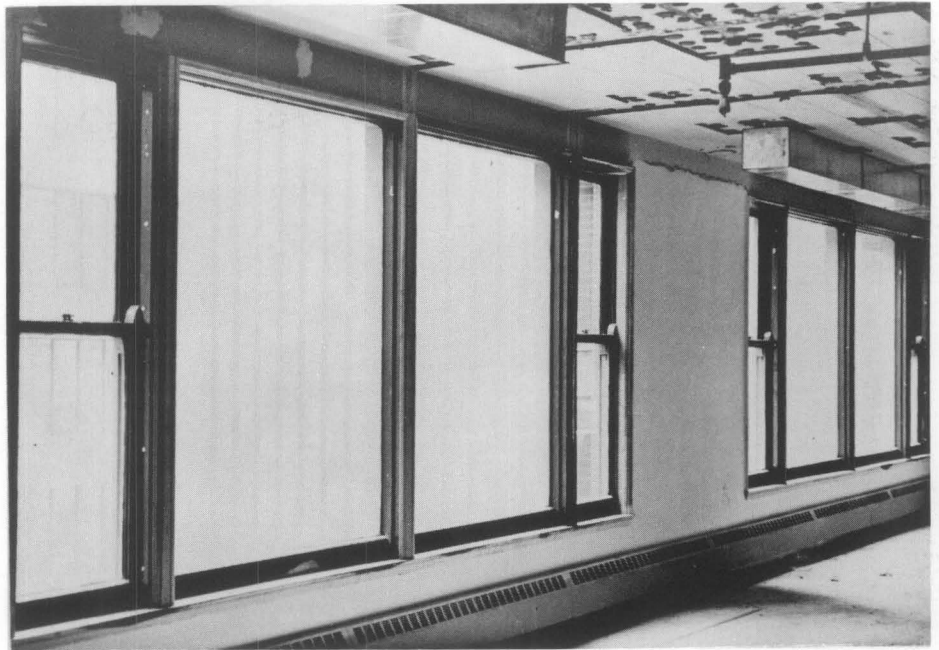
**Figure 3.** Approximately 1000 linear feet of matching window casing trim had to be installed. In many cases, damage had occurred where later partitions had intersected the windows. Lighter color wood shown in the photograph is the new trim prior to painting. Photo: Charles E. Fisher

Repair work on the windows was conducted at the site, working one floor at a time. Wood stops were removed, and the windows taken out of those frames needing repair. The hardware was cleaned and repaired, or replaced where missing. Only about 7% of the windows and trim required any major work. Most of the required work was due to the use during rehabilitation of two fixed windows per floor for trash removal and the material hoist or where later partitions intersecting the windows had damaged the wooden trim (see figure 3). The wood stops were then reattached using screws in order to facilitate future window work that might arise.

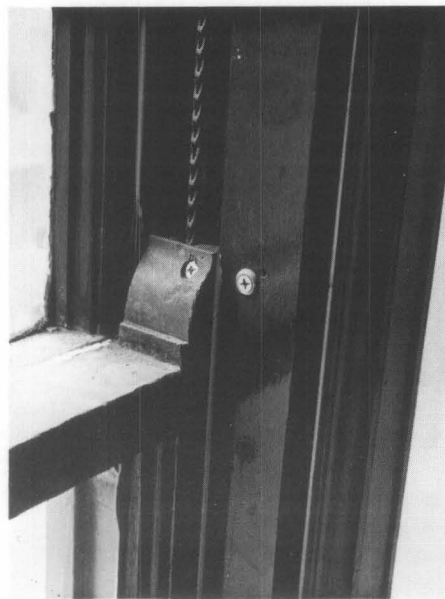
**Figure 4.** The only modification made to the windows was the addition of a screw through the decorative end of the sash stile to fix closed the operable portions. This decision grew out of the recommendations by the mechanical engineers. Photo: Charles E. Fisher

To prevent tenants from opening the windows, a screw was secured through the decorative extension on the stiles of both upper and lower sash (see figure

4). The work was done on schedule and within the original cost estimates.

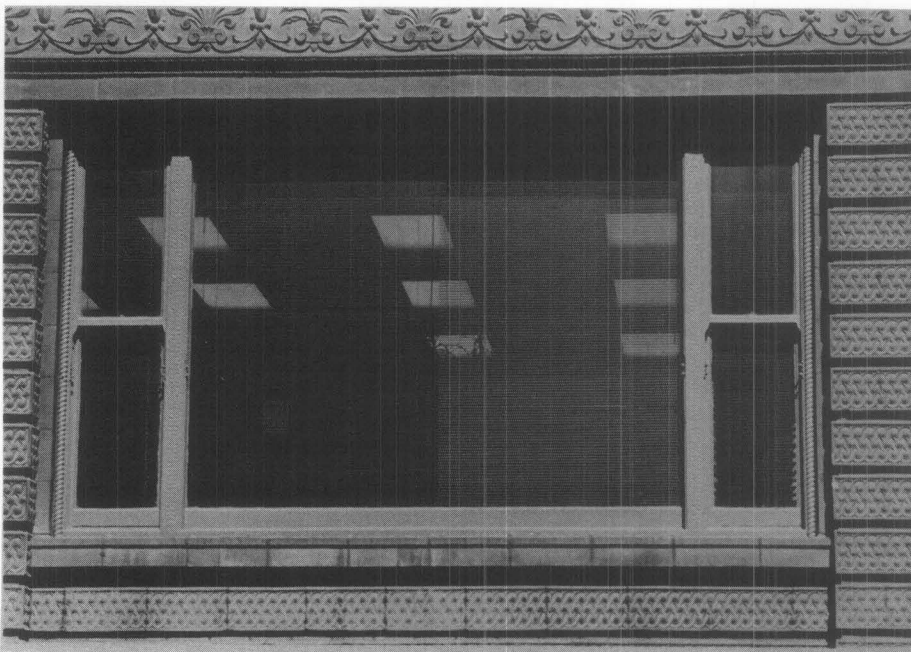
**Figure 5.** Careful planning and evaluation led to the conclusion that the most cost-effective approach was merely to repair the windows rather than undertake measures to upgrade their performance. Photo: Charles E. Fisher

This and other rehabilitation projects have shown the value of careful and objective evaluation of existing window conditions (*see figure 5*). Sound planning can result in window decisions that take into account good preservation decisions and the realities of the marketplace.
