Tech Notes

WORTHINGTON HOUSE Monocacy National Battlefield Frederick County, Maryland

WINDOWS NUMBER 10

Temporary Window Vents in Unoccupied Historic Buildings

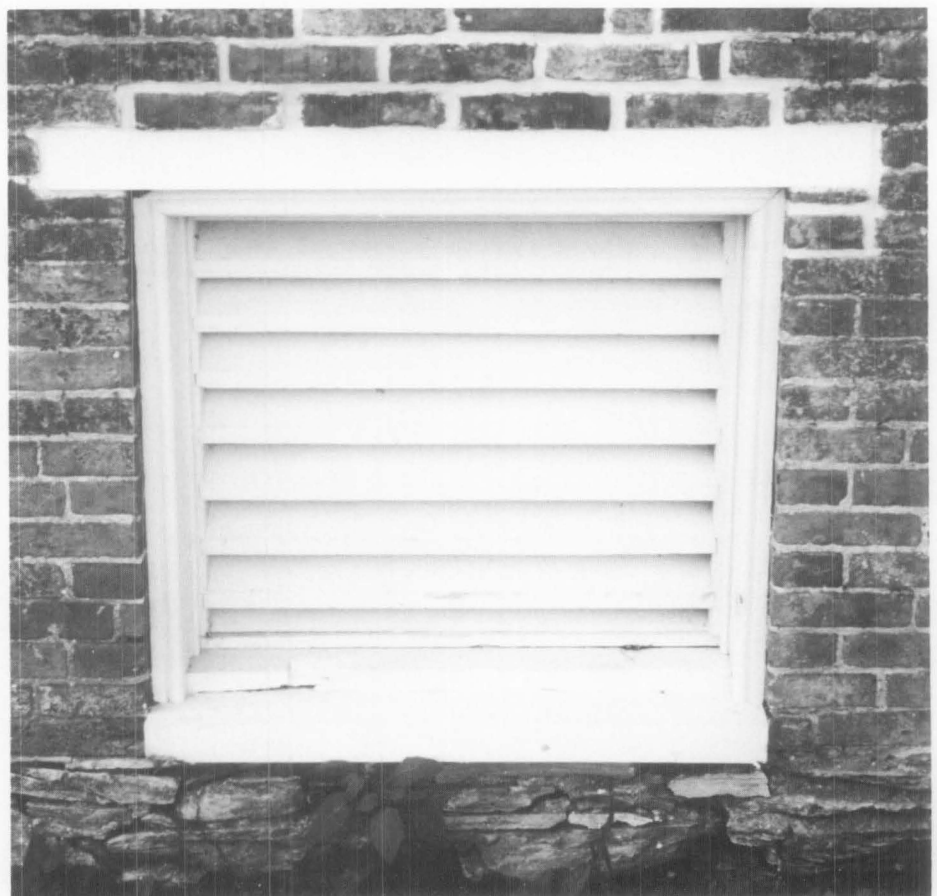
Figure 1. Full louvered vents were installed in all single-sash openings in the basement because of the more severe moisture problems present in that location. Photo: Charles Fisher

Wooden fixed louver vents were custom-made and installed. The easily fabricated louvers were sized to fit the lower sash opening — 34½" wide by 34¼" high on the first floor, while those for the smaller second floor windows were only 25¼" high. Full units were installed in all single-sash basement windows, since the window area was much less and the moisture problems more severe (see figure 1). At the same time, the three attic windows were also replaced with full louvers to encourage thorough multi-level ventilation.

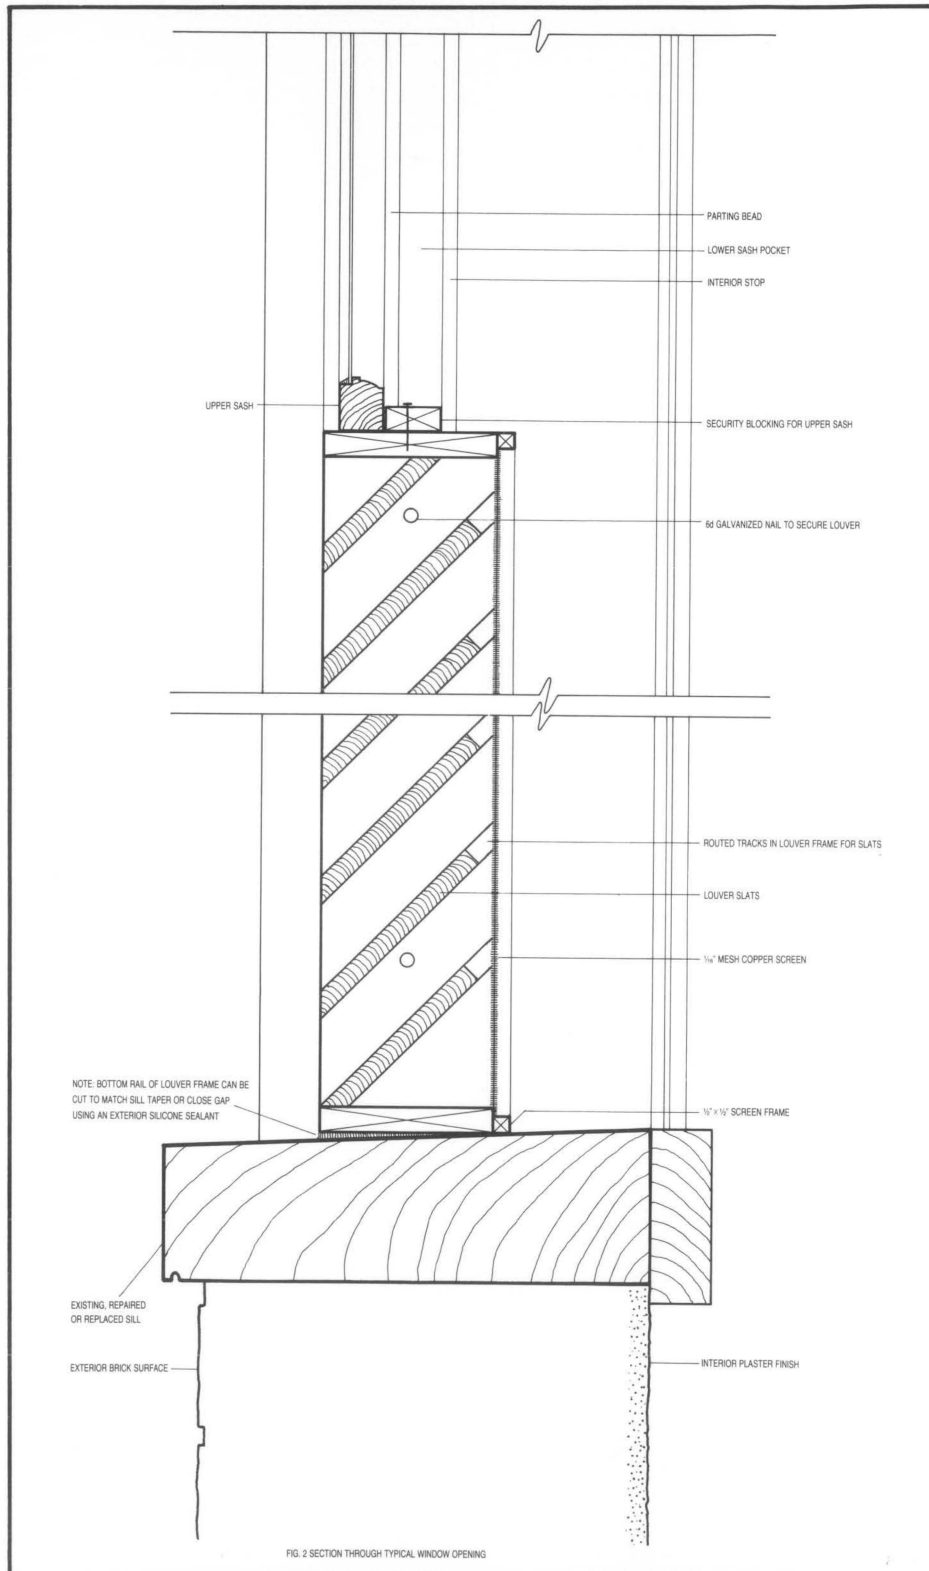
Figure 2. Section of the wooden louvers shows the simple manner in which they were made and assembled. Drawing: Thomas Vitanza

The louver frame was designed to fit snugly into the existing sash tracks and simultaneously to secure the glazed upper sash. An added benefit of the 6" stock width is that it provided a fairly rigid — and thus secure — louver frame. The louver frame was constructed of 1" x 6" shelf grade northeastern white pine; the louver slats were

made from 1" x 8" pine (see figure 2). The spacing of the louver slats did not exceed 4" in order to provide additional lateral strength (and security) to the frame. The relative closeness of the slats also would make it more difficult to kick out the grade level units. The slats were set into the frame at a 45 degree angle by routing a 1/4" deep dado

cut into the jamb of the louver. The exposed edges of the slats were plumb cut in order to create a water drip on the exterior.

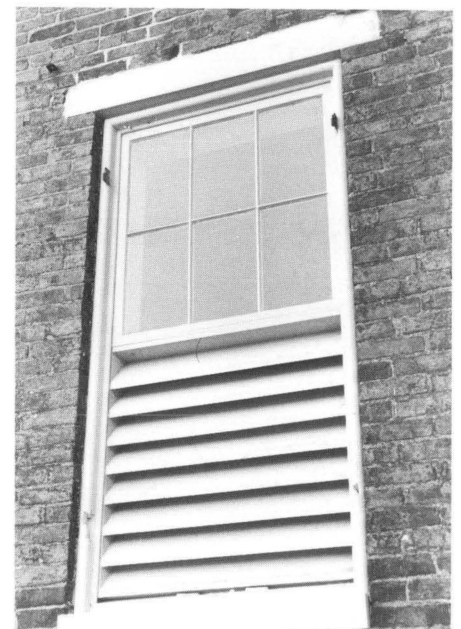
Figure 3. The exposed edges of the louver slats were plumb cut in order to create a water drip on the exterior. For aesthetic reasons, the louvers were painted the same color as the sash and trim. Photo: Charles Fisher

Prior to assembly, the louver members were primed using an alcohol base paint in order to get at least one protective coat on all surfaces. After assembly, they were given one shop coat of oil base exterior house paint. A final coat was applied after installation. For aesthetic reasons, the paint color used on the sash and trim was selected for the final coat on the louvers (see figure 3).

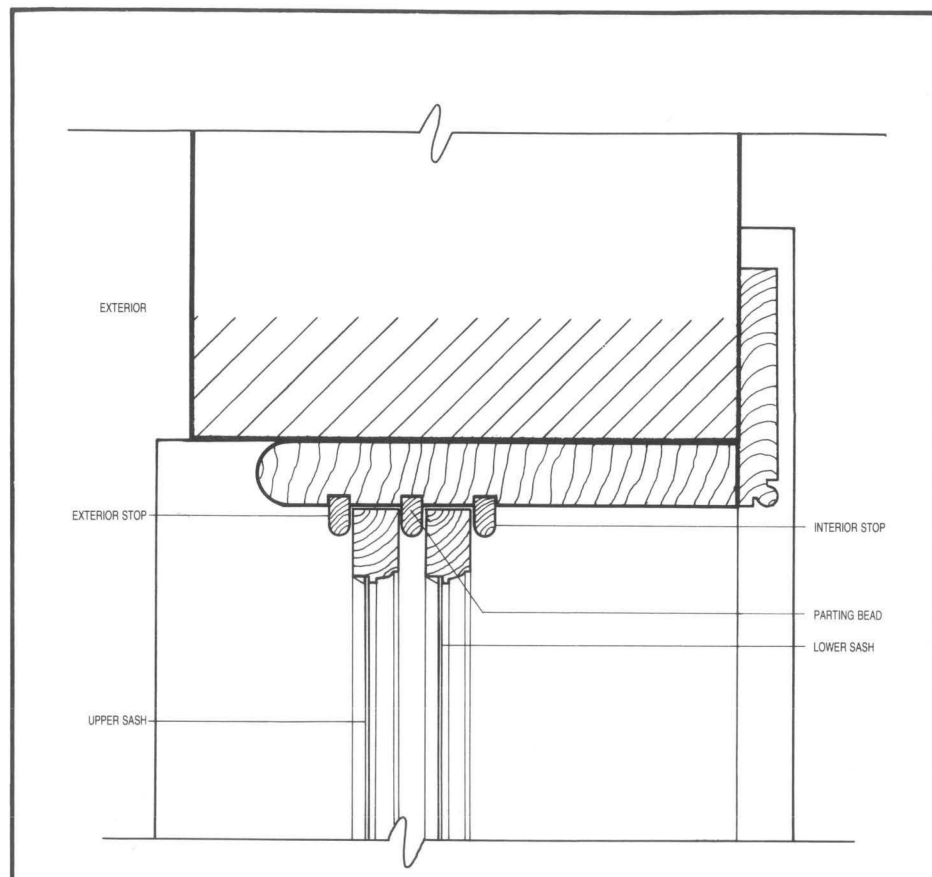
FIG. 4A. EXISTING WINDOW JAMB PRIOR TO LOUVER INSTALLATION

Figure 4. The lower sash (Figure 4a) were removed to permit installation of the louvers. To minimize damage to historic fabric in installing the louvers, temporary blocking was set between the parting bead and stops prior to nailing the units in place (Figure 4b). Drawings: Thomas Vitanza and Christina Henry.

In order to secure the vents in place, common 6d galvanized box nails were driven through the louver jambs into the sash tracks of the historic window jambs. To keep the jamb and stops from being damaged by the louver installation, temporary blocking was set between the parting bead and the inner and outer stops (see figure 4). By attaching the vents in this location, little damage was done as the nails were driven into the sash track rather than an exposed portion of the jamb. Once the building is returned to use, the lower sash will be installed and the nail holes will be filled with wood putty. Since the nails were driven in on the interior of the building, nearly 3" from the exterior wall, adequate security was achieved without driving the nails all the way in. Thus it will be relatively easy to grab onto the nail heads and back them out when the vents are eventually removed.

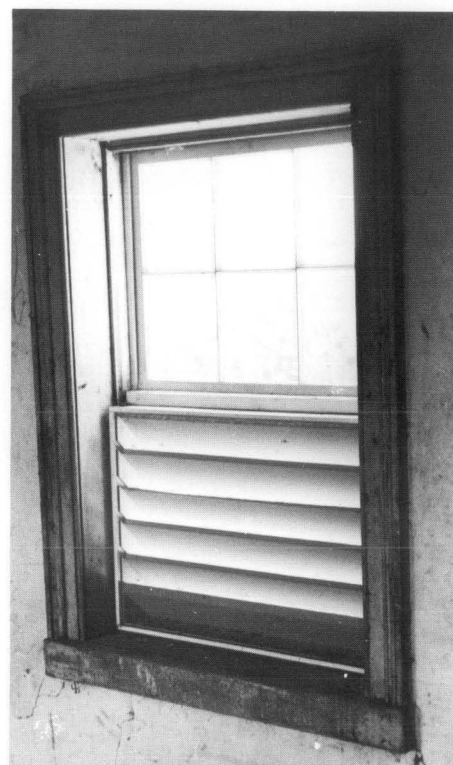
Figure 5. Screening was attached to the back side of the louvers to prevent the recurrence of insect, bird, and rodent infestation. Photo: Charles Fisher

After the louvers were secured in place, 1/16" mesh copper wire screening was installed on the interior of the louver frame using a 1/2" square wood frame. The screening is an integral part of the louver design. This seemingly minor detail was necessary to prevent the recurrence of insect, bird, and rodent infestation (see figure 5). The 1/16" mesh was specified to keep out the ever-present mud-dauber wasp, whose hive-building instincts have no regard for historic plaster or paint.

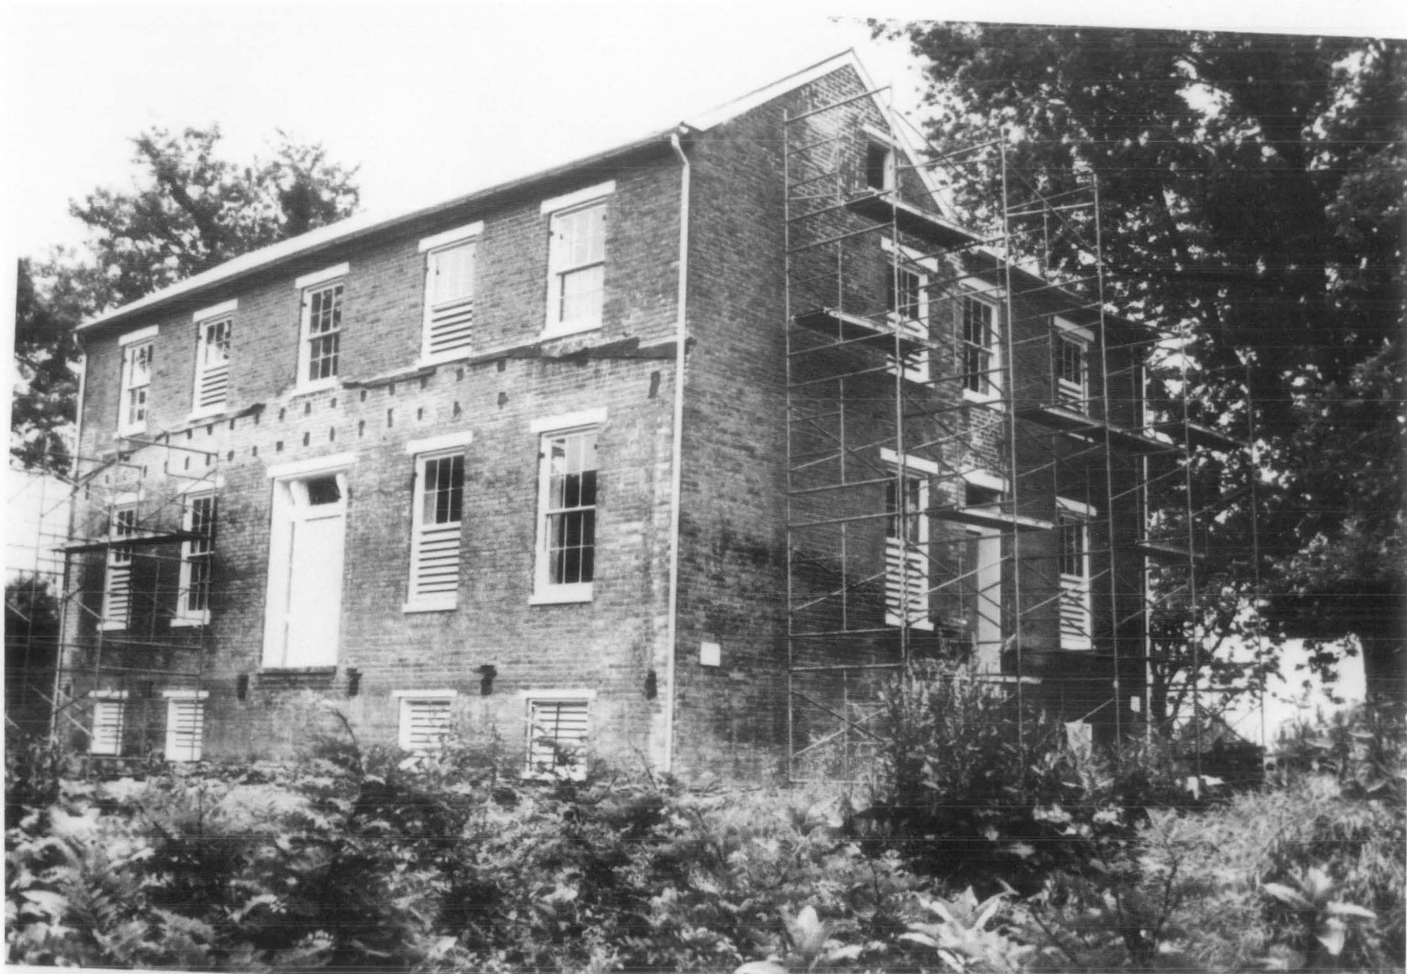
The window louvers installed in the Worthington House have proven effective over the past two years in providing the necessary ventilation for the building (see figure 6). Neither fungal attack nor condensation damage has recurred, and the interior air lacks even the typically humid, musty odor typically found in many older buildings. The louvers provide for good air movement within the building and a greater equilibrium between interior and exterior humidity levels and air temperatures, thus helping to protect the historic plaster and the significant interior finishes. The installation of the louver system in conjunction with the other sash work, and the overall exterior stabilization work has stimulated an interest in finding a use for the structure. As a temporary solution to a complex set of problems, the louver vents in the Worthington House have resolved a variety of issues. When used together with additional weatherproofing measures, this venting solution can be adopted for use in other buildings being mothballed.

Figure 6. The window louvers installed in the Worthington House have proven effective over the past two years in providing the necessary ventilation for the building. Photo: Tom Vitanza.
