Subject: Repair/Replacement of Missing or Altered Storefronts

- Applicable Standards:**
- 2. Retention of Historic Character
 - 6. Repair/Replacement of Deteriorated or Missing Features Based on Evidence
 - 9. Compatible New Additions/Alterations

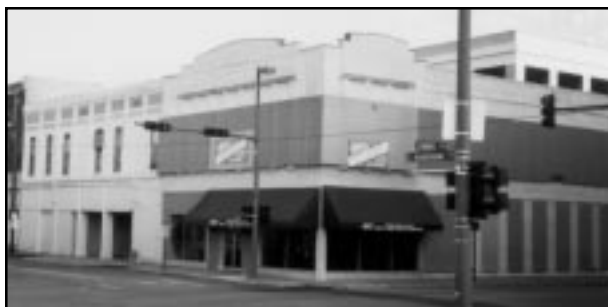
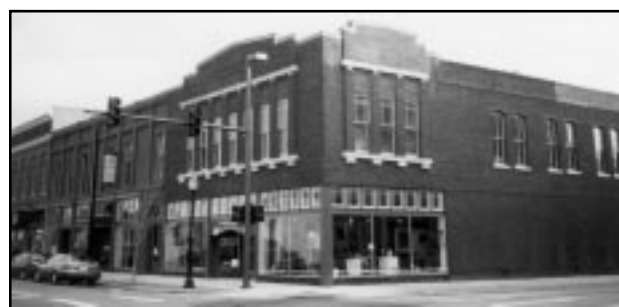
Before rehabilitation (left), the storefronts and the second floor windows were covered by plywood and metal panels. Removal of the panels revealed that the historic storefronts and windows were still intact and could be preserved (right).

When the plywood and metal panels were removed at the start of the rehabilitation, the historic storefront and the second floor

windows with their distinctive Craftsman-style details and muntin configuration were revealed to be intact, needing only minor repairs. On the left side of the building, the 1870s windows on the second floor were also intact and repairable. Although portions of the original storefronts had been removed to create garage door openings, the historic cast-iron frame itself remained, and only the missing display windows had to be replaced to re-establish these historic storefronts.

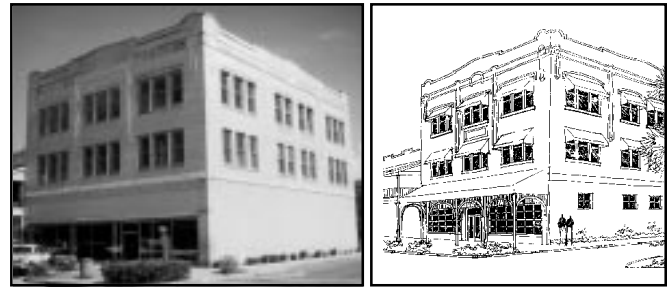
Application 2 (*Incompatible treatment later modified to meet the Standards*): The storefront of this three-story, brick, commercial building constructed in 1923, and used as a furniture store with offices and lodge rooms on the upper floors, had also been altered, probably in the 1960s. When rehabilitating the building for offices, the owner opted for a new storefront design to highlight the building's new use. The architect initially proposed large, multipaned display windows flanking a double-door entry topped by an arched awning supported by free-standing metal posts. Neither the storefront, particularly the multipaned windows which are representative of a much earlier architectural style, nor the awning was appropriate for the historic character of this 1923 building.

The storefront of this 1923 building had been changed in the 1960s (top left). The initial proposal for large, multi-pane display windows and an awning supported by freestanding posts (top right) was incompatible with the building's historic character. The revised design which simplified both the display windows and the awning is a compatible contemporary replacement storefront (bottom right).

The revised storefront design included replacing the multipaned windows with three large display windows and a double door entrance. The compatible new design also included a foreshortened transom that alluded to the original transom which could not be exposed in its entirety due to the existence of a later mezzanine. The awning was also redesigned to match the horizontal metal awning (visible in old photographs), which had hung from metal hooks still attached to the facade.

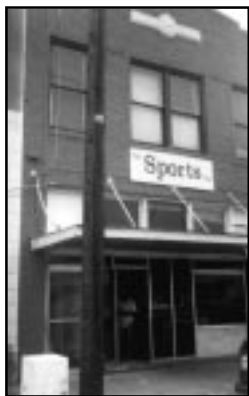
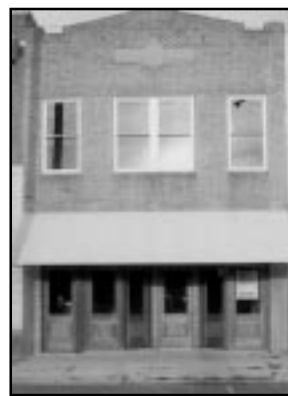
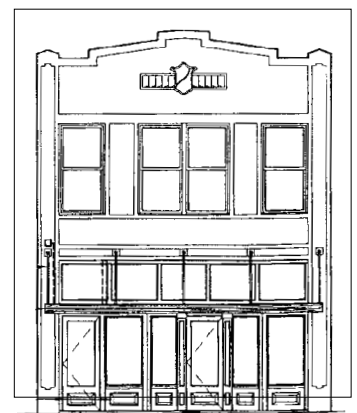
Application 3 (*Incompatible treatment later modified to meet the Standards*): This small, two-story brick building, originally constructed in 1889 as a newspaper office, had been “modernized” with an aluminum storefront installed in the 1950s. Although no historic photographs were found to show the building's original appearance, the storefront still had two entrances, one on the left leading to the upstairs, and another leading to the newspaper offices on the first floor. As part of a recent project to rehabilitate the building as a sports bar with apartments upstairs, a new, varnished wood storefront had been installed along with a very large awning that concealed the still extant, historic transom above the storefront. This new storefront was incompatible in scale, proportion, color and finish with the character of the historic building.

The storefront of this 1889 building was altered in the 1950s (left). The replacement storefront and awning were incompatible in scale, proportion, color and finish with the historic building (center). Remedial work to make the new storefront compatible will include re-installing a horizontal metal awning, painting the wood, and increasing the glass to wood ratio of the storefront (right).

Remedial work was proposed to bring the storefront into compliance with the Standards. The proportions of the storefront were corrected by lowering the height of the bulkhead panels and lengthening the glass in the display windows and the entrance doors. A traditional metal horizontal awning suspended from the facade would be installed which would once again reveal the transom. And, the new varnished wood of the storefront—the varnish already deteriorating rapidly on this west exposure, would be given a traditional painted finish, more appropriate to the character of the historic building and more protective of the wood.
