Subject: Alterations to Rear Elevations

- Applicable Standards:
- 2. Retention of Historic Character
 - 9. Compatible New Additions/Alterations

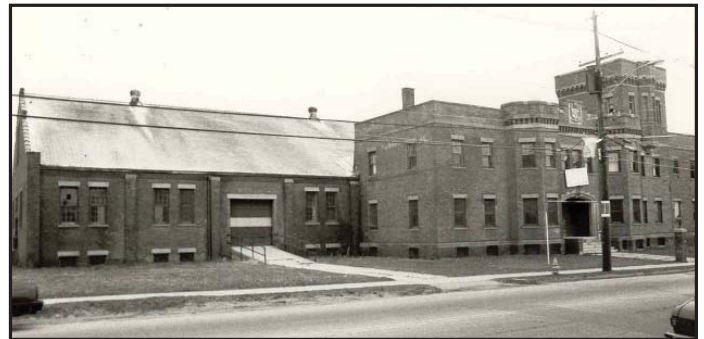
Above: The street elevation of the armory shows the head house on the right with a portion of the drill shed visible to the left.

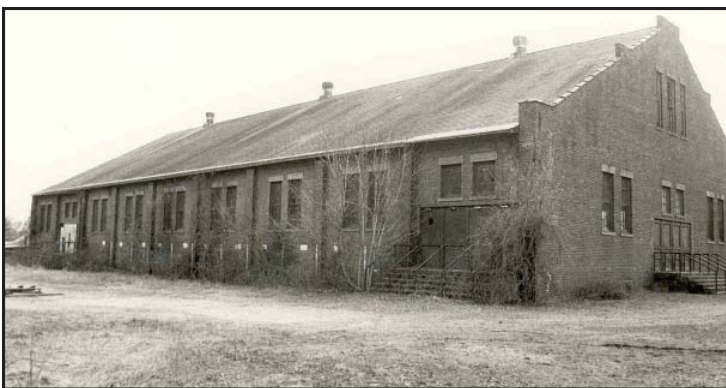
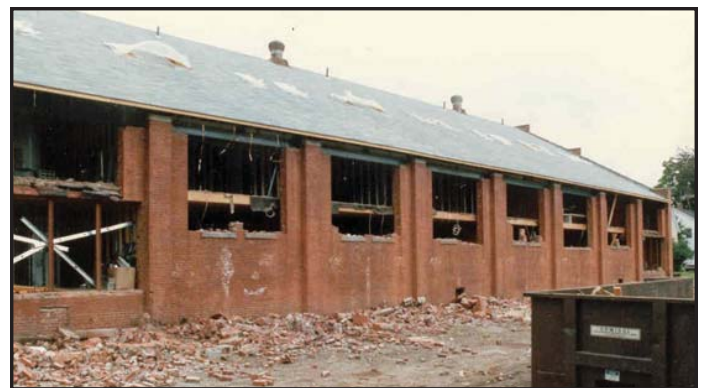
Left: Before rehabilitation the rear elevation of the drill shed, which is highly visible, is distinguished by paired, multi-pane wood windows in the bays. Right: During rehabilitation the historic windows were removed and the openings were enlarged.

These changes to the rear elevation are not compatible with the utilitarian character of the drill shed. The existing historic windows could have been retained and, with a few alterations, could have provided sufficient light and access to the apartments while retaining the building's character. Instead, wholesale removal of the sash and so much brick resulted in a loss of historic building material, and replacing it with stock doors and windows and wood decks changed the character of the drill shed from utilitarian to residential. The cumulative effect of these alterations negatively impacted the historic character of this distinctive and highly visible elevation. The rehabilitation project did not meet the Standards.

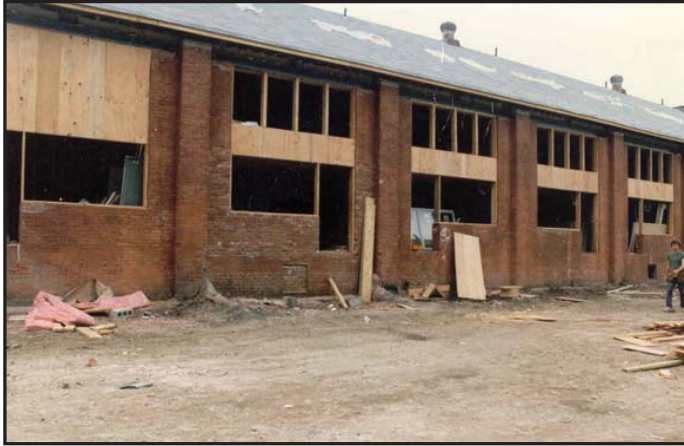
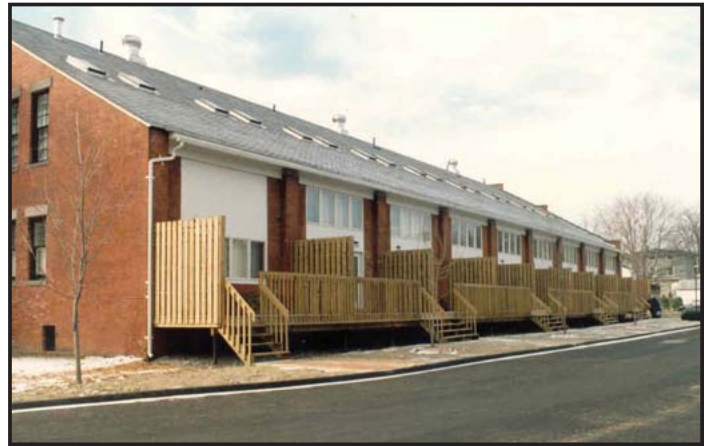
Above: The enlarged openings were infilled with wood panels, stock windows and doors (left). As a result, (right) the rear elevation of the drill house row has the residential appearance of townhouses.

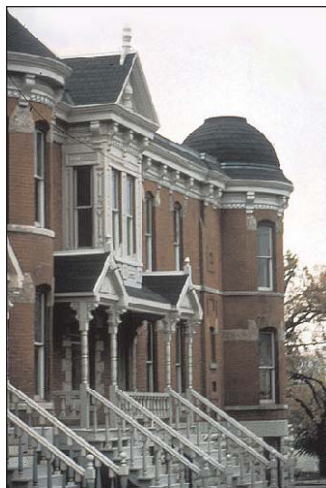
Right: Historic row houses retain their historic character on their primary elevations after rehabilitation.

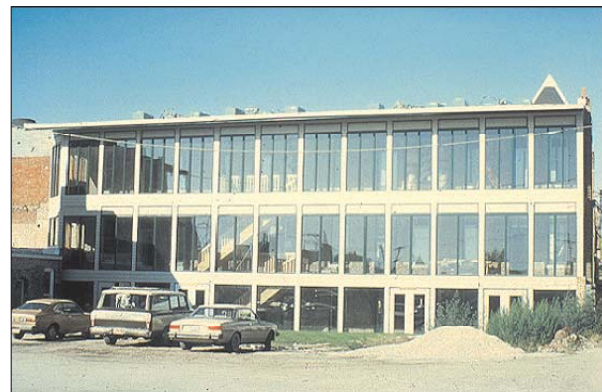
Application 2 (*Incompatible treatment*): Four row houses, part of a block of late-19th century brick row houses, were rehabilitated for office use. The office conversion involved some relatively minor changes to the interior layout and room configurations. Because it was done for a single business, some openings were made in the party walls that separated the individual houses in order to connect the interior spaces. The rehabilitation carefully retained the historic character of the exterior of the buildings on the front and their appearance as individual row houses. However, as part of the rehabilitation a continuous glass curtain wall was constructed across the back of the four row houses, completely obliterating their distinctive rear brick walls. As a result of this treatment the houses have lost their identity as separate buildings. In addition, the glass curtain wall is incompatible with the late 19th century historic brick row houses and with the residential character of the historic district. The rehabilitation project did not meet the Standards.

Above: The rear walls of the row houses were covered with a single glass curtain wall that is incompatible with the character of the historic houses as well as the character of the historic district.
