# Tech Notes

NATIONAL PARK SERVICE  
U.S. DEPARTMENT OF THE INTERIOR  
WASHINGTON, D.C.

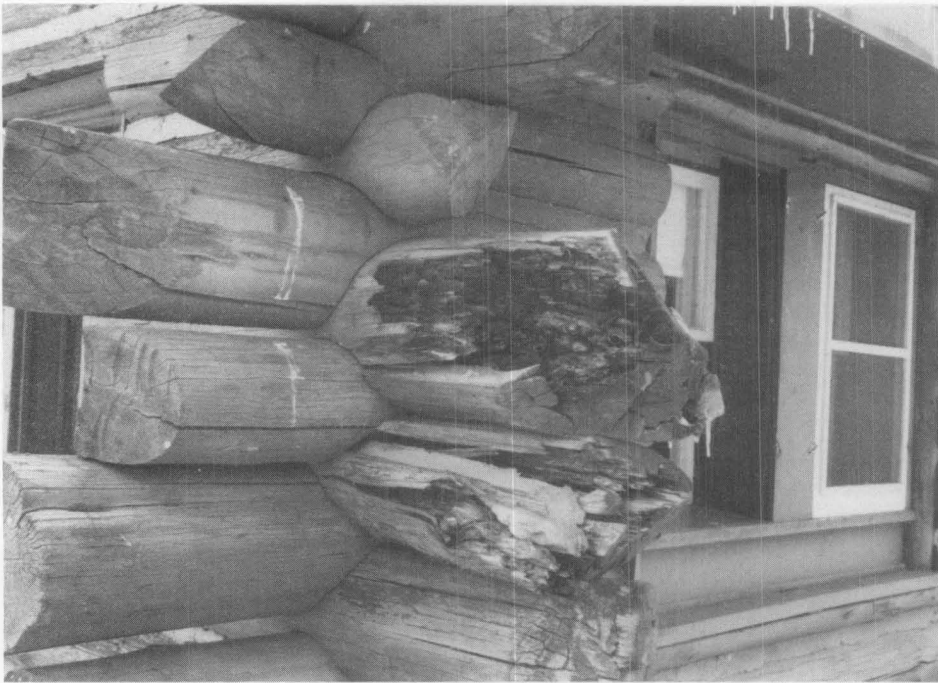
**Figure 1.** Typical deterioration of log crowns is seen at the Institute Building, adjacent to the Lamar Barn. This is the condition of many of the log crowns at the Lamar Barn prior to the repair and replacement work. Logs are notched at the corners. Photo: Harrison Goodall.

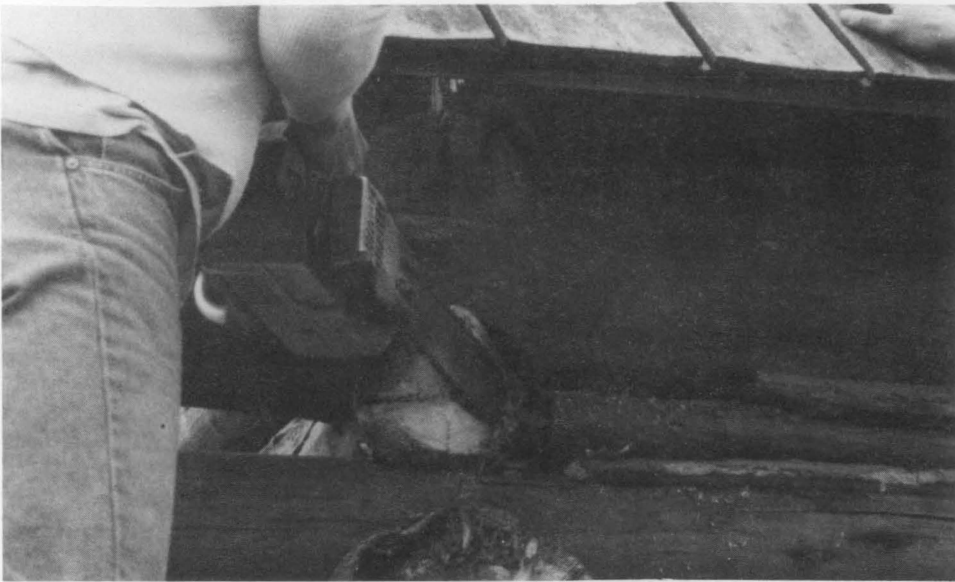
Figure 2. Small chainsaws were used to cut off deteriorated log crowns. The darker portions of wood at the log ends are the soft punky deteriorated fibers. Photo: Harrison Goodall.

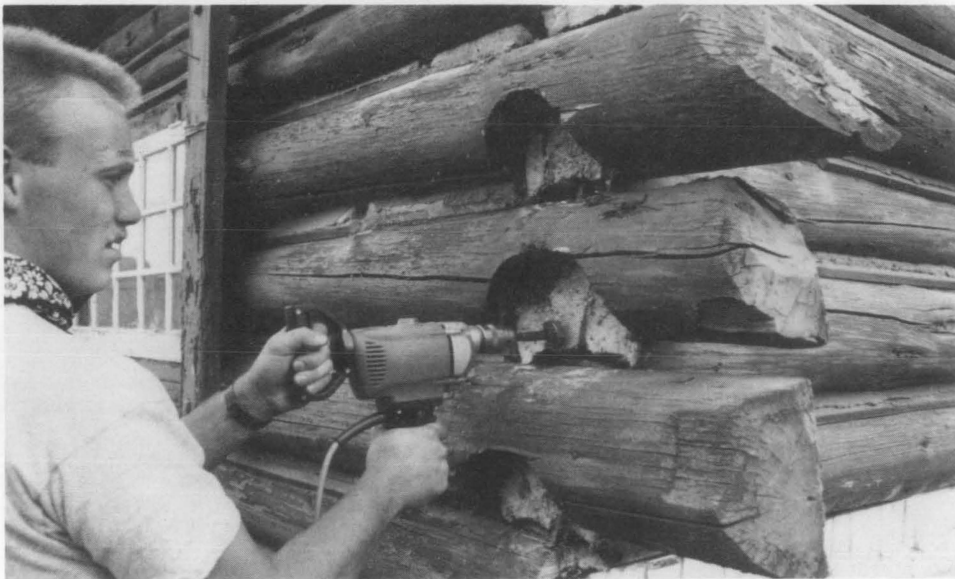
Figure 3. A plumber's bit was used to recess the crown back to the center line to create a flat surface for attaching the replacement crowns. Photo: Harrison Goodall.

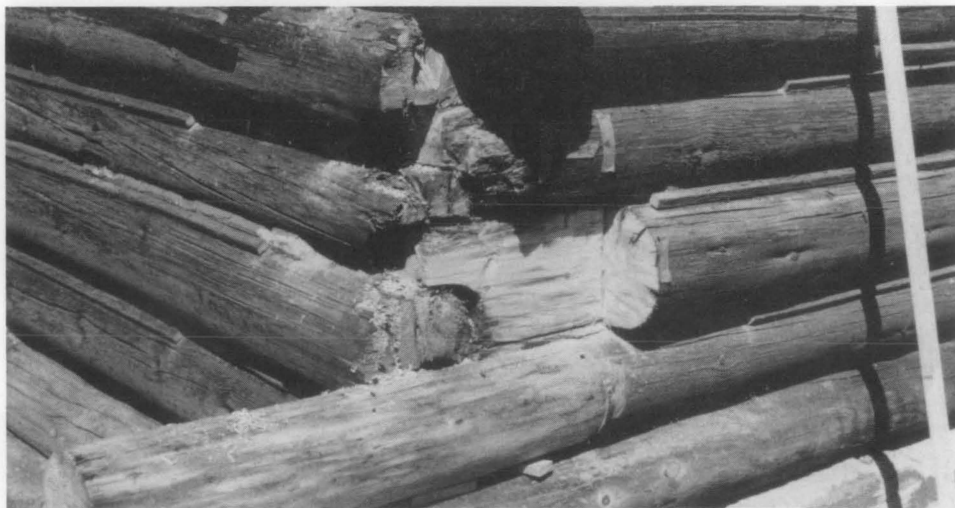
Figure 4. In a few cases, the deterioration had penetrated beyond the center line of the log corners and portions of the wall face were removed. Photo: Harrison Goodall.

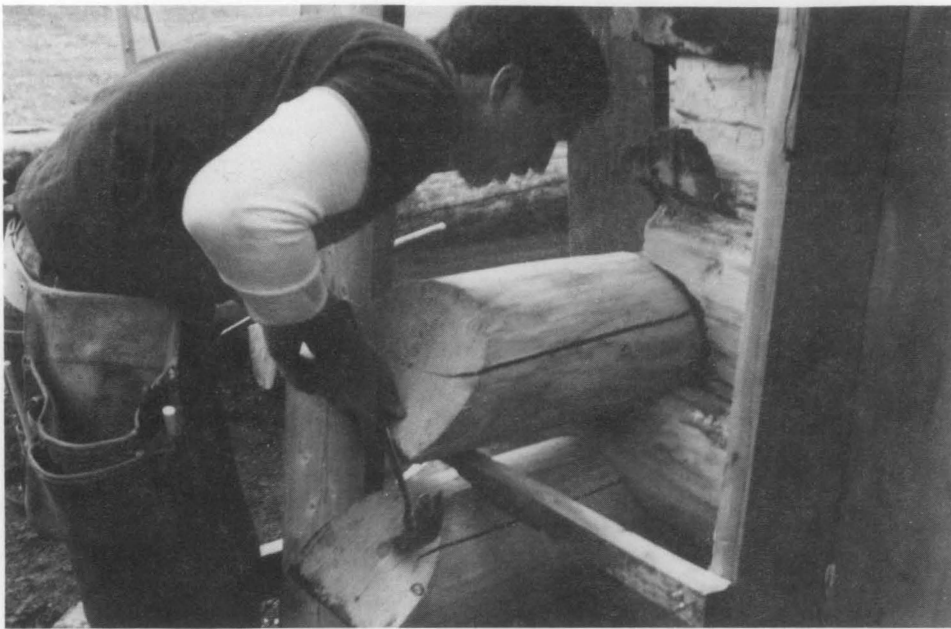
**Figure 5.** A framework or cribbing held the replacement crowns as they were fabricated. All the crowns had to be temporarily put in place to ensure a proper fit. Once stacked up, they were numbered to make sure they would be properly aligned at the time of anchorage.  
Photo: Harrison Goodall.

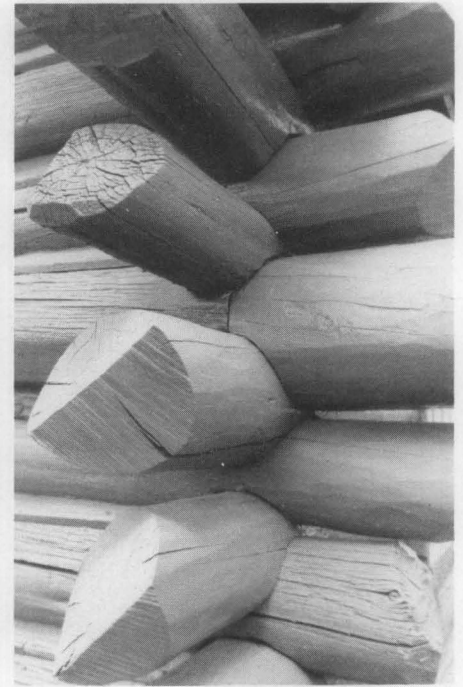
Figure 8. The joints between the historic logs and the new crowns are visible, but not disconcerting. The unsealed joint will help keep future decay isolated to the log crown. Photo: Rodd Wheaton.

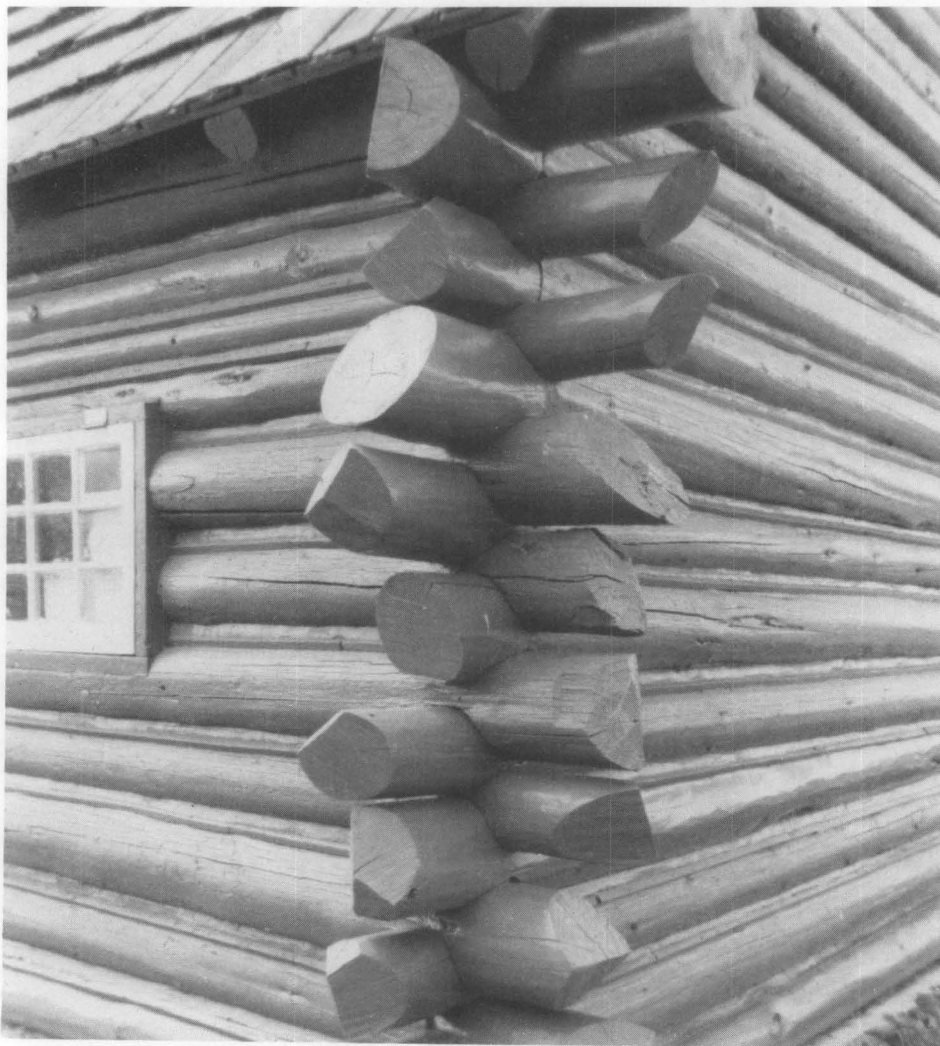
Figure 9. A repaired corner of the Lamar Barn. It is expected that the log crowns will need replacing in 10-30 years. Photo: Rodd Wheaton.

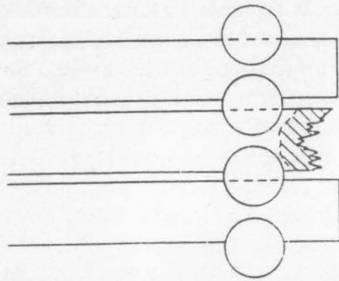
Deteriorated log crown.

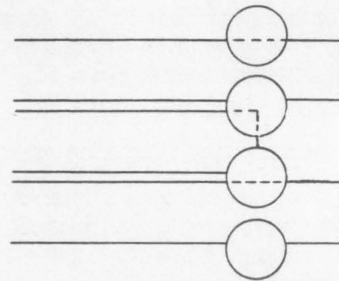
Remove deteriorated crown. Recess to the center line of the log wall. Remove all pockets of decay. Saturate the decay pockets with an epoxy consolidant.
