ALDRIDGE HOTEL
Shawnee, Oklahoma

Preservation Tech Notes

METALS NUMBER 6

Repair and Reproduction of Metal Canopies and Marquees with Glass Pendants

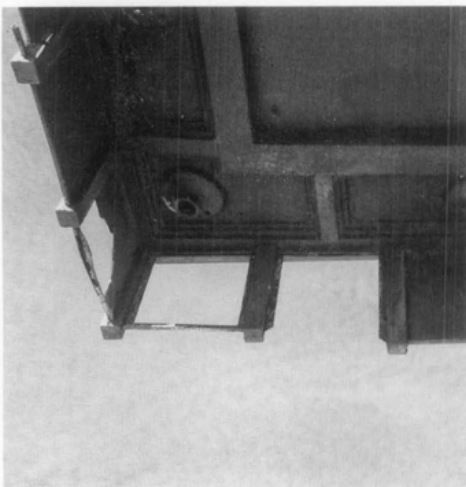
Figure 2. The underside of the main canopy's left corner, showing damage to copper pendant frames and missing glass.

By the time the rehabilitation work began, the main entrance canopy had suffered years of neglect and decay (see figure 1). The entire canopy had been painted green, masking the structure's original patina, ornate stamped ceiling, and colored glass pendants. Since the canopy was encased in copper, it was not possible to visually establish the condition of its internal structure. However, it was evident that the glass pendants located at the corners and along the sides were either missing or cracked. The pendant frames were also bent, twisted, or broken off (see figure 2).

meet code, as the existing glass was not tempered. Because of the extent of needed repairs, both the left and right corners and side sections, along with the ceiling panels, were completely dismantled and taken to the contractor's shop. Upon removal of these sections, it was discovered that the wood frame to which the copper was attached had rotted as a result of water seepage and needed to be replaced.

In addition to creating replacement frames for the broken and missing glass pendants, repairs were made to the existing copper cladding covering the canopy frame. The contractor straightened out copper that had been bent or twisted. New copper pieces were sleeved over damaged pieces or made to span missing portions, and then were soldered in place. Copper pop rivets were used to attach pieces where sleeving was not practical. To

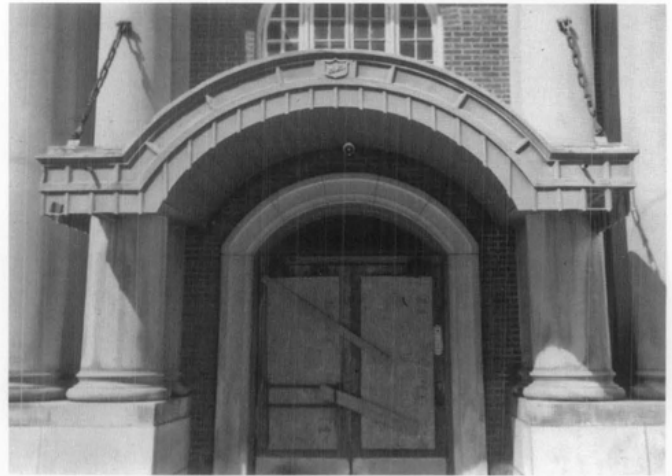
Figure 1. The Aldridge Hotel's south main entrance canopy as it existed at the start of the building's rehabilitation.

The initial task of the sheet metal contractor was to establish the condition of the canopy and determine what could be repaired and what needed to be replaced. The contractor began by surveying the copper cladding that covered the roof, sides and underside of the canopy structure. Since paint was covering the copper cladding, the decision was made to remove the non-historic paint to allow for a more thorough condition assessment.

Upon removal of the paint, it was evident that the archway and canopy roof were in sound condition. Ferrous armatures and attachments were inspected for rust since copper sheet is cathodic to iron. Approximately 40% of the glass pendant frames located along the canopy's sides required replacement and the canopy's galvanized metal ceiling needed to be repaired. It was also decided that all the glass panes would need to be replaced in order to

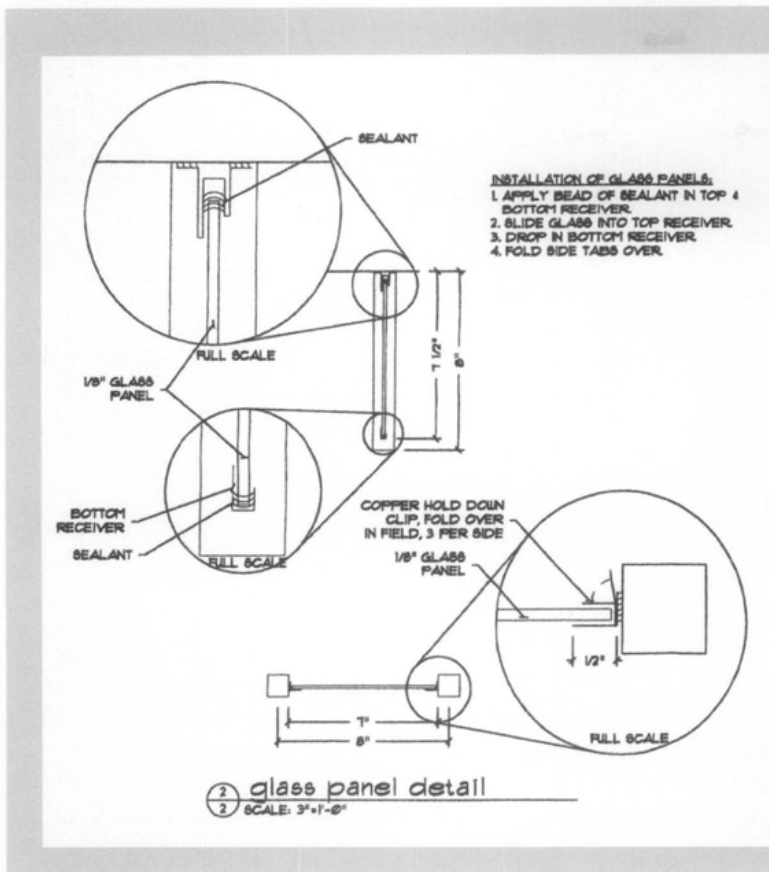
Figure 3. Details of the proposed replacement pendant frame, including how the pendant glass was to be installed. Drawing: The Hill Firm.

After transporting the dismantled canopy sections back to the shop, the sheet metal contractor took measurements of the existing pendants that were in good condition. Along with the canopy's original drawings, these measurements were used to create a pattern for the needed replacements. The design for the pendant, measuring 7 1/4" x 7 1/4" and made of 16 oz. copper, resembled a picture frame. At the bottom of the frame, a U-shaped channel provided a bottom receiver for the glass to help hold it in place. An extended U-channel was used along the top, providing extra room so the glass pane could slide up out of the bottom channel for replacement when broken. Affixed to the backside of the frame were four 1/2" copper clips, two on

each vertical side, which when folded over the glass, helped secure the lights in place (see figure 3).

After cutting and shaping the metal pieces, the new pendant frame was soldered together. Each frame was then soldered to the dividing posts between each pendant. These 1" square copper posts served as the connector between each pendant and provided structural strength for the row of glass pendants. At the top of each pendant frame, the metal sides included a flange at the upper end that enabled it to be affixed with screws to the underside of the canopy. An additional section of copper panned over the flanges provided for a weather tight seal.

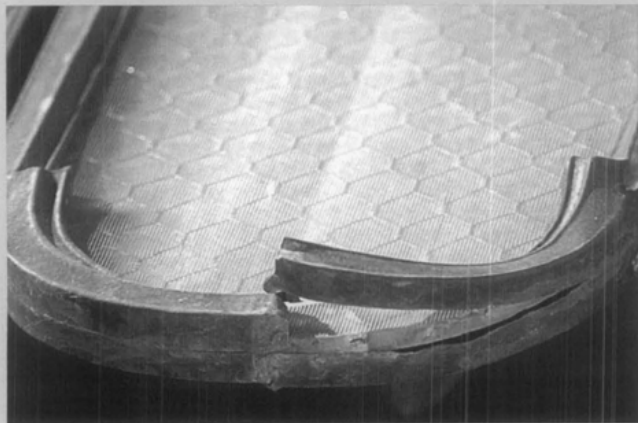
Figure b. In this double-faced pendant, the soldered joint on the outer face has failed where two adjacent pendant halves are connected.

Open joints: Metal joints connect individual pieces of the pendant frame. Where joints have opened up, water can seep inside and cause eventual rusting of the galvanized steel. In colder climates, metal deformation can occur from water freezing and expanding within the frame. Open joints should be cleaned, aligned, and re-soldered rather than simply filling voids with caulk or other sealants.

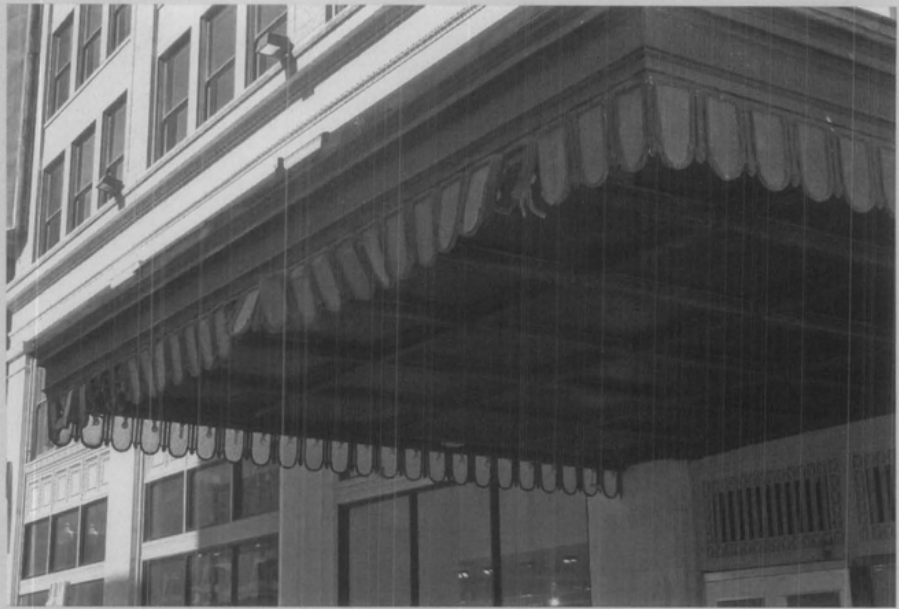
Figure a. Rust, paint failure, open joints, broken glass, or damaged and missing sections are indications that pendant frames are in need of repair.

Rust, paint failure, open joints, broken glass, or damaged and missing sections are indications that pendant frames are in need of repair. When the pendant frame is in reasonably good condition, it may be possible to make necessary repairs on-site. Where more extensive deterioration has occurred or where the wood substructure has deteriorated, sections of the canopy usually are removed and taken to a shop for repair or replacement work.

Rust: It is not uncommon for rust to appear on galvanized steel pendants. This occurs where the coating has failed, typically at failed joints or where the pendants have been damaged. The rust should be removed and the metal coated with a zinc oxide primer and then repainted.

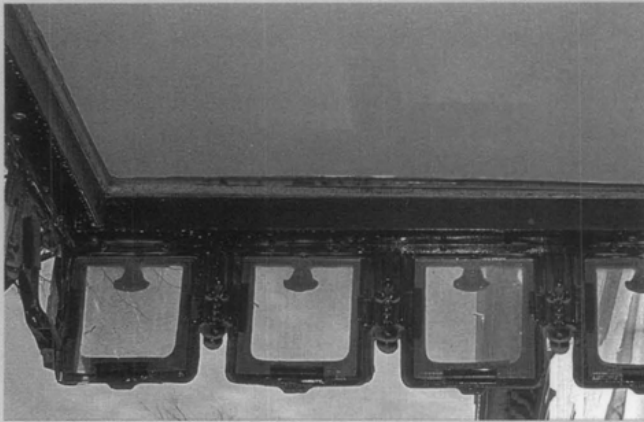
Figure c. Broken glass in single-faced pendants can be easily replaced from the back side, where the glass is held in place by metal tabs, as shown above, or by glazing putty.

Broken or missing glass: Glass breakage can result from stones and other airborne objects; deformation in the pendant frame from entrapped moisture that freezes and thaws; and impact from tall service vehicles or mechanical lifts. Glass in pendant frames that are open in the back are the easiest to replace since they are secured by exposed metal tabs. For most double-faced pendant frames, the glass originally was installed as the frame was soldered together. The recommended procedure is to detach the individual pendant frame from the canopy

and unsolder the connection with adjacent pendants. This allows for the individual pendant to be taken down, the old glass removed and measured, and new glass installed. With some pendants, the removal of individual ones is problematic and it may be possible to undertake the work in place. Alternately, it may be necessary to remove one or more pendants and replace them with new ones.

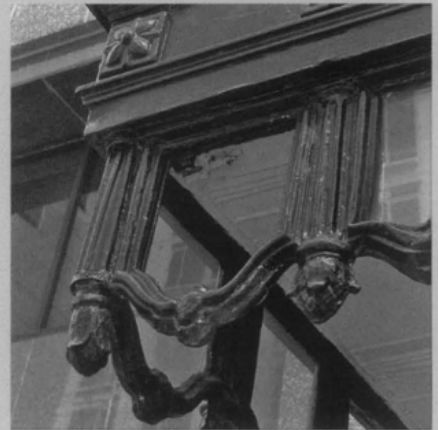
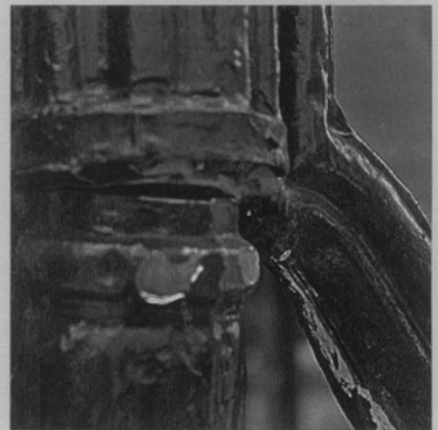
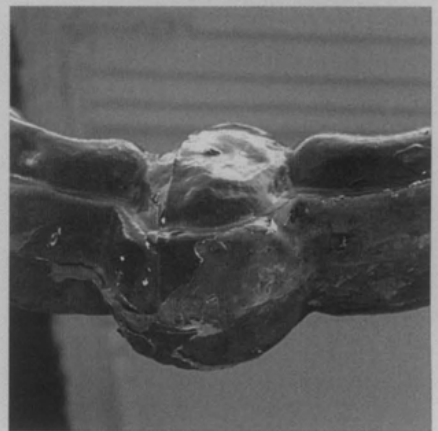
Figure d. Typical deteriorated conditions on pressed, galvanized metal pendants can include broken or missing glass (top); broken or misaligned elements (middle); and rust along the bottom of the pendant frames where water has collected (bottom). These conditions can usually be repaired.

Deteriorated, damaged or missing pendant frames: Depending upon their condition, it may be possible to remove old galvanized sheet metal elements to make repairs in the field or shop. Old stamped zinc is more difficult to repair. Long-term exposure to acid rain leads to deterioration, resulting in the zinc sheet being thinned and perforated. This tends to occur where water ponds, such as the bottom of the pendant frame. While new zinc sheet stampings may be bent or molded as needed to install, existing zinc stampings generally fatigue and fracture with a small amount of movement. As a result, when zinc pendant frames cannot be repaired in place, it usually will be necessary to replace them with new ones.

Where sections of the pendant frame are damaged or beyond repair, there are a number of possible steps that can be taken to correct this condition. Some of the old patterns of metal pendant frames are still manufactured so new matching replacement pieces may be available. Where various pendants are missing or damaged and matching new pieces are not available, it may be possible to purchase a similar pattern and group the new pieces on the sides back toward the building. Another alternative that works with some matching double-faced pendants is to scavenge needed sections by removing the backs of existing ones and using them

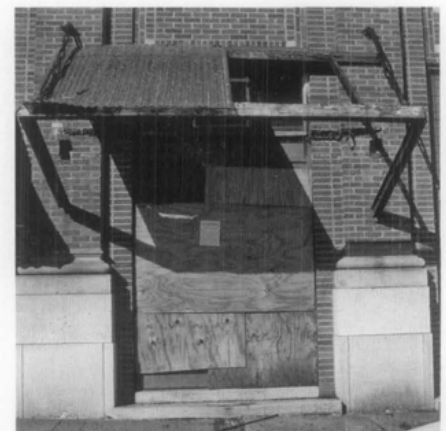
While a simple shed canopy existed at the east entrance at the start of the building rehabilitation, it was poorly constructed and in deteriorated condition (*see figure 5*). Physical evidence of the original canopy fortunately had survived. The pockets remained in the masonry wall that once carried the supporting beams and the historic overhead cables and anchors still were in use. The flat roofline of the original canopy clearly was evident against the building, cutting right below the transom over the doors. Furthermore, ghost marks on the brick wall helped to establish the height of the box canopy frame.

Figure 5. The east canopy entrance prior to the fabrication of its replacement. The original canopy had been replaced long ago with a simple covering that had deteriorated as well.

The new canopy consisted of a metal sub-frame, upon which a wood frame made of exterior grade plywood was attached. For the canopy cladding,

16 oz. copper was used along the top and sides. To match the patina of the existing canopy on the main entrance, the new canopy was chemically treated.

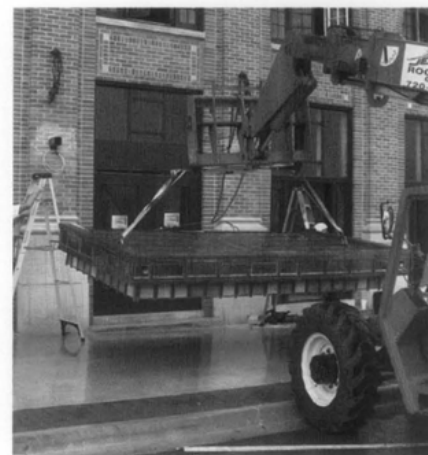
Figure 6. The installation of the new canopy required the use of a Sky Track and a special harness to ensure the protection of the copper frame. Photo courtesy of Thad Jennings, JENCO Roofing & Sheet Metal.

The greatest challenge in recreating the missing canopy came about during its installation. Since the entire canopy had been fabricated in the shop, a special crate was made to transport

the structure safely to the building. The contractor then used a lift to set the canopy into place (see figure 6). The entire process had to be handled with care, given the vulnerability of the canopy's soft copper skin and the hanging pendant frames.

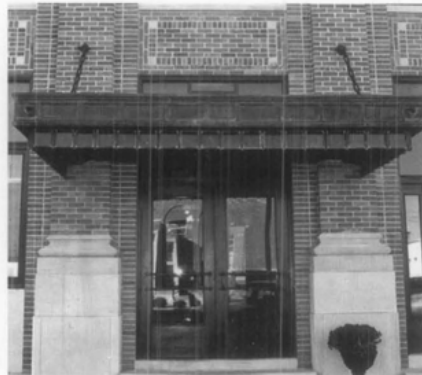
Figure 7. The new copper canopy on the east elevation of the Aldridge.
