Tech Notes

OLD WATKINS NATIONAL BANK

WINDOWS NUMBER 5

Interior Metal Storm Windows

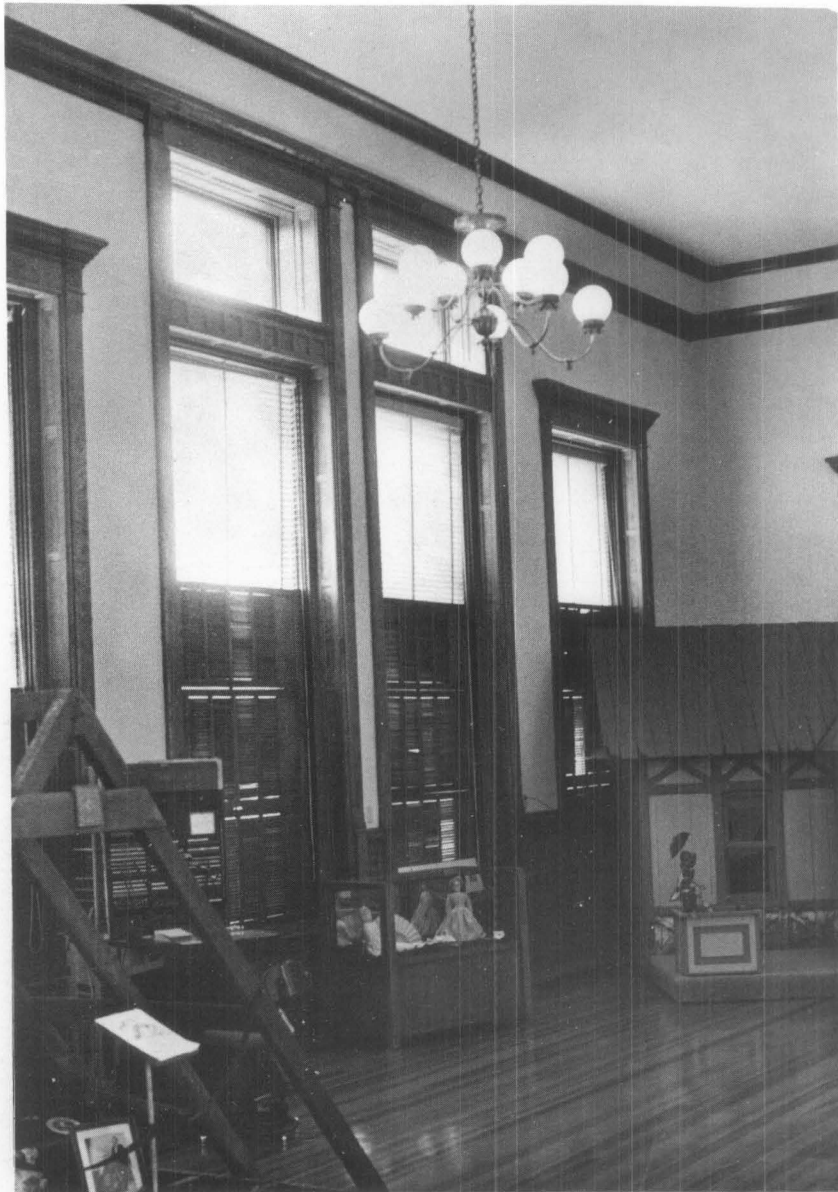
Figure 1. The monumental windows are elegantly detailed on the interior and contribute to the grandeur of the spacious banking rooms. The original interior shutters are still being used for comfort and light control. Photo: Charles E. Fisher

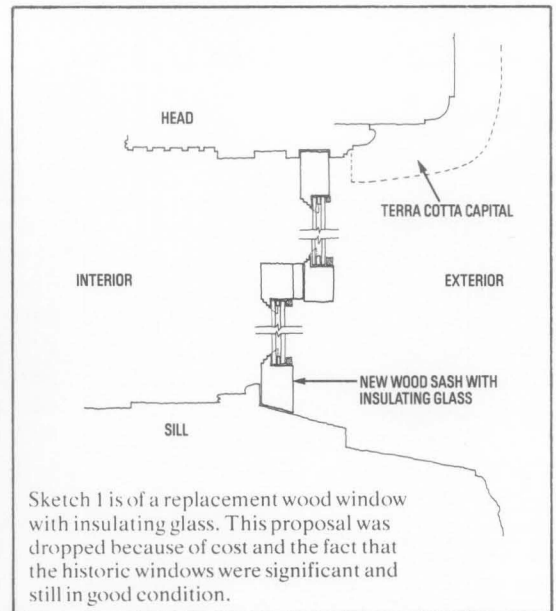
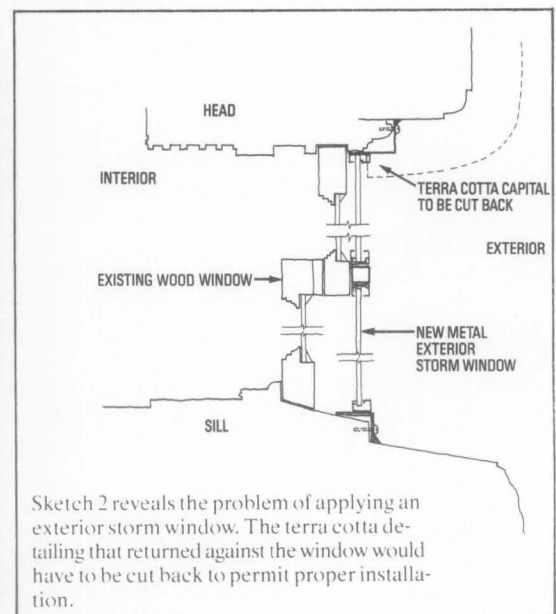
Use of exterior storm windows was initially explored both for energy conservation purposes and as a way to extend the useful life of the original windows (see figure 2). Unfortunately, the prices quoted for exterior storm windows by local contractors were around \$65,000, nearly double the budgeted amount. In addition to the high cost of exterior storm windows, one further problem with an exterior storm application arose when it was discovered that the decorative terra cotta capitals adjacent to the upper level window openings returned against the original frames. As a result, the proposed exterior storm windows could not be easily installed in these locations without cutting back or covering portions of the terra cotta (see figure 3).

Figure 2. As part of the planning, the architect prepared sketches of 4 possible window treatments to improve the energy performance of the windows.

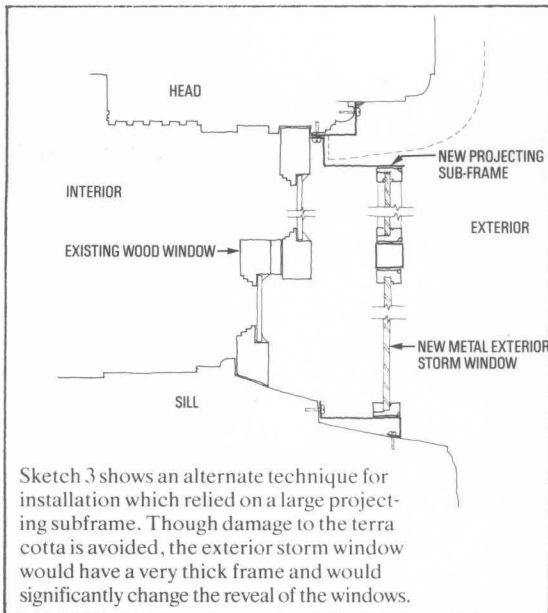
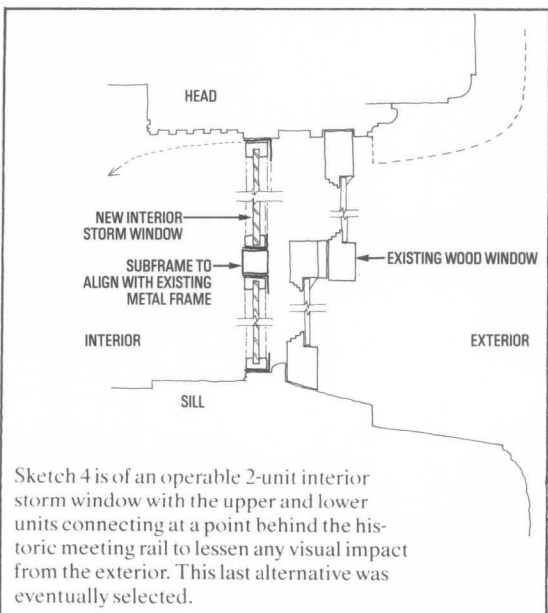
Figure 3. Exterior storm windows were initially considered but presented several problems. The terra cotta capitals on the pilasters returned against the windows, making normal installation difficult without damaging the terra cotta. Many of the windows also had round heads which would require additional custom work—these same windows on the interior had square tops. Photo: Charles E. Fisher

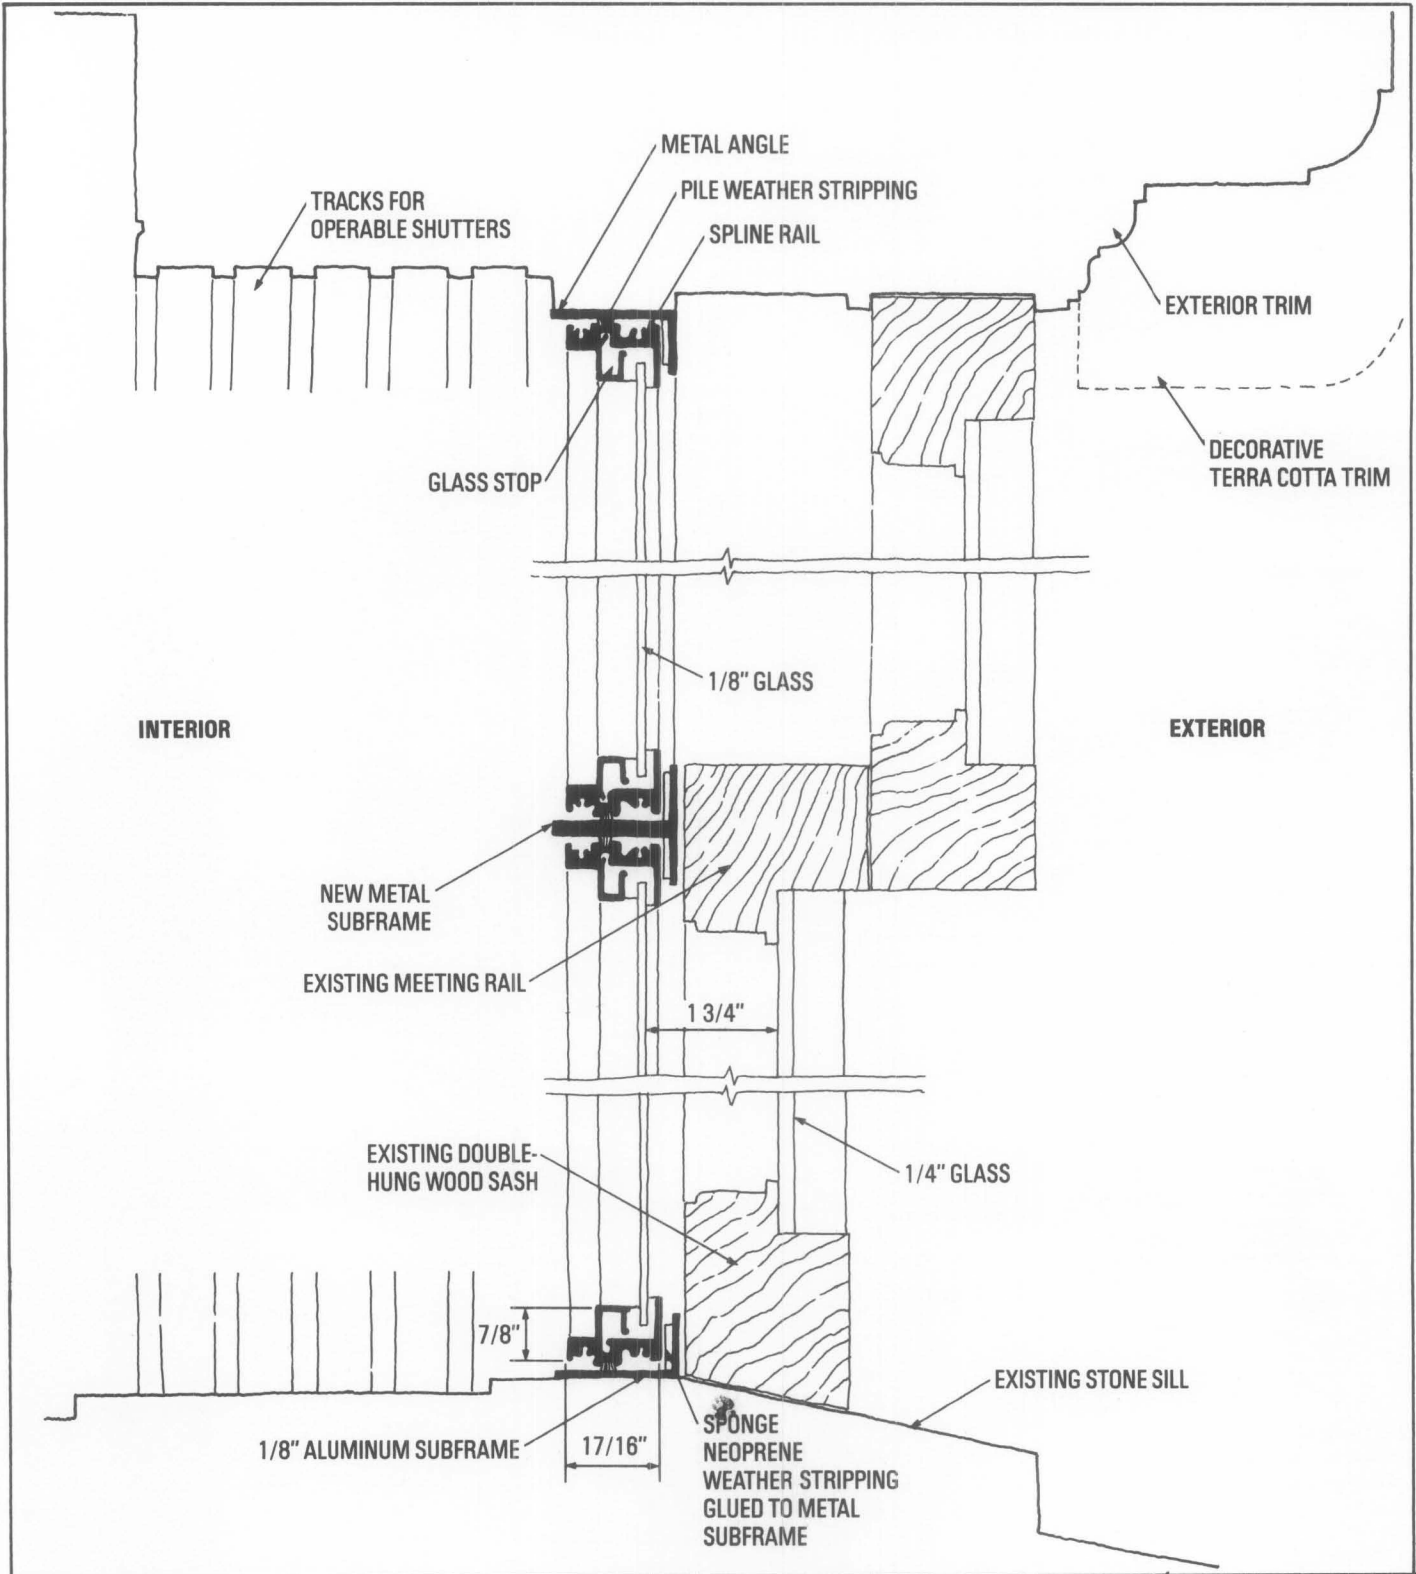
Figure 4. Section showing the new interior metal storm window set behind the historic wood sash. Drawing: Martha L. Werenfels

In searching for an interior storm window that met both the functional requirements and the concerns about visual qualities, the architect chose a commercially available metal storm window system. The storm window was designed to fit within the existing wooden jamb, thus resulting in minimal damage to historic material (see figure 4).

Mounted on pivot pins, the storm window relied on the pile weather stripping which ran continuously along the edge of the frame to serve as the seal between the metal subframe and the metal storm (see figure 4). Neoprene weather stripping was also added to the surface of the subframe to serve as a compression seal with the storm frame. Clear silicone caulk between the wood jamb and the subframe completed the seal.

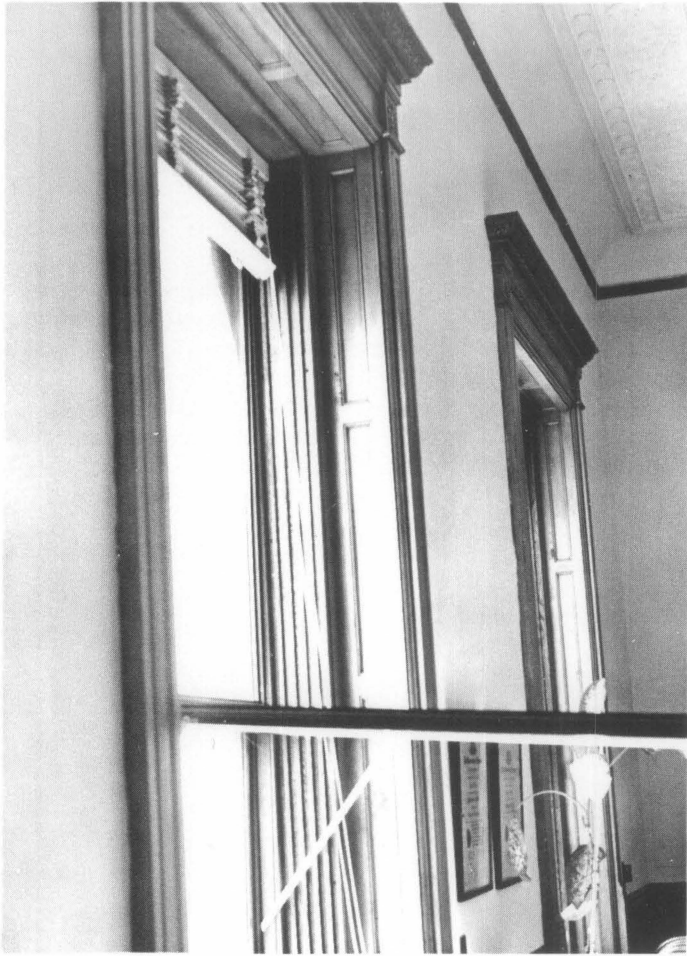
Figure 6. The windows were too large for only a single storm panel, necessitating the use of a structural subframe at the mid-section of the window. Both the upper and lower storm panels are operable and come together opposite the historic meeting rail. This element of the storm window is sufficiently thin that is not readily discernible from the outside. Photo: Charles E. Fisher

The subframe consisted of a $\frac{1}{8}$ " thick metal angle screwed to the wood jamb, serving as support and as a stop for the storm sash. On the large windows, the metal angle was paired to form a horizontal muntin, in line with the historic meeting rail, to accommodate an upper and lower storm panel, both of which pivoted (see figure 6). The frames were mounted in a location that pro-

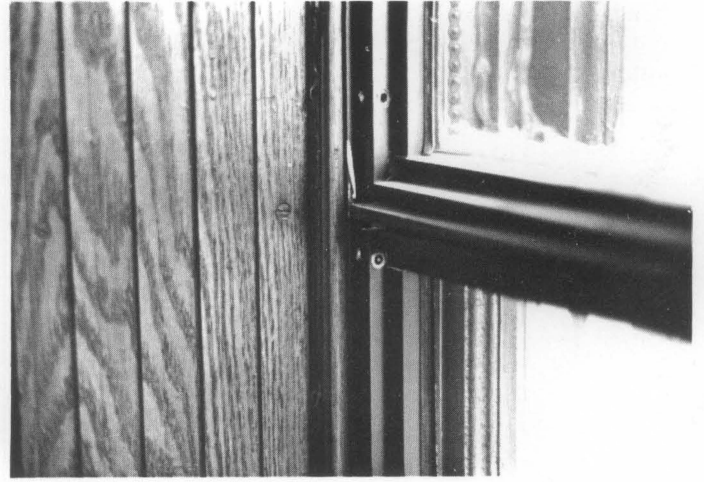
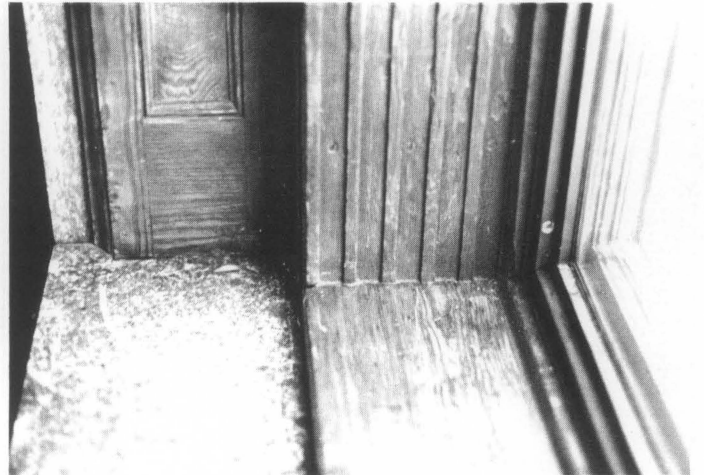
Figure 8. The decorative jamb panel on the left and the interior shutter tracks were unaffected by the installation of the interior storm window shown on the right. Photo: Charles E. Fisher

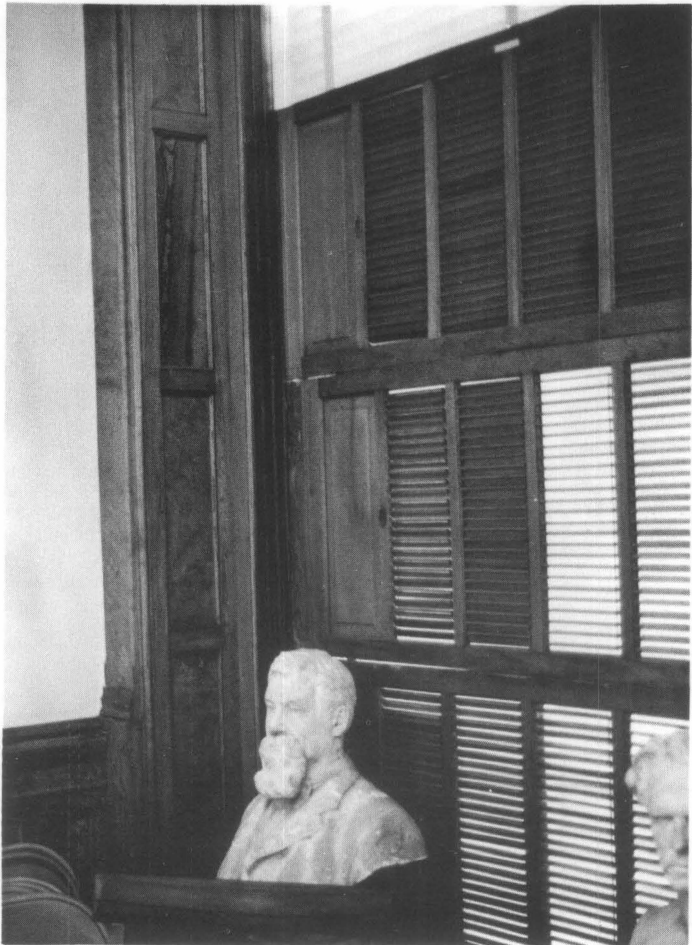
Figure 7. Continued use of the unique shutter system required that the frame of the interior storm window be narrow. The storm windows are set between the shutters and the historic sash. Photo: Charles E. Fisher

vided a sufficiently wide dead air space for energy conservation purposes, yet still allowed the interior shutters to remain operable (see figure 7).
