**BUILDING 149
CONSTITUTION PARK
Boston Navy Yard
(Charlestown Navy Yard)
Boston, Massachusetts**

Tech Notes

NUMBER 12

Aluminum Replacements for Steel Industrial Sash

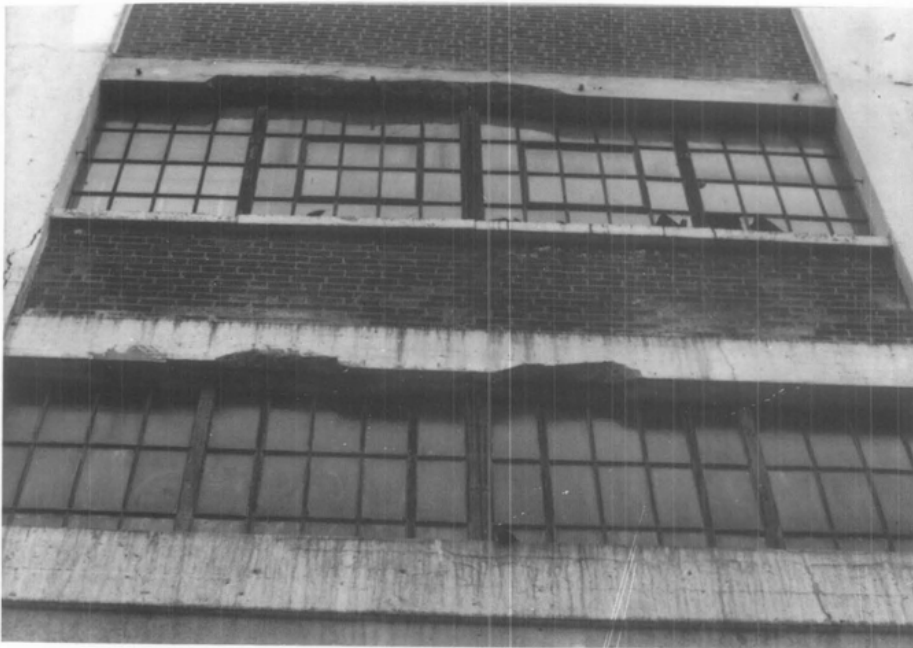
muntins with an exterior cove bead shape profile to the muntin. Most of the openings consisted of a bank of 4 side-by-side window units. Each of the middle two units consisted of 20 divided lites, including a 6-lite center hopper; the two end units were fixed and contained only 16 lites (see figure 1). Typical of pre-World War II steel windows, the glass panes had a narrower width than height. The vertical mullion connecting each unit was approximately 3" wide, noticeably dividing each opening into 4 window units.

Figure 1. Most of the openings consisted of a bank of 4 side-by-side steel window units. Each of the middle two units consisted of 20 divided lites, including a 6-lite center hopper; the two end units were fixed and contained only 16 lites.
Photo: William MacRostie

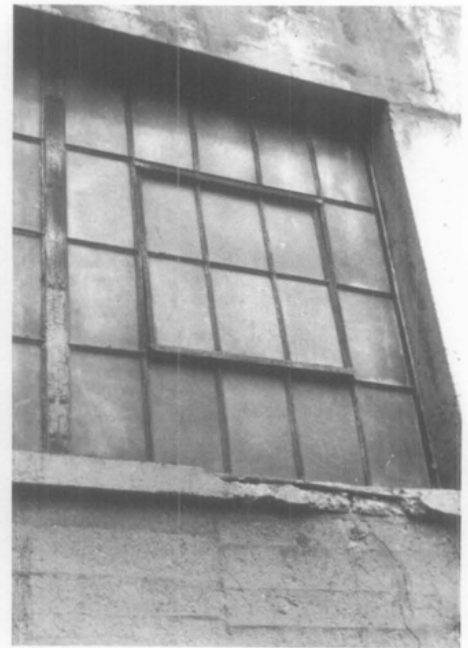
The contractor's survey of the historic windows in the spring of 1984 revealed that extensive rusting of the frames had occurred and that many were racked. The severe rusting had also contributed to the spalling of sections of the concrete sills, jambs, and spandrels (see figure 2). Repair and upgrading options to maintain the historic windows were quite limited due to the size of the glazing bars. The shallow depth of the metal glazing bars (muntins) seemingly precluded the installation of sealed insulating glass within the existing lites, even if the windows could structurally support the additional weight. The only practical way of double-glazing would have involved the use of interior storms with units that were either operable or were removable for ease of cleaning. Even then, however, the severe deteri-

Figure 2. Due to lack of maintenance, severe rusting of the steel frames had occurred, which contributed to the spalling of sections of the concrete sills, jambs, and spandrels. Photo: Charles Fisher

oration of the steel windows still would have needed to be addressed. Considering the size of the bay openings, the decision was made to replace the windows.

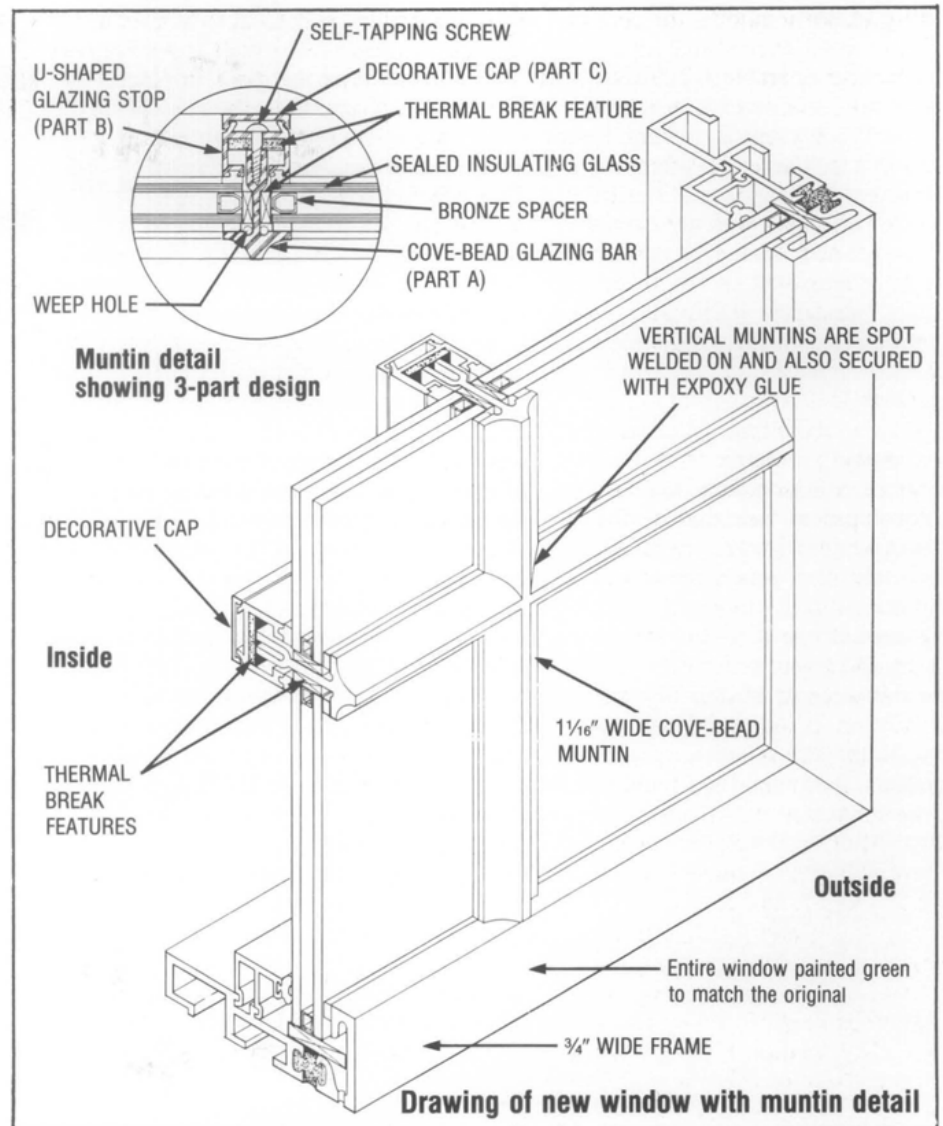
One of the first major design issues to be resolved concerned the need to match as closely as possible the shape and dimensions of the original 7/8" wide glazing bar (muntin) with its decorative cove-bead exterior profile to simulate the profile of the original steel window muntins. The project team concluded that in order to keep the muntin on the aluminum window as narrow as possible, the traditional cast thermal break (cast plastic) feature of most modern windows could not be used. Instead, a series of spacers and gaskets principally would be utilized to achieve a thermal break for energy conservation. By using this approach, the window fabricator would be able to use a 1/16" wide integral cove-bead muntin. The only short circuit in the thermal break would be at the point where screws were used to connect the inner and outer portions of the muntin (see figure 3).

Figure 3. Drawing of the aluminum replacement windows shows how the cove-bead muntin profile of the original steel windows was closely matched in the integral muntin system designed for the aluminum replacement window. A series of spacers and gaskets were used as the principal means of obtaining a thermal break in the window for energy purposes. Drawing: Peter Charles

designed to ensure that moisture build-up behind the glazing tape would seep outside, rather than inside the building (see figure 3). A twenty-foot mockup was eventually constructed and successfully tested according to accepted industry standards.

The basic aluminum window unit consisted of 9 different aluminum extrusions, including the decorative cove-bead muntin. The muntin assembly actually consisted of 3 extruded aluminum sections. The principal muntin section was the cove bead portion that had a long glazing channel with a receptor at the end (see figure 3). Attached to the interior-facing side of the muntin was a U-shaped glazing

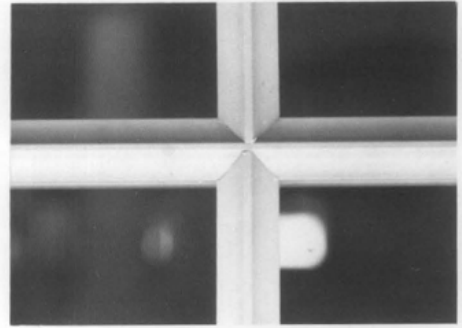
While the horizontal muntins were continuous across the window unit, the vertical muntins had mitre-joints where they intersected the horizontal muntins. The vertical muntins were secured through a combined use of epoxy glue and spot welding (see figure 4). A system of weep holes and channels was provided to ensure that any water trapped between the glazing tape and the glass and muntins would be diverted to the outside of the windows.

Figure 4. The vertical muntins had mitre joints where they intersected the horizontal muntins and were secured through a combined use of epoxy glue and spot welding. Photo: Charles Fisher

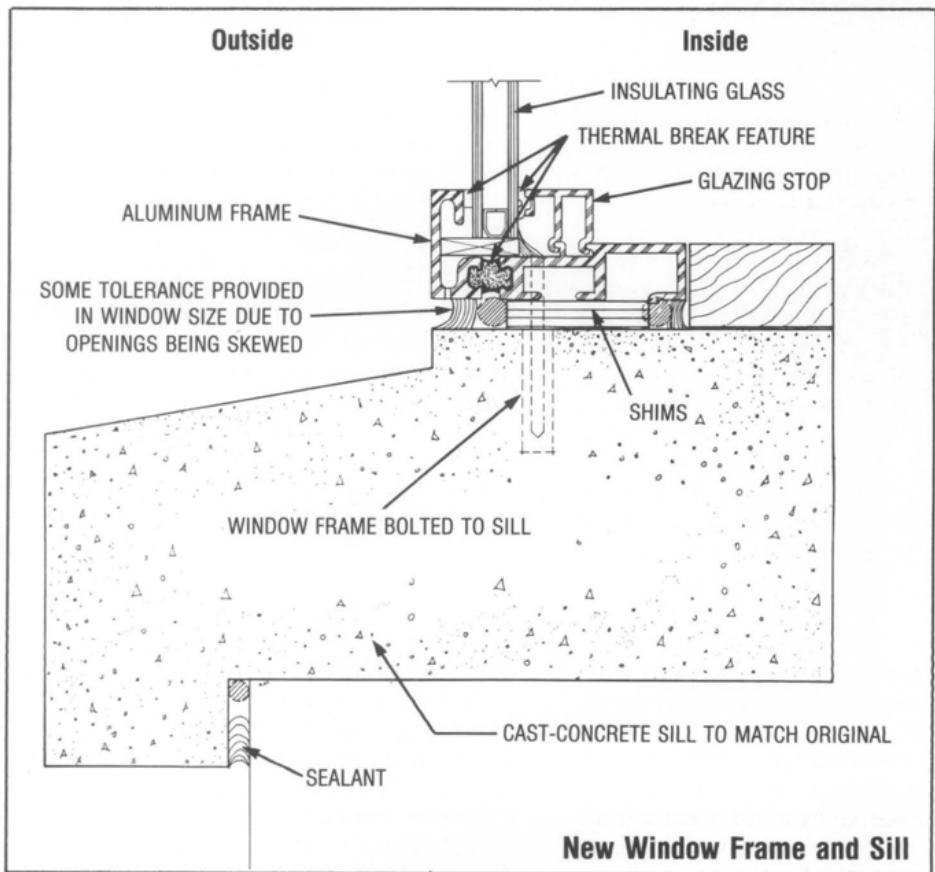
New Window Frame and Sill

Figure 5. The frame of each window unit was designed with a width of $\frac{3}{4}$ " in order to closely match that of the original windows. The frames were bolted to the face of the jambs, sill, and head of the masonry opening. Drawing: Peter Charles

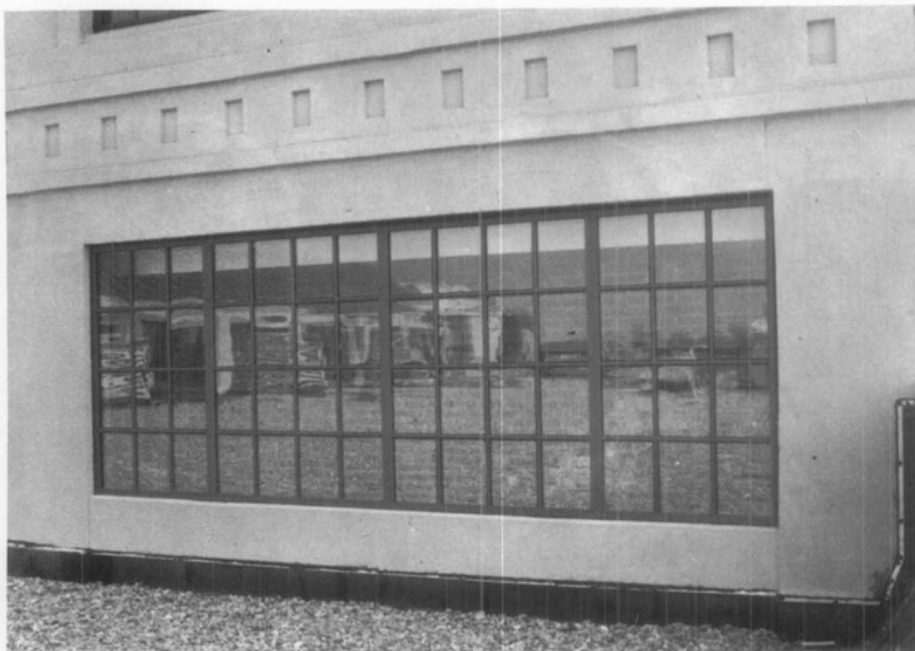
Figure 6. Fabrication and installation of the window units were complicated by the nine different types of windows in the building and by the considerable variations in the window heights for each type. Approximately 500 of the 2000 window units were the same size. Photo: Chuck Parrott

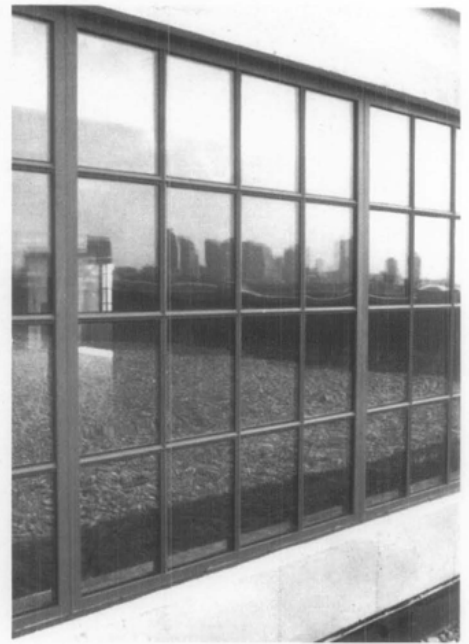
the greatest problem and biggest expense, since the limited tolerance for encroachment onto the glass area required very careful work (see figure 7).

Figure 7. Despite the difficulty encountered with proper glass sizing and spacer alignment in the sealed insulating glass, the end result is an innovative window that is both aesthetically pleasing and closely matches the historic appearance of the original steel design. The slight encroachment of the bronze spacer onto the visible glass area is not readily detectable from general view. Photo: Charles Fisher

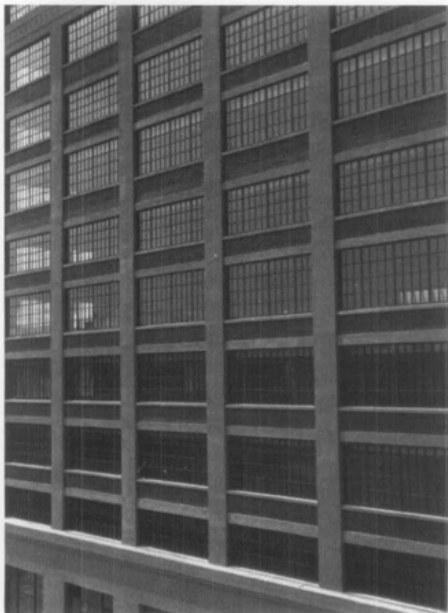
The window work at 149 Constitution Park was noteworthy in several ways. First, it represented a significant improvement over past attempts to recapture the distinctive qualities of a steel industrial window with narrow cove-bead glazing bars, using an aluminum replacement system with insulating glass (see figure 8). Equally important was the manner in which the new window system was developed for the project.

Figure 8. The window work at 149 Constitution Park represented a significant improvement over past attempts to recapture the distinctive qualities of a steel industrial window with narrow-bead glazing bars, using an aluminum replacement system with insulating glass. Success was achieved through careful and well coordinated planning. Photo: Charles Fisher.
