ARCHEOLOGICAL INVENTORY AND EVALUATION AT THE CARRIGAN AND BURCH PROPERTIES, LINCOLN HOME NATIONAL HISTORIC SITE, SPRINGFIELD ILLINOIS

BY
JANIS L. DIAL-JONES

Midwest Archeological Center
Technical Report 125

NATIONAL PARK SERVICE
Midwest Archeological Center

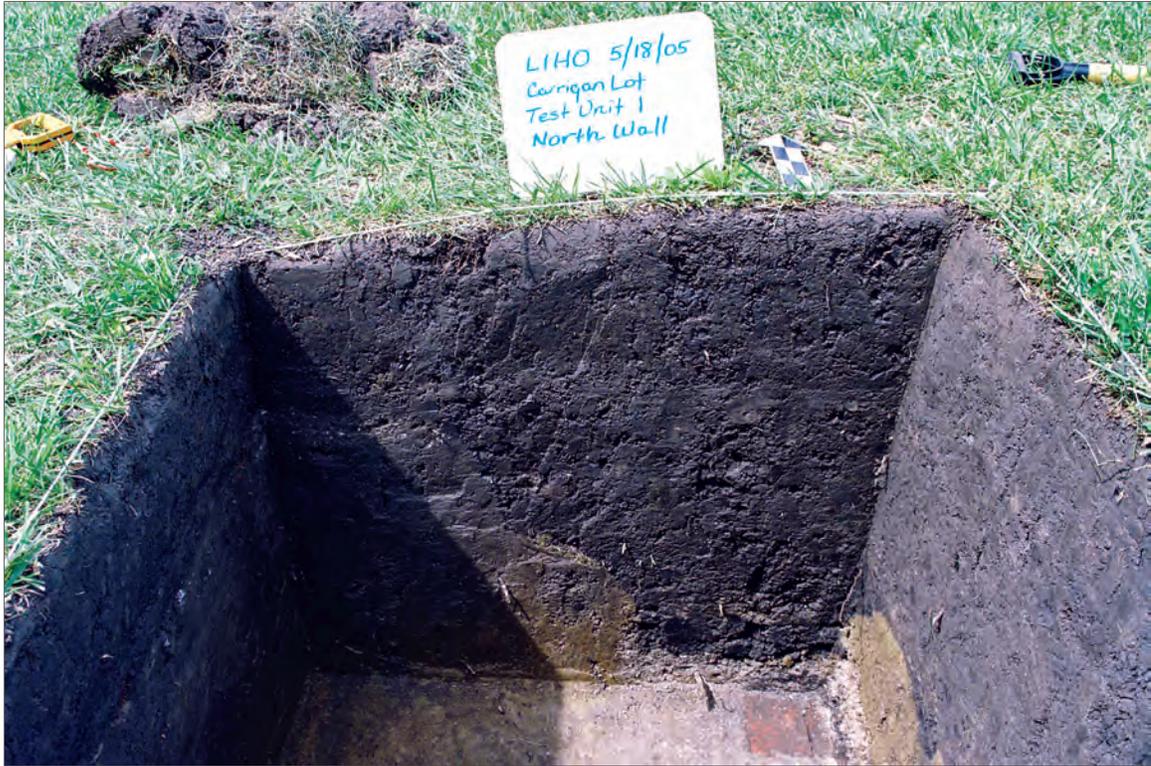
Figure 31. Carrigan lot, Test Unit 1, north unit wall profile showing the bottom of the builders trench for the Carrigan house foundation, now gone, and the southwest corner of the brick cellar floor.

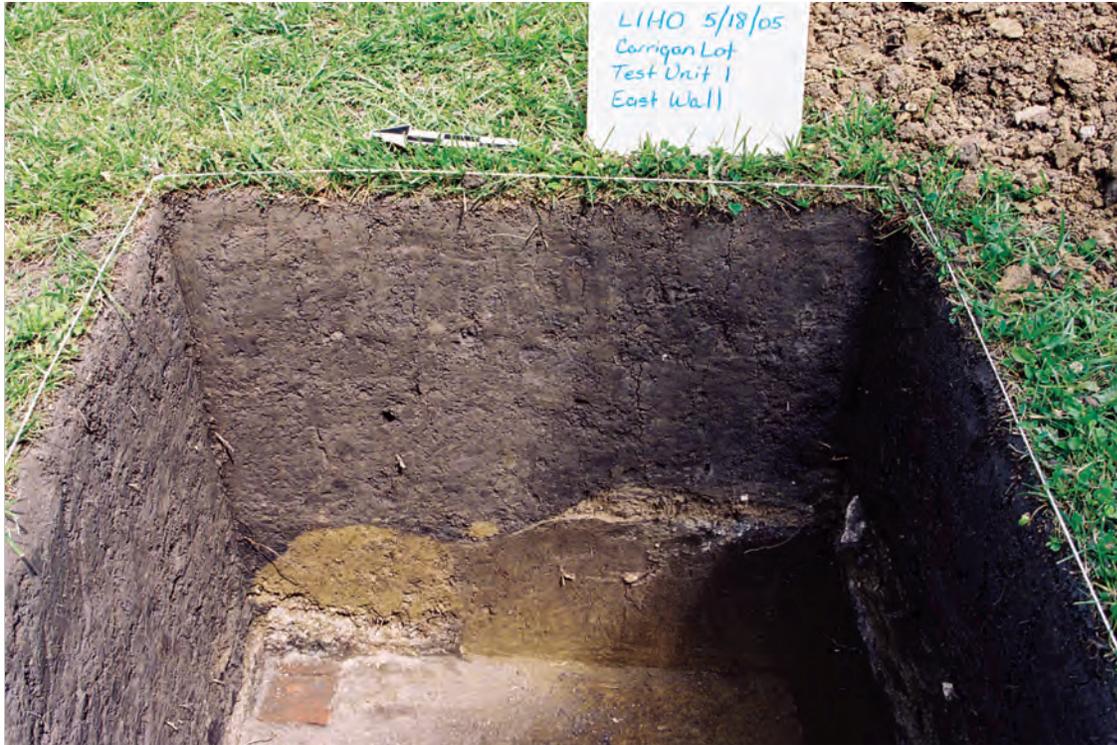
Figure 33. Carrigan lot, Test Unit 1, east unit wall profile showing the bottom of the builders trench for the Carrigan house foundation, now gone, and the southwest corner of the brick cellar floor.

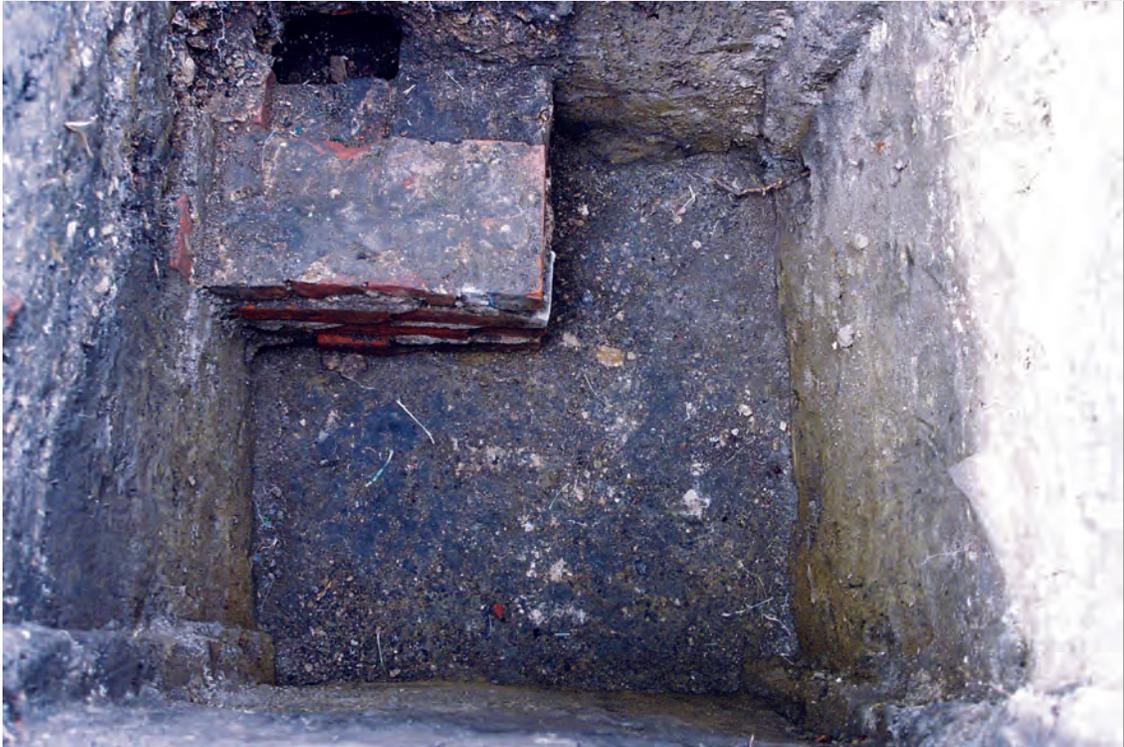
Figure 35. Carrigan lot, southeast corner of the foundation for the front section of the Carrigan house, seen at the bottom of Test Unit 2.

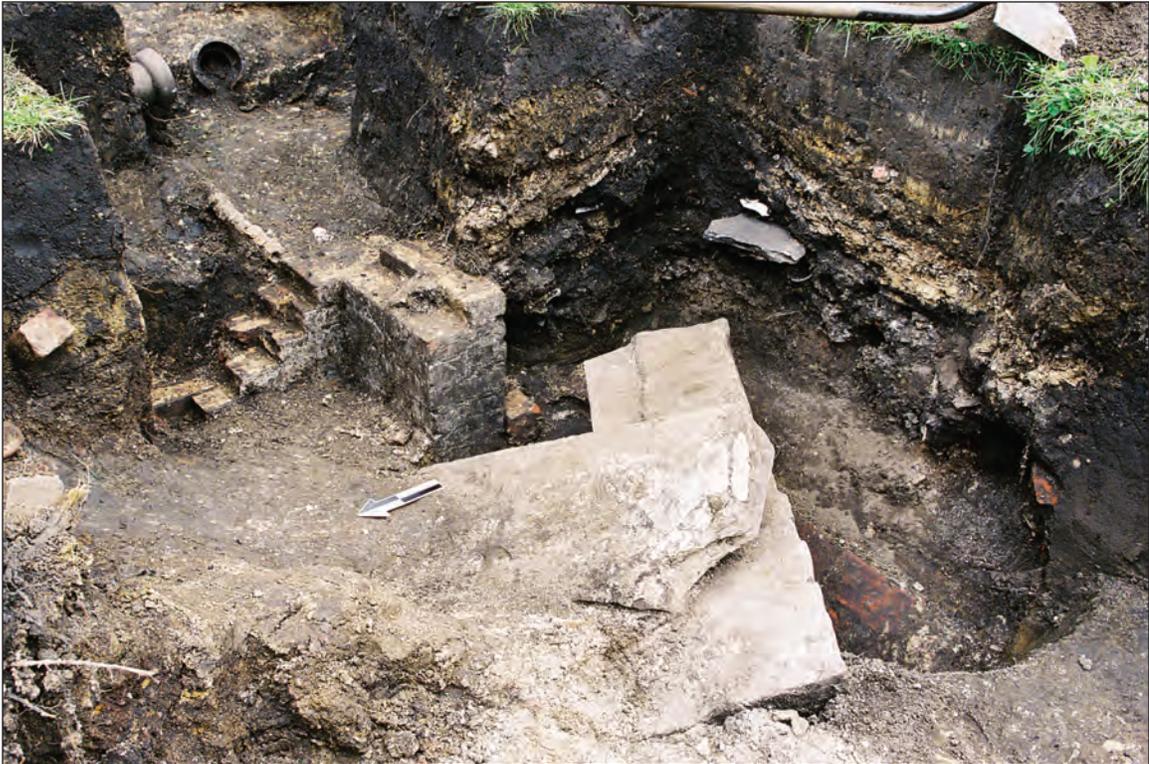
Figure 38. Carrigan lot, Test Unit 3/Trench 2, view southeast to remains of the southeast corner of the Carrigan/Irwin house (brick foundation at left center in photo), back cellar entry features, and stoneware drain tile and iron pipe extending from the cistern.

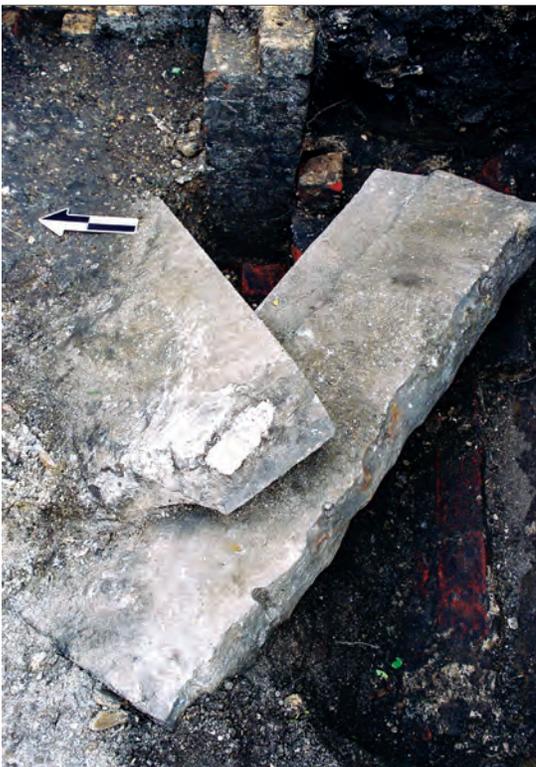
Figure 39. Carrigan lot, Test Unit 3/ Trenches 2 and 3, view east to back cellar entry features including the finished east jamb for the cellar entryway (top center), two displaced dressed stones, sloped brick paving (bottom right extending under a stone), and the remnants of brick cheek walls (bottom right and to right of jamb).

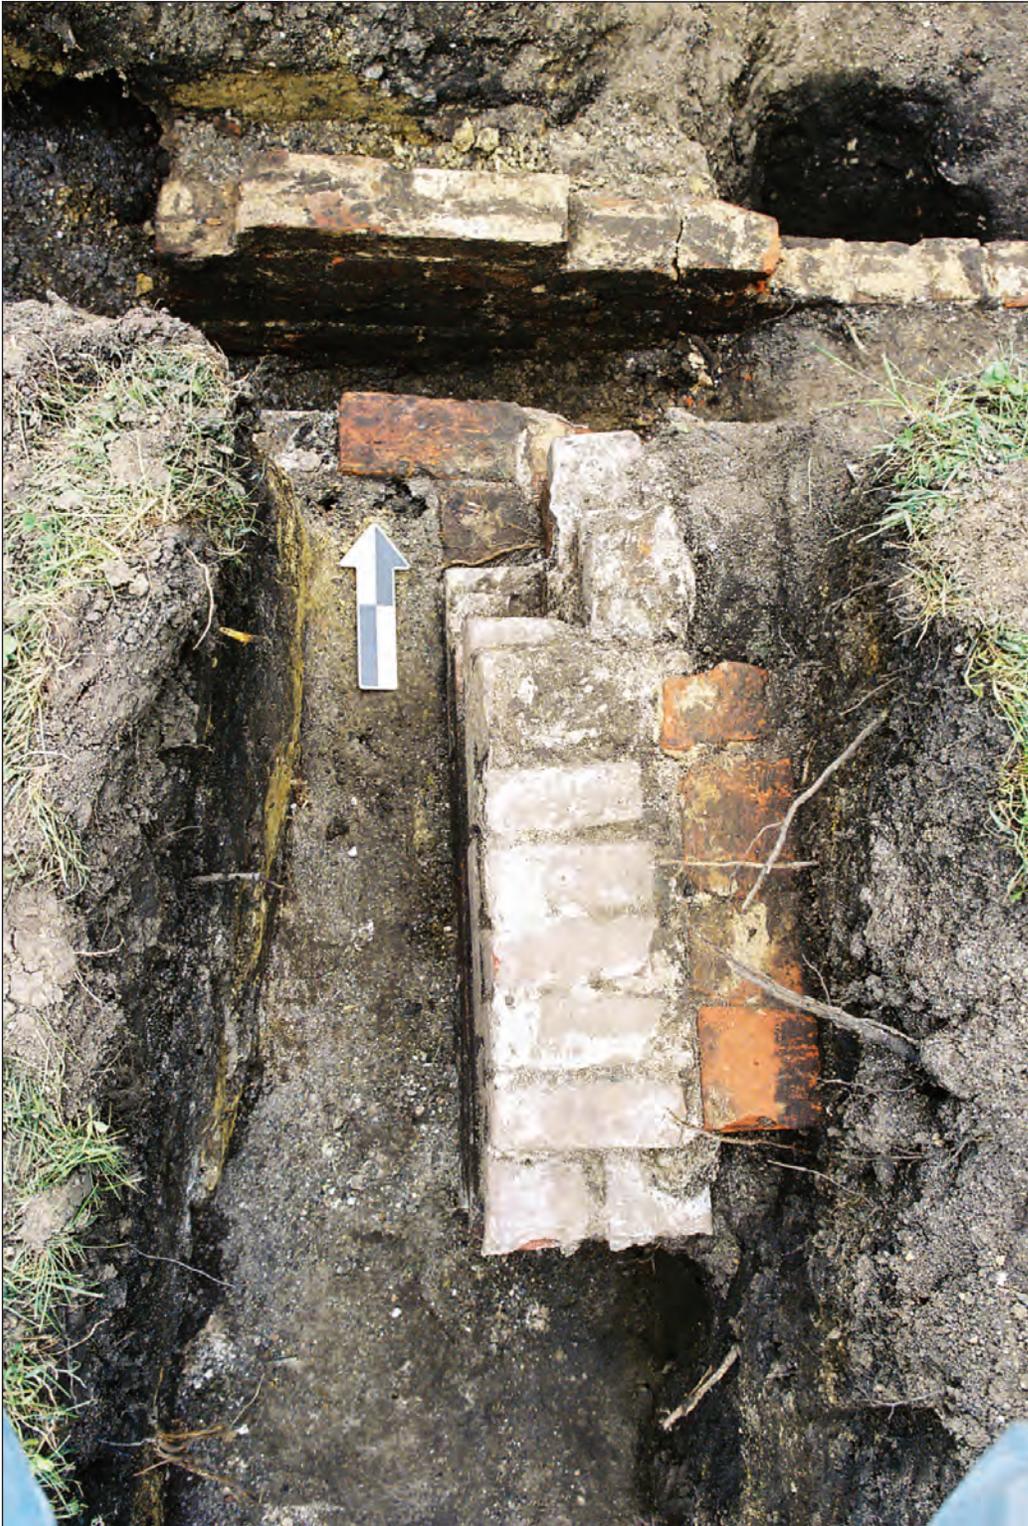
Figure 40. Carrigan lot, Trench 3, structural remains including the southwest corner of the Carrigan back addition (top left) and Carrigan foundation, an Irwin house wall (center), and four Carrigan half-bricks (along right side of Irwin wall).

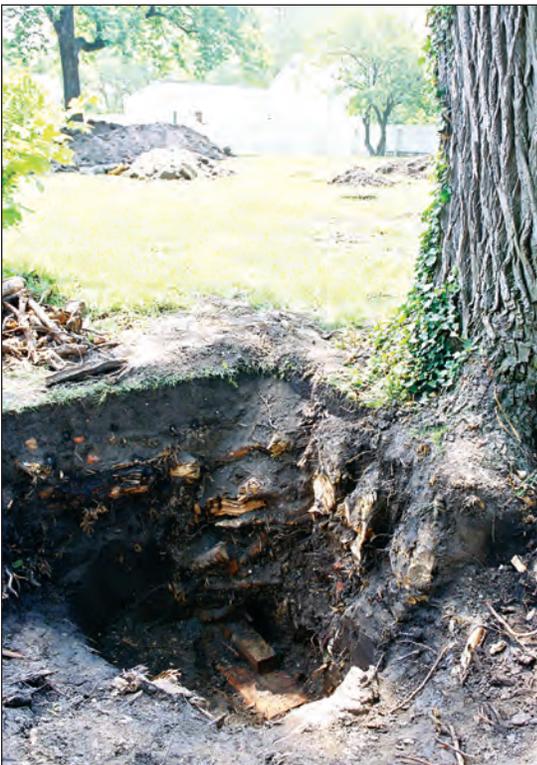
Figure 44. Carrigan lot, view southeast across Test Unit 5 excavated in 2005, with the northwest corner of the Carrigan house foundation exposed in the bottom of the unit.

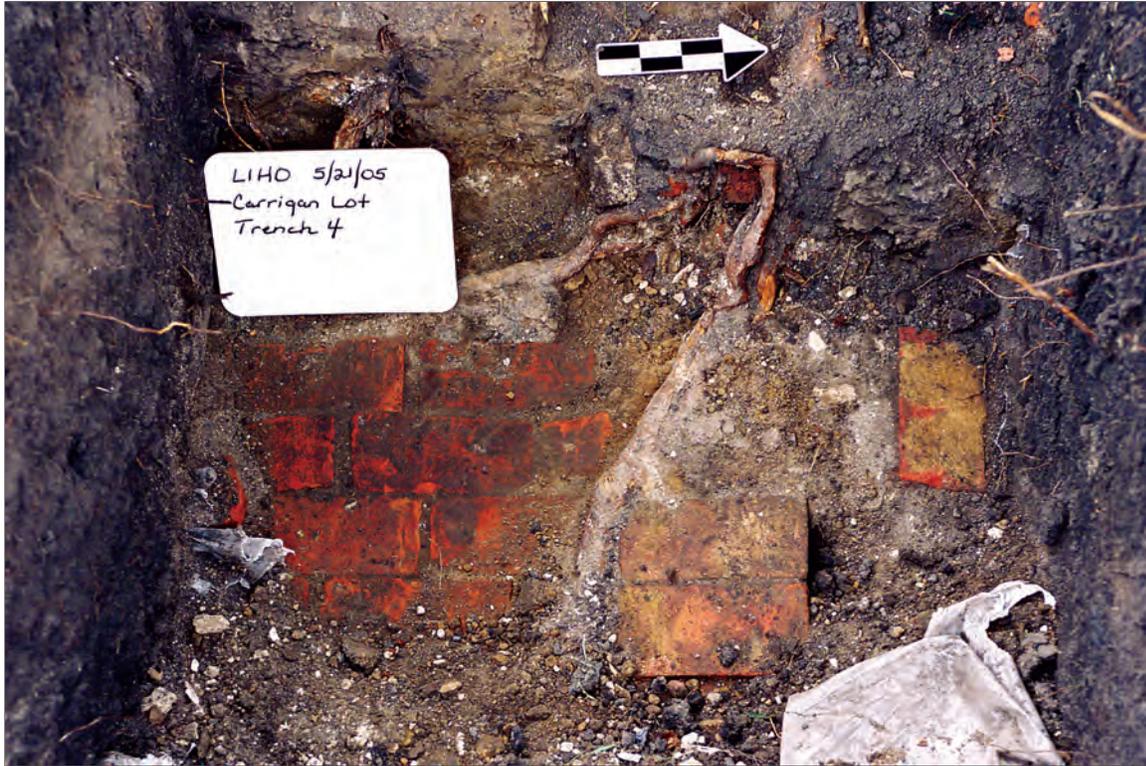
Figure 47. Carrigan lot, Trench 4, brick cellar floor (left) and brick foundation remains (right) at a jog in the front (west) wall of the Carrigan house.

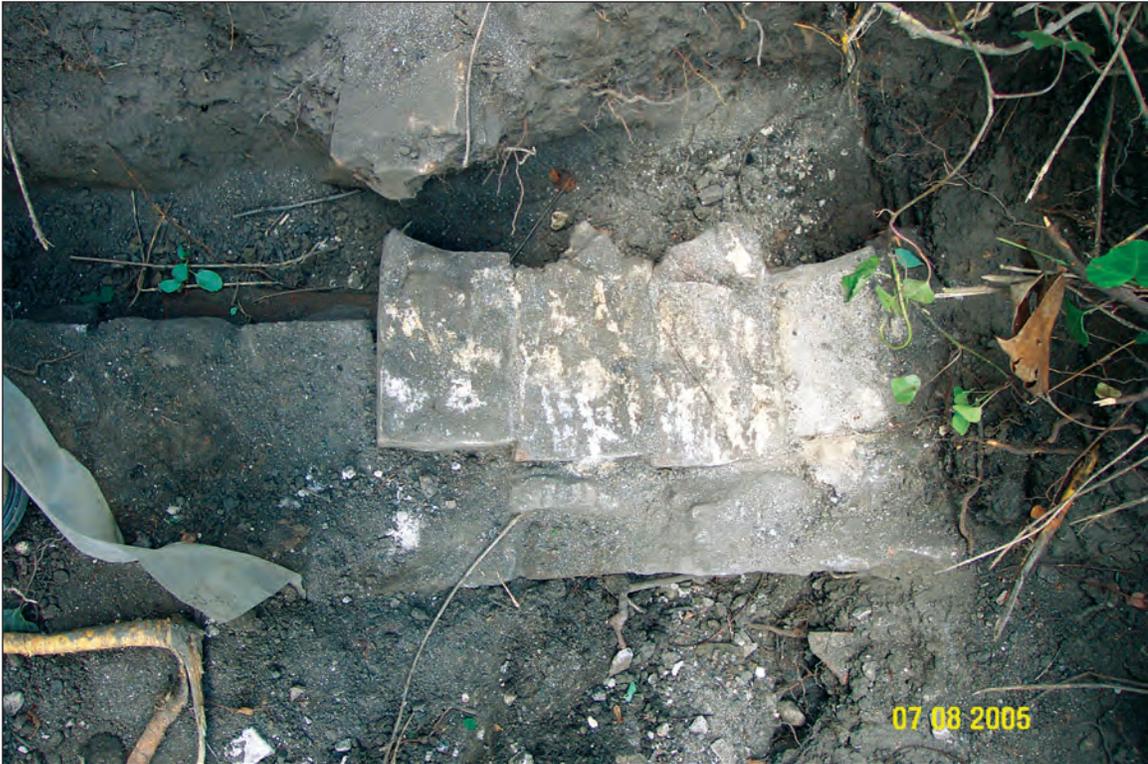
Figure 52. Carrigan lot, Trench 6, rough arc of Carrigan brick atop a north Irwin foundation wall.

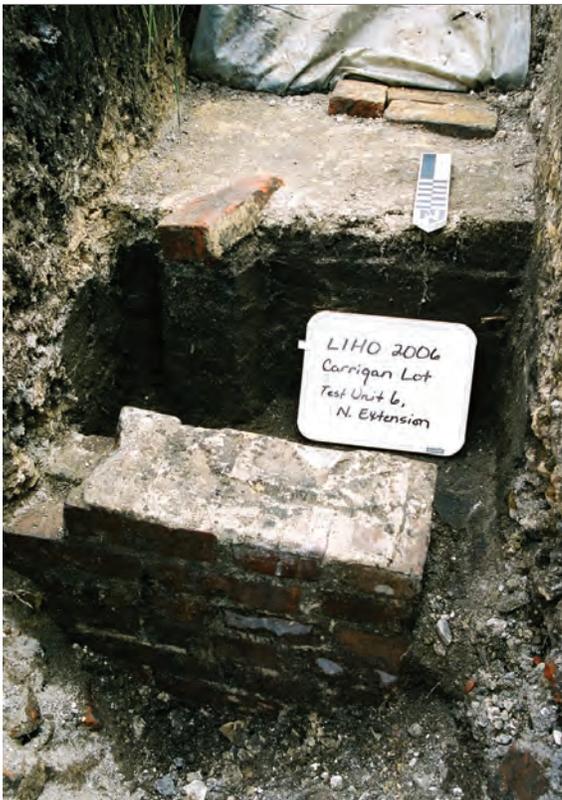
Figure 53. Carrigan lot, Test Unit 6, North Extension, view south to a section of the Irwin house foundation. An intact brick alignment interpreted as a Carrigan porch support structure is visible at the upper right in photo, partially covered with plastic laid in 2005.

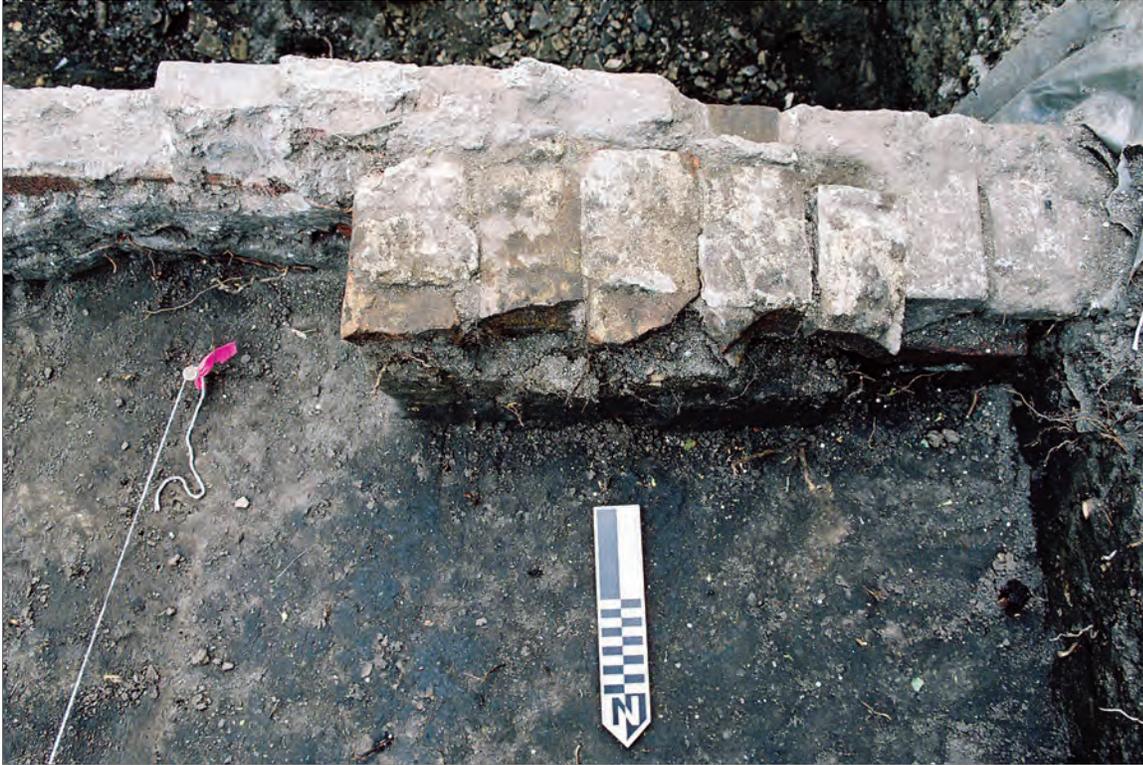
Figure 56. Carrigan lot, Test Unit 7, view south to the arc of Carrigan-era brick mortared to the north Irwin house foundation.

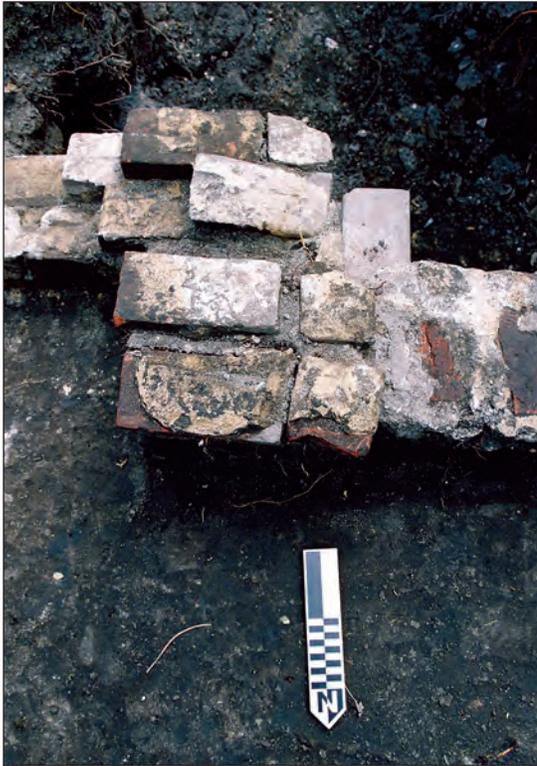
Figure 57. Carrigan lot, Test Unit 8, view south to the juncture of the back addition (top left) and the ell (middle right), and a possible four-brick pier (center) immediately outside the foundation.

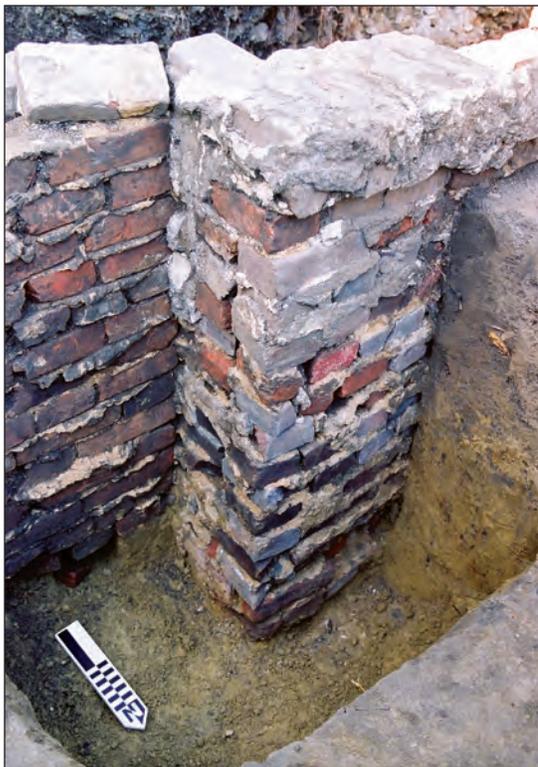
Figure 58. Carrigan lot, Test Unit 8, view southwest to the exterior face of the north foundation at the intersection of the back addition (left) and the ell (center and right). The possible brick pier was removed in the process of exposing this face of the wall.

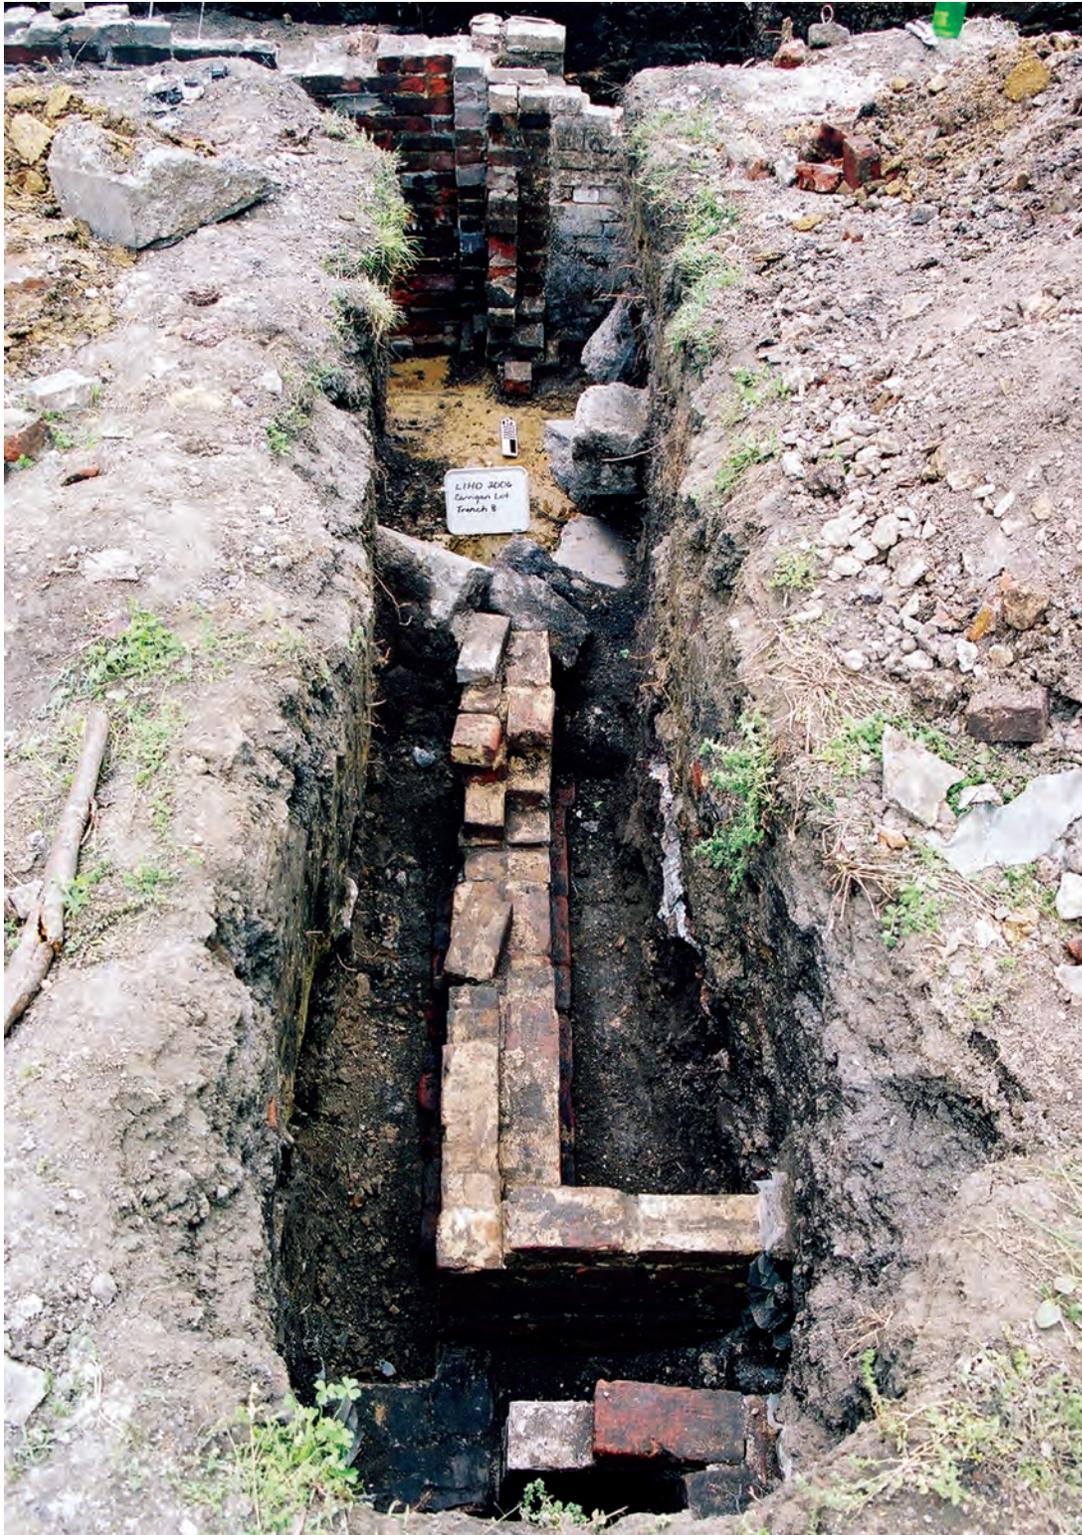
Figure 59. Carrigan lot, Trench 8, view north to the remains of the west foundation wall of the Carrigan back addition including the southwest corner of the back addition (lower center), a possible cellar entryway partially blocked by broken concrete fill, and northwest corner at the juncture with the ell (top center). The remains of Irwin construction are visible at the bottom of the photo.

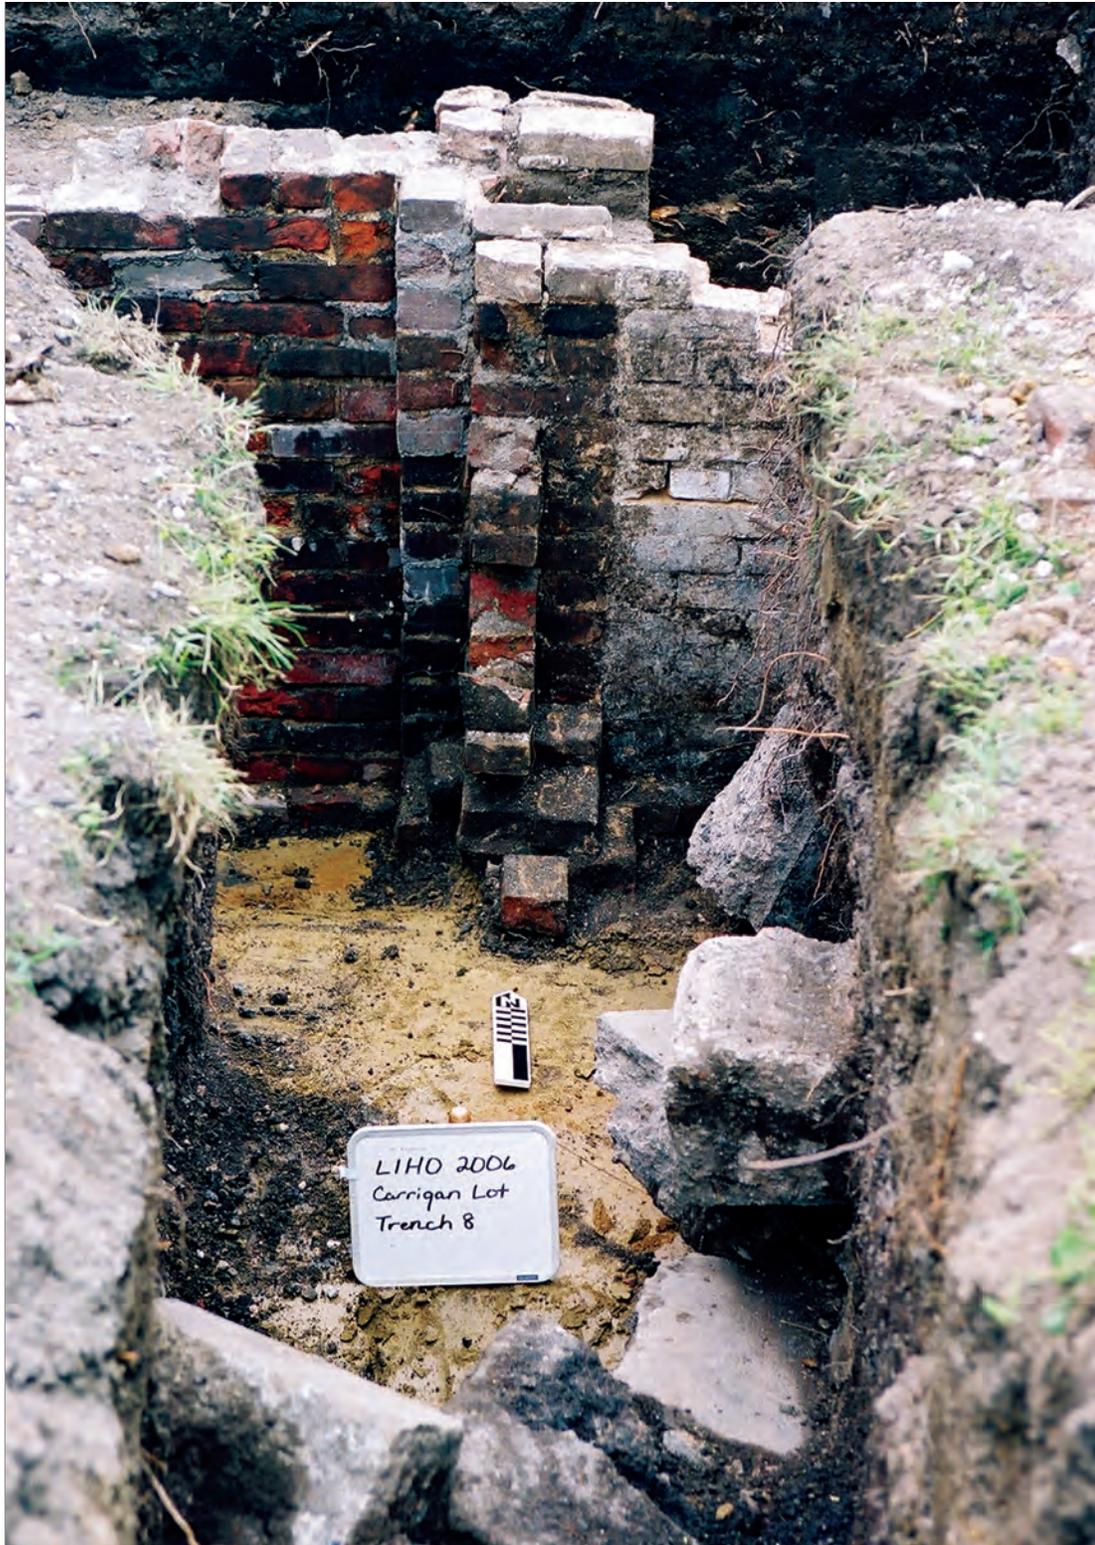
Figure 60. Carrigan lot, Trench 8, view north to closeup of the interior face of the north foundation at the juncture of the back addition and ell. Of the three vertical brick stacks/wythe in the center of the photo, the right two were part of the west wall of the back addition, and the left one served as a pilaster for the ell foundation wall. The possible brick pier lies above and immediately outside the remains of the north foundation at top center in photo.

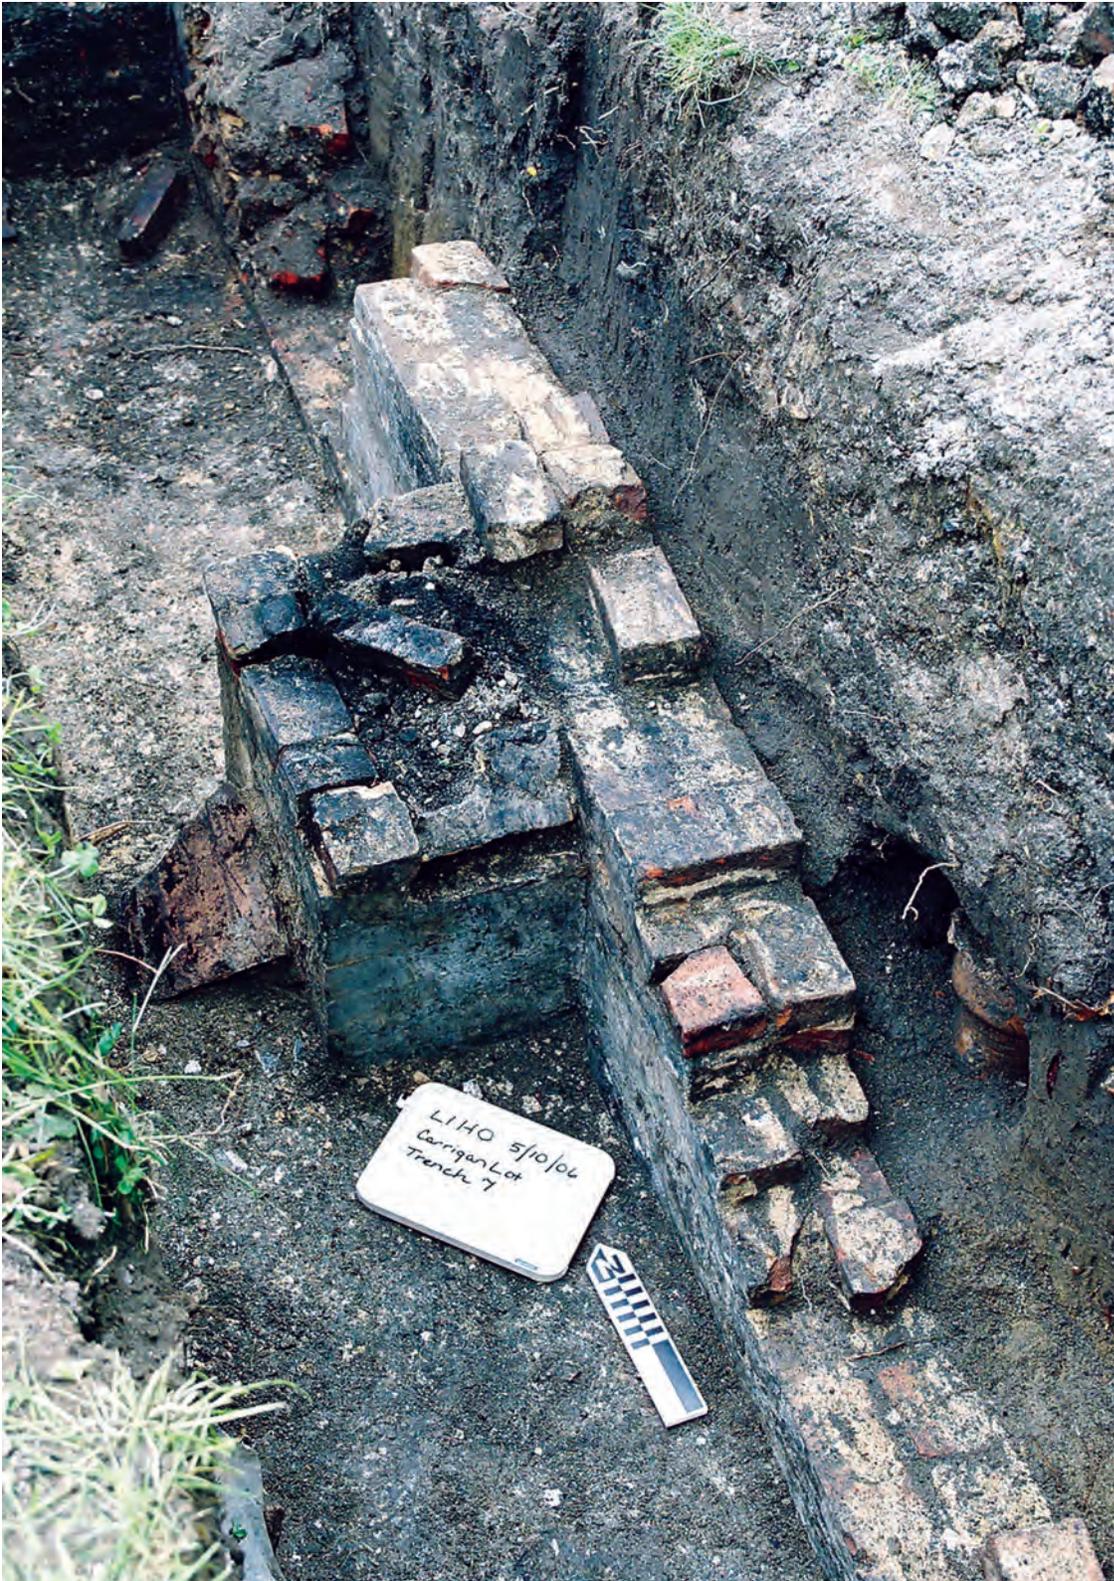
Figure 63. Carrigan lot, Trench 7, view northeast to the remains of the back (east) wall of the back addition to the Carrigan house, and the base of an early Irwin house chimney stack when first exposed.

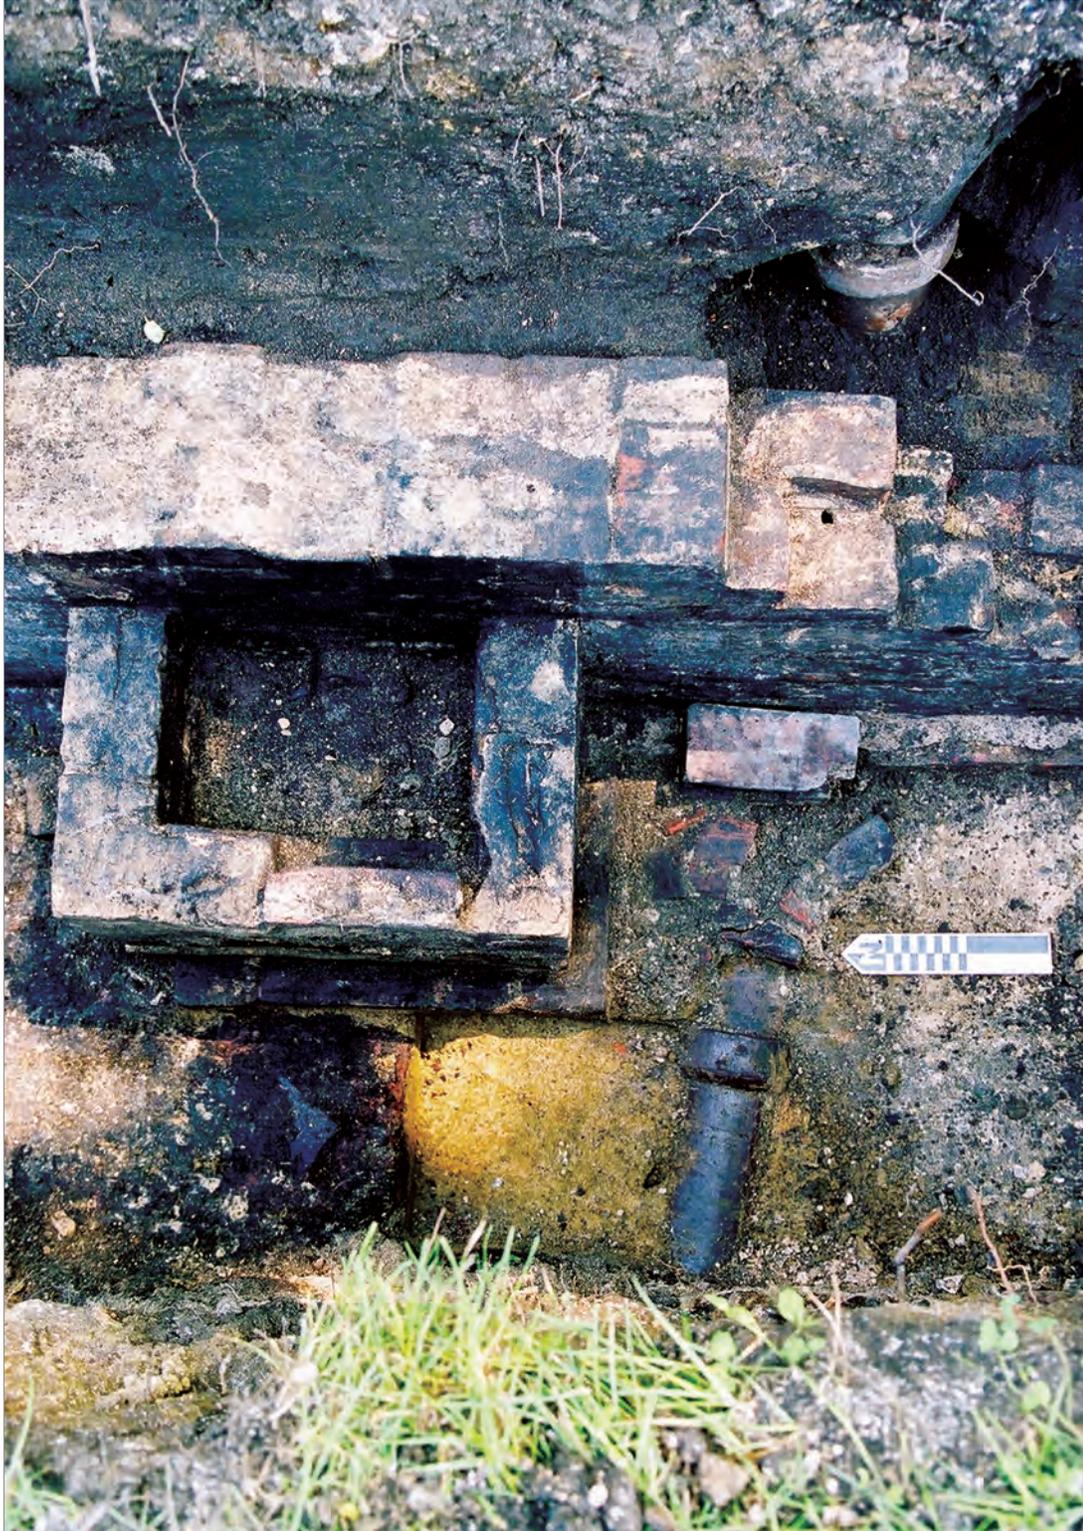
Figure 64. Carrigan lot, Trench 7, remains of the back (east) wall of the back addition to the Carrigan house, the base of an early Irwin house chimney stack after three courses were removed (sleeper brick in west wall may have served as cleanout port), stoneware drain tile extending from the cistern (vertical section outside the wall at upper right, and horizontal section set below cellar floor at lower right), and pressed brick atop displaced footing.

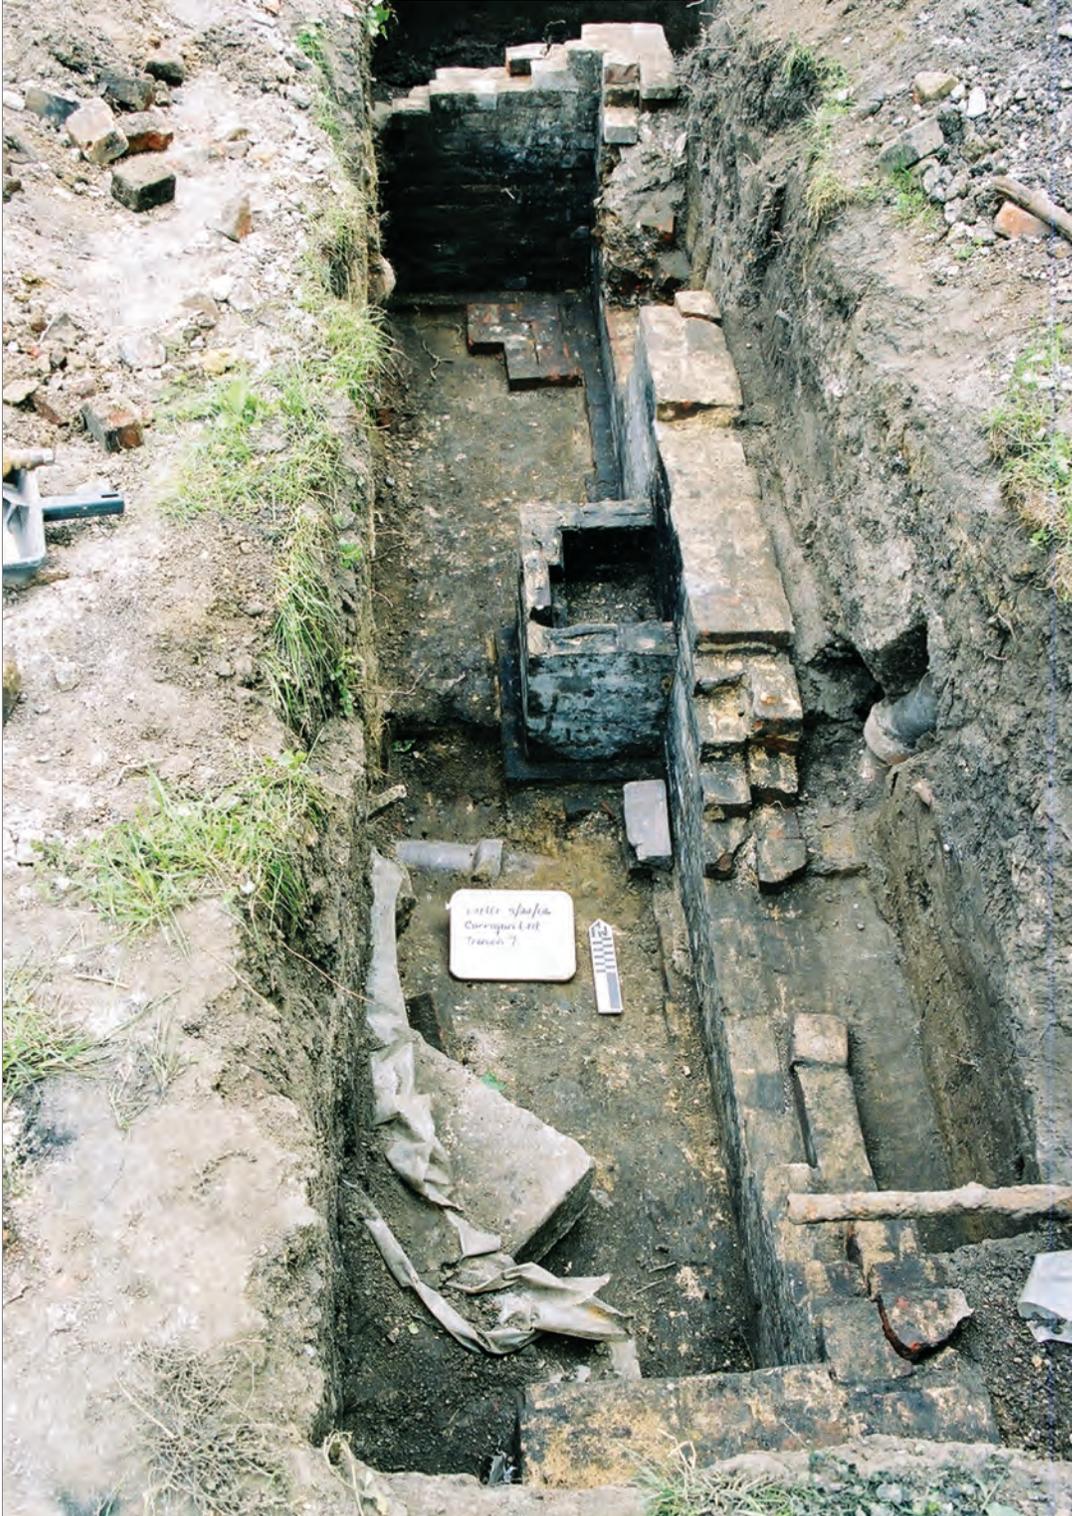
Figure 65. Carrigan lot, Trench 7, view north to the remains of the back (east) wall of the back addition to the Carrigan house (northeast corner at top of photo, east cellar entry jamb at bottom center), the base of an early Irwin house chimney stack, stoneware drain tile extending from the cistern, steel pipe from the cistern, partially exposed dressed stone in cellar fill, and brick support pad at northeast corner of cellar floor.

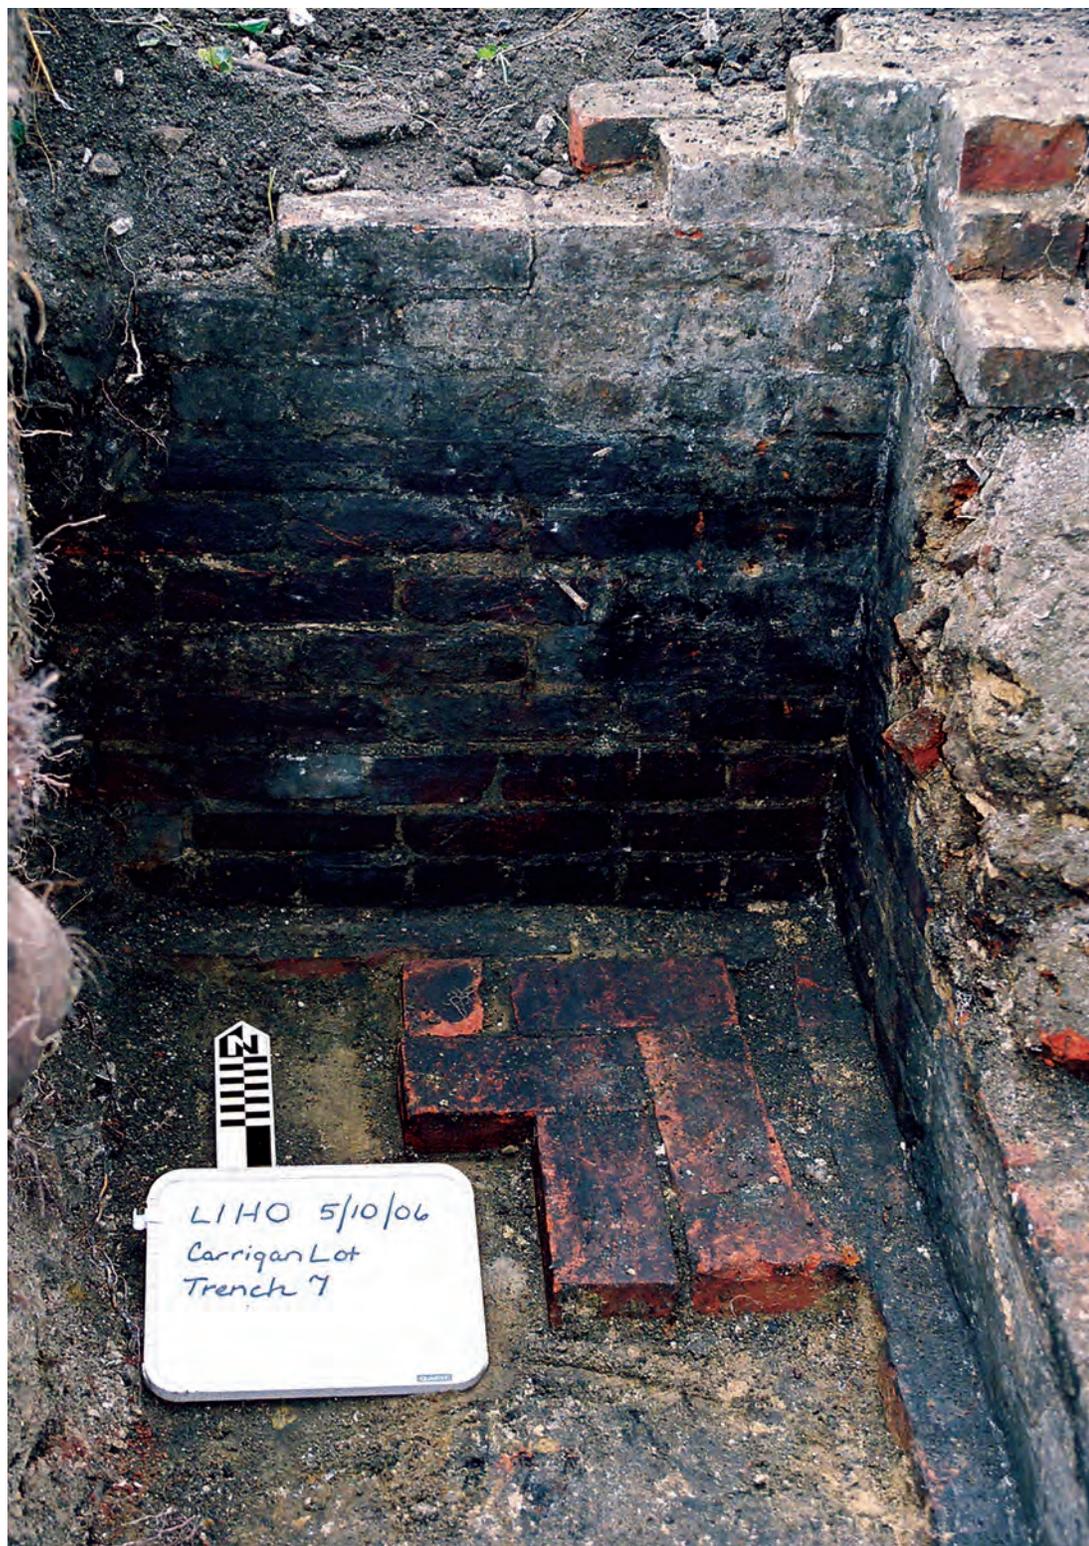
Figure 66. Carrigan lot, Trench 7, brick support pad at the northeast corner of the back cellar floor.

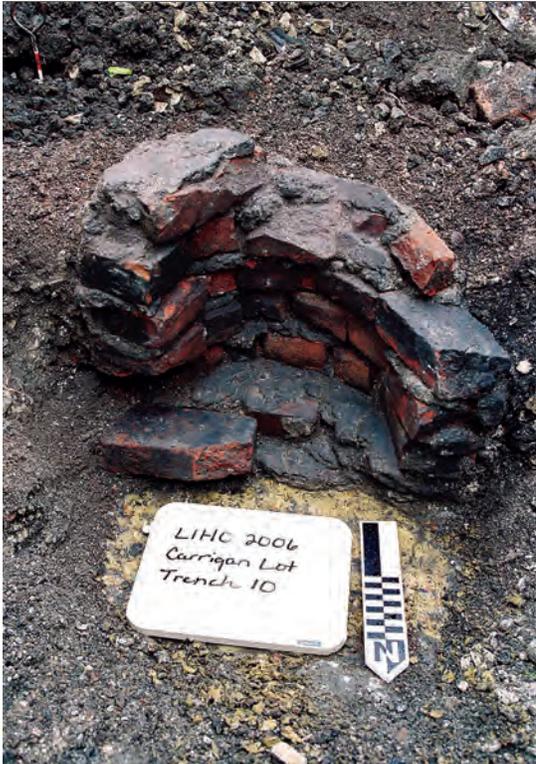
Figure 72. Carrigan lot, Trench 10, small partial ring of brick standing on a brick pad that is thought to represent a furnace-related feature of the Irwin house.

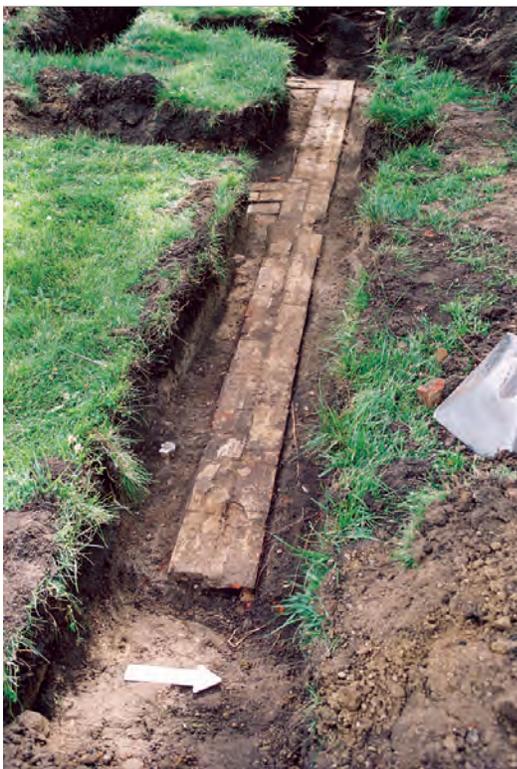
Figure 75. Burch lot, Trench 6, view southwest to remains of the north foundation of the Burch house with the northwest corner of the house at top center in photo.

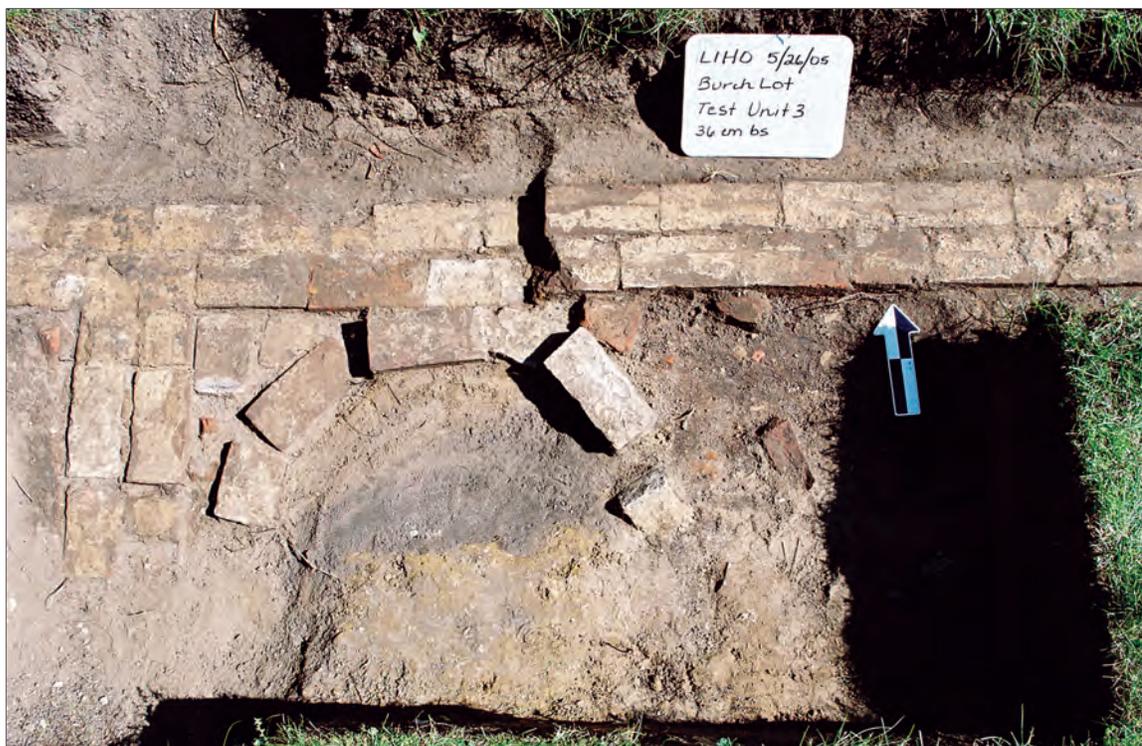
Figure 76. Burch lot, Test Unit 3, view north to the remains of an interior well along the north wall of the Burch house foundation. An interior wall of the house is immediately west (left) of the well. The small spaces between the walls and the well structure were filled with additional bricks. A marked soil change extended roughly east-west across the unit along the south edge of the well feature.
