ARCHEOLOGICAL INVENTORY AND EVALUATION AT THE CARRIGAN AND BURCH PROPERTIES, LINCOLN HOME NATIONAL HISTORIC SITE, SPRINGFIELD ILLINOIS

BY
JANIS L. DIAL-JONES

Midwest Archeological Center
Technical Report 125

NATIONAL PARK SERVICE
Midwest Archeological Center

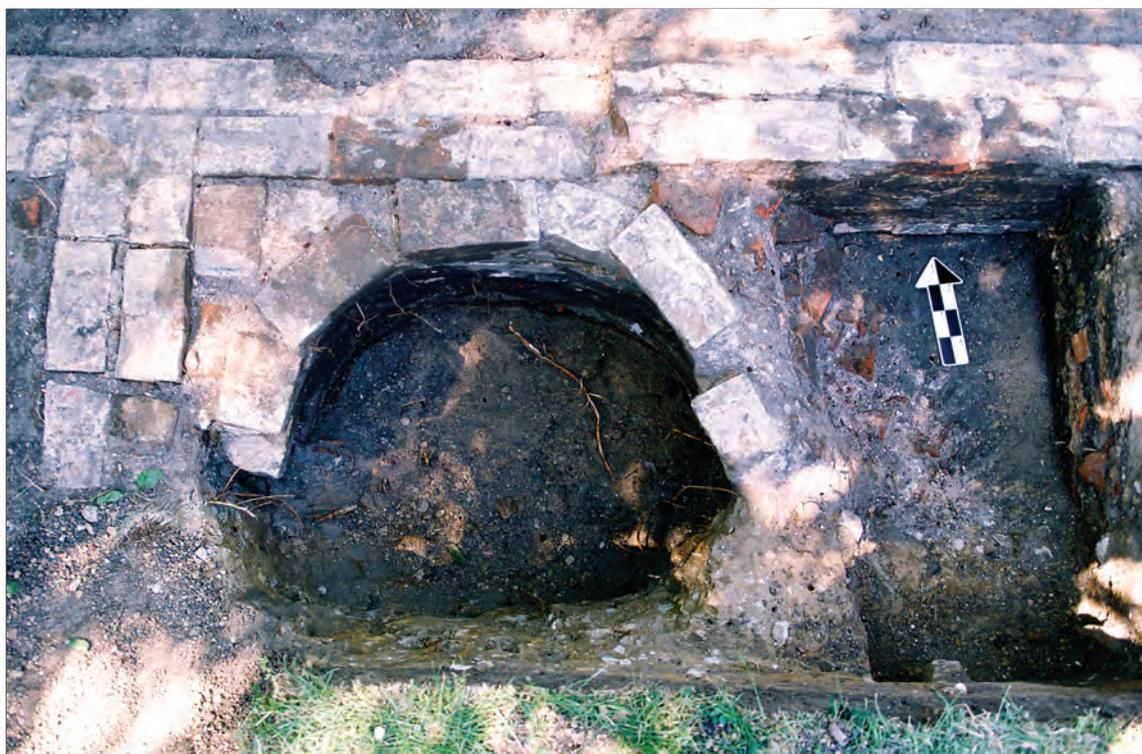
Figure 77. Burch lot, Test Unit 3, view north to the remains of the interior well along the north wall of the Burch house foundation after partial excavation.

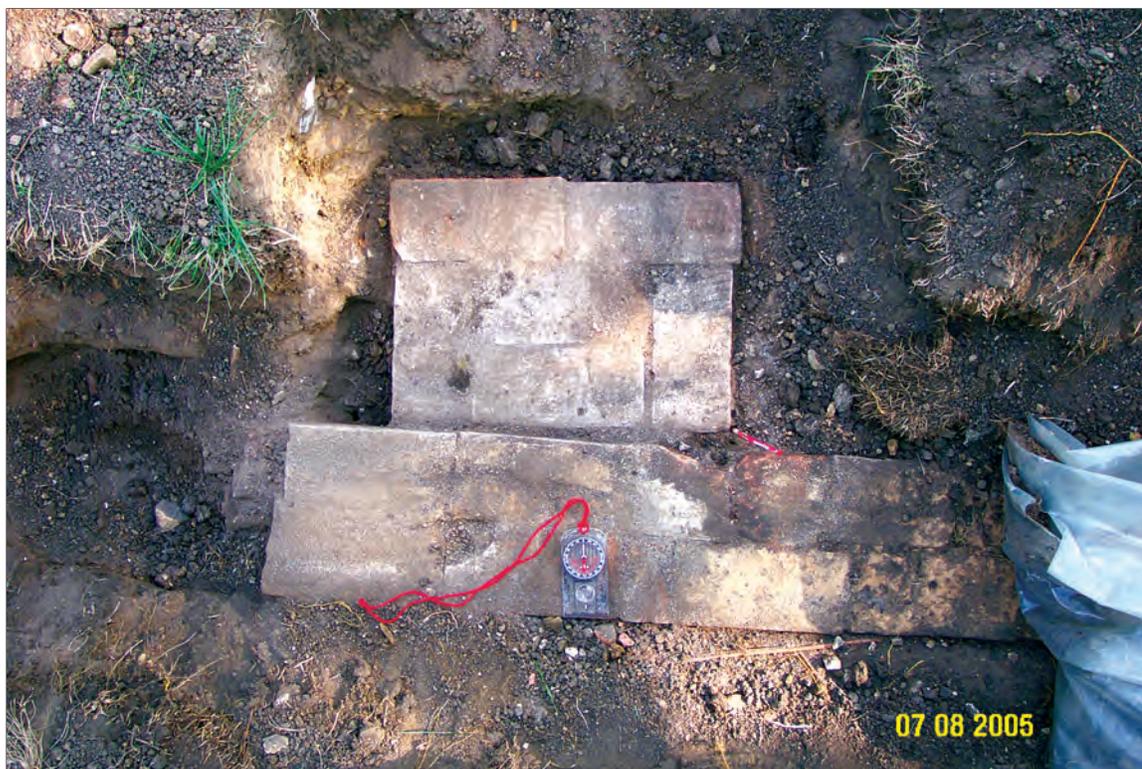
Figure 79. Burch lot, east end of Trench 6, view south to a probable chimney base along the interior face of the north foundation of the Burch house.

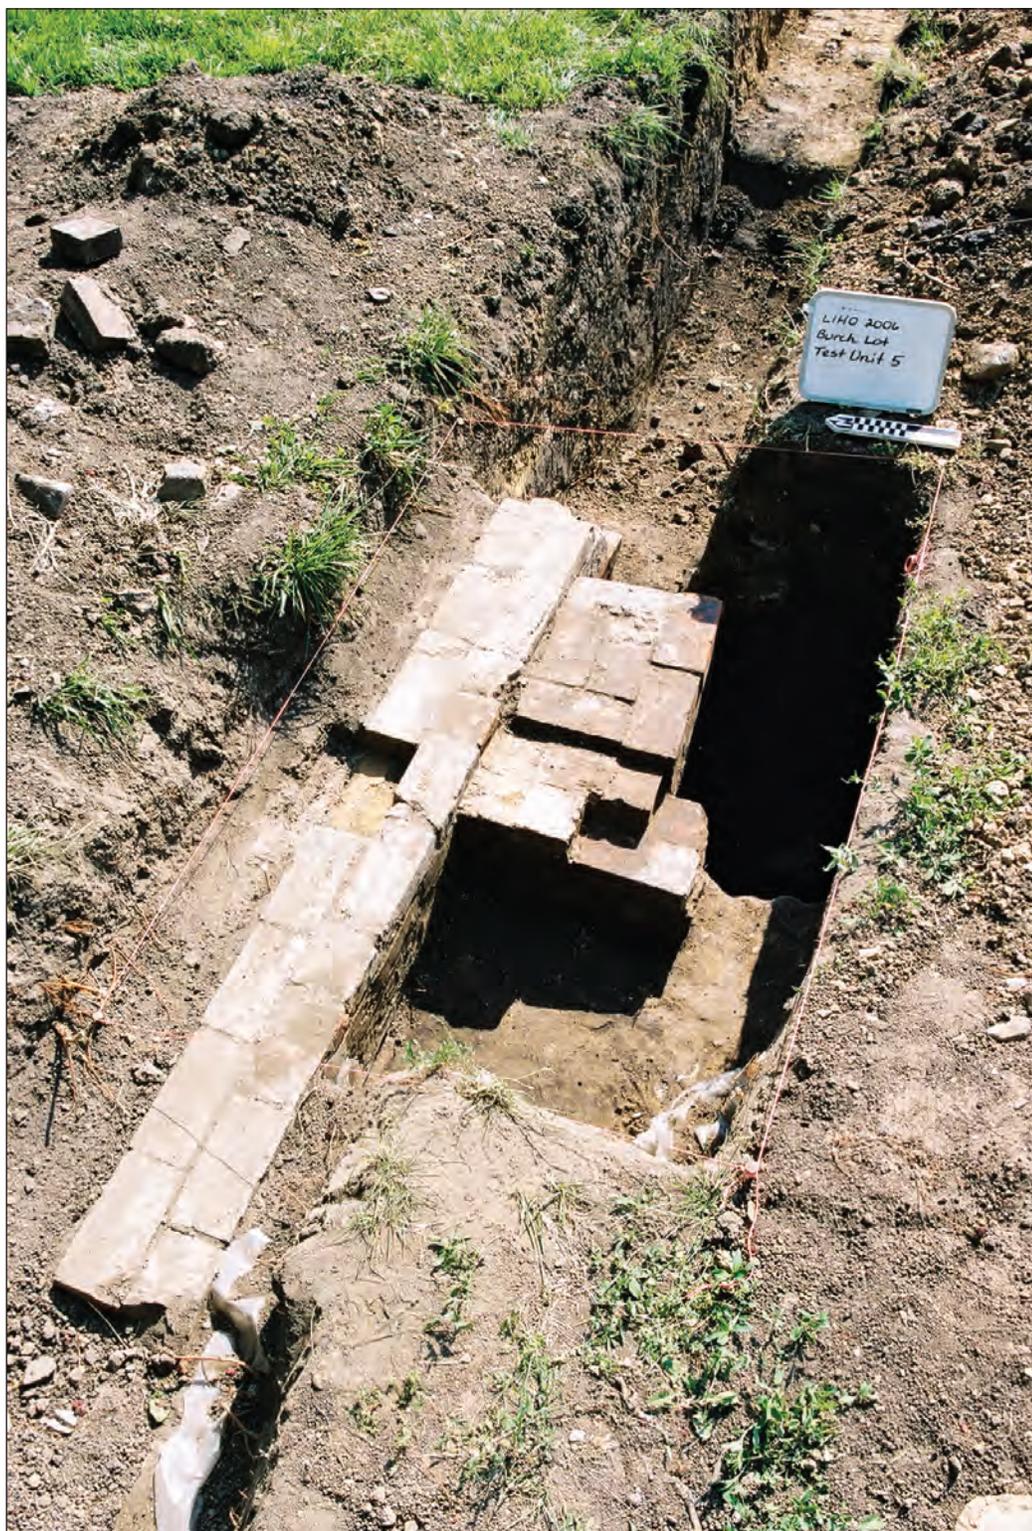
Figure 81. Burch lot, Test Unit 5, view northeast to remains of the north foundation of the Burch house, an interior wall intersection with the north foundation, and a probable chimney base (on east side of interior wall).

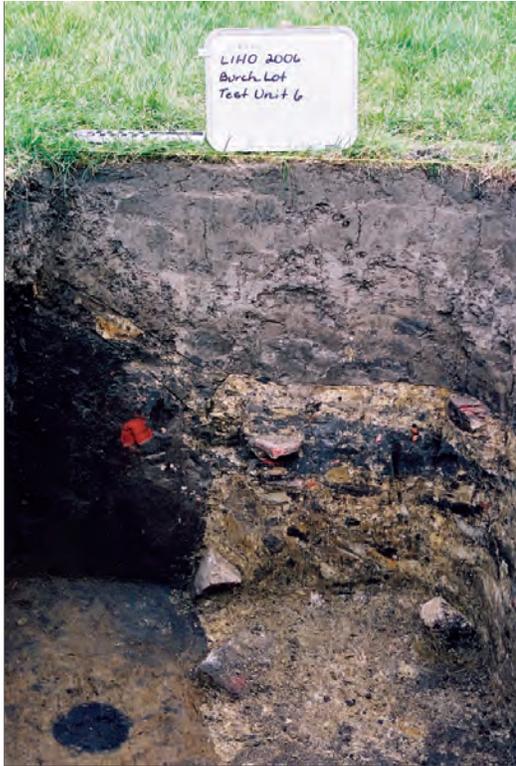
Figure 83. Burch lot, Test Unit 6, east unit wall profile showing yellow and white clay fill in the area where a twentieth century apartment building stood. The base of a post hole stain is also visible in the floor of the unit (lower left in photo).
