Tech Notes

BUILDING 149
CONSTITUTION PARK
Boston Navy Yard
(Charlestown Navy Yard)
Boston, Massachusetts

NUMBER 12

Aluminum Replacements for Steel Industrial Sash

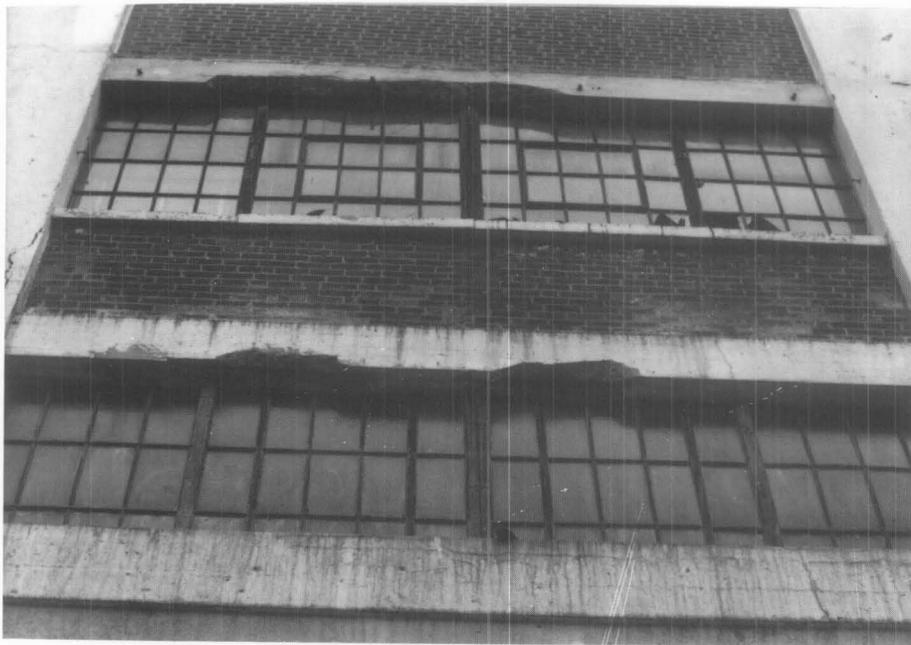
muntins with an exterior cove bead shape profile to the muntin. Most of the openings consisted of a bank of 4 side-by-side window units. Each of the middle two units consisted of 20 divided lites, including a 6-lite center hopper; the two end units were fixed and contained only 16 lites (see figure 1). Typical of pre-World War II steel windows, the glass panes had a narrower width than height. The vertical mullion connecting each unit was approximately 3" wide, noticeably dividing each opening into 4 window units.

Figure 1. Most of the openings consisted of a bank of 4 side-by-side steel window units. Each of the middle two units consisted of 20 divided lites, including a 6-lite center hopper; the two end units were fixed and contained only 16 lites.
Photo: William MacRostie

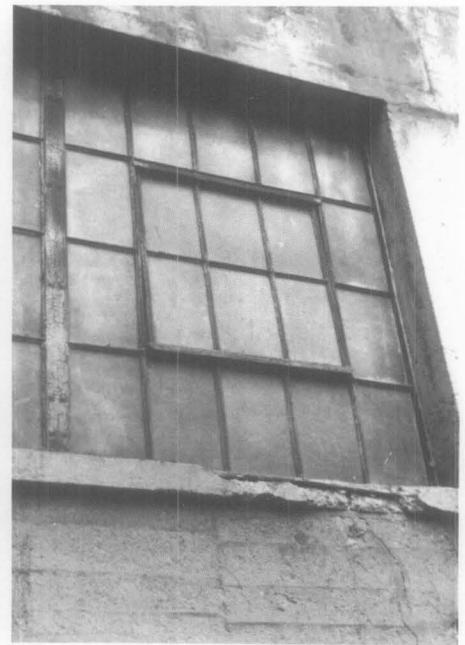
The contractor's survey of the historic windows in the spring of 1984 revealed that extensive rusting of the frames had occurred and that many were racked. The severe rusting had also contributed to the spalling of sections of the concrete sills, jambs, and spandrels (see figure 2). Repair and upgrading options to maintain the historic windows were quite limited due to the size of the glazing bars. The shallow depth of the metal glazing bars (muntins) seemingly precluded the installation of sealed insulating glass within the existing lites, even if the windows could structurally support the additional weight. The only practical way of double-glazing would have involved the use of interior storms with units that were either operable or were removable for ease of cleaning. Even then, however, the severe deteri-

Figure 2. Due to lack of maintenance, severe rusting of the steel frames had occurred, which contributed to the spalling of sections of the concrete sills, jambs, and spandrels. **Photo: Charles Fisher**

oration of the steel windows still would have needed to be addressed. Considering the size of the bay openings, the decision was made to replace the windows.

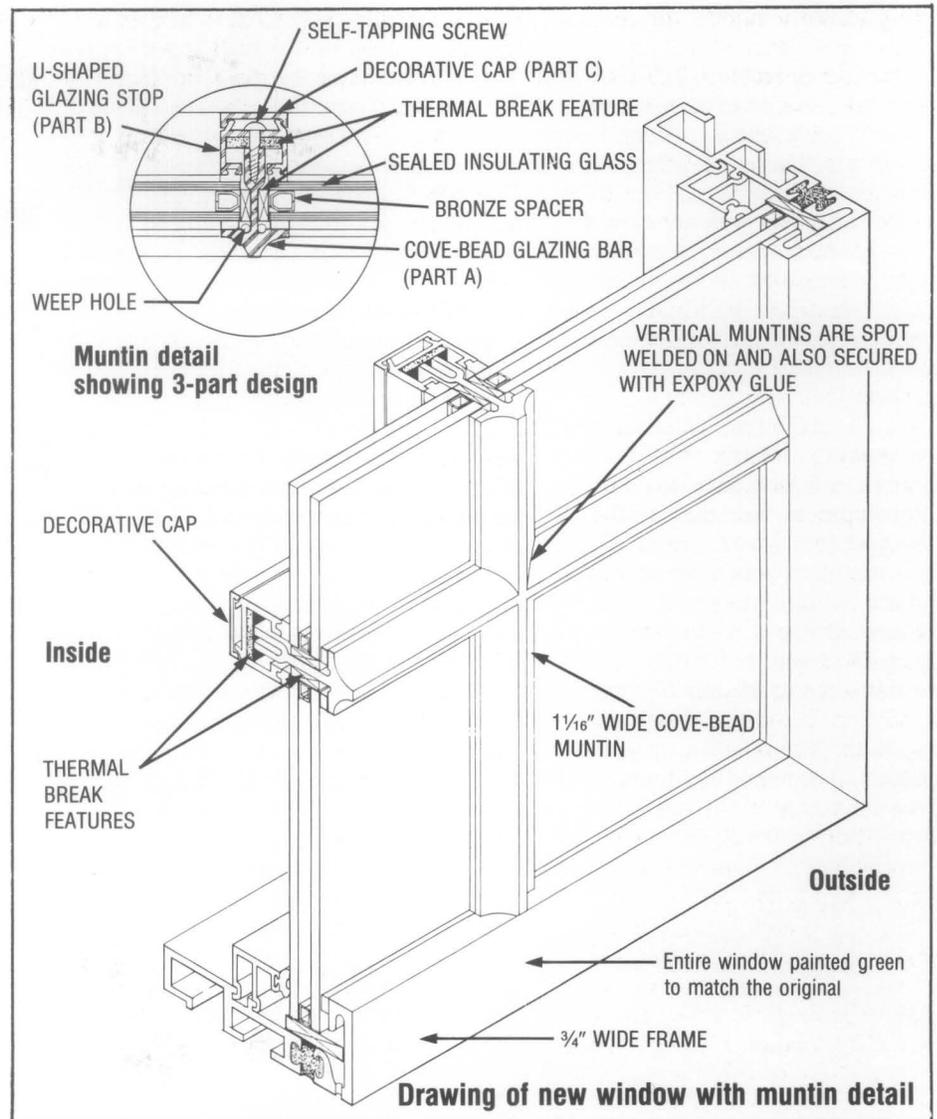
One of the first major design issues to be resolved concerned the need to match as closely as possible the shape and dimensions of the original 7/8" wide glazing bar (muntin) with its decorative cove-bead exterior profile to simulate the profile of the original steel window muntins. The project team concluded that in order to keep the muntin on the aluminum window as narrow as possible, the traditional cast thermal break (cast plastic) feature of most modern windows could not be used. Instead, a series of spacers and gaskets principally would be utilized to achieve a thermal break for energy conservation. By using this approach, the window fabricator would be able to use a 1/16" wide integral cove-bead muntin. The only short circuit in the thermal break would be at the point where screws were used to connect the inner and outer portions of the muntin (see figure 3).

Figure 3. Drawing of the aluminum replacement windows shows how the cove-bead muntin profile of the original steel windows was closely matched in the integral muntin system designed for the aluminum replacement window. A series of spacers and gaskets were used as the principal means of obtaining a thermal break in the window for energy purposes. Drawing: Peter Charles

The basic aluminum window unit consisted of 9 different aluminum extrusions, including the decorative cove-bead muntin. The muntin assembly actually consisted of 3 extruded aluminum sections. The principal muntin section was the cove bead portion that had a long glazing channel with a receptor at the end (see figure 3). Attached to the interior-facing side of the muntin was a U-shaped glazing

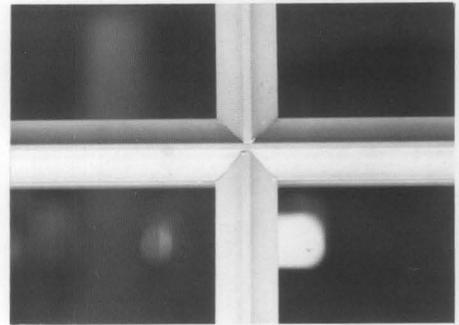
While the horizontal muntins were continuous across the window unit, the vertical muntins had mitre-joints where they intersected the horizontal muntins. The vertical muntins were secured through a combined use of epoxy glue and spot welding (see figure 4). A system of weep holes and channels was provided to ensure that any water trapped between the glazing tape and the glass and muntins would be diverted to the outside of the windows.

Figure 4. The vertical muntins had mitre joints where they intersected the horizontal muntins and were secured through a combined use of epoxy glue and spot welding. Photo: Charles Fisher

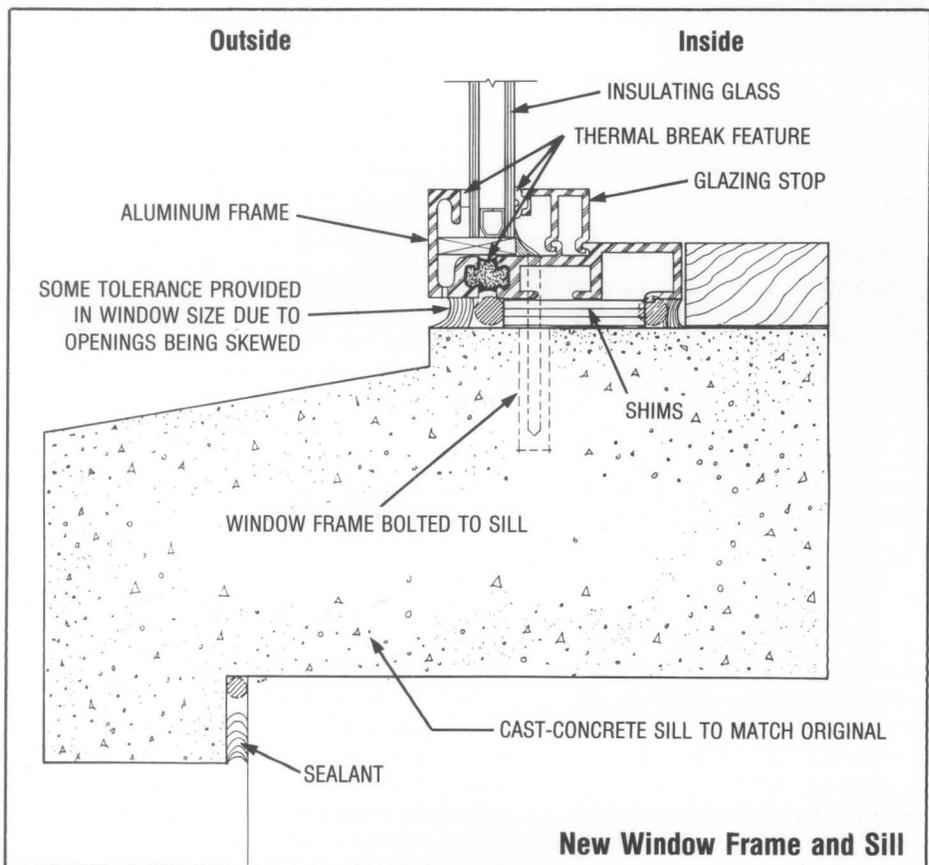
New Window Frame and Sill

Figure 5. The frame of each window unit was designed with a width of $\frac{3}{4}$ " in order to closely match that of the original windows. The frames were bolted to the face of the jambs, sill, and head of the masonry opening. Drawing: Peter Charles

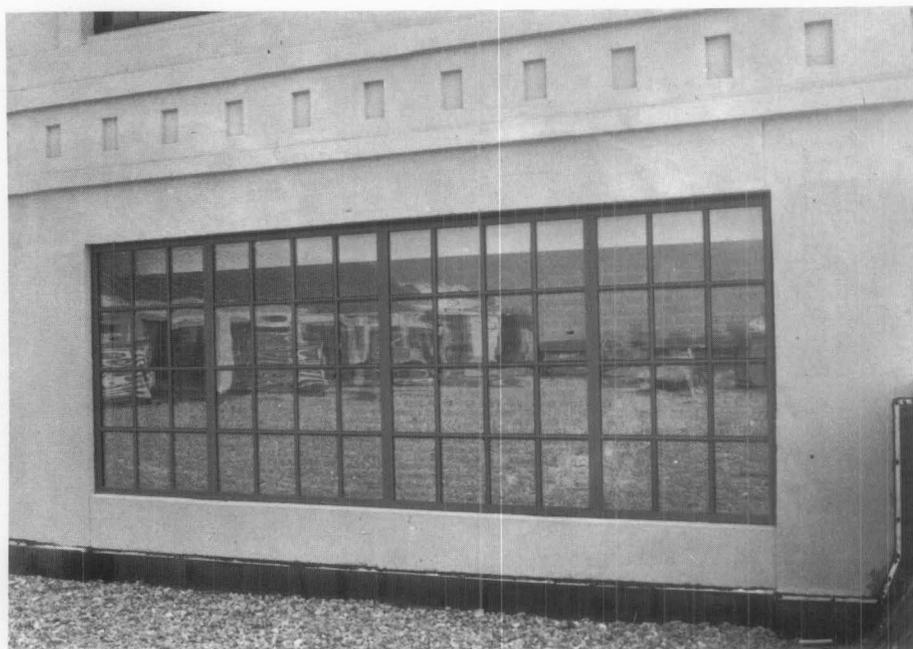
Figure 6. Fabrication and installation of the window units were complicated by the nine different types of windows in the building and by the considerable variations in the window heights for each type. Approximately 500 of the 2000 window units were the same size. Photo: Chuck Parrott

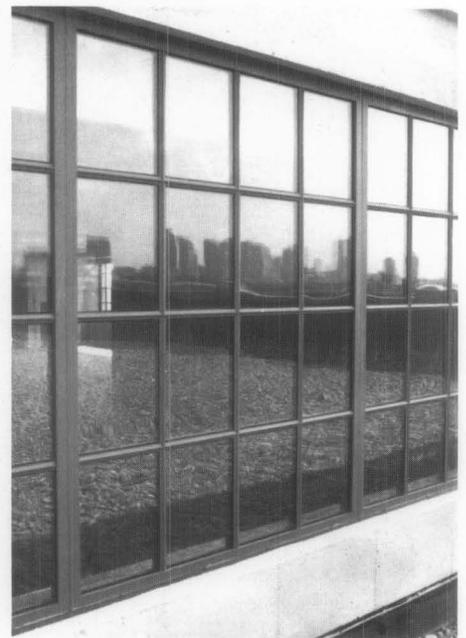
the greatest problem and biggest expense, since the limited tolerance for encroachment onto the glass area required very careful work (see figure 7).

Figure 7. Despite the difficulty encountered with proper glass sizing and spacer alignment in the sealed insulating glass, the end result is an innovative window that is both aesthetically pleasing and closely matches the historic appearance of the original steel design. The slight encroachment of the bronze spacer onto the visible glass area is not readily detectable from general view. Photo: Charles Fisher

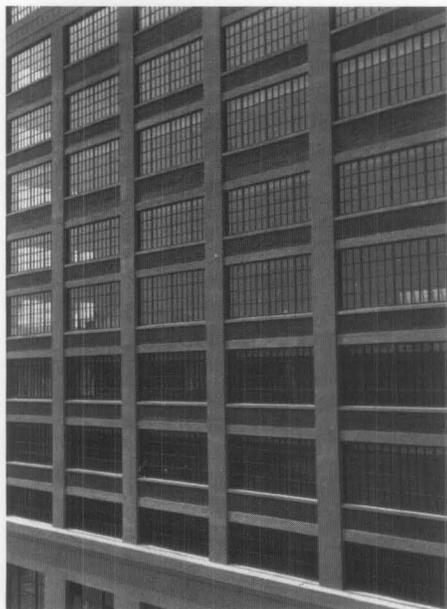
The window work at 149 Constitution Park was noteworthy in several ways. First, it represented a significant improvement over past attempts to recapture the distinctive qualities of a steel industrial window with narrow cove-bead glazing bars, using an aluminum replacement system with insulating glass (see figure 8). Equally important was the manner in which the new window system was developed for the project.

Figure 8. The window work at 149 Constitution Park represented a significant improvement over past attempts to recapture the distinctive qualities of a steel industrial window with narrow-bead glazing bars, using an aluminum replacement system with insulating glass. Success was achieved through careful and well coordinated planning. Photo: Charles Fisher.
