MULTIDISCIPLINARY ACCIDENT INVESTIGATION TEAM NARRATIVE/DIAGRAM

NL-020-18

MAIT SUPPLEMENTAL

- A mechanical inspection of the Forest River to determine if there were any pre-existing conditions that caused or contributed to the cause of the mechanical failure, which potentially caused the fire

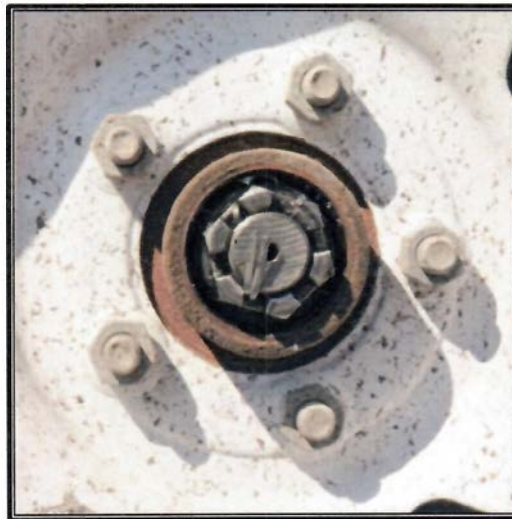
Left-Front Spindle with Dust Cap Removed

The ends of the spindles were threaded, allowing the brake hub to be held in place with a castle nut. There was a vertical, off center hole in the end of the spindles for a cotter pin. The cotter pins were intended to keep the castle nuts from loosening. The left-front and left-rear brake hubs rotated freely. The left-front and left-rear axle castle nuts were slightly over tight, and the brake hubs had no endplay.¹ The castle nuts should have been finger tight; pliers were needed to loosen the nuts.

The left-front and left-rear-inner bearings were discolored from overheating due to an insufficient amount of grease and/or from having no end play. The missing roller from the left-rear-inner bearing was not found.

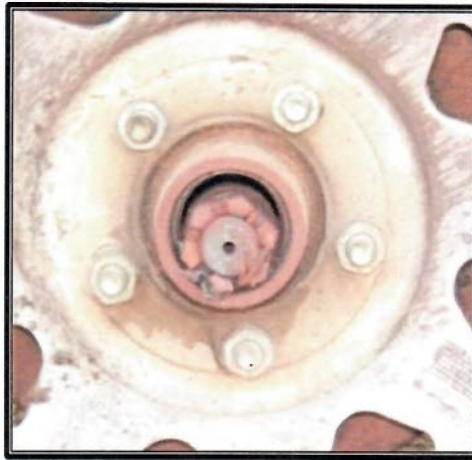
Right-Front Spindle with Missing Dust Cap

The right-front and right-rear axle, castle nuts, and cotter pins were damaged. The right-front castle nut was in contact with the brake hub, and the castle nut was fused to the spindle. An air impact wrench and socket were required to remove the castle nut.

The failure of the bearings caused the right-front and right-rear brake hubs to contact the castle nuts that held the brake hubs on the spindles. The brake hubs were no longer centered on the spindles, which caused the brake components to detach from the backing plates. The right-front and right-rear spindle dust caps were missing. It was undetermined as to the length of time the spindle dust caps were missing. If the dust caps had been place, they most likely detached at the time of the bearing failures and/or when the brake hubs were no longer centered on the spindles.

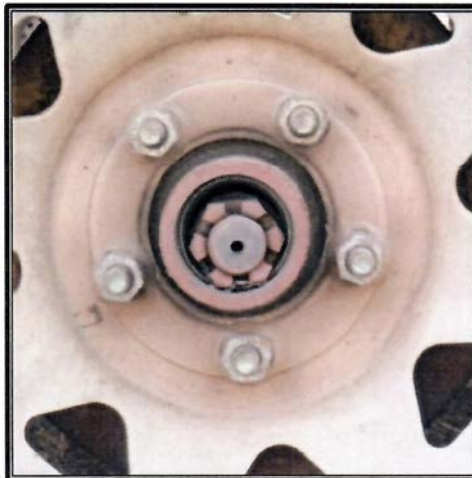
Right-Rear Spindle with Missing Dust Cap

The right-rear castle nut was in contact with the brake hub, and the castle nut was fused to the spindle. The right-rear axle cotter pin was sheared off. The right-rear brake hub had less damage to the bearing race and seat than the right-front brake hub. A socket could not be used to remove the castle nut. An air chisel was used to rotate the castle nut. The castle nut became stripped and could not be removed. The air chisel deformed the castle nut to the point that the brake hub could be removed with the castle nut still attached to the spindle.

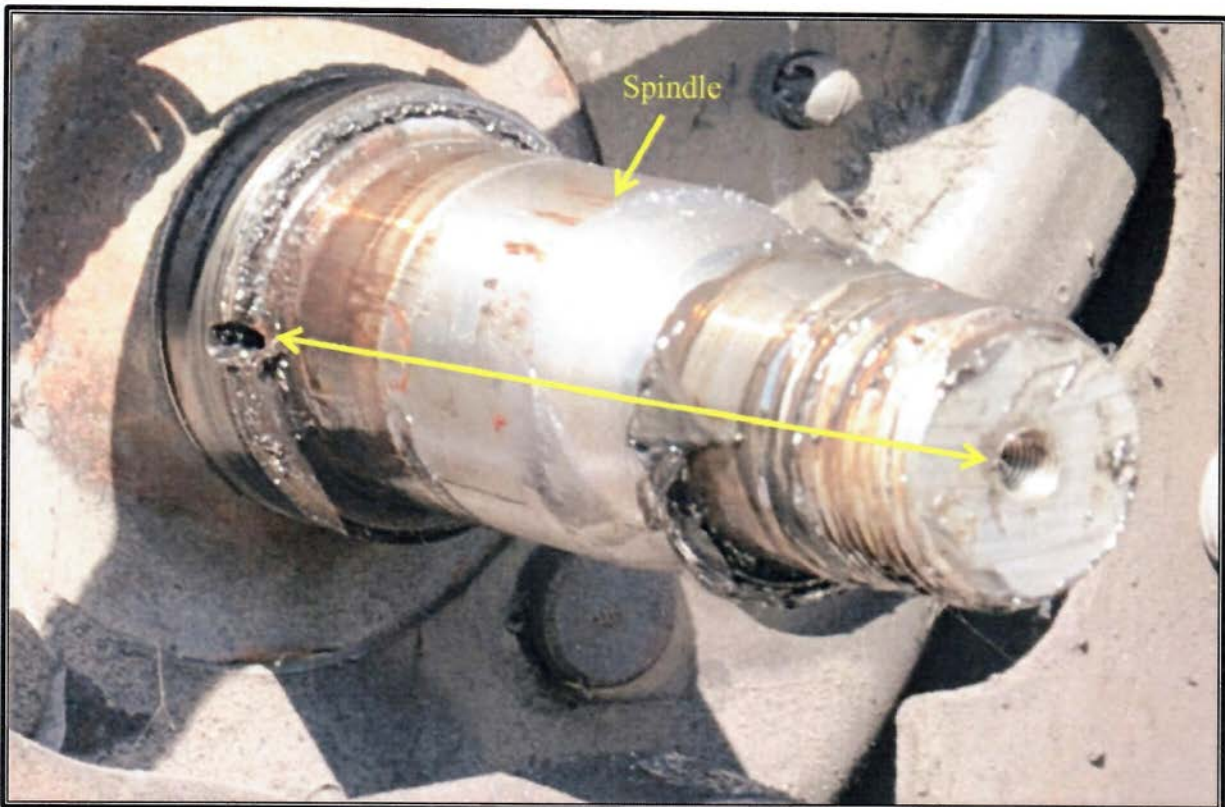
Undamaged Left-Front Spindle

The outer faces of the spindles were threaded and had a horizontal channel that extended through the center of the spindles and exited where the rear bearing was seated. The threaded portion and horizontal channel were designed to have a grease fitting and allow new grease to be added to the bearings. All four spindles were missing the grease fittings. It was undetermined if the grease fittings were installed by the factory and were missing or if they were intentionally left out by the factory. The left-front and left-rear spindles were undamaged.

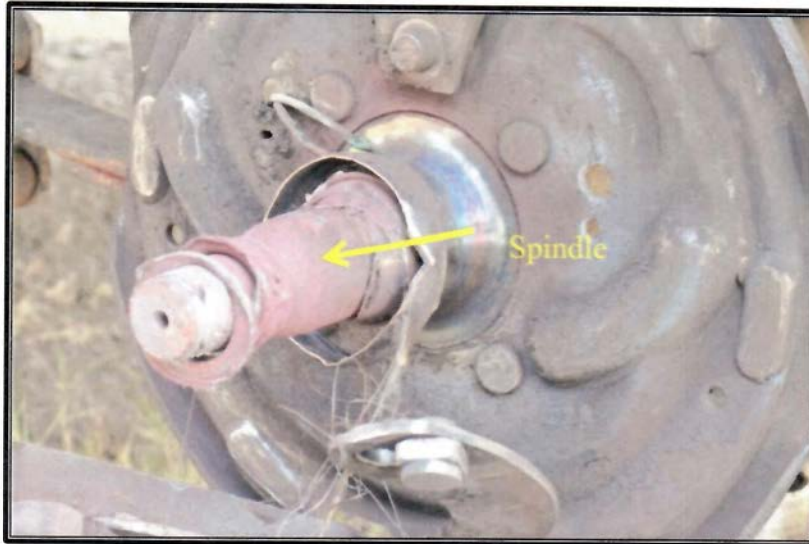
Damaged Right-Front Spindle

The right-front and right-rear spindles were discolored, pitted, and had damaged bearing components fused to them.

The right-front and right-rear wheels, brake assemblies, brake hubs, bearing assemblies, spindles, and castle nuts all had thermal damage. The right-front and right-rear bearing assemblies overheated and failed, most likely due to an insufficient amount of grease and/or no end play, as observed on the left-front and left-rear bearing assemblies.

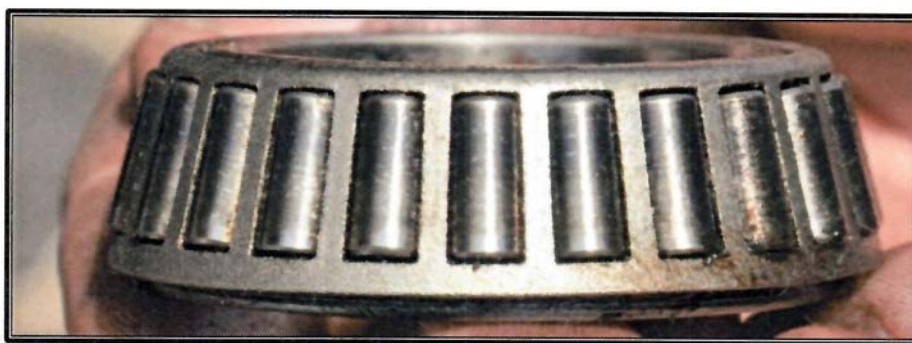
Left-Front-Inner Bearing

The bearing assemblies were housed in the brake hubs. Each brake hub had two bearing assemblies; an inner and outer. The bearing assemblies centered the brake hubs on the spindle and managed the radial and axial load of the vehicle. The left-front-inner bearing, rollers and race were discolored. The photographs below show the grease removed from the surface.

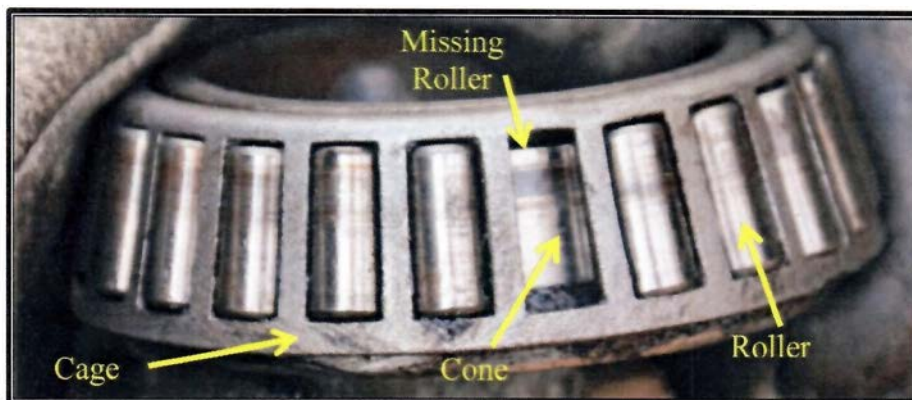
Left-Rear-Inner Bearing

The left-rear-inner bearing, rollers, cone, and race were discolored; and one roller was missing.

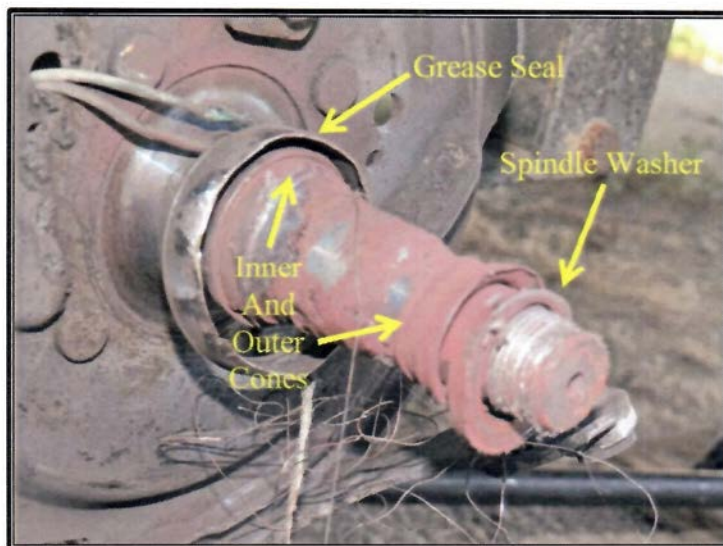
Right-Front Spindle

The right-front and right-rear inner and outer bearing assemblies were severely damaged and were missing all of the rollers and cages. The inner and outer cones remained on the spindles.

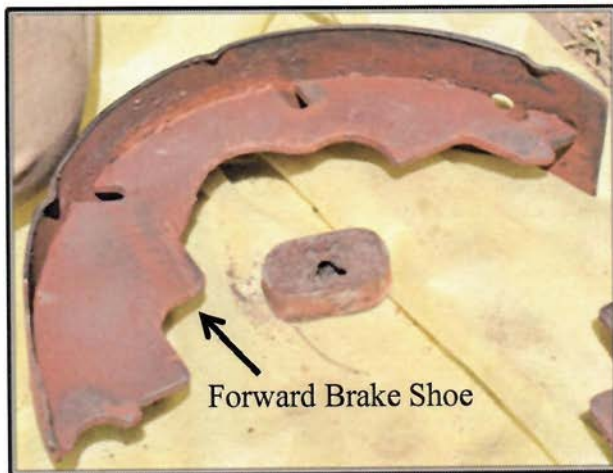
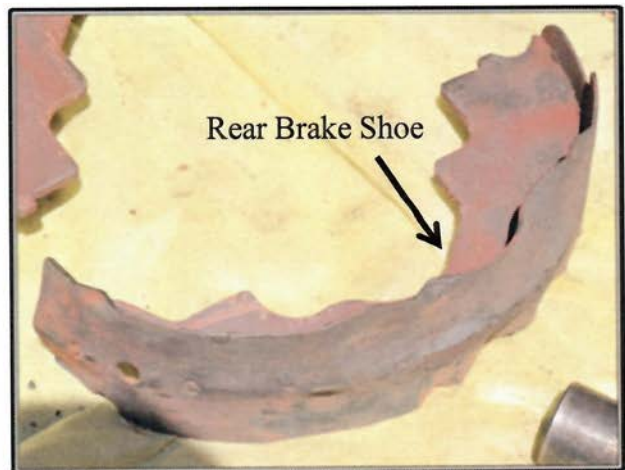
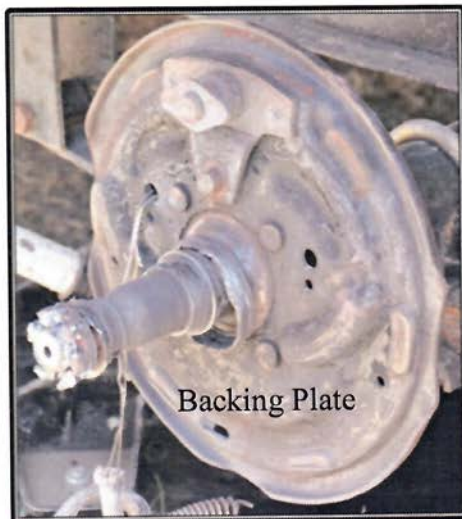
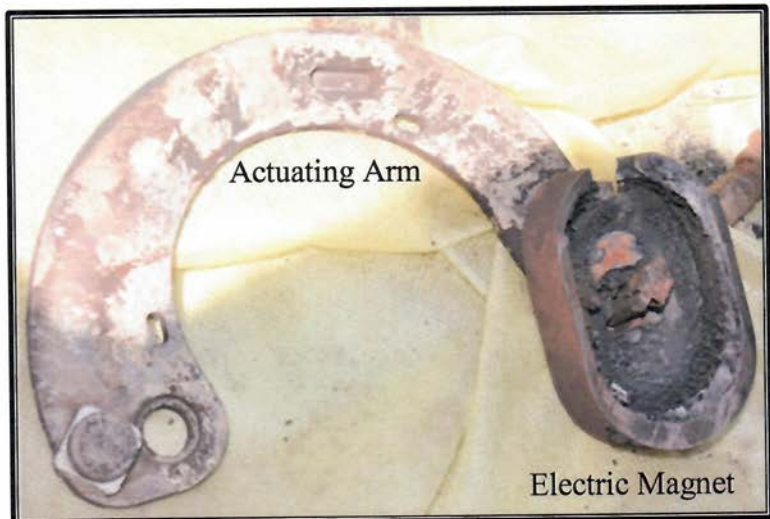
Right-Rear Brake Components

The right-front and right-rear brake components were detached from the backing plates and were found loose in the brake hubs. The brake shoes were designed to be secured to the backing plates with hold down springs, pins, and retainers. None of the aforementioned parts were found during the inspection. The right-front and right-rear brake assemblies were also missing the brake adjusting screw springs. The right-front and right-rear brake assemblies did have the brake return spring and the brake adjusting screw. All brake shoes on the right side were void of any friction material; they were discolored and deformed. The electric magnets attached to the actuating arms for each of the right side brake assemblies were melted, and the windings were displaced from the housing.

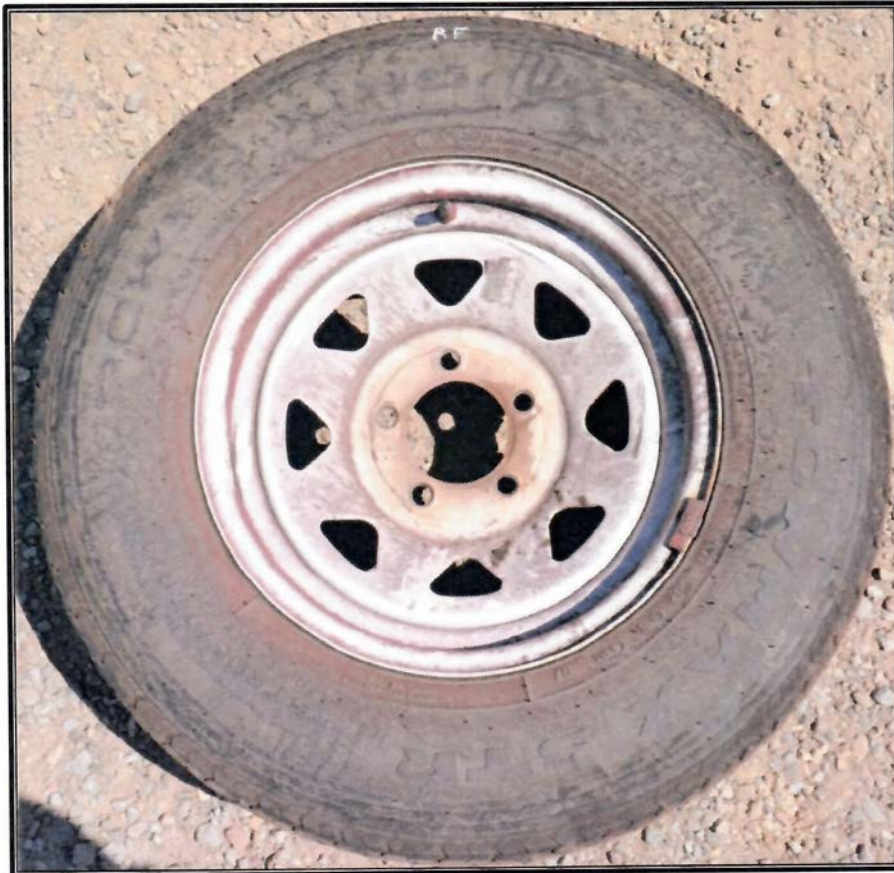
Right-Front Tire and Wheel

This tire was manufactured in the 23rd week of 2014. The tire was unremarkable. The wheel-mounting surface, around the bolt holes, was discolored.

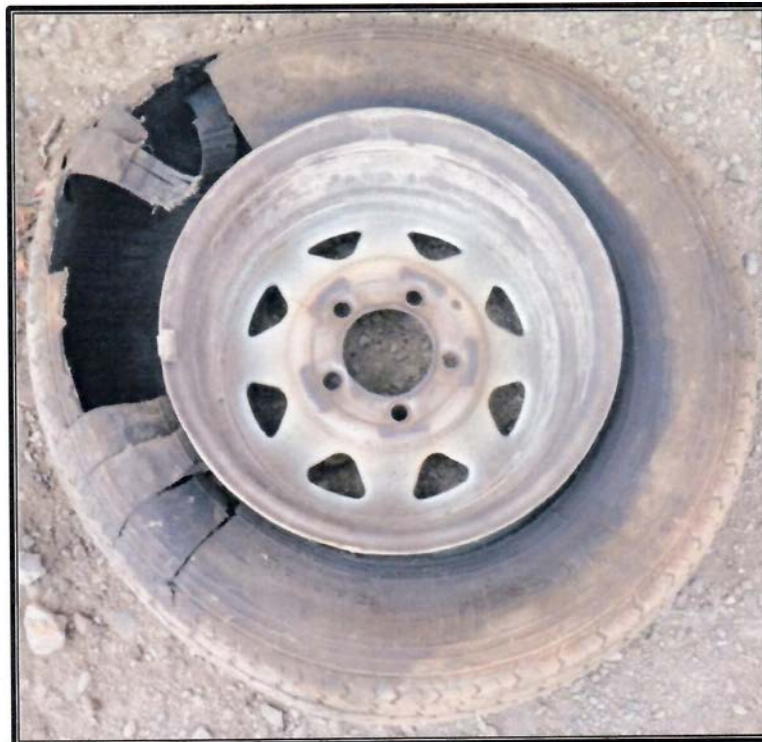
Right-Rear Inboard Tire and Wheel

The portion of the tire with the DOT number showing the week and year the tire was manufactured was missing. The outboard sidewall was unremarkable. The inboard sidewall bead seat was de-beaded around the circumference. The inboard sidewall had multiple tears and pieces missing from the 6:30 to the 10:30 positions, approximately 19 inches in chord length. The wheel-mounting surface, around the bolt holes, was discolored. There was no indication the tire had a prior flat repair.

The right-front and right-rear wheels were bolted to the brake hubs. With the brake hubs no longer centered on the spindles, the tires on the right-front and right-rear may have been tilted causing the top and bottom of the tire to be displaced inward or outward. Normally, the weight of vehicle and the heat generated from tires in contact with road would be spread over the entire tread surface. If the tires were tilted, the weight of the vehicle on the right side and the heat generated by the tires in contact with the road could be concentrated into a narrow section of the tread. The friction between the detached brake components, brake hubs, and the spindles caused these components to produce heat. The heat then spread to the wheels, which most likely caused the inflation pressure in the tires to increase. However, it was undetermined if the right-rear tire "blowout" was due to an inflation pressure increase and/or from the tires being tilted. The right-rear wheel did not show any signs of having had contact with the roadway, and the tire did not have any exposed metal cords from the tread.
