Burnett Inlet Cannery

Current Condition

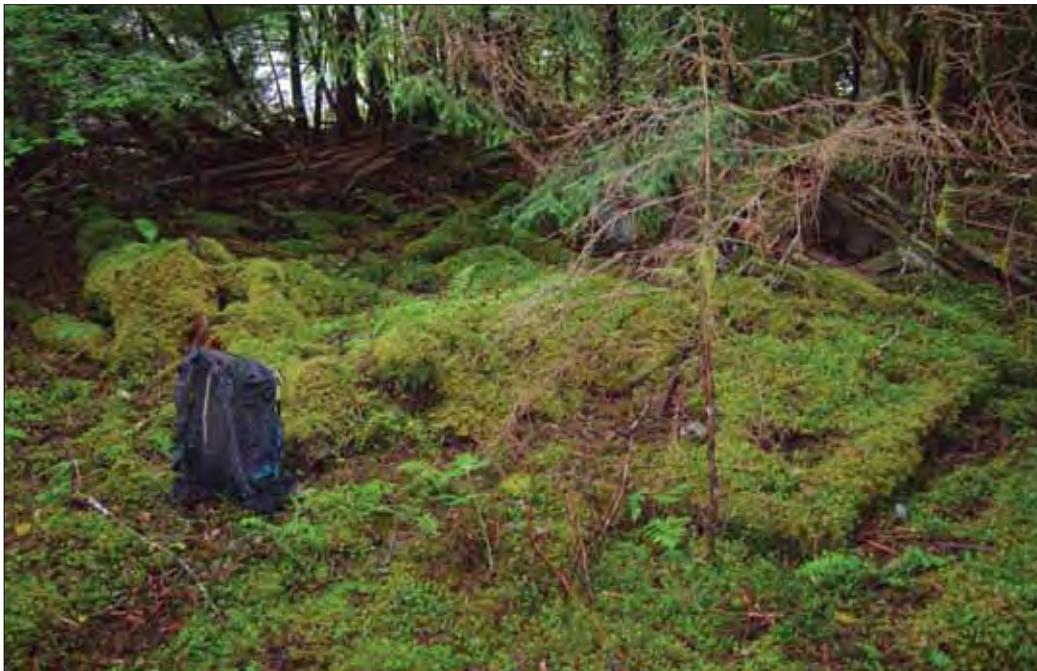
Figure 183.

inside the treeline in 2008 was about 10'x12', or about the size of a wall tent (Figure 183), and had the appearance of a temporary sportsman's camp a few decades old at most. The doghouse (Feature 26) could be considered the only standing building at the Funter Bay cannery (Figure 184), and it may postdate the Aleut occupation.

A moss-covered rectangle of 2"x6" planks (possibly Smith's (2003) Feature 23) post-dates the 1940 cannery fire and appears to be a tent platform no more than a few decades old.

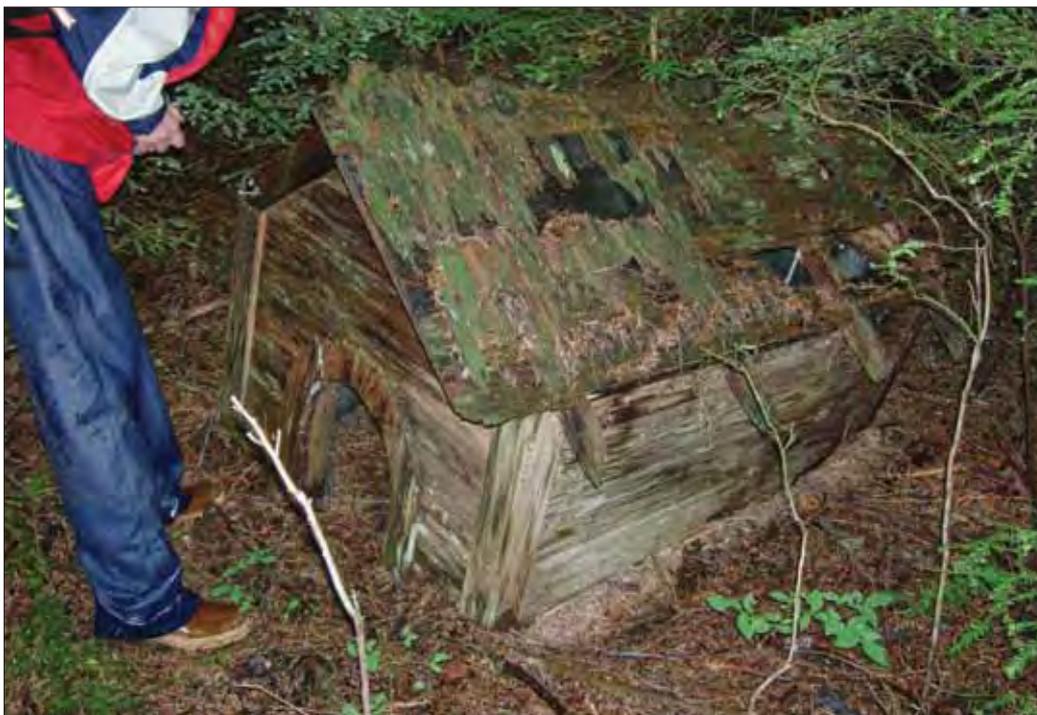
Figure 184.

The most intact building at the Burnett Inlet cannery is a doghouse.

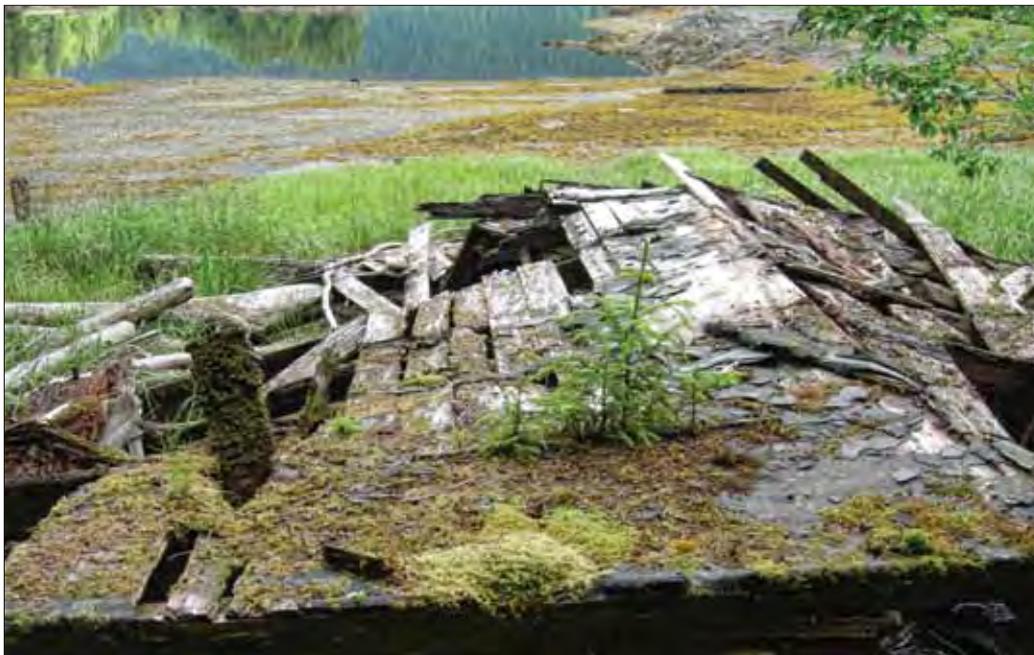
Figure 185.

Of the 11 building ruins mapped in 2003, four were reconfirmed in 2008: Features 2, 11, 19, and 24. Feature 2 is a collapsed wood frame building straddling the treeline, with half of the ruin in the intertidal zone and half in the uplands (Figure 182). Within the

pile of lumber are 1"x8", 2"x8", and 4"x12" planks, as well as logs ranging from 8" to 14" in diameter. The roof had a gable facing out into the cove, and the northwest half of the roof has fallen in place to cap the ruin (Figure 185). Bits of tarpaper still adhere to the roof boards. This building ruin and the associated pilings (Feature 1) may represent the bunkhouse depicted in a wartime photograph contributed by Gertrude Svarney (Figure 175). A building (one of two) appears at this location on the USGS topographic map for the locality, based on aerial photography decades old.

Feature 2 is a building ruin at the treeline on the shore of the protected cove (here looking northeast), counter-clockwise from Cannery Point.

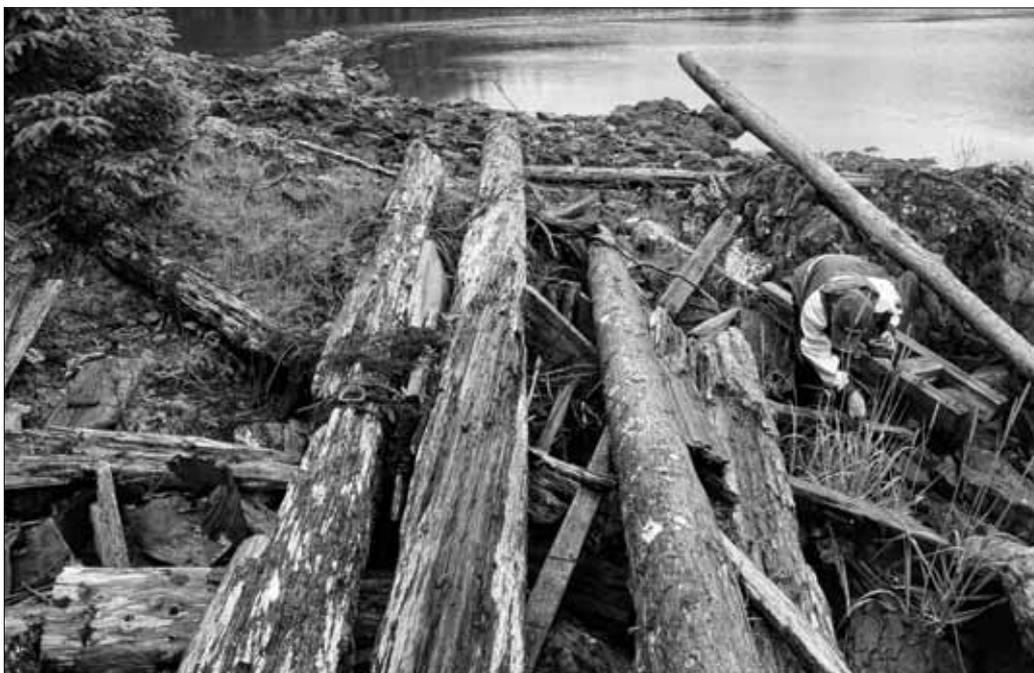
Figure 186.

In 2008 a collection of round and square timbers and other boards (Feature 11) at the high tide mark was found near the north end of the point where a wartime cannery building

once stood (Figure 178), but it didn't clearly represent that building. Some of the material had drifted in, and no piling stubs were visible (Figure 186). Smith (2003) observed a belt-driven

Feature 11 is a collection of round and square timbers on the beach where the central building in Figure 178 would have been, though at least some of the material has drifted in (note shackle around log left of center).

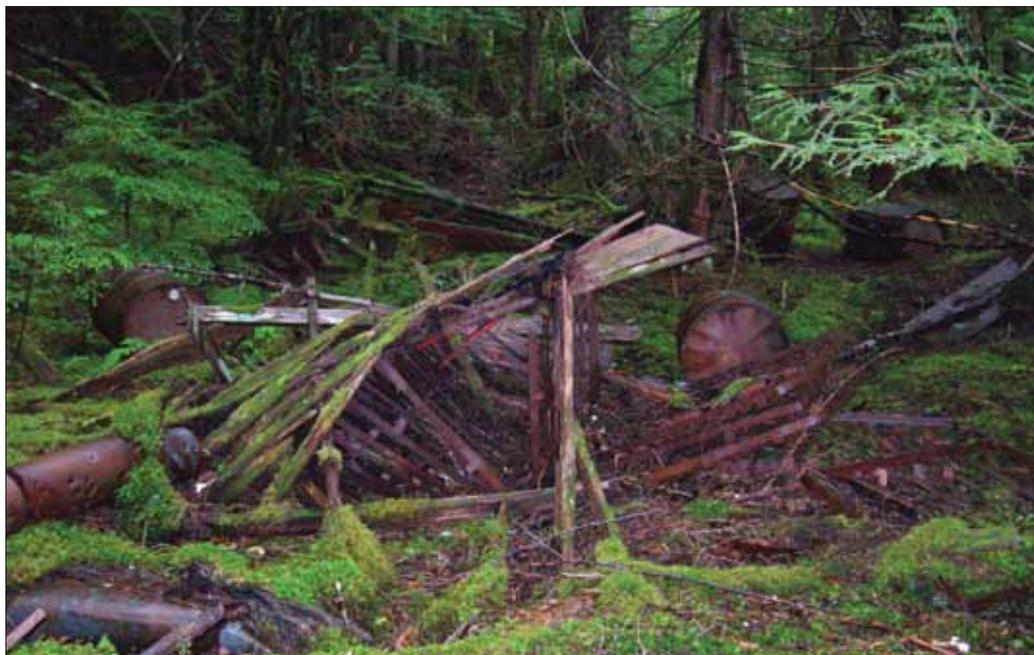
Red paint could still be seen in 2003 on the frame members of Feature 19 – a building collapsed upon about 15 ferrous racks used to hold cans in the cannery’s retorts. The feature was evident in 2008 (Figure 187), though the

Figure 187.
 Feature 19 is a wood frame building collapsed around metal artifacts including strap-steel trays used to hold cans for insertion into the retorts.

paint was indiscernible. Other large metal items including several 55-gallon drums were nearby.

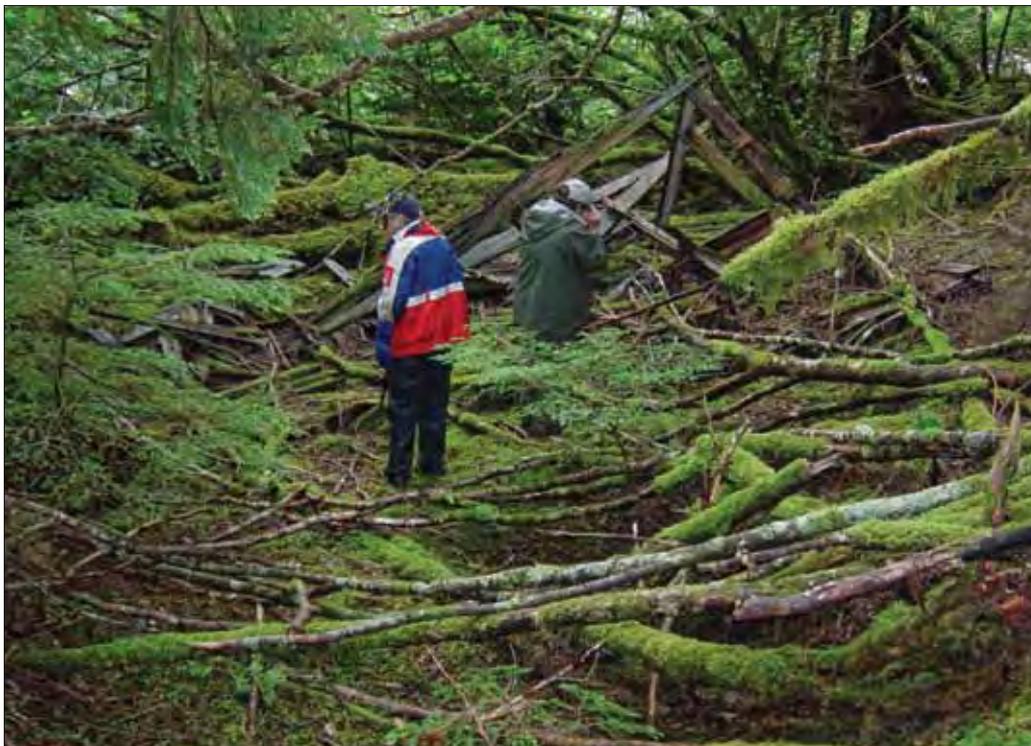
Figure 188.

The fourth building ruin detected in 2008 was Feature 24 at the south end of the shore facing Burnett Inlet (Figure 182), described by Smith (2003) as about 22'x20'. USFS investigations documented tongue-and-groove siding and a window frame, and considered it to be the site's most intact building at that time (Table 1). Smith (2003) detected paint of an undetermined color on the siding. In 2008 Feature 24 barely protrudes above the forest floor more than any other building ruin (Figure 188).

Patricia Roppel and Becky Saleeby inspect the collapsed building designated as Feature 24.

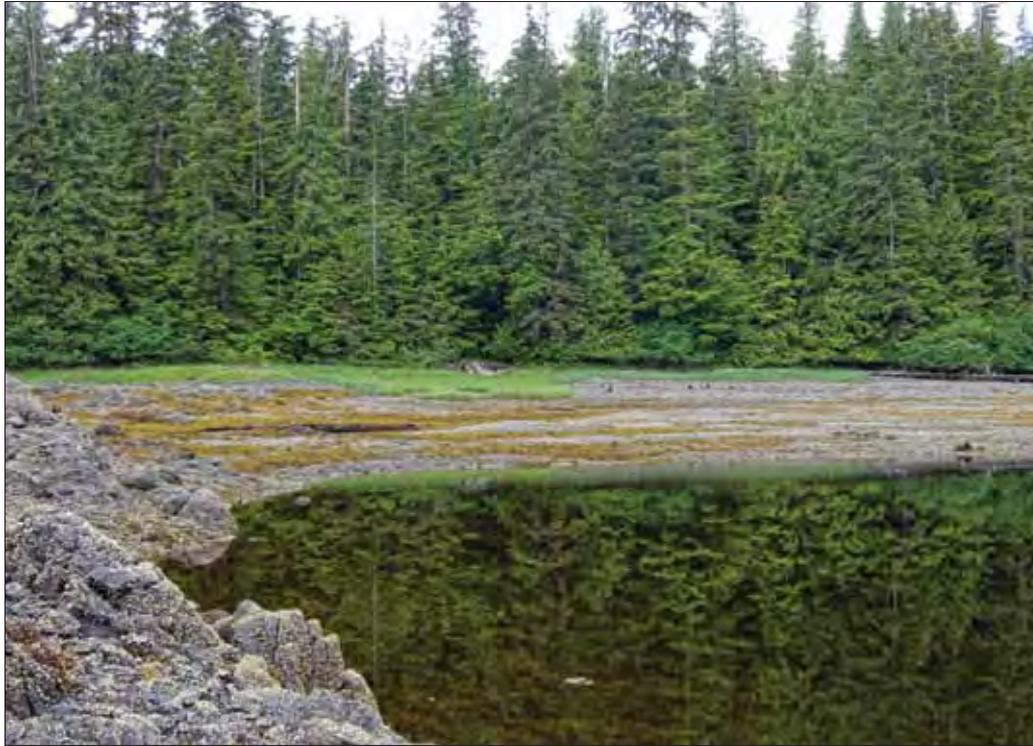
Figure 189.
 Along the southwest shore of the cove are intertidal piling stubs (Feature 1, center) and a building ruin (Feature 2, left of center). This is possibly the site of the building in Figure 175.

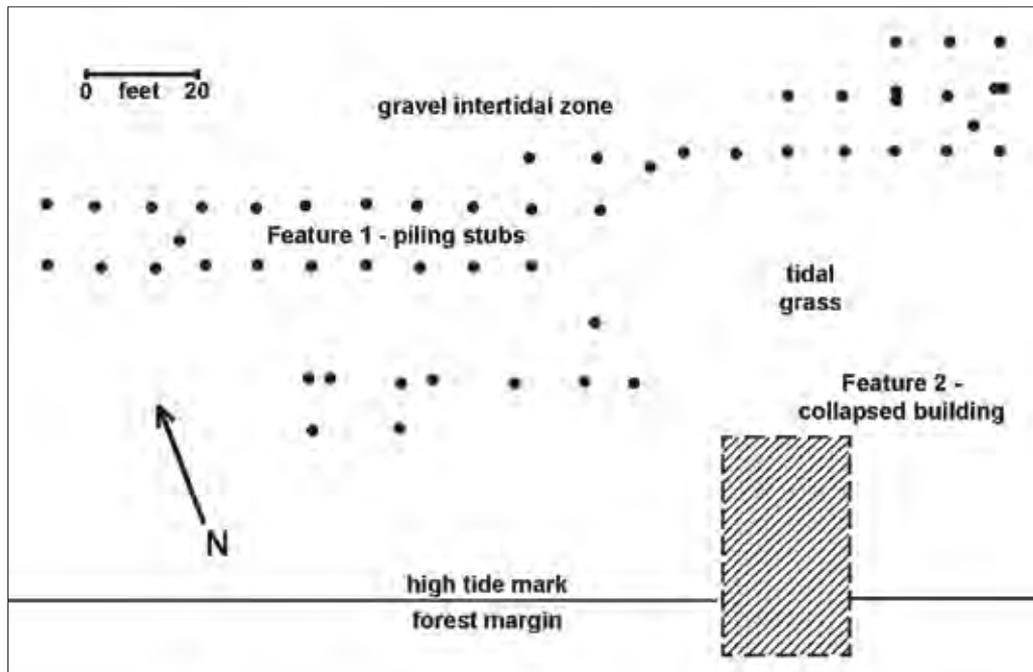
Figure 190.
 Together, Features 1 and 2 in 2008 displayed 54 piling stubs, compared to the earlier count of 15 (Smith 2003).

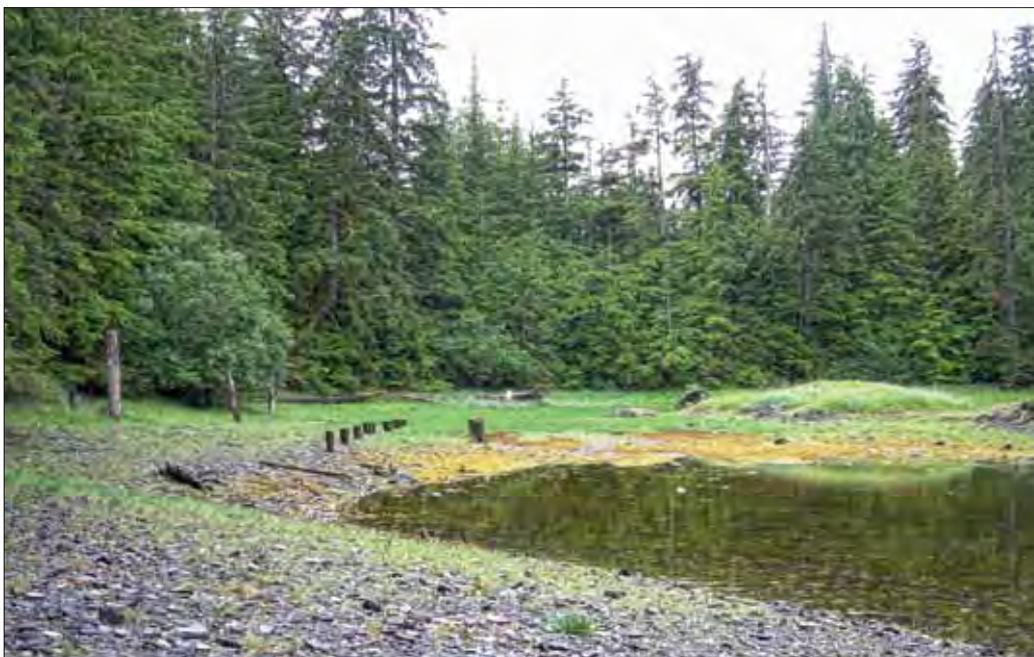
Figure 191.

Along the east shore of the cove is another set of intertidal pilings, designated Feature 3. Smith (2003) counted 22 pilings in three rows (Figure 182). The upper row consists of three tall pilings, while the two lower rows contain more pilings uniformly cut flat 20" above the beach gravel (Figure 191). USFS measured the feature as a 72'x42' rectangle. The feature appears to be a grid for stranding boats at high tide so that hull work can be performed.

Along the southeast side of the cove are three rows of pilings (Feature 3) with the two lower rows cut 20" above the gravel and three taller pilings forming the upper row – likely remains of a grid used to elevate boats at high tide so that hull work could be performed.

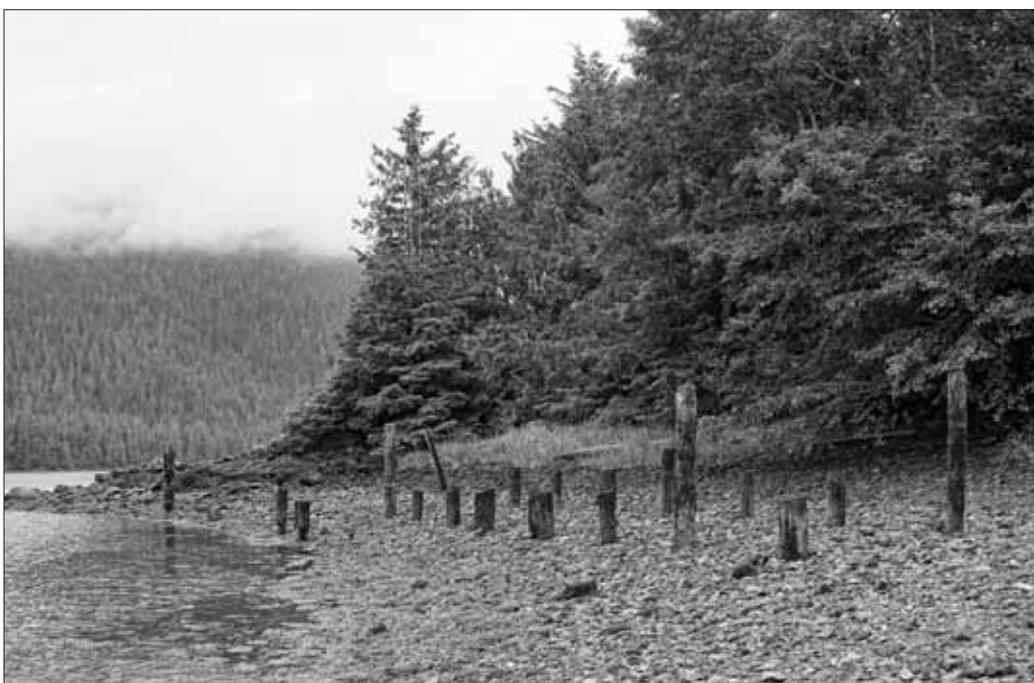
Figure 192.

Feature 7 is a collection of 29 piling remnants in three rows just inside the cove from cannery point, spanning an area of about 120'x30' (Figure

Feature 7 is a collection of 29 piling remnants in three rows just inside the cove from Cannery Point, spanning a 120'x30' area.

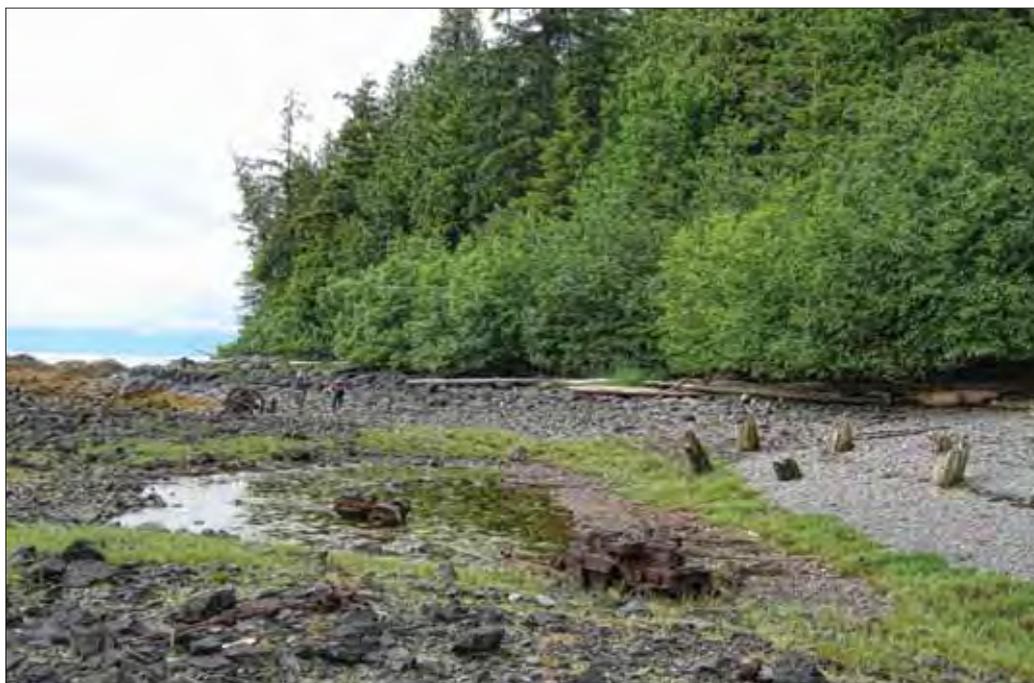
Figure 193.

A collection of 11 intertidal pilings (USFS's schematic map shows seven) on the east side of Cannery Point is Feature 16 (Figure 193), and a small group of three pilings 50' further south is Feature 17. This area is part of the

The shore on the east side of Cannery Point – home to the cannery’s extensive industrial complex until the 1940 fire – now displays only a few pilings along with rusty metal machinery (Feature 16 is at right).

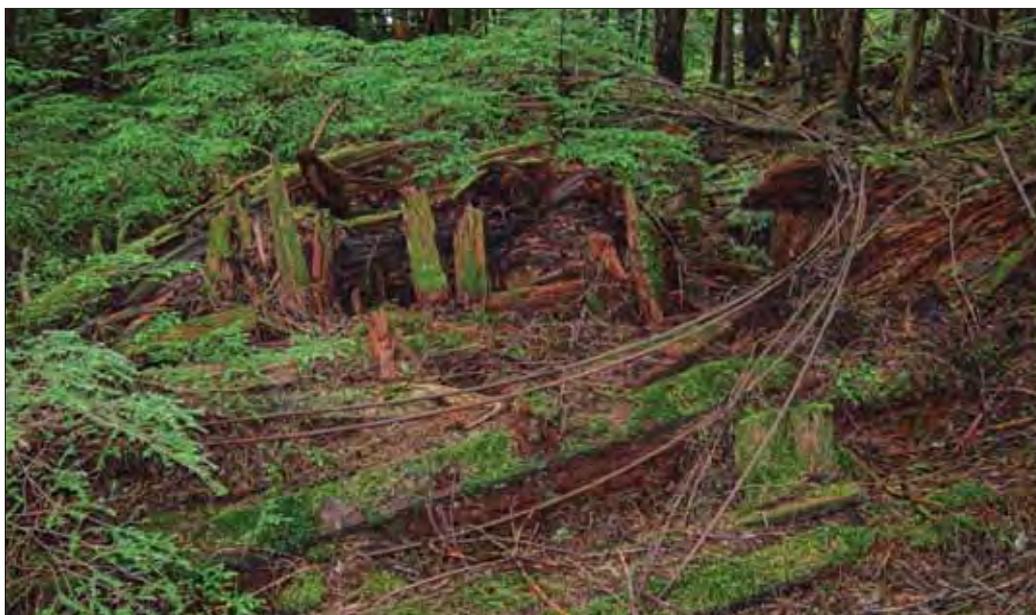
Figure 194.

The ruins of two wood-stave tanks remain at Cannery Point. Feature 22 is a pile of rotten wood including pilings and other members of an 18'x22' platform, with the collapsed staves of a tank that must have been about 18' in diameter. In 2008 the feature was barely discernible under a thick cover of moss and alder growth. Smith (2003) observed oil and said in her

field notes that the place “reeks of oil,” and the shore location (Figure 182) is typical of historic cannery fuel tank placement (see the Funter Bay cannery). Feature 25 is another wood-stave tank on a rotten wood platform, similar in appearance to the first but elevated on the rocky ridge forming Cannery Point. Smith (2003) noted wood-stave pipe leading from the tank to various building ruins and consequently judged it to be a water tank. The rotten staves, compression hoops, and other structural elements of Feature 25 (Figure 194) are more visible than those of Feature 22.

Feature 25 is the ruin of a wood-stave tank – probably a water tank – similar to the cannery’s wood-stave fuel tank (Feature 22).

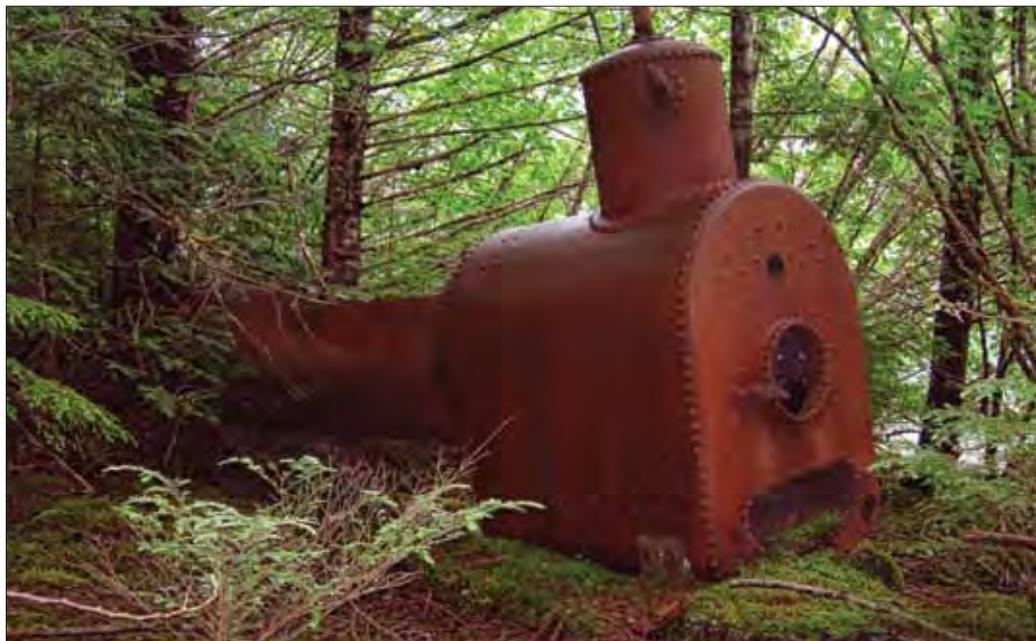
Figure 195.

Three stationary pieces of equipment were recognized in 2003 and again in 2008: a boiler, an engine, and a vat. The boiler (Feature 15) is of the tubular type and is devoid of identifying

markings (Figure 195). The remains of the firebox indicate an oil-fired system rather than wood- or coal-fired. The foundation is not visible and the apparatus has sunk unevenly into the forest floor. The boiler is in its original location judging from a wartime photograph (Figure 176).

A large oil-fired boiler (Feature 15) remains in its wartime position just inside the treeline where the 1940 cannery fire dropped it through a burned floor (Figure 176).

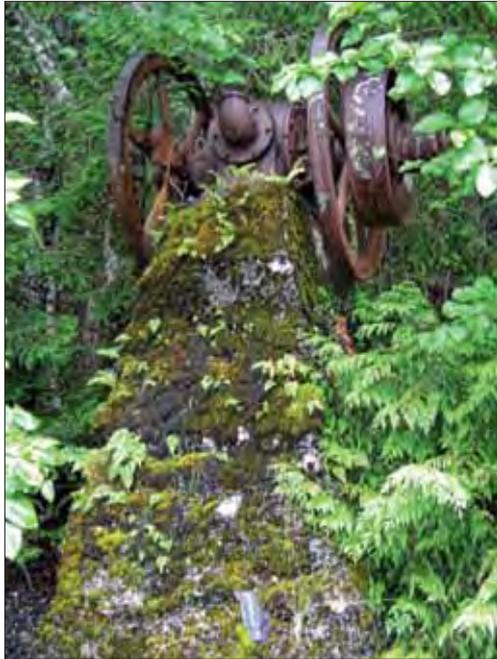
Figure 196.

The remains of at least three engines were observed at Cannery Point but only one – Feature 14 – is stationary. That feature is a pyramidal concrete pedestal surmounted by a large engine oriented so the drive belt would have run perpendicular to shore (Figure 196). The feature (a survivor of

A concrete pedestal at the high tide line supports a large engine (Feature 14) – another survivor of the 1940 fire (Figure 178).

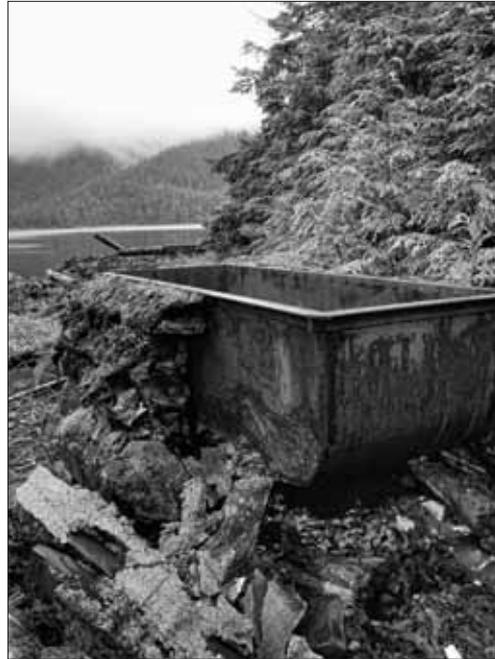
Figure 197.

The third stationary feature (Feature 10) is a ferrous vat set in a stone masonry vault at the high tide mark on the very north end of Cannery Point (Figure 182). It measures about 10'x6' by 4½' high, and the masonry at the north end has a cavity containing charcoal and reddened rock (Figure 197). Globes of nearby tar suggest the vat was used to heat and liquefy tar so that fishing nets could be dipped into it, to preserve the cotton web. Boxes for dipping seine nets into heated tar were a typical feature at early canneries (Mobley 1999:62-63), though Richard Stokes – who worked at the Burnett Inlet cannery before the 1940 fire, insisted the seiners didn't tar their nets to preserve them but instead hosed them with “blue stone” (copper sulfite).

At the north end of Cannery Point is a metal vat encased in rock masonry, probably to dip seine nets in hot tar to preserve them.
