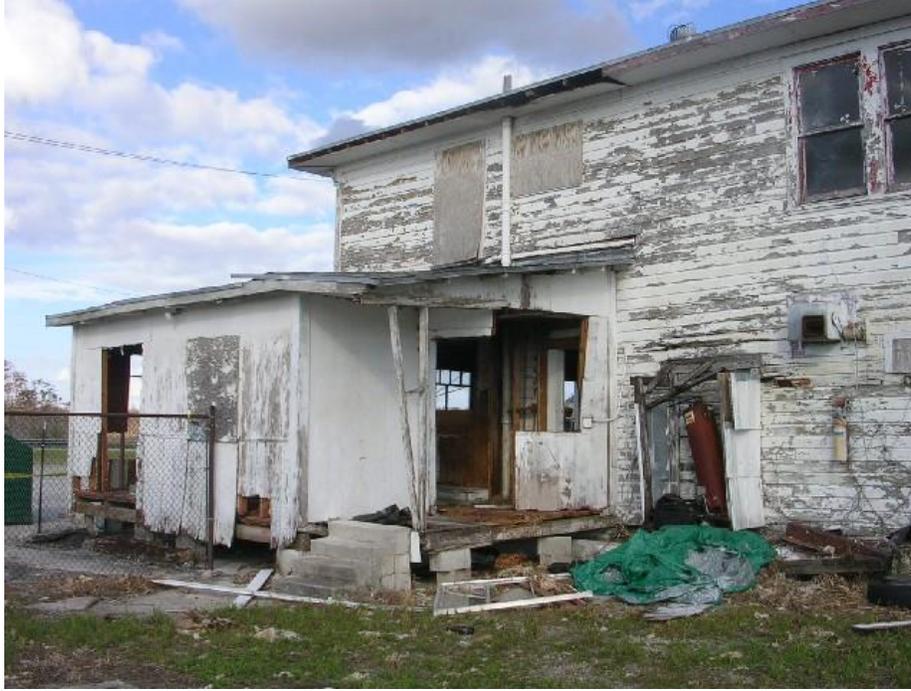
Photo 1: The south and west elevations of the west shed addition. Much of the building fabric was in an advanced state of deterioration prior to the hurricane.

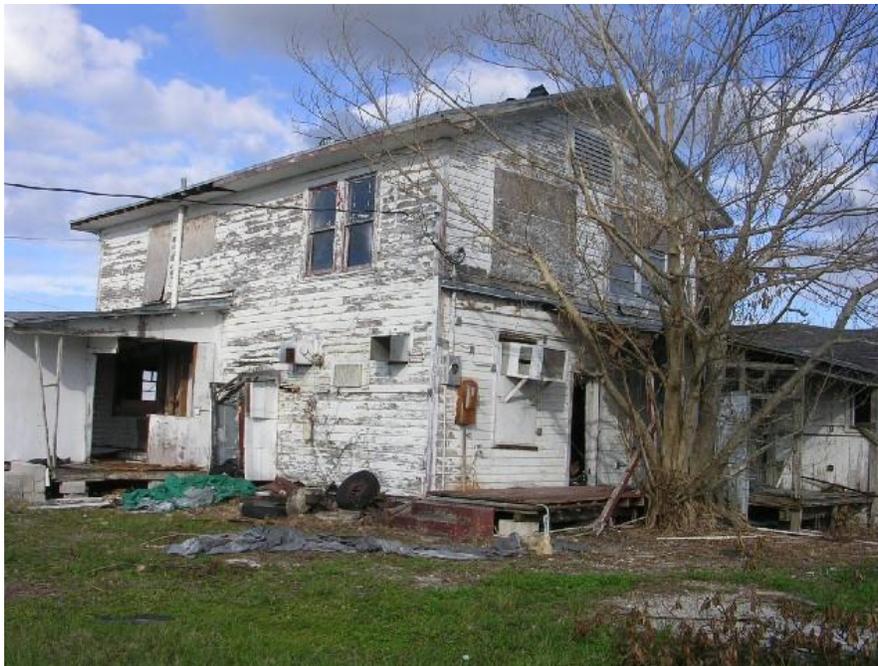
Photo 2: The south and west elevations of the Historic Addition. All of this structure from the stack vent between the two plywood covered windows back, probably dates to c.1957 when the Station was moved.

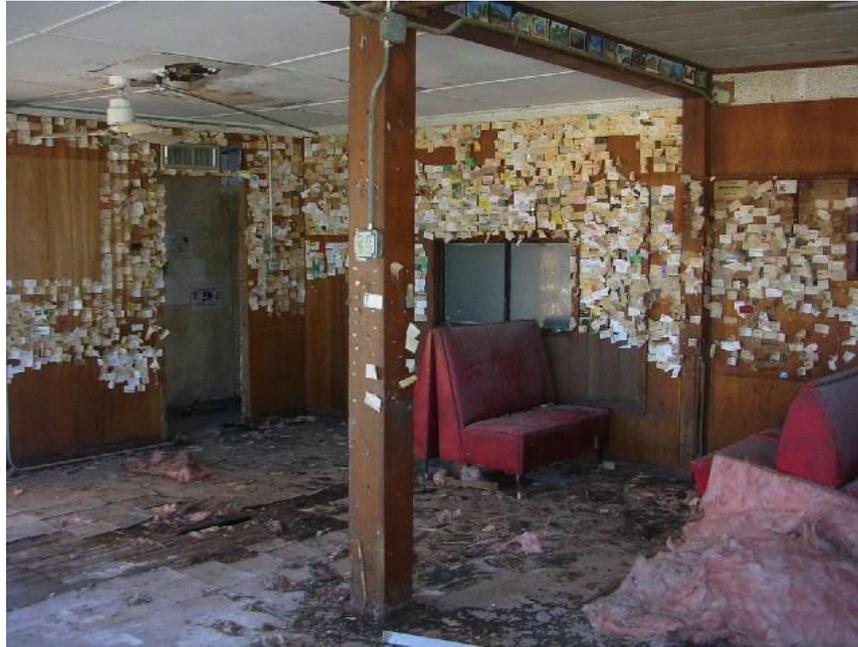
Photo 3: Interior view of the Historic Addition, looking southeast, taken from within the footprint of the Original Structure. The post in the center of the picture indicates the southeast corner of the footprint of the Original Structure. Note the hundreds of business cards stapled to the press-board paneling from former patrons.

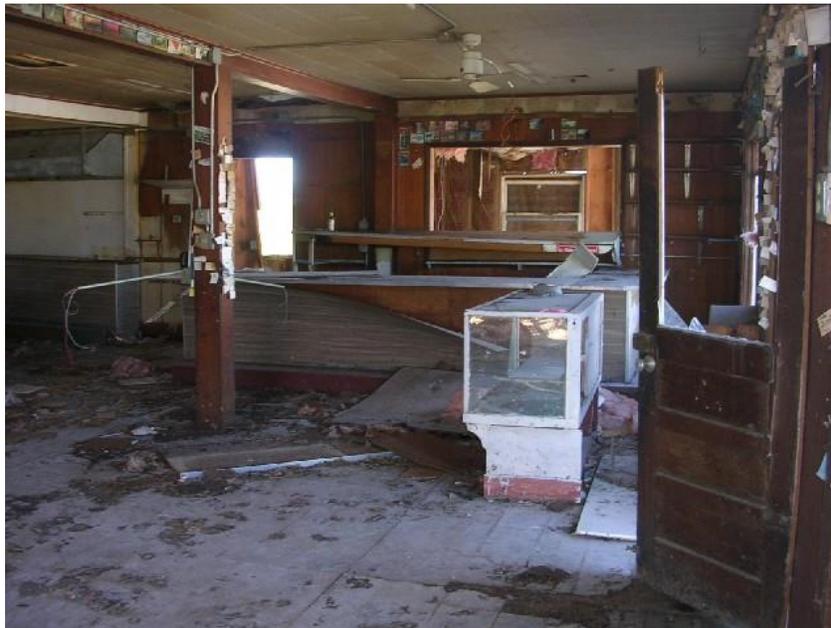
Photo 4: Interior view of the Historic Addition, looking west. The post and beam on the left delineate what would have been the south wall of the Original Structure. Note the modern front door is missing the top rail due in part to termite damage.

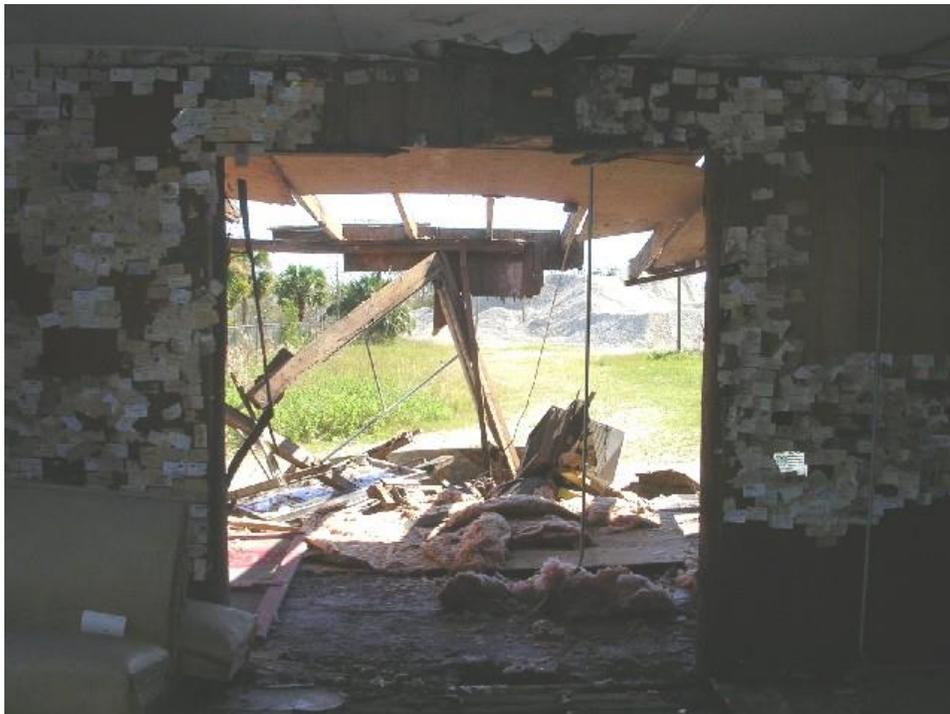
Photo 6: This doorway led from the Historic Addition to the east shed addition. A leaky roof led to the total deterioration of the header which also resulted in the hole in the floor below. The east side of this wall is clad with exterior shiplap siding, indicating that it was, at one time, an exterior wall.

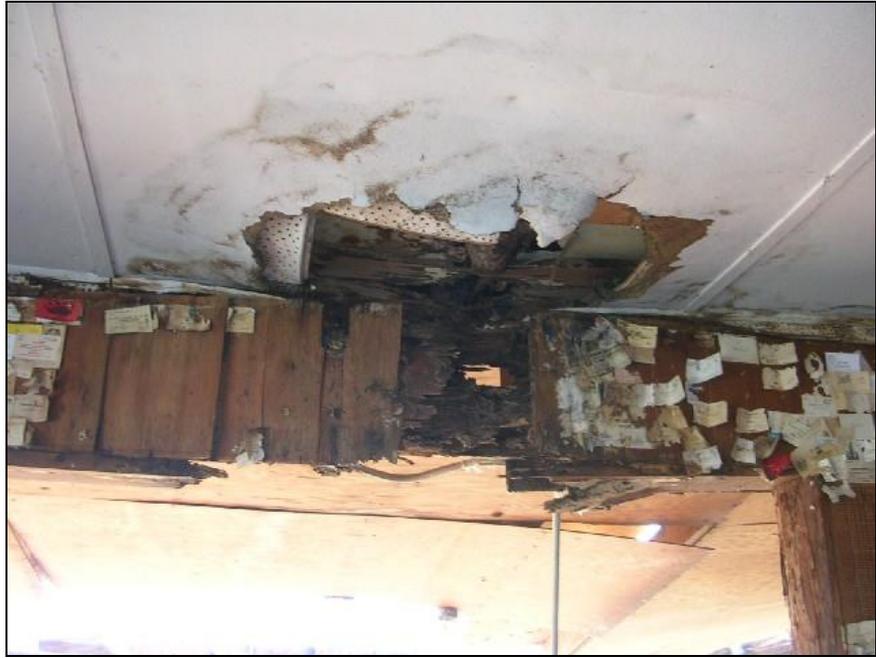
Photo 7: A close-up view of the rotted header shown in Photo 6.

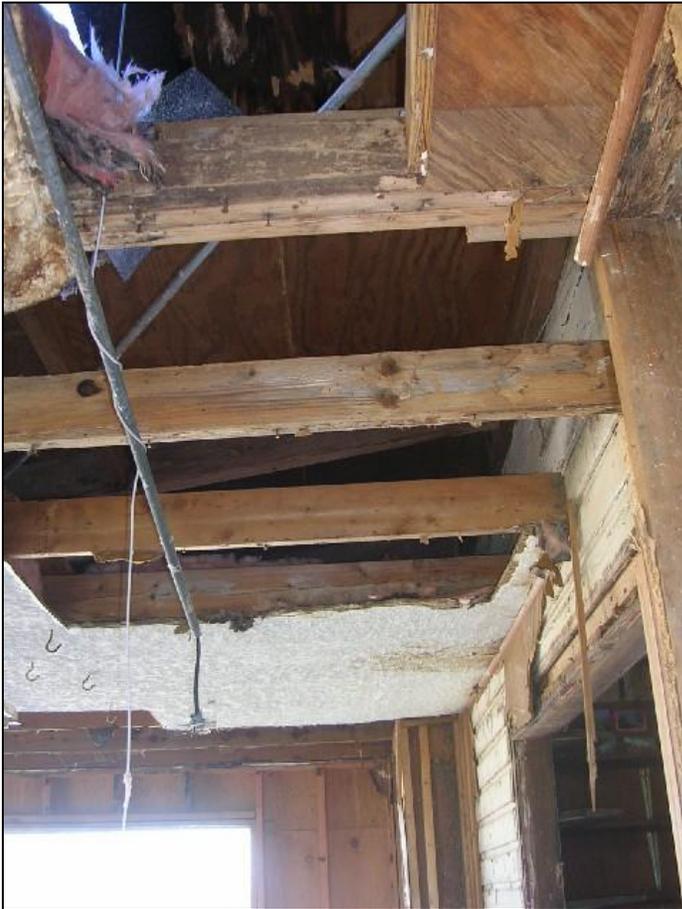
Photo 8: The roof framing for the west addition is toe-nailed to the exterior siding.

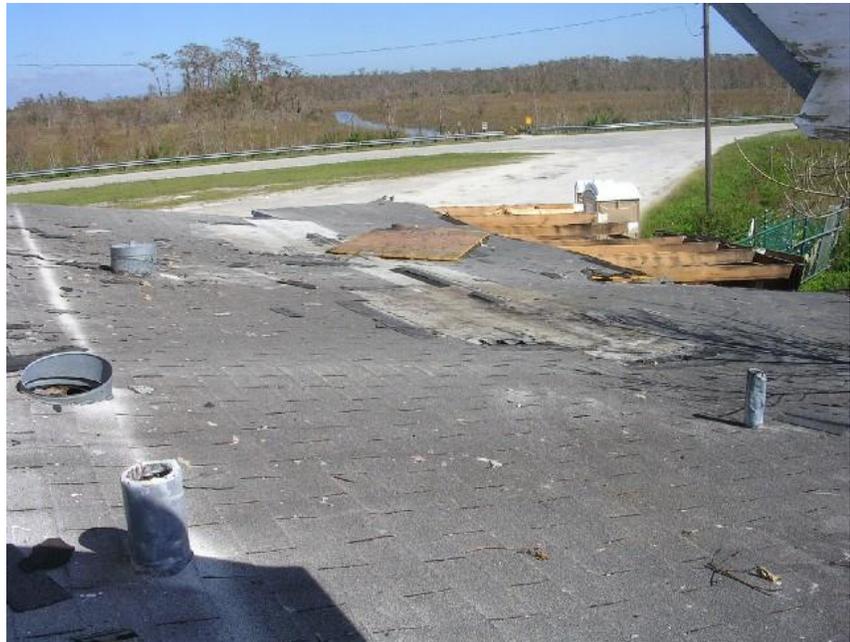
Photo 14: Roof over the east shed additions looking north. Note the roofing that has come off the recent addition. Note also the two vents with no covers.

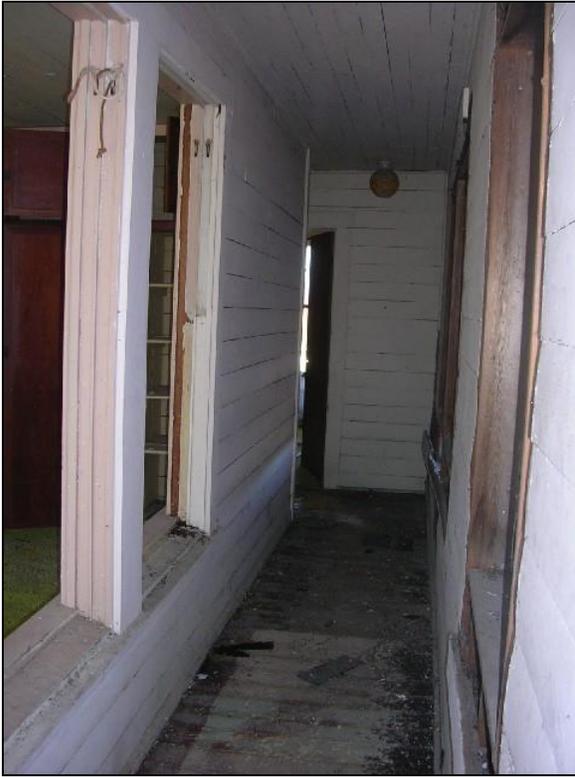
Photo 15: Hallway leading from the second floor stair landing to the second floor of the Original Structure. Note the weighted windows on the left indicating this was an exterior wall.

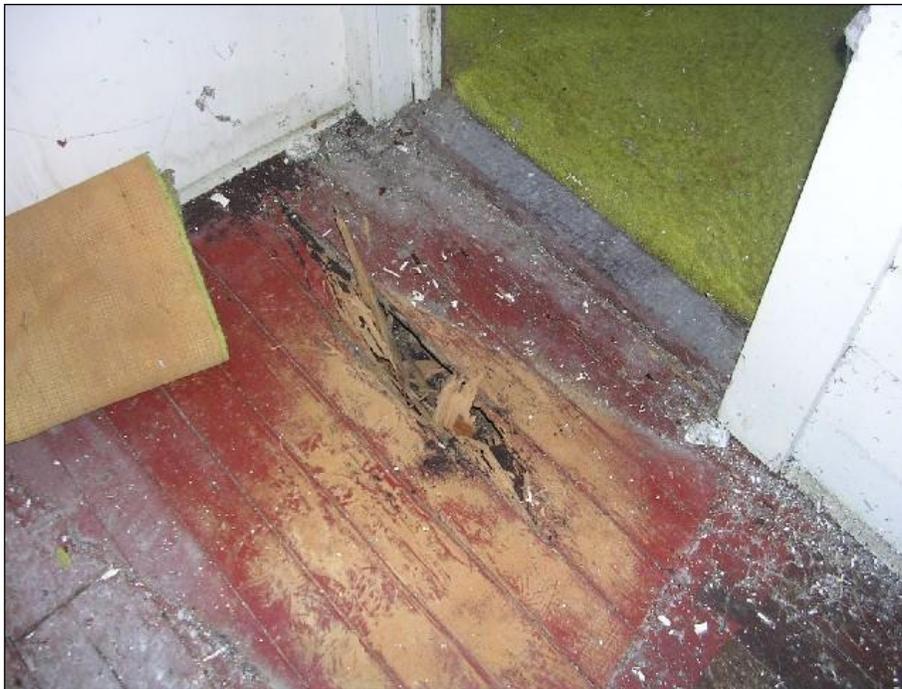
Photo 18: Termite damage in the hallway adjacent to the upper room of the Original Structure

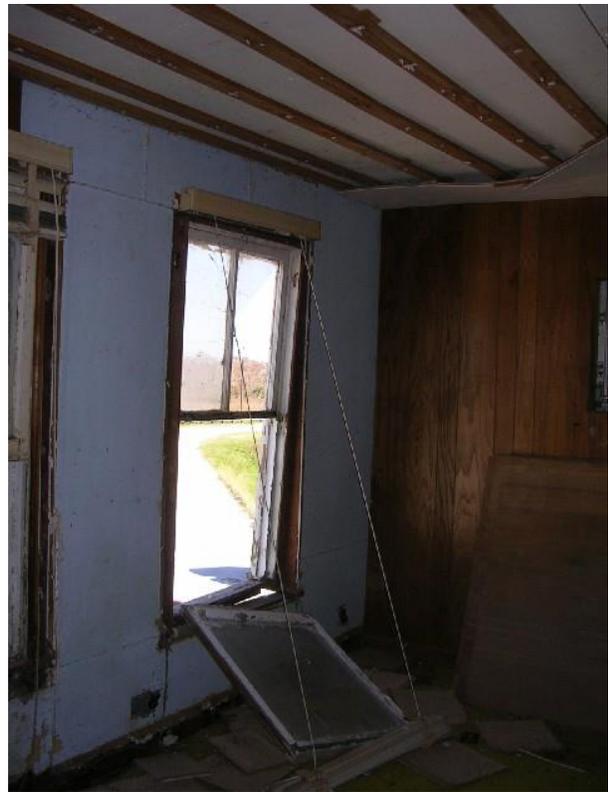
Photo 20: Northeast window of the Original Structure. Note how the jamb was pushed out of the frame.

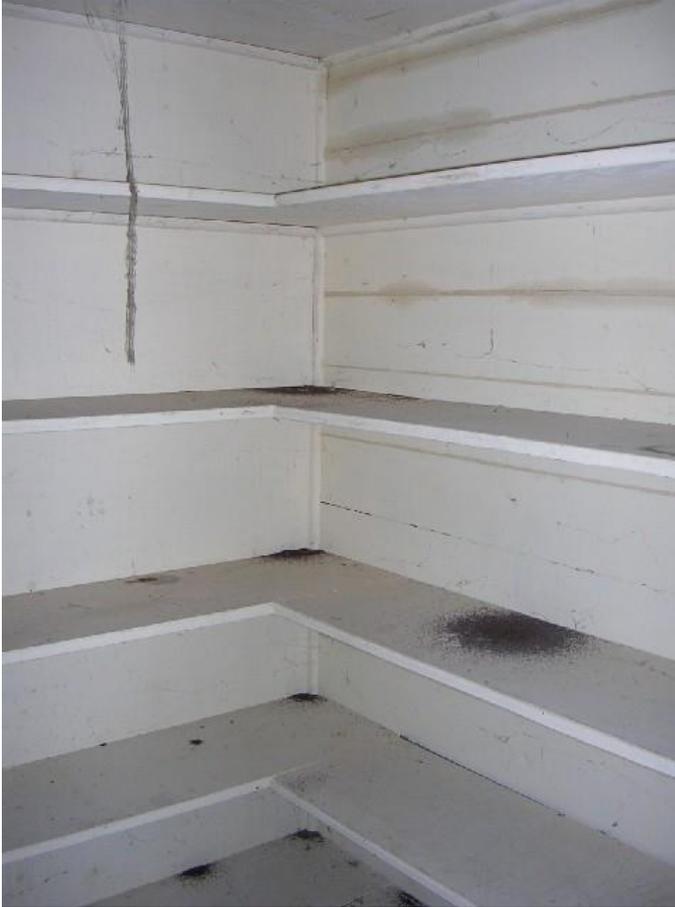
Photo 23: Interior of the upstairs closet showing evidence of termite infestation.

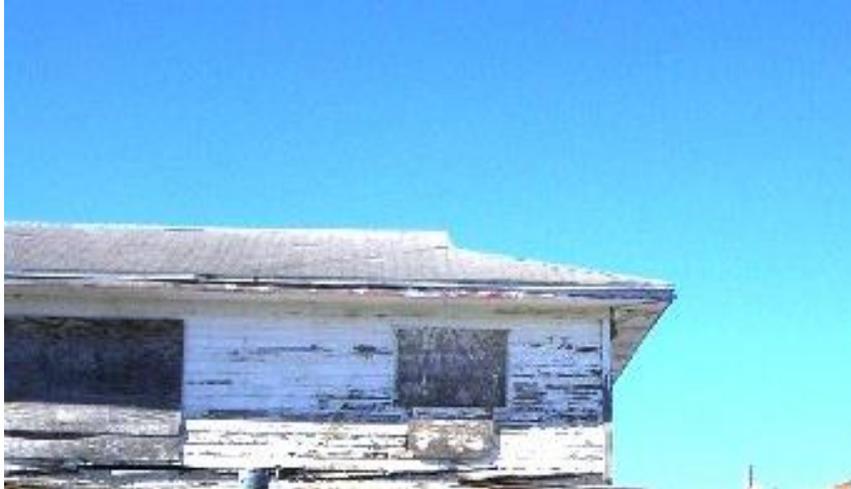
Photo 26: Close up of the east side of the roof. The faint outline of the original roof is visible.

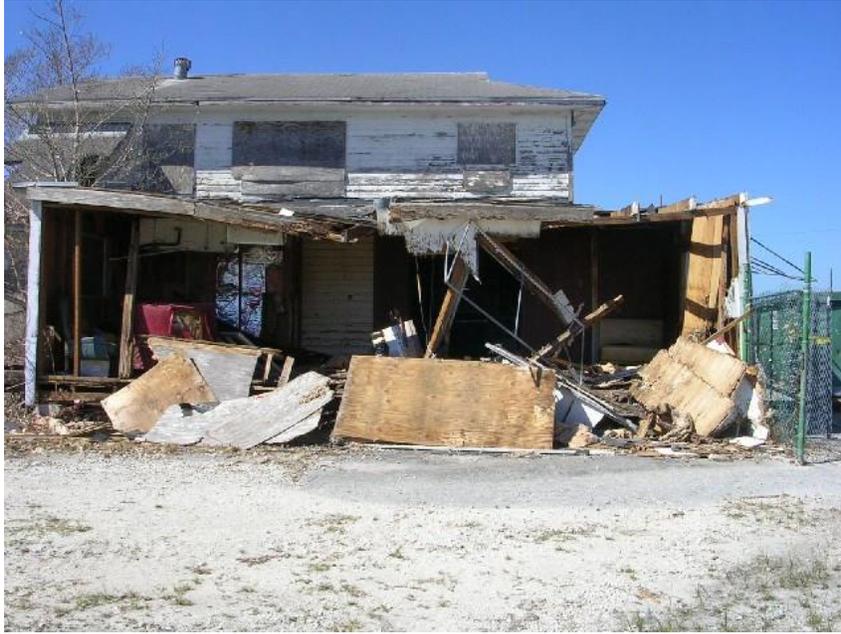
Photo 27: East elevation of the structure showing hurricane damage.

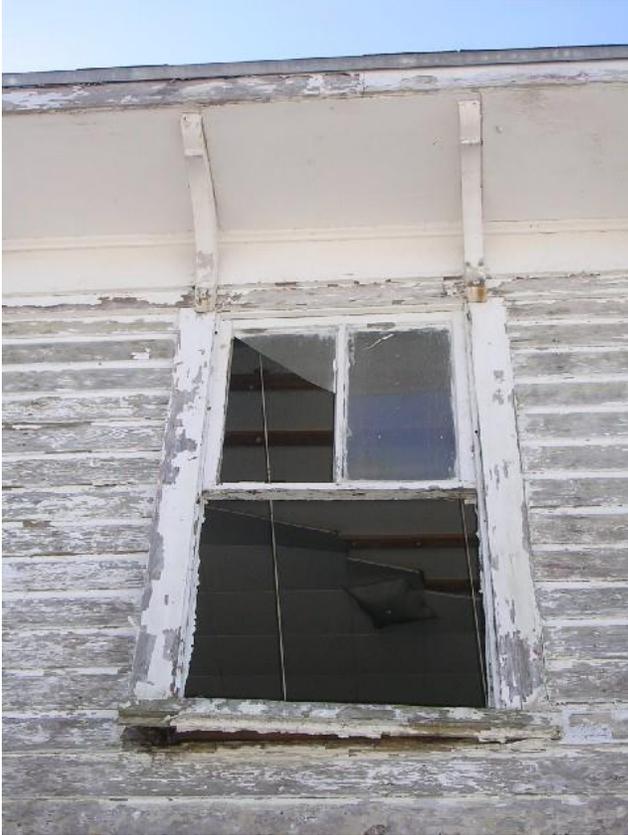
Photo 29: Northeast window showing the window frame pulled away from the rough framing.

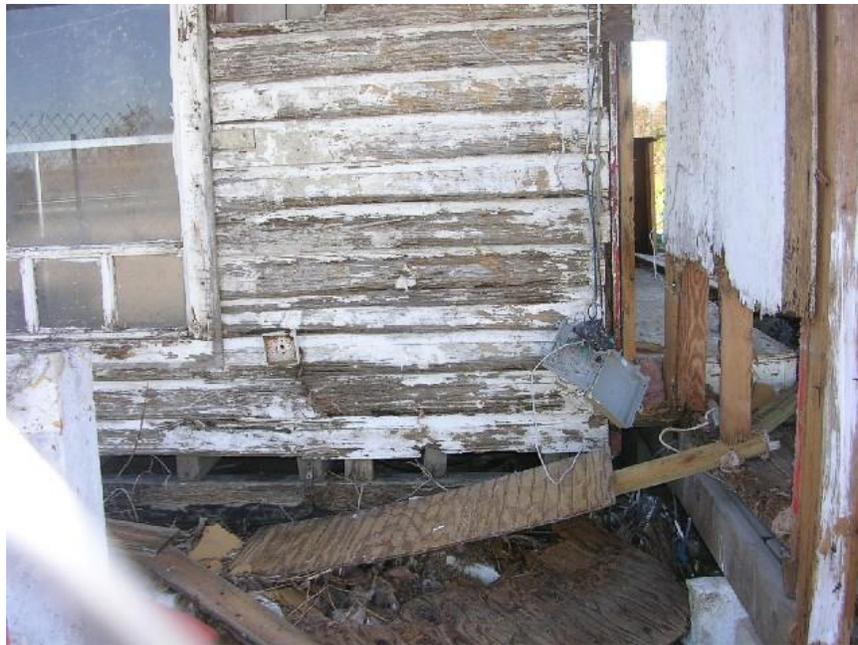
Photo 30: Northwest corner showing damaged siding and accumulated debris.

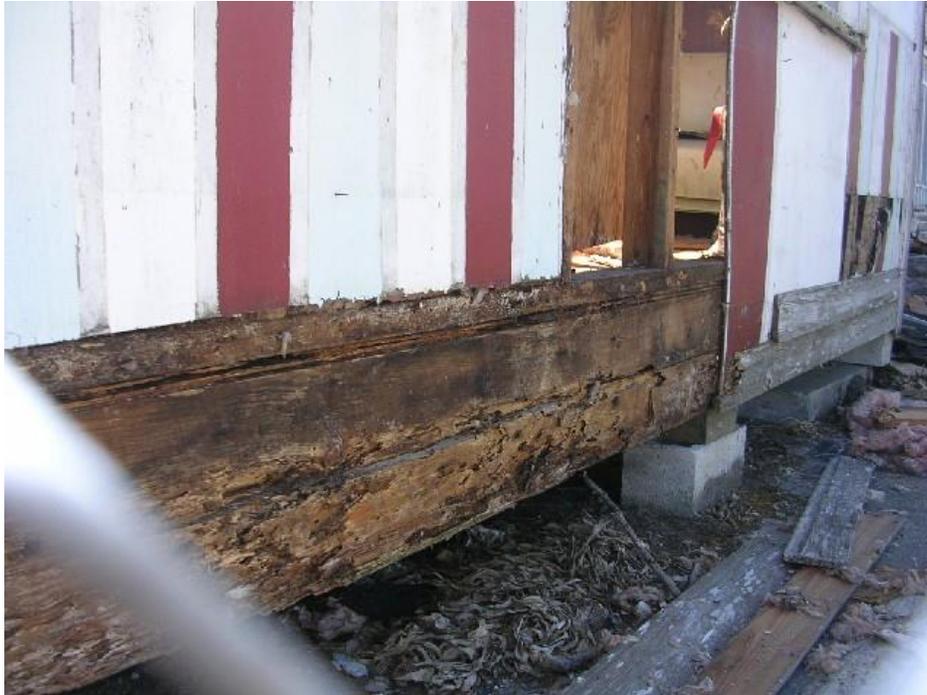
Photo 31: North sill of the east addition showing termite damage.

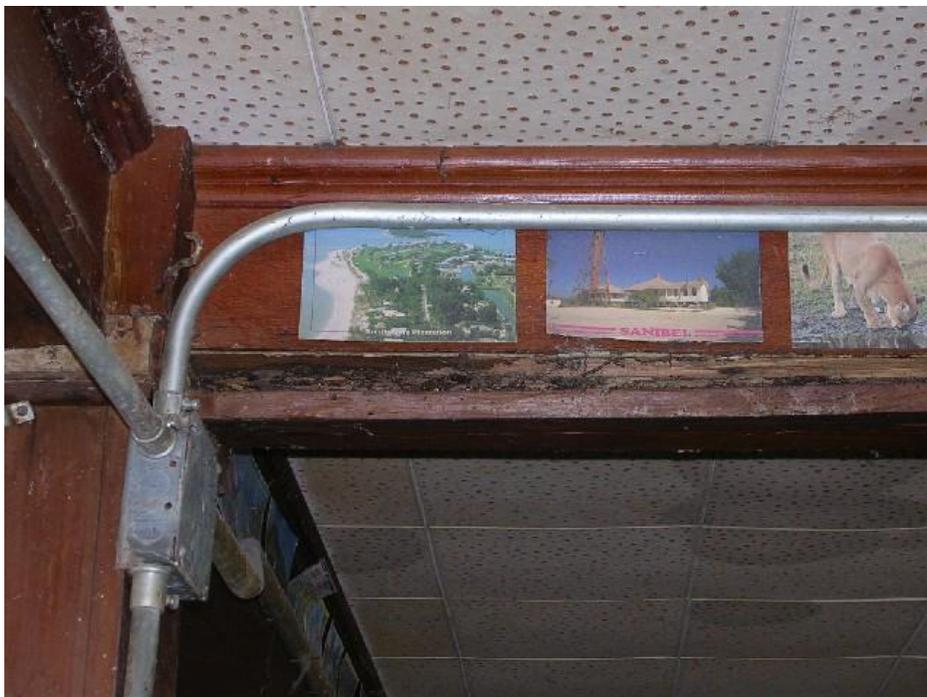
Photo 31: Beam at southeast corner of Original Structure showing termite damage.

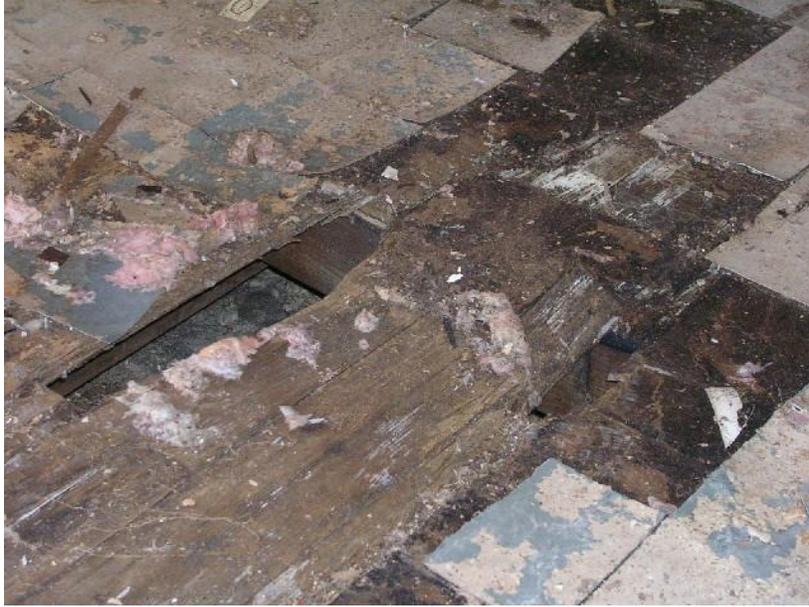
Photo 31: Hole in the floor of the Historic Addition.

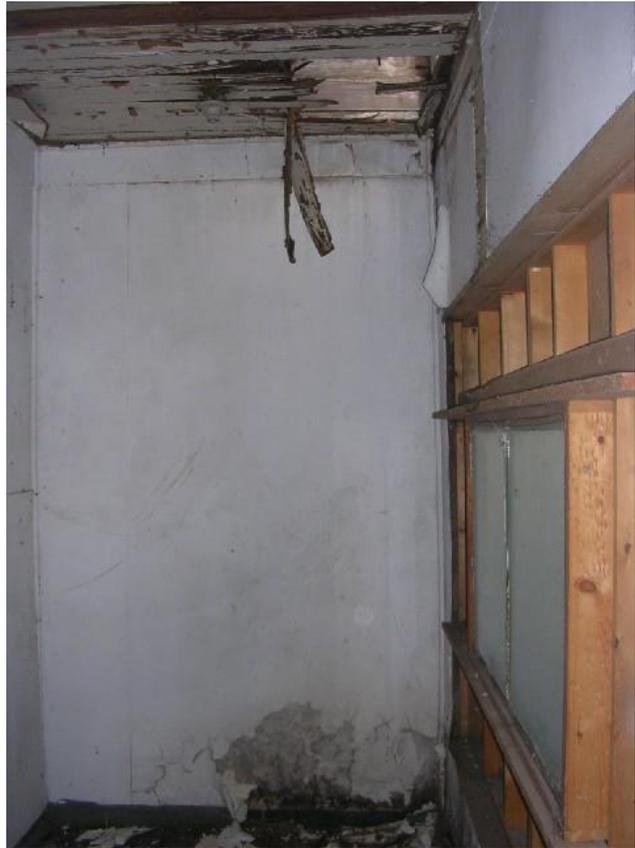
Photo 34: Damaged caused by missing turbine over the Historic Addition.

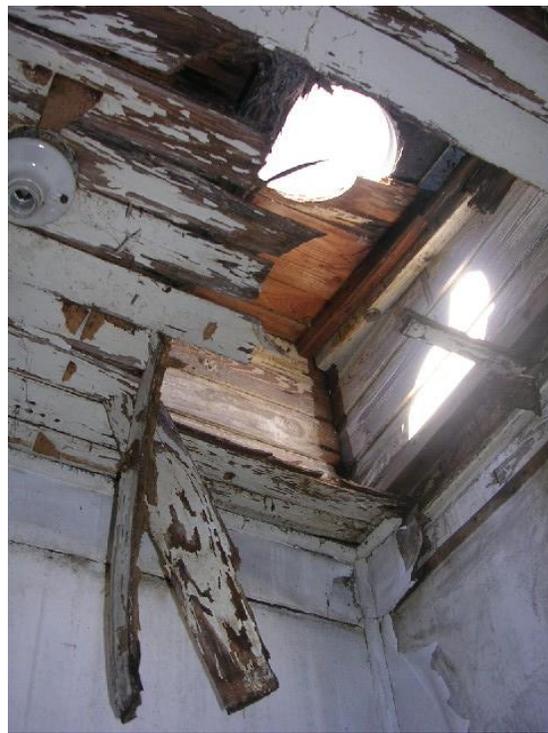
Photo 36: Open vent allowing water infiltration

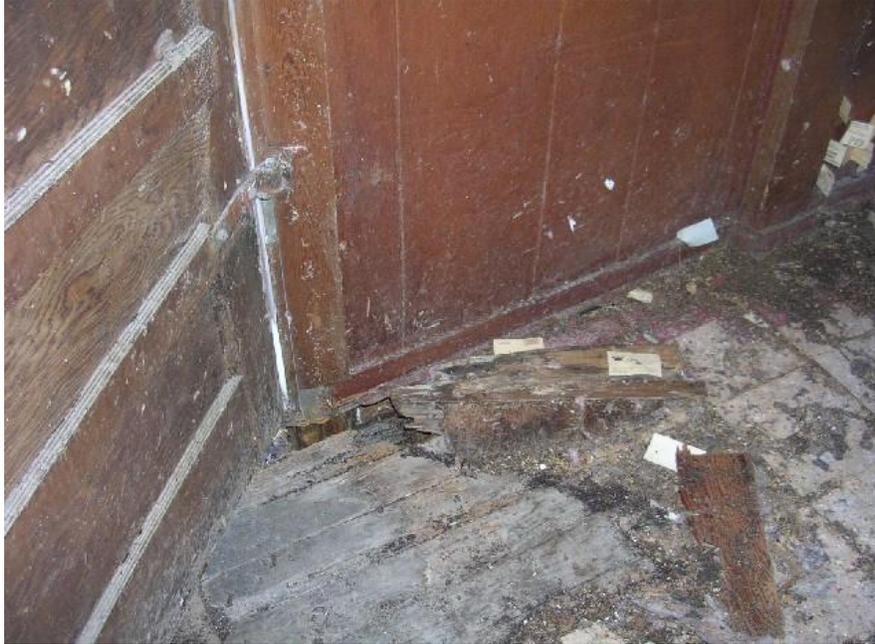
Photo 37: North elevation, adjacent to front door, showing location of hole in the floor, probably from water penetrating around door,

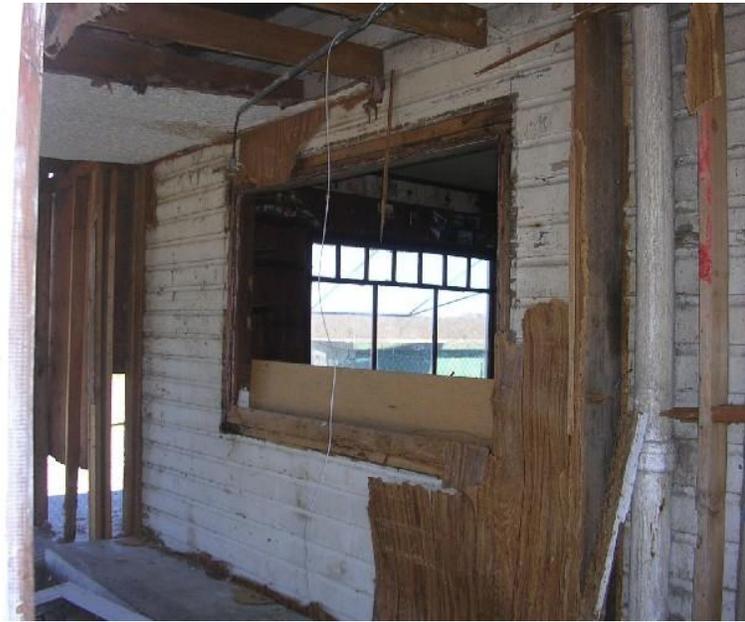
Photo 39: Opening between the Original Structure and the west addition to be covered as part of stabilization.
