**STRUCTURAL ASSESSMENT REPORT
FOR
HISTORIC MONROE STATION STABILIZATION**

**BIG CYPRESS NATIONAL PRESERVE
50910 Tamiami Trail East
Ochopee, FL, 33943**

September 19, 2008

BICY Contract No. C5120085452

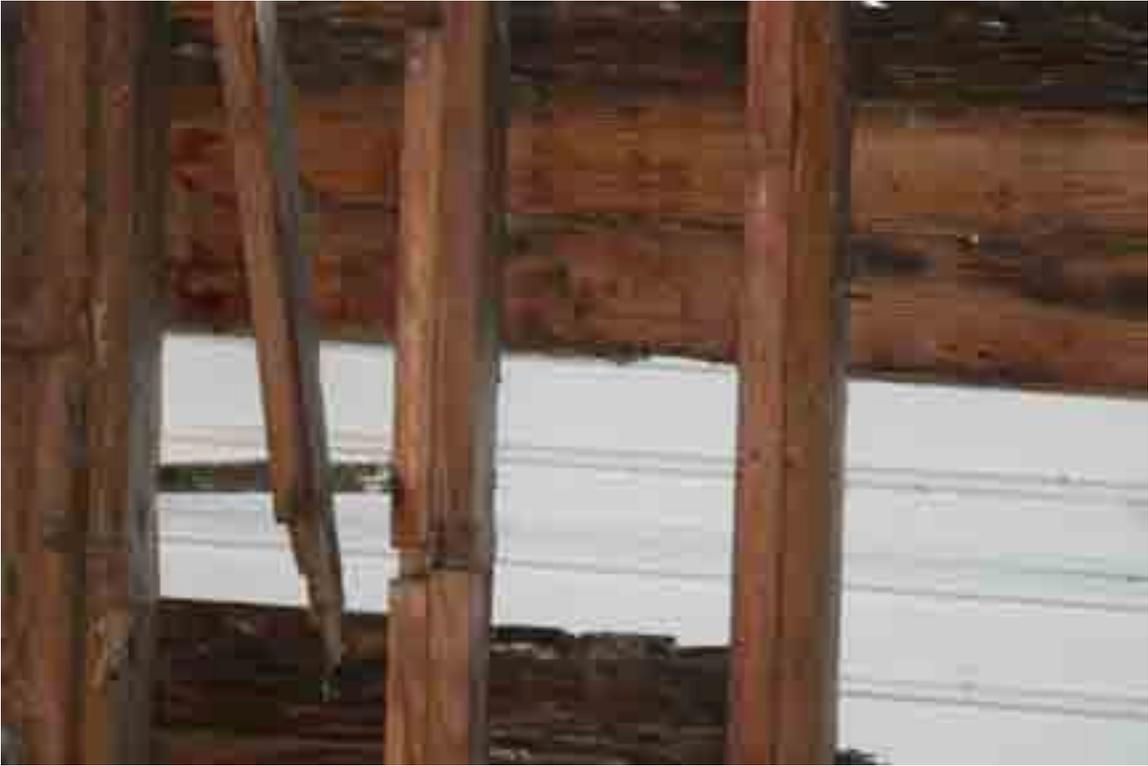
PHOTOGRAPH NO. A1

- 1) As previously stated, the rear, one-story area of the original construction was completely removed. Also, the east and south walls of the main area were also completely removed (replaced by wood columns) (Refer to Photographs No.'s A18 through A21). Therefore, the only remaining walls are the north and west walls of the main area. Unfortunately, almost all of the remaining original studs are significantly deteriorated and/or have been cut or notched to accommodate later construction (Refer to Photographs No.'s A1 through A14, A22, A23, A25 through A28, A34 and A35).

- 2) Unfortunately, almost all of the historical wall siding from the original first floor has been removed or is severely deteriorated (Refer to Photographs No.'s A1 through A9, A11 through A14, A22, A25 through A28, A34, A35, A85 through A87 and A90 through A96). It is possible that some of the historical wood siding which was removed (from removal of the east and south walls of the main portion and from the removal of the rear, one-story area) was re-used in the later additions. Further investigation would be necessary to determine if this is the case, and if so, if it is in adequate condition for re-use.

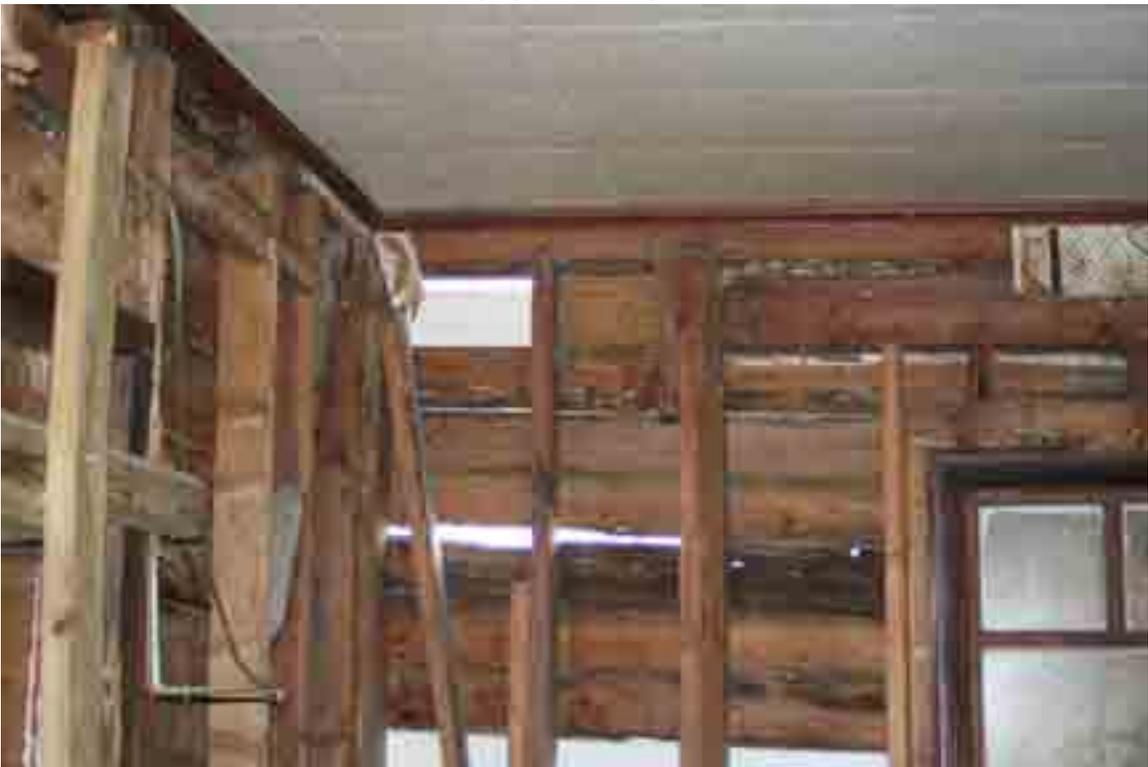
PHOTOGRAPH NO. A2

As previously stated, the original east and south walls of the first floor were removed and replaced with wood columns and beams. There have also been several changes to wall openings (a consequently to the original wall studs) in the front (north) and west walls of the original construction (Refer to Photographs No.'s A2 through A12, A14, A20, A25 and A26 through A28).

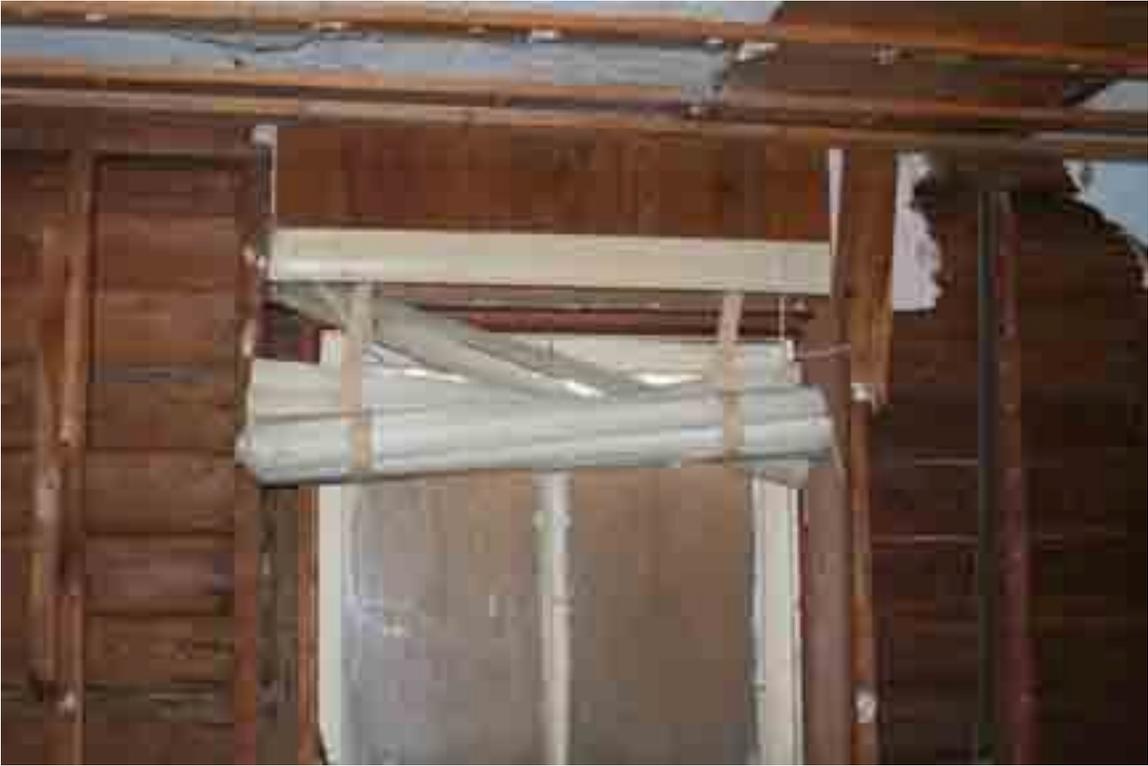
PHOTOGRAPH NO. A54

- 1) Most of the original studs in the original exterior walls on the second floor remain in place, and most of these are largely in serviceable condition (Refer to Photographs No.'s A48 through A84). Some studs have been previously cut to modify wall openings (Refer to Photographs No.'s A65, A68, and A71 through A73).
- 2) The second floor wall studs are not, however, adequately sized and spaced to meet current Building Code requirements, and it will be necessary to add many more studs all around. This is required to resist direct wind pressures perpendicular to the walls and to resist tension and compression forces due to the need for the walls to act as shearwalls to transfer lateral wind loads to the horizontal diaphragms and to the ground.

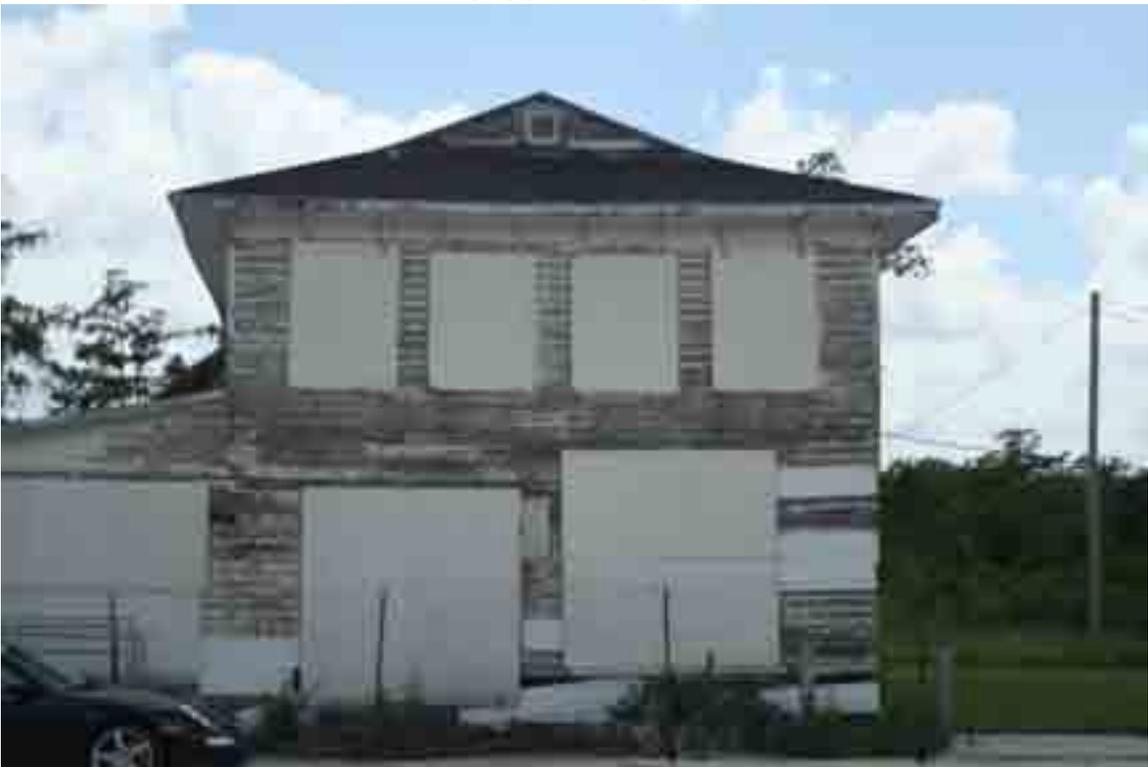
PHOTOGRAPH NO. A95

remove them, and they are not included in this investigation (Refer to Photographs No.'s A91 through A96). This investigation is limited to the structural systems which remain extant from the original construction. The rear one-story section of the original construction and the exterior west side stair no longer exist. The east and south walls of the original construction at the first floor have also been previously removed and replaced with wood columns along the former south wall and wood beams below the second floor along the former east and south walls.
