EXISTING INTERIOR APPEARANCE

Keeper's Dwelling

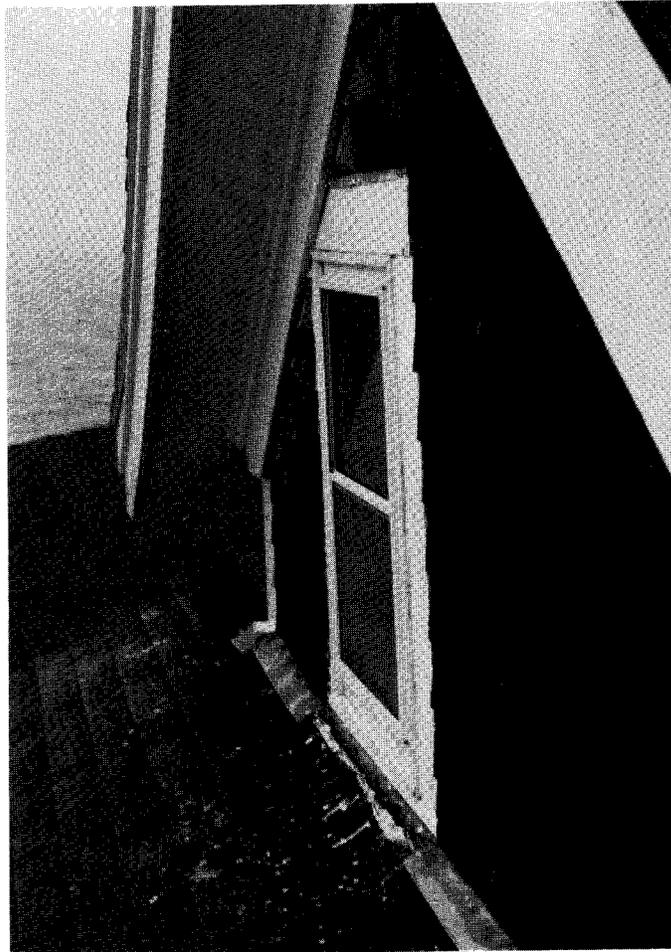
- The lead flashing below the ell window has failed, partly due to improper patching (fig. 120). The metal flashing is trough-shaped and has several holes, which collects water and allows it to penetrate to the interior of the roof structure. This has presumably caused the staining and attendant dark mold on the ceiling of the north vestibule below the window.
- An open joint between the gable end trim where it passes over the ell window's head trim may be admitting moisture.

Figure 120. Keeper's Dwelling ell, deteriorated flashing at north elevation.

- Replace all failed flashing.
- Seal the open joint between the gable end trim and the north window's head trim.

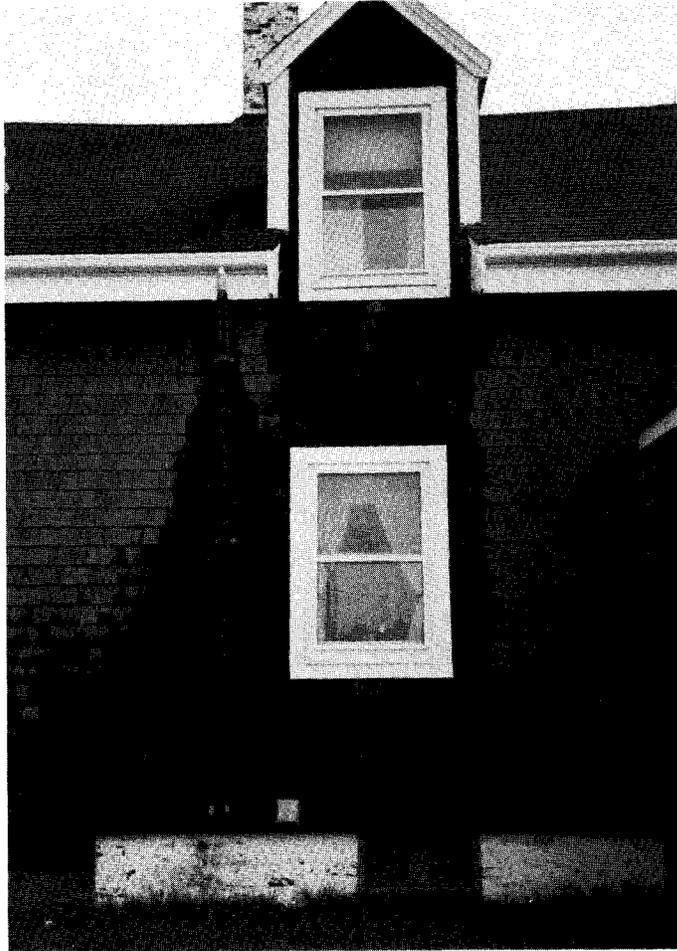
- The corner board and wood siding at the northwest corner appear to have been chewed by an animal.
- The basement window sills are deteriorated.
- Due to the lack of a downspout at the north section of the gutter, water is soaking a large portion of the wood siding below the gutter (fig. 124).

Figure 124. Keeper's Dwelling, water staining at west elevation.

- Install leaders, downspouts, elbows, and splash blocks.
- Properly treat the end grain of all wood trim likely to absorb moisture.
- Paint the posts and latticework at the base of the porch to match the house foundation.
- Verify the structural integrity of the porch's support structure.
- Repair and replace the wood trim of the porch columns to match its circa-1930's appearance in profile and dimension.
- Relocate steps from the north elevation to the west elevation to match the circa-1930's appearance.

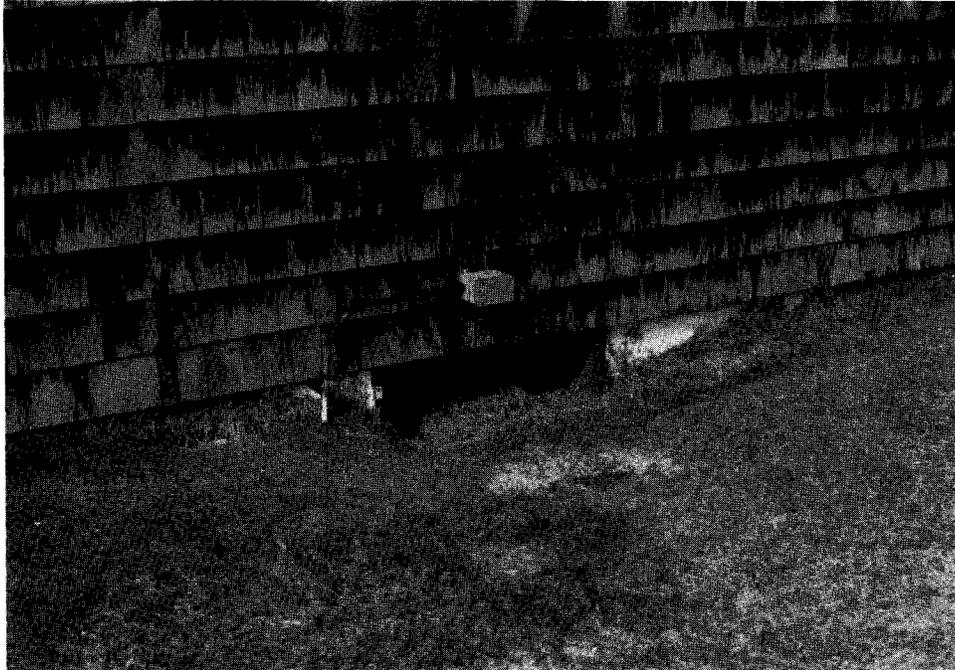
- All downspouts are missing.
- The grade is built up against the bottom of the wood siding and over the sill of the basement window (figs. 125 and 126).
- The sill of the entry door drops at the east end.
- There is damaged/deteriorated wood trim at the edge of the entry roof.
- The step flashing is improperly installed over the asphalt roof shingles at the entry.

Figure 125. Keeper's Dwelling, built-up grade against wood siding at east elevation.

- Install leaders, downspouts, elbows, and splash blocks at both gutter sections.
- Verify the condition of the flashing at the termination of the built-in gutters.
- Scrape and paint the metal vent stack.
- Regrade surrounding soil to a minimum of 6 inches below the bottom of the wood siding, where possible, sloping away from the building.
- Regrade soil to a level below the basement window sill.
- Install a proper scupper at the valley of the interconnected dormer roofs.
- Reset the sill of the entry door sill in a level condition.
- Replace all step flashing.
- Repair/replace deteriorated wood trim.

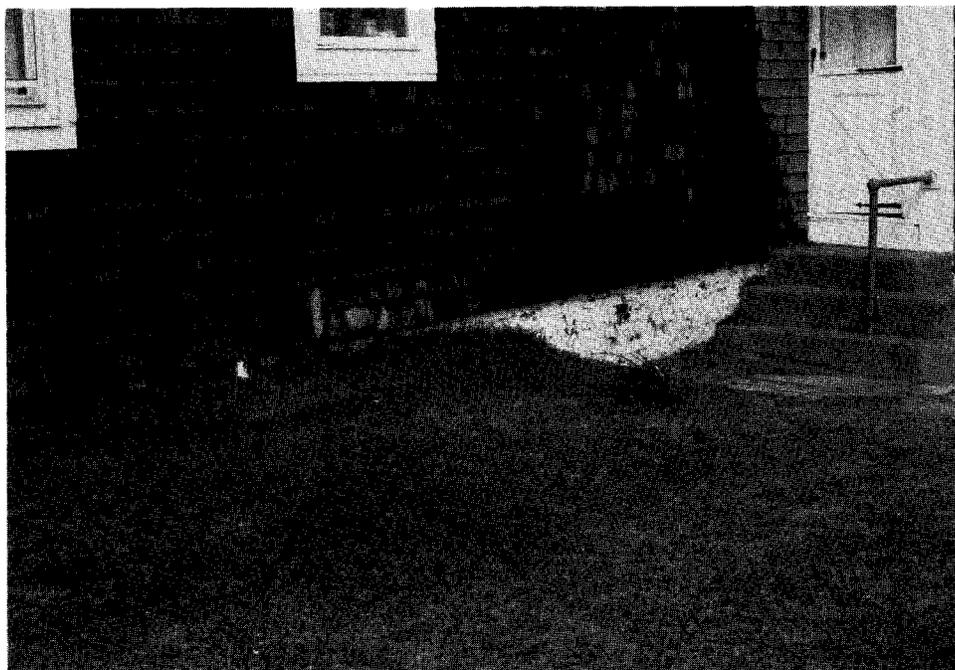
Figure 126. Keeper's Dwelling, built-up grade against wood siding of east elevation.

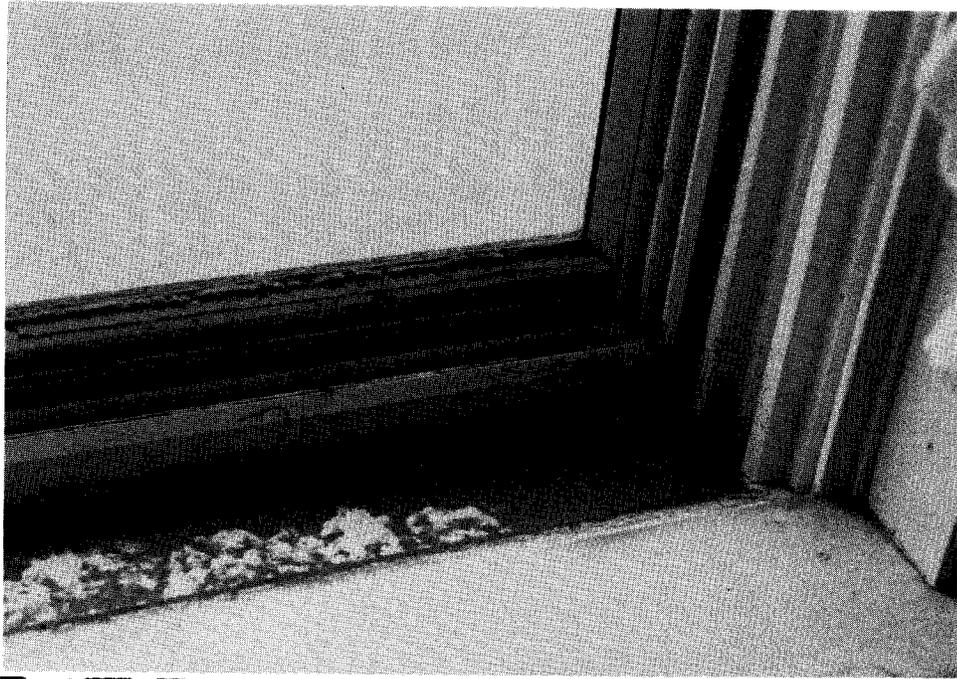
The interior wall and ceiling surfaces of the Keeper's Dwelling are contemporary and in good condition. Sand is being windblown around the window frames on all elevations, occasionally creating a damming effect at the sill, preventing water to drain out (fig. 127).

Figure 127. Keeper's Dwelling, typical interior window sill with wind-blown sand.

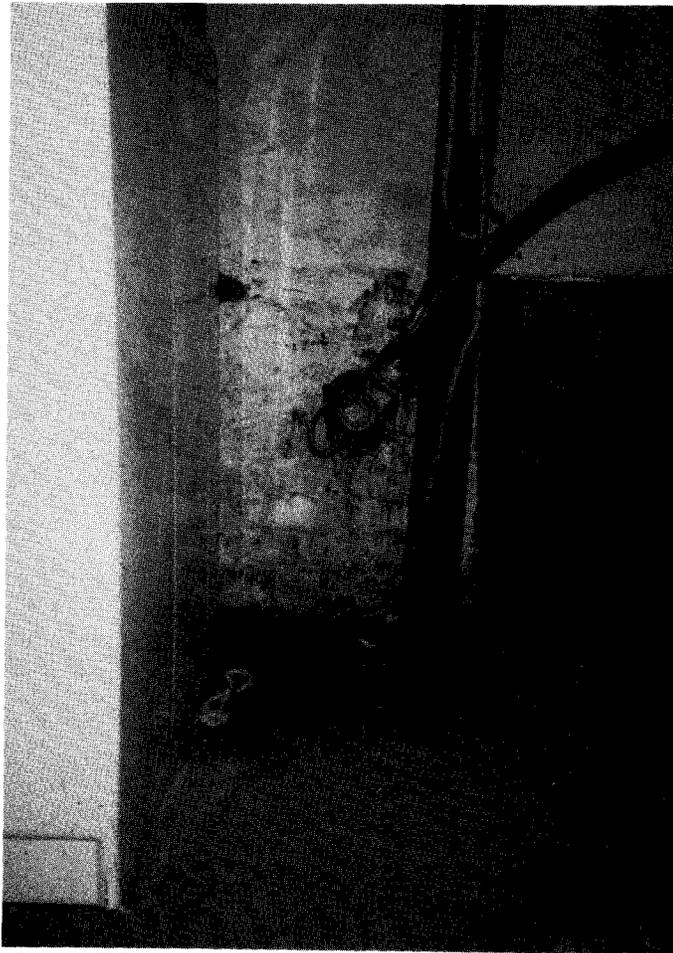
- There is a leak from holes in the corroded metal bulkhead, especially at the juncture of the bulkhead and the wall.
- Water is seeping into the basement approx. 18 inches above the floor, through brick joints behind the sink on the east wall, and ponding at the low point against the cistern wall (figs. 128 and 129).
- Water is also entering from the 4 1/2-inch metal pipe set in the east wall approx. 12 inches above the floor, which contains water supply pipes for the hot-water heater.
- There are eroded mortar joints and separating brick units in the masonry wall at the north side of the west foundation wall (fig. 130).
- Orange staining is running from the chimney flue opening onto the parged chimney surface.
- The wood cellar sashes and frames are deteriorated.

Figure 128. Keeper's Dwelling, water penetration around pipes at east wall of basement.

- Determine the source of the moisture penetration along the east wall.
- Regrade and/or damp-proof the bulkhead retaining walls.
- Install a new bulkhead with proper seal/flashing.
- Rebuild the damaged walls and repoint deteriorated mortar joints.
- Rebuild the cellar sashes with storm panels, and screened panels to ventilate the basement during the summer.

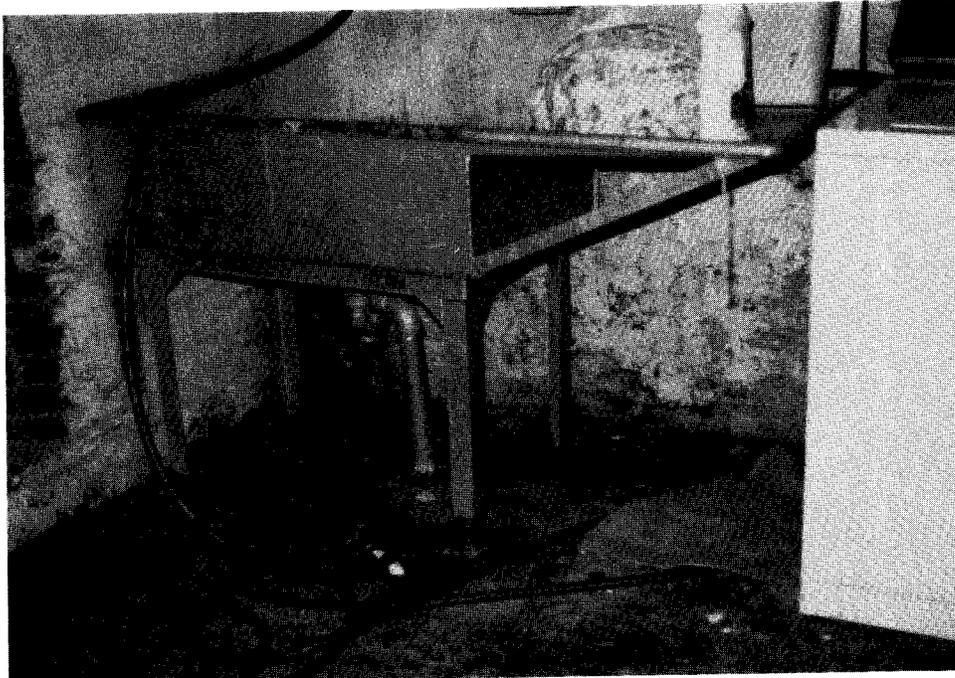
Figure 129. Keeper's Dwelling, ponding of water on floor at east wall of basement.

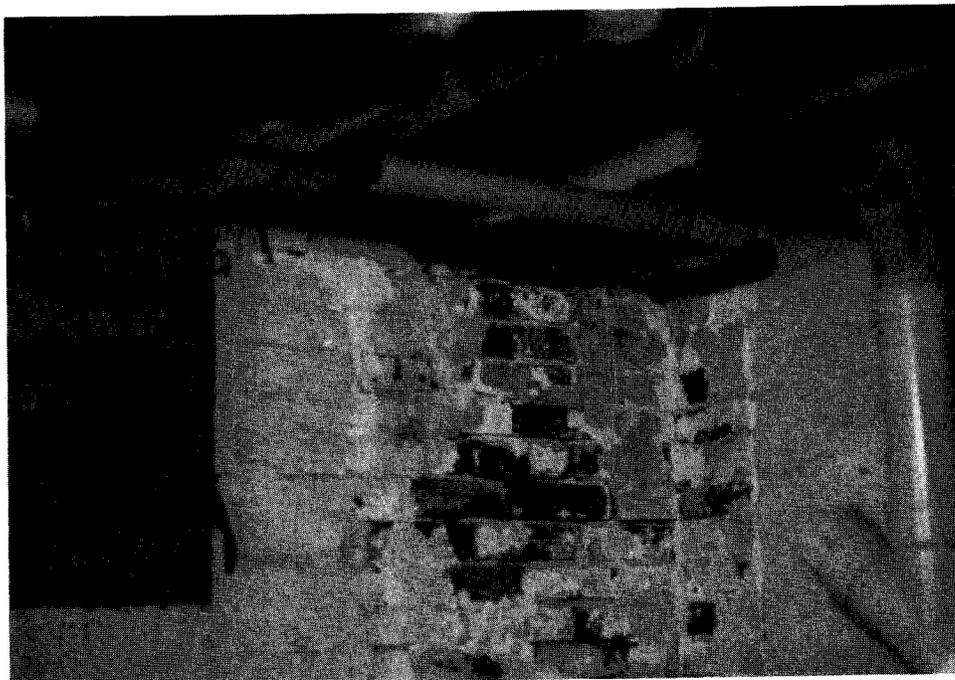
Figure 130. Keeper's Dwelling, masonry cracks at northwest corner of basement.

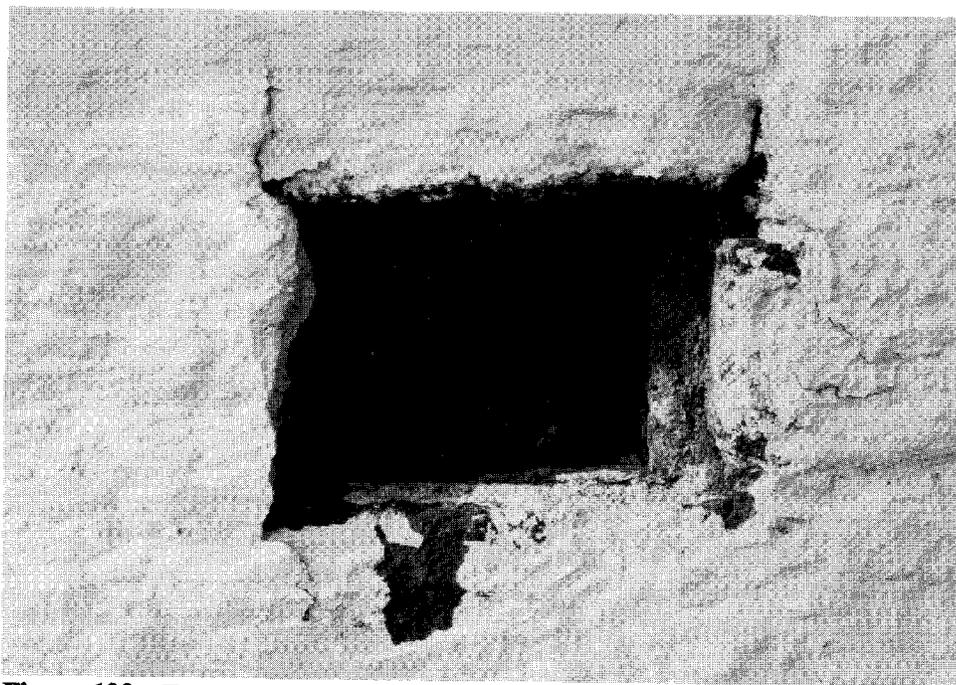
Figure 138. Tower, spalled brick face under west window of south elevation.

- Replace/consolidate spalled bricks and recoat them.
- Provide a more controlled means of ventilation to allow drying out of the interior after periods of high humidity.
- Use of a waterproof coating should be considered only if the problem persists after all other remedial and repair work is completed.

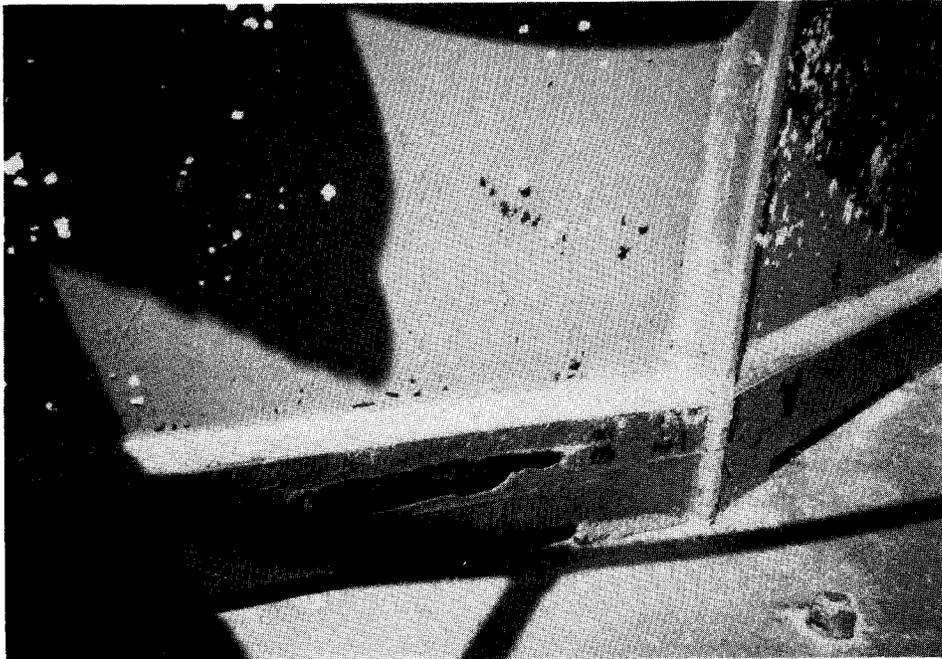
Figure 143. Tower, corroded metal vent cover at base of Lantern.

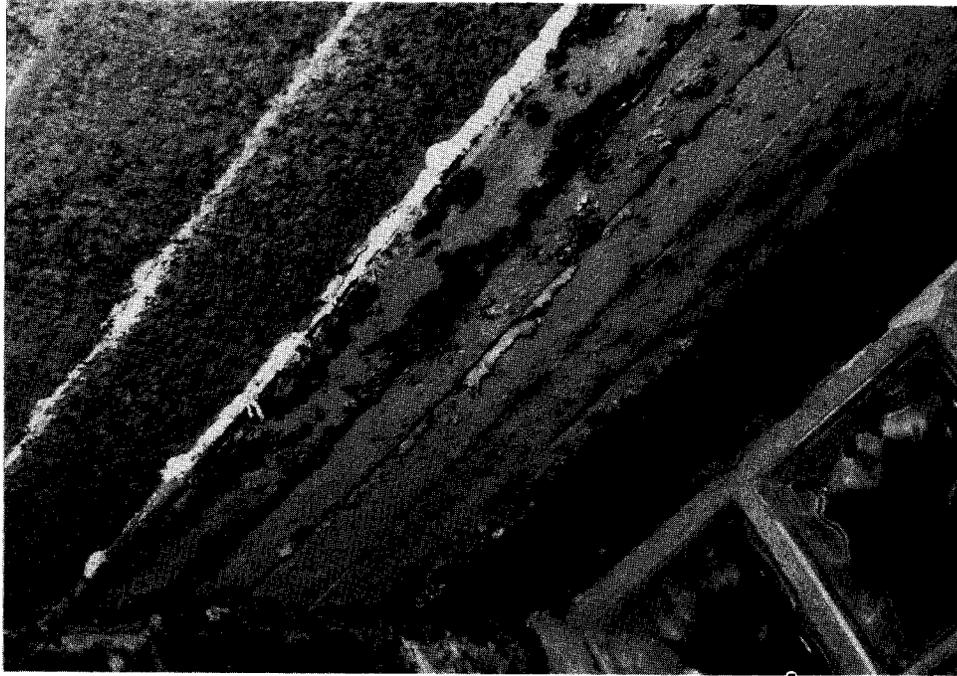
Figure 148. Tower, detail of deteriorated metal lintels of south-wall windows, First Level.

- Apply a damp-proof course at the new Tower foundation during relocation.
- Determine the source of moisture penetration above the windows.
- Replace the deteriorated metal-angle lintel at each window head.

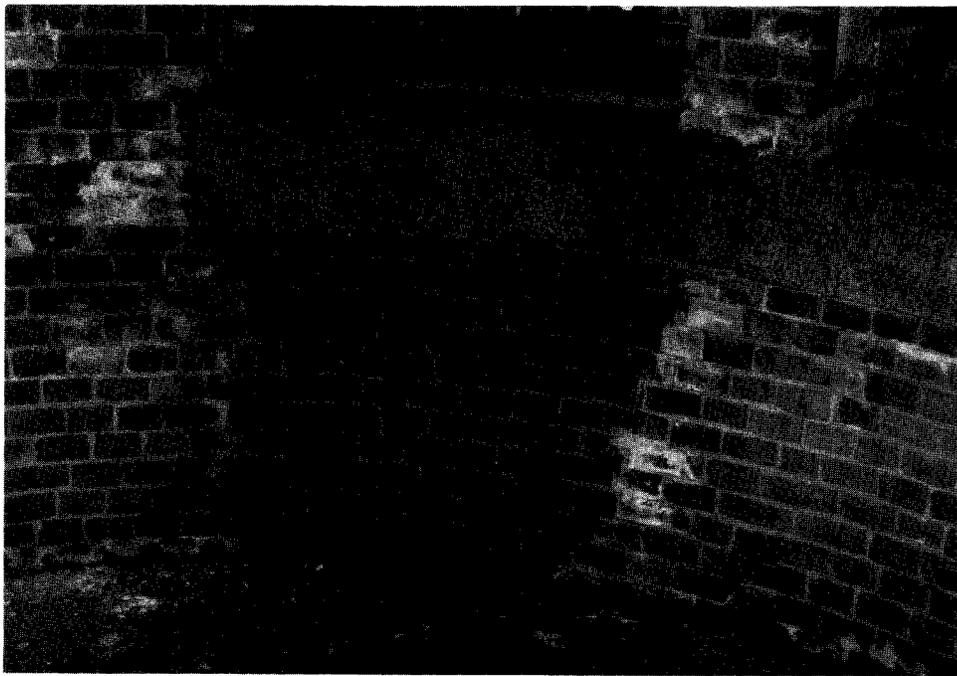
Figure 149. Tower, water saturation below sill of east window in south elevation, First Level.

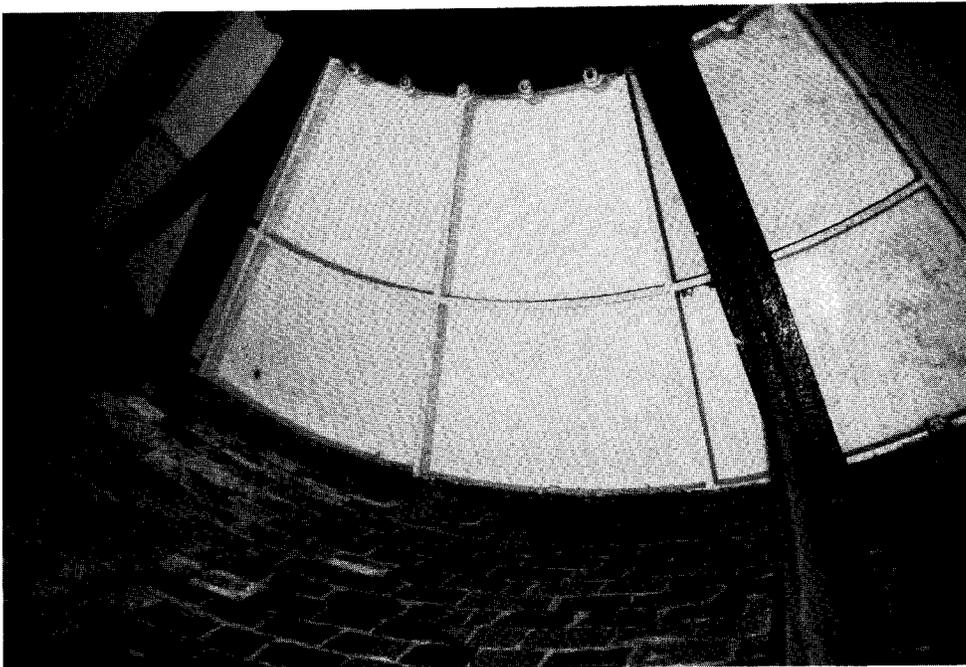
Figure 150. Tower, corroded metal edge at underside of stair landing, east wall of First Level.

- Scrape and paint all surfaces of the metal stairway.

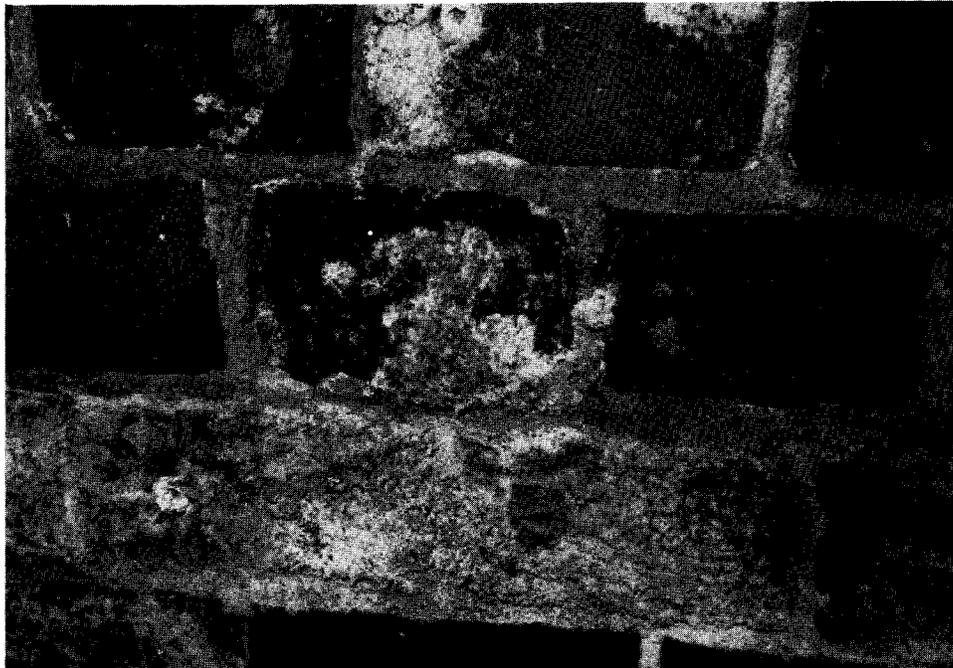
Figure 151. Tower, salt crystals on deteriorated brick faces, east wall of First Level.

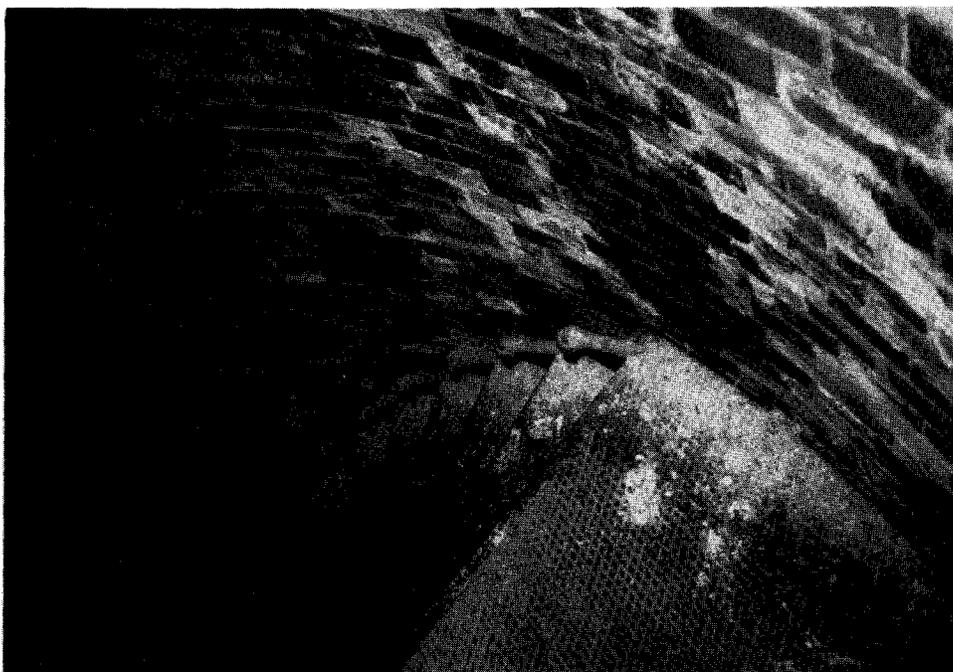
Figure 152. Tower, deposits of salt crystals and brick dust at steps and stair landing, east wall of First Level.

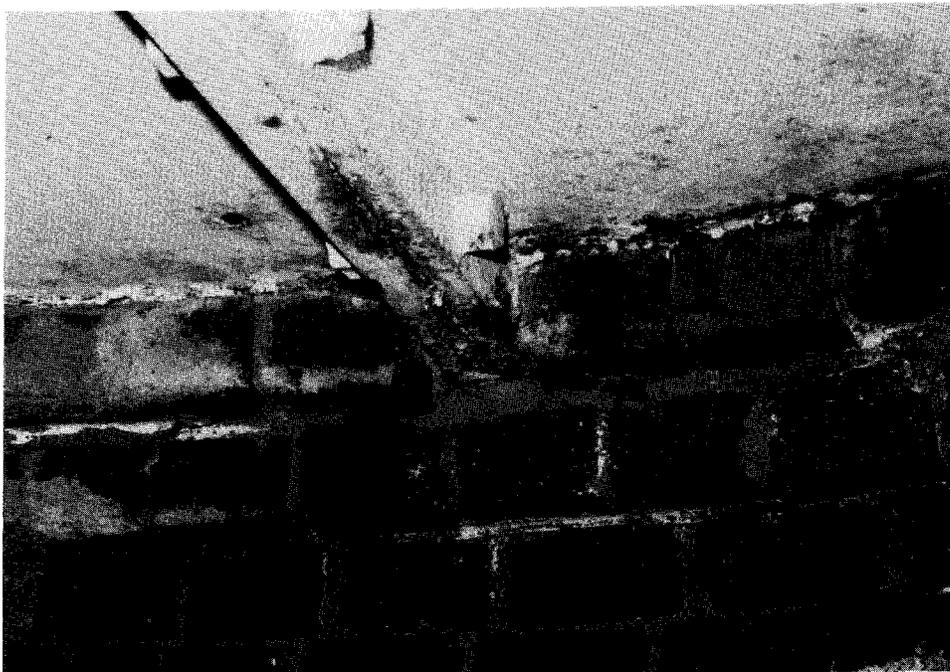
Figure 154. Tower, corrosion at edge of metal deck and flanges of Weight Deck.

- Scrape and paint all corroding metal.
- Repair the diagonal stepped crack in the masonry.
- Determine the source(s) of moisture penetration.
- Treat the ends of the stairway treads where they intersect the brick Tower wall, to provide a moisture barrier.

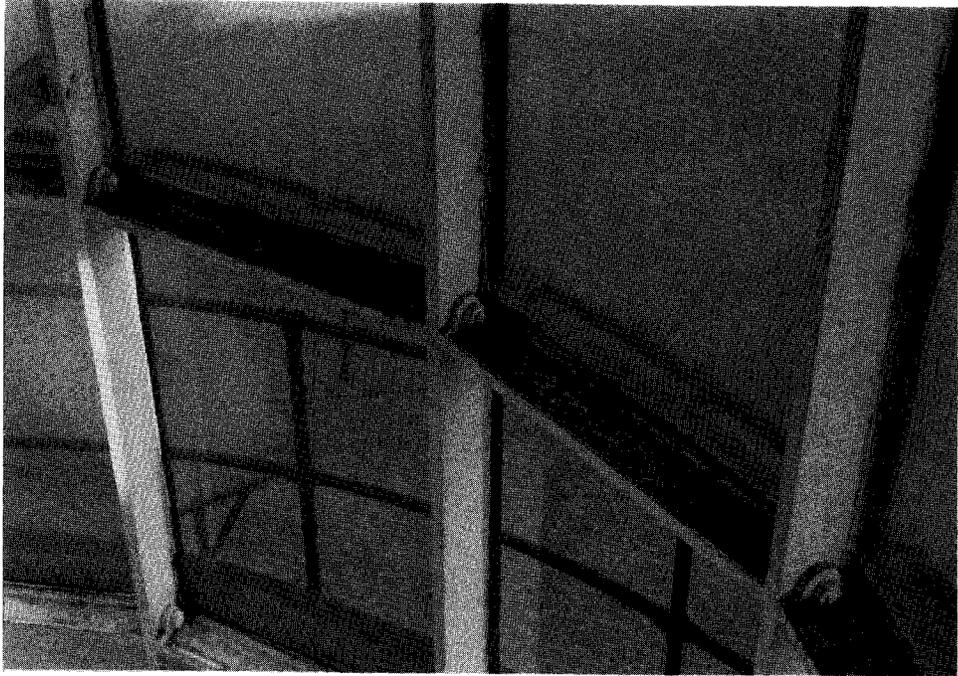
Figure 158. Tower, corrosion staining at horizontal mullions of Lantern Deck window wall.

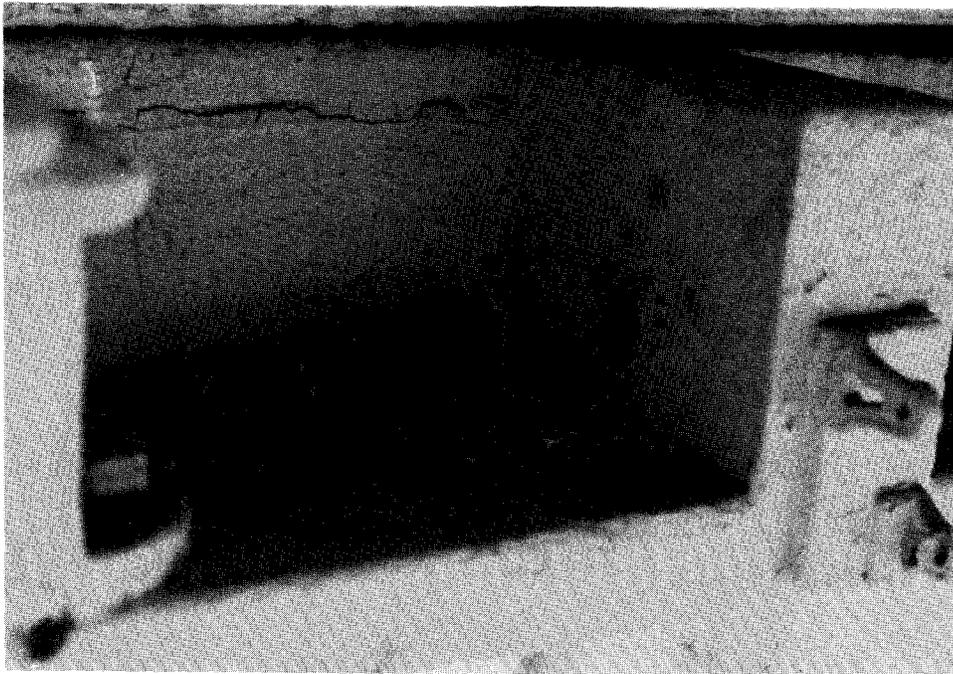
Figure 159. Tower, displaced pin at top of Lantern Deck window wall.

- Consider increasing ventilation for the Lantern Deck by removing the concrete from some of the ventilation boxes at the heads of the windows. Vents should be controlled to prevent the ingress of windblown moisture.
- Consider providing weep holes in the steel channels that form the horizontal mullions between the Lantern's windows, to keep water from pooling in the channel.
- Reseal the window panels in their frames.
- Replace the loose pin at the top of the west wall.
