HISTORIC STRUCTURE REPORT

THE ATWOOD-HIGGINS HOUSE

Cape Cod National Seashore

September 1980

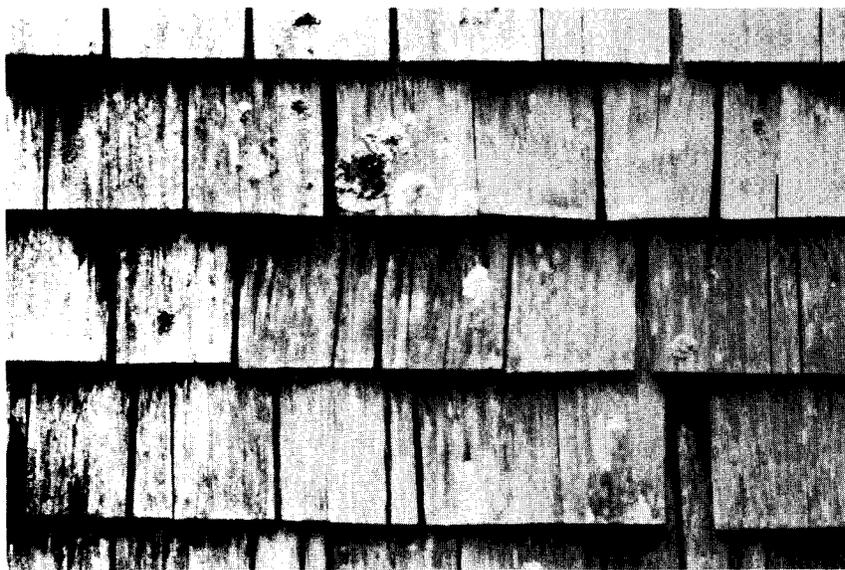
Illustration 102. Atwood-Higgins House: East-Elevation
Shingles, Fungal Growth.

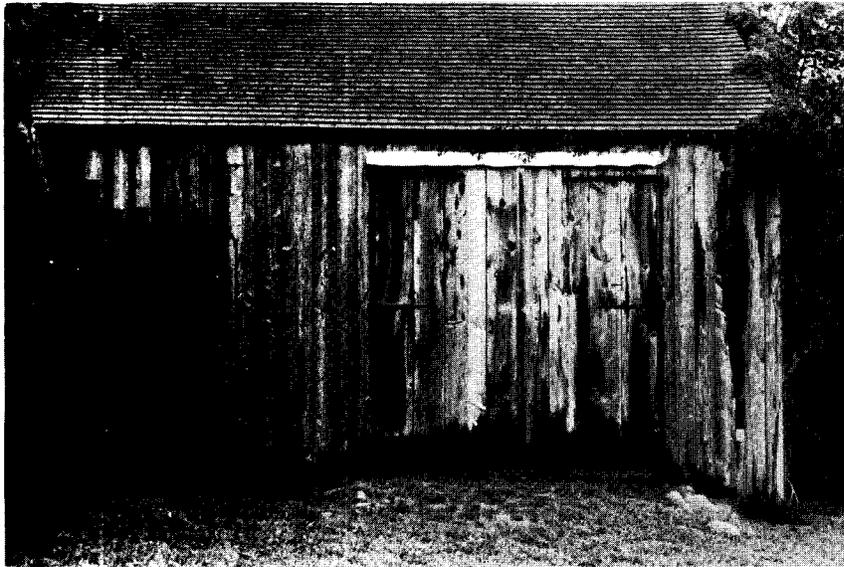
Illustration 103. Atwood-Higgins Barn: Rising Damp.

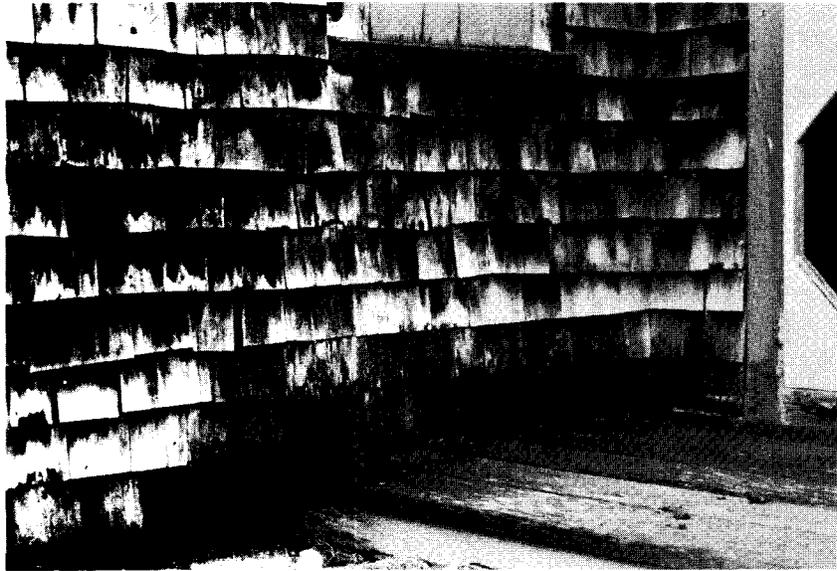
Illustration 105. Atwood-Higgins Country Store: Worn Shingles.

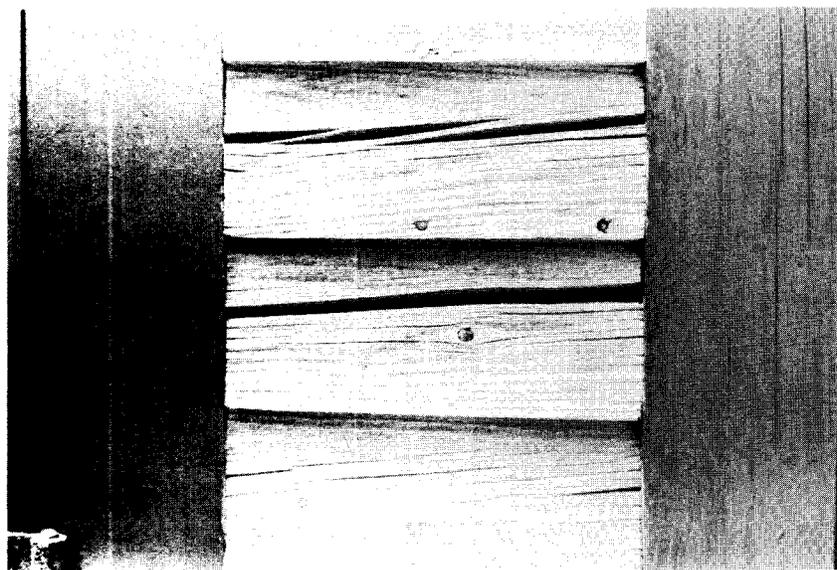
Illustration 106. Atwood-Higgins Country Store: Split Clapboards.

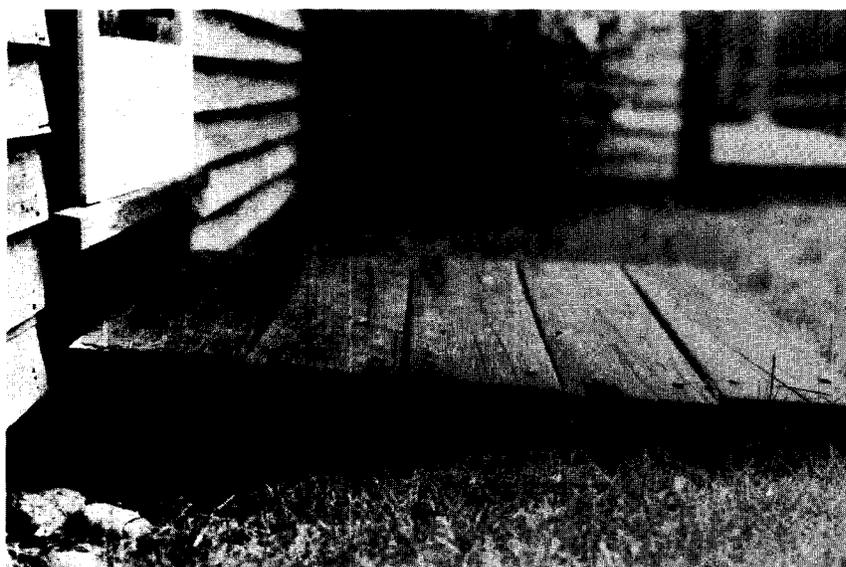
Illustration 108. Atwood-Higgins Country Store: Worn Entrance Steps.
