VII. EXISTING CONDITIONS AND RESTORATION RECOMMENDATIONS

Completion Report, restoration of Captain Penniman House and Barn, historic structures, Eastham, Massachusetts, Cape Cod National Seashore. PCP B-3-2, FY-1963

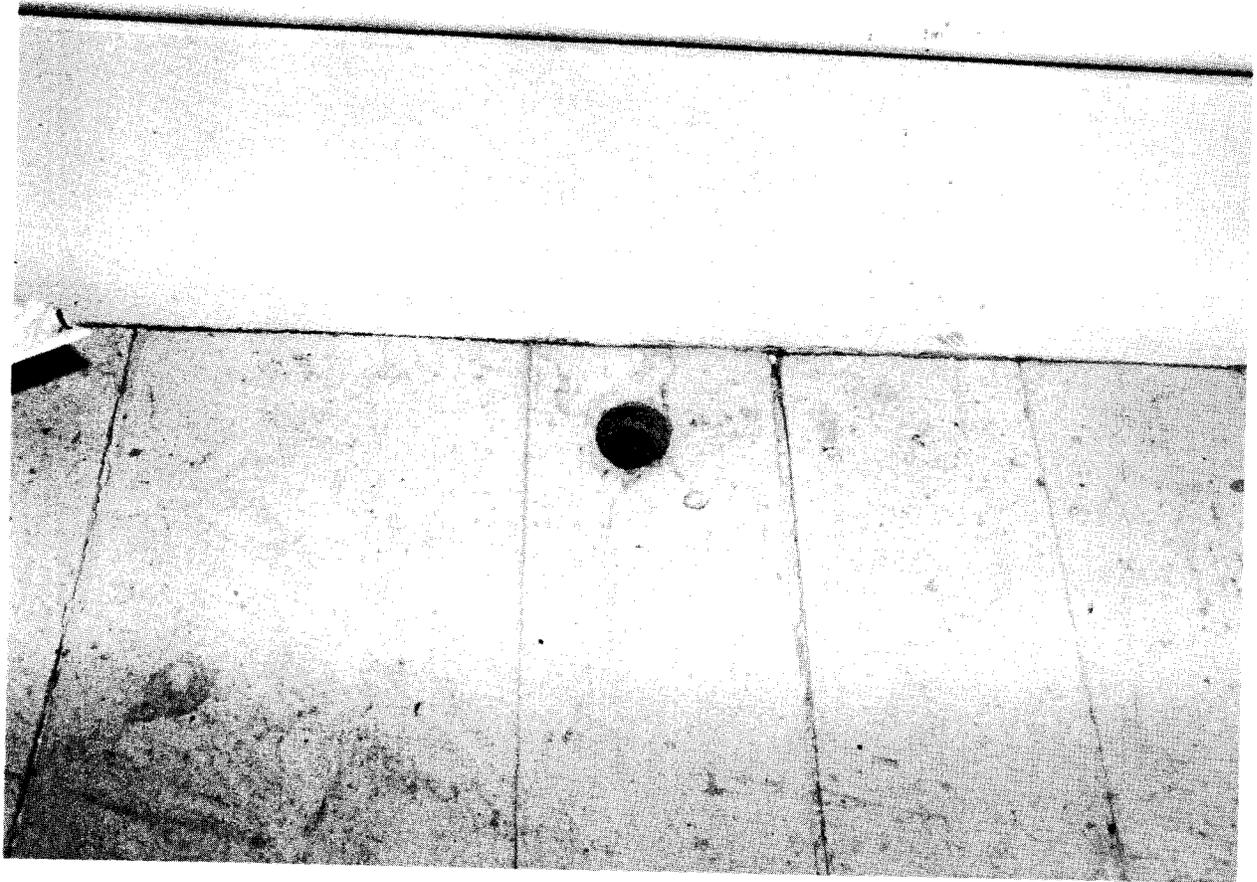
Located in the floor along the east wall is a hole 1-1/4 inches in diameter (Ill. 126). It was cut for the water-supply pipe that ran from the underground cistern up to the attic cistern.

Illustration 126. Penniman House: Northeast Bedroom (Room 206),
Hole in Floor, Marking Former Location of Pipe
Between Cisterns (1984).

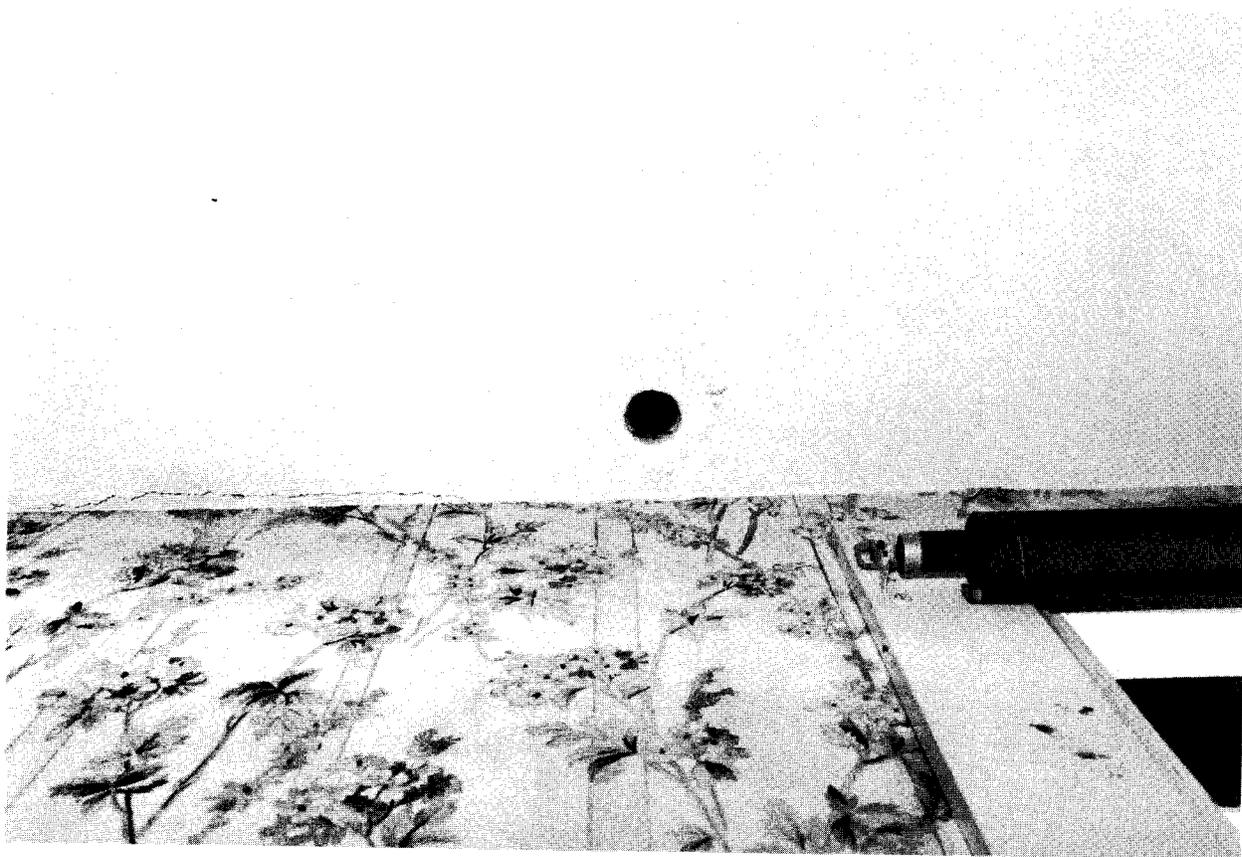
Illustration 127. Penniman House: Northeast Bedroom (Room 206),
Hole in Ceiling, Marking Former Location of Pipe
Between Cisterns (1984).

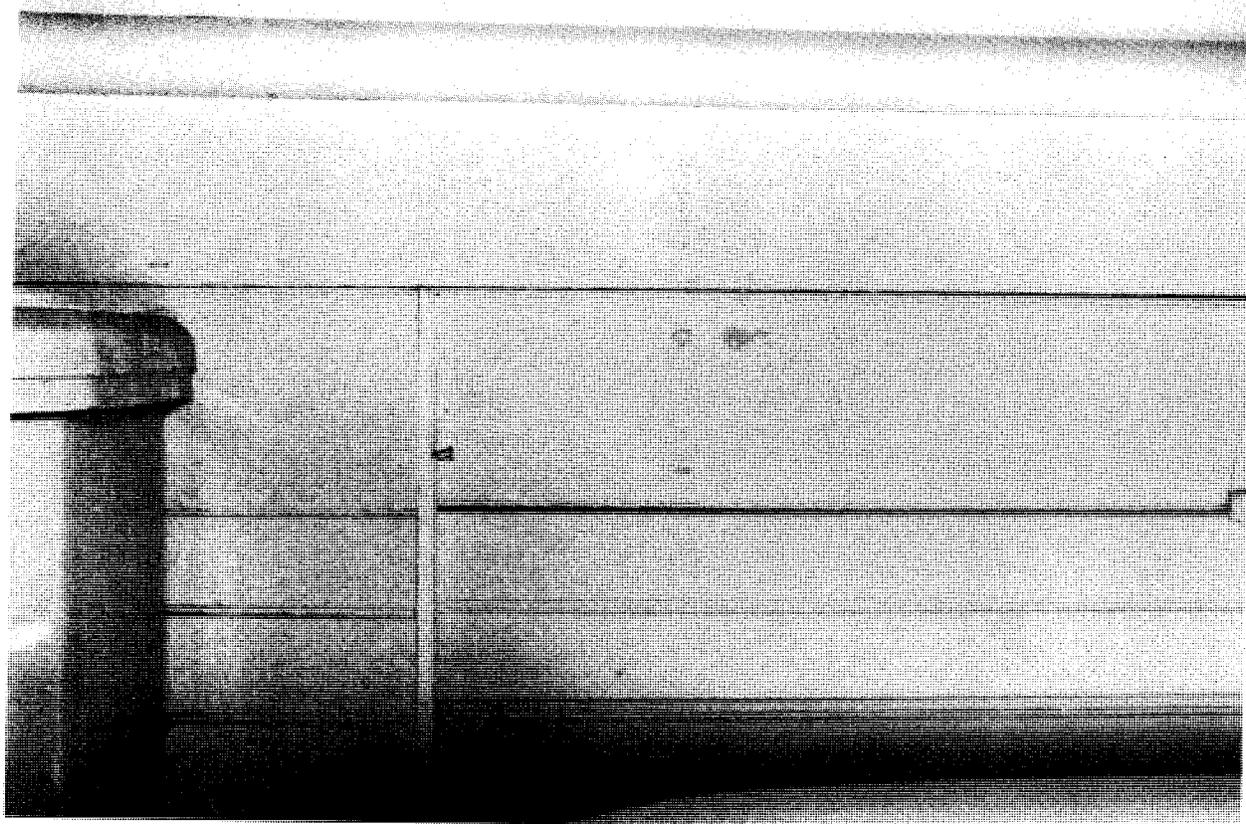
Illustration 130. Penniman House: Bathroom (Room 207), East Wall,
Showing Wainscot Patches Marking Former Location
of Original Fixtures (1984).

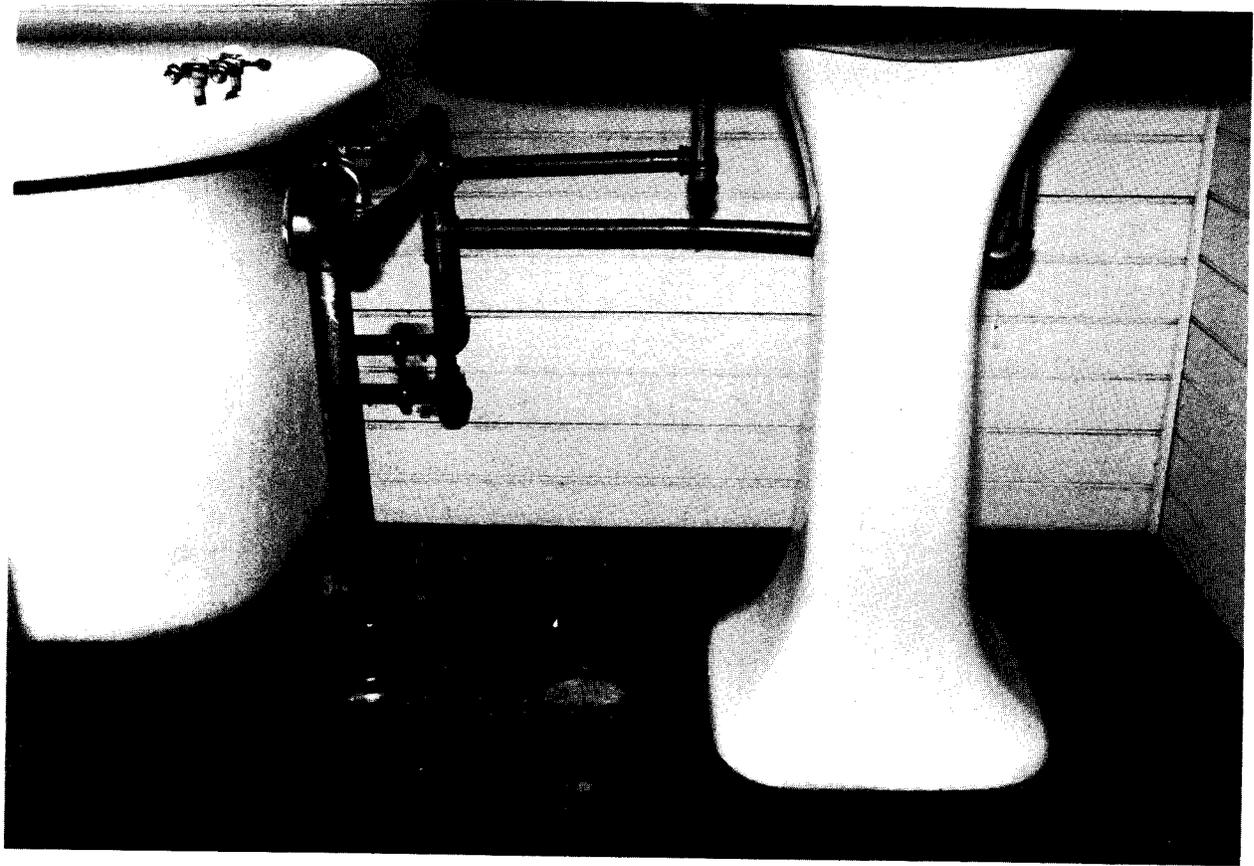
Illustration 133. Penniman House: Bathroom (Room 207),
Plumbing for Existing Tub, and Hole in Floor
Remaining from Historic Drain (1984).

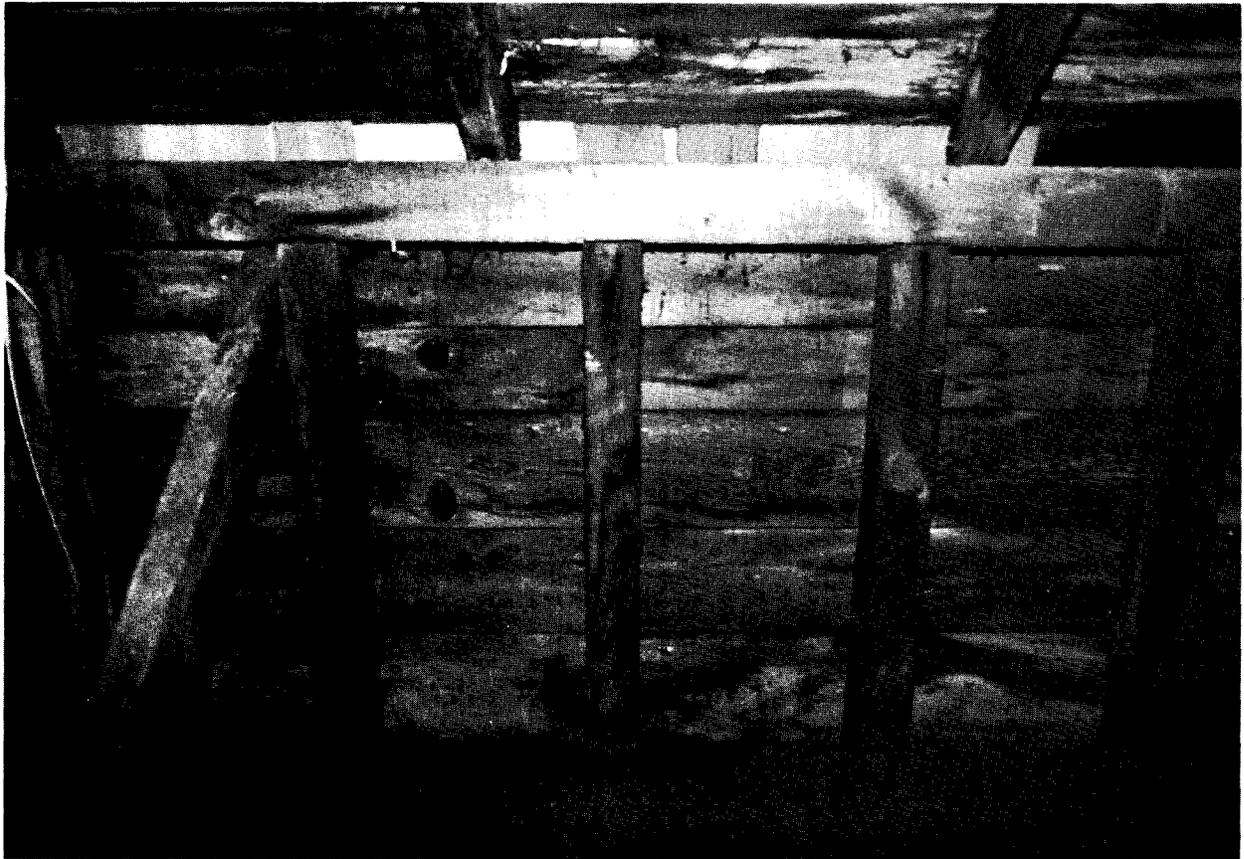
Illustration 138. Penniman House: Unfinished Attic Space (Room 301),
Holes in Sheathing of Lower Section of Mansard Roof, Marking
Former Location of Attic-Cistern Overflow Pipe (1984).

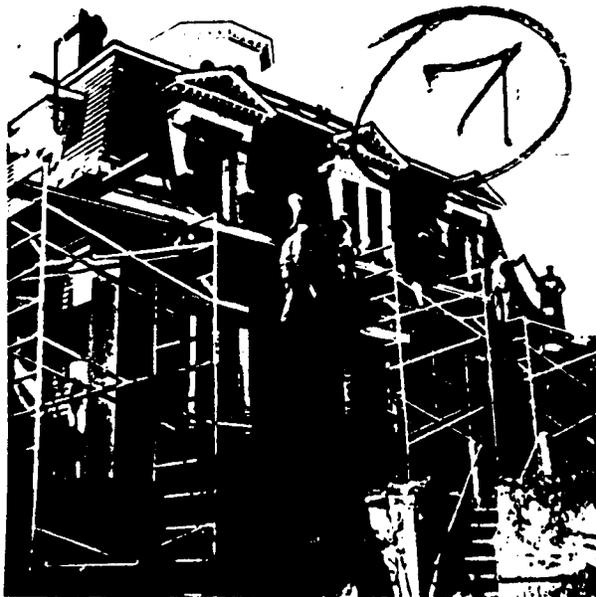
Work in progress on East Elevation. Rotted roof shingles are being replaced. Paint being removed from clapboards by scraping and remover.

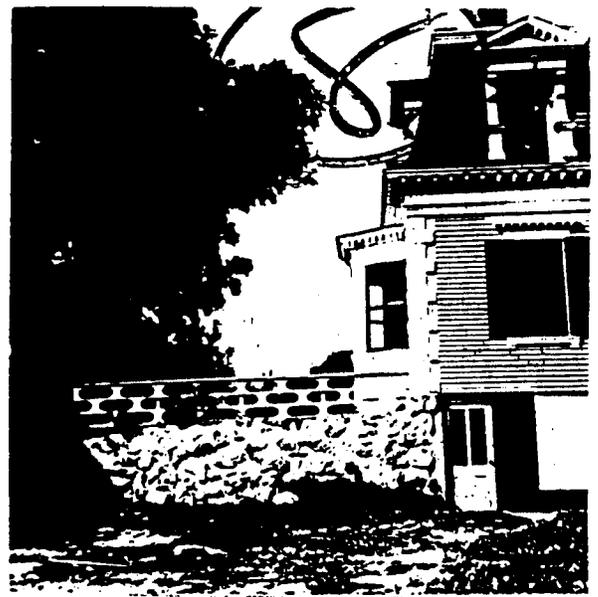
Portion of East elevation after restoration, showing new fence to replace badly rotted fence along top of stone wall.

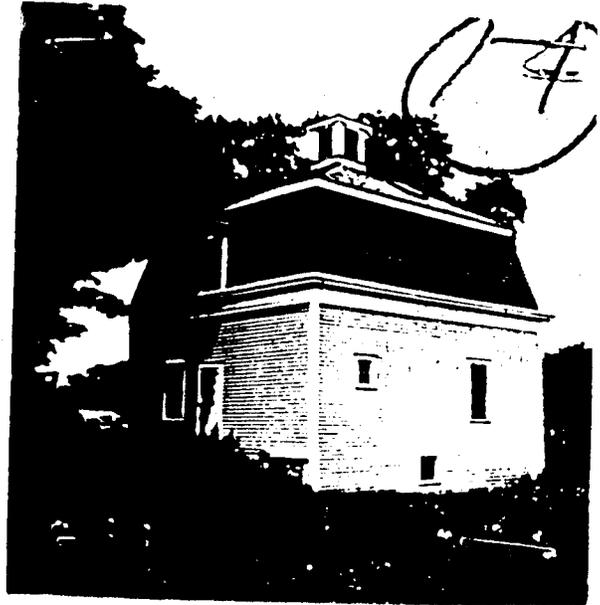
West and South sides of the barn, after restoration, which included replacement and painting of all wall clapboards, roof shingles and cornice members, also re-building the cupola.

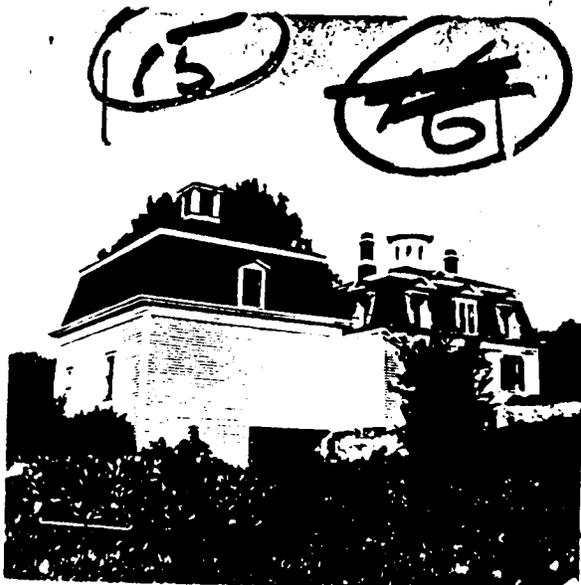
South and East sides of the barn, showing similar restoration of all wall clapboards, roof shingles and cornice members, also new roof dormer to replace the original dormer.

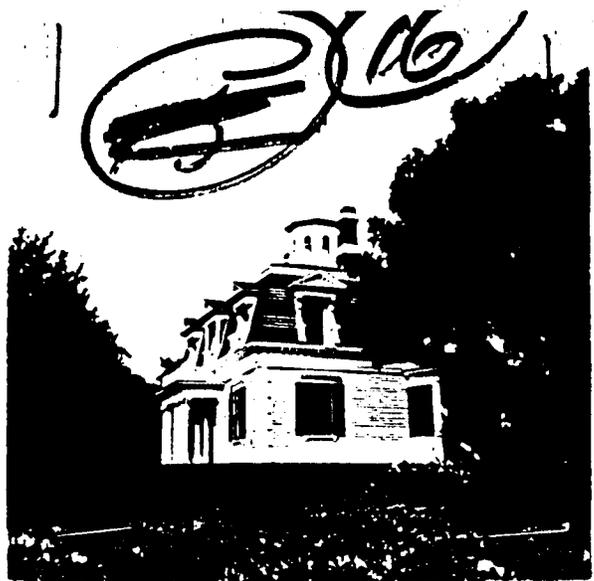
South wall of the house, showing part of the West front elevation after restoration. See page 1 of this Report for colors used, which matched original colors for house and barn.
