HISTORIC STRUCTURE REPORT
THREE SISTERS LIGHTHOUSES
CAPE COD NATIONAL SEASHORE
MASSACHUSETTS

by
A. Berle Clemensen
and
William W. Howell
with
H. Thomas McGrath
and
Elayne Anderson

January 1986

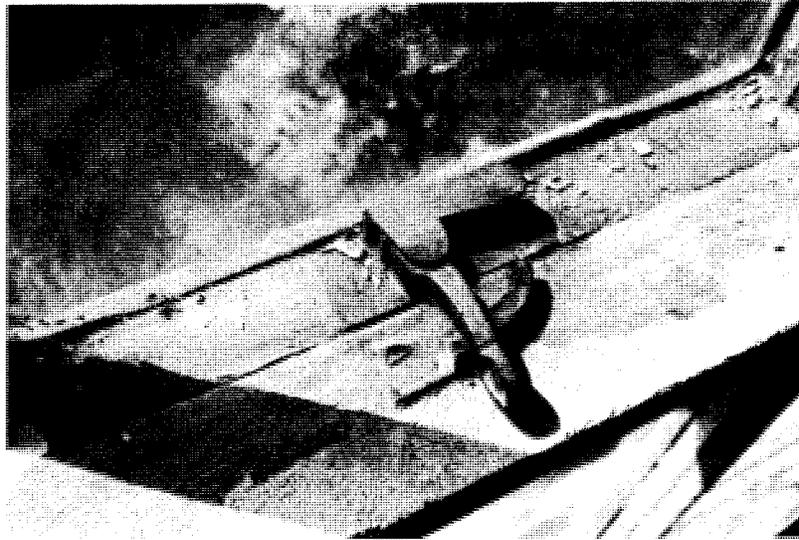
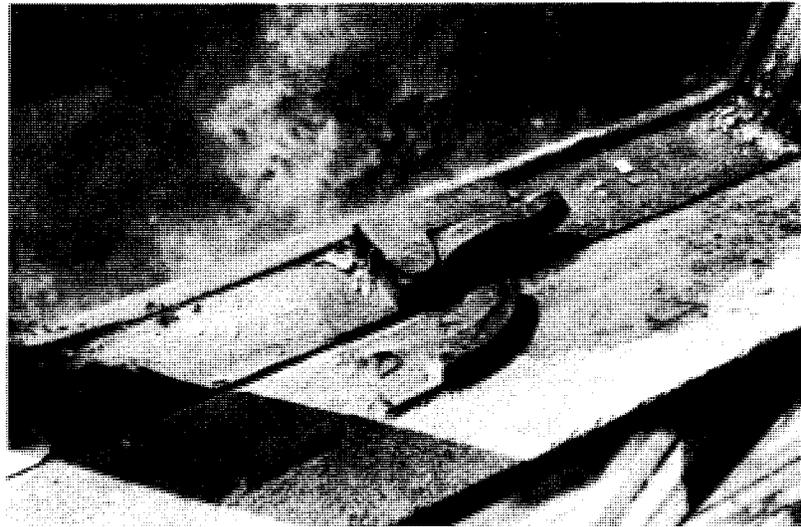
Historic sash lock (two views) in the North Twin
Photograph by W. Howell June 1983

The historic windows are six-over-six single-hung sash. Sash fasteners are the helical spring type similar to Judd's patent as illustrated on page 77 in the Russell and Erwin Catalogue of American Hardware (see Figure 16). The sash pulleys are the standard iron sheaves mortised into the jambs. Historic pulleys have rectangular faceplates; the nonhistoric faceplates have rounded ends. Shutter hardware was found on the South Twin, but it is considered nonhistoric because there is no evidence of shutter hardware on the other towers and the historic photographs do not show shutters.
