HISTORIC STRUCTURE REPORT
THREE SISTERS LIGHTHOUSES
CAPE COD NATIONAL SEASHORE
MASSACHUSETTS

by
A. Berle Clemensen
and
William W. Howell
with
H. Thomas McGrath
and
Elayne Anderson

January 1986

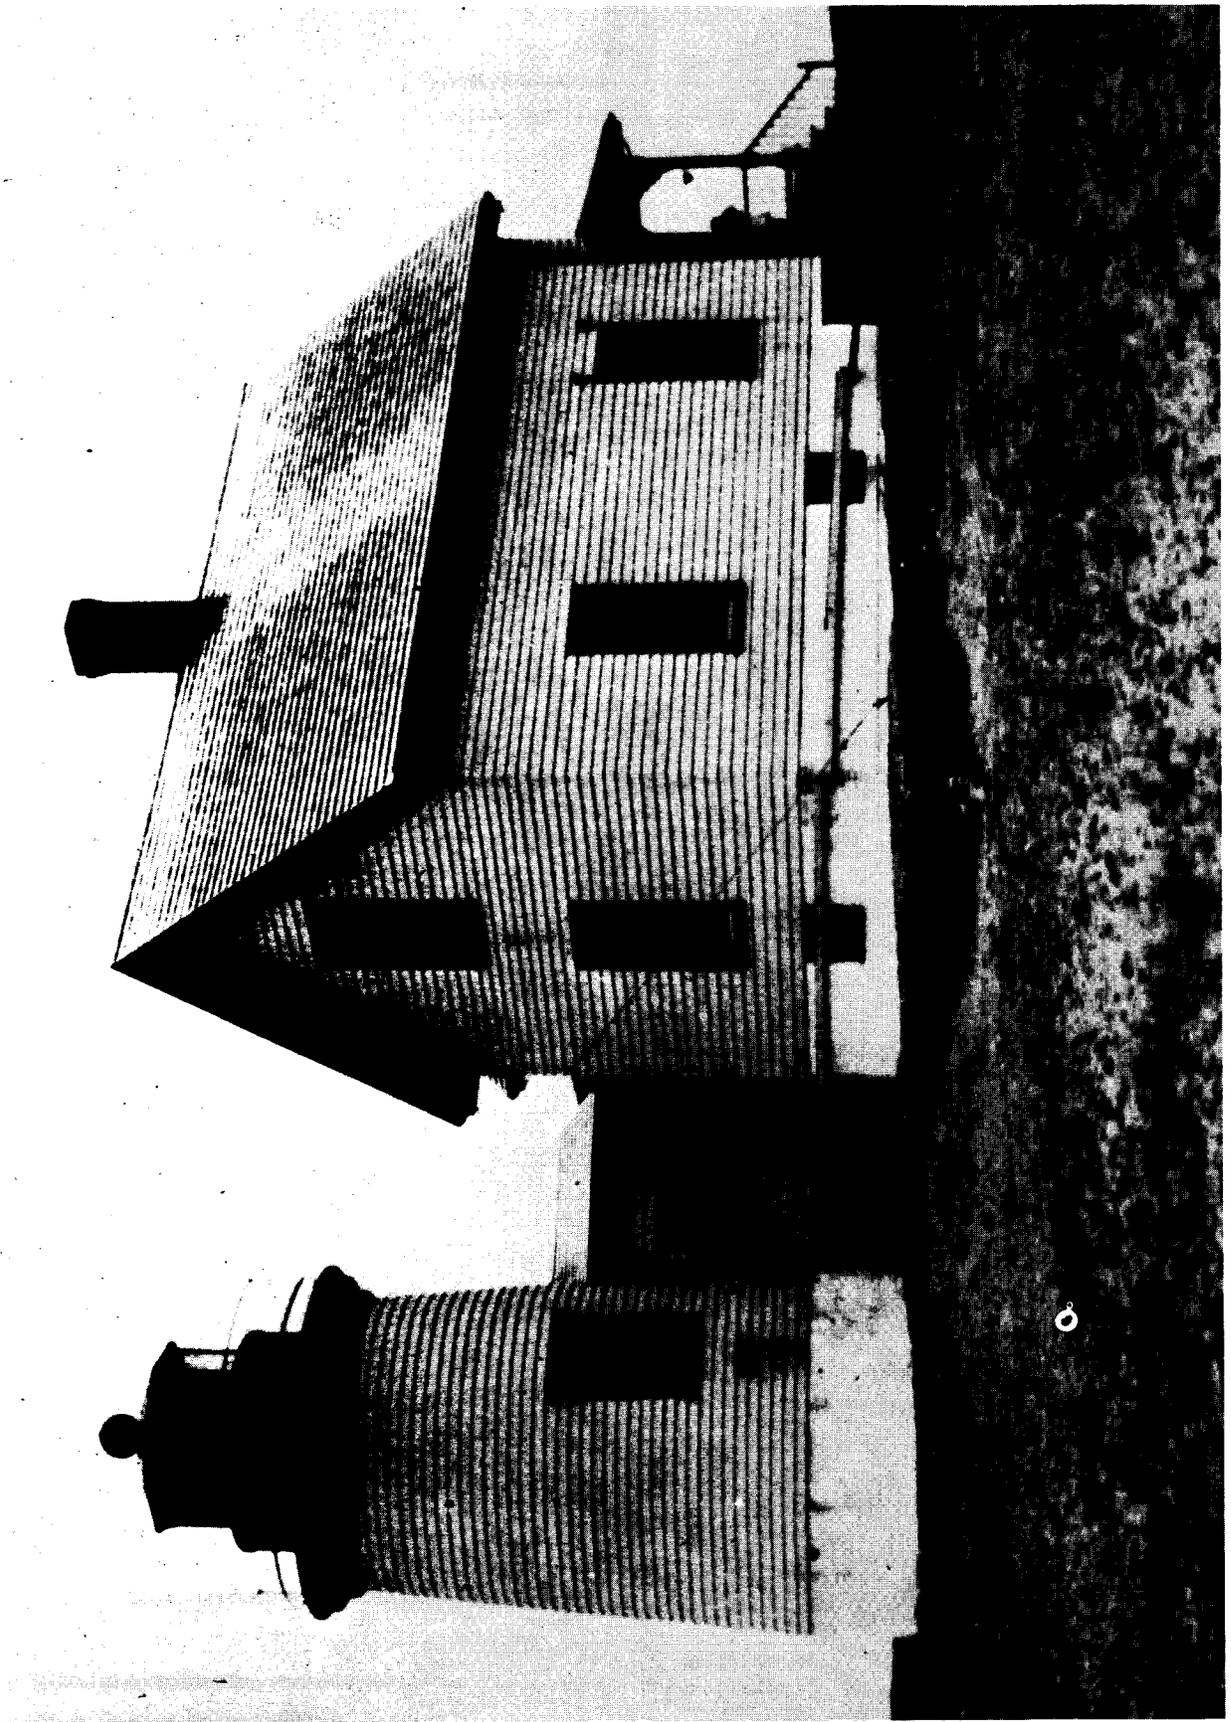
Within days after the single light began to function, the second district inspector reported that the tower was so poorly constructed that, despite its low height, even moderate winds caused it to vibrate. The shaking interfered with the flashing apparatus. The inspector asked permission to install four galvanized guy wires as a means of stabilizing the tower. The guy wires are visible in Figure 5.²⁸

This May 1915 photograph shows the original tower window which was identical to the ones in the other two lights. Guy wires placed on the tower in 1911 to stabilize it are also visible as well as the connection to the 1875 wood frame keeper's dwelling.

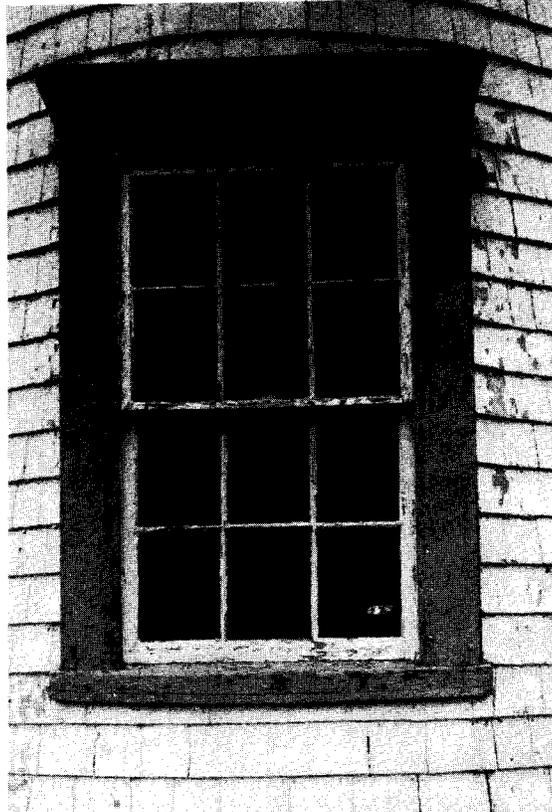
Figure 10

The three towers have three windows each--two at the first floor and one at the second. Only one window at the first floor of each tower is original (see Figure 10). The evidence for this conclusion is drawn from Figures 3 and 4, paint layering (see Appendix D), and moulding profiles (see Sheet 6). The original windows in the Beacon and the North Twin are to the left of the door. In the South Twin, the original window is to the right of the door. An examination of the historic photographs for window/door relationships shows that the North and South Twins were originally in the north and south positions, respectively, of the Three Sisters and the Beacon was the central tower. The original windows are six-over-six single-hung sash with sash openings of 2 feet-7 inches wide and 4 feet-4 $\frac{1}{4}$ inches high. The nonhistoric windows in the Beacon are two-over-two single-hung sash with 2 feet-3- $\frac{3}{4}$ inches wide and 4 feet-5 $\frac{1}{2}$ inches high sash openings. The nonhistoric windows in the North and South Twins are six-over-six single-hung sash with 2 feet-6 $\frac{1}{2}$ inches wide and 4 feet-4 inches high sash openings. There is no firm documentary evidence to date the non-historic windows. The fact that the later windows on the Twins match each other but differ from those on the Beacon strongly suggests that they were installed by the private owners. The most logical time for the private owners to have undertaken this work is in the course of converting the towers to residential use. Therefore a date of c. 1920-1925 is suggested for the non-historic windows. The sash openings are contemporary with the sash.

Historic window at the Beacon,
typical for all three structures
