Building Number: 16

Original Name: Recreation/ Multi-Purpose

Est. Year of Construction: 1951

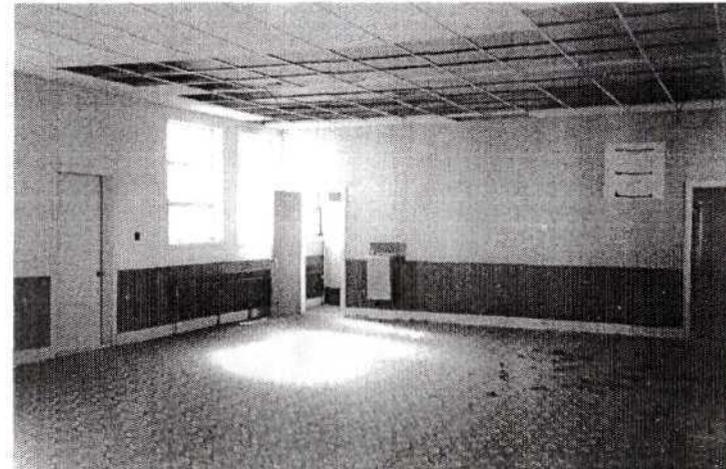
Interior.

- *Ceiling*
Interior ceiling is in **fair condition**. Cracks and holes exist where electrical fixtures were removed. Acoustic ceiling tile (ACT) missing. Advise repair on existing ceiling.
- *Wall*
Interior finishes, including paint, wallpaper and wood paneling, are in **fair condition**. Water damage to interior wall needs to be repaired.
- *Trim*
All baseboard, door, and window trim is in **fair/good condition**. Advise that all pieces be refinished.
- *Floor*
Vinyl tile in bathroom is in **good condition**, **poor condition** in utility room. Carpet covers a plywood subfloor in the two main spaces. **Condition is fair**; advise replacement of carpet and tile.

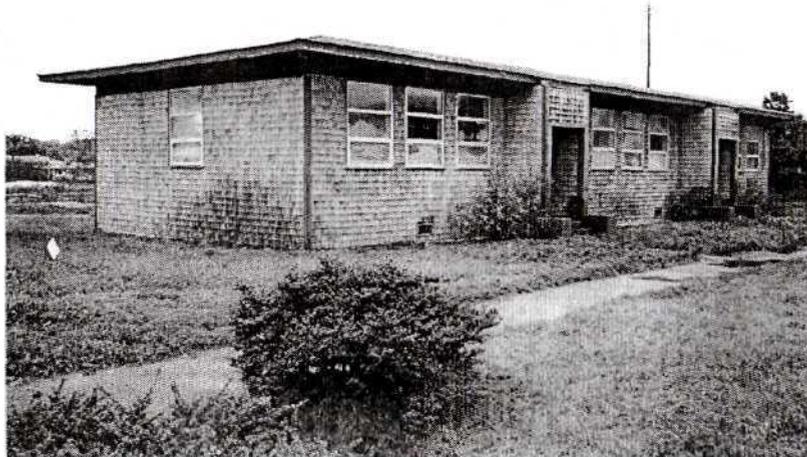
View from northeast.

- *Roof*
Asphalt shingle roof is in **fair condition**. Advise to keep and maintain as is.
- *Wall*
Exterior is sheathed in white cedar shingles that have been weathered. **Condition is poor**. Recommend that south and east elevations be replaced (+/- 1,100 SF).
- *Trim*
Wood trim in **fair condition**. Advise replacement of rotted eave and corner trim (+/- 125 LF).
- *Foundation*
The foundation is concrete masonry unit (CMU) with poured concrete steps. 16" sq. CMU piers.

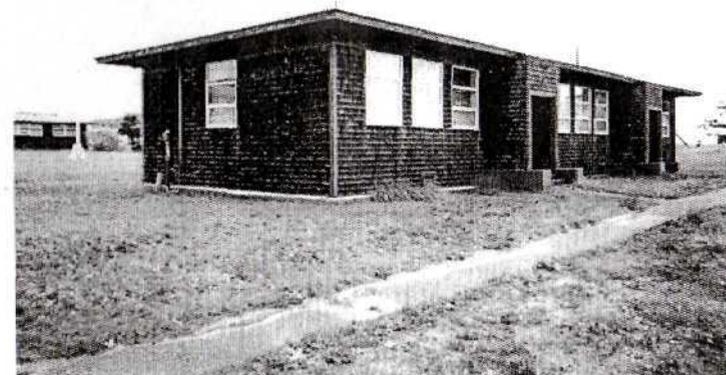
View from southwest.

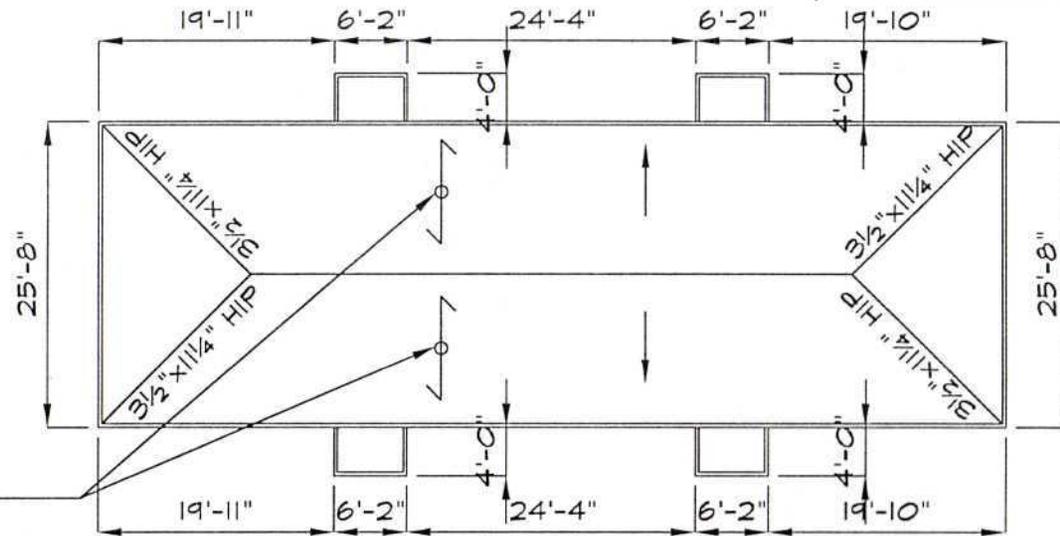
16 ROOF

Hip Roof: 15-degree slope; wood 2 x 8 rafters @ 24" O.C.; 2 x 8 C.J. and 3½" x 11¼" hips in **good condition**. Insulation above ceiling.

2x8 NOM.
RAFTERS
2x8 NOM. C.J.
VERTICAL 2x4 NOM.
TO CENTER OF C.J.
BOLTED TO RAFTERS

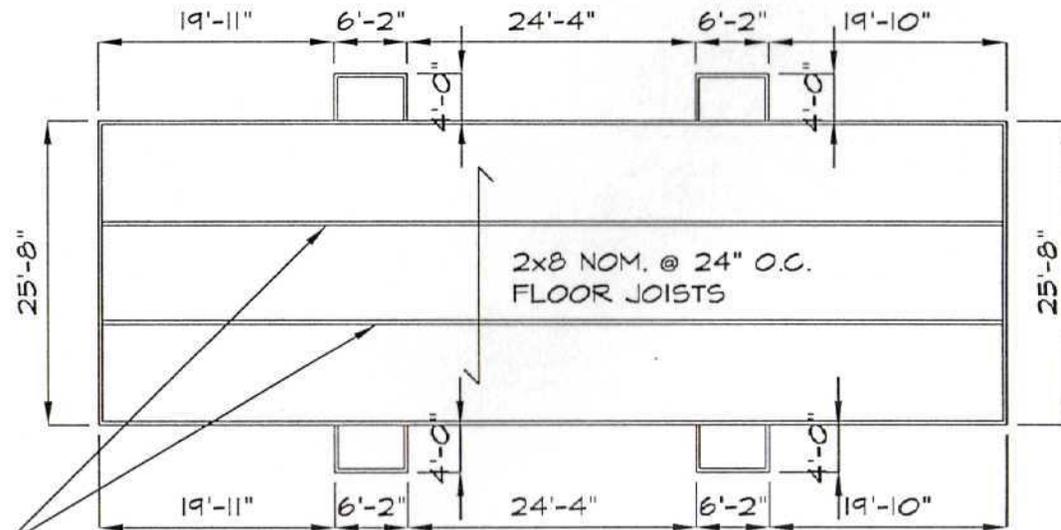
16 FIRST FLOOR

Floor: 2 x 8 @ 24" O.C. over 7¼" x 9½" beams spanning between 16" x 16" CMU piers.

7/4"x9 1/2" BEAM
SPANNING 10'-0" BETWEEN
16"x16" CMU PIERS
